# McCash Fire Structure Triage Assessment

CASRF000651  
August 18, 2021

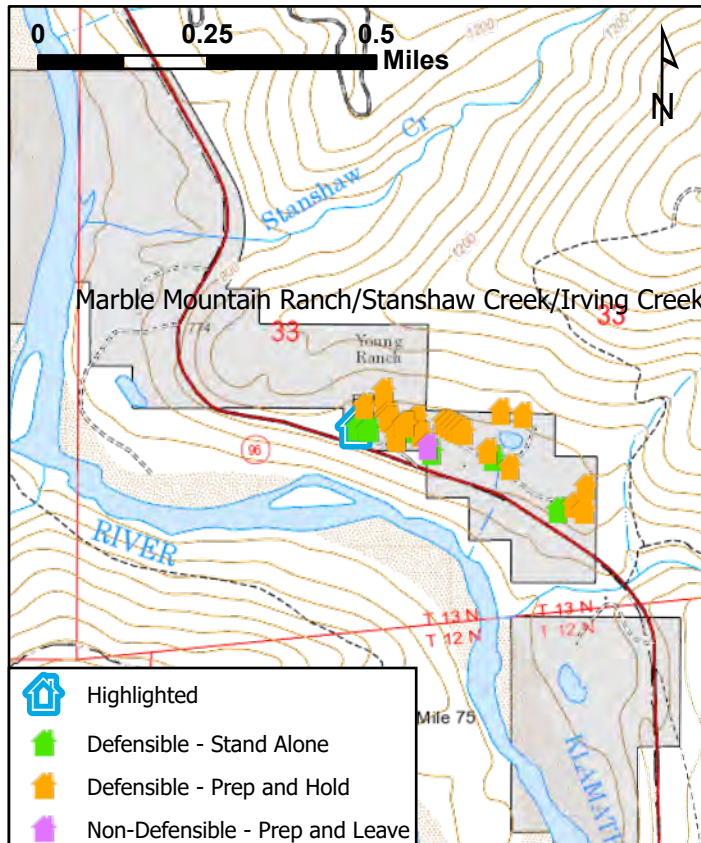
**Safety Zone(s):** Potential safety zone(s) in area  
**Comm With ICP:**  
**Water Supply:** No reliable water source nearby  
**Fuel Type:**  
**Defensible Space:**  
**Hazards:**

**Defensible, Stand Alone**

**FIRESCOPE Tactics:** Prep and Go

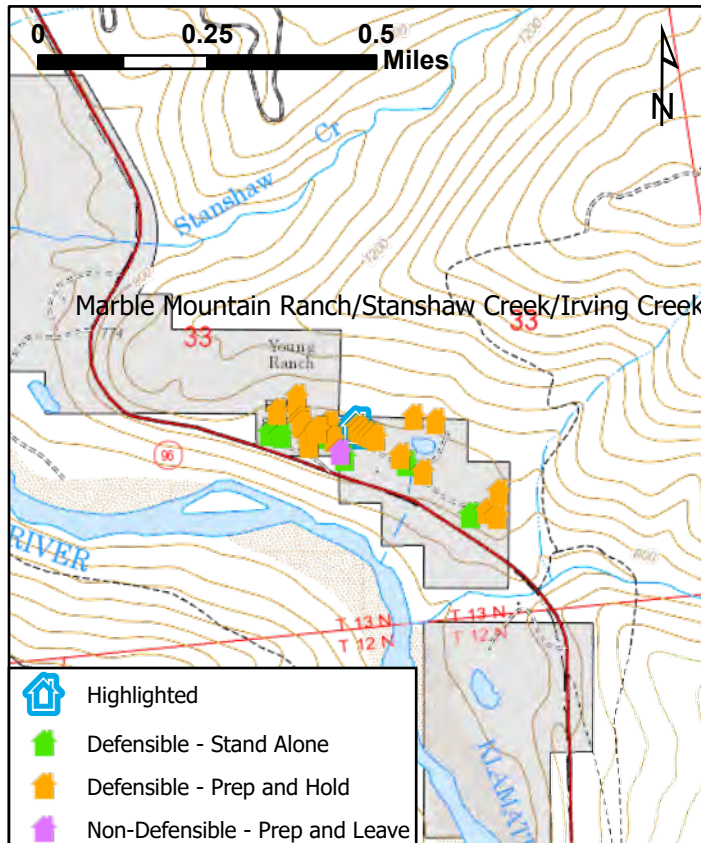
**Roof Material:** Noncombustible or not applicable  
**Siding Material:** Wood or open sided  
**Electrical Power:** Yes  
**Gas to Structure:** Yes  
**Comments:**

**Safety Zone(s):**  
**Comm With ICP:**  
**Water Supply:**  
**Fuel Type:** Shrub or timber  
**Defensible Space:** 30 ft treated  
**Hazards:**

**Defensible, Prep and Hold**

**FIRESCOPE Tactics:** Prep and Defend

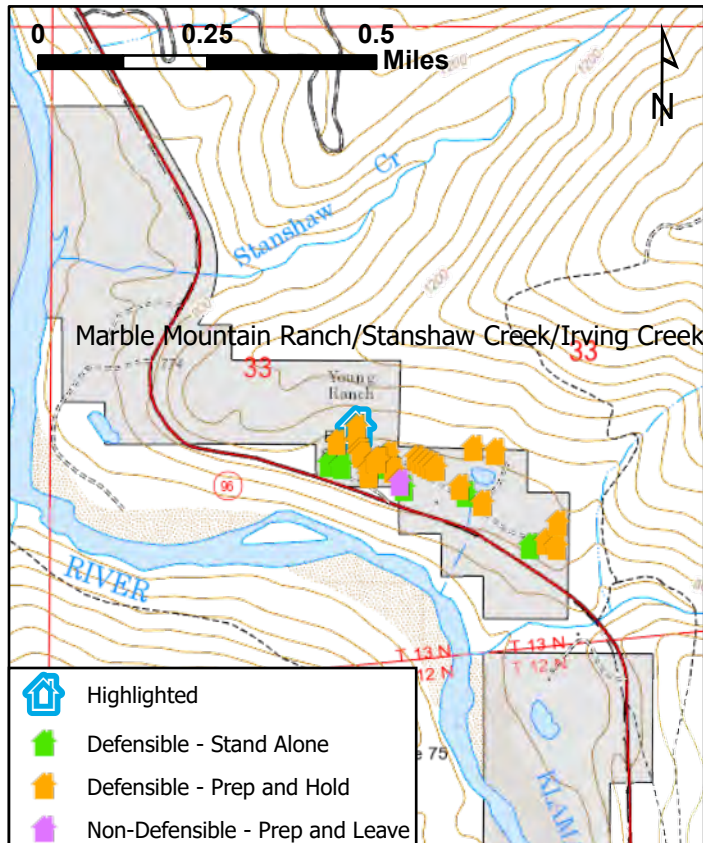
**Safety Zone(s):** Potential safety zone(s) in area  
**Comm With ICP:** Yes  
**Water Supply:** Reliable water source nearby  
**Fuel Type:**  
**Defensible Space:** 30 ft treated  
**Hazards:** Diesel tanks and generators

**Defensible, Prep and Hold**

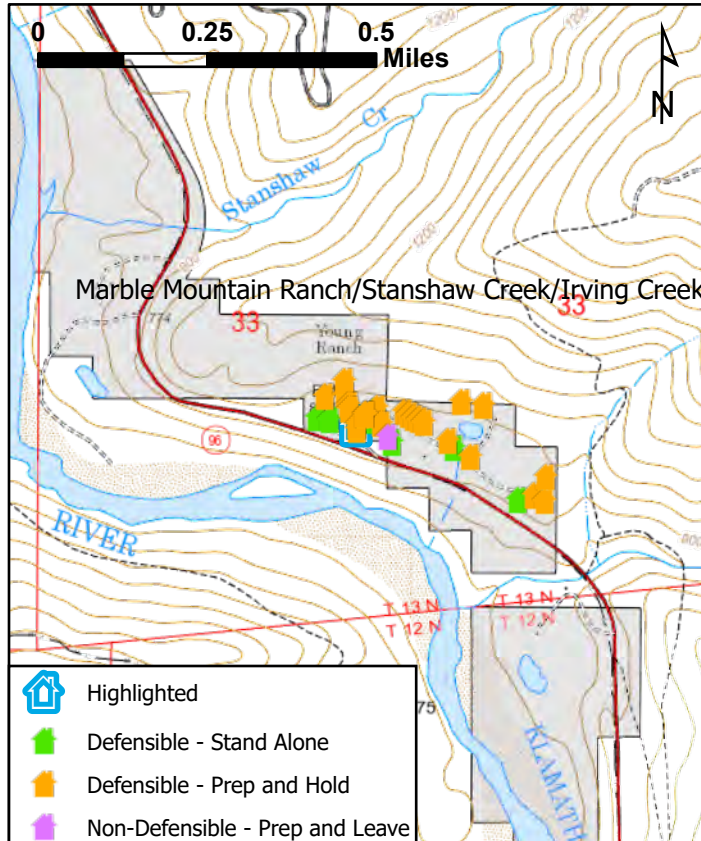
**Safety Zone(s):** Potential safety zone(s) in area  
**Comm With ICP:** Yes  
**Water Supply:** Pressurized hydrant(s) or fixed sprinkler system  
**Fuel Type:** Shrub or timber  
**Defensible Space:** Less than 30 ft treated  
**Hazards:** Propane tanks for bbq

**Defensible, Prep and Hold**

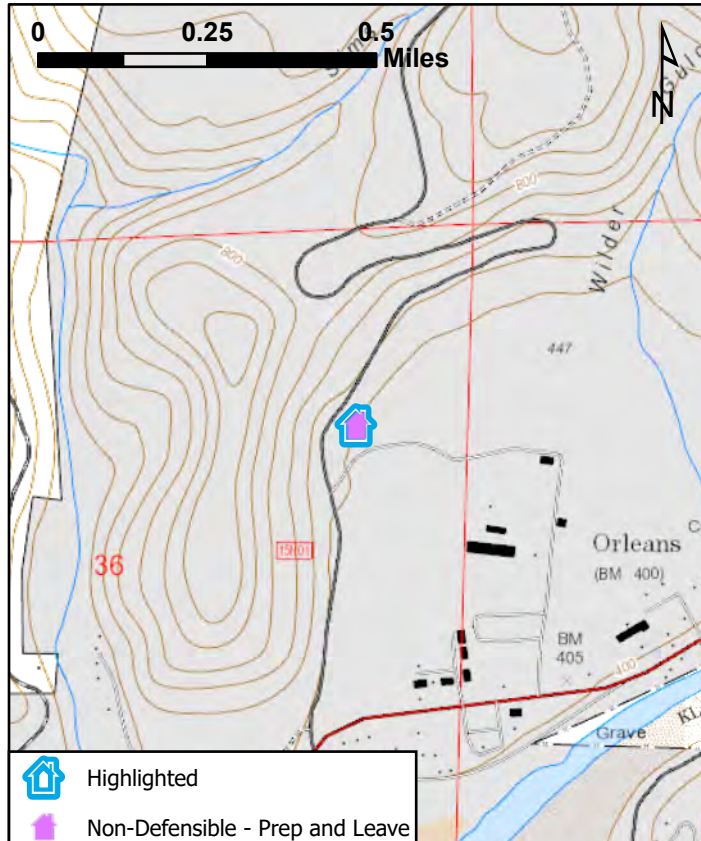
**Safety Zone(s):** No safety zone(s) in area  
**Comm With ICP:** Yes  
**Water Supply:** No reliable water source nearby  
**Fuel Type:** Shrub or timber  
**Defensible Space:** No defensible space  
**Hazards:** Heavy fuel loading, LP tanks, Household debris

**Non-Defensible, Prep and Leave**

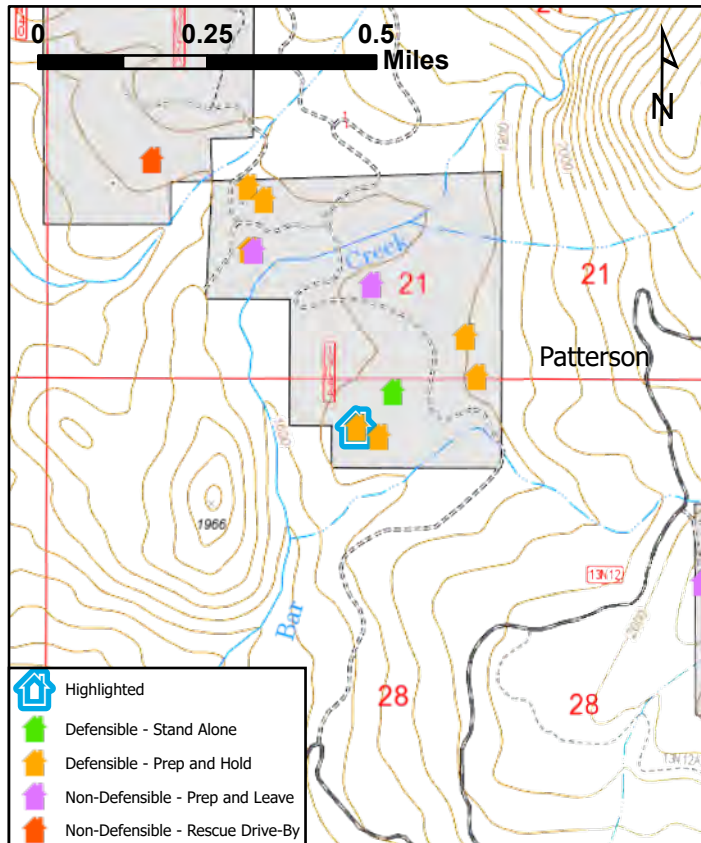
**Roof Material:** Noncombustible or not applicable  
**Siding Material:** Wood or open sided  
**Electrical Power:** No  
**Gas to Structure:** Yes  
**Comments:** Walt Simpson. Raised cinder block foundation, wood siding with metal roof.

**Safety Zone(s):** No safety zone(s) in area  
**Comm With ICP:** No  
**Water Supply:** Limited or dependent on electricity  
**Fuel Type:** Shrub or timber  
**Defensible Space:** 30 ft treated  
**Hazards:** Propane tank

**Defensible, Prep and Hold**

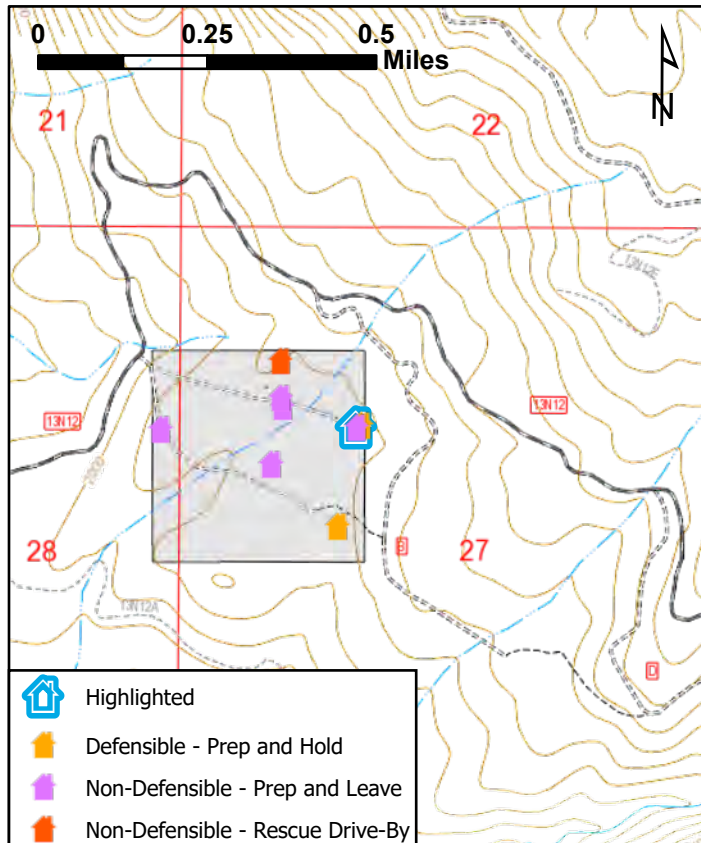
**Safety Zone(s):** No safety zone(s) in area  
**Comm With ICP:** Yes  
**Water Supply:** No reliable water source nearby  
**Fuel Type:** Shrub or timber  
**Defensible Space:** No defensible space  
**Hazards:** Heavy fuel load

**Non-Defensible, Prep and Leave**

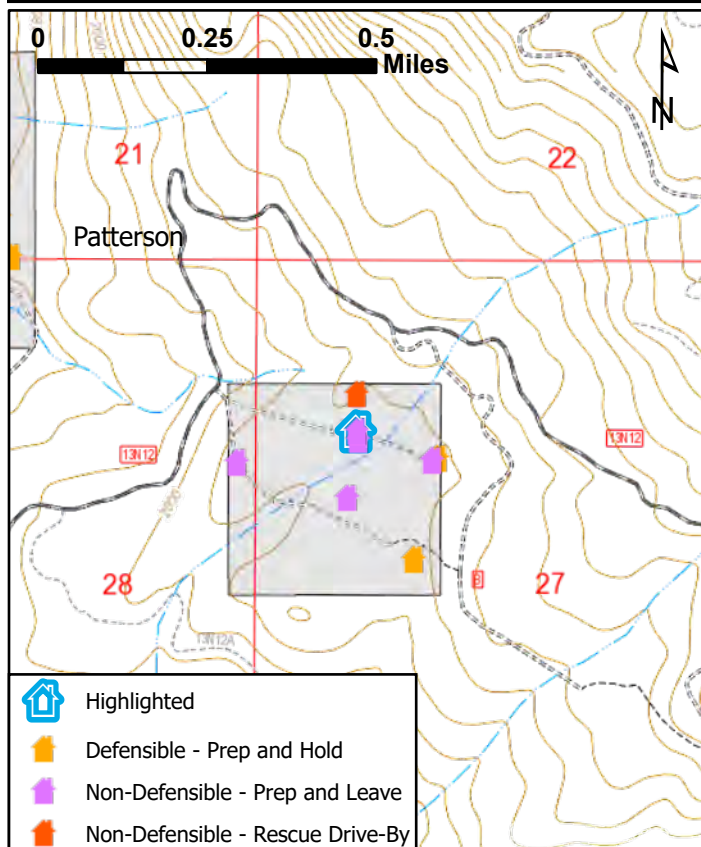
**Safety Zone(s):** No safety zone(s) in area  
**Comm With ICP:** Yes  
**Water Supply:** No reliable water source nearby  
**Fuel Type:** Shrub or timber  
**Defensible Space:** 30 ft treated  
**Hazards:** Collapse potential

**Non-Defensible, Prep and Leave**

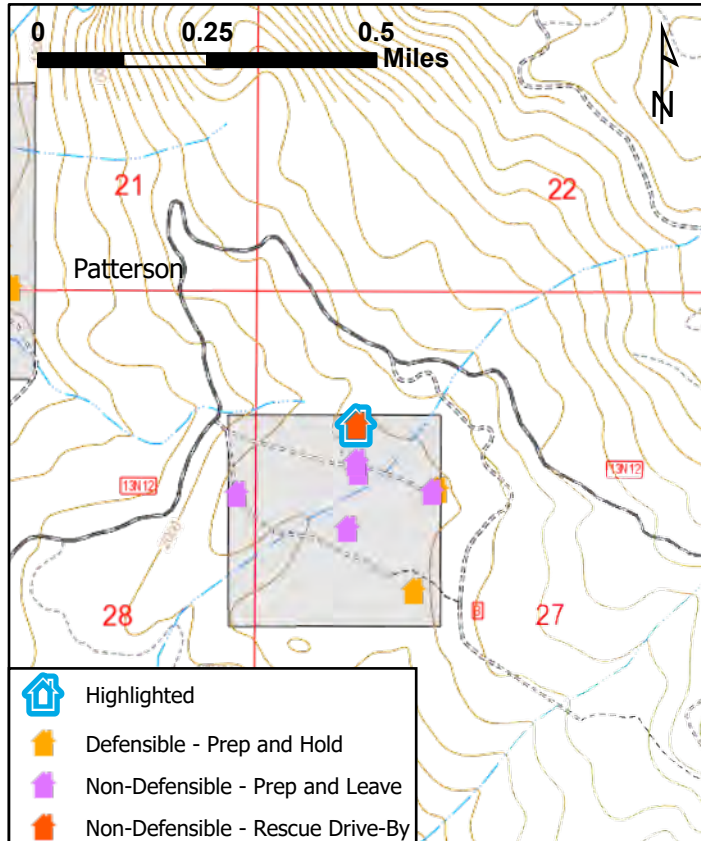
**Safety Zone(s):** No safety zone(s) in area  
**Comm With ICP:** Yes  
**Water Supply:** No reliable water source nearby  
**Fuel Type:** Shrub or timber  
**Defensible Space:** No defensible space  
**Hazards:** Structure itself and surrounding fuels

**Non-Defensible, Rescue, Drive By**

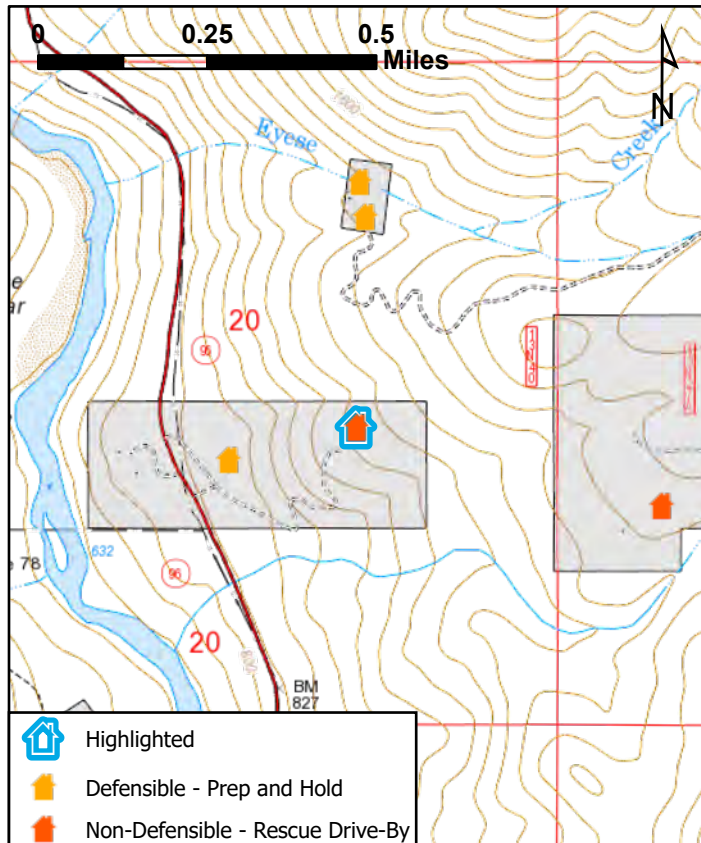
**Safety Zone(s):** No safety zone(s) in area  
**Comm With ICP:** Yes  
**Water Supply:** No reliable water source nearby  
**Fuel Type:** Shrub or timber  
**Defensible Space:** No defensible space  
**Hazards:** Overgrown vegetation around structure

**Non-Defensible, Rescue, Drive By**

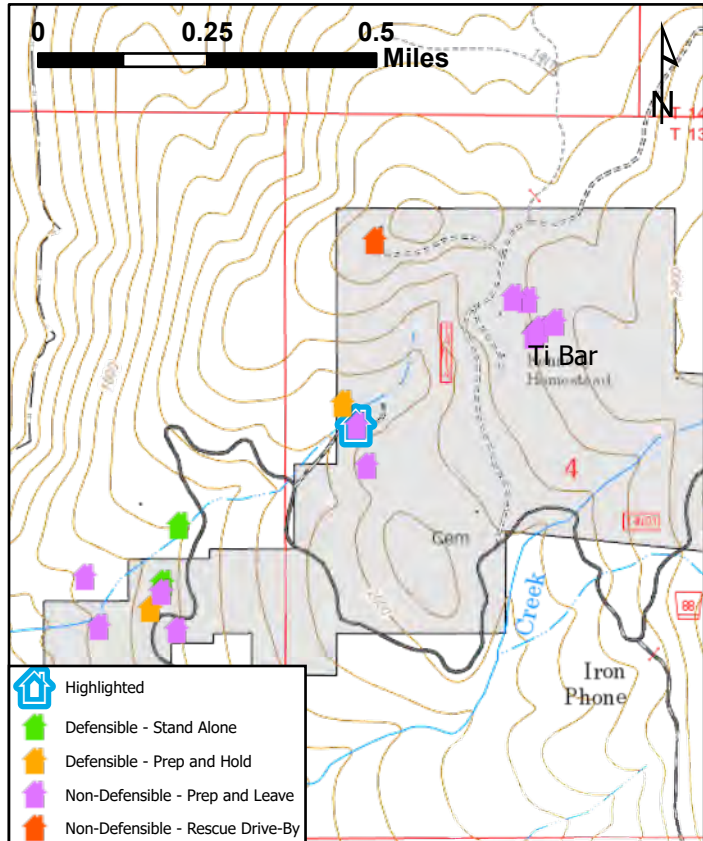
**Safety Zone(s):** Potential safety zone(s) in area  
**Comm With ICP:** Yes  
**Water Supply:** Reliable water source nearby  
**Fuel Type:**  
**Defensible Space:** No defensible space  
**Hazards:** Trash

**Non-Defensible, Prep and Leave**

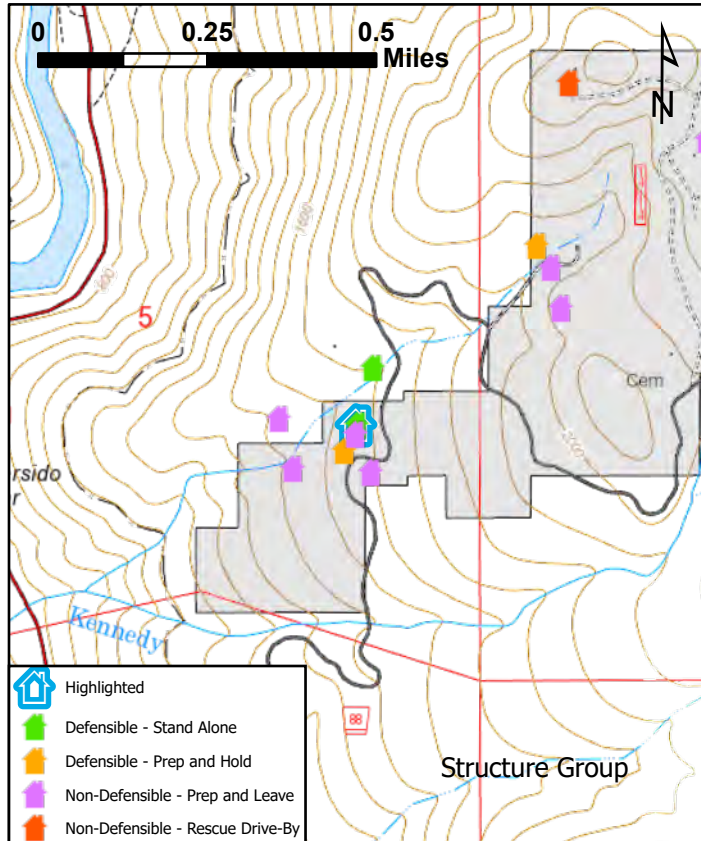
**Safety Zone(s):** Potential safety zone(s) in area  
**Comm With ICP:** Yes  
**Water Supply:** Pressurized hydrant(s) or fixed sprinkler system  
**Fuel Type:** Grass and shrub, hardwood litter  
**Defensible Space:** 100 ft treated  
**Hazards:** Propane tank 50 feet beyond structure

**Defensible, Stand Alone**
