McCash Fire Structure Triage Assessment

CASRF000651
August 20, 2021

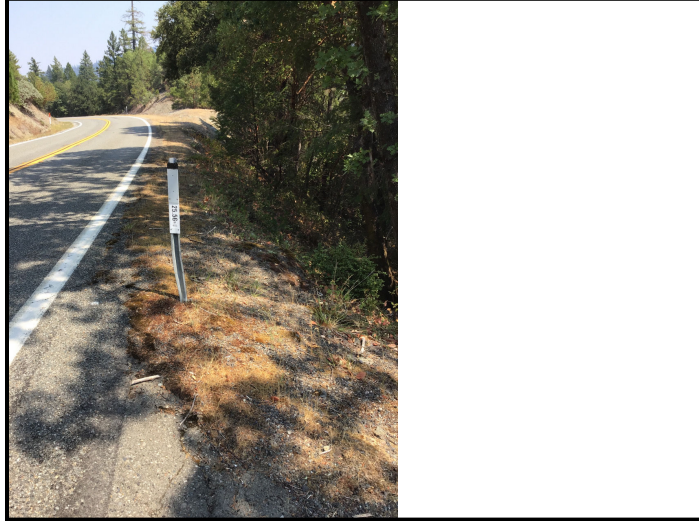
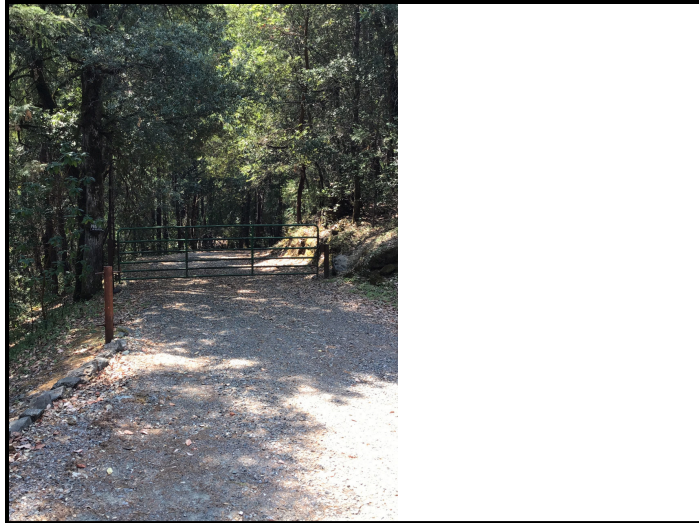
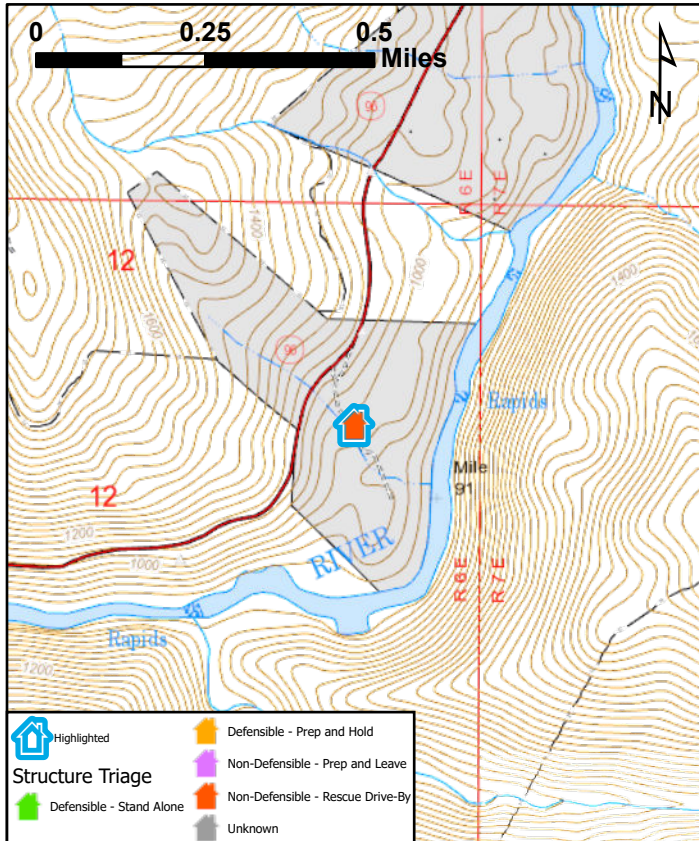
Roof Material: Combustible or no roof
Siding Material: Wood or open sided
Electrical Power: Unknown
Gas to Structure: Unknown
Comments: Not defensible

Safety Zone(s): No safety zone(s) in area
Comm With ICP: Yes
Water Supply: No reliable water source nearby
Fuel Type: Shrub or timber
Defensible Space: No defensible space
Hazards: Tight closed area 1 way ingress/egress. Ink won propane bottles and septics.

Non-Defensible, Rescue, Drive By

Mitigation Time (in hours): 16
Mitigation Description: Complete prep

FIRESCOPE Tactics: Tactical Patrol

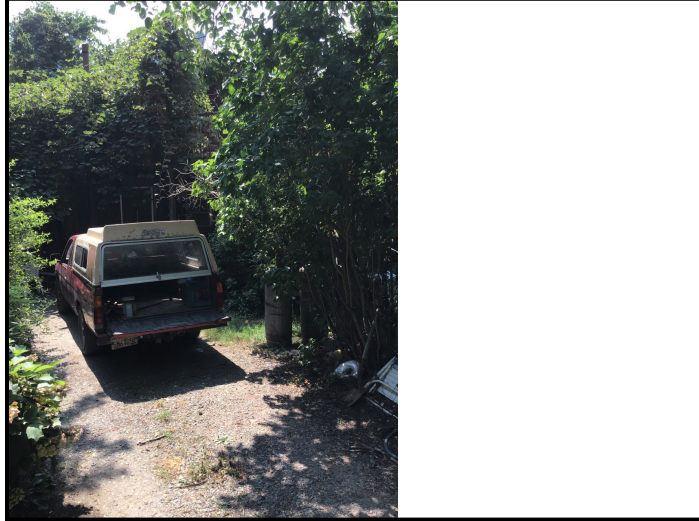
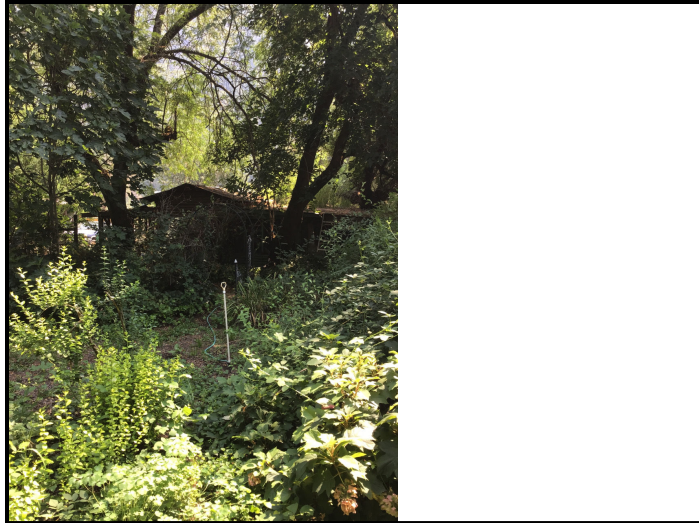
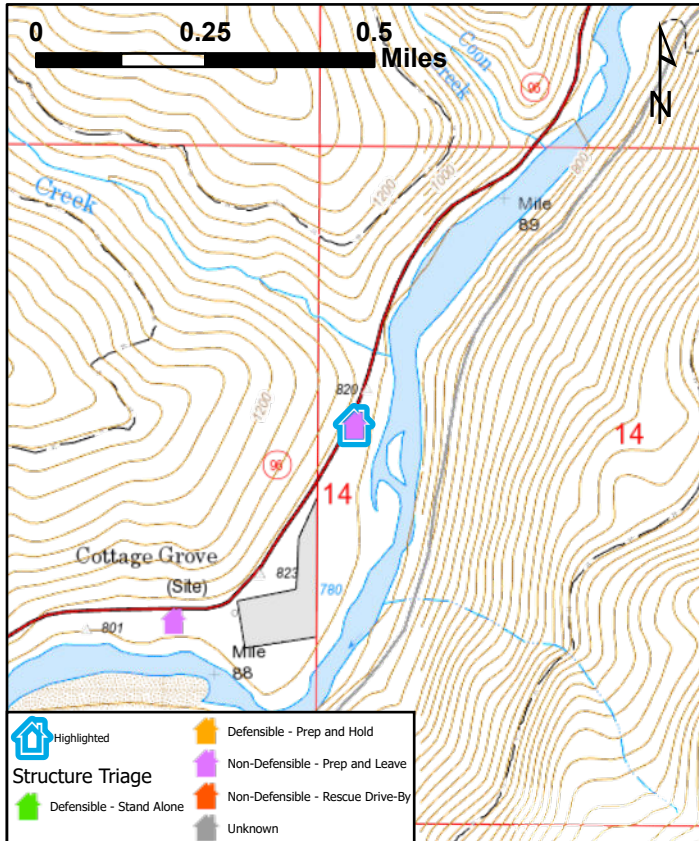
Roof Material: Combination of fire resistant and combustible
Siding Material: Wood or open sided
Electrical Power: No
Gas to Structure: Unknown
Comments: Closed canopy on structures. Resident name Kathy Harvey. No phone or power. Outbuilding are old with mix of open sides

Safety Zone(s): No safety zone(s) in area
Comm With ICP: Yes
Water Supply: Reliable water source nearby
Fuel Type: Shrub or timber
Defensible Space: No defensible space
Hazards: Highway old out builders bottom of canyon next to the Klamath river

Non-Defensible, Prep and Leave

Mitigation Time (in hours): 8
Mitigation Description: Prep along river and property

Resources Needed to Protect Structure: 2 type 3 engines. Best practice would be prep below house along river. problems will be embers into building from north side

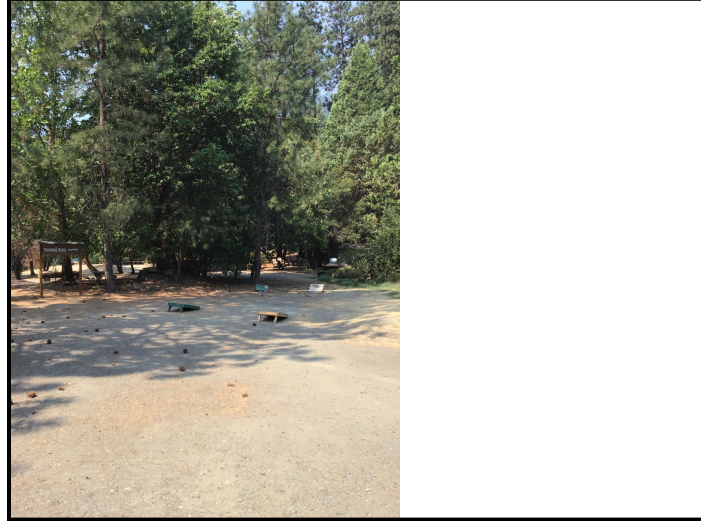
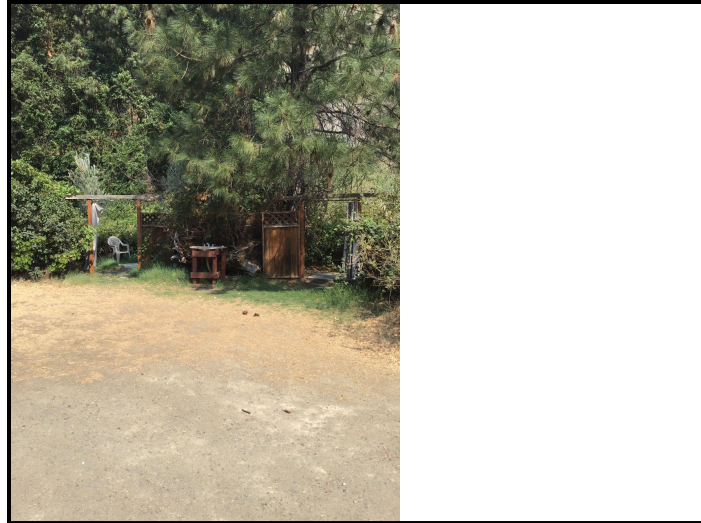
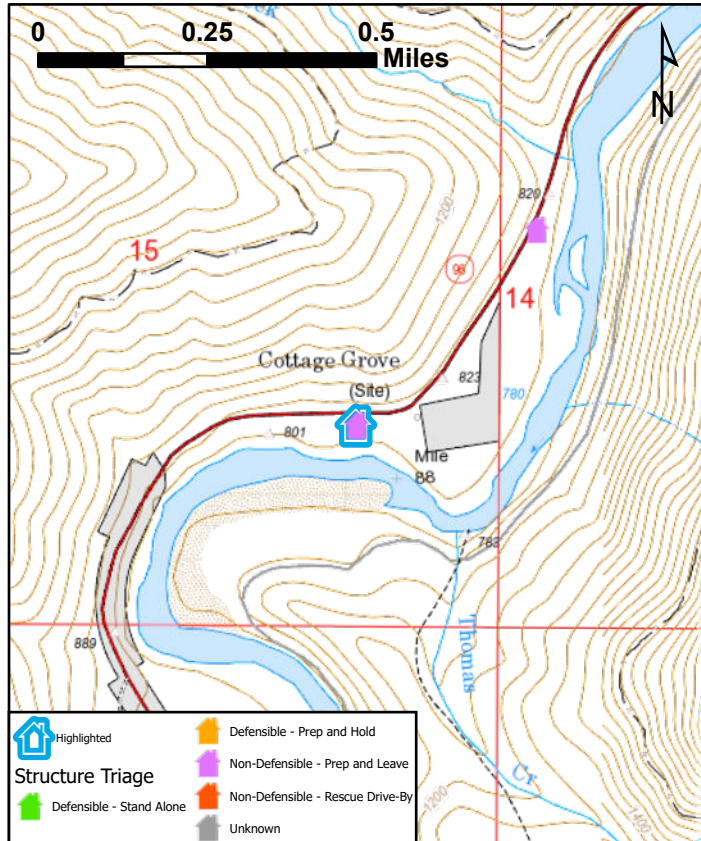
Roof Material: Combination of fire resistant and combustible
Siding Material: Wood or open sided
Electrical Power: No
Gas to Structure: Unknown
Comments: No primary residents used more for camping

Safety Zone(s): No safety zone(s) in area
Comm With ICP: Yes
Water Supply: Reliable water source nearby
Fuel Type: Shrub or timber
Defensible Space: 30 ft treated
Hazards: Open outbuildings able to catch embers outdoor showers 5 ports johns

Non-Defensible, Prep and Leave

FIRESCOPE Tactics: Check and Go

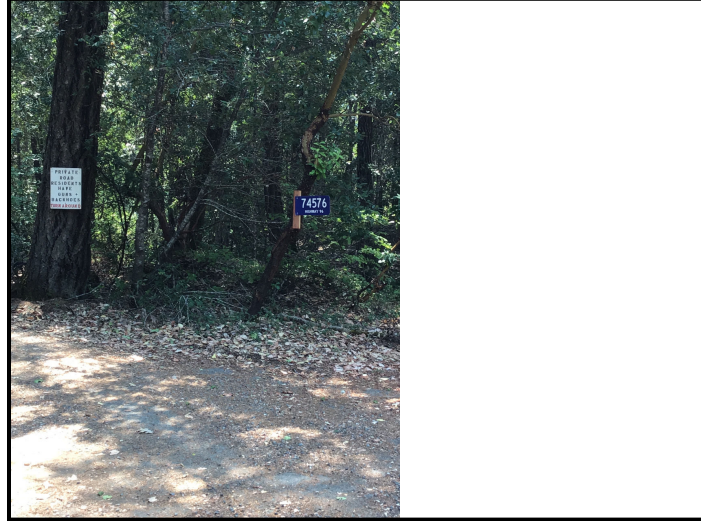
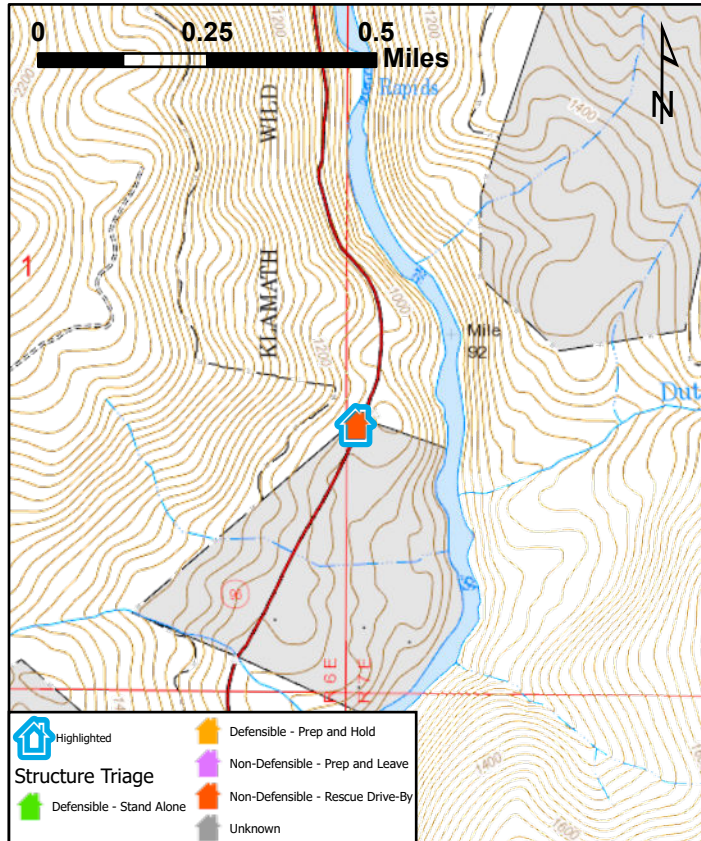
Safety Zone(s): No safety zone(s) in area
Comm With ICP: Yes
Water Supply:
Fuel Type: Shrub or timber
Defensible Space: No defensible space
Hazards: Unknown on all below. Residents seem to be present. Didn't want to find a deep hole! Access in is over 1/4 mile to residents.

Non-Defensible, Rescue, Drive By

FIRESCOPE Tactics: Tactical Patrol
