# McCash Fire Structure Triage Assessment

CASRF000651  
August 20, 2021

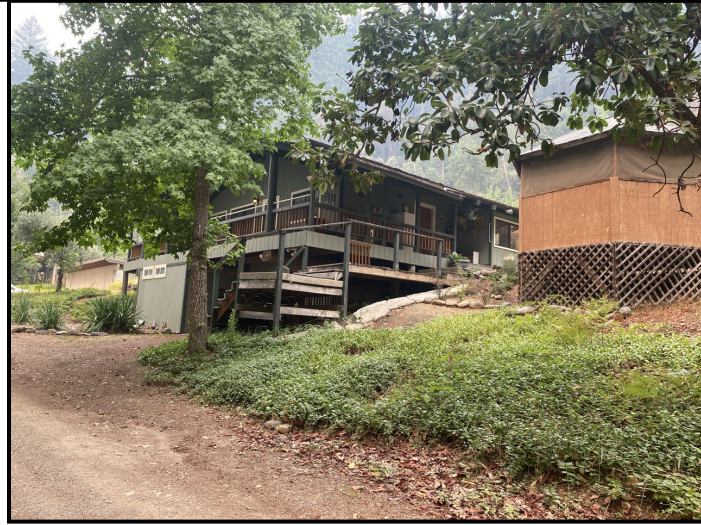
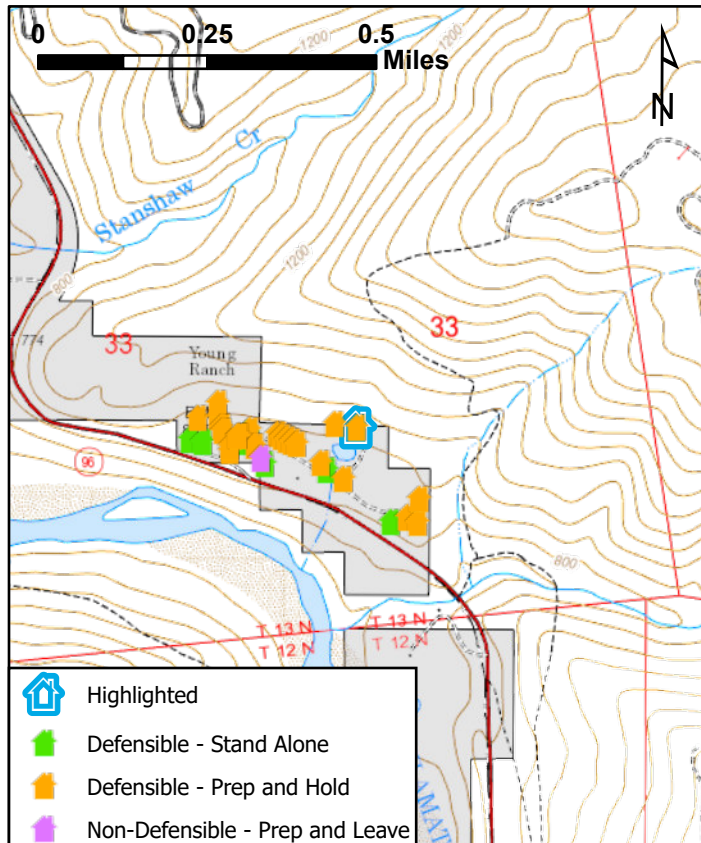
**Area:** Marble Mountain Ranch  
**Address:**  
**Assigned Structure Number:** 137  
**Type of Structure:** Residential  
**Primary Structures:**  
**Outbuildings:** 1  
**Is the building Occupied?:** Yes  
**Coordinates (DDM):** ,

**Roof Material:** Noncombustible or not applicable  
**Siding Material:** Wood or open sided  
**Electrical Power:** Yes  
**Gas to Structure:** Yes  
**Comments:** Structure now has three side sprinklers and north east side 1"lat for protection. Supply comes off landowner well points and

**Safety Zone(s):** Potential safety zone(s) in area  
**Comm With ICP:**  
**Water Supply:** Reliable water source nearby  
**Fuel Type:** Shrub or timber  
**Defensible Space:** 30 ft treated  
**Hazards:**

**Defensible, Prep and Hold**

**Mitigation Time (in hours):**  
**Mitigation Description:** Cleaned around structure for hazards

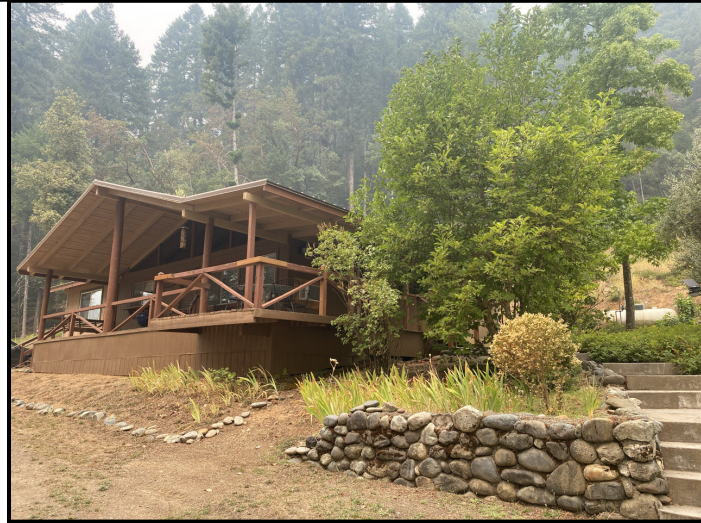
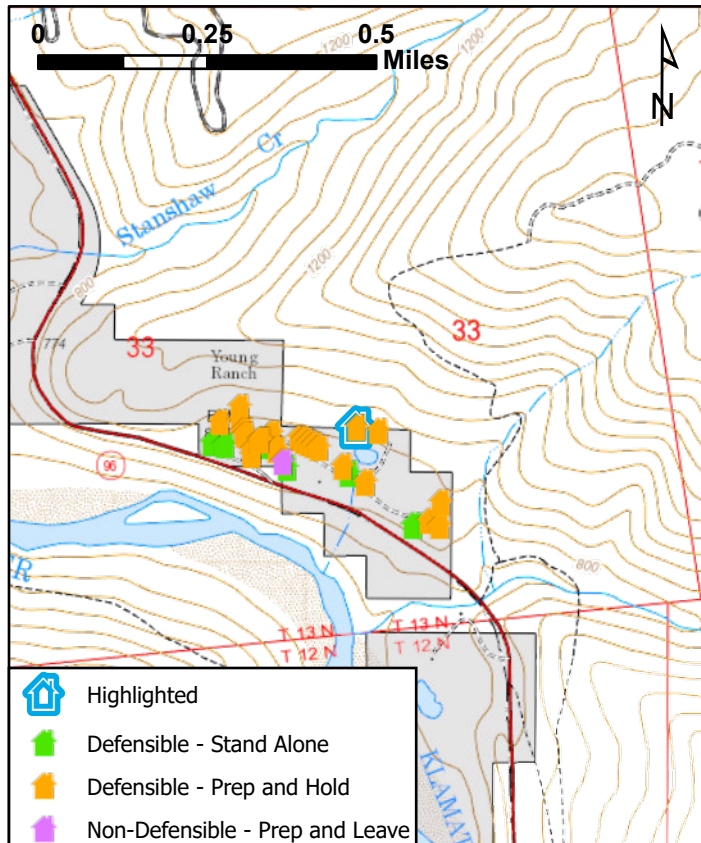
**Area:** Marble Mountain Ranch  
**Address:**  
**Assigned Structure Number:** 138  
**Type of Structure:** Residential  
**Primary Structures:**  
**Outbuildings:**  
**Is the building Occupied?:** Yes  
**Coordinates (DDM):** ,

**Roof Material:** Noncombustible or not applicable  
**Siding Material:** Wood or open sided  
**Electrical Power:** Yes  
**Gas to Structure:** Yes  
**Comments:** Two sprinklers installed around the rear of the house connected to the lay from house to the east. Tested and have great

**Safety Zone(s):**  
**Comm With ICP:**  
**Water Supply:** Reliable water source nearby  
**Fuel Type:** Shrub or timber  
**Defensible Space:** No defensible space  
**Hazards:** Propane tank

**Defensible, Prep and Hold**

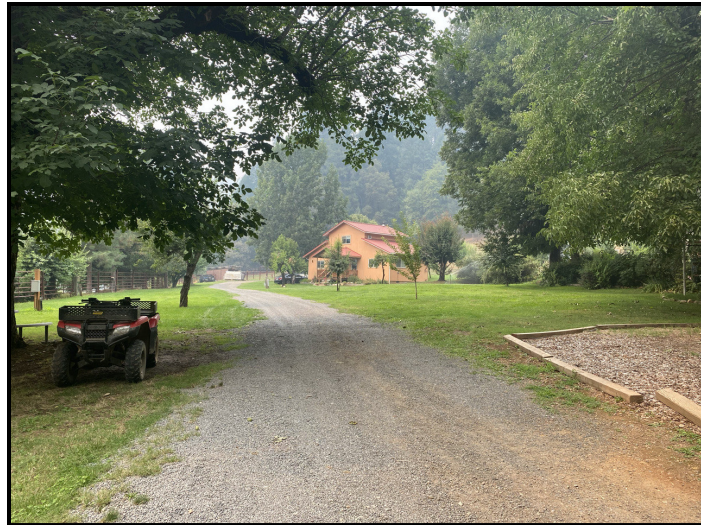
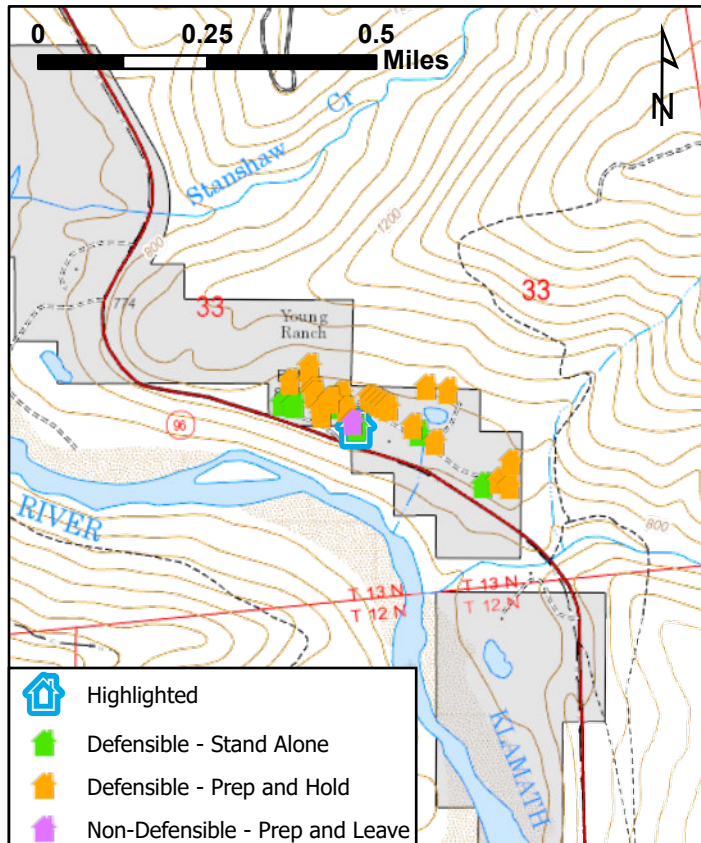
**Area:** Marble Mountain Ranch  
**Address:** 92520 Hwy 96  
**Assigned Structure Number:** 79  
**Type of Structure:** Residential  
**Primary Structures:** 15  
**Outbuildings:** 3  
**Is the building Occupied?:** Yes  
**Coordinates (DDM):** ,

**Roof Material:** Noncombustible or not applicable  
**Siding Material:** Vinyl  
**Electrical Power:** Yes  
**Gas to Structure:** Yes  
**Comments:**

**Safety Zone(s):** Potential safety zone(s) in area  
**Comm With ICP:** No  
**Water Supply:** Reliable water source nearby  
**Fuel Type:** Shrub or timber  
**Defensible Space:** 100 ft treated  
**Hazards:**

**Defensible, Stand Alone**

**Mitigation Time (in hours):** 10  
**Mitigation Description:** Some handline needed to protect penstock water source. Sprinklers and pumps set up.

**Resources Needed to Protect Structure:** Two type 3 engines

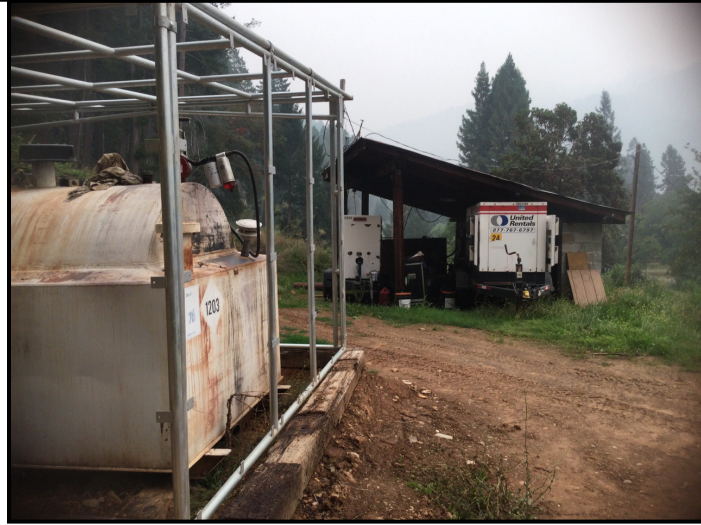
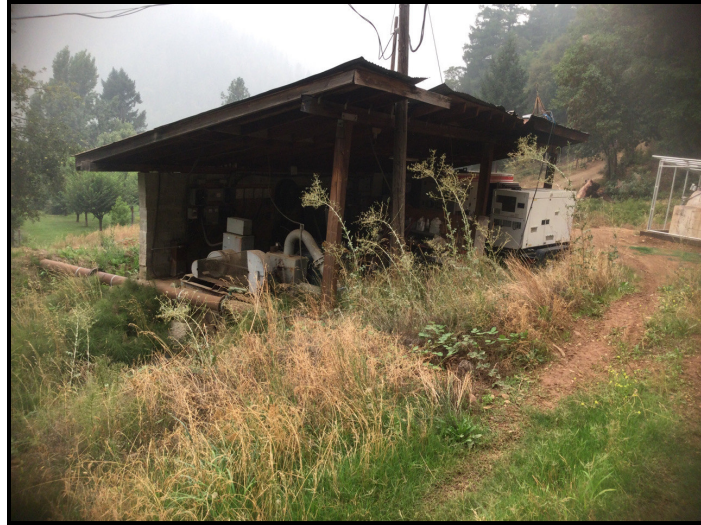
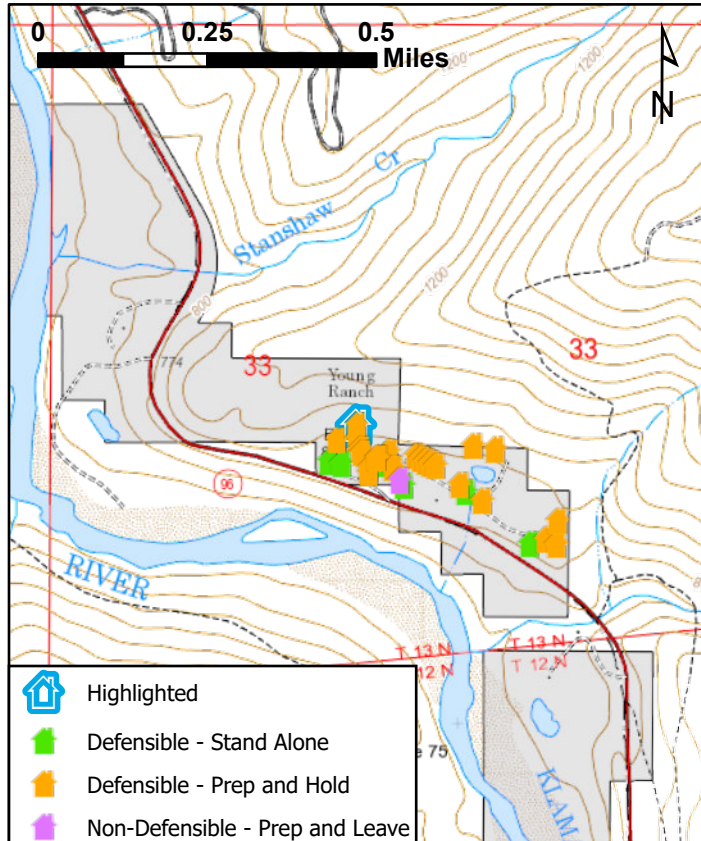
**Safety Zone(s):** Potential safety zone(s) in area  
**Comm With ICP:** Yes  
**Water Supply:** Reliable water source nearby  
**Fuel Type:**  
**Defensible Space:** 30 ft treated  
**Hazards:** Diesel tanks and generators

**Defensible, Prep and Hold**

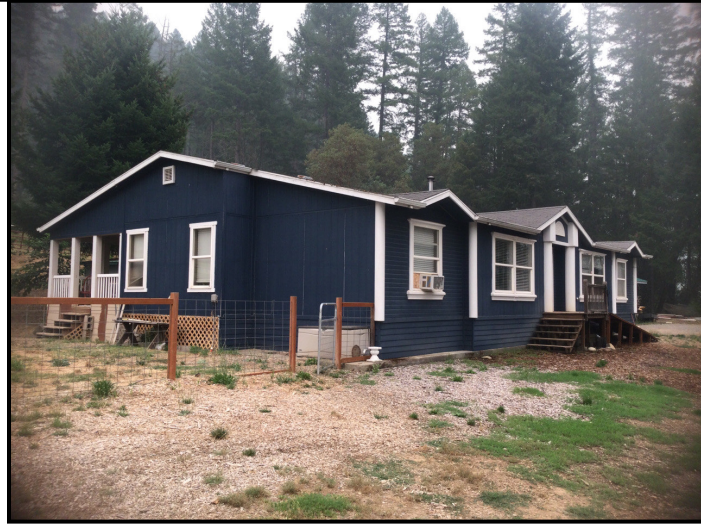
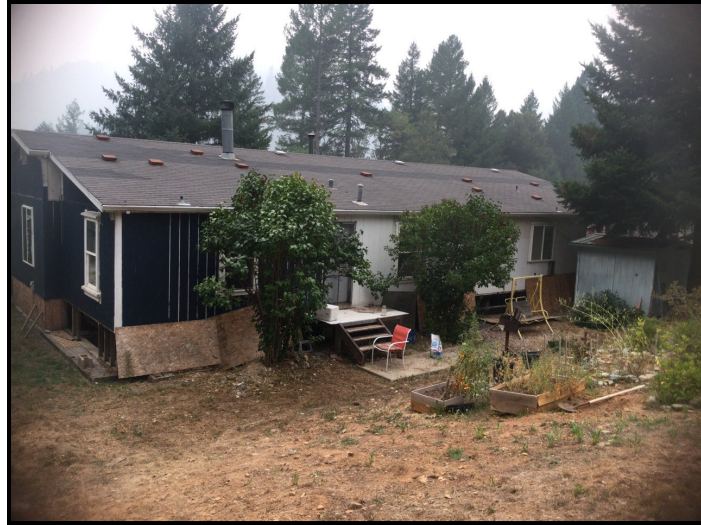
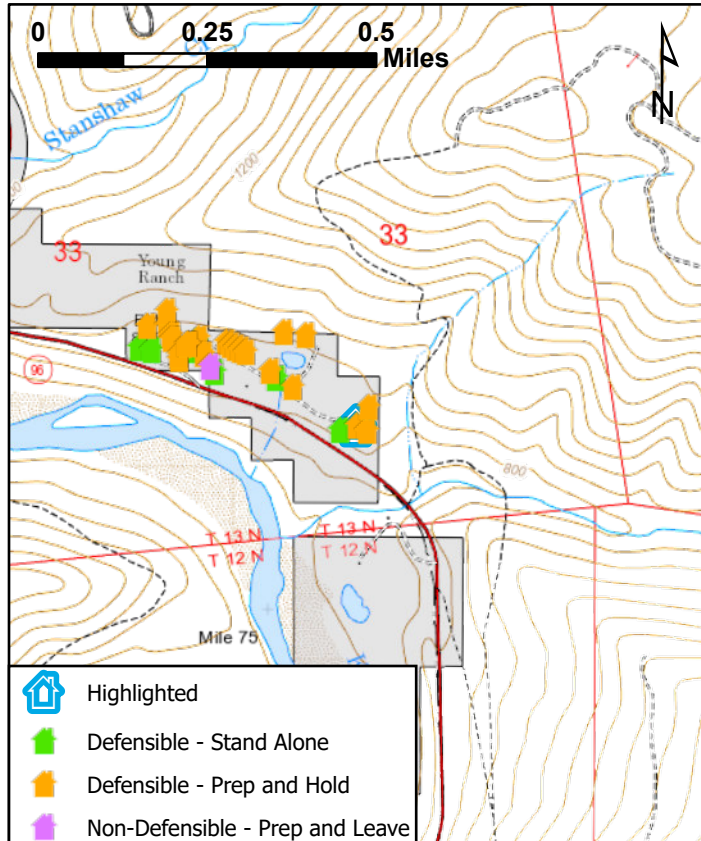
**Safety Zone(s):** Potential safety zone(s) in area  
**Comm With ICP:**  
**Water Supply:** Reliable water source nearby  
**Fuel Type:**  
**Defensible Space:** 100 ft treated  
**Hazards:** Propane tank N/W side of structure

**Defensible, Prep and Hold**

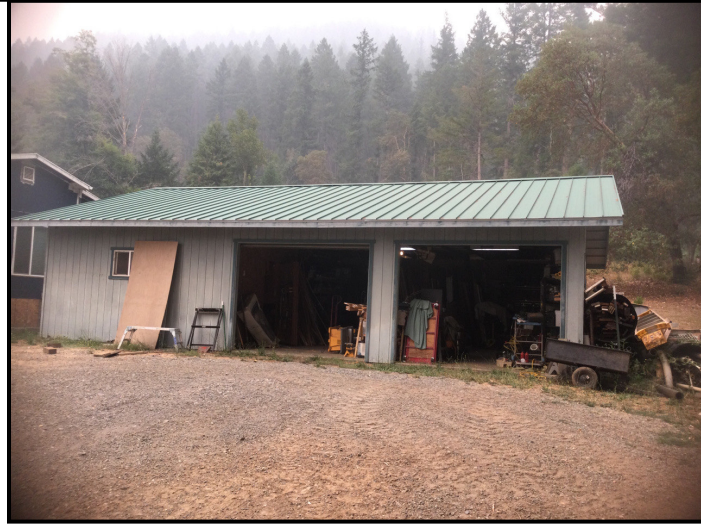
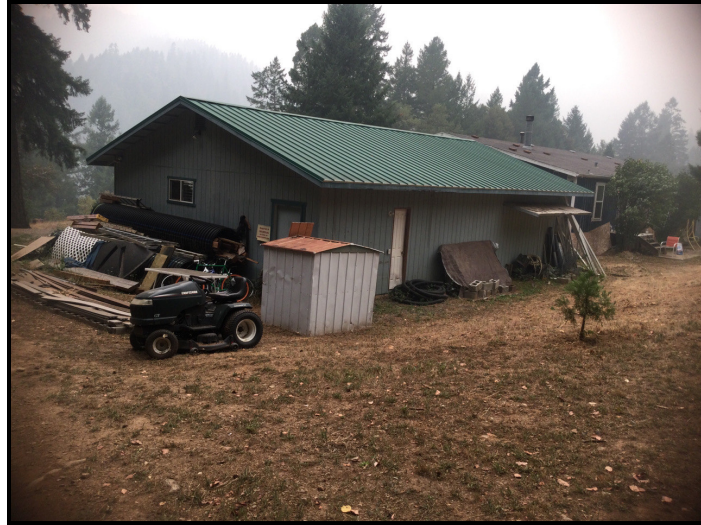
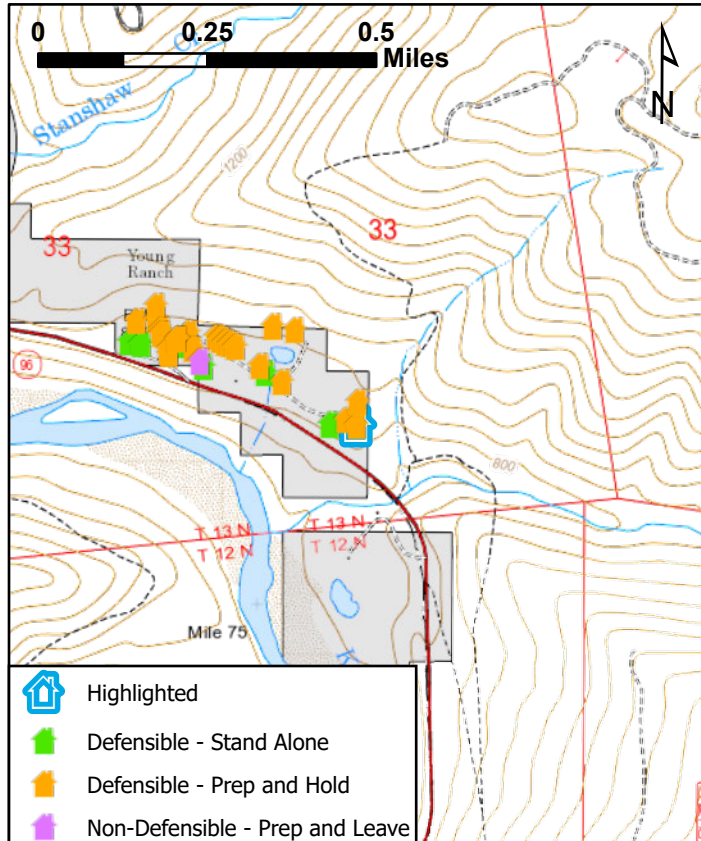
**Safety Zone(s):** Potential safety zone(s) in area  
**Comm With ICP:**  
**Water Supply:** Reliable water source nearby  
**Fuel Type:**  
**Defensible Space:** 30 ft treated  
**Hazards:** Lots of construction Material on the s/e side

**Defensible, Prep and Hold**

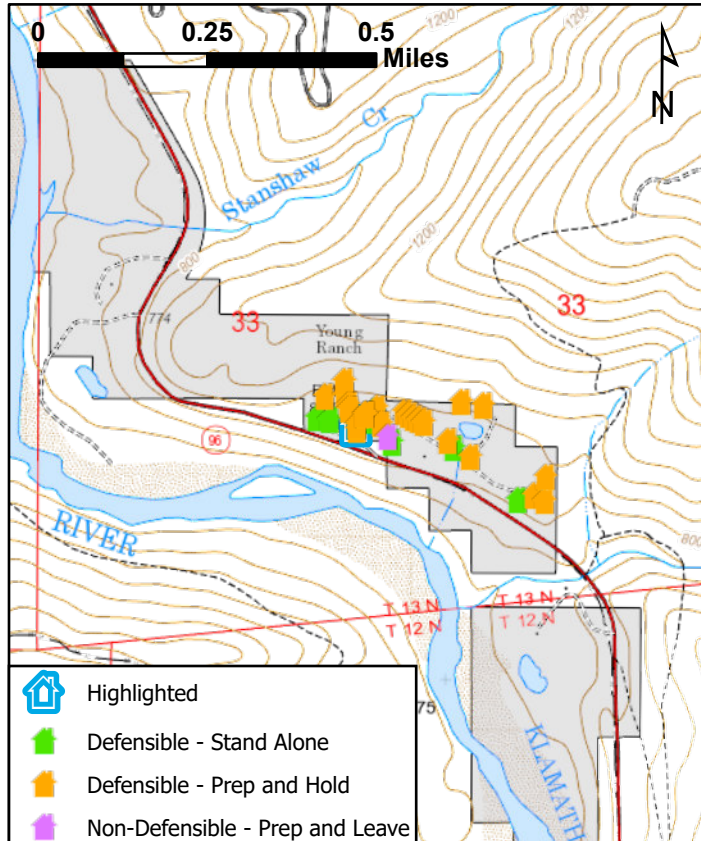
**Safety Zone(s):** Potential safety zone(s) in area  
**Comm With ICP:** Yes  
**Water Supply:** Pressurized hydrant(s) or fixed sprinkler system  
**Fuel Type:** Shrub or timber  
**Defensible Space:** Less than 30 ft treated  
**Hazards:** Propane tanks for bbq

**Defensible, Prep and Hold**
