McCash Fire Structure Triage Assessment

CASRF000651
August 20, 2021

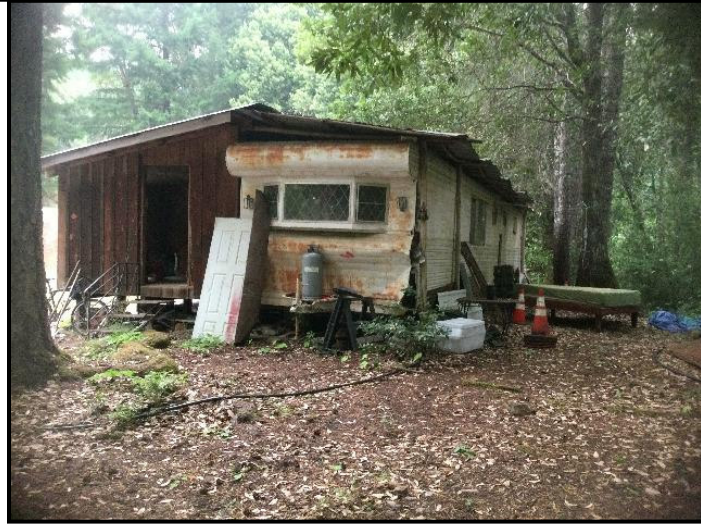
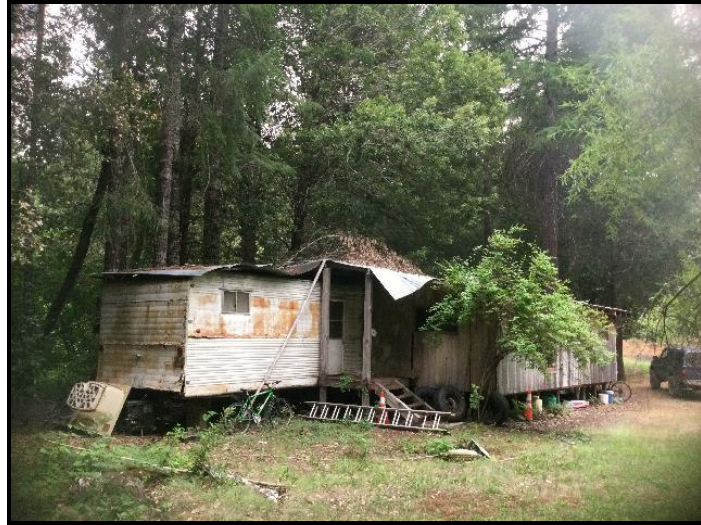
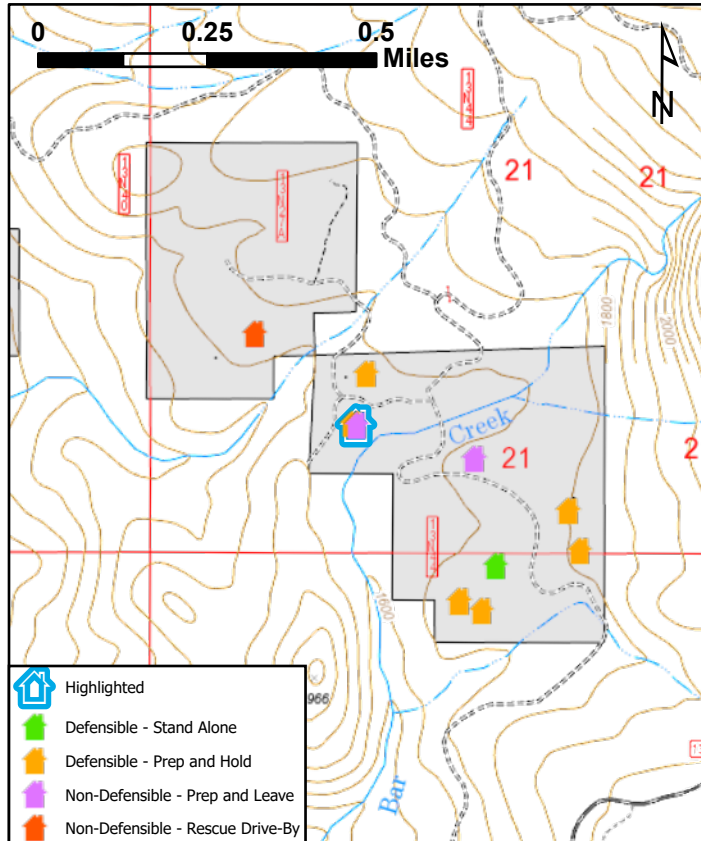
Area: Patterson
Address: 13n27
Assigned Structure Number: 100
Type of Structure: Residential
Primary Structures: 1
Outbuildings:
Is the building Occupied?: Yes
Coordinates (DDM): 41°29.919'N, 123°30.401'W

Roof Material: Noncombustible or not applicable
Siding Material: Wood or open sided
Electrical Power: Yes
Gas to Structure: No
Comments:

Safety Zone(s): No safety zone(s) in area
Comm With ICP: Yes
Water Supply: No reliable water source nearby
Fuel Type: Shrub or timber
Defensible Space: Less than 30 ft treated
Hazards:

Non-Defensible, Prep and Leave

Mitigation Time (in hours): 1
Mitigation Description: Scratch line and remove combustibles

Resources Needed to Protect Structure: Sprinkler, a pump could be set up in Sandy Bar Creek, east of structures, 250'

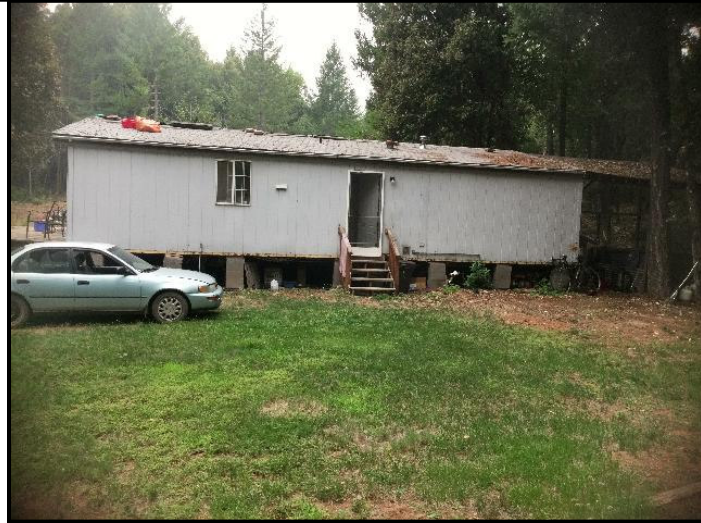
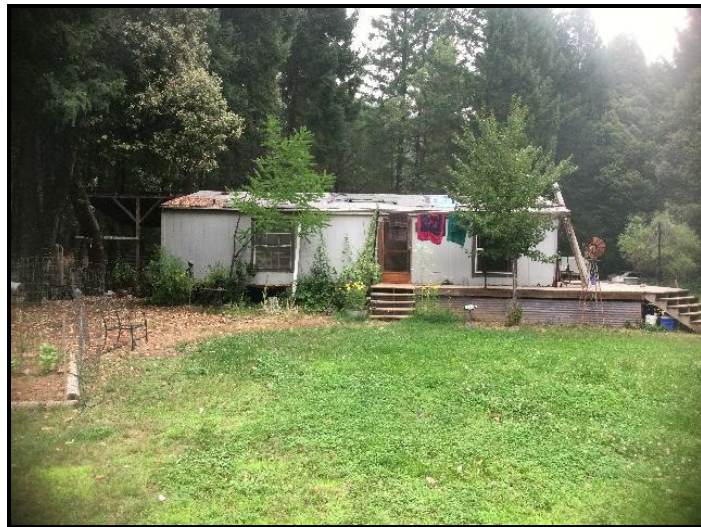
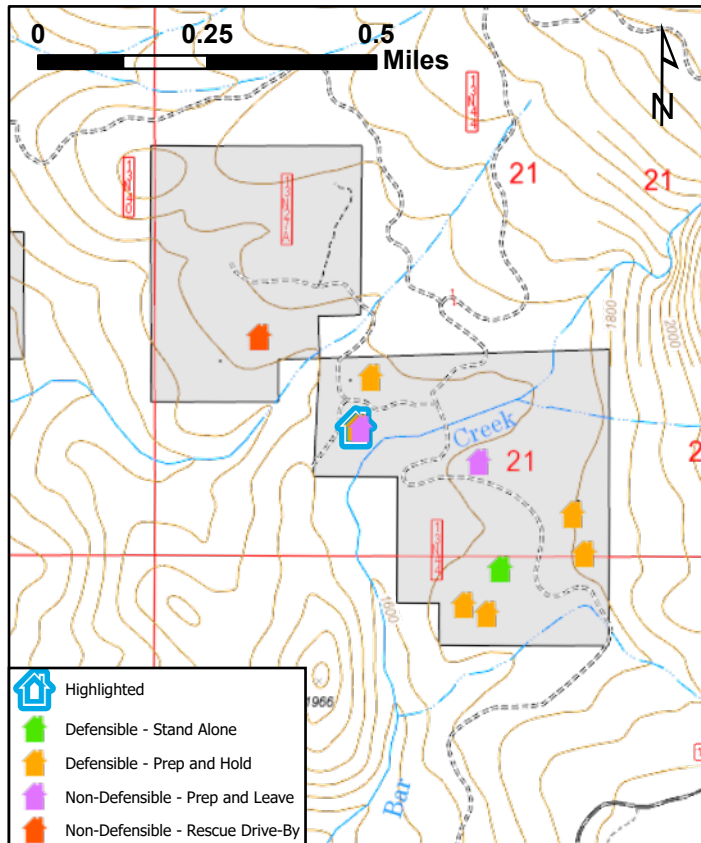
Area: Patterson
Address: 3401 sand bar
Assigned Structure Number: 101
Type of Structure: Residential
Primary Structures: 1
Outbuildings:
Is the building Occupied?: Yes
Coordinates (DDM): 41°29.920'N, 123°30.409'W

Roof Material: Fire resistant- tar,rubberized
Siding Material: Wood or open sided
Electrical Power: Yes
Gas to Structure: Yes
Comments: Scott rents from Watsons.

Safety Zone(s): No safety zone(s) in area
Comm With ICP: Yes
Water Supply: Reliable water source nearby
Fuel Type: Shrub or timber
Defensible Space: Less than 30 ft treated
Hazards:

Defensible, Prep and Hold

Mitigation Time (in hours): 1
Mitigation Description: Scratch line and remove ground fuels

Resources Needed to Protect Structure: Sprinkler

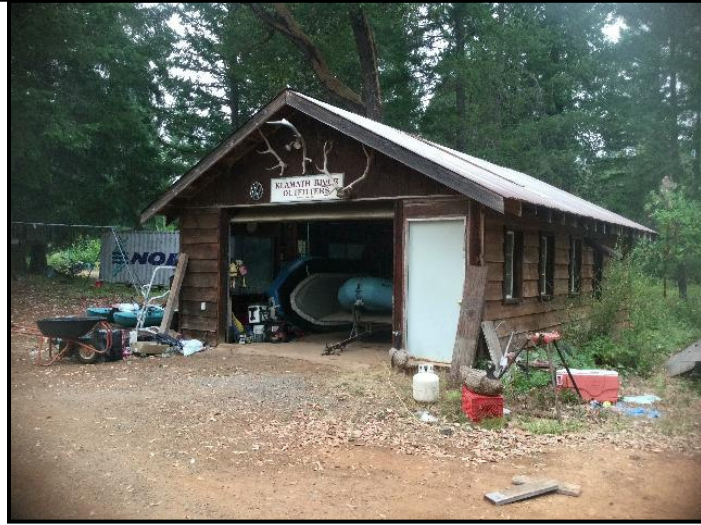
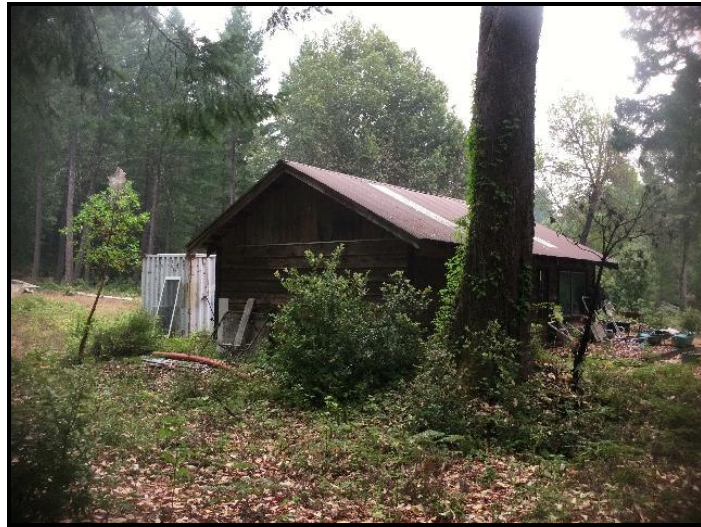
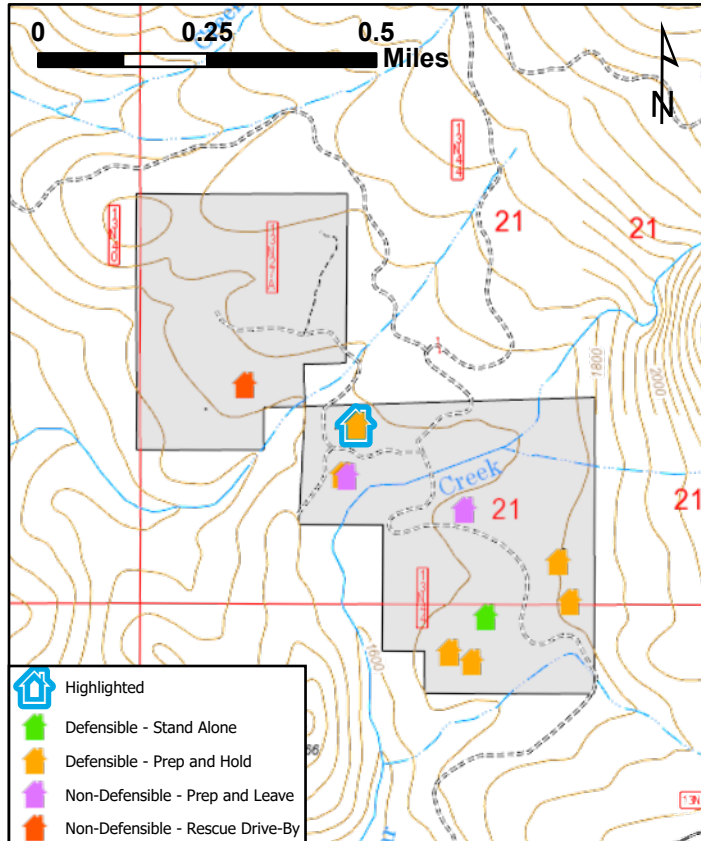
Area: Patterson
Address: 3400(1) sand bar
Assigned Structure Number: 103
Type of Structure: Outbuilding
Primary Structures: 1
Outbuildings:
Is the building Occupied?: No
Coordinates (DDM): 41°29.985'N, 123°30.385'W

Roof Material: Noncombustible or not applicable
Siding Material: Wood or open sided
Electrical Power: Yes
Gas to Structure: No
Comments: Watson's detached workshop

Safety Zone(s): No safety zone(s) in area
Comm With ICP: Yes
Water Supply: Limited or dependent on electricity
Fuel Type: Shrub or timber
Defensible Space: Less than 30 ft treated
Hazards:

Defensible, Prep and Hold

Mitigation Time (in hours): 1
Mitigation Description: Scratch line & remove combustibles

Resources Needed to Protect Structure: Sprinkler

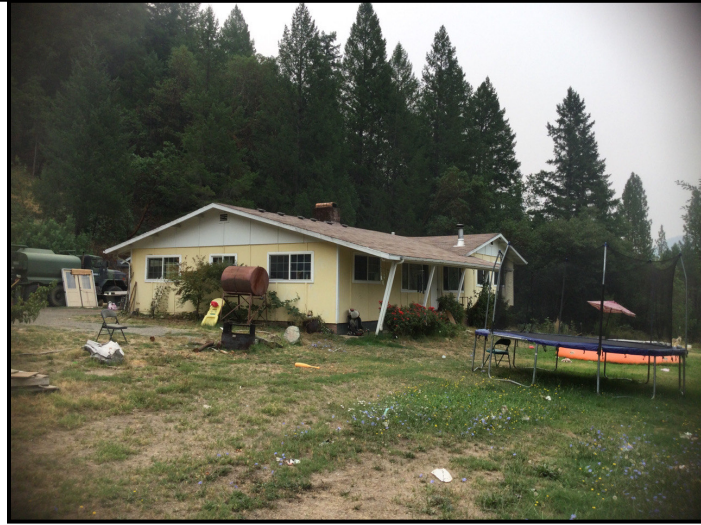
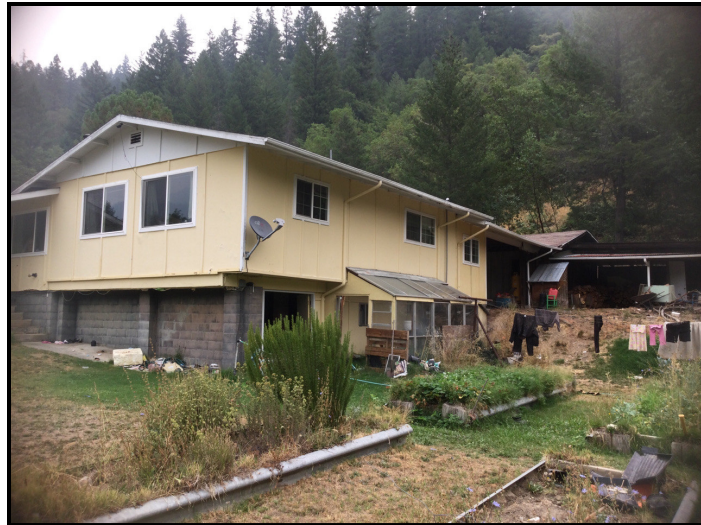
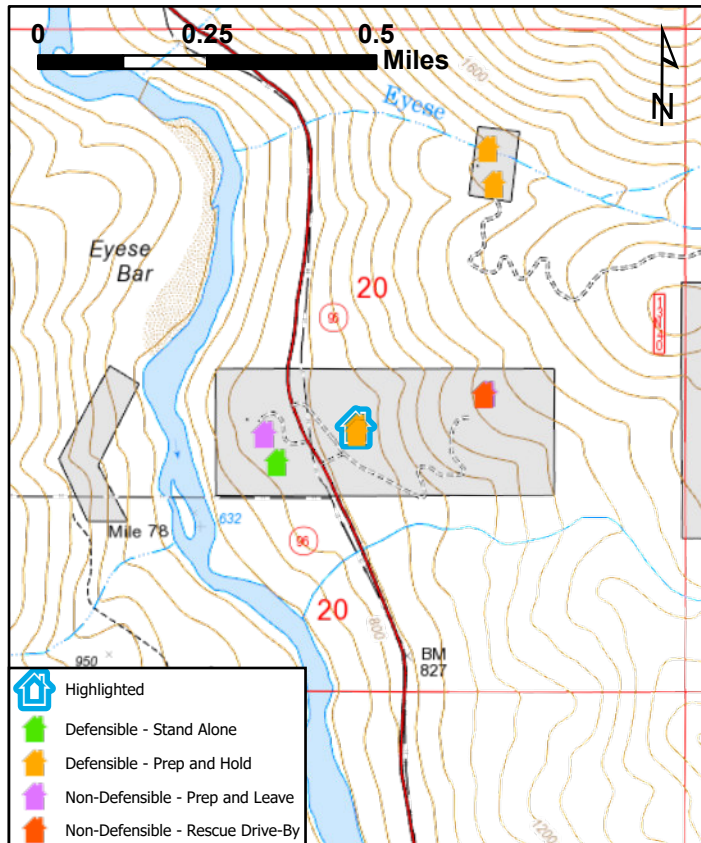
Area: Patterson
Address:
Assigned Structure Number: 104
Type of Structure: Residential
Primary Structures: 1
Outbuildings: 1
Is the building Occupied?: Yes
Coordinates (DDM): 41° 30.092' N, 123° 31.318' W

Roof Material: Fire resistant- tar, rubberized
Siding Material: Wood or open sided
Electrical Power: Yes
Gas to Structure: Yes
Comments: Crisper McCallister 530-469-3299 tribal rep. (3) 3,000 gallon water tenders on property and 2,500 pumpkin

Safety Zone(s): Potential safety zone(s) in area
Comm With ICP: Yes
Water Supply: Reliable water source nearby
Fuel Type:
Defensible Space: 30 ft treated
Hazards: Multiple wolves on chains throughout property

Defensible, Prep and Hold

Mitigation Time (in hours): 3
Mitigation Description: Fuel reduction on uphill side of property. Removal of combustibles around house

Resources Needed to Protect Structure: Sprinkler, 1 engine

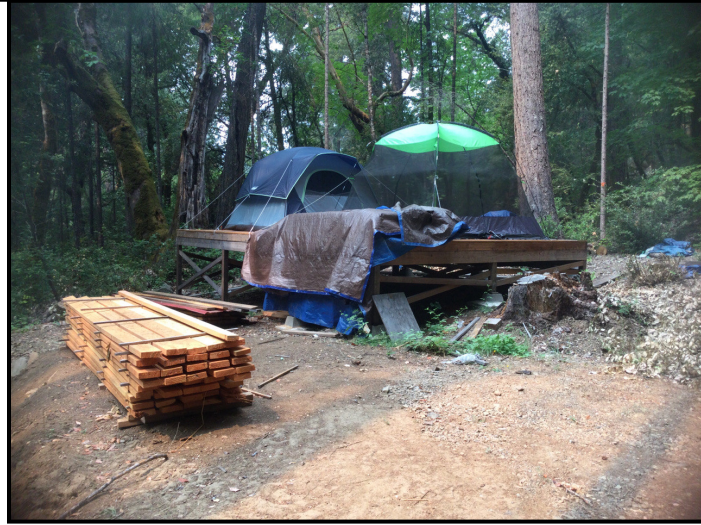
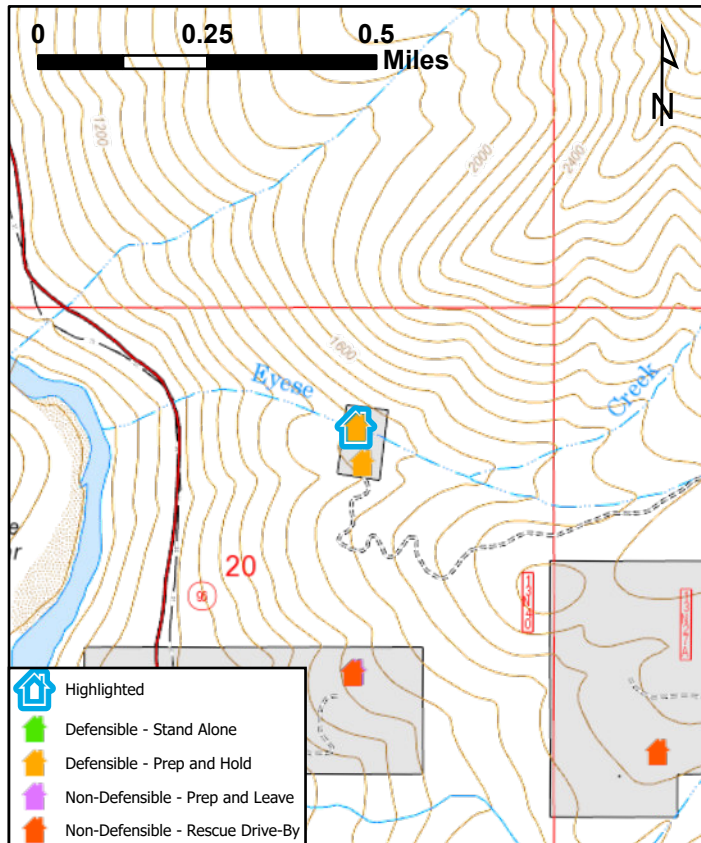
Area: Patterson
Address:
Assigned Structure Number: 105
Type of Structure: Residential
Primary Structures: 1
Outbuildings:
Is the building Occupied?: Yes
Coordinates (DDM): 41° 30.451' N, 123° 31.096' W

Roof Material: Combustible or no roof
Siding Material:
Electrical Power: No
Gas to Structure: No
Comments: Cabin under construction

Safety Zone(s): No safety zone(s) in area
Comm With ICP: Yes
Water Supply: Reliable water source nearby
Fuel Type: Shrub or timber
Defensible Space: Less than 30 ft treated
Hazards:

Defensible, Prep and Hold

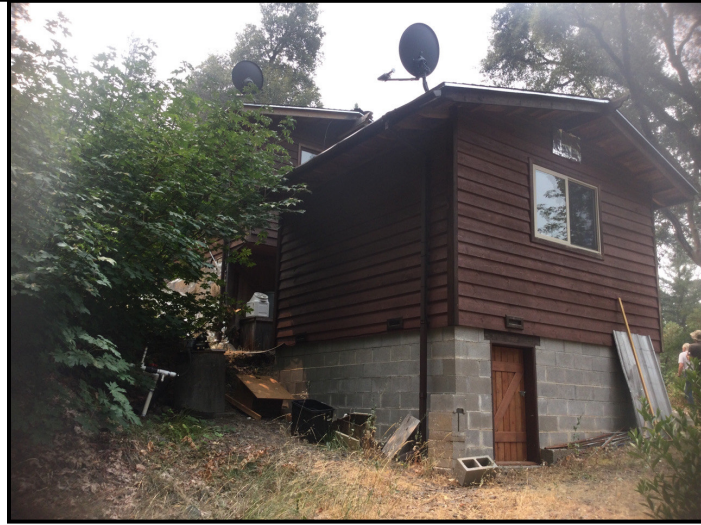
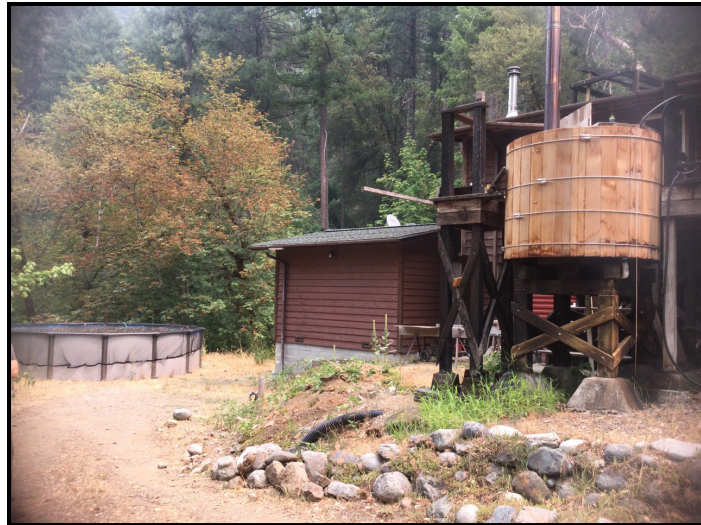
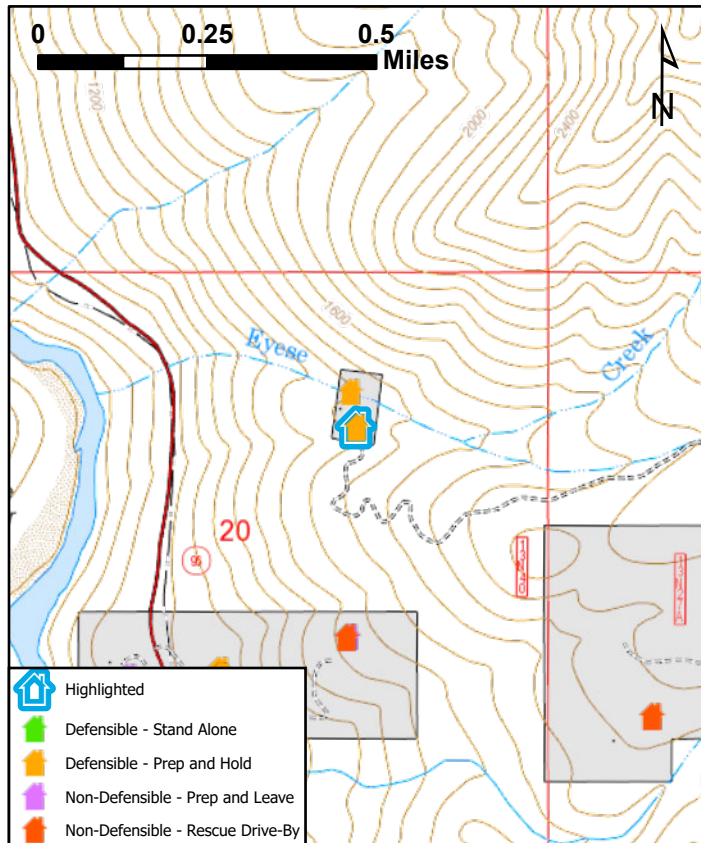
Area: Patterson
Address:
Assigned Structure Number: 106
Type of Structure: Residential
Primary Structures: 1
Outbuildings: 1
Is the building Occupied?: Yes
Coordinates (DDM): ,

Roof Material: Noncombustible or not applicable
Siding Material: Wood or open sided
Electrical Power: Yes
Gas to Structure: Yes
Comments: 14,000 gallon pool, misting system along entire eaves of roof, solar. Marshall and Leanna Carson Hansen. 530 509-5012-

Safety Zone(s): No safety zone(s) in area
Comm With ICP: Yes
Water Supply: Reliable water source nearby
Fuel Type: Shrub or timber
Defensible Space: Less than 30 ft treated
Hazards:

Defensible, Prep and Hold

Mitigation Time (in hours): 2
Mitigation Description: Remove vegetation, clear combustibles

Resources Needed to Protect Structure: Sprinkler kit, engine

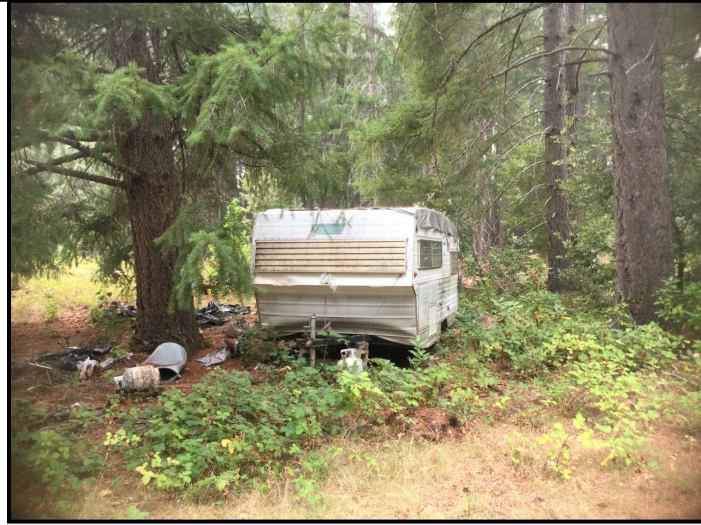
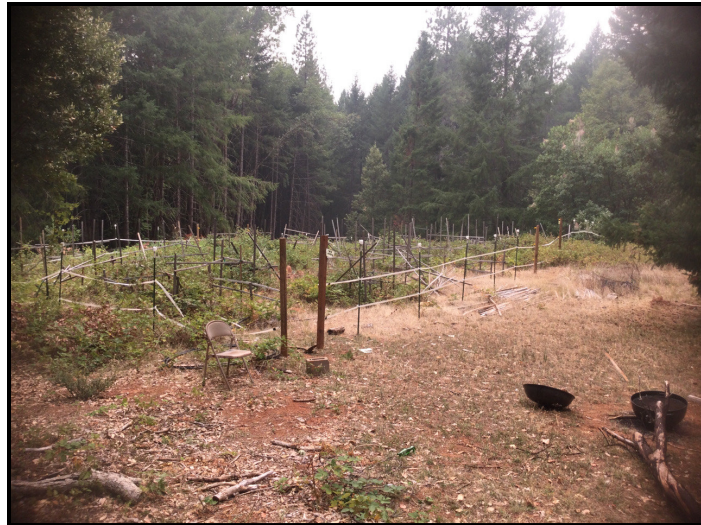
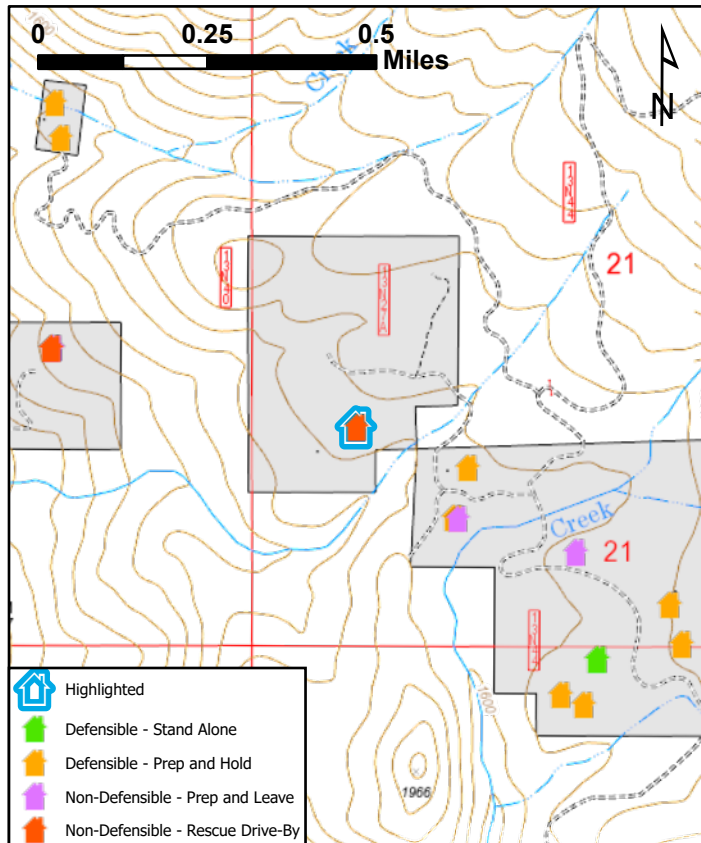
Area: Patterson
Address:
Assigned Structure Number: 107
Type of Structure: Residential
Primary Structures: 1
Outbuildings:
Is the building Occupied?: No
Coordinates (DDM): ,

Roof Material: Combination of fire resistant and combustible
Siding Material: Vinyl
Electrical Power: No
Gas to Structure: No
Comments: Abandoned bumper pull trailer

Safety Zone(s): No safety zone(s) in area
Comm With ICP: Yes
Water Supply: No reliable water source nearby
Fuel Type: Shrub or timber
Defensible Space: No defensible space
Hazards:

Non-Defensible, Rescue, Drive By

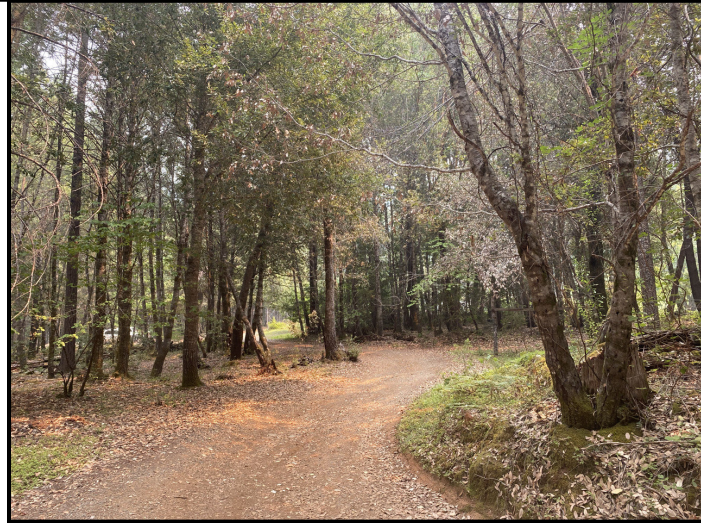
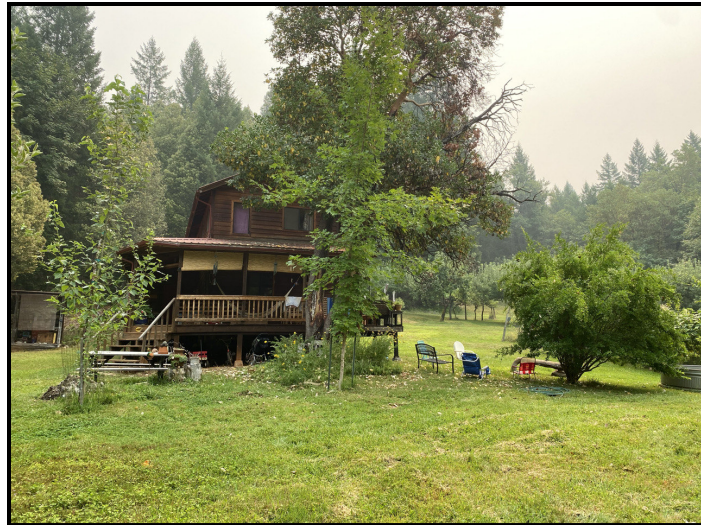
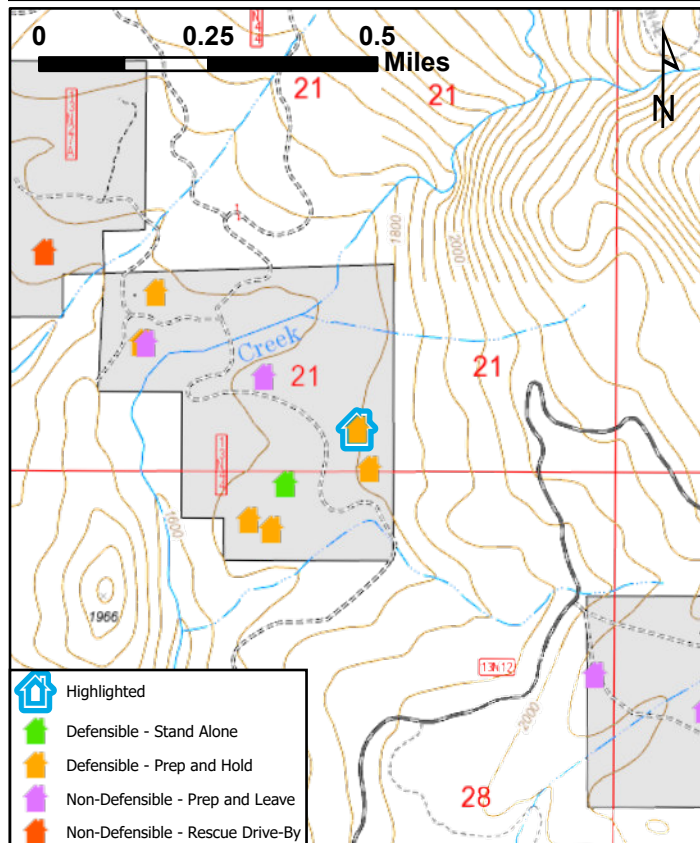
Area: Patterson
Address: Sandy bar rd
Assigned Structure Number: 131
Type of Structure: Residential
Primary Structures: 2
Outbuildings: 1
Is the building Occupied?: Yes
Coordinates (DDM): ,

Roof Material: Combustible or no roof
Siding Material: Wood or open sided
Electrical Power: No
Gas to Structure: Yes
Comments: Denise Bearding. 30' defensible spacing to the east and north. 100' defensible to the south and west.

Safety Zone(s): No safety zone(s) in area
Comm With ICP: No
Water Supply: Limited or dependent on electricity
Fuel Type: Shrub or timber
Defensible Space: 30 ft treated
Hazards:

Defensible, Prep and Hold

Mitigation Time (in hours): 2
Mitigation Description: Some raking, hose and sprinkler set up.

Resources Needed to Protect Structure: 1 type three engine

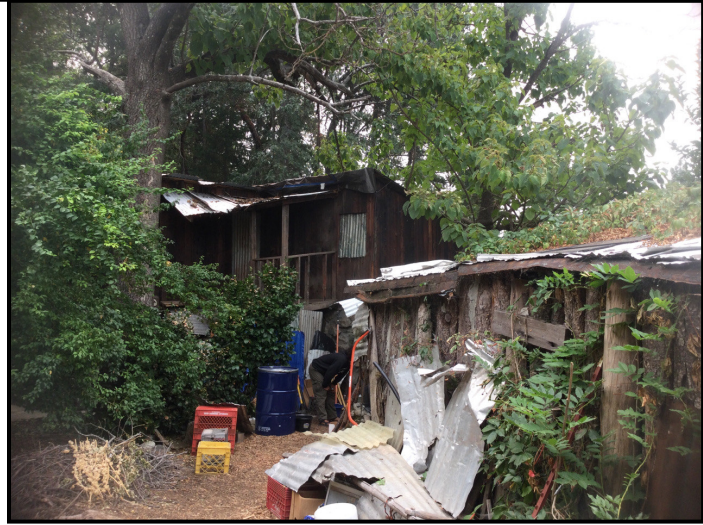
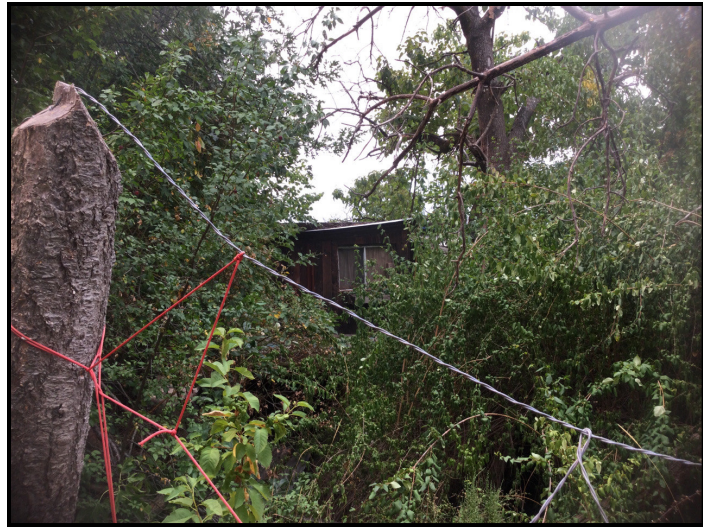
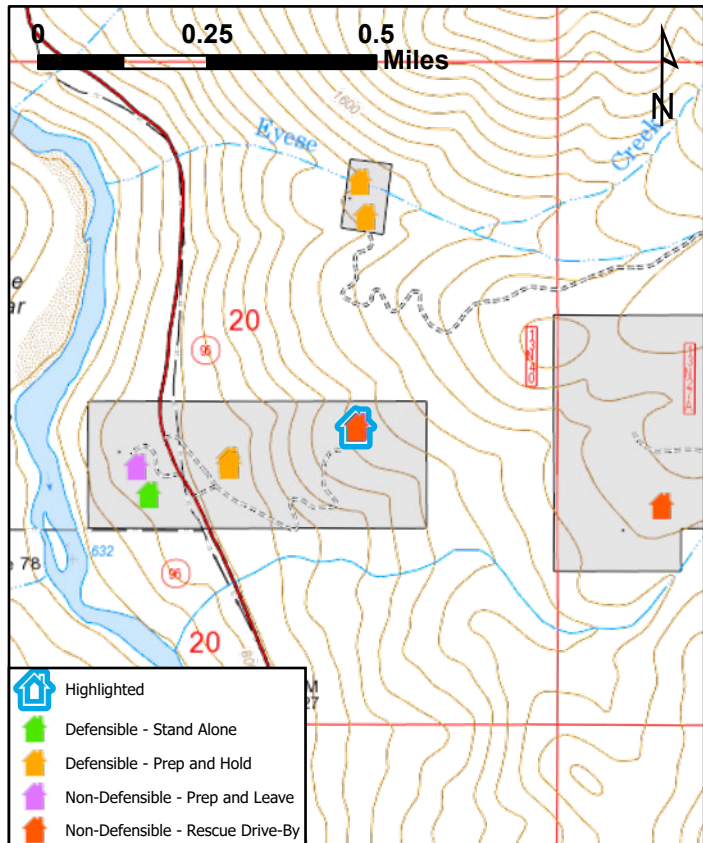
Area: Patterson
Address:
Assigned Structure Number: 132
Type of Structure: Residential
Primary Structures: 1
Outbuildings: 0
Is the building Occupied?: Yes
Coordinates (DDM): 41° 30.135' N, 123° 31.099' W

Roof Material: Combustible or no roof
Siding Material: Wood or open sided
Electrical Power: No
Gas to Structure: No
Comments: "Bear man" 50 yr old "tree house". Occupied by elderly couple in their 80,s

Safety Zone(s): No safety zone(s) in area
Comm With ICP: Yes
Water Supply: No reliable water source nearby
Fuel Type: Shrub or timber
Defensible Space: No defensible space
Hazards: Overgrown vegetation around structure

Non-Defensible, Rescue, Drive By

Mitigation Time (in hours): 8
Mitigation Description: Not savable despite mitigation

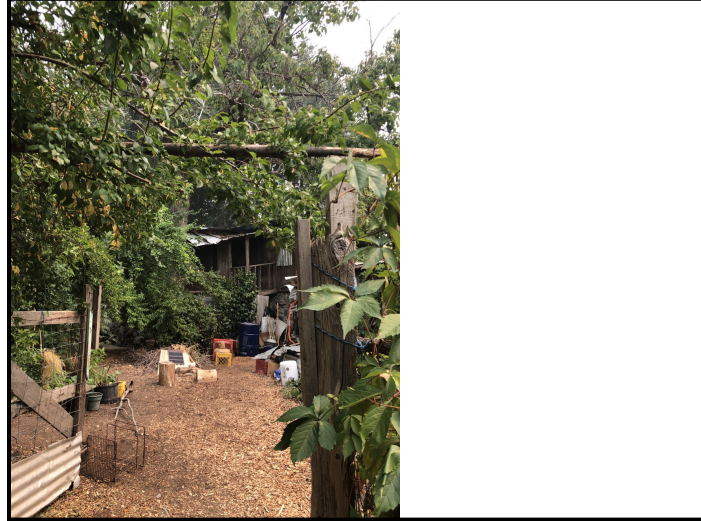
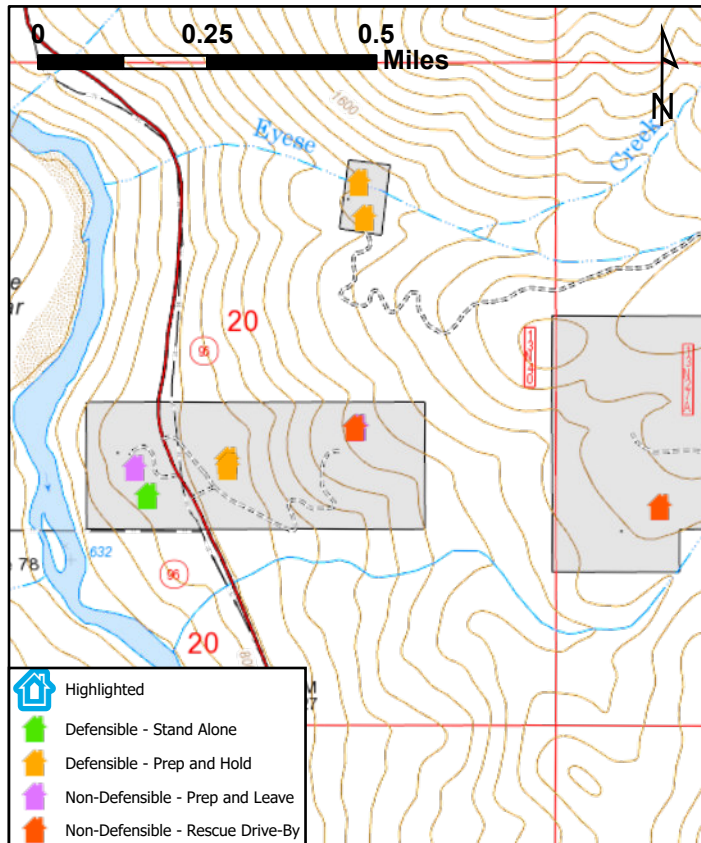
Area: Patterson
Address: Unknown
Assigned Structure Number: 156
Type of Structure: Residential
Primary Structures: 1
Outbuildings: 3
Is the building Occupied?: Yes
Coordinates (DDM): 41° 30.136' N, 123° 31.097' W

Roof Material: Combustible or no roof
Siding Material: Wood or open sided
Electrical Power: No
Gas to Structure: Unknown
Comments: Structures are a mix of wood and rock, one structure is no longer occupied, both right next to each other with vegetation

Safety Zone(s): No safety zone(s) in area
Comm With ICP: Yes
Water Supply: No reliable water source nearby
Fuel Type: Shrub or timber
Defensible Space: No defensible space
Hazards: Bad access, brush close to structure, structures themselves have fuel right amongst them.

Non-Defensible, Prep and Leave

Mitigation Time (in hours): 12
Mitigation Description: Place sprinklers, pumps, and tanks around structure. Evaluate ability and homeowner comfort with improving defensible space around structure.

Resources Needed to Protect Structure: One crew, one Type VI engine

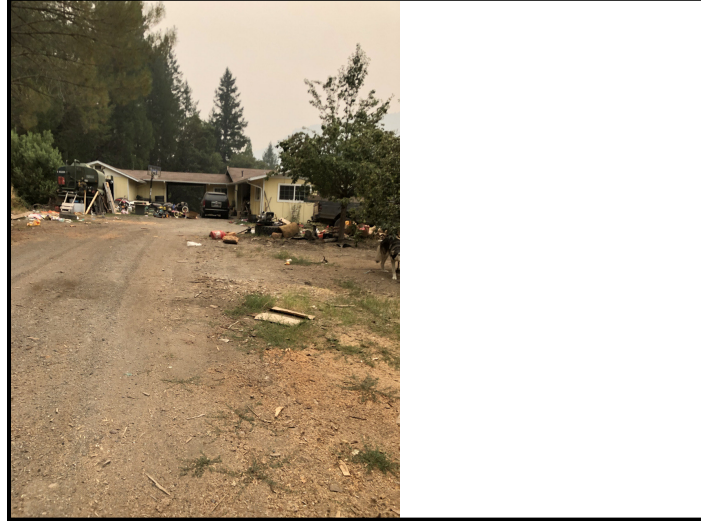
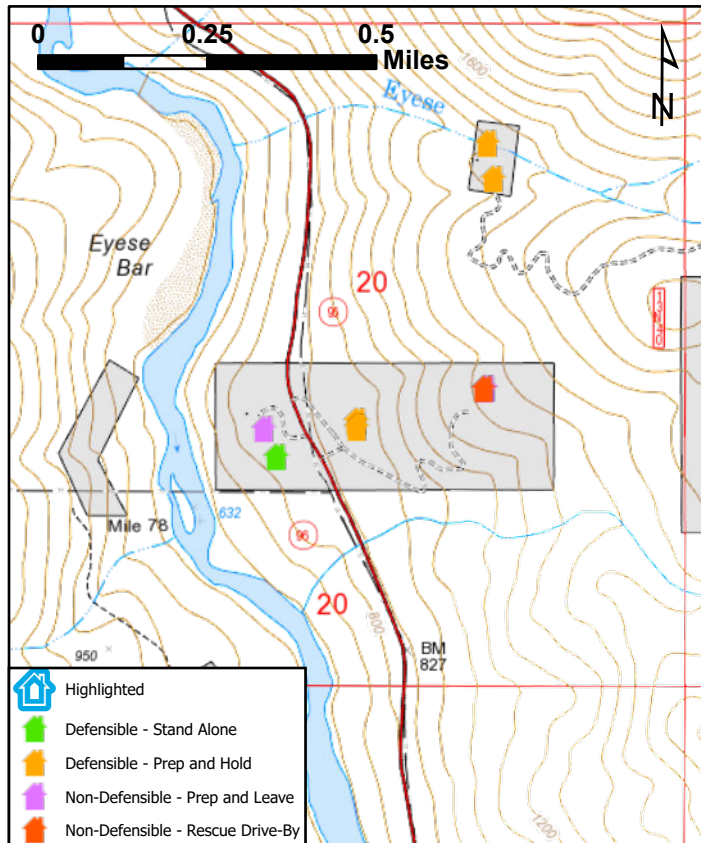
Area: Patterson
Address: Unknown
Assigned Structure Number: 157
Type of Structure: Residential
Primary Structures: 1
Outbuildings:
Is the building Occupied?: Yes
Coordinates (DDM): 41° 30.085' N, 123° 31.317' W

Roof Material: Fire resistant- tar, rubberized
Siding Material: Wood or open sided
Electrical Power: No
Gas to Structure: Yes
Comments: Good defensible space around structure, good access, one water tender full with 4,000 gallons. Old skid road across top of

Safety Zone(s): Potential safety zone(s) in area
Comm With ICP: Yes
Water Supply: Limited or dependent on electricity
Fuel Type: Shrub or timber
Defensible Space: 100 ft treated
Hazards: Multiple vehicles on property that may or may not be operable, lots of excess debris around the structure.

Defensible, Prep and Hold

Mitigation Time (in hours): 4
Mitigation Description: Place sprinklers and tanks around structures.

Resources Needed to Protect Structure: One Type III

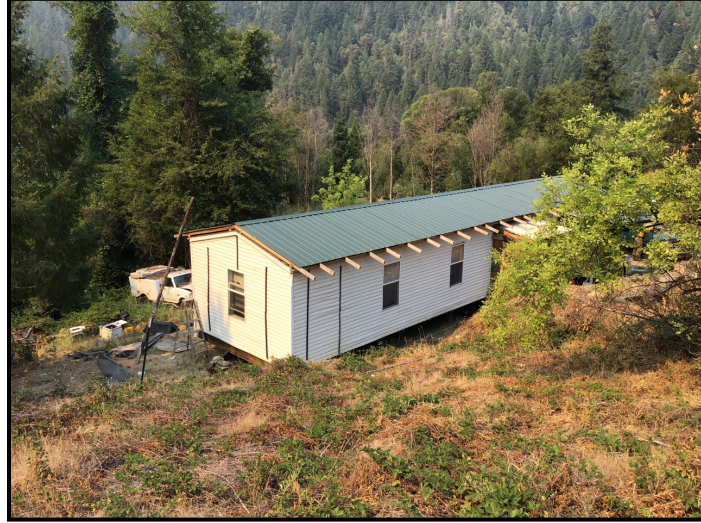
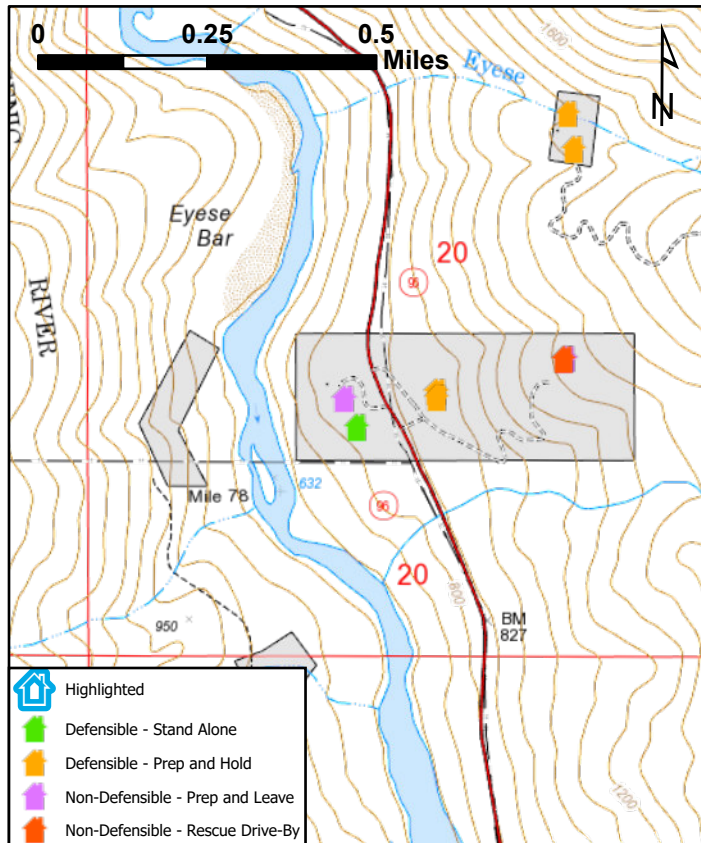
Area: Patterson
Address:
Assigned Structure Number: 175
Type of Structure: Residential
Primary Structures: 1
Outbuildings: 3
Is the building Occupied?: Yes
Coordinates (DDM): 41° 30.046' N, 123° 31.454' W

Roof Material:
Siding Material: Vinyl
Electrical Power: No
Gas to Structure: Yes
Comments: Orien and chastity Met with Gary (owner) he is weed eating a path to the neighbors swimming pool for water access. One

Safety Zone(s): No safety zone(s) in area
Comm With ICP: Yes
Water Supply: No reliable water source nearby
Fuel Type: Grass/tundra,northern hardwood litter
Defensible Space: 30 ft treated
Hazards:

Defensible, Stand Alone

Mitigation Time (in hours): 2
Mitigation Description: Prep around structure, setup tank, sprinklers

Resources Needed to Protect Structure: Crew to prep

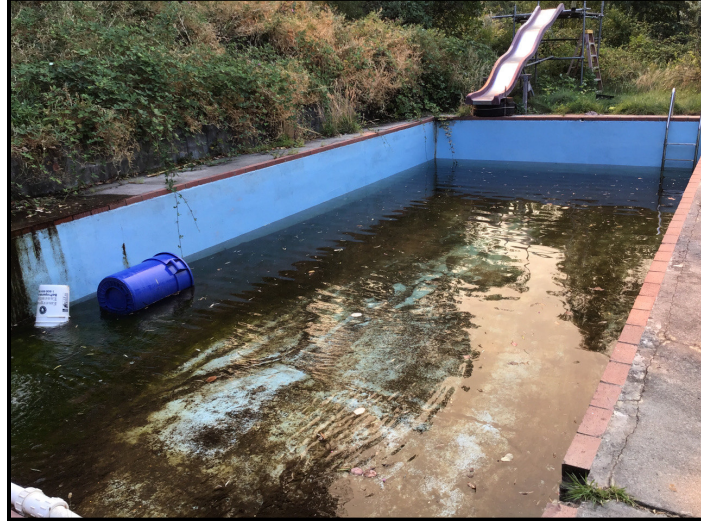
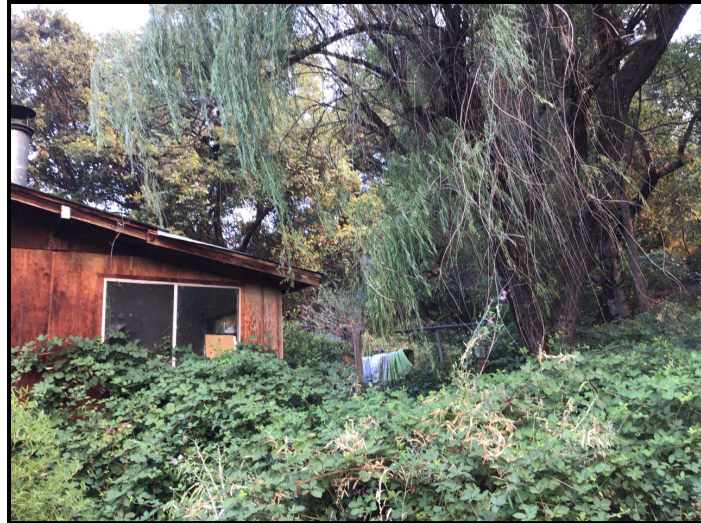
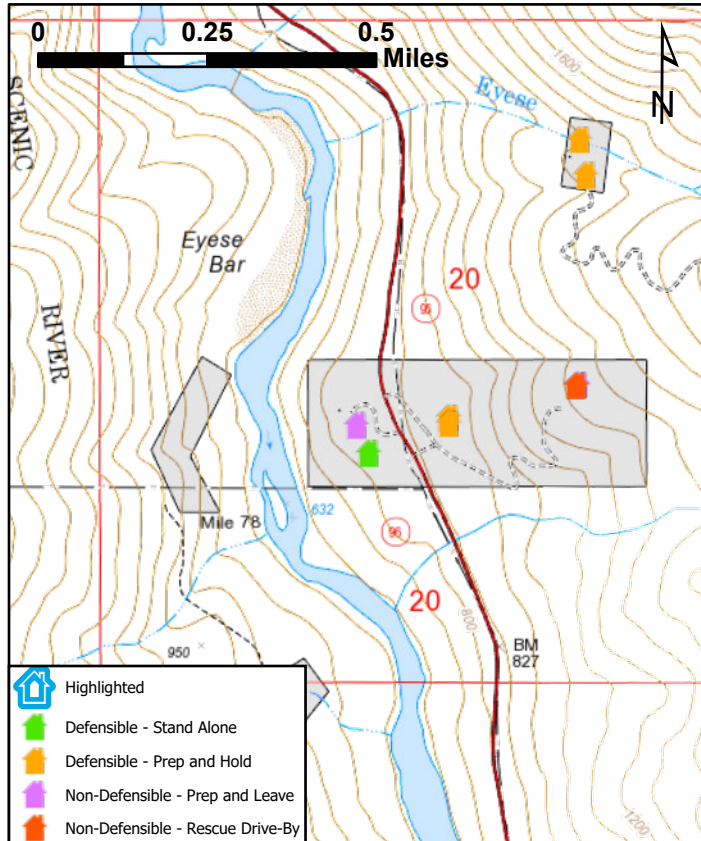
Area: Patterson
Address: 90121 hwy 96
Assigned Structure Number: 176
Type of Structure: Residential
Primary Structures: 1
Outbuildings: 3
Is the building Occupied?: Yes
Coordinates (DDM): 41° 30.082' N, 123° 31.475' W

Roof Material: Noncombustible or not applicable
Siding Material: Wood or open sided
Electrical Power: Yes
Gas to Structure: Yes
Comments: Richard Glasgow. Very little clearance but large swimming pool. Now structure has been brushed back min 25ft, two

Safety Zone(s): Potential safety zone(s) in area
Comm With ICP: Yes
Water Supply: Reliable water source nearby
Fuel Type: Shrub or timber
Defensible Space: Less than 30 ft treated
Hazards: Propane

Non-Defensible, Prep and Leave

Mitigation Time (in hours): 3
Mitigation Description: Pump in pool, saw work, hose, sprinklers

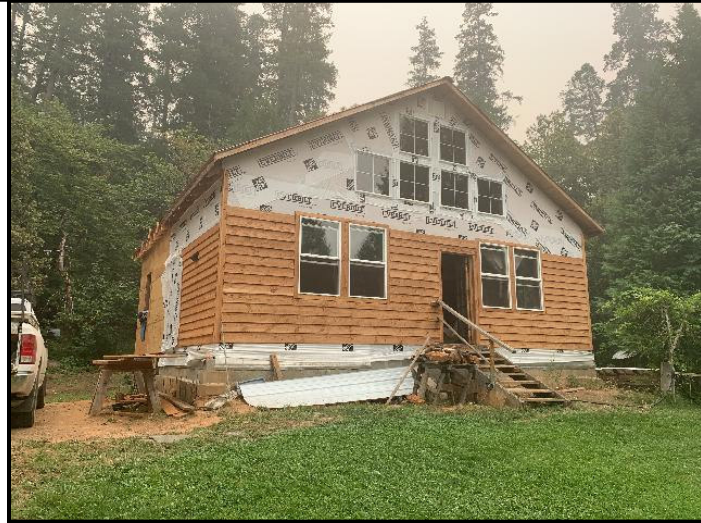
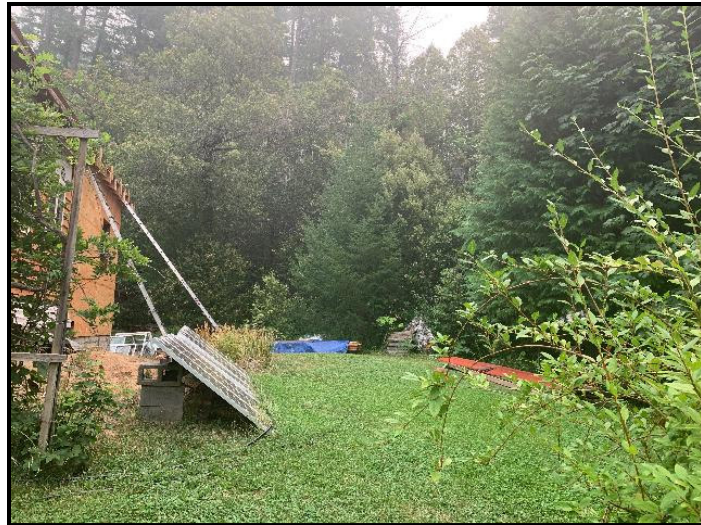
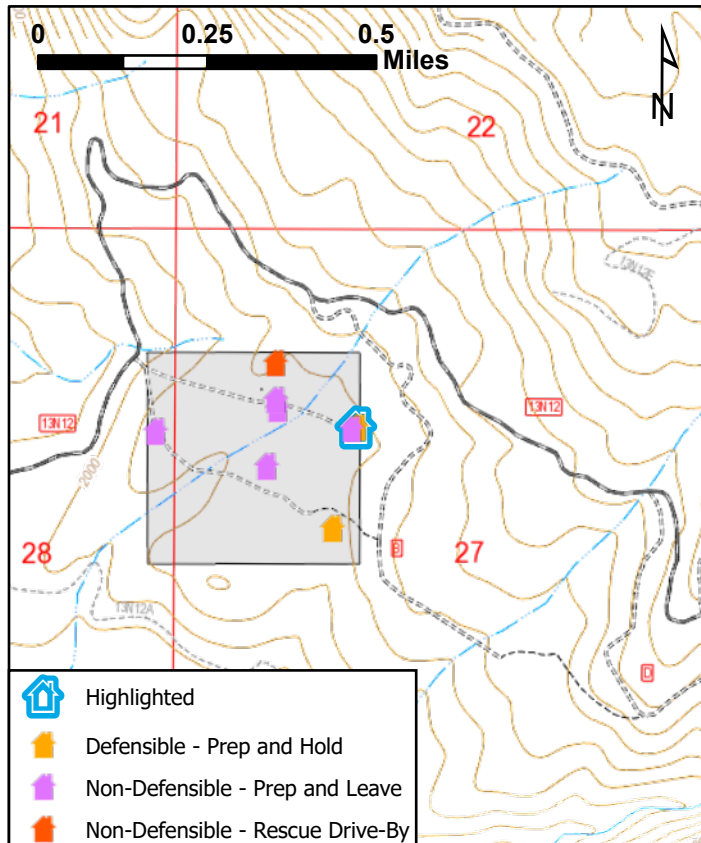
Area: Patterson
Address: 13N12A(3)
Assigned Structure Number: 69
Type of Structure: Residential
Primary Structures: 1
Outbuildings:
Is the building Occupied?: Yes
Coordinates (DDM): 41°29.502'N, 123°29.286'W

Roof Material: Noncombustible or not applicable
Siding Material: Wood or open sided
Electrical Power: Yes
Gas to Structure: Yes
Comments: Bruce Robison's house

Safety Zone(s): Potential safety zone(s) in area
Comm With ICP: Yes
Water Supply: No reliable water source nearby
Fuel Type: Shrub or timber
Defensible Space: 30 ft treated
Hazards:

Defensible, Prep and Hold

Mitigation Time (in hours): 15
Mitigation Description: Thin / remove combustibles

Resources Needed to Protect Structure: Sprinkler

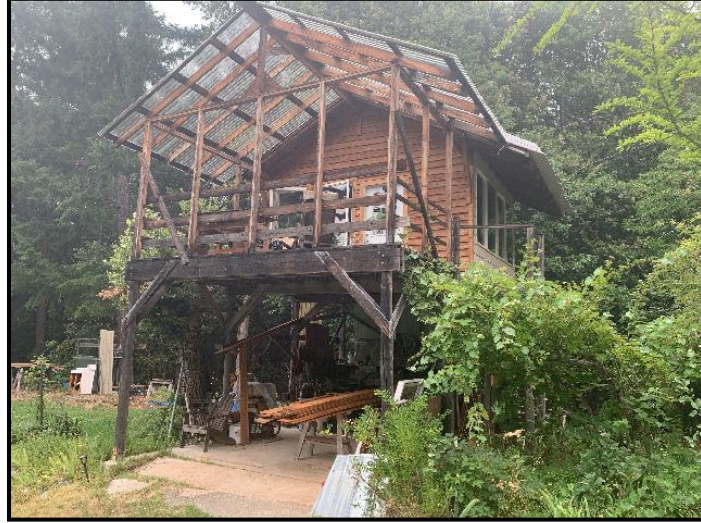
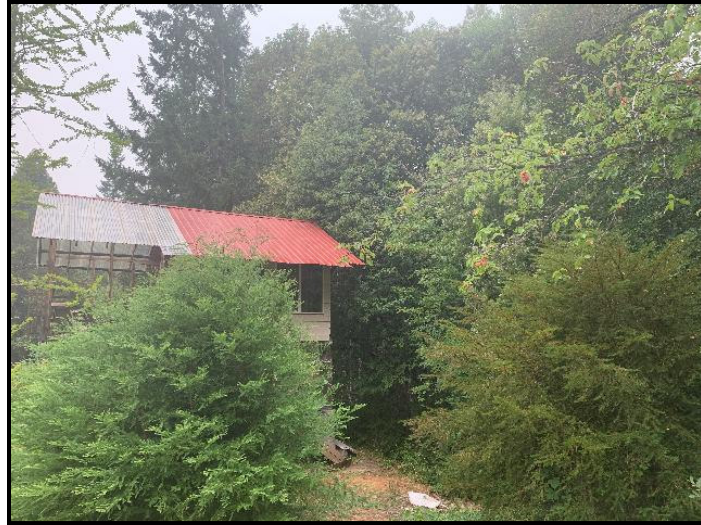
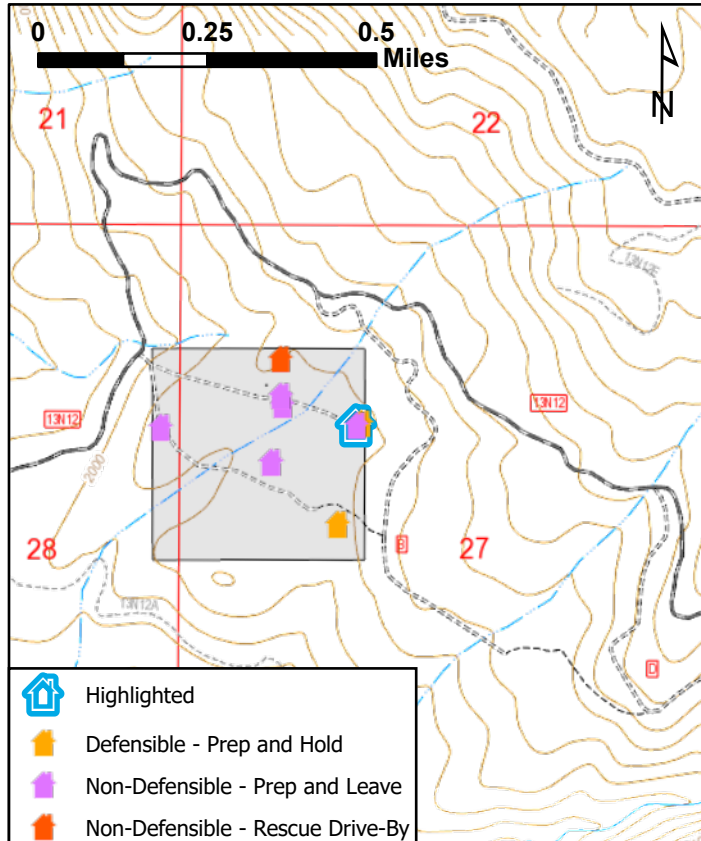
Area: Patterson
Address: 13N12A(4)
Assigned Structure Number: 70
Type of Structure: MixedUse
Primary Structures: 1
Outbuildings:
Is the building Occupied?: Yes
Coordinates (DDM): 41°29.500'N, 123°29.295'W

Roof Material: Noncombustible or not applicable
Siding Material: Wood or open sided
Electrical Power: Yes
Gas to Structure: No
Comments: Robison's guest house. Storage on first floor, bedroom on second

Safety Zone(s): No safety zone(s) in area
Comm With ICP: Yes
Water Supply: No reliable water source nearby
Fuel Type: Shrub or timber
Defensible Space: No defensible space
Hazards: Heavy fuel load

Mitigation Time (in hours): 90
Mitigation Description: Canopies touching structure

Non-Defensible, Prep and Leave

Resources Needed to Protect Structure: Sprinkler
