McCash Fire Structure Triage Assessment

CASRF000651
August 20, 2021

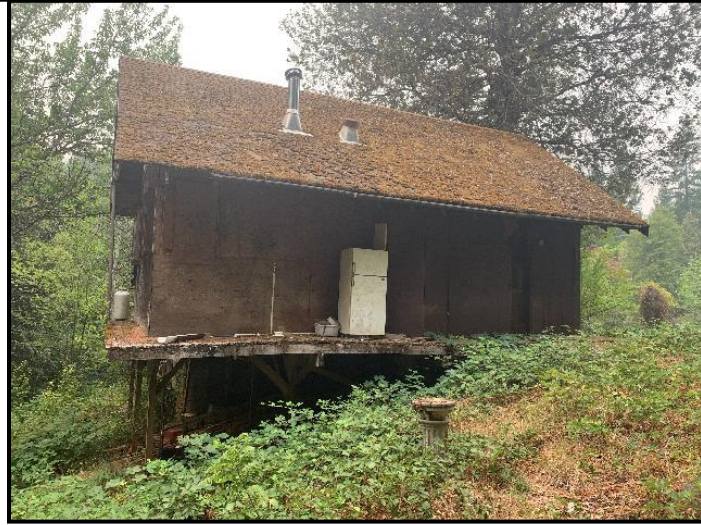
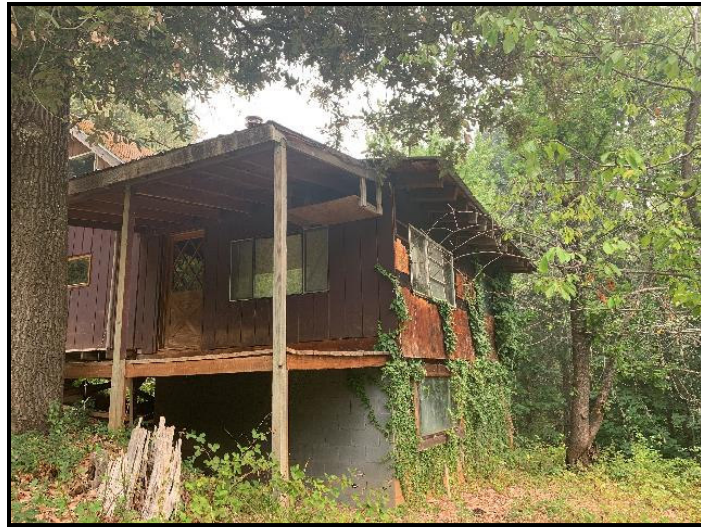
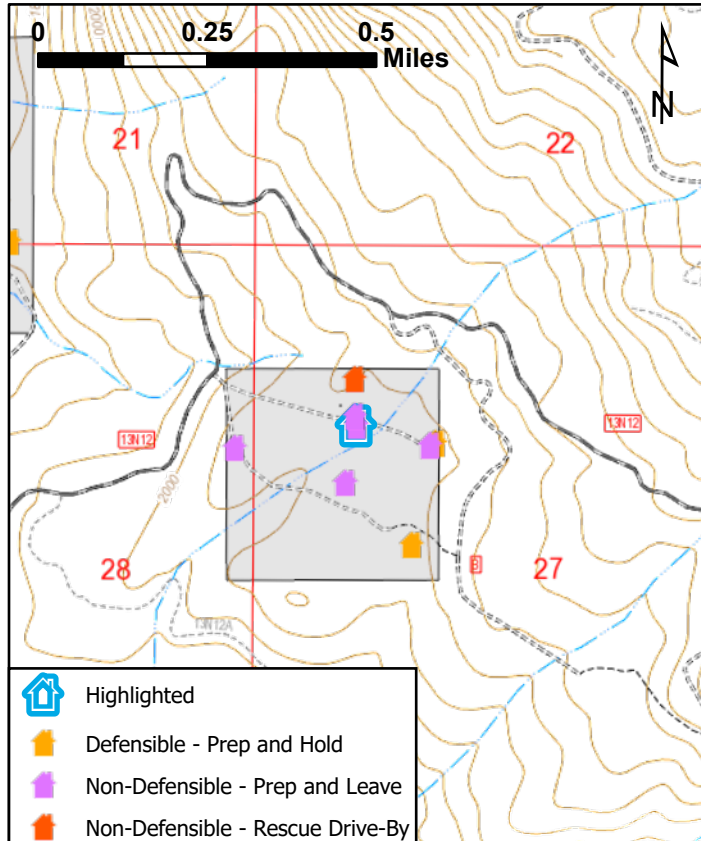
Area: Patterson
Address: 13N12B(1)
Assigned Structure Number: 72
Type of Structure: Residential
Primary Structures: 1
Outbuildings:
Is the building Occupied?: No
Coordinates (DDM): 41°29.525'N, 123°29.422'W

Roof Material: Combustible or no roof
Siding Material: Wood or open sided
Electrical Power: No
Gas to Structure: No
Comments: Brinkley's house. Moss overgrown on roof

Safety Zone(s): No safety zone(s) in area
Comm With ICP: Yes
Water Supply: No reliable water source nearby
Fuel Type: Shrub or timber
Defensible Space: Less than 30 ft treated
Hazards:

Non-Defensible, Prep and Leave

Mitigation Time (in hours): 45
Mitigation Description: Scratch line and thinning

Resources Needed to Protect Structure: Sprinkler

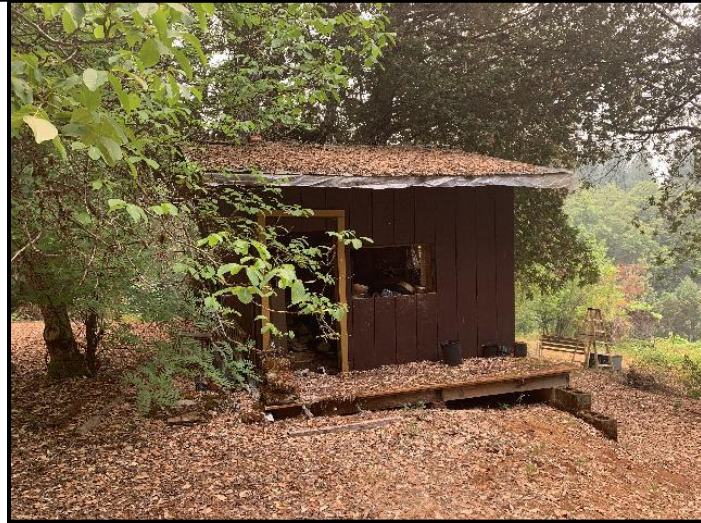
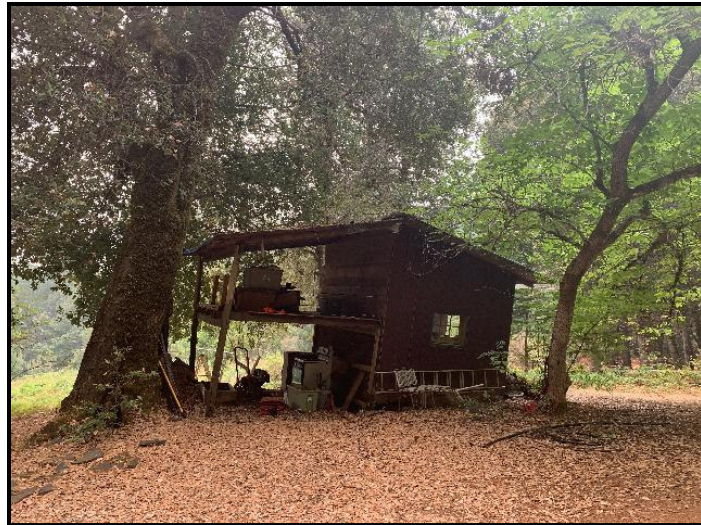
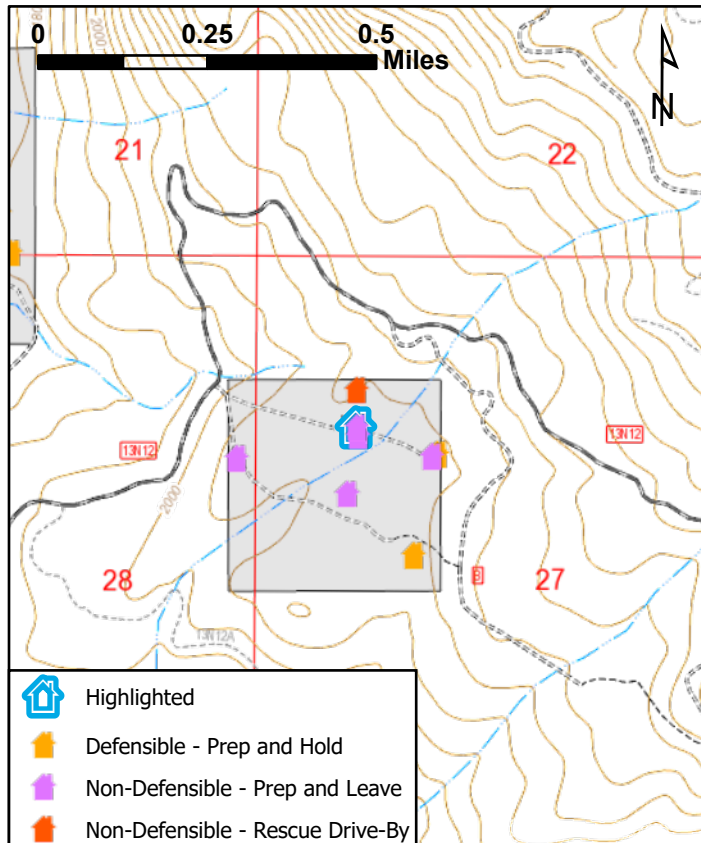
Area: Patterson
Address: 13N12B(1b)
Assigned Structure Number: 73
Type of Structure: Outbuilding
Primary Structures: 1
Outbuildings:
Is the building Occupied?: No
Coordinates (DDM): 41°29.537'N, 123°29.425'W

Roof Material: Combination of fire resistant and combustible
Siding Material: Wood or open sided
Electrical Power: No
Gas to Structure: No
Comments:

Safety Zone(s): No safety zone(s) in area
Comm With ICP: Yes
Water Supply: No reliable water source nearby
Fuel Type: Shrub or timber
Defensible Space: 30 ft treated
Hazards: Collapse potential

Non-Defensible, Prep and Leave

Mitigation Time (in hours): 1
Mitigation Description: Scratch line

Resources Needed to Protect Structure: Sprinkler

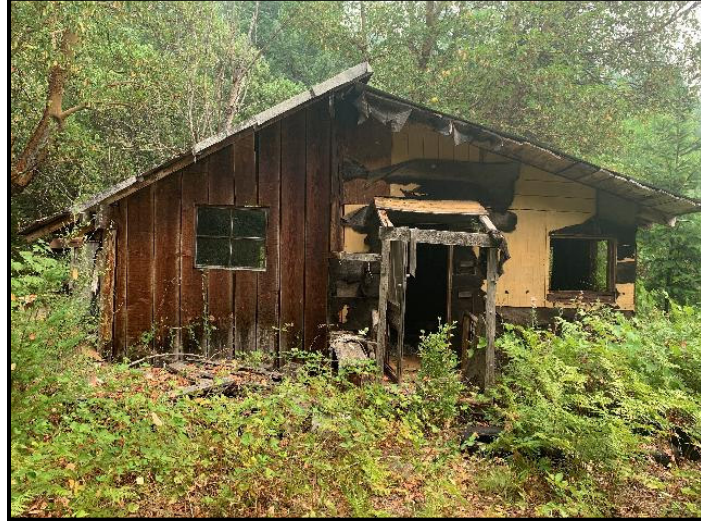
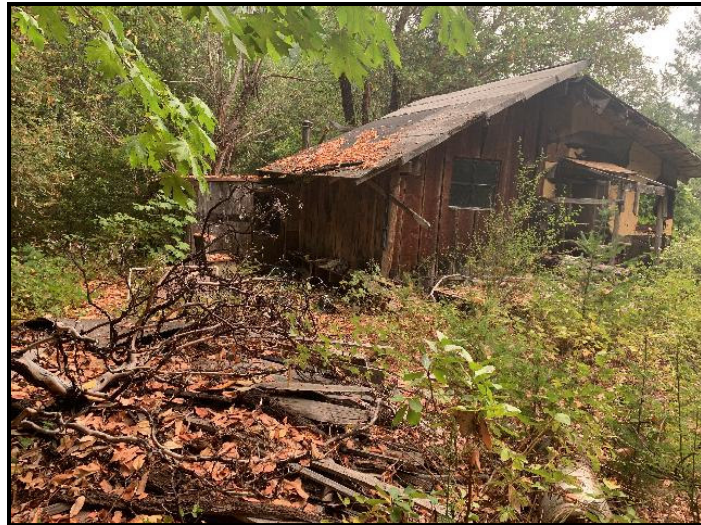
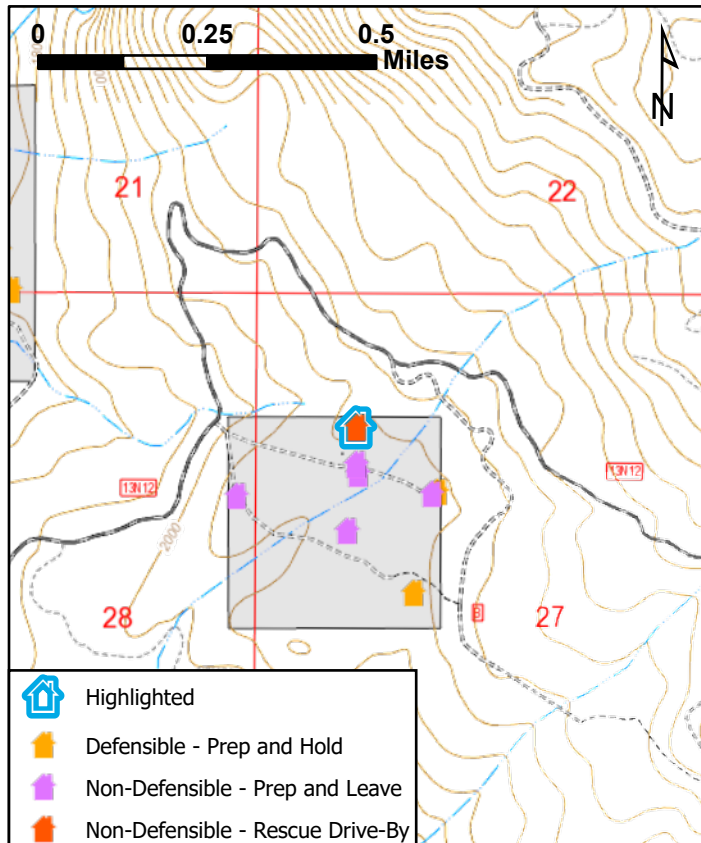
Area: Patterson
Address: 13N12B(2)
Assigned Structure Number: 74
Type of Structure: Residential
Primary Structures: 1
Outbuildings:
Is the building Occupied?: No
Coordinates (DDM): 41°29.584'N, 123°29.425'W

Safety Zone(s): No safety zone(s) in area
Comm With ICP: Yes
Water Supply: No reliable water source nearby
Fuel Type: Shrub or timber
Defensible Space: No defensible space
Hazards: Structure itself and surrounding fuels

Non-Defensible, Rescue, Drive By

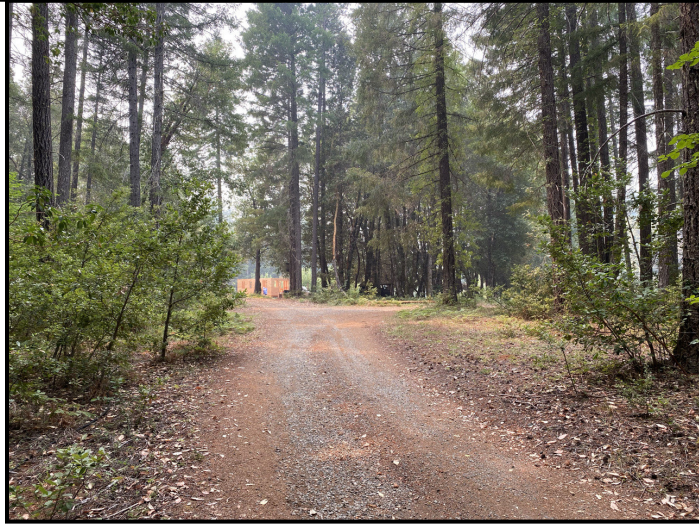
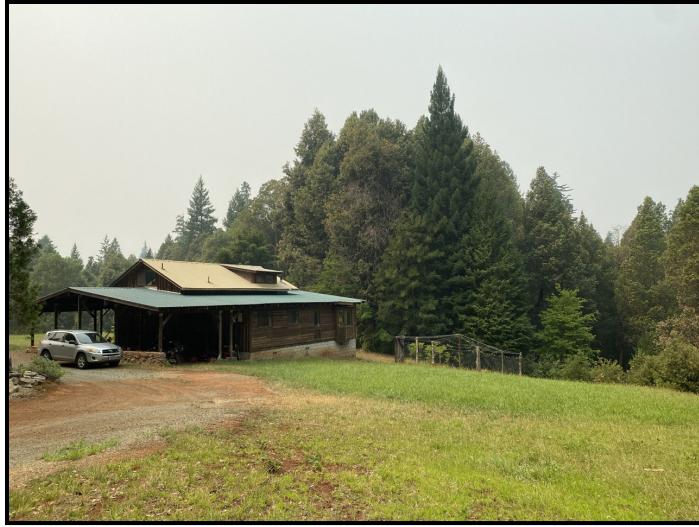
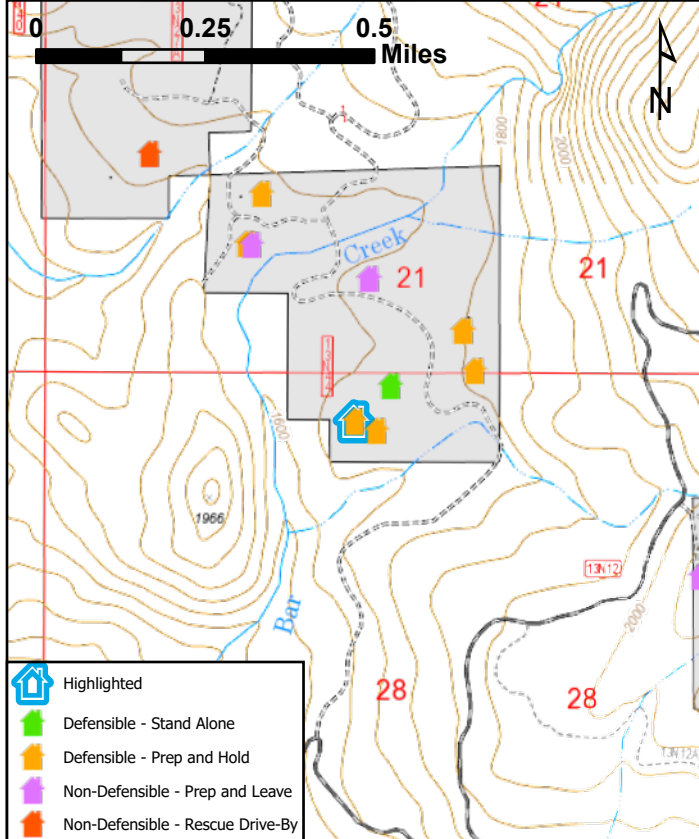
Roof Material: Noncombustible or not applicable
Siding Material: Wood or open sided
Electrical Power: No
Gas to Structure: Yes
Comments: Walt Simpson. Raised cinder block foundation, wood siding with metal roof.

Safety Zone(s): No safety zone(s) in area
Comm With ICP: No
Water Supply: Limited or dependent on electricity
Fuel Type: Shrub or timber
Defensible Space: 30 ft treated
Hazards: Propane tank

Defensible, Prep and Hold

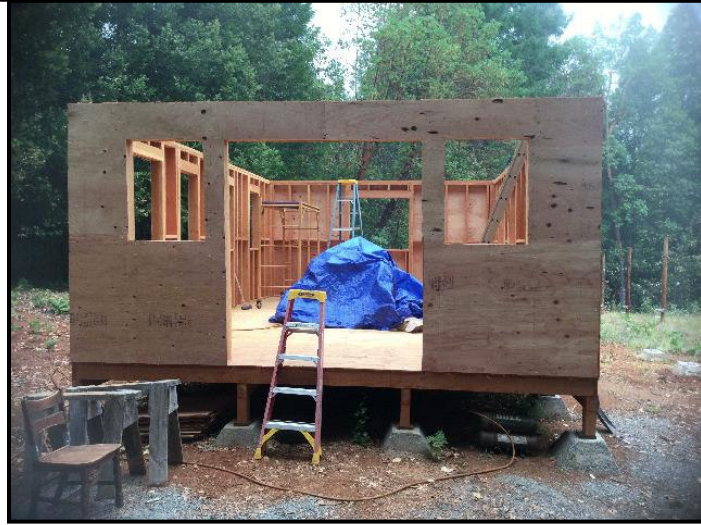
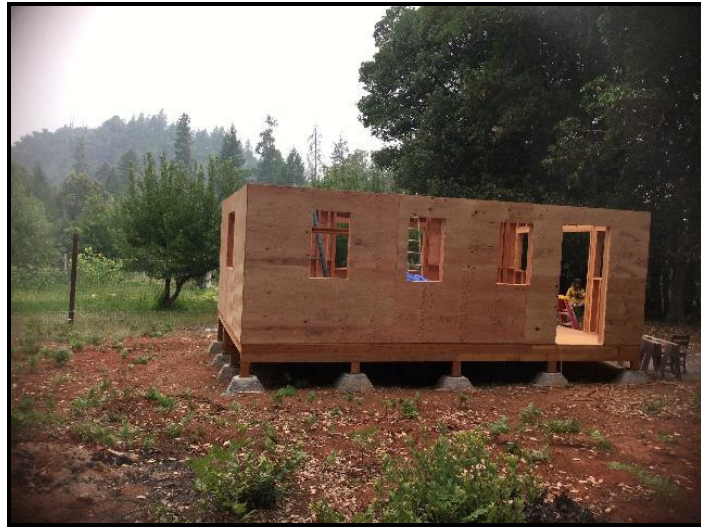
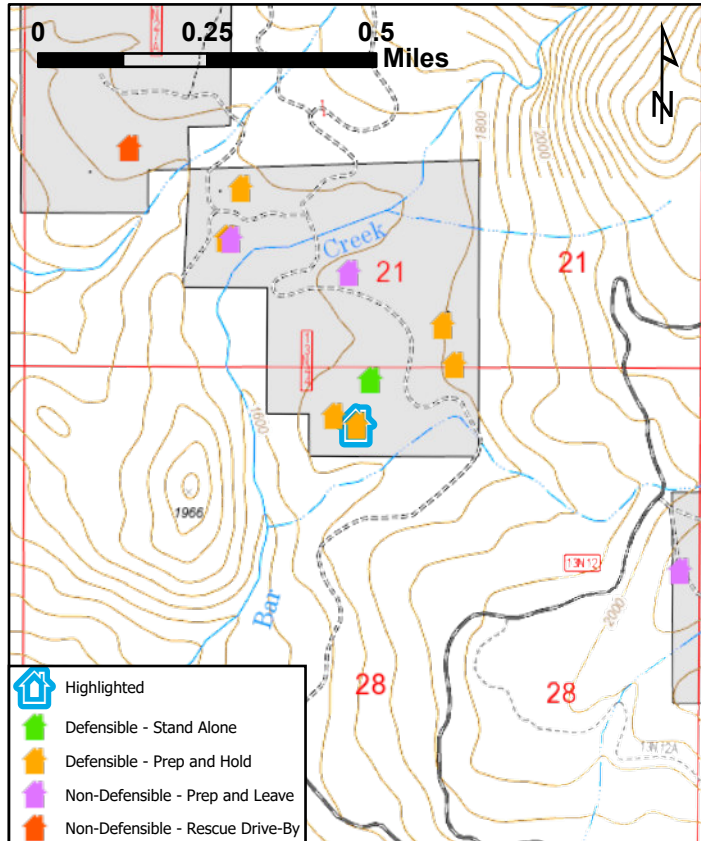
Safety Zone(s): No safety zone(s) in area
Comm With ICP: Yes
Water Supply: Limited or dependent on electricity
Fuel Type: Shrub or timber
Defensible Space: 30 ft treated
Hazards:

Defensible, Prep and Hold

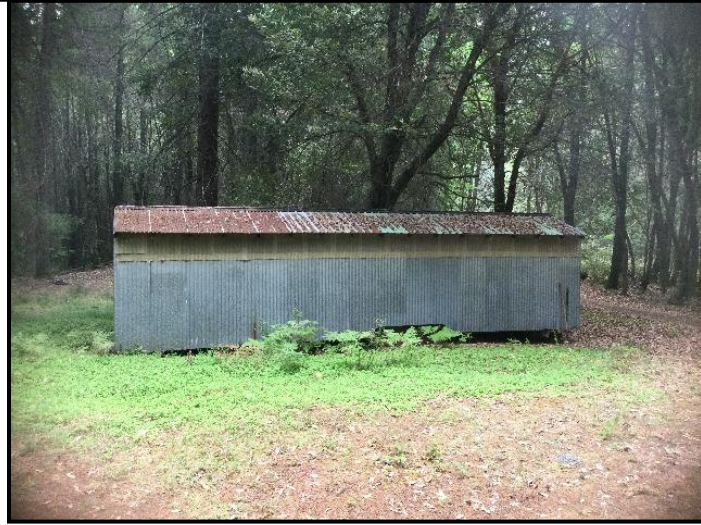
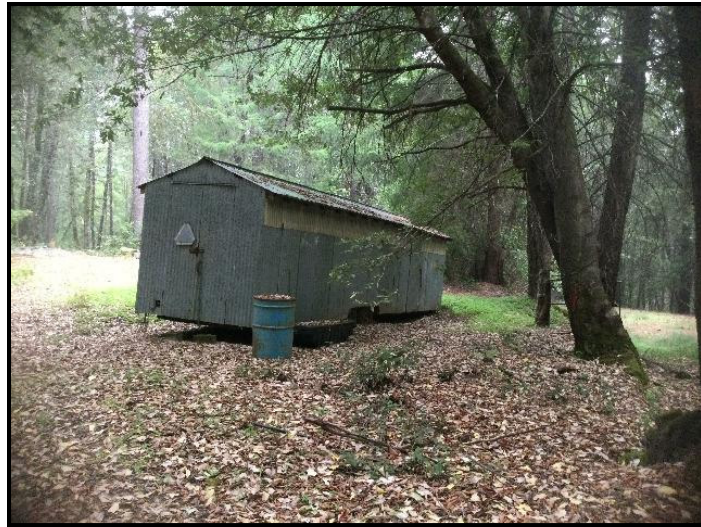
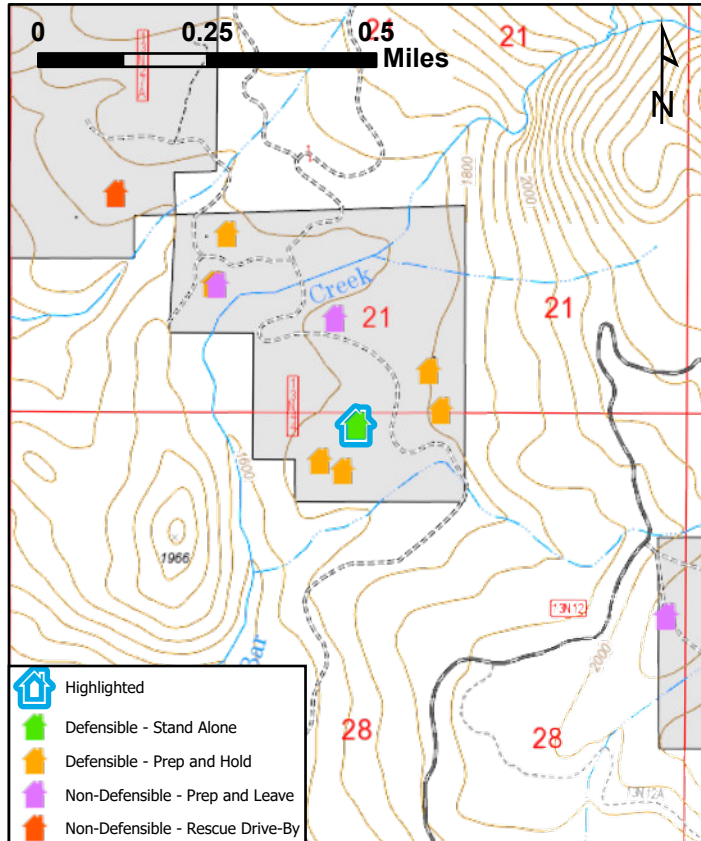
Safety Zone(s): No safety zone(s) in area
Comm With ICP: Yes
Water Supply: No reliable water source nearby
Fuel Type: Shrub or timber
Defensible Space: 30 ft treated
Hazards:

Defensible, Stand Alone

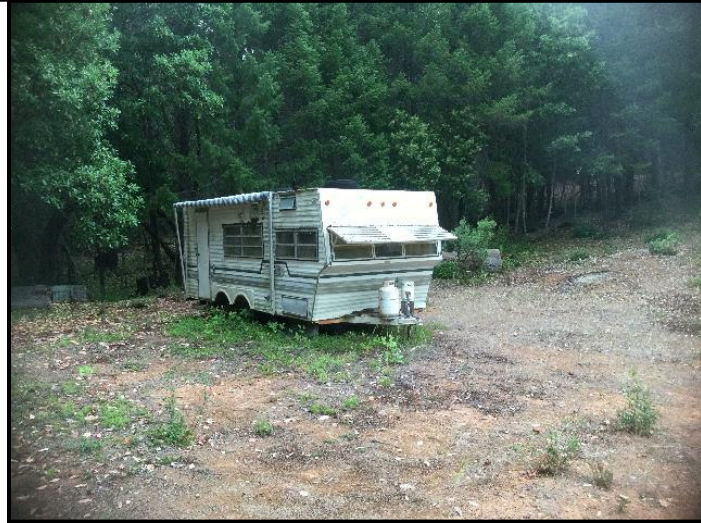
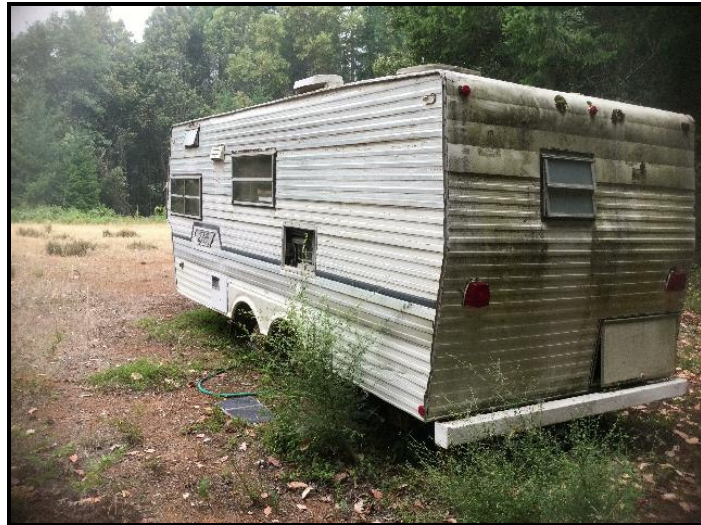
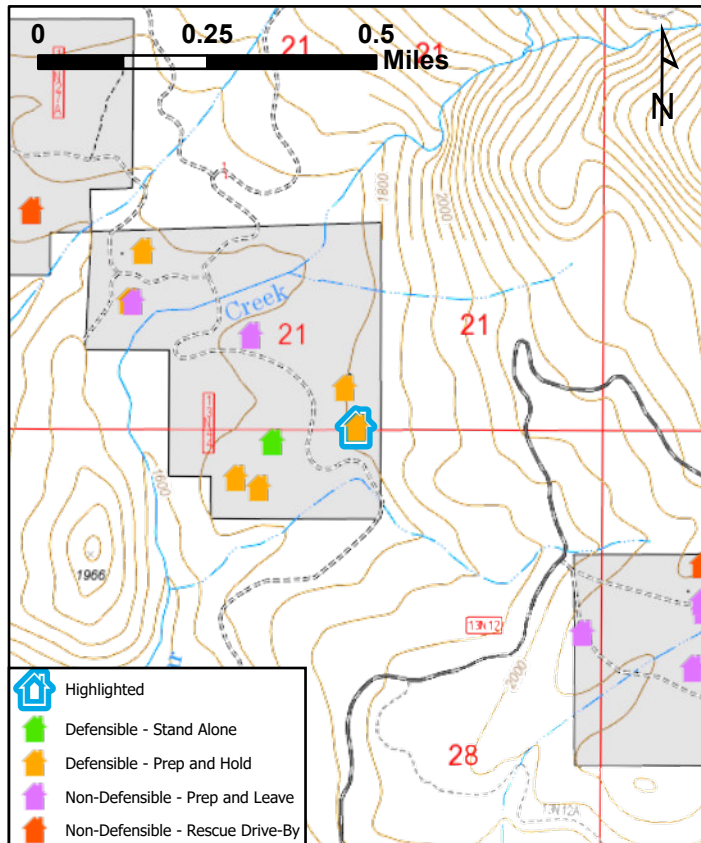
Safety Zone(s): Potential safety zone(s) in area
Comm With ICP: Yes
Water Supply: No reliable water source nearby
Fuel Type: Shrub or timber
Defensible Space: Less than 30 ft treated
Hazards:

Defensible, Prep and Hold

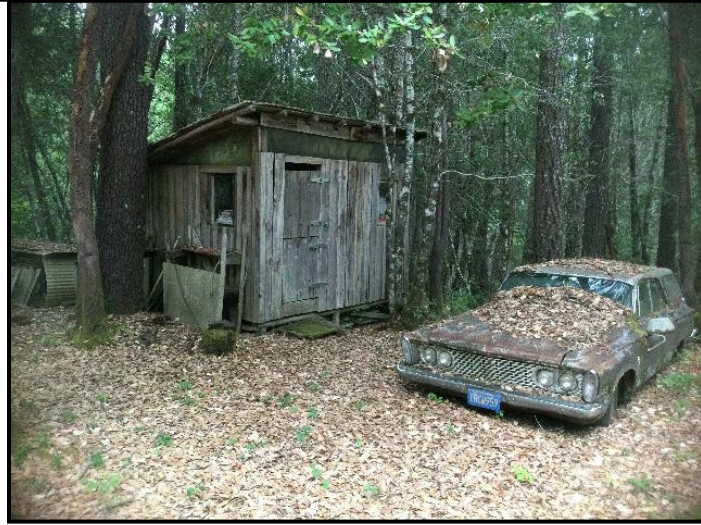
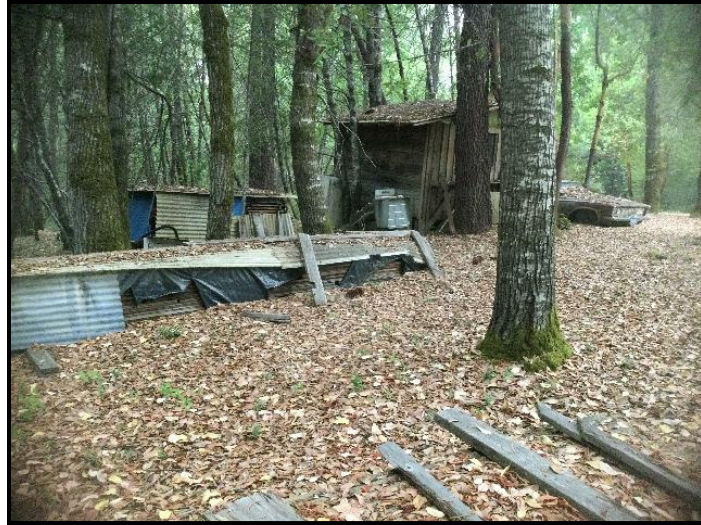
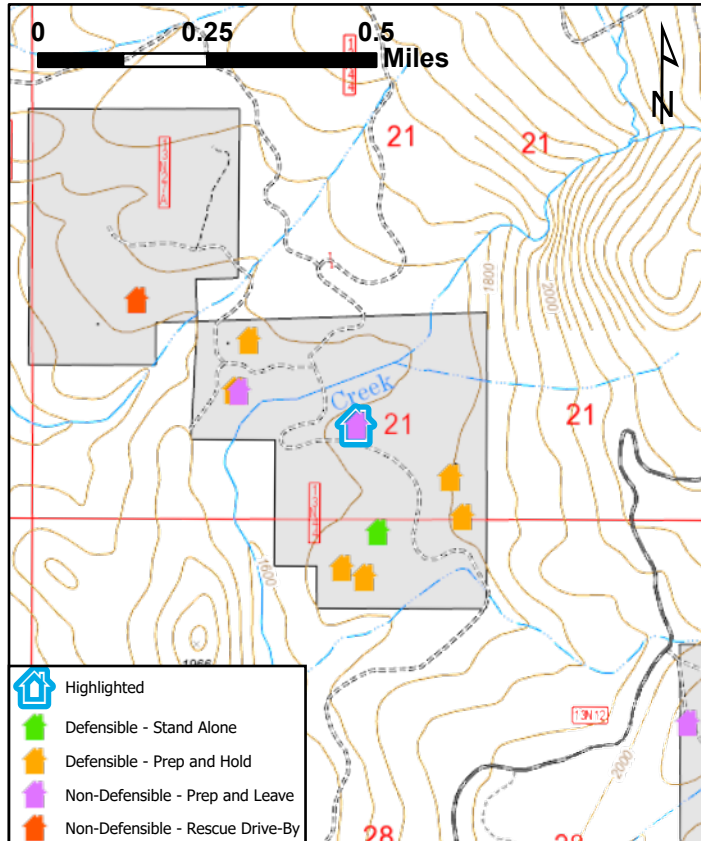
Safety Zone(s): No safety zone(s) in area
Comm With ICP: Yes
Water Supply: No reliable water source nearby
Fuel Type: Shrub or timber
Defensible Space: Less than 30 ft treated
Hazards:

Non-Defensible, Prep and Leave
