McCash Fire Structure Triage Assessment

CASRF000651
August 20, 2021

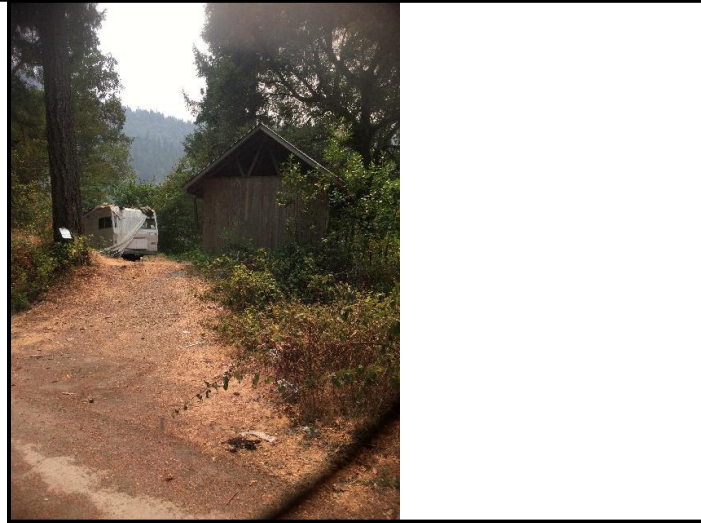
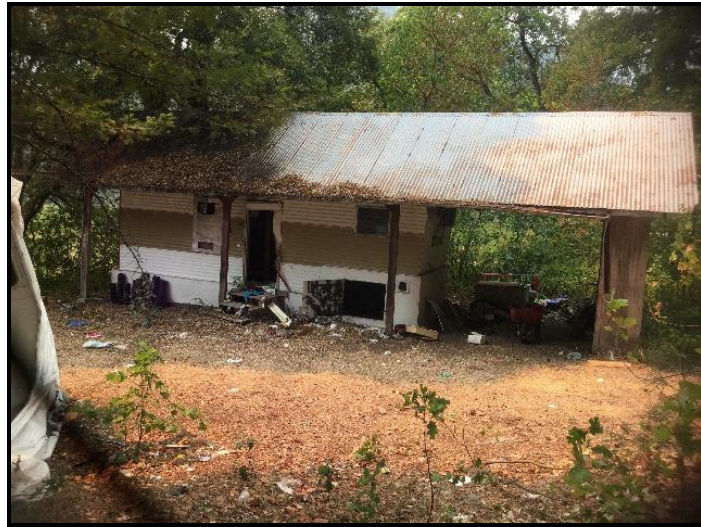
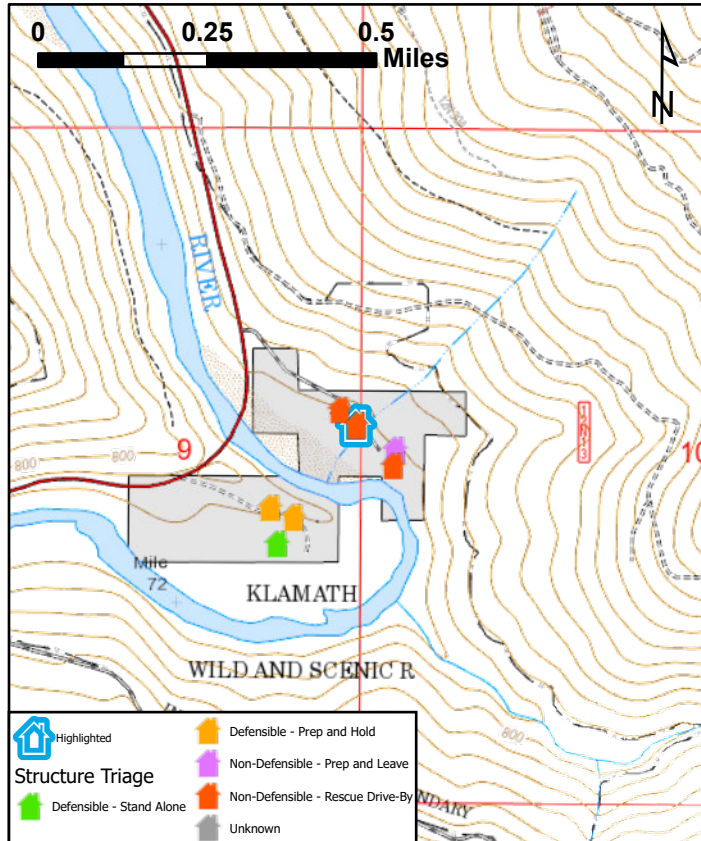
Area: Rodgers Creek
Address: Unknown
Assigned Structure Number: 159
Type of Structure: Outbuilding
Primary Structures: 1
Outbuildings: 2
Is the building Occupied?: No
Coordinates (DDM): 41° 26.918' N, 123° 29.499' W

Roof Material: Combustible or no roof
Siding Material: Wood or open sided
Electrical Power: No
Gas to Structure: No
Comments: 3 travel trailers. Main one has wood roof over the top. All abandon

Safety Zone(s): No safety zone(s) in area
Comm With ICP: Yes
Water Supply: Reliable water source nearby
Fuel Type: Shrub or timber
Defensible Space: Less than 30 ft treated
Hazards: River bottom. Abandon vehicles and trash.

Non-Defensible, Rescue, Drive By

Mitigation Time (in hours): 2
Mitigation Description: Brush out and line structure

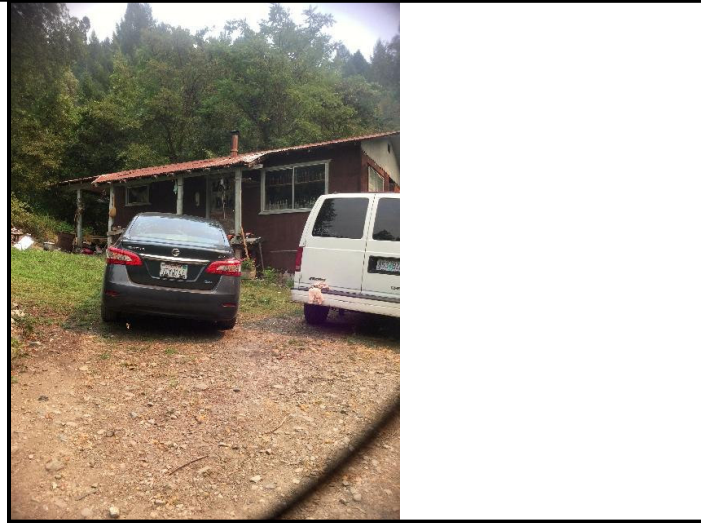
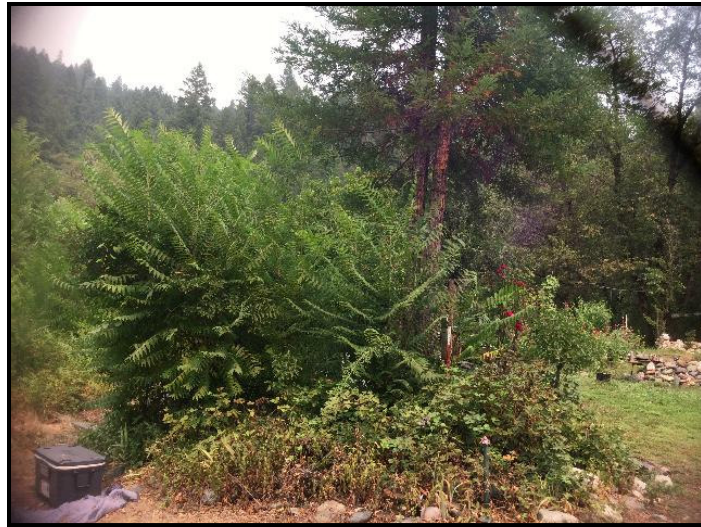
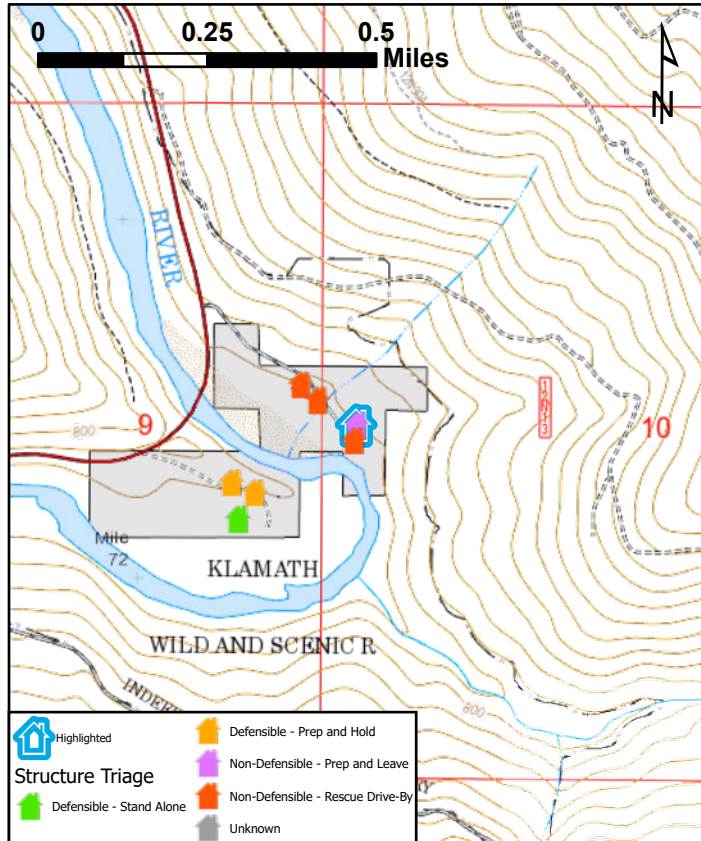
Area: Rodgers Creek
Address: Unknown
Assigned Structure Number: 160
Type of Structure: Residential
Primary Structures: 1
Outbuildings: 2
Is the building Occupied?: Yes
Coordinates (DDM): 41° 26.887' N, 123° 29.433' W

Roof Material: Noncombustible or not applicable
Siding Material: Wood or open sided
Electrical Power: No
Gas to Structure: No
Comments: 1500 gallon water tank uphill from the house.

Safety Zone(s): No safety zone(s) in area
Comm With ICP: Yes
Water Supply: Reliable water source nearby
Fuel Type: Shrub or timber
Defensible Space: Less than 30 ft treated
Hazards: Canyon/ river bottom

Non-Defensible, Prep and Leave

Mitigation Time (in hours): 2
Mitigation Description: Brush around the back of house and line the structure. Hose lay and several sprinklers

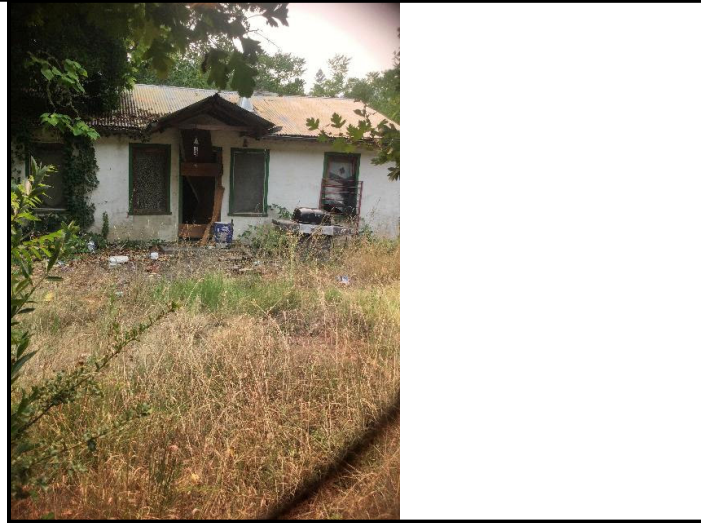
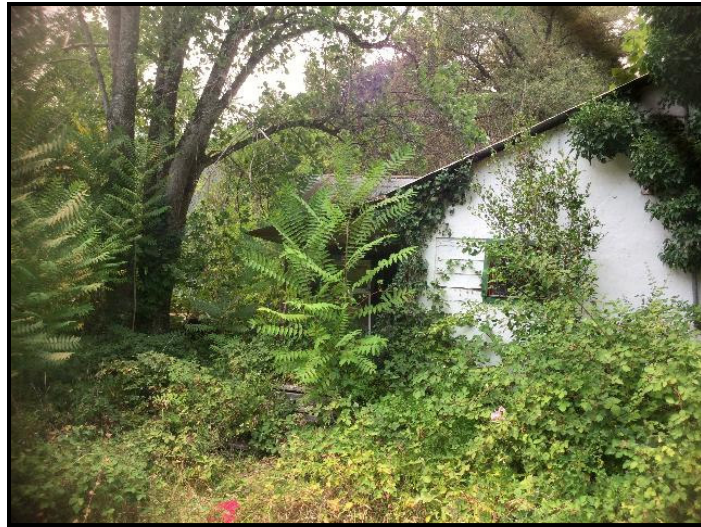
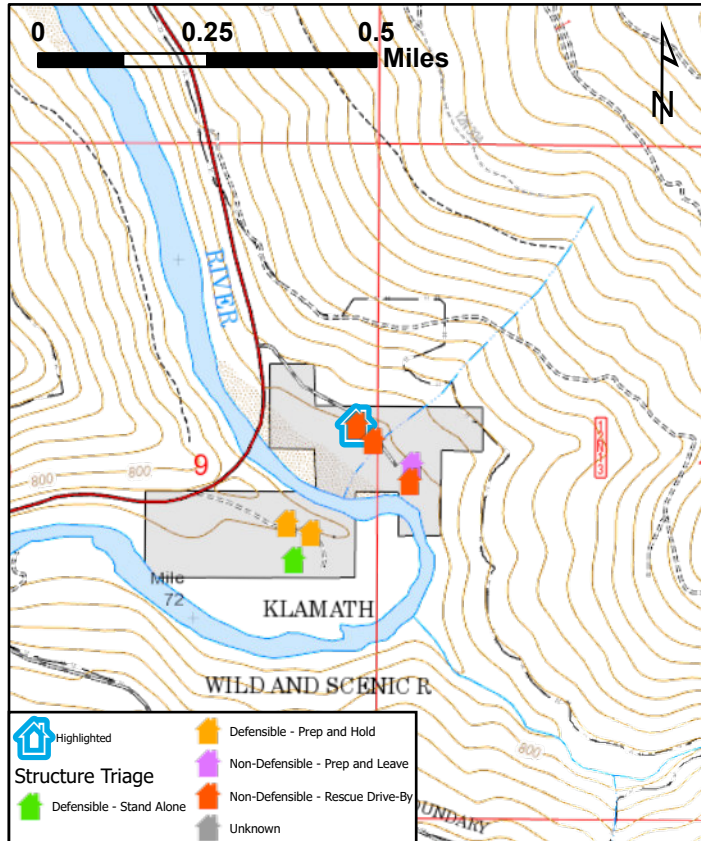
Area: Rodgers Creek
Address: Rodgers creek
Assigned Structure Number: 161
Type of Structure: Residential
Primary Structures: 1
Outbuildings: 0
Is the building Occupied?: No
Coordinates (DDM): 41° 26.938' N, 123° 29.528' W

Roof Material: Noncombustible or not applicable
Siding Material: Rock, concrete, metal
Electrical Power: Unknown
Gas to Structure: Unknown
Comments: Abandon house no front door and broken windows.

Safety Zone(s): No safety zone(s) in area
Comm With ICP: Yes
Water Supply: Reliable water source nearby
Fuel Type: Shrub or timber
Defensible Space: Less than 30 ft treated
Hazards: River bottom. Hazardous waste and abandoned vehicles

Non-Defensible, Rescue, Drive By

Mitigation Time (in hours): 2
Mitigation Description: Brush out next to stucuture and set up sprinklers if needed

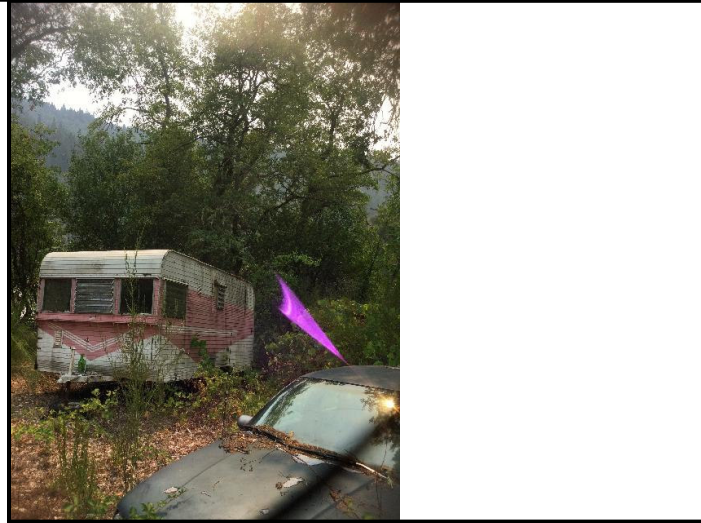
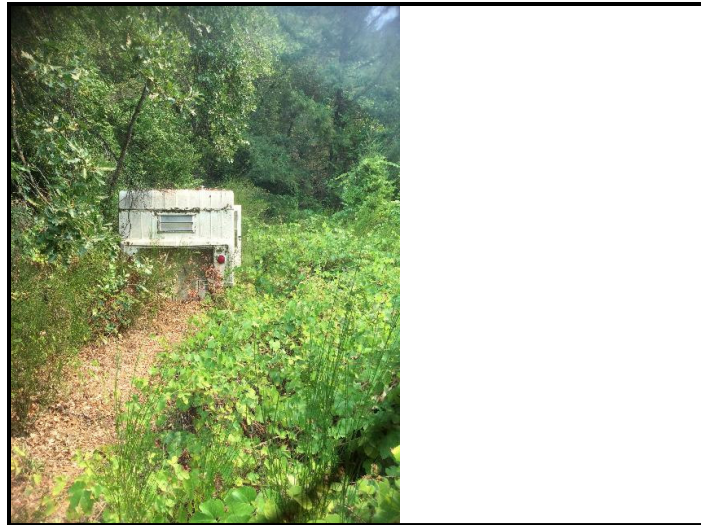
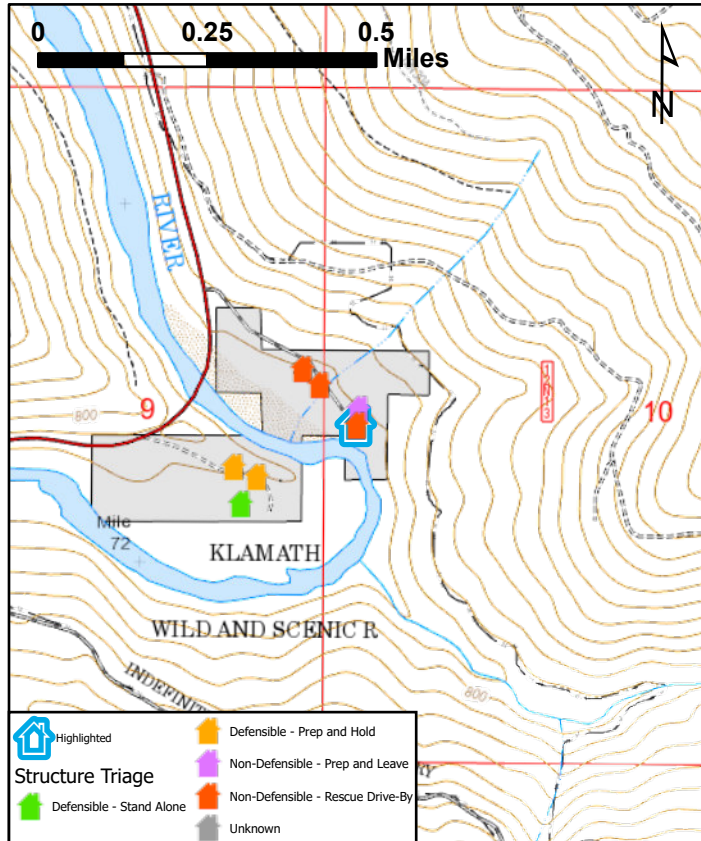
Area: Rodgers Creek
Address: Unknown
Assigned Structure Number: 162
Type of Structure: Outbuilding
Primary Structures: 1
Outbuildings: 1
Is the building Occupied?: No
Coordinates (DDM): 41° 26.866' N, 123° 29.436' W

Roof Material: Noncombustible or not applicable
Siding Material: Rock, concrete, metal
Electrical Power: No
Gas to Structure: No
Comments: Abandon travel trailer. Out building is another old trailer 100 yards to the east.

Safety Zone(s): No safety zone(s) in area
Comm With ICP: Yes
Water Supply: Reliable water source nearby
Fuel Type: Shrub or timber
Defensible Space: No defensible space
Hazards:

Non-Defensible, Rescue, Drive By

Mitigation Time (in hours): 1
Mitigation Description: Brush out and rake

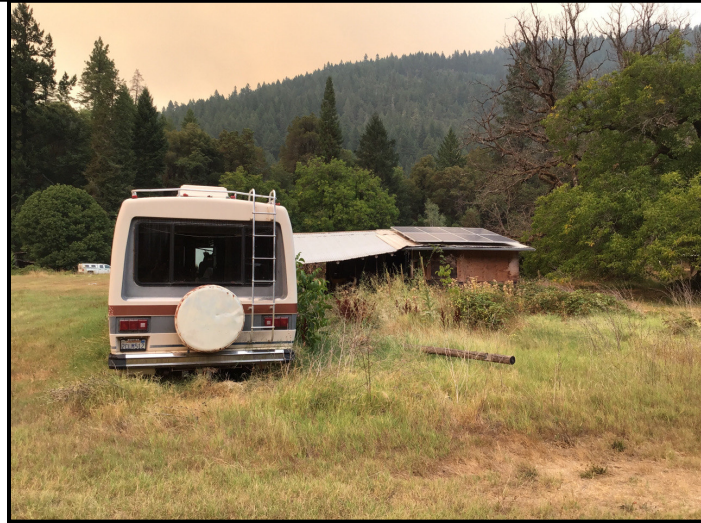
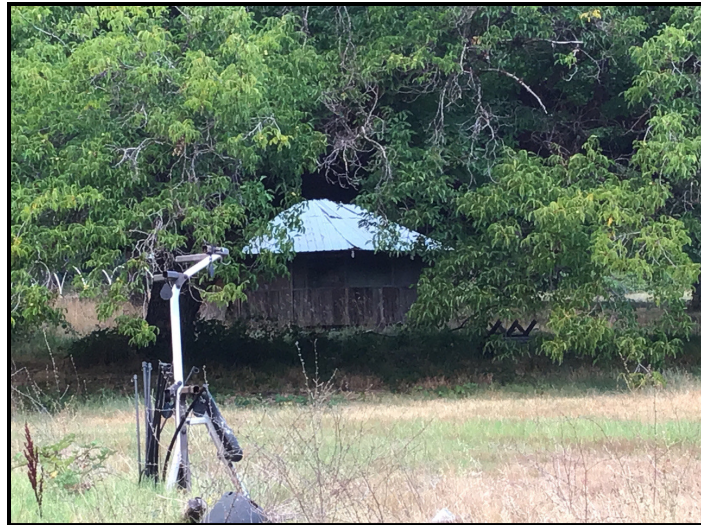
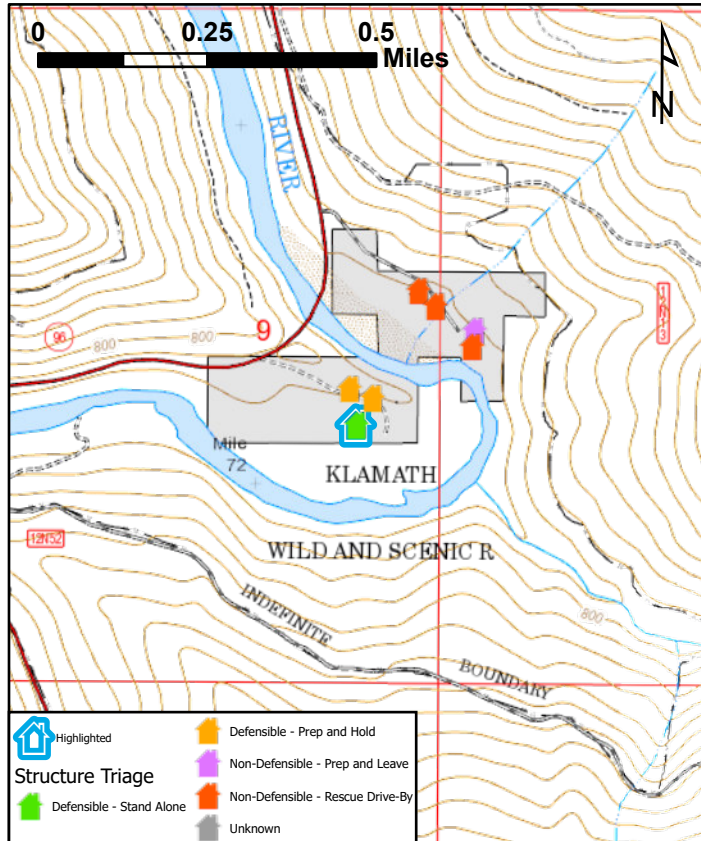
Area: Rodgers Creek
Address:
Assigned Structure Number: 165
Type of Structure: Outbuilding
Primary Structures:
Outbuildings: 3
Is the building Occupied?: Yes
Coordinates (DDM): 41° 26.765' N, 123° 29.634' W

Roof Material: Noncombustible or not applicable
Siding Material:
Electrical Power: Yes
Gas to Structure: No
Comments: Solar station, round storage shed and dilapidated RV

Safety Zone(s): Potential safety zone(s) in area
Comm With ICP: Yes
Water Supply: No reliable water source nearby
Fuel Type: Grass/tundra, northern hardwood litter
Defensible Space: 30 ft treated
Hazards: Solar panel batteries

Defensible, Stand Alone

Mitigation Time (in hours): 2
Mitigation Description: Scrape line, pump, water tank, sprinklers. Main power source,

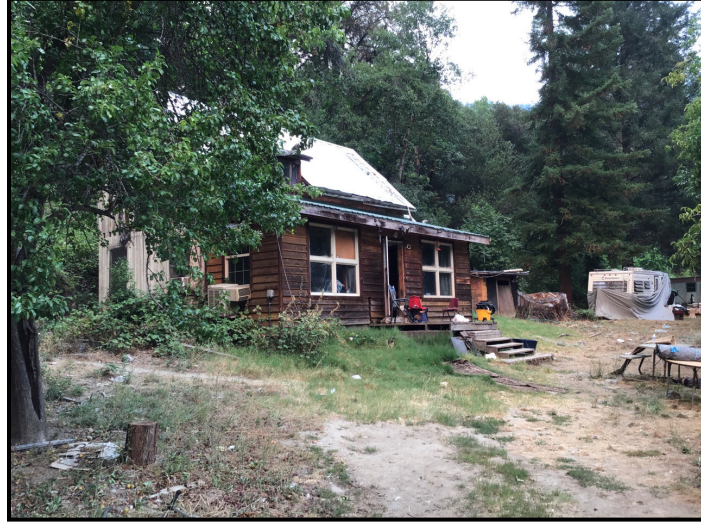
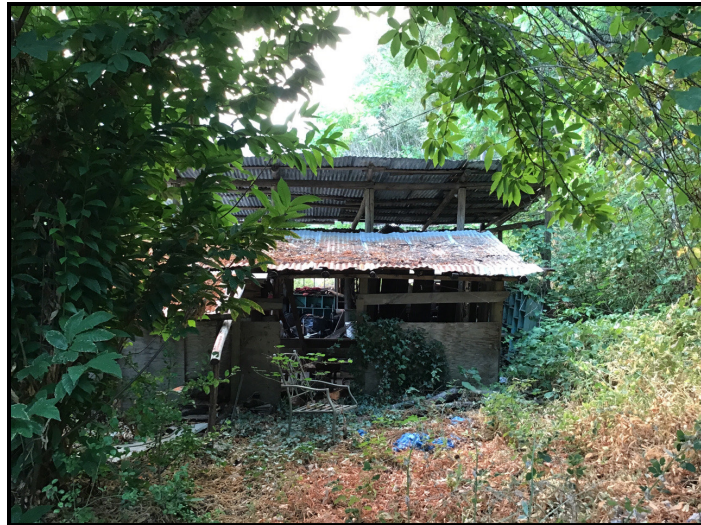
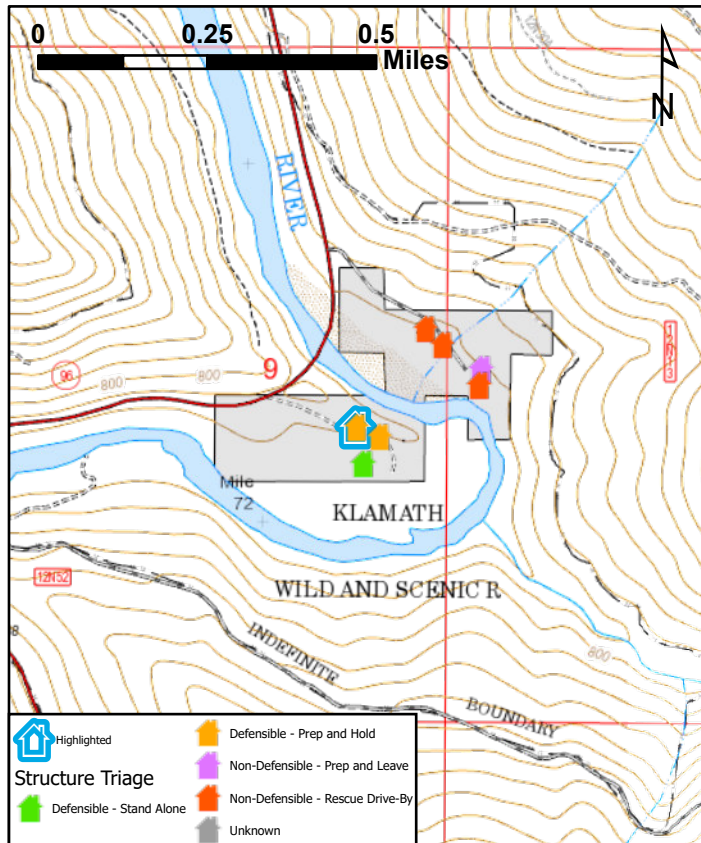
Area: Rodgers Creek
Address:
Assigned Structure Number: 168
Type of Structure: Residential
Primary Structures:
Outbuildings: 2
Is the building Occupied?: Yes
Coordinates (DDM): 41° 26.811' N, 123° 29.646' W

Roof Material: Noncombustible or not applicable
Siding Material: Wood or open sided
Electrical Power: Yes
Gas to Structure: Yes
Comments: On generator power, propane Asa Donahue+ kids

Safety Zone(s): Potential safety zone(s) in area
Comm With ICP: Yes
Water Supply: No reliable water source nearby
Fuel Type: Shrub or timber
Defensible Space: Less than 30 ft treated
Hazards:

Defensible, Prep and Hold

Mitigation Time (in hours): 3
Mitigation Description: Set up tank, pump, sprinklers, brush back of house

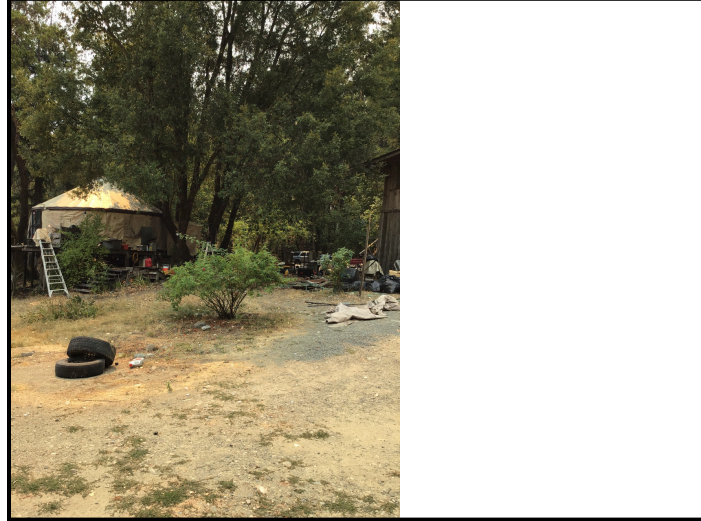
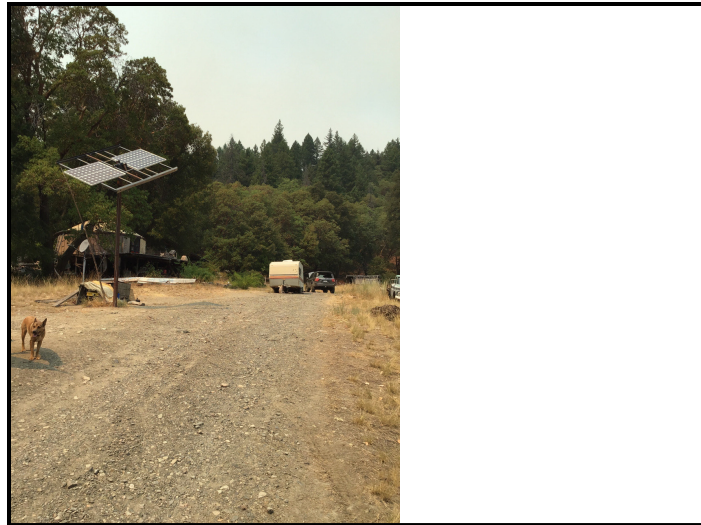
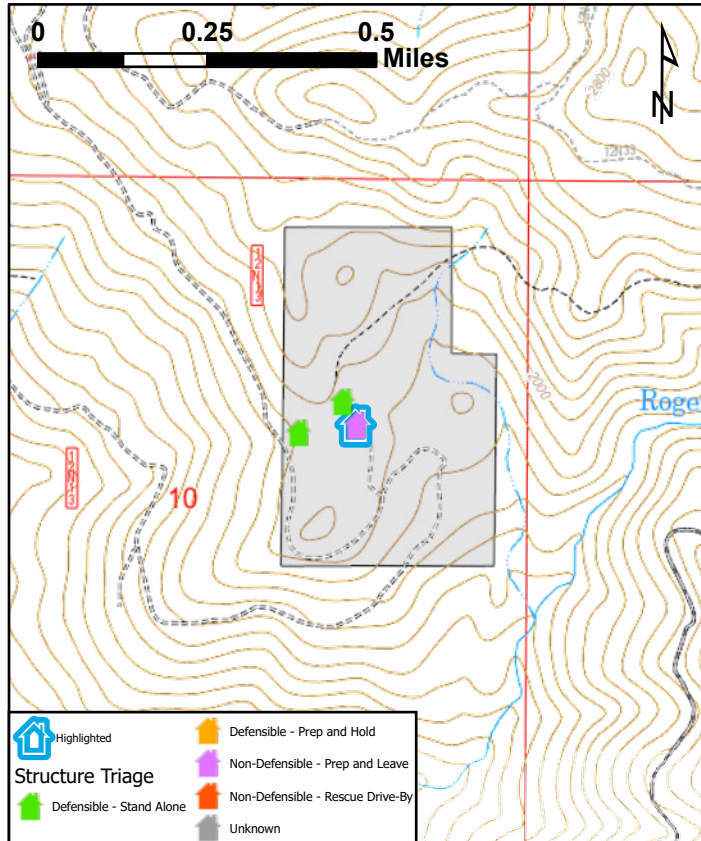
Area: Rodgers Creek
Address:
Assigned Structure Number: 176
Type of Structure: Residential
Primary Structures: 1
Outbuildings: 1
Is the building Occupied?: Yes
Coordinates (DDM): 41° 26.981' N, 123° 28.625' W

Roof Material: Combustible or no roof
Siding Material: Wood or open sided
Electrical Power: No
Gas to Structure: No
Comments: Building has small LP tank with solar electric Rudy Galindo

Safety Zone(s): Potential safety zone(s) in area
Comm With ICP: Yes
Water Supply: No reliable water source nearby
Fuel Type: Shrub or timber
Defensible Space: 30 ft treated
Hazards: General trash and debris, small LP tanks under yurt,

Non-Defensible, Prep and Leave

Mitigation Time (in hours): 4
Mitigation Description: Remove leaf litter, trash and debris, plumb with sprinkler kit and pumpkin

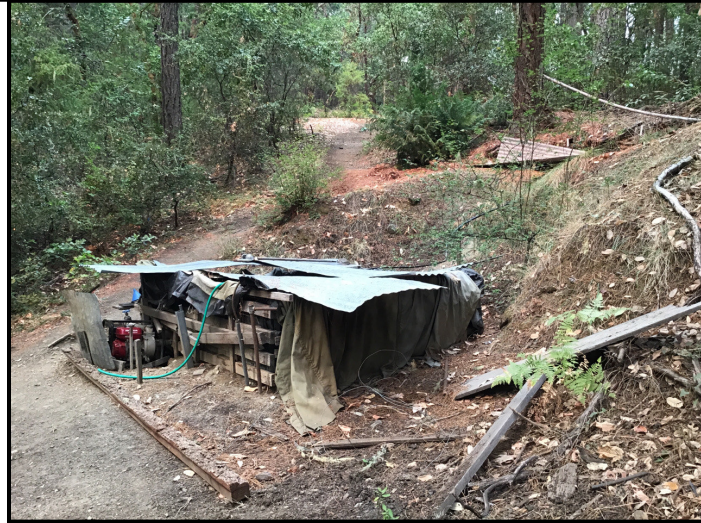
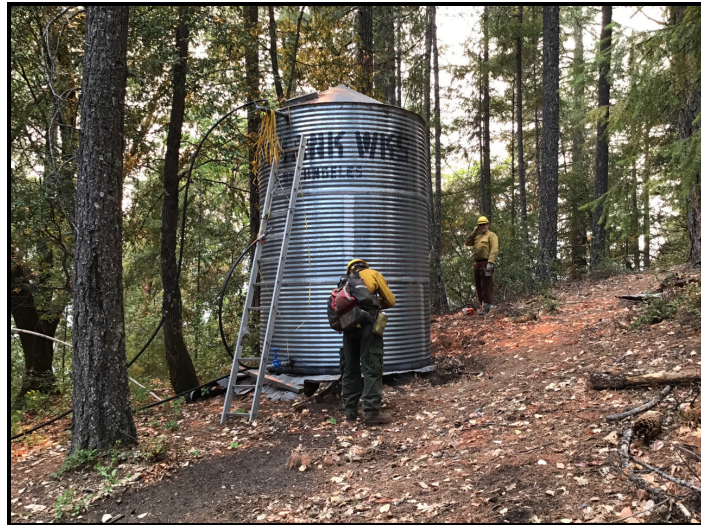
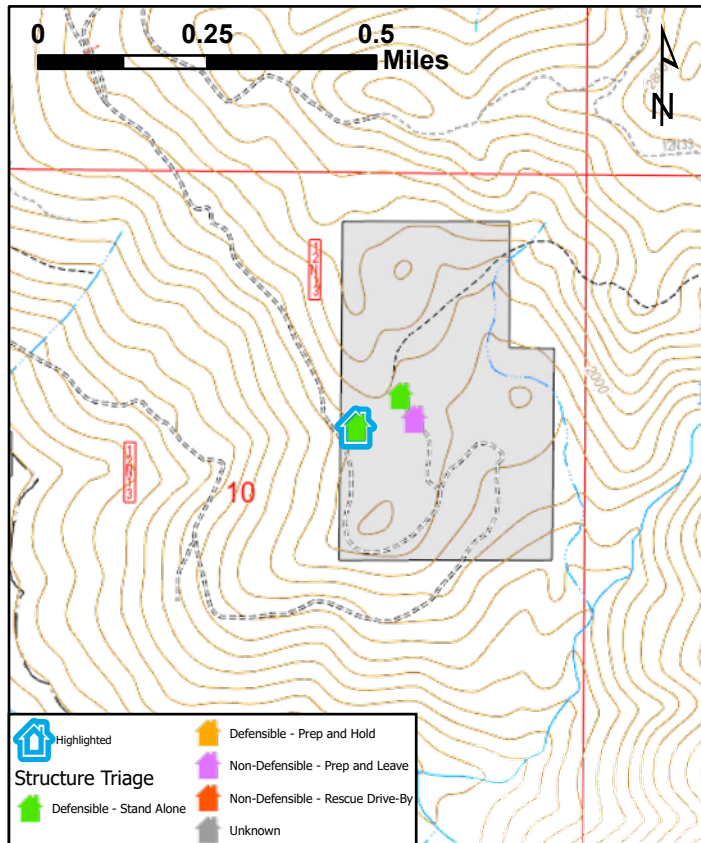
Area: Rodgers Creek
Address:
Assigned Structure Number: 177
Type of Structure: Outbuilding
Primary Structures:
Outbuildings: 1
Is the building Occupied?: No
Coordinates (DDM): 41° 26.970' N, 123° 28.723' W

Roof Material: Noncombustible or not applicable
Siding Material: Wood or open sided
Electrical Power: No
Gas to Structure: No
Comments: Water well with pump

Defensible, Stand Alone

Mitigation Time (in hours): 1
Mitigation Description: Hand line
