McCash Fire Structure Triage Assessment

CASRF000651
August 20, 2021

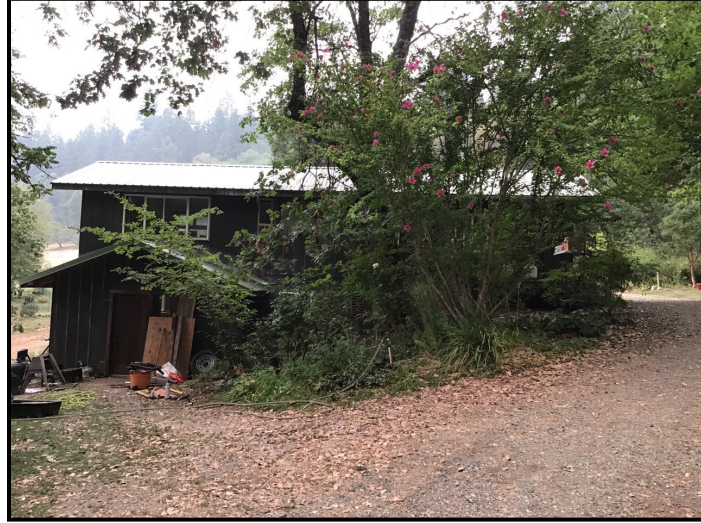
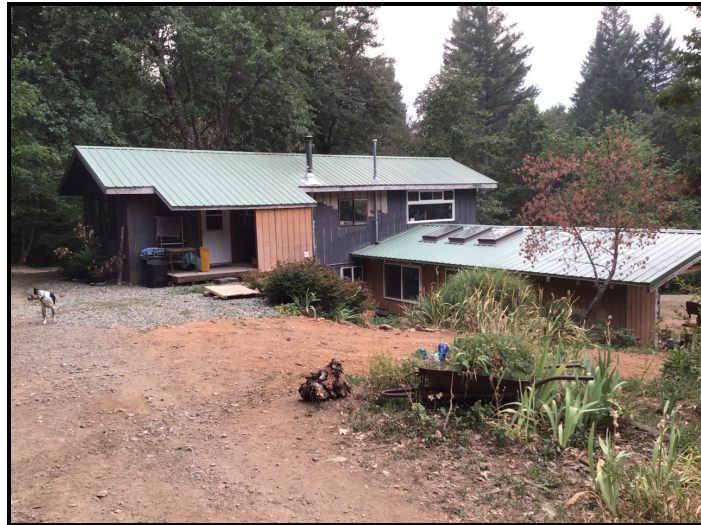
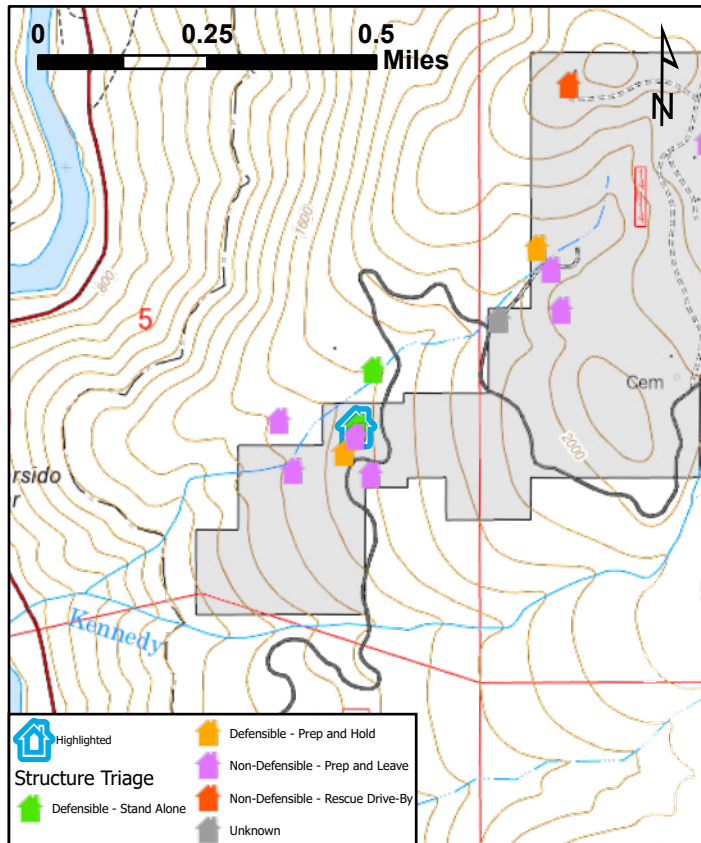
Area: Ti Bar Road
Address: 2117 carter creek
Assigned Structure Number: 108
Type of Structure: Residential
Primary Structures: 1
Outbuildings: 1
Is the building Occupied?: No
Coordinates (DDM): 41° 32.679' N, 123° 30.991' W

Roof Material: Noncombustible or not applicable
Siding Material: Wood or open sided
Electrical Power: Yes
Gas to Structure: Yes
Comments: Residence and enclosed work shop

Safety Zone(s): Potential safety zone(s) in area
Comm With ICP: Yes
Water Supply: Pressurized hydrant(s) or fixed sprinkler system
Fuel Type: Grass and shrub, hardwood litter
Defensible Space: 100 ft treated
Hazards: Propane tank 50 feet beyond structure

Defensible, Stand Alone

Mitigation Time (in hours): 1
Mitigation Description: Rake, remove materials from side of structure

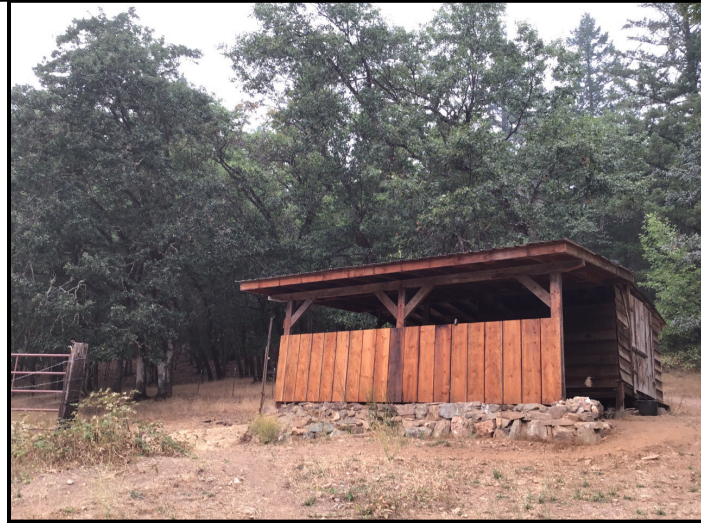
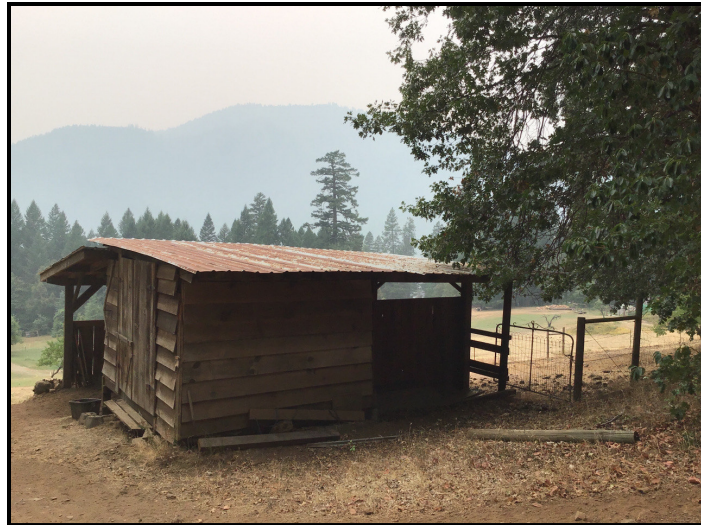
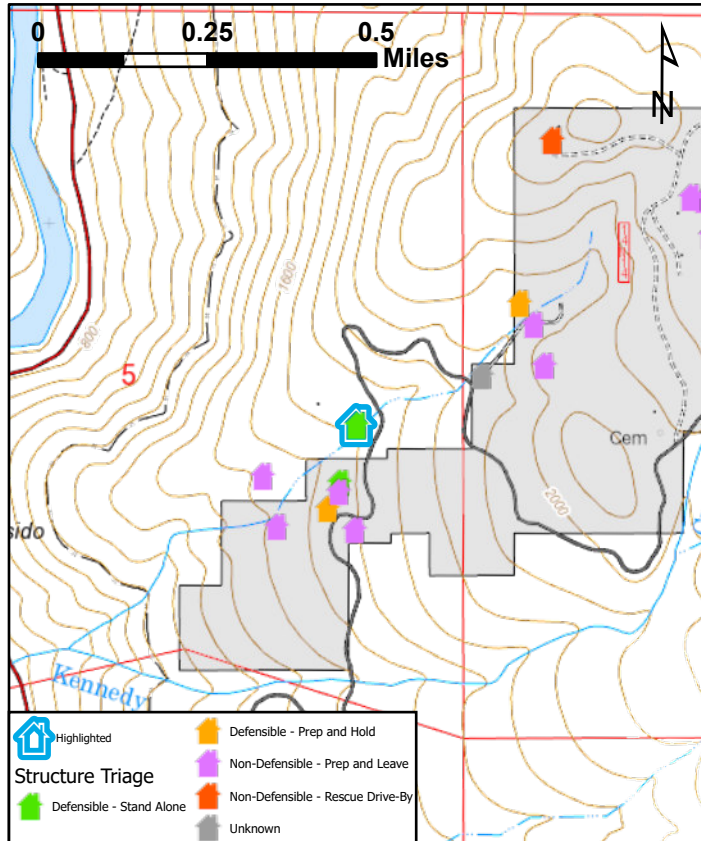
Area: Ti Bar Road
Address: 2117 Carter Creek
Assigned Structure Number: 109
Type of Structure: Outbuilding
Primary Structures:
Outbuildings: 1
Is the building Occupied?: No
Coordinates (DDM): 41° 32.753' N, 123° 30.963' W

Roof Material: Noncombustible or not applicable
Siding Material: Wood or open sided
Electrical Power: No
Gas to Structure: No
Comments: Horse barn

Safety Zone(s): Potential safety zone(s) in area
Comm With ICP: Yes
Water Supply: No reliable water source nearby
Fuel Type: Grass and shrub, hardwood litter
Defensible Space: No defensible space
Hazards:

Defensible, Stand Alone

Mitigation Time (in hours): 1
Mitigation Description: Scratch line, low priority , small horse barn

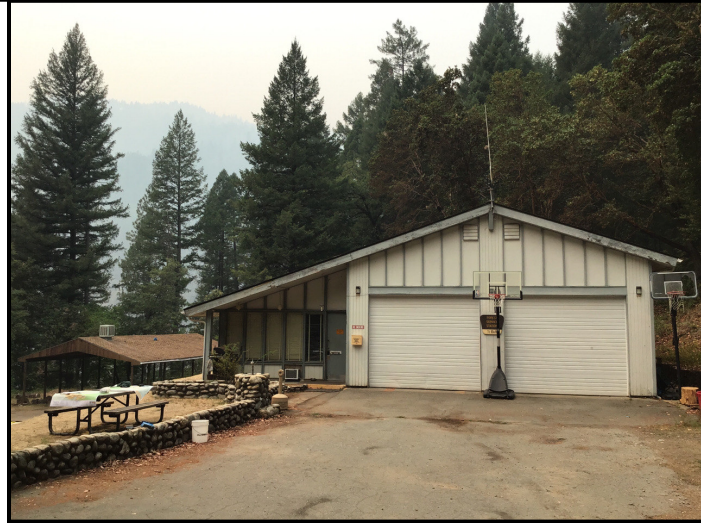
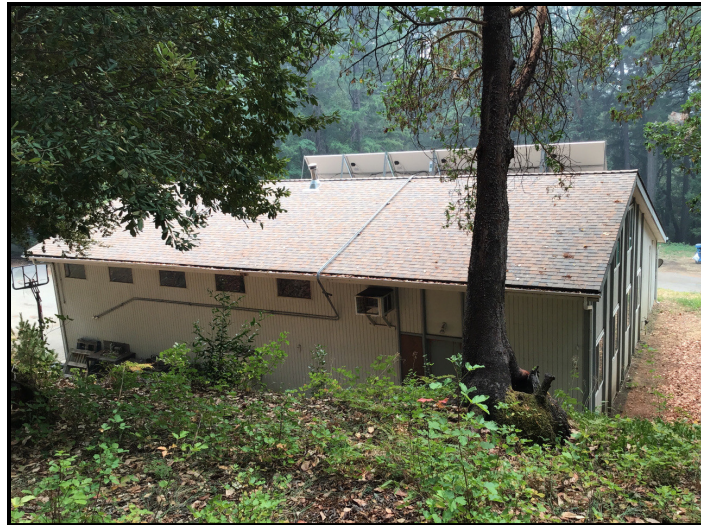
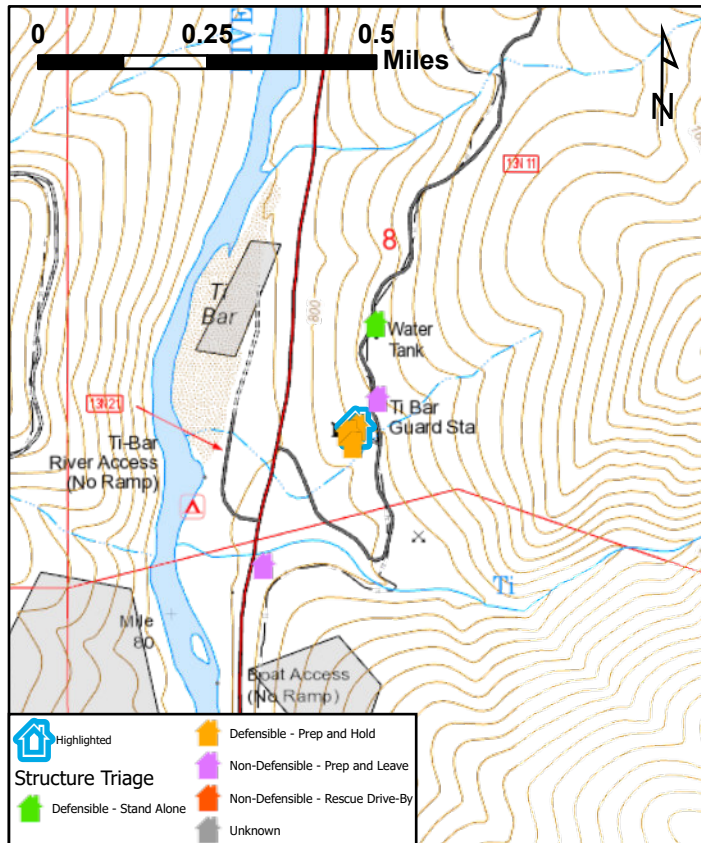
Area: Ti Bar Road
Address: 410 Ti Bar Road
Assigned Structure Number: 110
Type of Structure: MixedUse
Primary Structures: 1
Outbuildings: 2
Is the building Occupied?: Yes
Coordinates (DDM): 41.527915, 123.523914

Roof Material: Combustible or no roof
Siding Material: Wood or open sided
Electrical Power: Yes
Gas to Structure: Yes
Comments: Ti Bar Station. Propane tank 100' up hill of station

Safety Zone(s): Potential safety zone(s) in area
Comm With ICP: Yes
Water Supply: Limited or dependent on electricity
Fuel Type: Shrub or timber
Defensible Space: 30 ft treated
Hazards: Fuel shed within 20' of building

Defensible, Prep and Hold

Mitigation Time (in hours): 3
Mitigation Description: Clear roof of leaf litter. Clear vegetation around structure and propane tank. Lay hose perimeter and set up sprinkler system

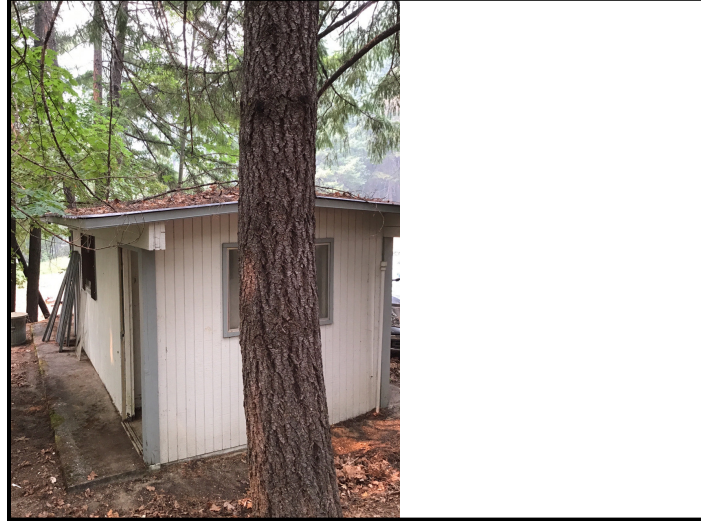
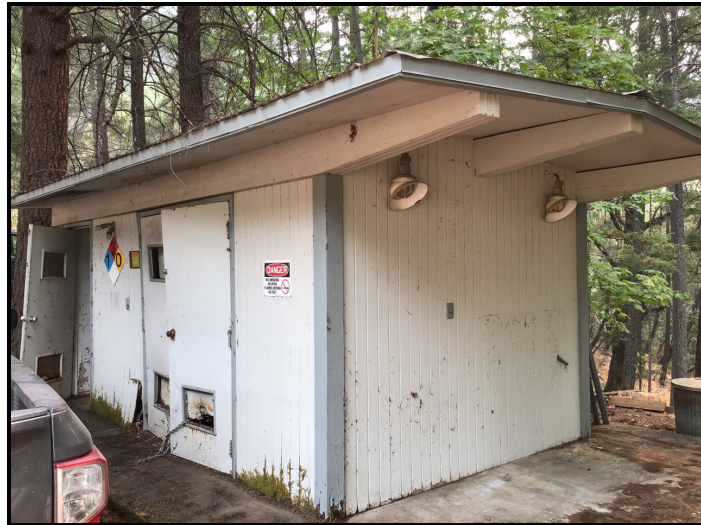
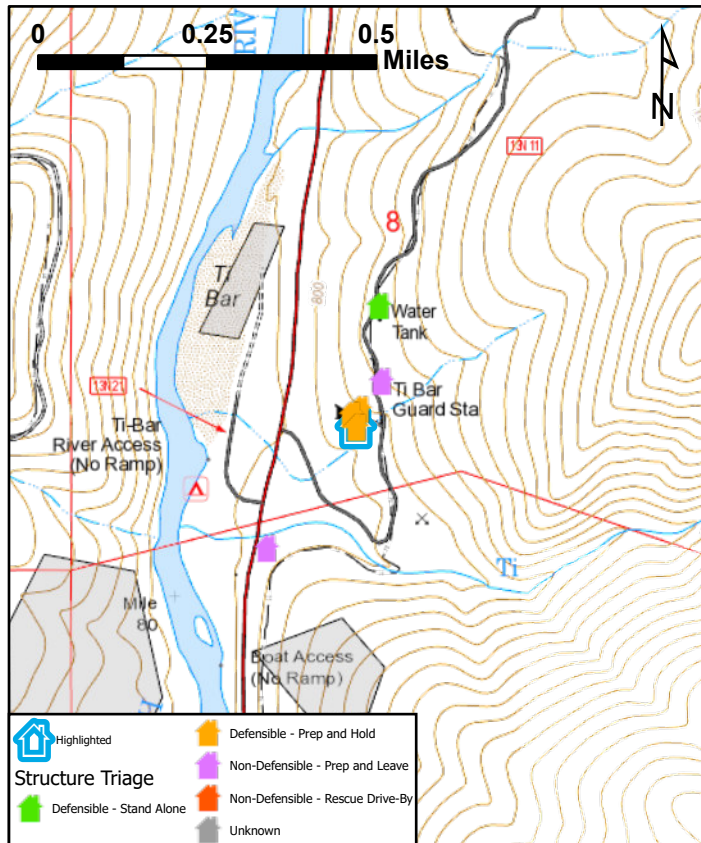
Area: Ti Bar Road
Address: 410 Ti Bar Road
Assigned Structure Number: 112
Type of Structure: Outbuilding
Primary Structures:
Outbuildings:
Is the building Occupied?: No
Coordinates (DDM): 41 31.657', -123 31.418'

Roof Material: Noncombustible or not applicable
Siding Material: Wood or open sided
Electrical Power: Yes
Gas to Structure: No
Comments: Old gas house. Used as storage shed. Metal roof. Broken doors

Safety Zone(s): Potential safety zone(s) in area
Comm With ICP: Yes
Water Supply: Limited or dependent on electricity
Fuel Type: Shrub or timber
Defensible Space: Less than 30 ft treated
Hazards:

Defensible, Prep and Hold

Mitigation Time (in hours): 1
Mitigation Description: Clean off Roof leaf litter and from around shed. Seal broken doors with scrap plywood.

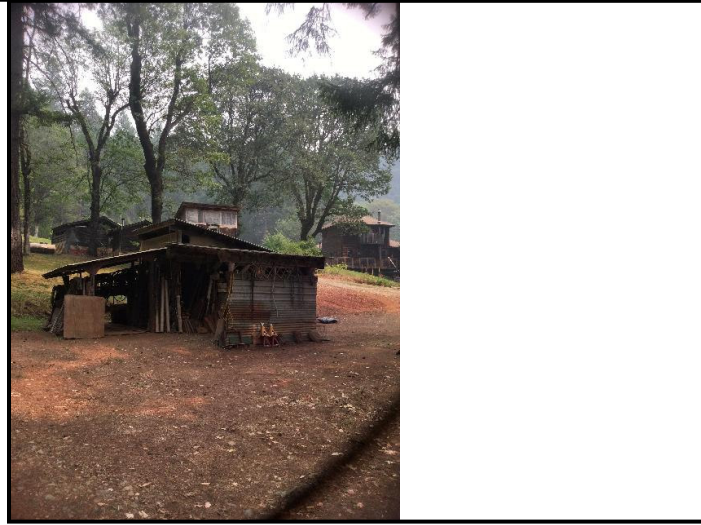
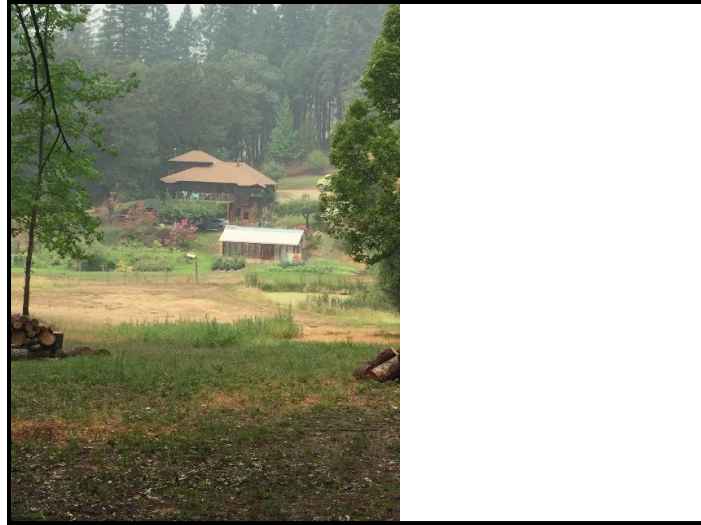
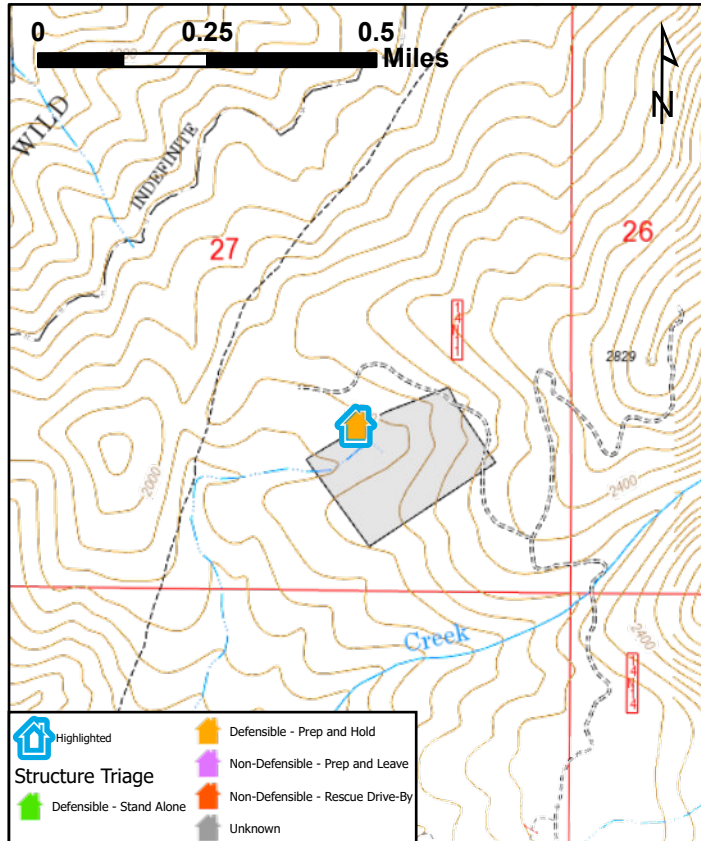
Area: Ti Bar Road
Address: 6 ti bar rd
Assigned Structure Number: 113
Type of Structure: Residential
Primary Structures: 1
Outbuildings: 6
Is the building Occupied?: Yes
Coordinates (DDM): 41°34.368'N, 123°30.545'W

Roof Material: Noncombustible or not applicable
Siding Material: Wood or open sided
Electrical Power: Yes
Gas to Structure: Yes
Comments: Structure has new shingle roof and well maintained grounds with personal sprinkler system in place 1sprinkler on roof

Safety Zone(s): Potential safety zone(s) in area
Comm With ICP: Yes
Water Supply: No reliable water source nearby
Fuel Type: Grass and shrub, hardwood litter
Defensible Space: 100 ft treated
Hazards: Fuel (diesel/gas) in one of outbuildings 250 gallon propane tank

Defensible, Prep and Hold

Mitigation Time (in hours): 1
Mitigation Description: Minimal mitigation no saw work

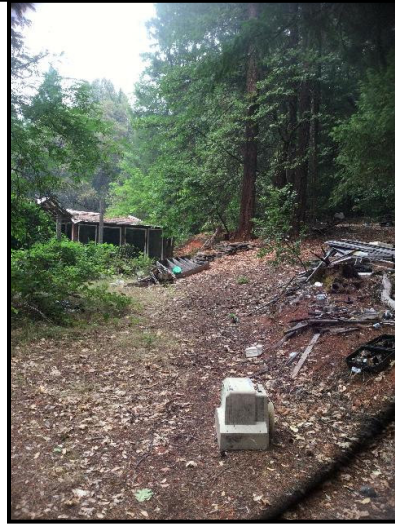
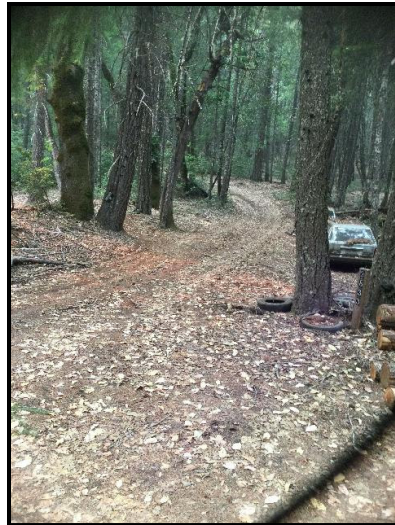
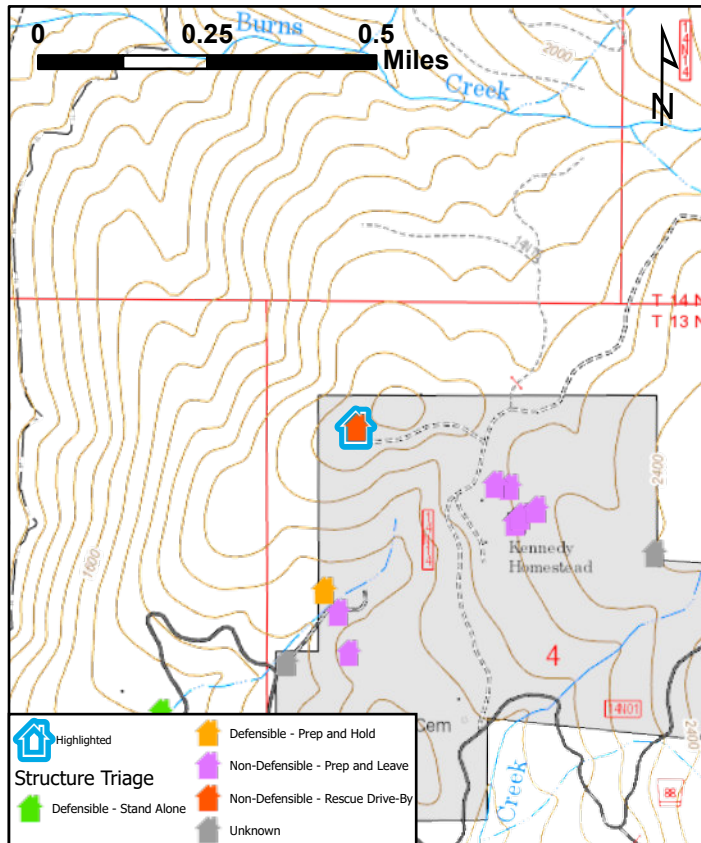
Area: Ti Bar Road
Address: 3833 carter creek rd
Assigned Structure Number: 114
Type of Structure: Residential
Primary Structures: 1
Outbuildings:
Is the building Occupied?: No
Coordinates (DDM): 41°33.121'N, 123°30.630'W

Roof Material: Combustible or no roof
Siding Material: Wood or open sided
Electrical Power: Unknown
Gas to Structure: Unknown
Comments: Non defensible

Safety Zone(s): No safety zone(s) in area
Comm With ICP: Yes
Water Supply: No reliable water source nearby
Fuel Type: Shrub or timber
Defensible Space: No defensible space
Hazards: Multiple hazards, including vehicles, structures, yard debris etc 1

Non-Defensible, Rescue, Drive By

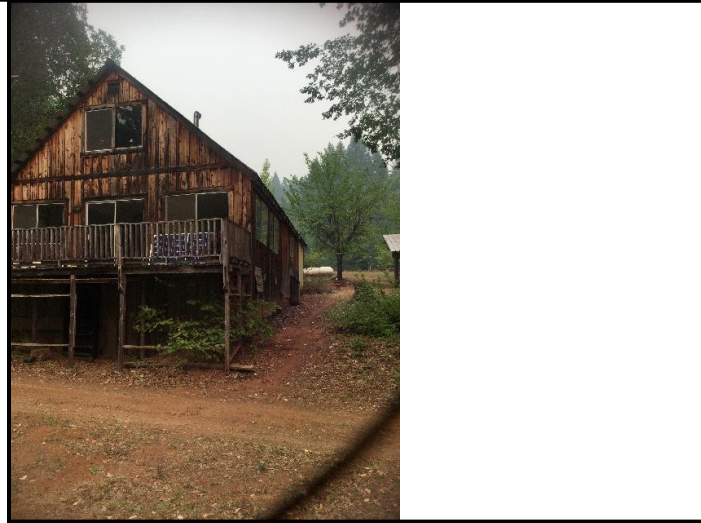
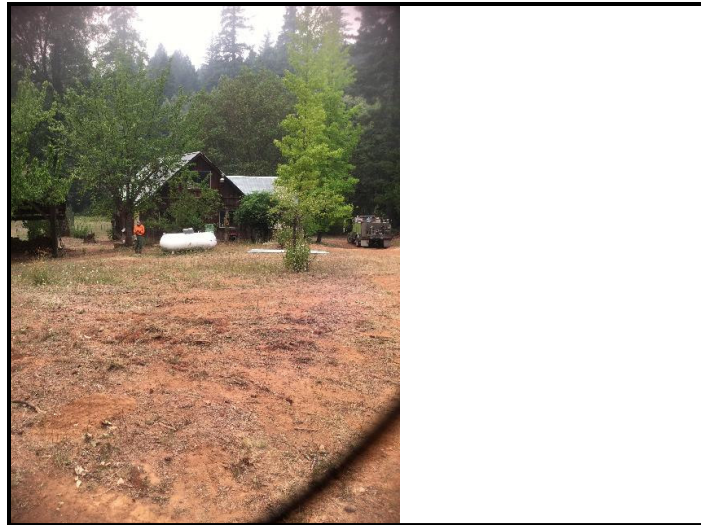
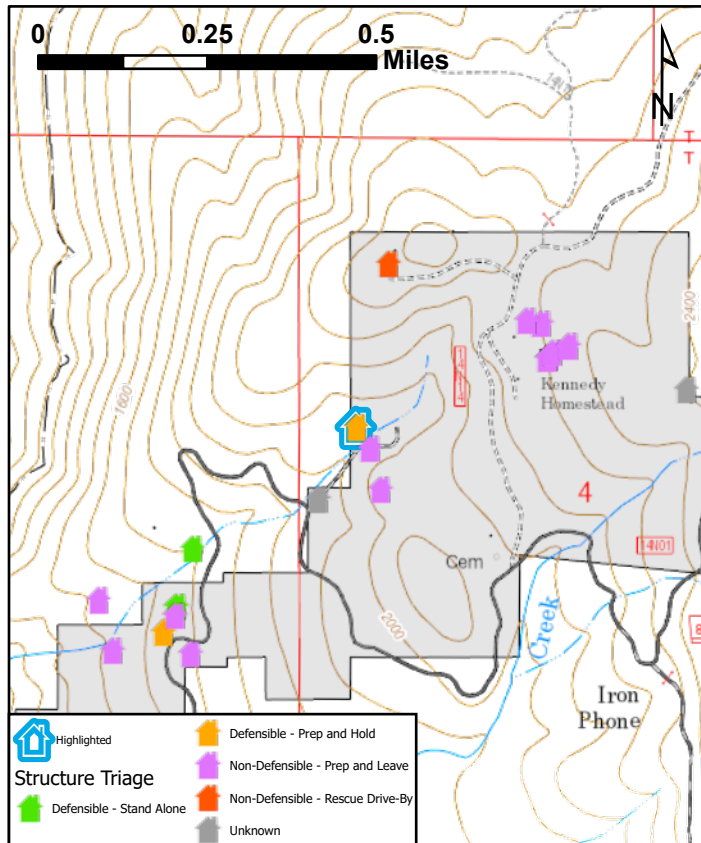
Area: Ti Bar Road
Address: 2803 ti bar rd
Assigned Structure Number: 115
Type of Structure: Residential
Primary Structures: 1
Outbuildings: 2
Is the building Occupied?: Yes
Coordinates (DDM): 41° 32.911' N, 123° 30.684' W

Roof Material: Noncombustible or not applicable
Siding Material: Wood or open sided
Electrical Power: Yes
Gas to Structure: Yes
Comments: Structure has above ground 250 gallon propane tank 50' to the east also a few hardwoods touching structure

Safety Zone(s): Potential safety zone(s) in area
Comm With ICP: Yes
Water Supply: Reliable water source nearby
Fuel Type: Shrub or timber
Defensible Space: 100 ft treated
Hazards: One way in/out

Defensible, Prep and Hold

Mitigation Time (in hours): 1
Mitigation Description: Possible lite saw work /hand tool work (rakes)

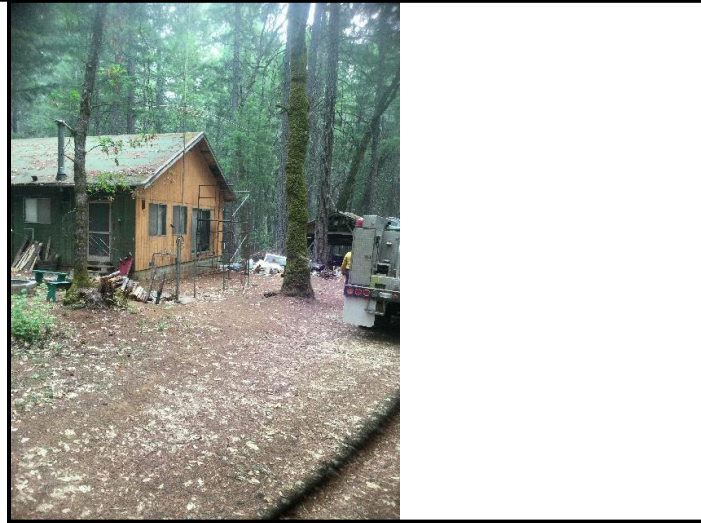
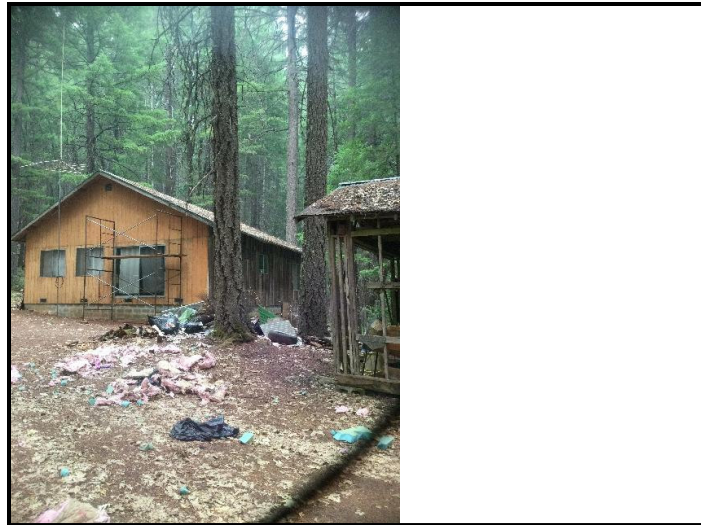
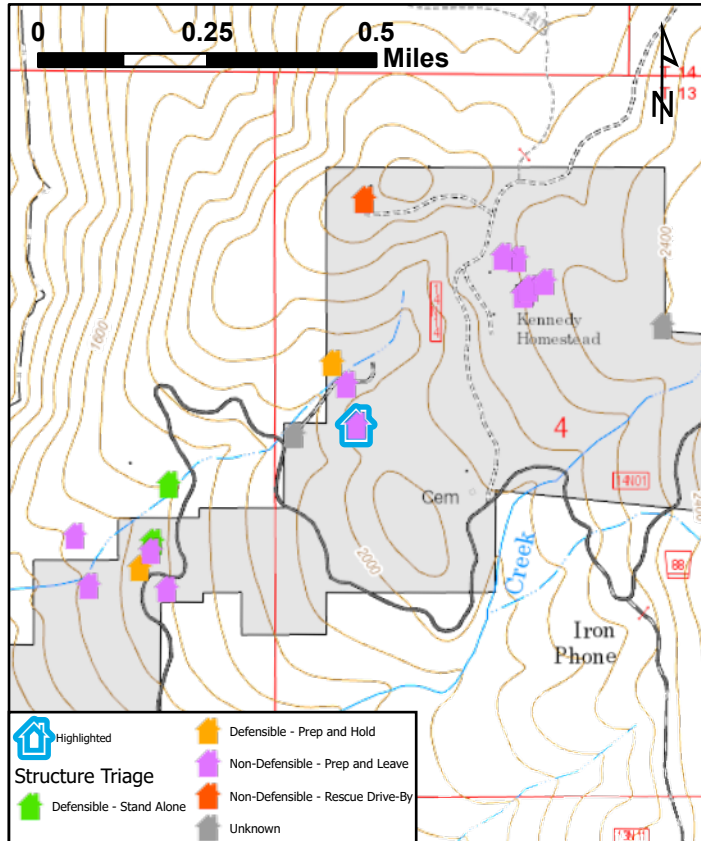
Area: Ti Bar Road
Address: 2803 A
Assigned Structure Number: 116
Type of Structure: Residential
Primary Structures: 1
Outbuildings: 1
Is the building Occupied?: Unknown
Coordinates (DDM): 41° 32.831' N, 123° 30.642' W

Roof Material: Noncombustible or not applicable
Siding Material: Wood or open sided
Electrical Power: Unknown
Gas to Structure: Unknown
Comments: Structure is above 2803 gene strouss residence

Safety Zone(s): No safety zone(s) in area
Comm With ICP: Yes
Water Supply: Reliable water source nearby
Fuel Type: Shrub or timber
Defensible Space: Less than 30 ft treated
Hazards: Yard debris/timber

Non-Defensible, Prep and Leave

Mitigation Time (in hours): 2
Mitigation Description: Brushing and limbing ladder fuels, move yard debris, cut hand line around structure/ prep and leave

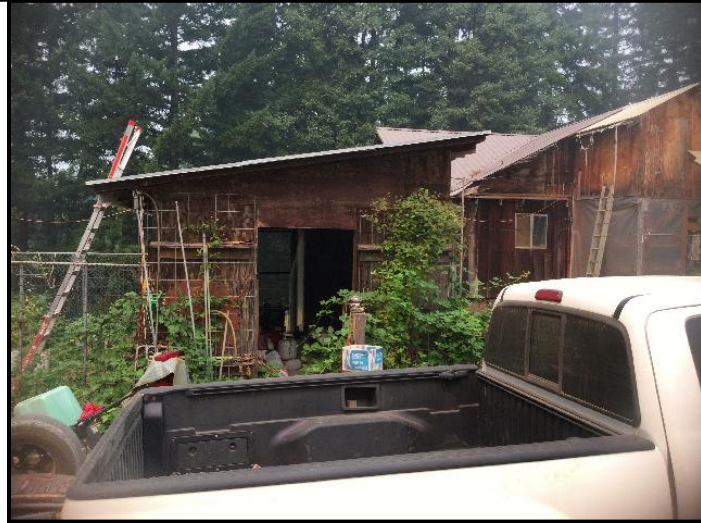
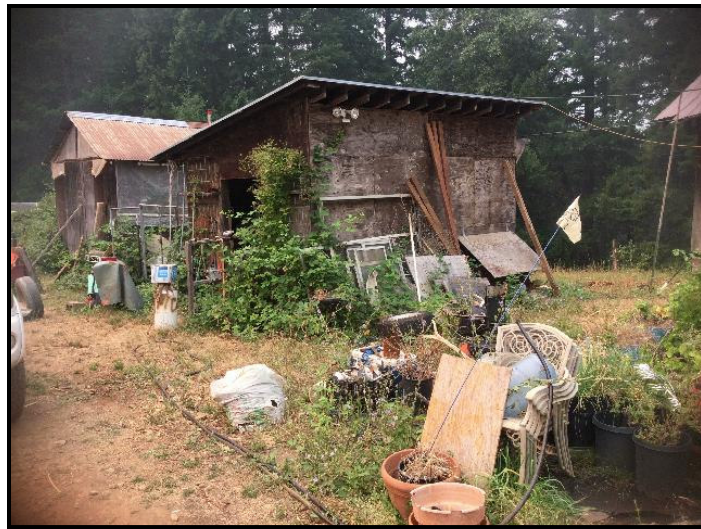
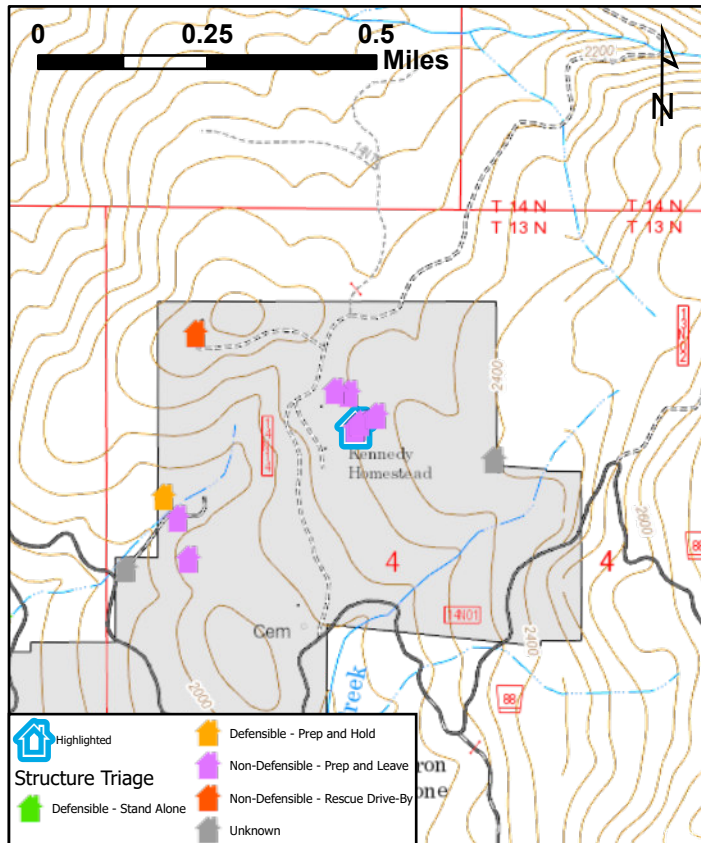
Area: Ti Bar Road
Address: 3904 Carter Creek Rd
Assigned Structure Number: 118
Type of Structure: Industrial
Primary Structures: 1
Outbuildings: 6
Is the building Occupied?: No
Coordinates (DDM): 41°33.002'N, 123°30.355'W

Roof Material: Combination of fire resistant and combustible
Siding Material: Wood or open sided
Electrical Power: Yes
Gas to Structure: No
Comments: Shed adjacent to primary residence

Safety Zone(s): No safety zone(s) in area
Comm With ICP: Yes
Water Supply: No reliable water source nearby
Fuel Type: Shrub or timber
Defensible Space: No defensible space
Hazards: Household and agricultural debris, LP tanks, fuel cans, household and agricultural chemicals

Non-Defensible, Prep and Leave

Mitigation Time (in hours): 2
Mitigation Description: Removal of debris

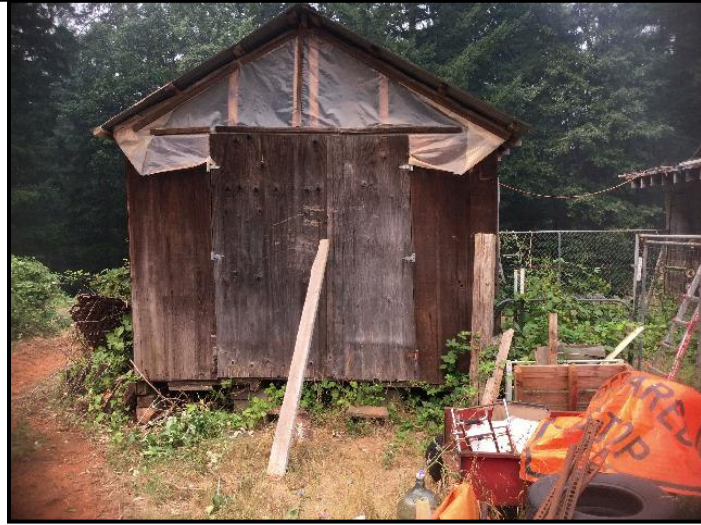
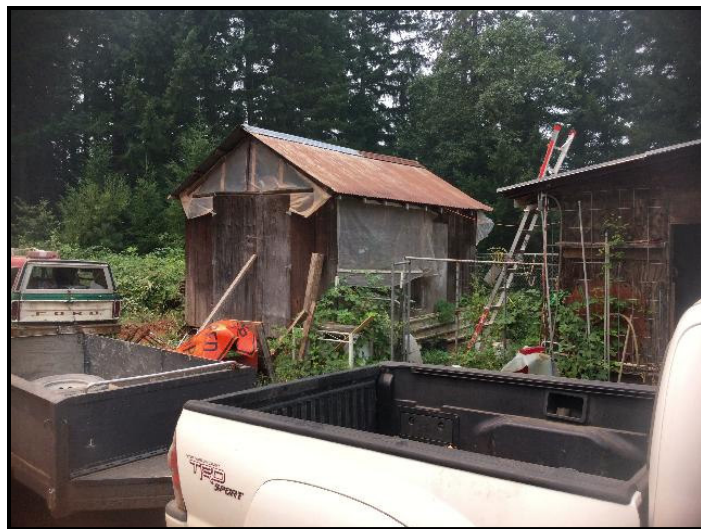
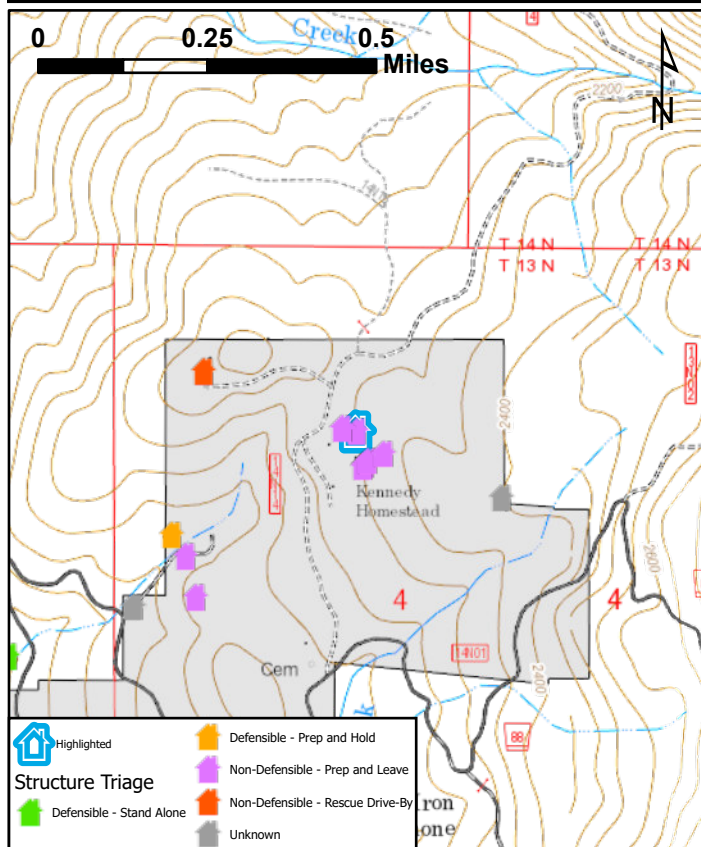
Area: Ti Bar Road
Address: 3904 Carter Creek Rd
Assigned Structure Number: 119
Type of Structure: Outbuilding
Primary Structures: 1
Outbuildings: 6
Is the building Occupied?: No
Coordinates (DDM): 41°33.045'N, 123°30.368'W

Roof Material: Combustible or no roof
Siding Material: Wood or open sided
Electrical Power: Yes
Gas to Structure: Unknown
Comments: Shed adjacent to primary structure

Safety Zone(s): No safety zone(s) in area
Comm With ICP: Yes
Water Supply: No reliable water source nearby
Fuel Type: Shrub or timber
Defensible Space: No defensible space
Hazards: Adjacent fuels containing tires content of structure unknown

Non-Defensible, Prep and Leave

Mitigation Time (in hours): 1
Mitigation Description: Remove all debris set up sprinkler

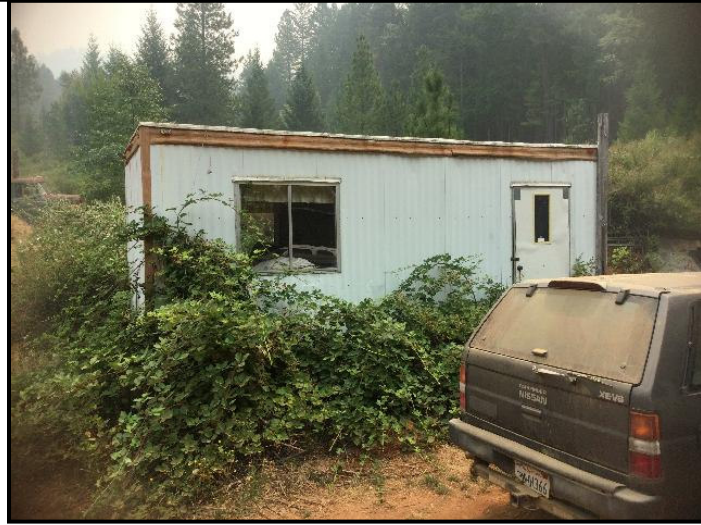
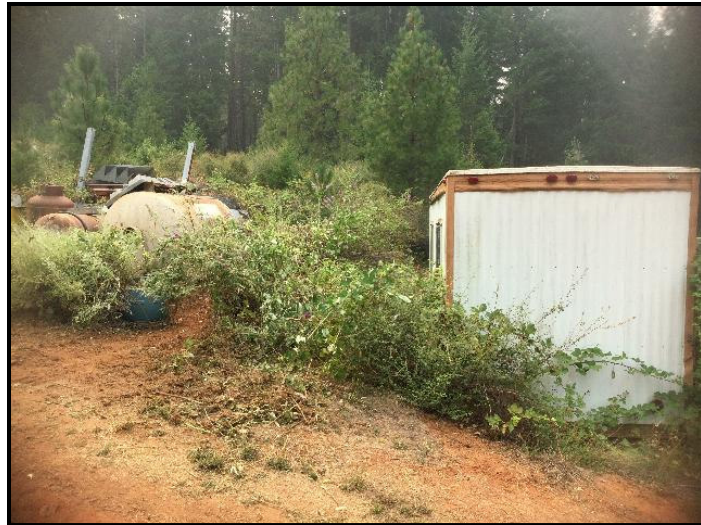
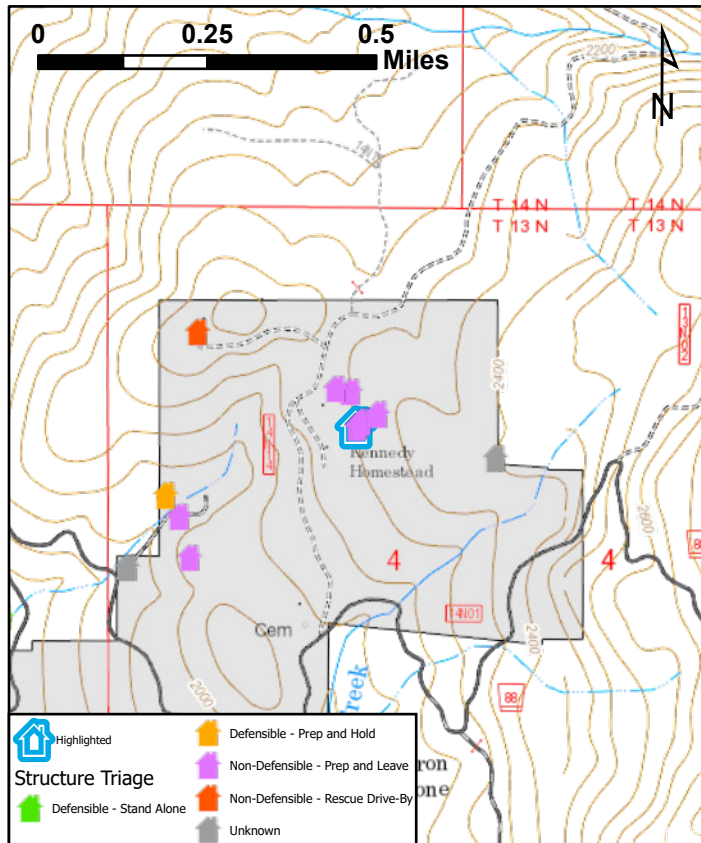
Area: Ti Bar Road
Address: 3904 Carter Creek Rd
Assigned Structure Number: 120
Type of Structure: Outbuilding
Primary Structures: 1
Outbuildings: 6
Is the building Occupied?: No
Coordinates (DDM): 41°33.000'N, 123°30.357'W

Roof Material: Combustible or no roof
Siding Material: Rock, concrete, metal
Electrical Power: Unknown
Gas to Structure: Unknown
Comments: Portable building across road from primary structure

Safety Zone(s): No safety zone(s) in area
Comm With ICP: Yes
Water Supply: No reliable water source nearby
Fuel Type: Grass and shrub, hardwood litter
Defensible Space: No defensible space
Hazards: Heavy fuel load, debris, LP tanks

Non-Defensible, Prep and Leave

Mitigation Time (in hours): 1
Mitigation Description: Remove fuel and debris set up sprinkler

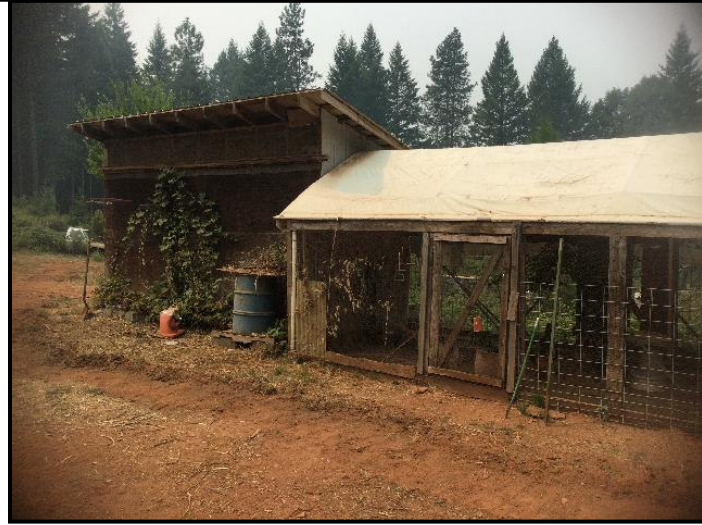
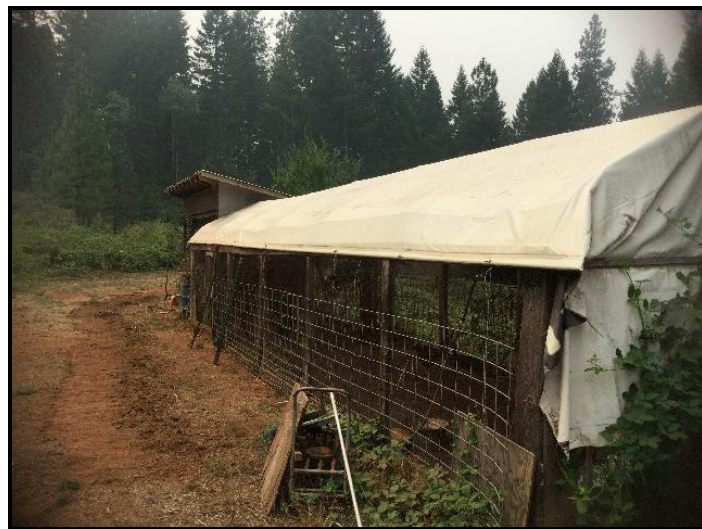
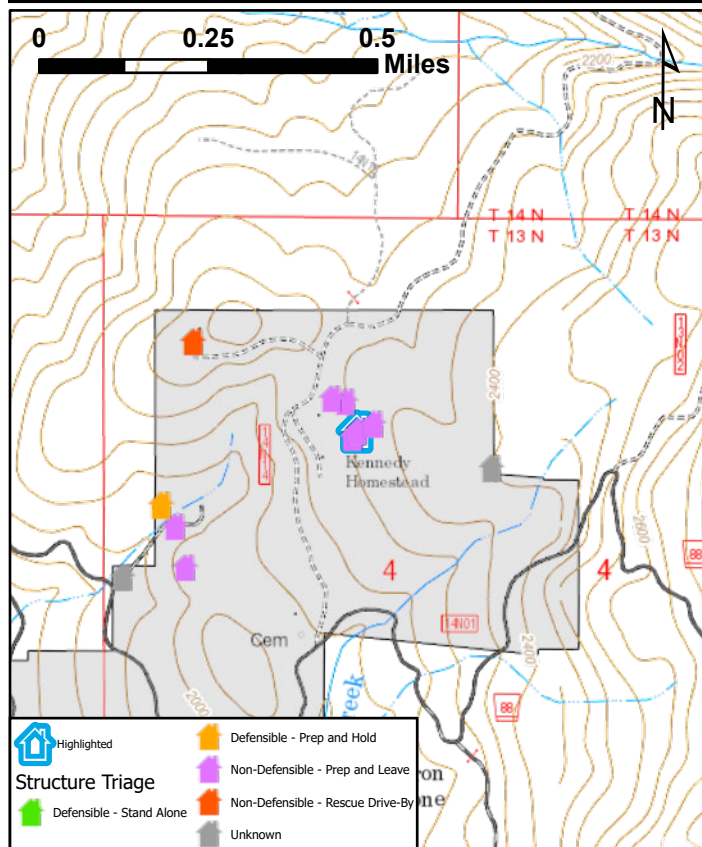
Area: Ti Bar Road
Address: 3904 Carter Creek Rd
Assigned Structure Number: 121
Type of Structure: Outbuilding
Primary Structures: 1
Outbuildings: 6
Is the building Occupied?: No
Coordinates (DDM): 41°33.008'N, 123°30.348'W

Roof Material: Combination of fire resistant and combustible
Siding Material: Wood or open sided
Electrical Power: No
Gas to Structure: No
Comments: Chicken coop up hill from primary structures.

Safety Zone(s): No safety zone(s) in area
Comm With ICP: Yes
Water Supply: No reliable water source nearby
Fuel Type: Grass and shrub, hardwood litter
Defensible Space: Less than 30 ft treated
Hazards: Fuel loading

Non-Defensible, Prep and Leave

Mitigation Time (in hours): 1
Mitigation Description: Clear adjacent fuel plum sprinkler

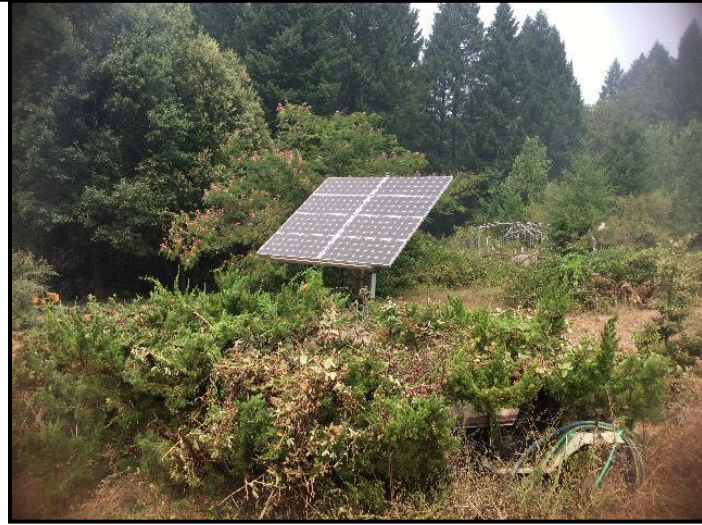
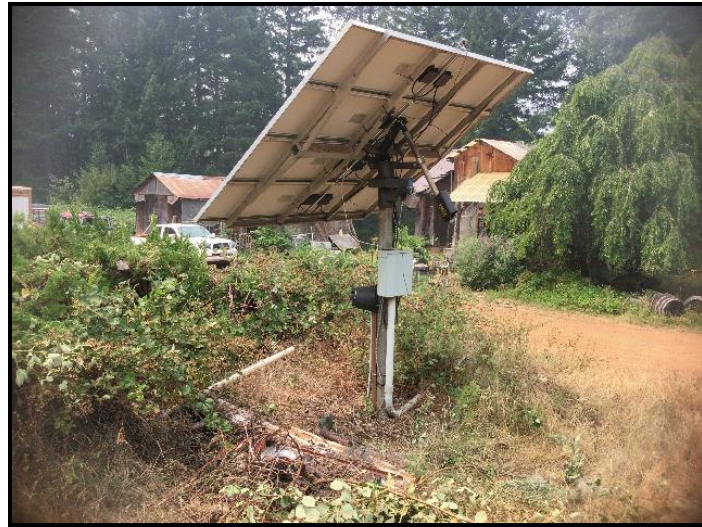
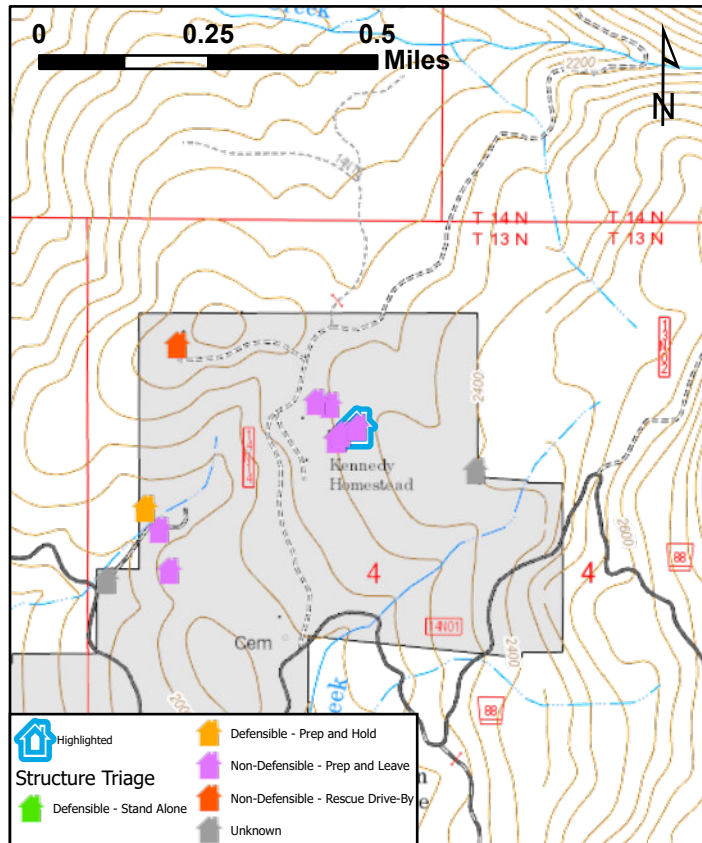
Area: Ti Bar Road
Address: 3904 Carter Creek Rd
Assigned Structure Number: 122
Type of Structure: Outbuilding
Primary Structures: 1
Outbuildings: 6
Is the building Occupied?: No
Coordinates (DDM): 41°33.017'N, 123°30.321'W

Roof Material: Noncombustible or not applicable
Siding Material: Not applicable
Electrical Power: Yes
Gas to Structure: No
Comments: Solar array

Safety Zone(s): No safety zone(s) in area
Comm With ICP: Yes
Water Supply: No reliable water source nearby
Fuel Type: Grass and shrub, hardwood litter
Defensible Space: Less than 30 ft treated
Hazards: Adjacent fuel

Non-Defensible, Prep and Leave

Mitigation Time (in hours): 1
Mitigation Description: Remove fuel and debris

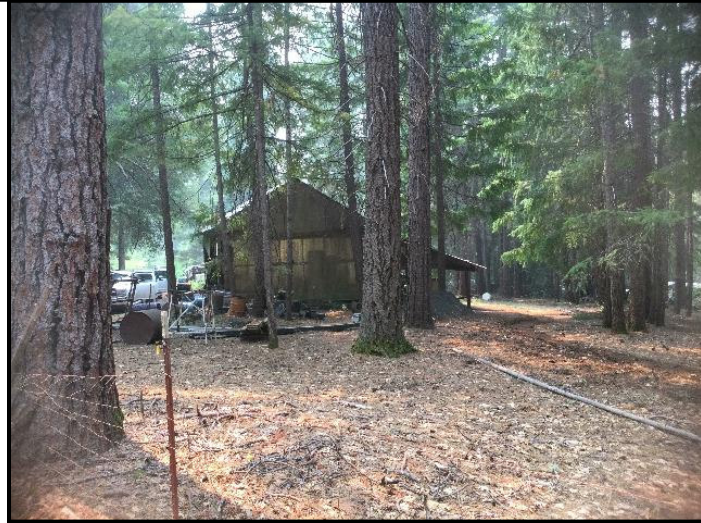
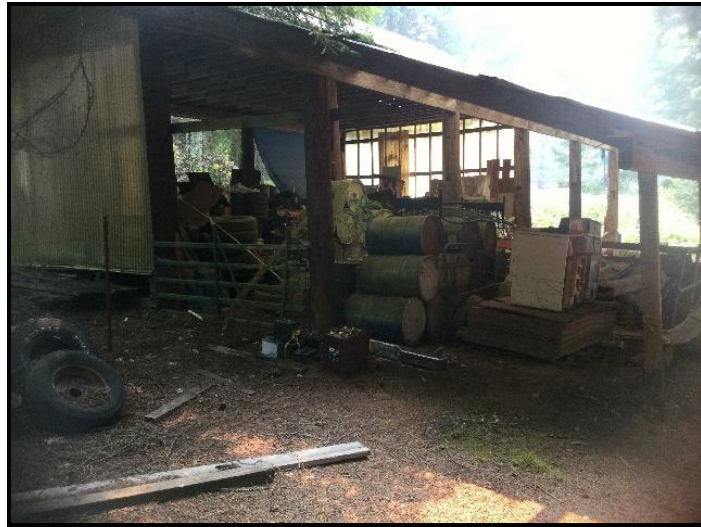
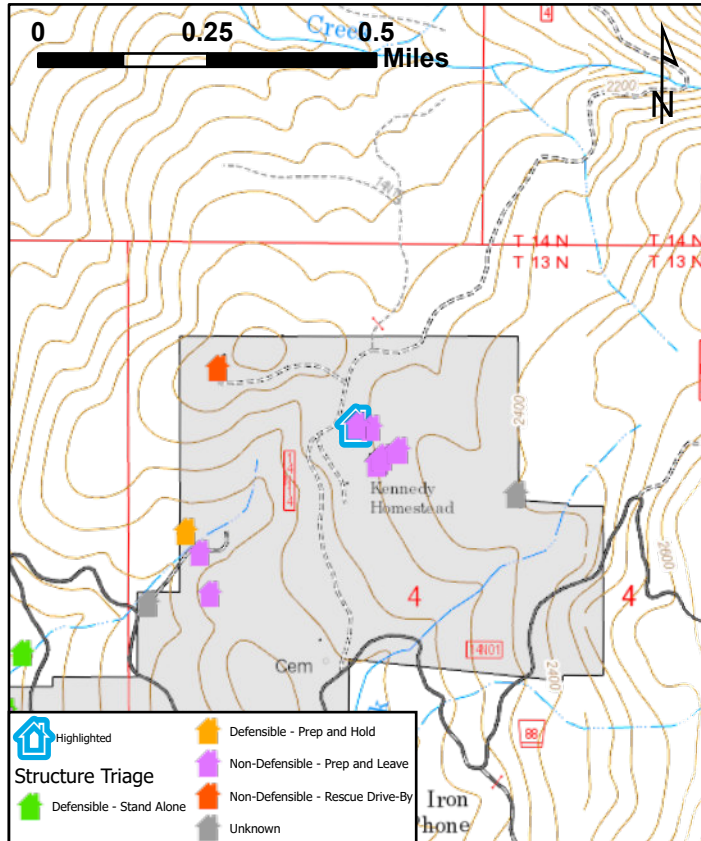
Area: Ti Bar Road
Address: 3904 Carter Creek Rd
Assigned Structure Number: 123
Type of Structure: Outbuilding
Primary Structures: 1
Outbuildings: 6
Is the building Occupied?: No
Coordinates (DDM): 41°33.049'N, 123°30.393'W

Roof Material: Combination of fire resistant and combustible
Siding Material: Wood or open sided
Electrical Power: No
Gas to Structure: No
Comments: Large open barn down hill from primary structure

Safety Zone(s): No safety zone(s) in area
Comm With ICP: Yes
Water Supply: No reliable water source nearby
Fuel Type: Shrub or timber
Defensible Space: Less than 30 ft treated
Hazards: Debris and contents of structure flammable

Non-Defensible, Prep and Leave

Mitigation Time (in hours): 1
Mitigation Description: Reduce fuel load, handling, sprinkler

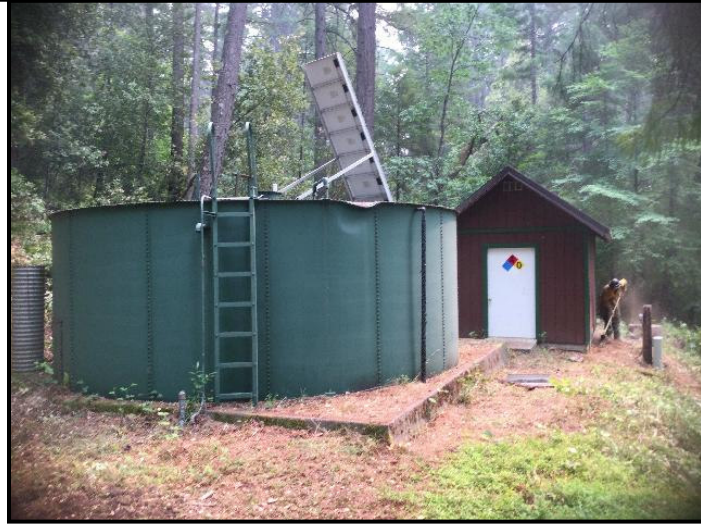
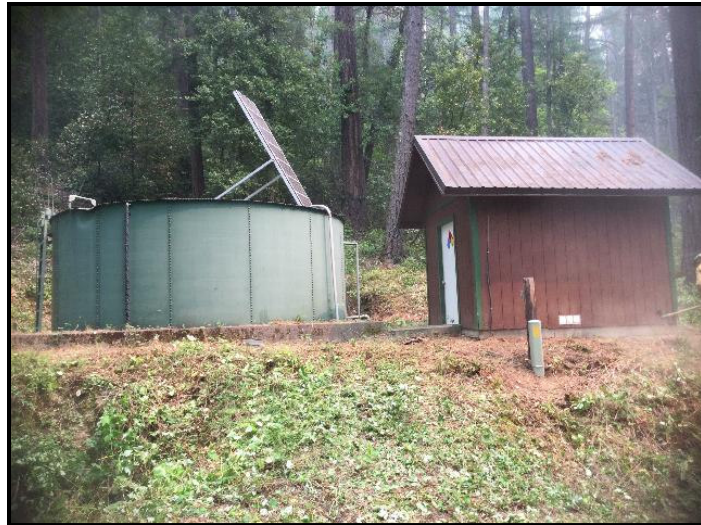
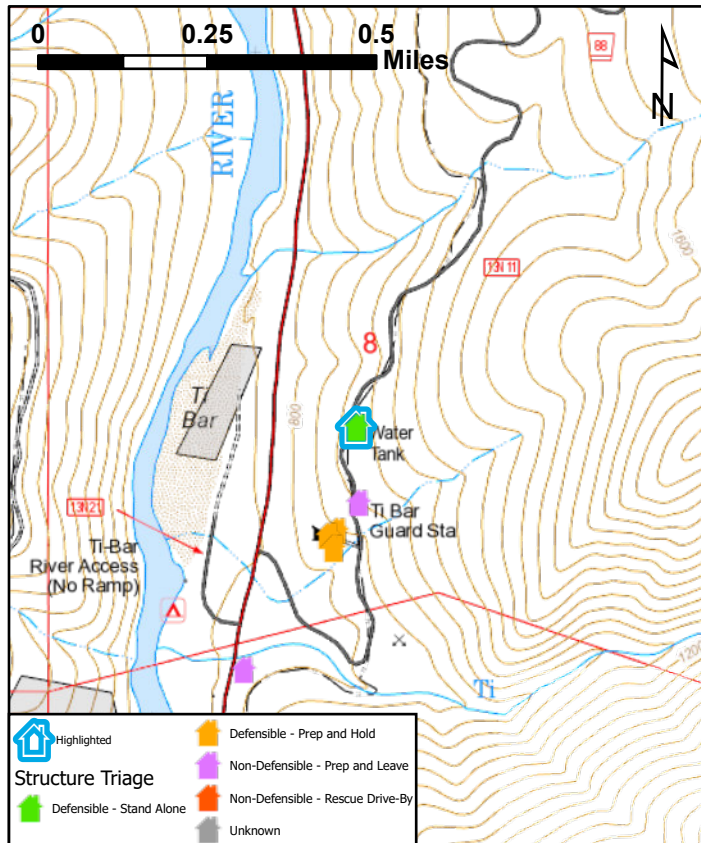
Area: Ti Bar Road
Address: 410.1 Carter Creek Rd
Assigned Structure Number: 124
Type of Structure: Outbuilding
Primary Structures: 1
Outbuildings:
Is the building Occupied?: No
Coordinates (DDM): 41°31.808'N, 123°31.403'W

Roof Material: Noncombustible or not applicable
Siding Material: Wood or open sided
Electrical Power: Yes
Gas to Structure: No
Comments: Generator house and water tank

Safety Zone(s): No safety zone(s) in area
Comm With ICP: Yes
Water Supply: No reliable water source nearby
Fuel Type: Shrub or timber
Defensible Space: Less than 30 ft treated
Hazards: Flammable liquid in building, buried cable between building and road

Defensible, Stand Alone

Mitigation Time (in hours): 2
Mitigation Description: Reduce fuel load and handling around structure and utilities.
