McCash Fire Structure Triage Assessment

CASRF000651
August 20, 2021

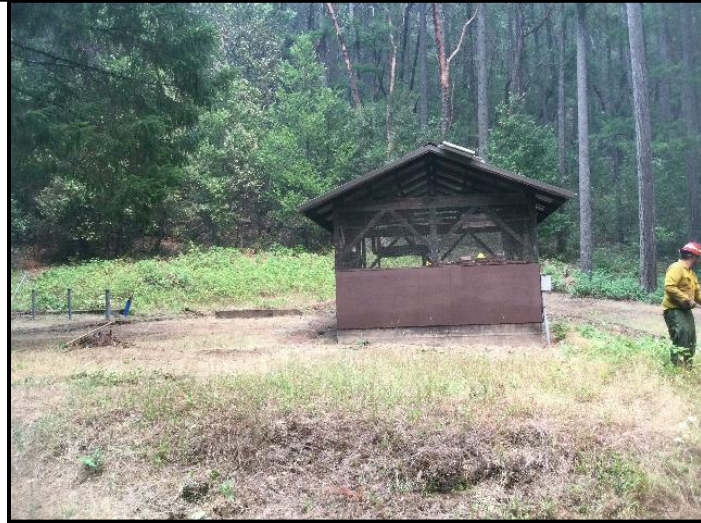
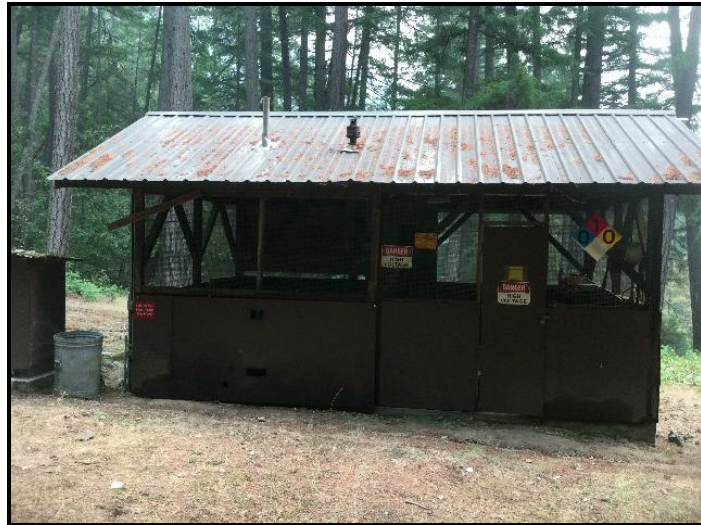
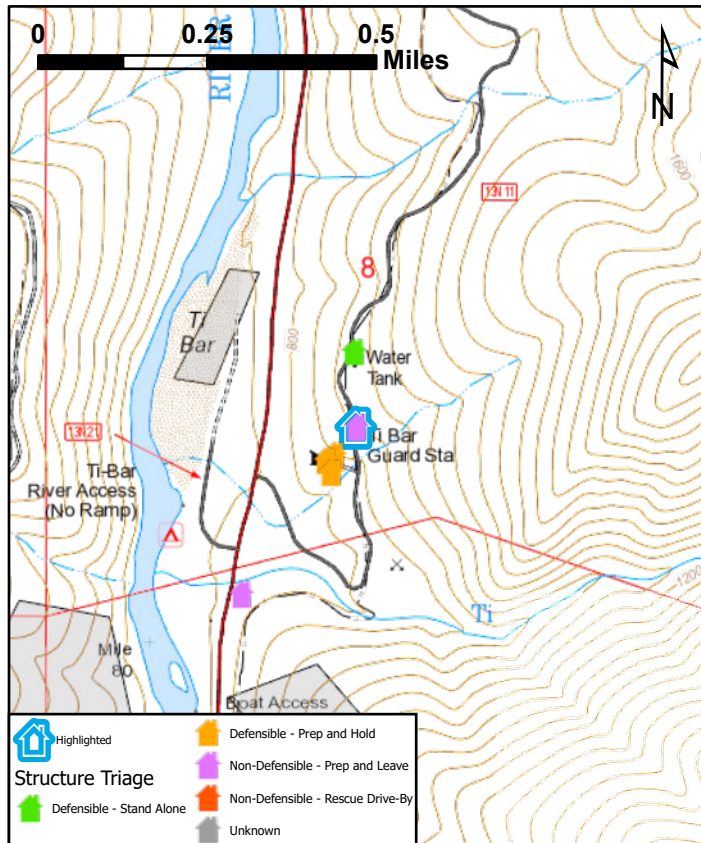
Area: Ti Bar Road
Address: 410.2 Carter Creek Rd
Assigned Structure Number: 125
Type of Structure: Industrial
Primary Structures: 1
Outbuildings:
Is the building Occupied?: No
Coordinates (DDM): 41°31.711'N, 123°31.398'W

Safety Zone(s): No safety zone(s) in area
Comm With ICP: Yes
Water Supply: Reliable water source nearby
Fuel Type: Shrub or timber
Defensible Space: Less than 30 ft treated
Hazards: High voltage, flammable liquid, buried cable near road

Non-Defensible, Prep and Leave
