McCash Fire Structure Triage Assessment

CASRF000651
August 23, 2021

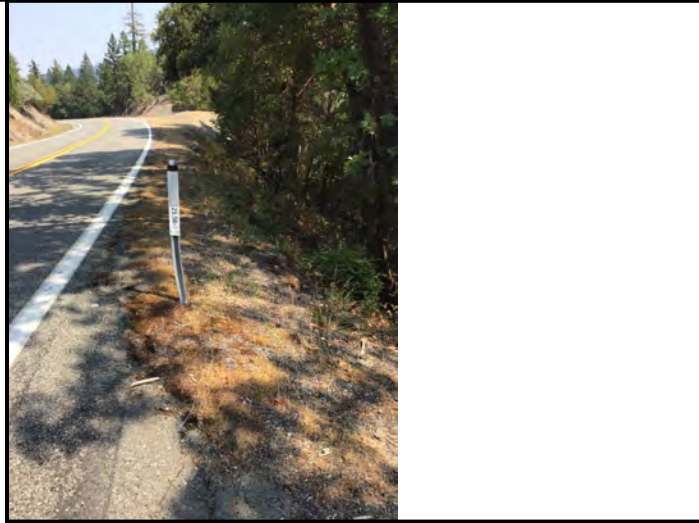
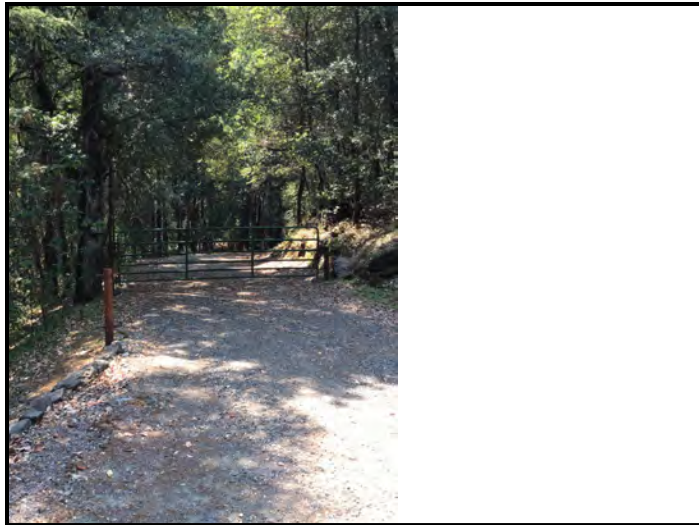
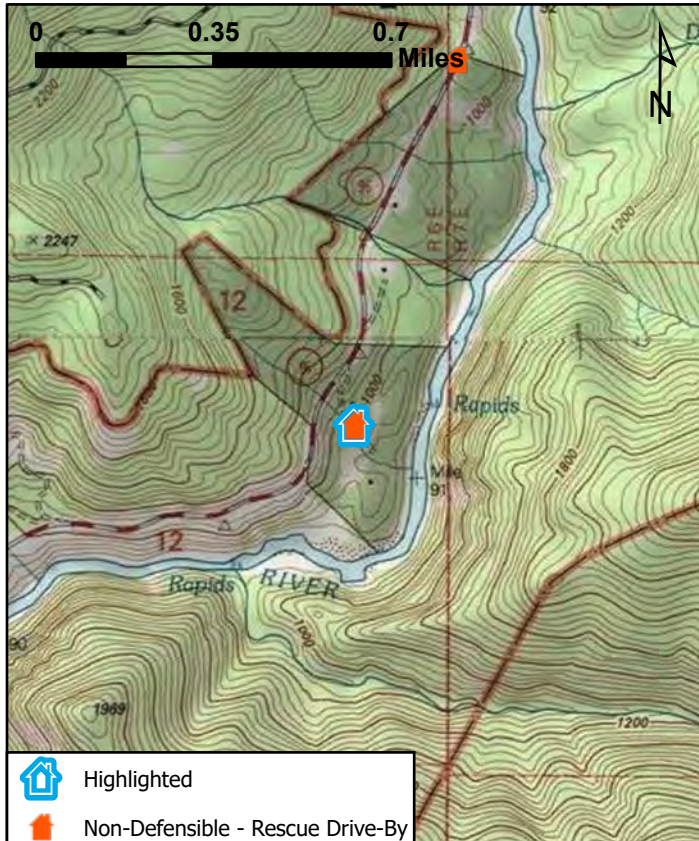
Area: Cottage Grove
Address:
Assigned Structure Number: 145
Type of Structure: Residential
Primary Structures: 1
Outbuildings: 2
Is the building Occupied?: Unknown
Coordinates (DDM): 41° 37.345' N, 123° 28.082' W

Roof Material: Combustible or no roof
Siding Material: Wood or open sided
Electrical Power: Unknown
Gas to Structure: Unknown
Comments: Not defensible

Safety Zone(s): No safety zone(s) in area
Comm With ICP: Yes
Water Supply: No reliable water source nearby
Fuel Type: Shrub or timber
Defensible Space: No defensible space
Hazards: Tight closed area 1 way ingress/egress. Ink won propane bottles and septics.

Non-Defensible, Rescue, Drive By

Mitigation Time (in hours): 16
Mitigation Description: Complete prep

FIRESCOPE Tactics: Tactical Patrol

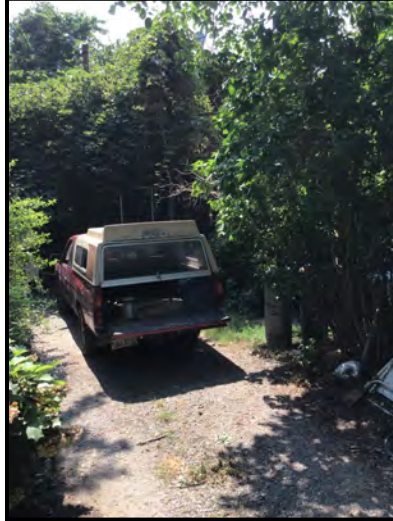
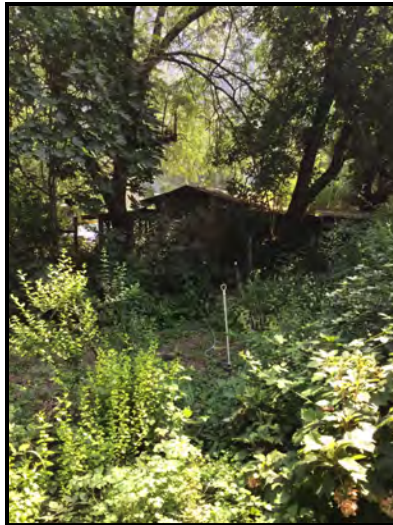
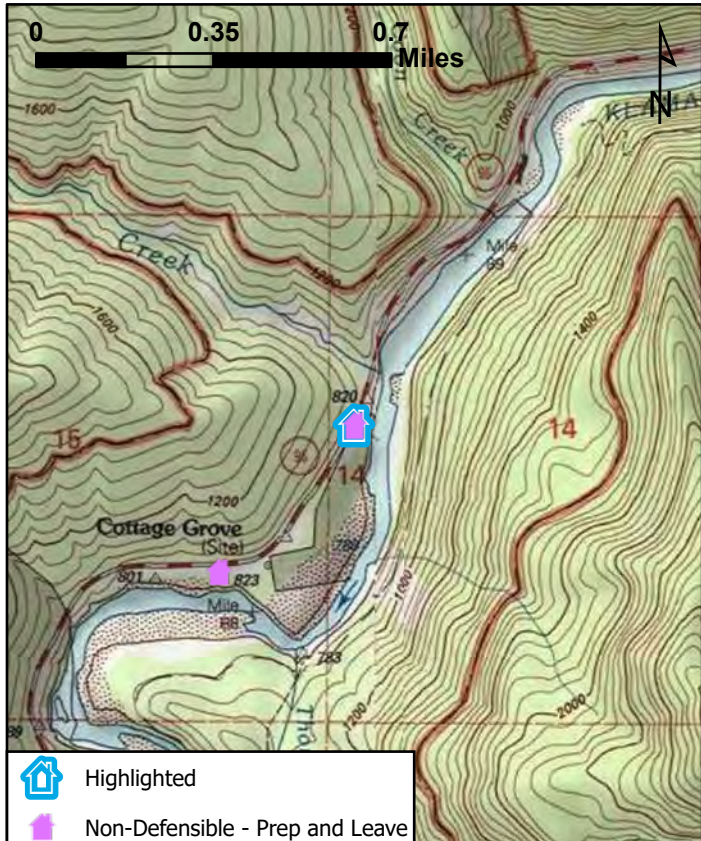
Area: Cottage Grove
Address:
Assigned Structure Number: 146
Type of Structure: Residential
Primary Structures: 2
Outbuildings: 4
Is the building Occupied?: Yes
Coordinates (DDM): 41° 36.406' N, 123° 30.116' W

Roof Material: Combination of fire resistant and combustible
Siding Material: Wood or open sided
Electrical Power: No
Gas to Structure: Unknown
Comments: Closed canopy on structures. Resident name Kathy Harvey. No phone or power. Outbuilding are old with mix of open sides and wood construction. Numerous old vehicles on both sides of the highway.

Safety Zone(s): No safety zone(s) in area
Comm With ICP: Yes
Water Supply: Reliable water source nearby
Fuel Type: Shrub or timber
Defensible Space: No defensible space
Hazards: Highway old out builders bottom of canyon next to the Klamath river

Non-Defensible, Prep and Leave

Mitigation Time (in hours): 8
Mitigation Description: Prep along river and property

Resources Needed to Protect Structure: 2 type 3 engines. Best practice would be prep below house along river. problems will be embers into building from north side of canyon.

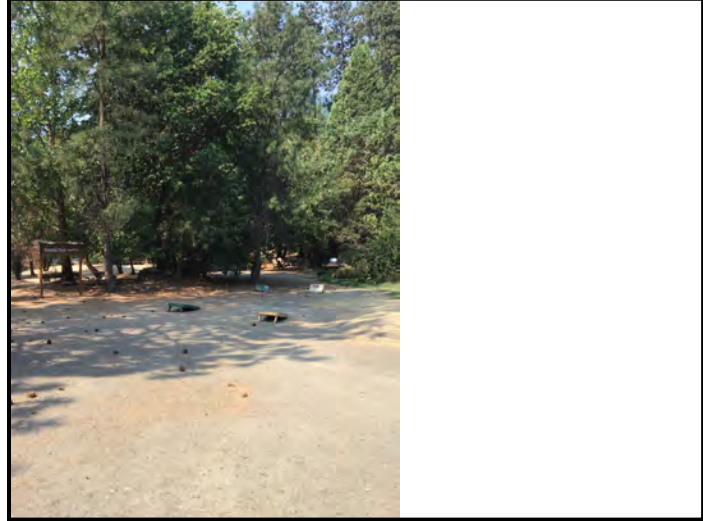
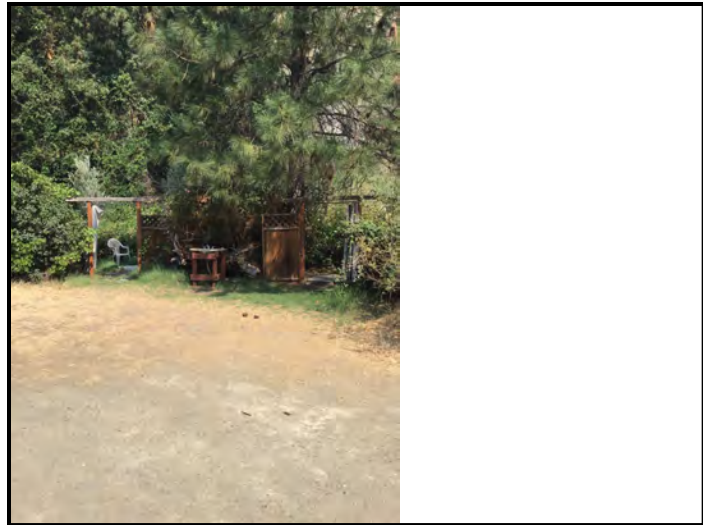
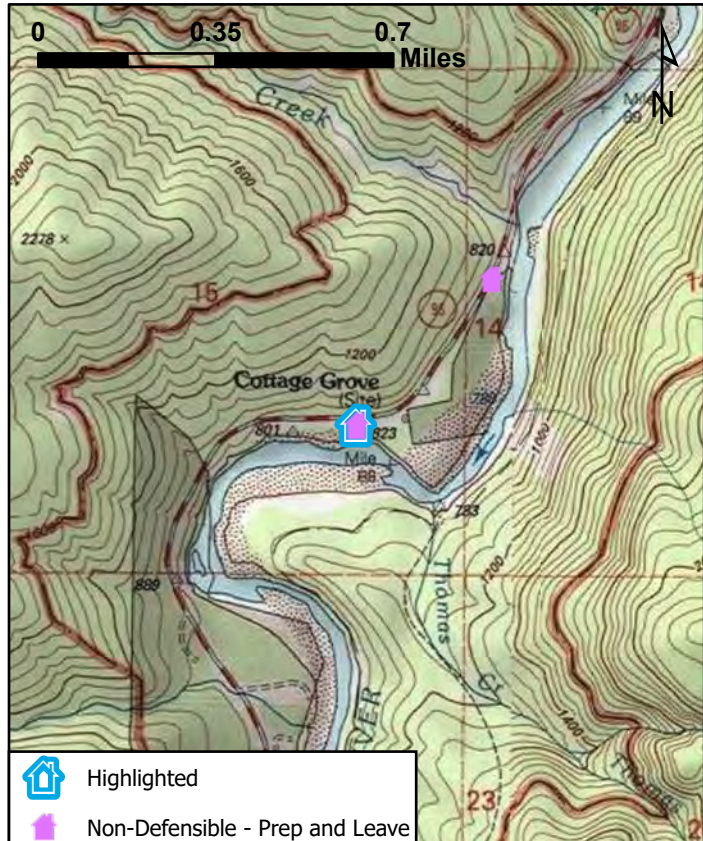
Area: Cottage Grove
Address:
Assigned Structure Number: 147
Type of Structure: Other
Primary Structures: 0
Outbuildings: 2
Is the building Occupied?: No
Coordinates (DDM): 41° 36.153' N, 123° 30.423' W

Roof Material: Combination of fire resistant and combustible
Siding Material: Wood or open sided
Electrical Power: No
Gas to Structure: Unknown
Comments: No primary residents used more for camping

Safety Zone(s): No safety zone(s) in area
Comm With ICP: Yes
Water Supply: Reliable water source nearby
Fuel Type: Shrub or timber
Defensible Space: 30 ft treated
Hazards: Open outbuildings able to catch embers outdoor showers 5 ports johns

Non-Defensible, Prep and Leave

FIRESCOPE Tactics: Check and Go

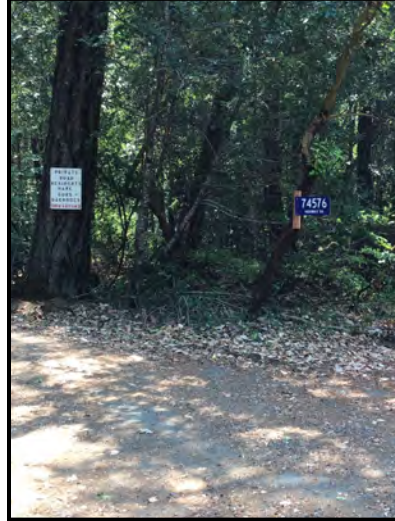
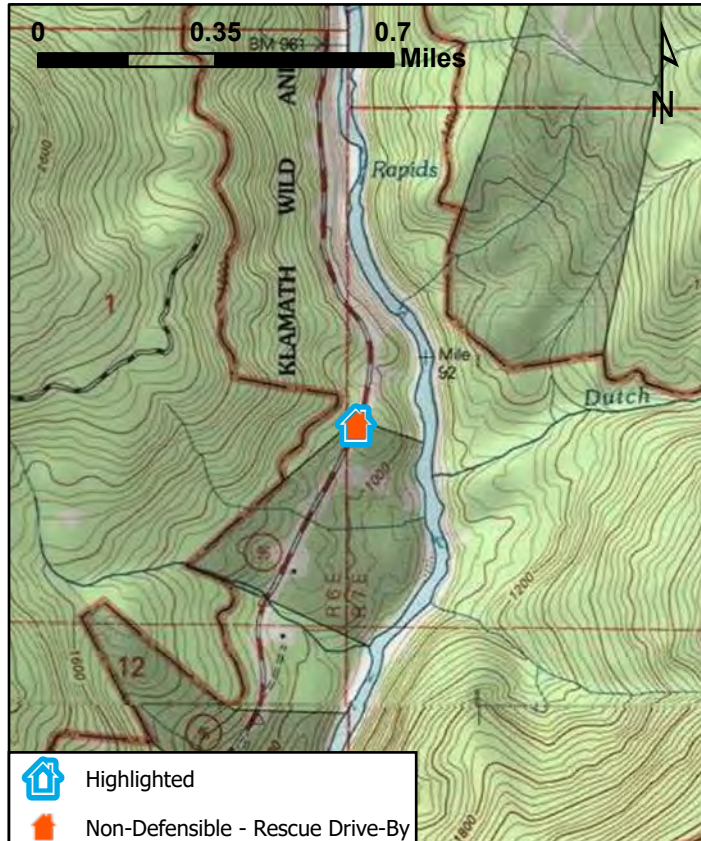
Area: Cottage Grove
Address:
Assigned Structure Number: 148
Type of Structure: Residential
Primary Structures:
Outbuildings:
Is the building Occupied?: Unknown
Coordinates (DDM): 41° 37.974' N, 123° 27.851' W

Safety Zone(s): No safety zone(s) in area
Comm With ICP: Yes
Water Supply:
Fuel Type: Shrub or timber
Defensible Space: No defensible space
Hazards: Unknown on all below. Residents seem to be present. Didn't want to find a deep hole! Access in is over 1/4 mile to residents.

Non-Defensible, Rescue, Drive By

FIRESCOPE Tactics: Tactical Patrol

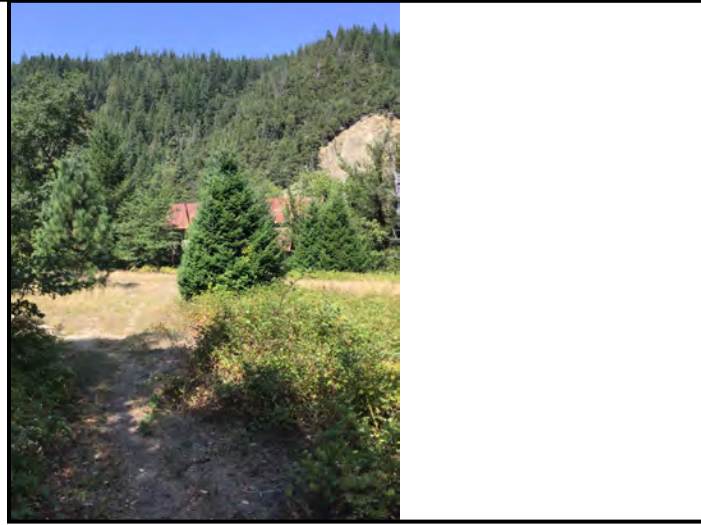
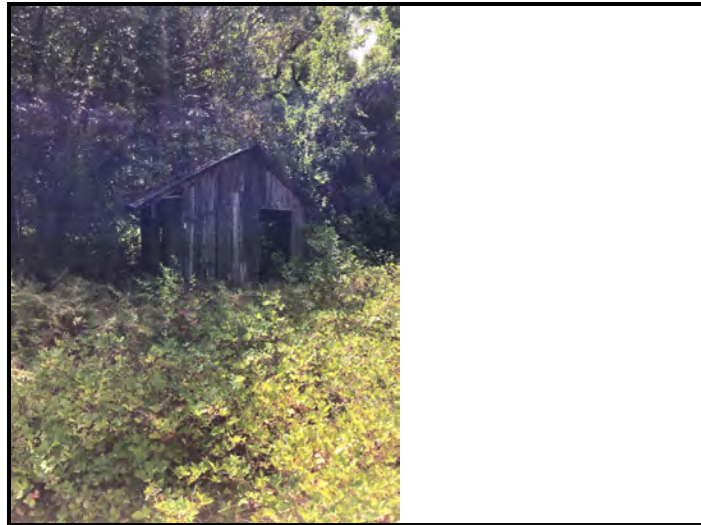
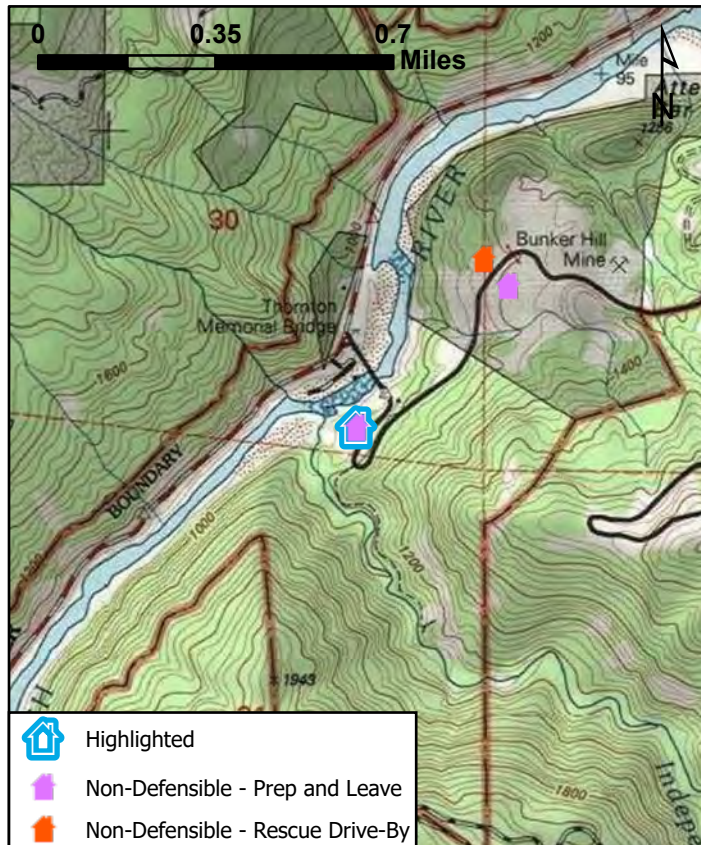
Area: Cottage Grove
Address:
Assigned Structure Number: 193
Type of Structure: Residential
Primary Structures: 2
Outbuildings:
Is the building Occupied?: No
Coordinates (DDM): 41° 39.483' N, 123° 27.003' W

Roof Material: Combination of fire resistant and combustible
Siding Material: Wood or open sided
Electrical Power: No
Gas to Structure: No
Comments: Historic mining buildings. Metal roof. No windows or doors on either building. Main bunk house structure is open on the underside also exposed wood underneath. Building will need hand prep with hose lay and sprinklers. Structure rap will also be needed to close windows and door entry's.

Safety Zone(s): No safety zone(s) in area
Comm With ICP: Yes
Water Supply: No reliable water source nearby
Fuel Type: Shrub or timber
Defensible Space: Less than 30 ft treated
Hazards: The building it's self. No road access. Walk in from 15n17y 100 yards.

Non-Defensible, Prep and Leave

Mitigation Time (in hours): 6
Mitigation Description: Main bunk house structure is open on the underside also exposed wood underneath. Building will need hand prep with hose lay and sprinklers. No water at site best option will be a fold a tank with pump. Structure wrap will also be needed to close windows and door entry's. Smaller
Resources Needed to Protect Structure: 1 engine to start pump and leave.

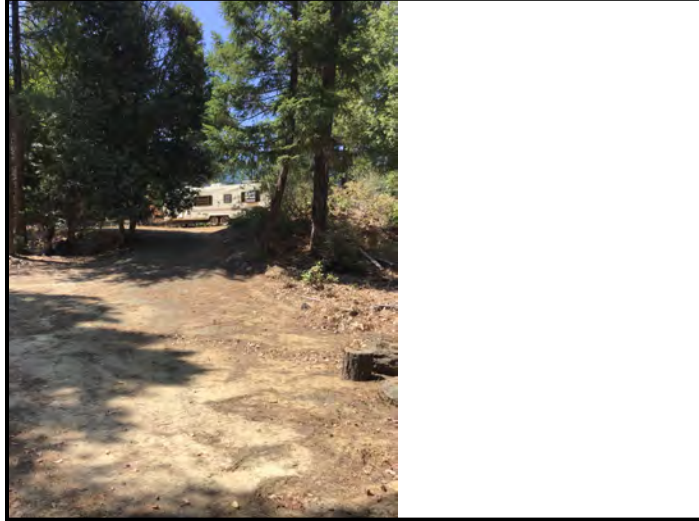
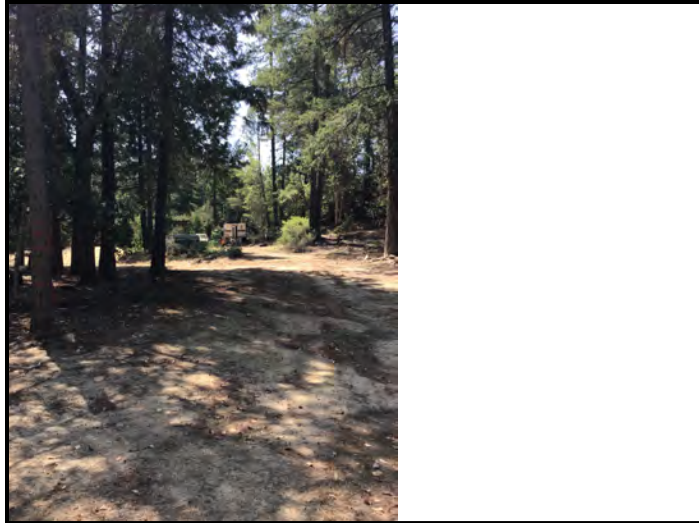
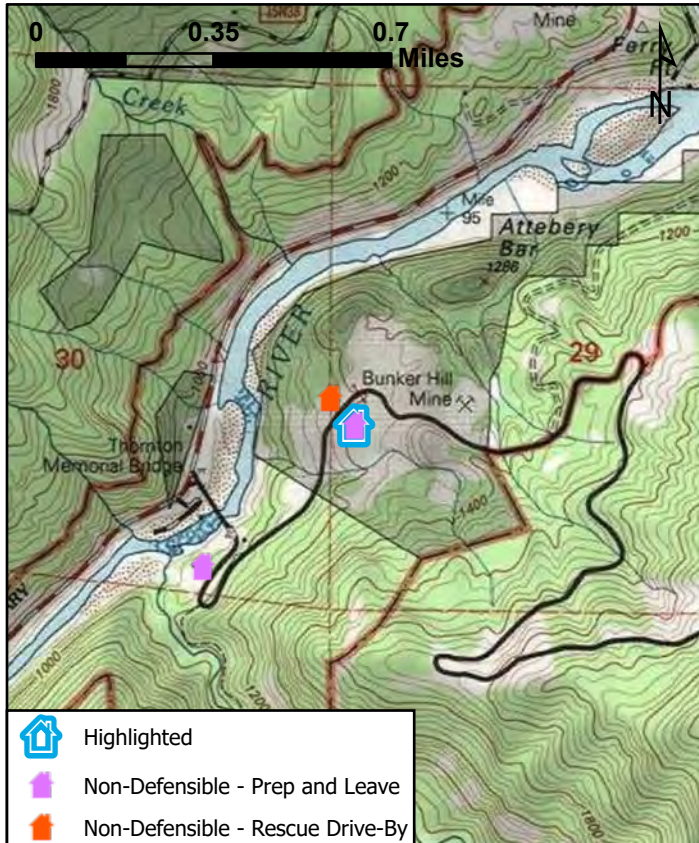
Area: Cottage Grove
Address:
Assigned Structure Number: 194
Type of Structure: Residential
Primary Structures: 3
Outbuildings:
Is the building Occupied?: Unknown
Coordinates (DDM): 41° 39.726' N, 123° 26.657' W

Roof Material: Combination of fire resistant and combustible
Siding Material: Vinyl
Electrical Power: Unknown
Gas to Structure: Unknown
Comments: 1 truck camper, 1 travel trailer and 1 house, house is metal siding and roof but is open on some sides with exposed insulation. It appears that all three could be separate residence. None would be primary residence. Shared mining claim? Road in is good 2 track with turn around for type 6 at the end. Some space has been cleared around

Safety Zone(s): No safety zone(s) in area
Comm With ICP: Yes
Water Supply: No reliable water source nearby
Fuel Type: Shrub or timber
Defensible Space: 30 ft treated
Hazards: Unknown septic, propane tanks.

Non-Defensible, Prep and Leave

Mitigation Time (in hours): 2
Mitigation Description: Minimal prep around buildings saw work brush dragging. Fold a tank with house lay and pump. Also could be burned around and held by engine in right situation.

Resources Needed to Protect Structure: 1 type 3 or 6
