# McCash Fire Structure Triage Assessment

CASRF000651  
August 23, 2021

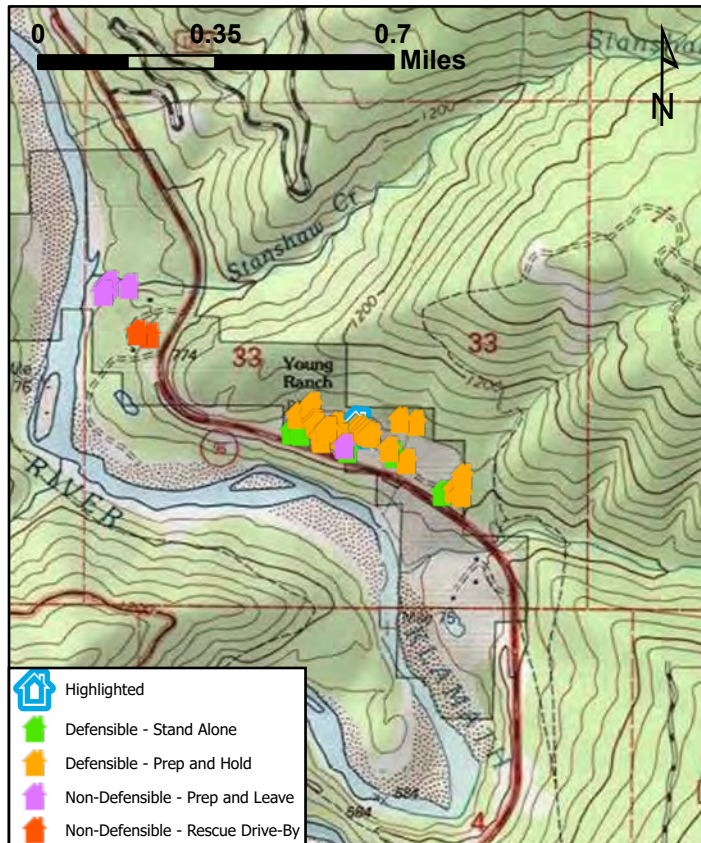
**Area:** Marble Mountain Ranch  
**Address:**  
**Assigned Structure Number:** 133  
**Type of Structure:** Residential  
**Primary Structures:**  
**Outbuildings:**  
**Is the building Occupied?:**  
**Coordinates (DDM):** ,

**Roof Material:** Noncombustible or not applicable  
**Siding Material:** Wood or open sided  
**Electrical Power:** Yes  
**Gas to Structure:** Yes  
**Comments:**

**Safety Zone(s):**  
**Comm With ICP:**  
**Water Supply:**  
**Fuel Type:** Shrub or timber  
**Defensible Space:** 30 ft treated  
**Hazards:**

**Defensible, Prep and Hold**

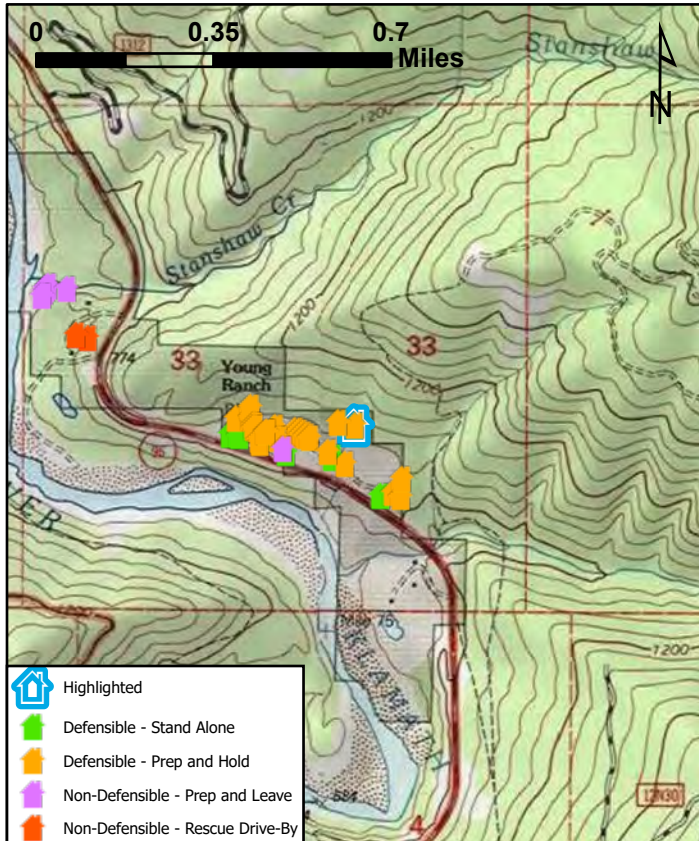
**Area:** Marble Mountain Ranch  
**Address:**  
**Assigned Structure Number:** 137  
**Type of Structure:** Residential  
**Primary Structures:**  
**Outbuildings:** 1  
**Is the building Occupied?:** Yes  
**Coordinates (DDM):** 41° 28.339' N, 123° 29.989' W

**Roof Material:** Noncombustible or not applicable  
**Siding Material:** Wood or open sided  
**Electrical Power:** Yes  
**Gas to Structure:** Yes  
**Comments:** Structure now has three side sprinklers and north east side 1"lat for protection. Supply comes off landowner well points and the lat feeds the home to the west

**Safety Zone(s):** Potential safety zone(s) in area  
**Comm With ICP:**  
**Water Supply:** Reliable water source nearby  
**Fuel Type:** Shrub or timber  
**Defensible Space:** 30 ft treated  
**Hazards:**

**Defensible, Prep and Hold**

**Mitigation Time (in hours):**  
**Mitigation Description:** Cleaned around structure for hazards

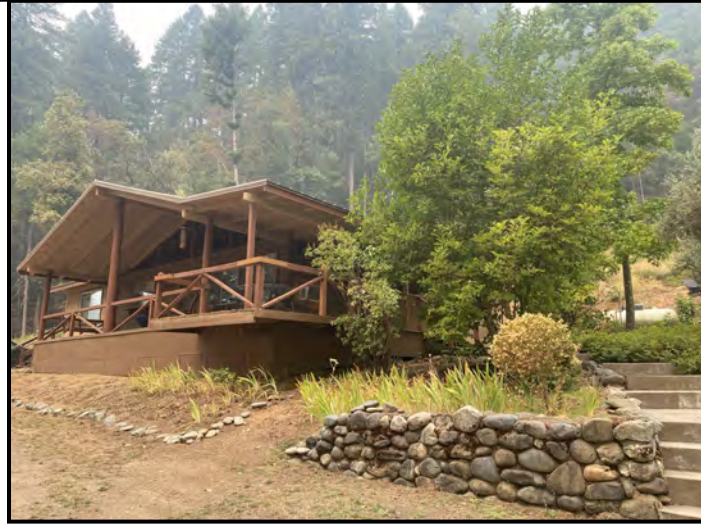
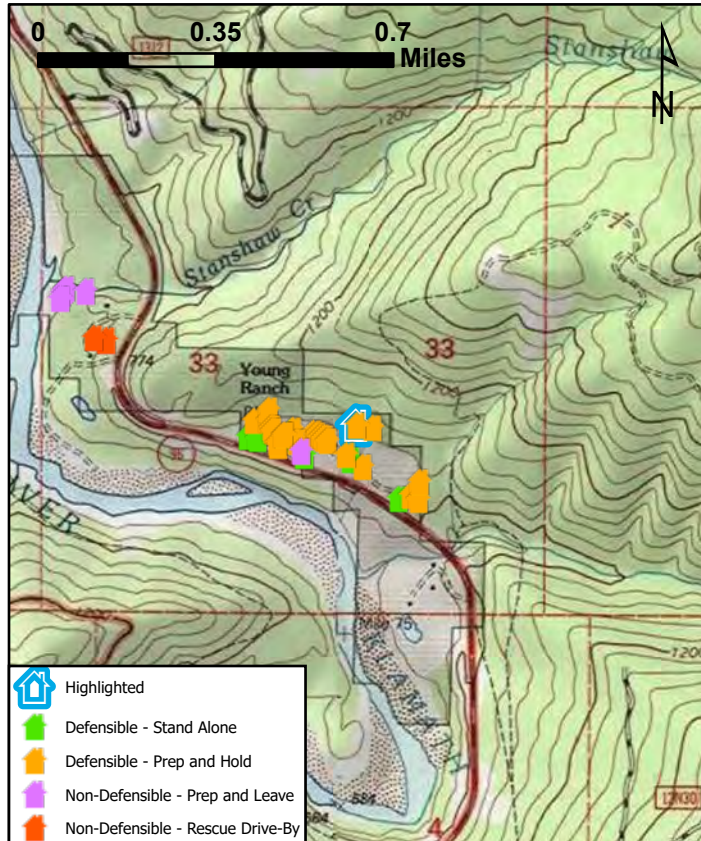
**Area:** Marble Mountain Ranch  
**Address:**  
**Assigned Structure Number:** 138  
**Type of Structure:** Residential  
**Primary Structures:**  
**Outbuildings:**  
**Is the building Occupied?:** Yes  
**Coordinates (DDM):** 41° 28.343' N, 123° 30.027' W

**Roof Material:** Noncombustible or not applicable  
**Siding Material:** Wood or open sided  
**Electrical Power:** Yes  
**Gas to Structure:** Yes  
**Comments:** Two sprinklers installed around the rear of the house connected to the lay from house to the east. Tested and have great coverage. 1" lat for use in middle of lay near propane tank.

**Safety Zone(s):**  
**Comm With ICP:**  
**Water Supply:** Reliable water source nearby  
**Fuel Type:** Shrub or timber  
**Defensible Space:** No defensible space  
**Hazards:** Propane tank

**Defensible, Prep and Hold**

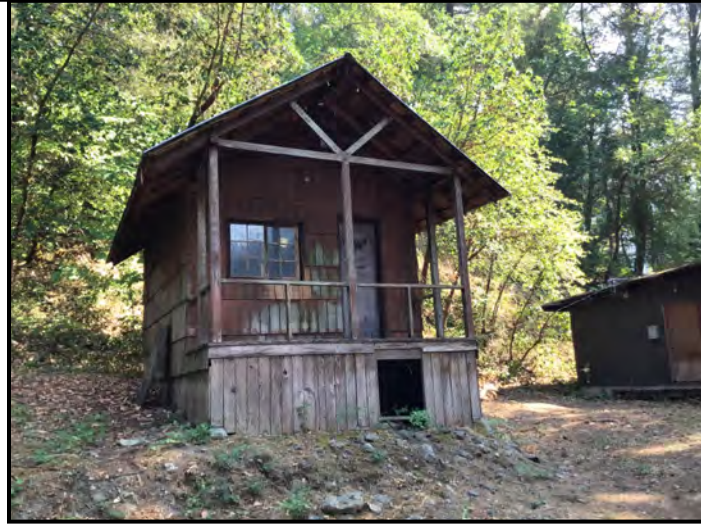
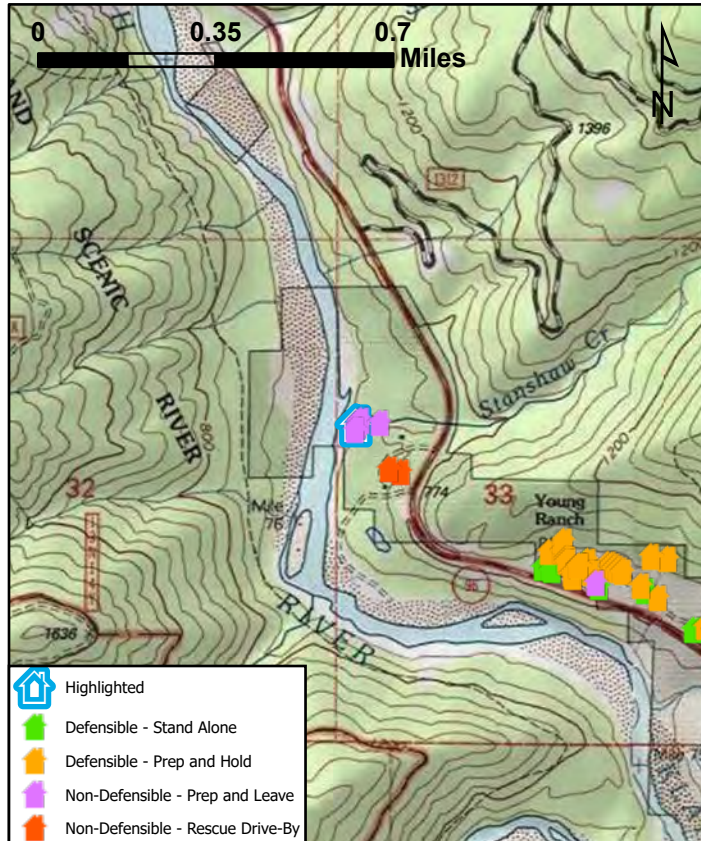
**Area:** Marble Mountain Ranch  
**Address:**  
**Assigned Structure Number:** 178  
**Type of Structure:** Residential  
**Primary Structures:**  
**Outbuildings:**  
**Is the building Occupied?:** No  
**Coordinates (DDM):** 41° 28.565' N, 123° 30.701' W

**Roof Material:** Noncombustible or not applicable  
**Siding Material:** Wood or open sided  
**Electrical Power:** Unknown  
**Gas to Structure:** Unknown  
**Comments:** Small cabin type bedroom

**Safety Zone(s):** Potential safety zone(s) in area  
**Comm With ICP:** Yes  
**Water Supply:** Reliable water source nearby  
**Fuel Type:** Shrub or timber  
**Defensible Space:** 30 ft treated  
**Hazards:**

**Non-Defensible, Prep and Leave**

**Mitigation Time (in hours):** 2  
**Mitigation Description:** Brush around the rear of structure and rake around bottom

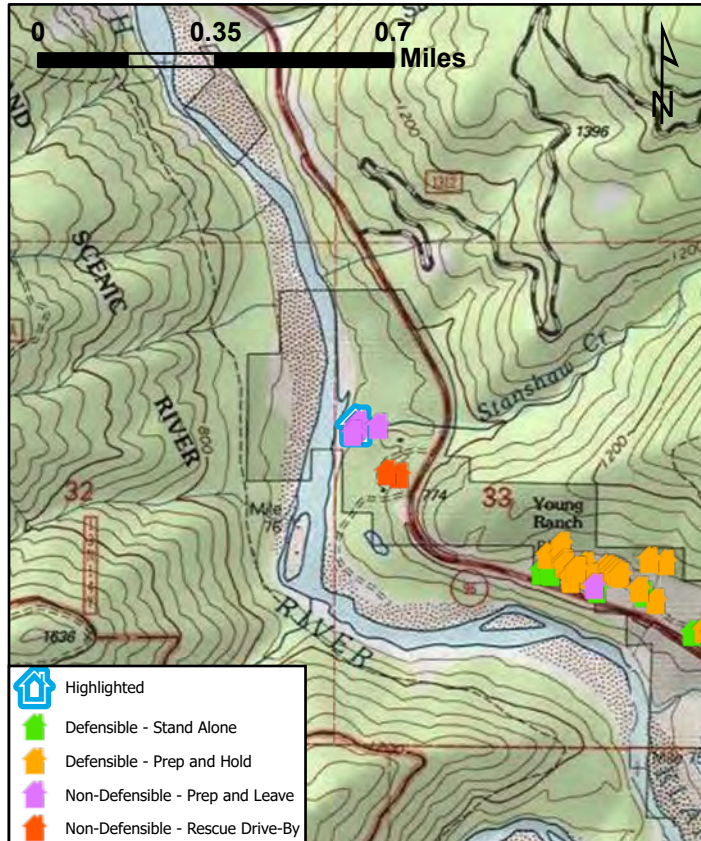
**Area:** Marble Mountain Ranch  
**Address:**  
**Assigned Structure Number:** 179  
**Type of Structure:** Residential  
**Primary Structures:**  
**Outbuildings:**  
**Is the building Occupied?:** No  
**Coordinates (DDM):** 41° 28.571' N, 123° 30.697' W

**Roof Material:** Noncombustible or not applicable  
**Siding Material:** Wood or open sided  
**Electrical Power:** Unknown  
**Gas to Structure:** Unknown  
**Comments:** Small cabin type bedroom

**Safety Zone(s):** Potential safety zone(s) in area  
**Comm With ICP:** Yes  
**Water Supply:** Reliable water source nearby  
**Fuel Type:** Shrub or timber  
**Defensible Space:** 30 ft treated  
**Hazards:**

# Non-Defensible, Prep and Leave

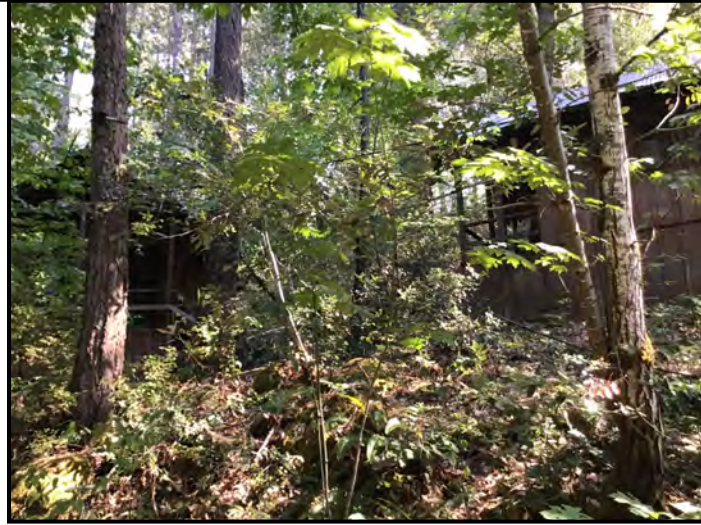
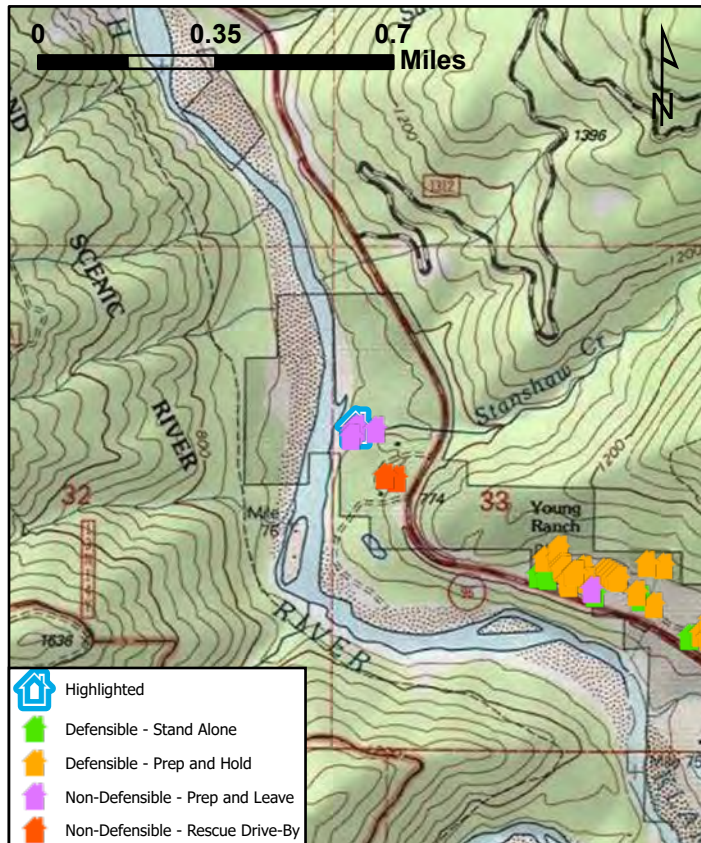
**Area:** Marble Mountain Ranch  
**Address:**  
**Assigned Structure Number:** 180  
**Type of Structure:** Residential  
**Primary Structures:** 2  
**Outbuildings:** 1  
**Is the building Occupied?:** No  
**Coordinates (DDM):** 41° 28.574' N, 123° 30.691' W

**Roof Material:** Noncombustible or not applicable  
**Siding Material:** Wood or open sided  
**Electrical Power:** Unknown  
**Gas to Structure:** Unknown  
**Comments:** Two cabin type bedrooms

**Safety Zone(s):** Potential safety zone(s) in area  
**Comm With ICP:** Yes  
**Water Supply:** Reliable water source nearby  
**Fuel Type:** Shrub or timber  
**Defensible Space:** 30 ft treated  
**Hazards:** Limited access down the driveway road

**Non-Defensible, Prep and Leave**

**Mitigation Time (in hours):** 4  
**Mitigation Description:** Brush around the rear of both cabins and rake around the bottom

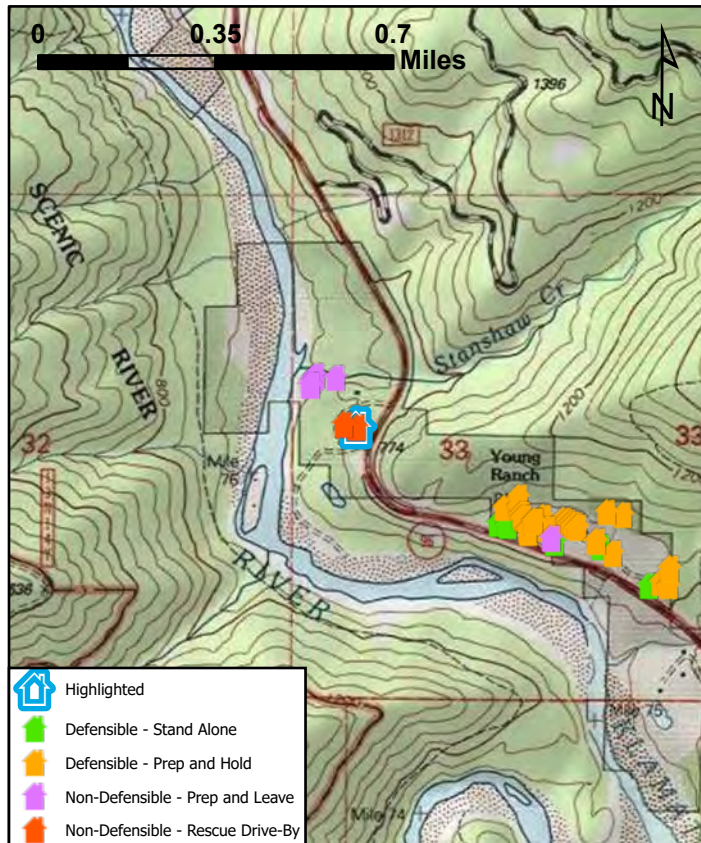
**Safety Zone(s):** No safety zone(s) in area  
**Comm With ICP:** Yes  
**Water Supply:** No reliable water source nearby  
**Fuel Type:**  
**Defensible Space:** No defensible space  
**Hazards:** Unknown

**Non-Defensible, Rescue, Drive By**

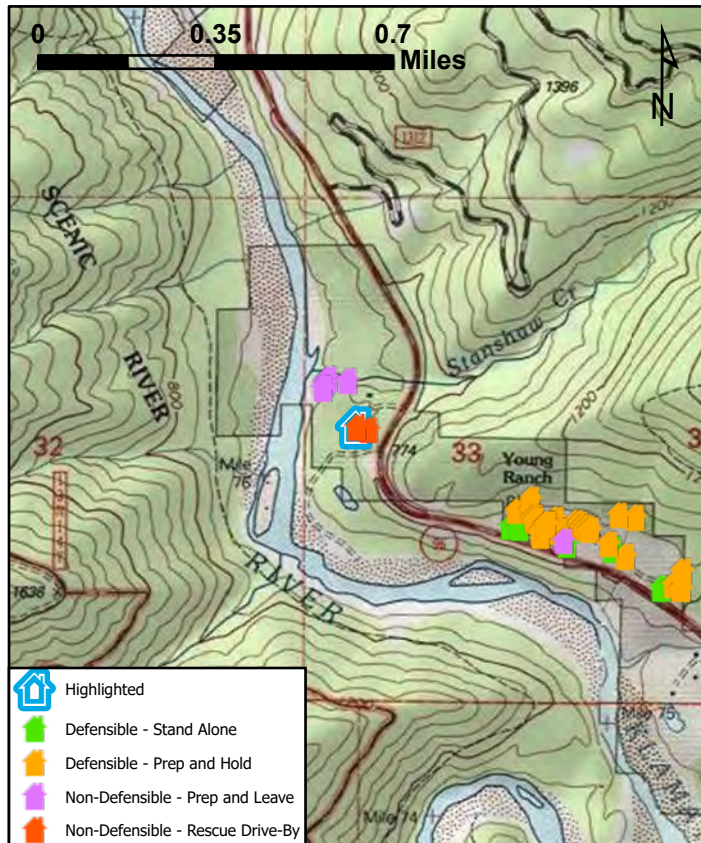
**Safety Zone(s):** No safety zone(s) in area  
**Comm With ICP:**  
**Water Supply:** No reliable water source nearby  
**Fuel Type:**  
**Defensible Space:** No defensible space  
**Hazards:** Unknown

**Non-Defensible, Rescue, Drive By**

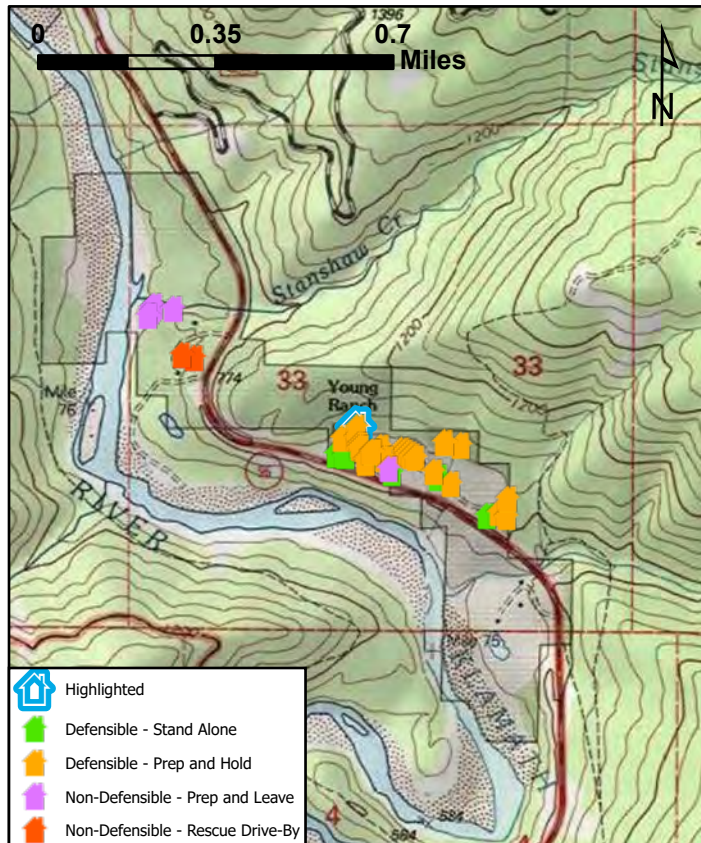
**Safety Zone(s):** Potential safety zone(s) in area  
**Comm With ICP:** Yes  
**Water Supply:** Reliable water source nearby  
**Fuel Type:**  
**Defensible Space:** 30 ft treated  
**Hazards:** Diesel tanks and generators

**Defensible, Prep and Hold**

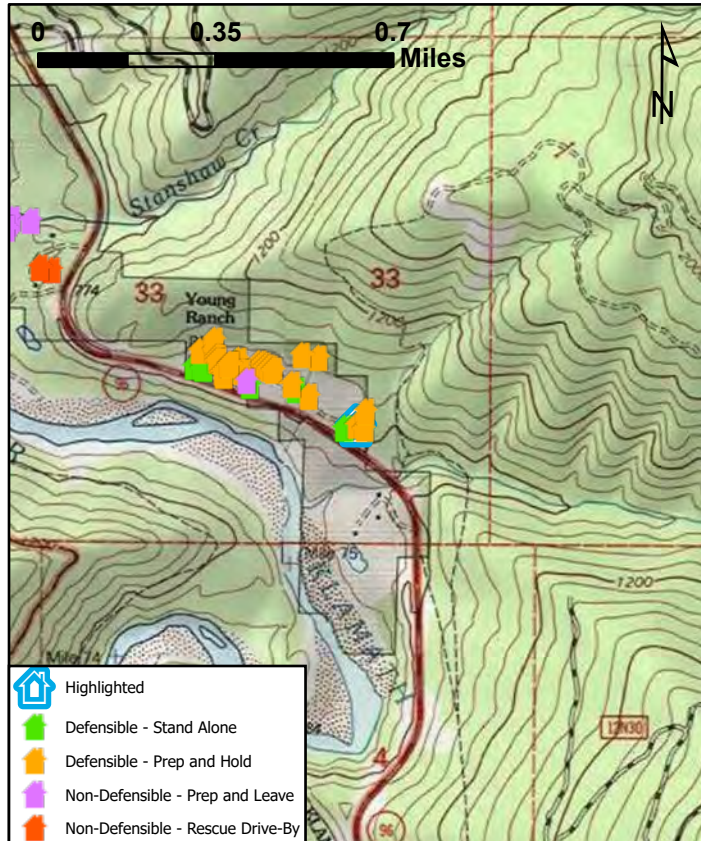
**Safety Zone(s):** Potential safety zone(s) in area  
**Comm With ICP:**  
**Water Supply:** Reliable water source nearby  
**Fuel Type:**  
**Defensible Space:** 100 ft treated  
**Hazards:** Propane tank N/W side of structure

**Defensible, Prep and Hold**

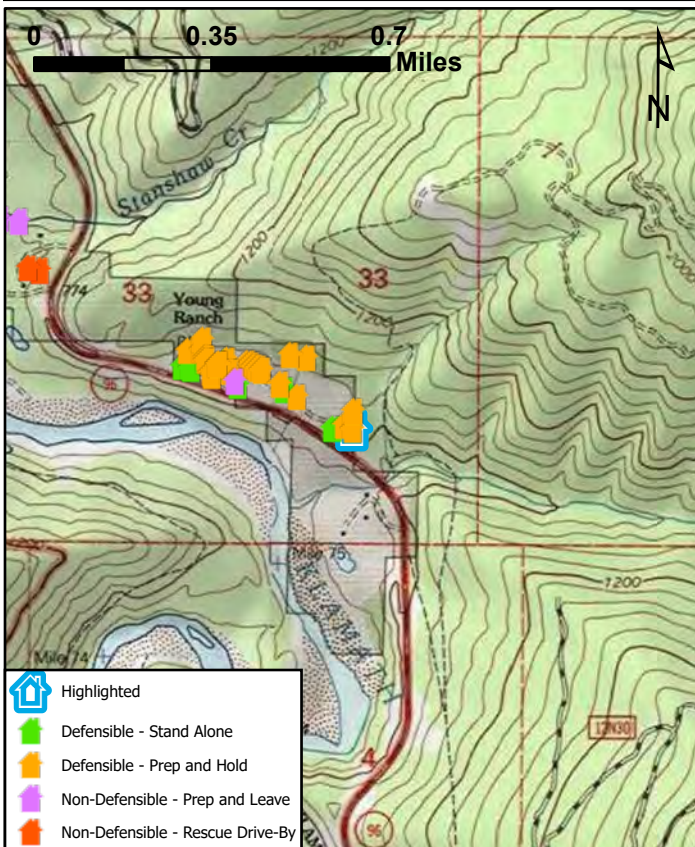
**Safety Zone(s):** Potential safety zone(s) in area  
**Comm With ICP:**  
**Water Supply:** Reliable water source nearby  
**Fuel Type:**  
**Defensible Space:** 30 ft treated  
**Hazards:** Lots of construction Material on the s/e side

**Defensible, Prep and Hold**

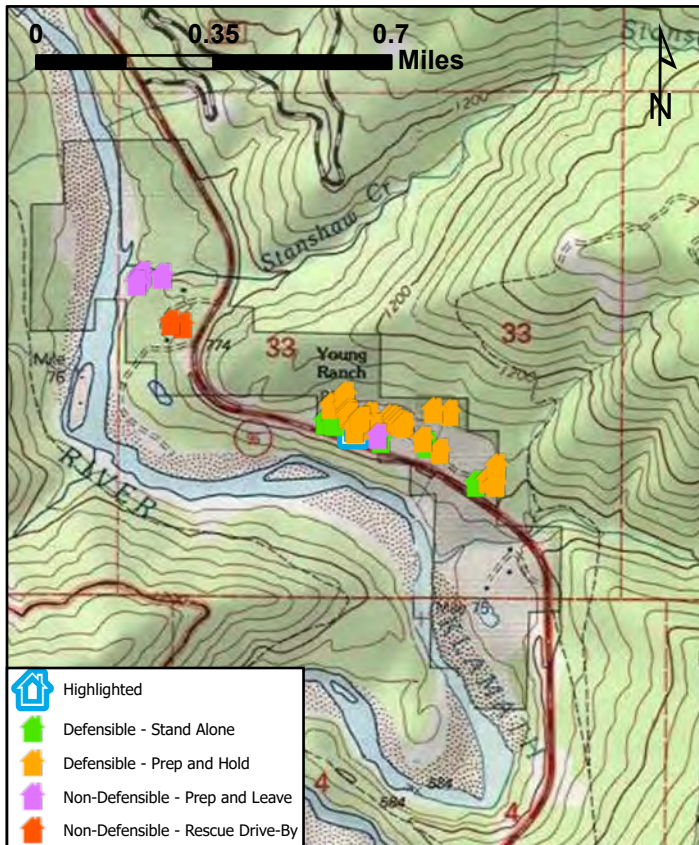
**Safety Zone(s):** Potential safety zone(s) in area  
**Comm With ICP:** Yes  
**Water Supply:** Pressurized hydrant(s) or fixed sprinkler system  
**Fuel Type:** Shrub or timber  
**Defensible Space:** Less than 30 ft treated  
**Hazards:** Propane tanks for bbq

**Defensible, Prep and Hold**
