McCash Fire Structure Triage Assessment

CASRF000651
August 23, 2021

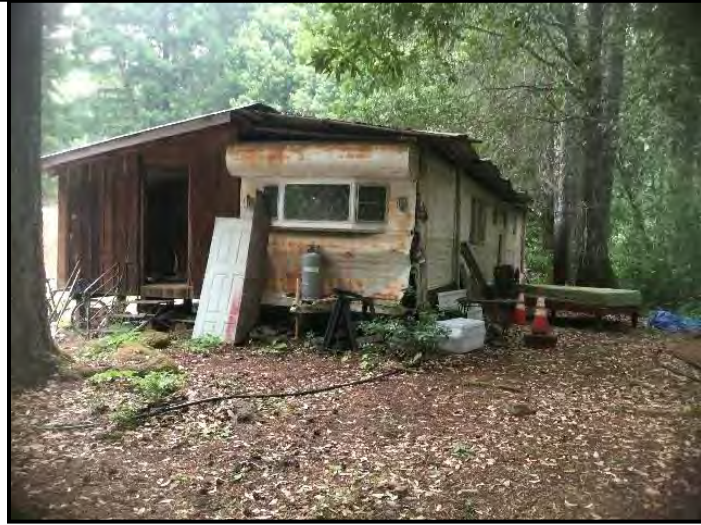
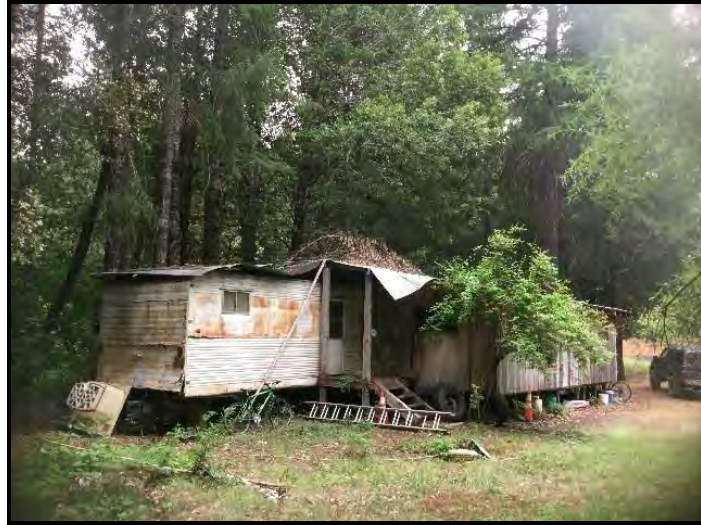
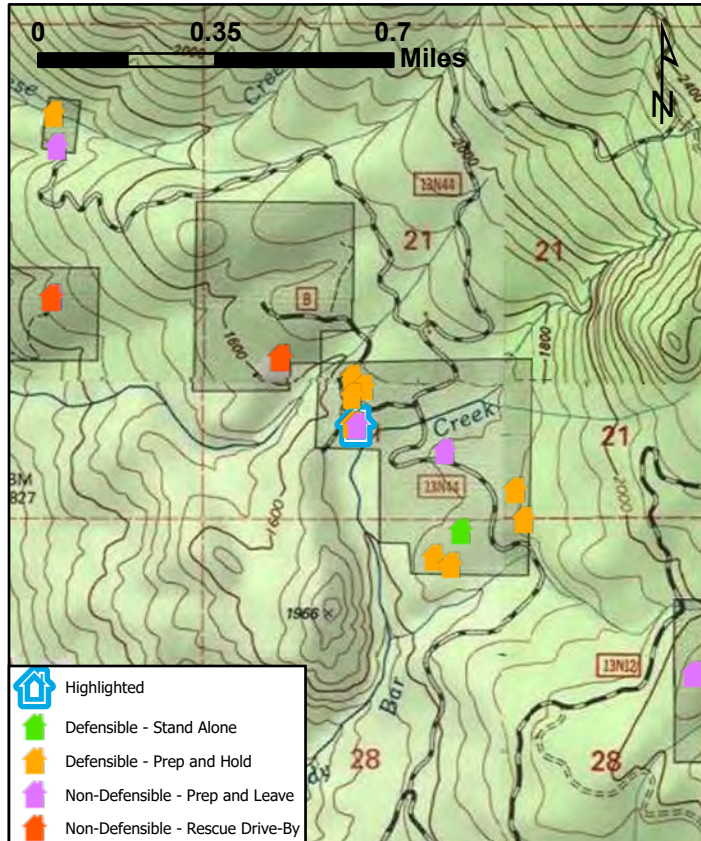
Area: Patterson
Address: 13n27
Assigned Structure Number: 100
Type of Structure: Residential
Primary Structures: 1
Outbuildings:
Is the building Occupied?: Yes
Coordinates (DDM): 41° 29.919' N, 123° 30.401' W

Roof Material: Noncombustible or not applicable
Siding Material: Wood or open sided
Electrical Power: Yes
Gas to Structure: No
Comments:

Safety Zone(s): No safety zone(s) in area
Comm With ICP: Yes
Water Supply: No reliable water source nearby
Fuel Type: Shrub or timber
Defensible Space: Less than 30 ft treated
Hazards:

Non-Defensible, Prep and Leave

Mitigation Time (in hours): 1
Mitigation Description: Scratch line and remove combustibles

Resources Needed to Protect Structure: Sprinkler, a pump could be set up in Sandy Bar Creek, east of structures, 250'

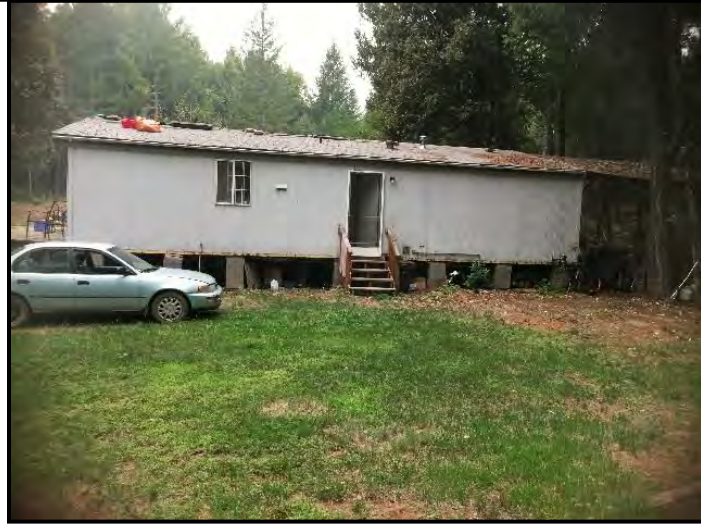
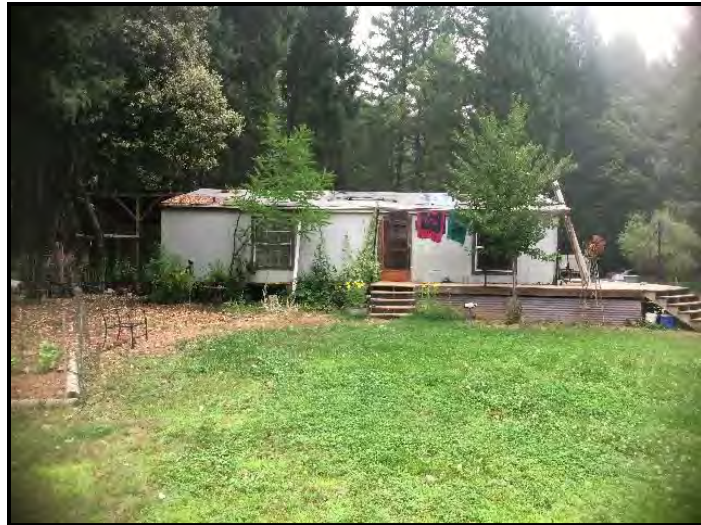
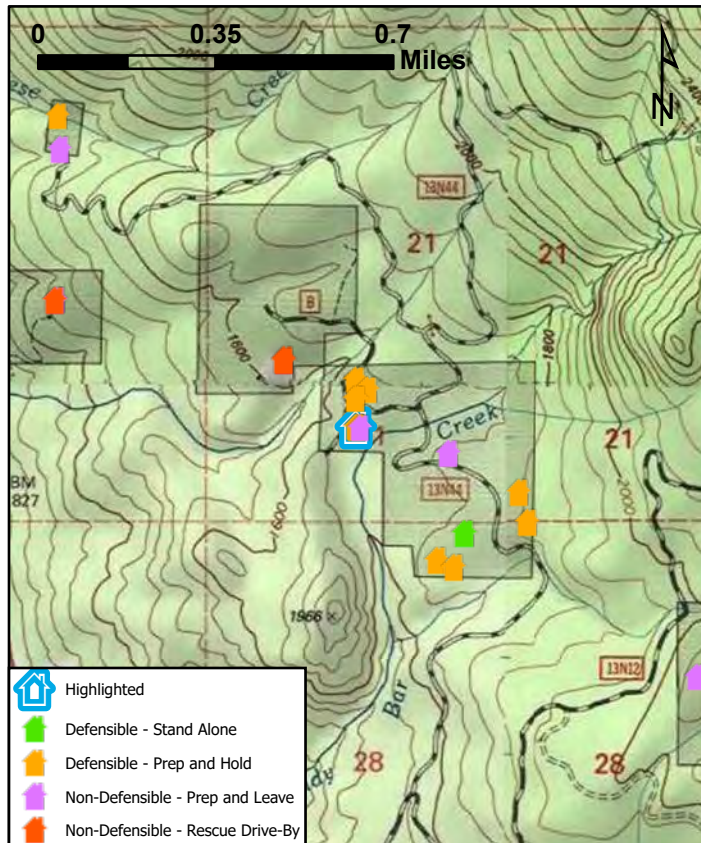
Area: Patterson
Address: 3401 sand bar
Assigned Structure Number: 101
Type of Structure: Residential
Primary Structures: 1
Outbuildings:
Is the building Occupied?: Yes
Coordinates (DDM): 41° 29.920' N, 123° 30.409' W

Roof Material: Fire resistant- tar, rubberized
Siding Material: Wood or open sided
Electrical Power: Yes
Gas to Structure: Yes
Comments: Scott rents from Watsons.

Safety Zone(s): No safety zone(s) in area
Comm With ICP: Yes
Water Supply: Reliable water source nearby
Fuel Type: Shrub or timber
Defensible Space: Less than 30 ft treated
Hazards:

Defensible, Prep and Hold

Mitigation Time (in hours): 1
Mitigation Description: Scratch line and remove ground fuels

Resources Needed to Protect Structure: Sprinkler

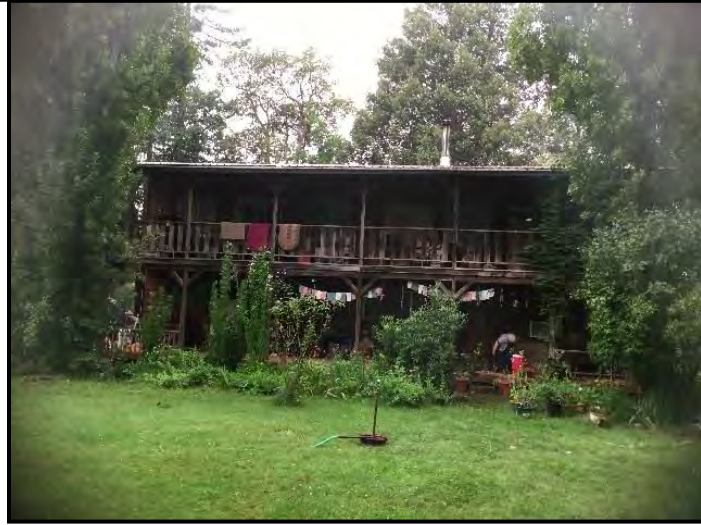
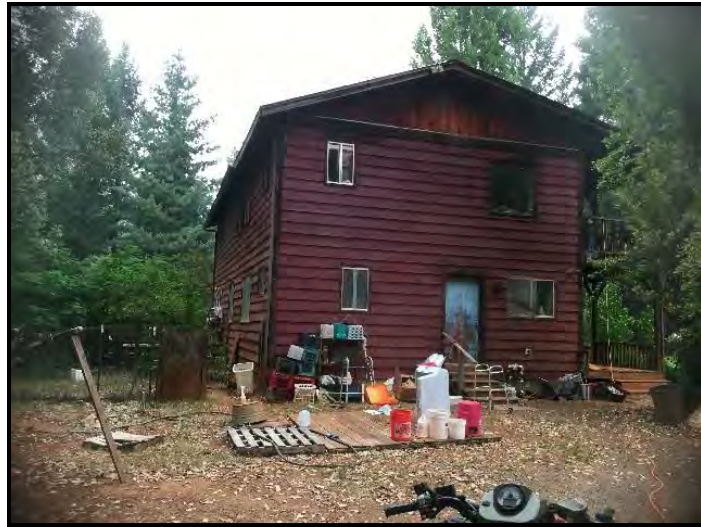
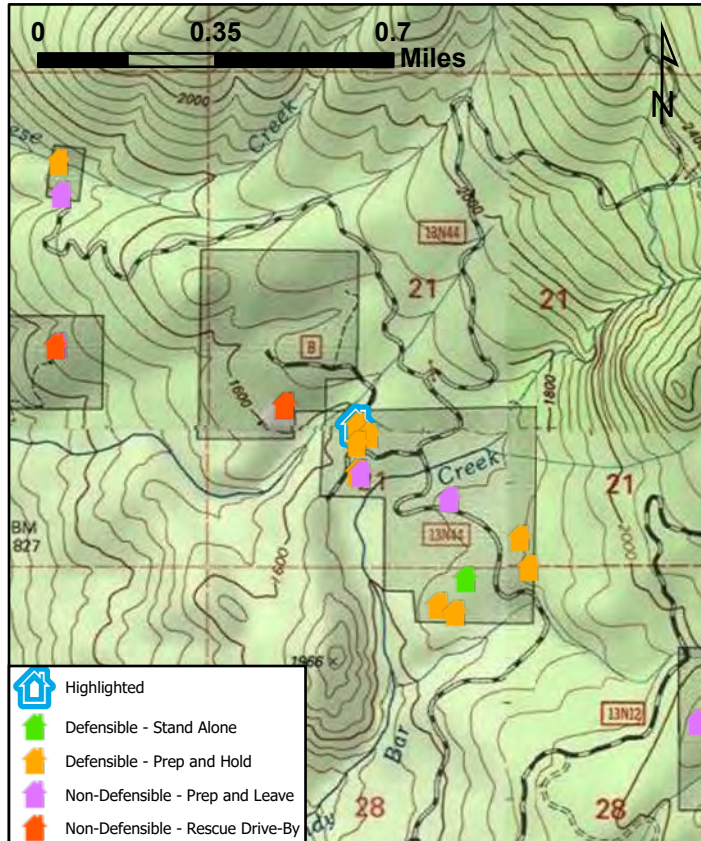
Area: Patterson
Address: 3400 sandy bar rd
Assigned Structure Number: 102
Type of Structure: Residential
Primary Structures: 1
Outbuildings: 1
Is the building Occupied?: Yes
Coordinates (DDM): 41° 30.001' N, 123° 30.412' W

Roof Material: Noncombustible or not applicable
Siding Material: Wood or open sided
Electrical Power: Yes
Gas to Structure: Yes
Comments: Edna & Wally Watson. 2" water suppl from river, canopy touches house in multiple areas

Safety Zone(s): No safety zone(s) in area
Comm With ICP: Yes
Water Supply: Limited or dependent on electricity
Fuel Type: Shrub or timber
Defensible Space: 30 ft treated
Hazards:

Defensible, Prep and Hold

Mitigation Time (in hours): 1
Mitigation Description: Remove combustibles around house, some saw work

Resources Needed to Protect Structure: Sprinkler, 1 engine

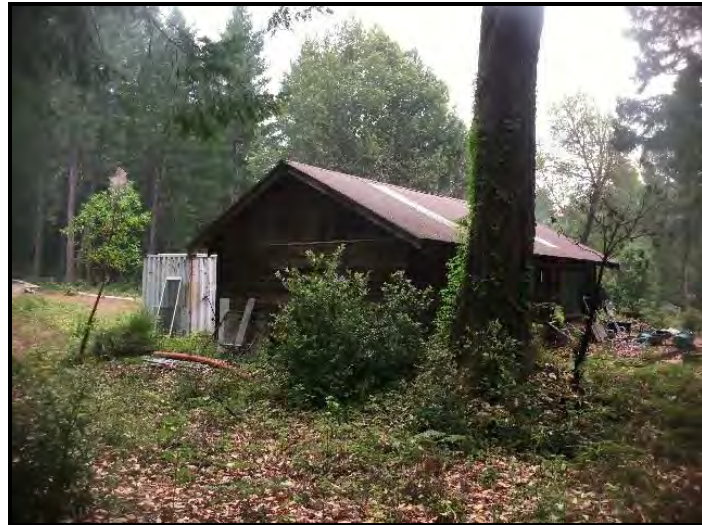
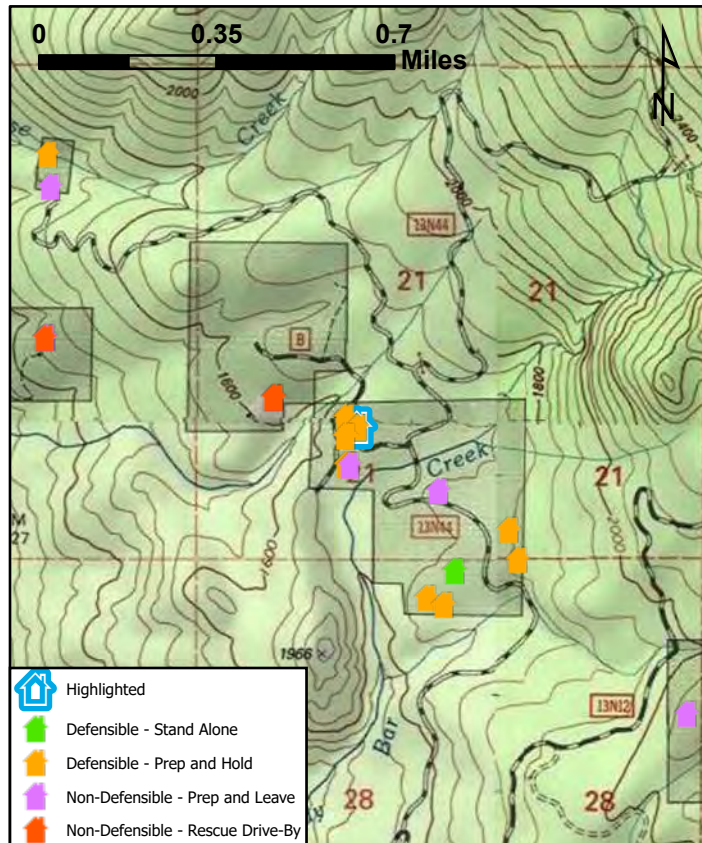
Area: Patterson
Address: 3400(1) sand bar
Assigned Structure Number: 103
Type of Structure: Outbuilding
Primary Structures: 1
Outbuildings:
Is the building Occupied?: No
Coordinates (DDM): 41° 29.985' N, 123° 30.385' W

Roof Material: Noncombustible or not applicable
Siding Material: Wood or open sided
Electrical Power: Yes
Gas to Structure: No
Comments: Watson's detached workshop

Safety Zone(s): No safety zone(s) in area
Comm With ICP: Yes
Water Supply: Limited or dependent on electricity
Fuel Type: Shrub or timber
Defensible Space: Less than 30 ft treated
Hazards:

Defensible, Prep and Hold

Mitigation Time (in hours): 1
Mitigation Description: Scratch line & remove combustibles

Resources Needed to Protect Structure: Sprinkler

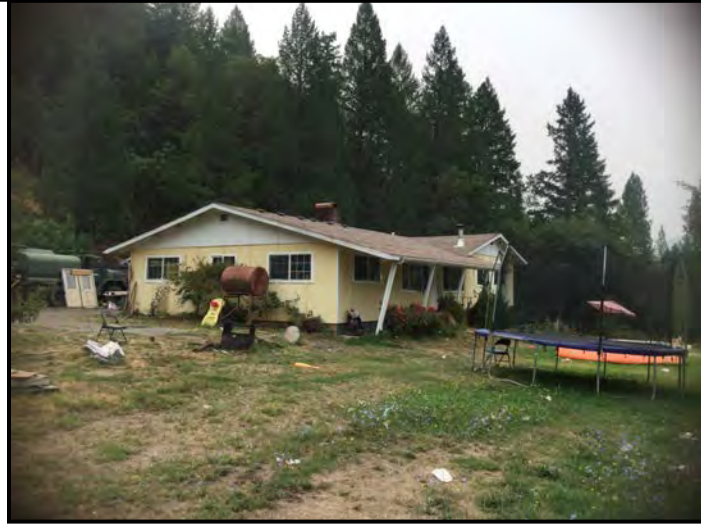
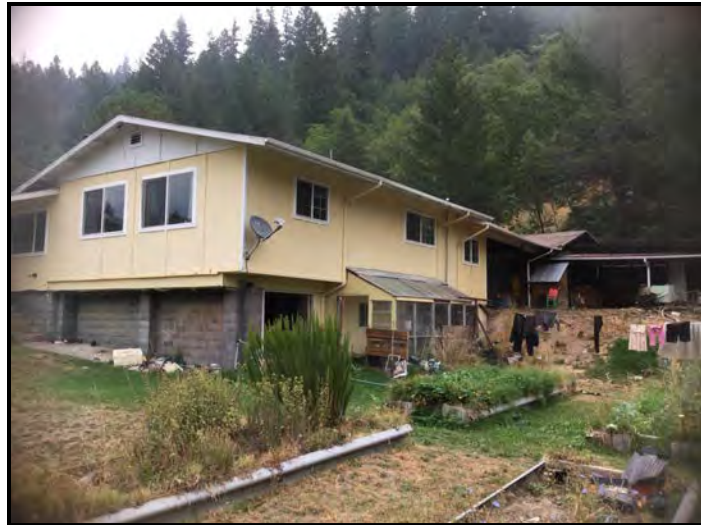
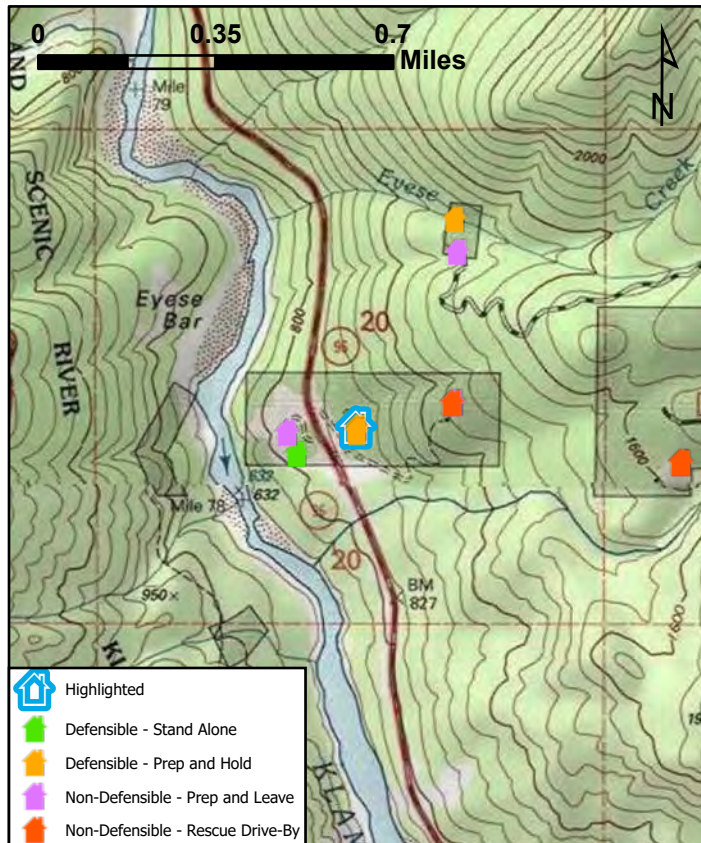
Area: Patterson
Address:
Assigned Structure Number: 104
Type of Structure: Residential
Primary Structures: 1
Outbuildings: 1
Is the building Occupied?: Yes
Coordinates (DDM): 41° 30.092' N, 123° 31.318' W

Roof Material: Fire resistant- tar, rubberized
Siding Material: Wood or open sided
Electrical Power: Yes
Gas to Structure: Yes
Comments: Crispin McCallister 530-469-3299 tribal rep. (3) 3,000 gallon water tenders on property and 2,500 pumpkin

Safety Zone(s): Potential safety zone(s) in area
Comm With ICP: Yes
Water Supply: Reliable water source nearby
Fuel Type:
Defensible Space: 30 ft treated
Hazards: Multiple wolves on chains throughout property

Defensible, Prep and Hold

Mitigation Time (in hours): 3
Mitigation Description: Fuel reduction on uphill side of property. Removal of combustibles around house. Crew did work up slope around house. Limbed around the house and down the southern egress driveway out. Homeowner has fire fighting equipment onsite along with sprinklers
Resources Needed to Protect Structure: Sprinkler, 1 engine

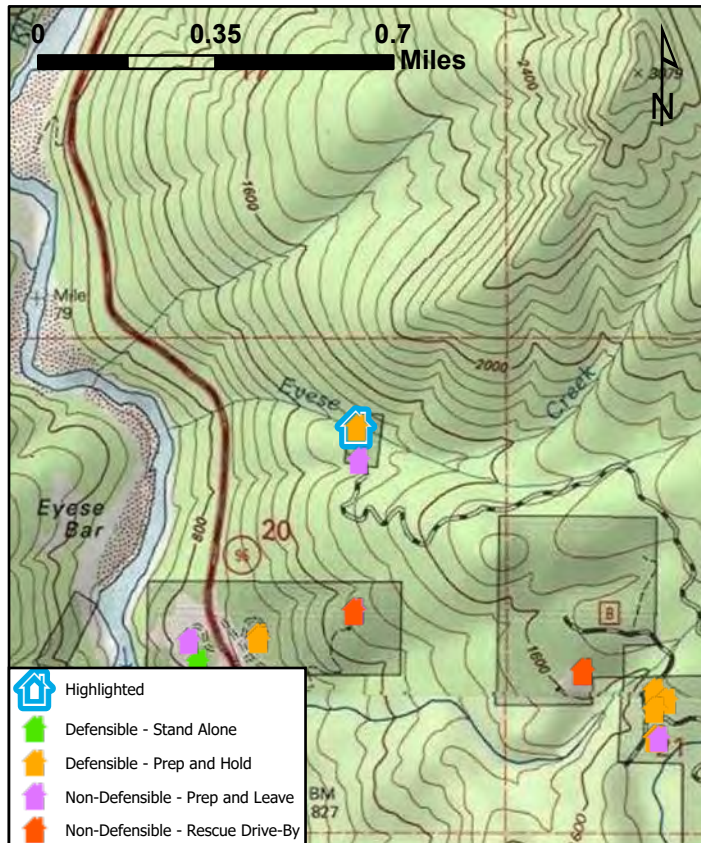
Area: Patterson
Address:
Assigned Structure Number: 105
Type of Structure: Residential
Primary Structures: 1
Outbuildings:
Is the building Occupied?: Yes
Coordinates (DDM): 41° 30.451' N, 123° 31.096' W

Roof Material: Combustible or no roof
Siding Material:
Electrical Power: No
Gas to Structure: No
Comments: Cabin under construction

Safety Zone(s): No safety zone(s) in area
Comm With ICP: Yes
Water Supply: Reliable water source nearby
Fuel Type: Shrub or timber
Defensible Space: Less than 30 ft treated
Hazards:

Defensible, Prep and Hold

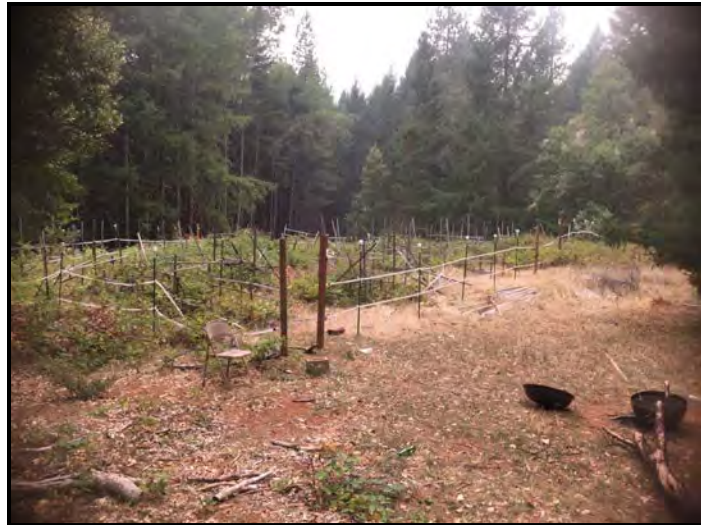
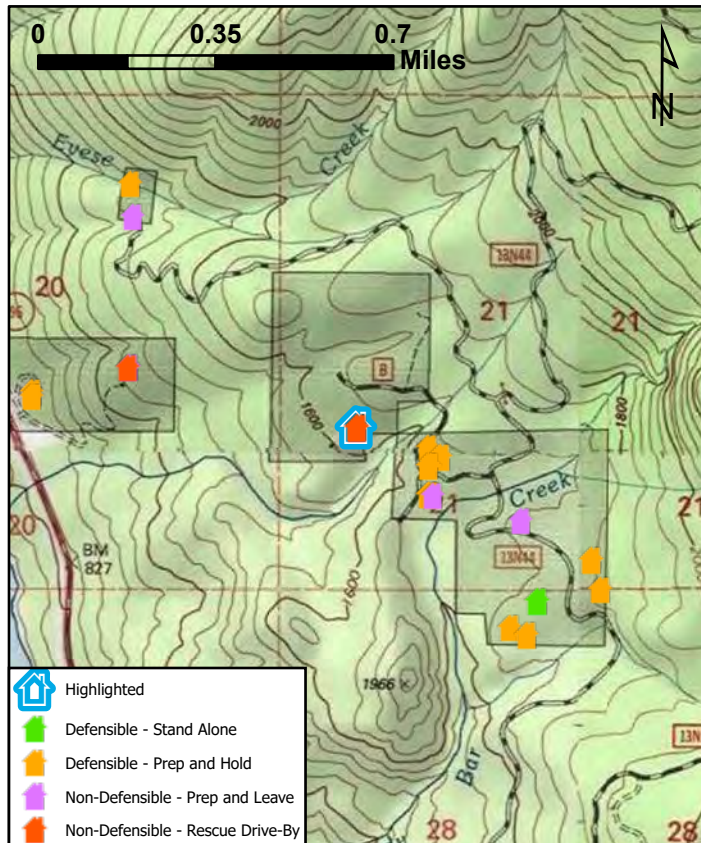
Area: Patterson
Address:
Assigned Structure Number: 107
Type of Structure: Residential
Primary Structures: 1
Outbuildings:
Is the building Occupied?: No
Coordinates (DDM): 41° 30.036' N, 123° 30.576' W

Roof Material: Combination of fire resistant and combustible
Siding Material: Vinyl
Electrical Power: No
Gas to Structure: No
Comments: Abandoned bumper pull trailer

Safety Zone(s): No safety zone(s) in area
Comm With ICP: Yes
Water Supply: No reliable water source nearby
Fuel Type: Shrub or timber
Defensible Space: No defensible space
Hazards:

Non-Defensible, Rescue, Drive By

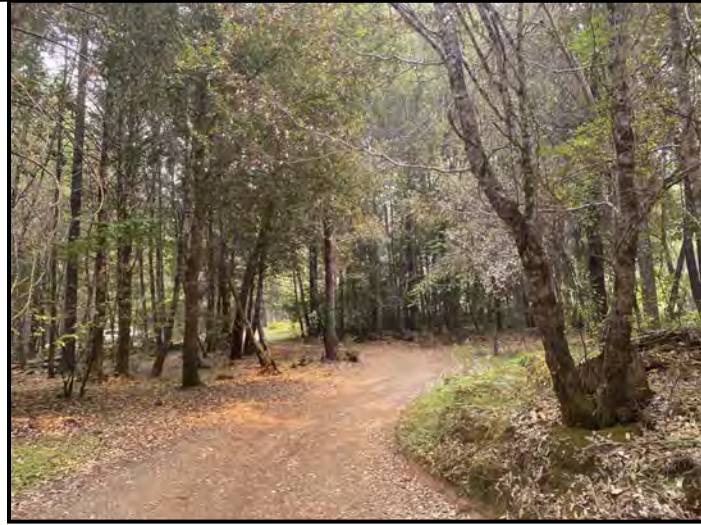
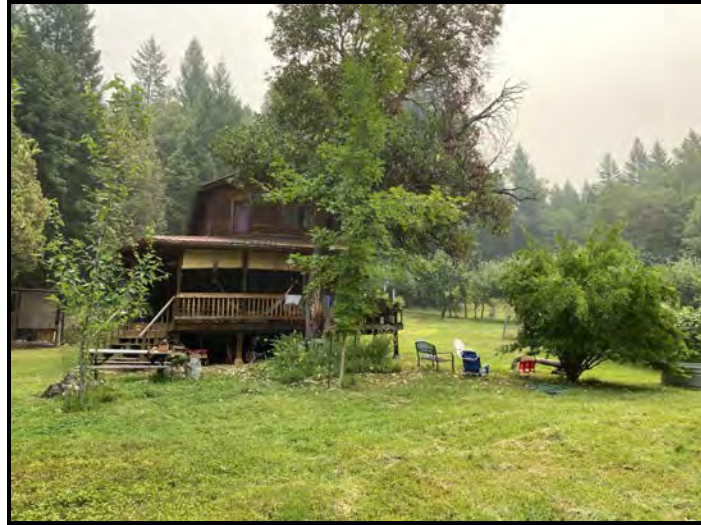
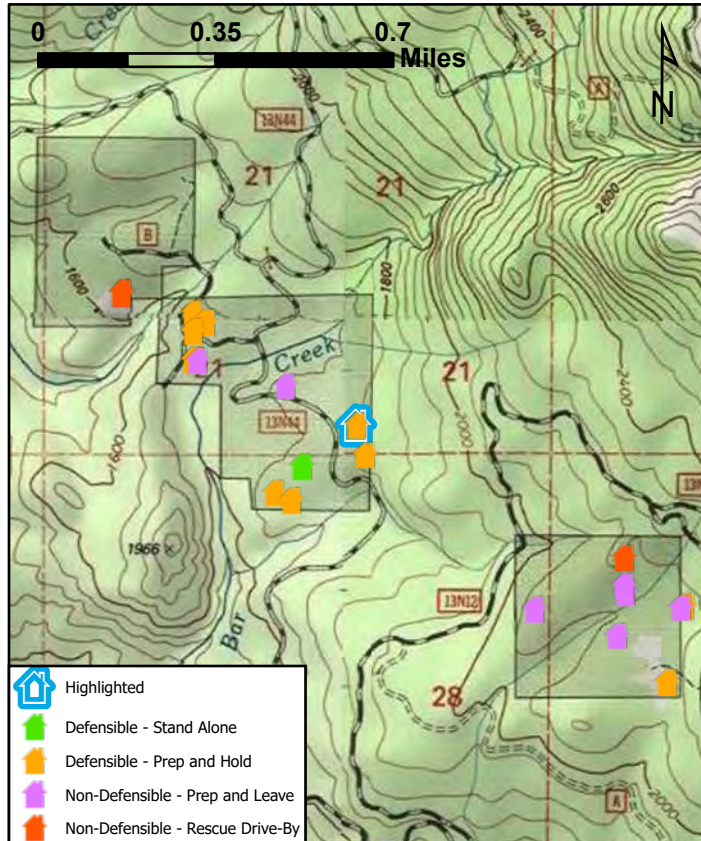
Area: Patterson
Address: Sandy bar rd
Assigned Structure Number: 131
Type of Structure: Residential
Primary Structures: 2
Outbuildings: 1
Is the building Occupied?: Yes
Coordinates (DDM): 41° 29.810' N, 123° 30.038' W

Roof Material: Combustible or no roof
Siding Material: Wood or open sided
Electrical Power: No
Gas to Structure: Yes
Comments: Denise Bearding. 30' defensible spacing to the east and north. 100' defensible to the south and west.

Safety Zone(s): No safety zone(s) in area
Comm With ICP: No
Water Supply: Limited or dependent on electricity
Fuel Type: Shrub or timber
Defensible Space: 30 ft treated
Hazards:

Defensible, Prep and Hold

Mitigation Time (in hours): 2
Mitigation Description: Some raking, hose and sprinkler set up.

Resources Needed to Protect Structure: 1 type three engine

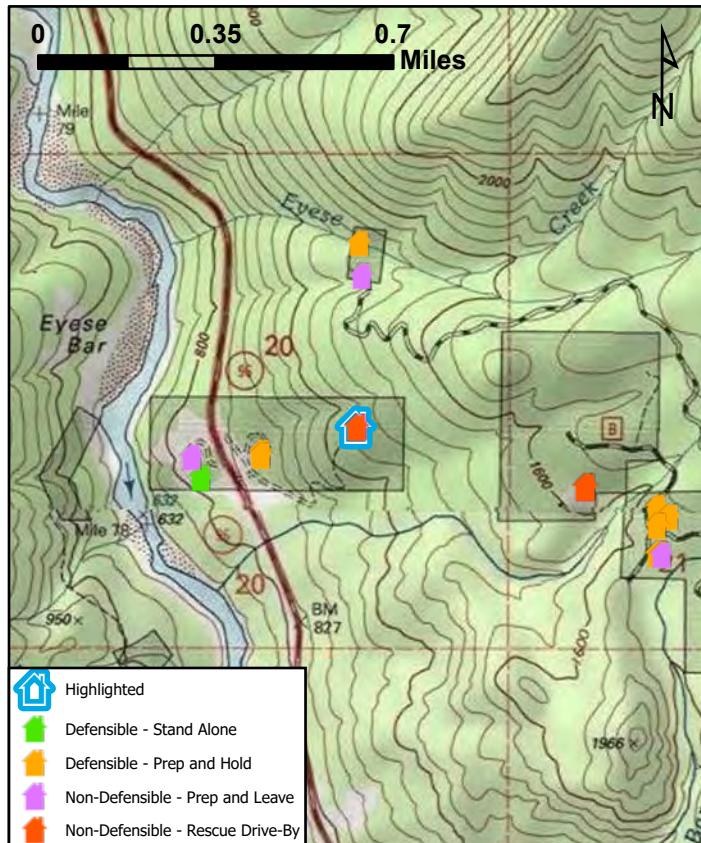
Area: Patterson
Address:
Assigned Structure Number: 132
Type of Structure: Residential
Primary Structures: 1
Outbuildings: 0
Is the building Occupied?: Yes
Coordinates (DDM): 41° 30.135' N, 123° 31.099' W

Roof Material: Combustible or no roof
Siding Material: Wood or open sided
Electrical Power: No
Gas to Structure: No
Comments:

Safety Zone(s): No safety zone(s) in area
Comm With ICP: Yes
Water Supply: No reliable water source nearby
Fuel Type: Shrub or timber
Defensible Space: No defensible space
Hazards: Overgrown vegetation around structure

Mitigation Time (in hours): 8
Mitigation Description: Not savable despite mitigation. Property caretaker said that is not a structure and to remove from our list

Non-Defensible, Rescue, Drive By

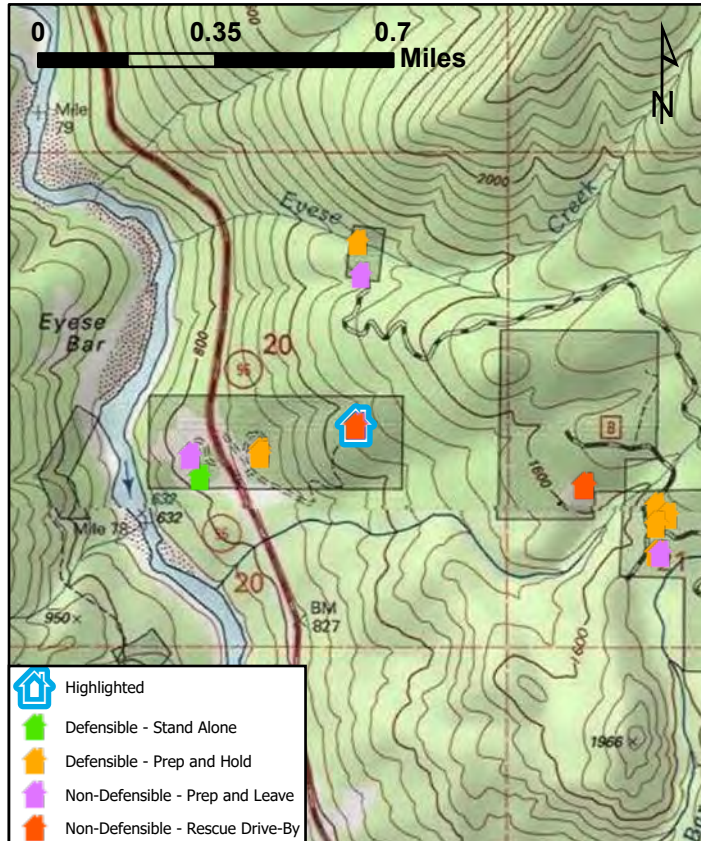
Area: Patterson
Address: Unknown
Assigned Structure Number: 156
Type of Structure: Residential
Primary Structures: 1
Outbuildings: 3
Is the building Occupied?: Yes
Coordinates (DDM): 41° 30.136' N, 123° 31.097' W

Roof Material: Combustible or no roof
Siding Material: Wood or open sided
Electrical Power: No
Gas to Structure: Unknown
Comments: Structures are a mix of wood and rock, one structure is no longer occupied, both right next to each other with vegetation growing with in the structure area. Wood outbuilding with metal roof, treehouses on property that may be occupied but others who occasionally live on property.

Safety Zone(s): No safety zone(s) in area
Comm With ICP: Yes
Water Supply: No reliable water source nearby
Fuel Type: Shrub or timber
Defensible Space: Less than 30 ft treated
Hazards: Bad access, brush close to structure, structures themselves have fuel right amongst them.

Non-Defensible, Prep and Leave

Mitigation Time (in hours): 12
Mitigation Description: Place sprinklers, pumps, and tanks around structure. Evaluate ability and homeowner comfort with improving defensible space around structure. Crew has completed the mitigation work around structure, 40+ft raked limb up around house and shed 10+ft. 4 side sprinkler kit set
Resources Needed to Protect Structure: One crew, one Type VI engine

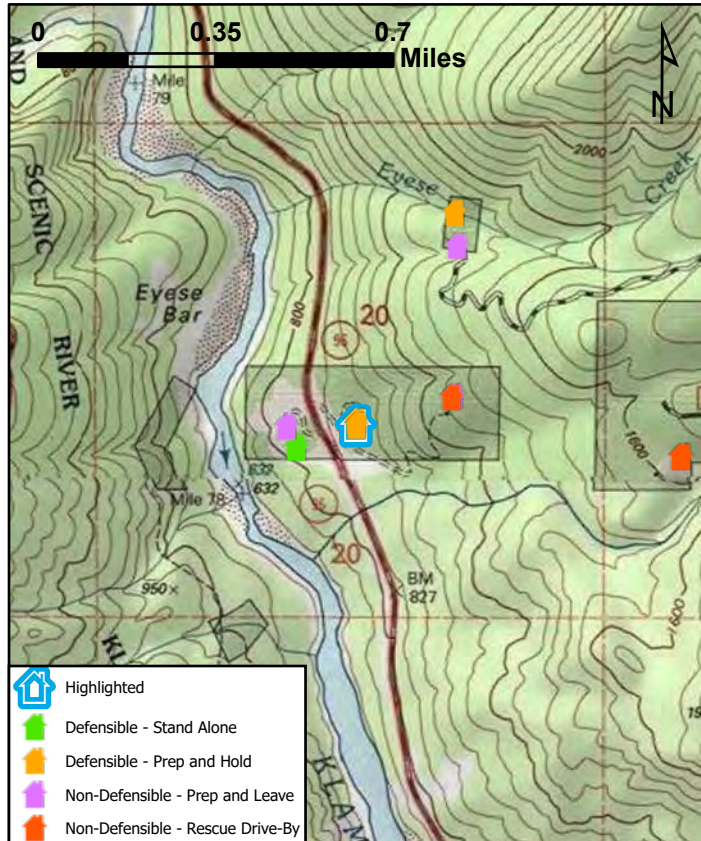
Area: Patterson
Address: Unknown
Assigned Structure Number: 157
Type of Structure: Residential
Primary Structures: 1
Outbuildings:
Is the building Occupied?: Yes
Coordinates (DDM): 41° 30.085' N, 123° 31.317' W

Roof Material: Fire resistant- tar,rubberized
Siding Material: Wood or open sided
Electrical Power: No
Gas to Structure: Yes
Comments: Good defensible space around structure, good access, one water tender full with 4,000 gallons. Old skid road across top of structure. Old trailer above structure.

Safety Zone(s): Potential safety zone(s) in area
Comm With ICP: Yes
Water Supply: Limited or dependent on electricity
Fuel Type: Shrub or timber
Defensible Space: 100 ft treated
Hazards: Multiple vehicles on property that may or may not be operable, lots of excess debris around the structure.

Defensible, Prep and Hold

Mitigation Time (in hours): 4
Mitigation Description: Place sprinklers and tanks around structures.

Resources Needed to Protect Structure: One Type III

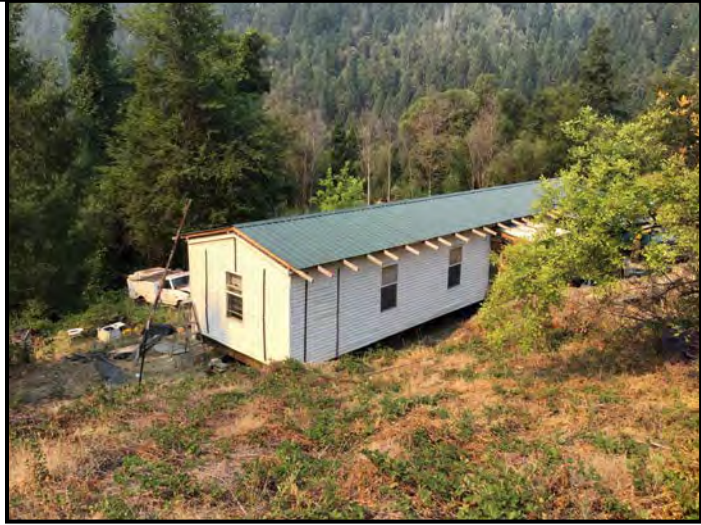
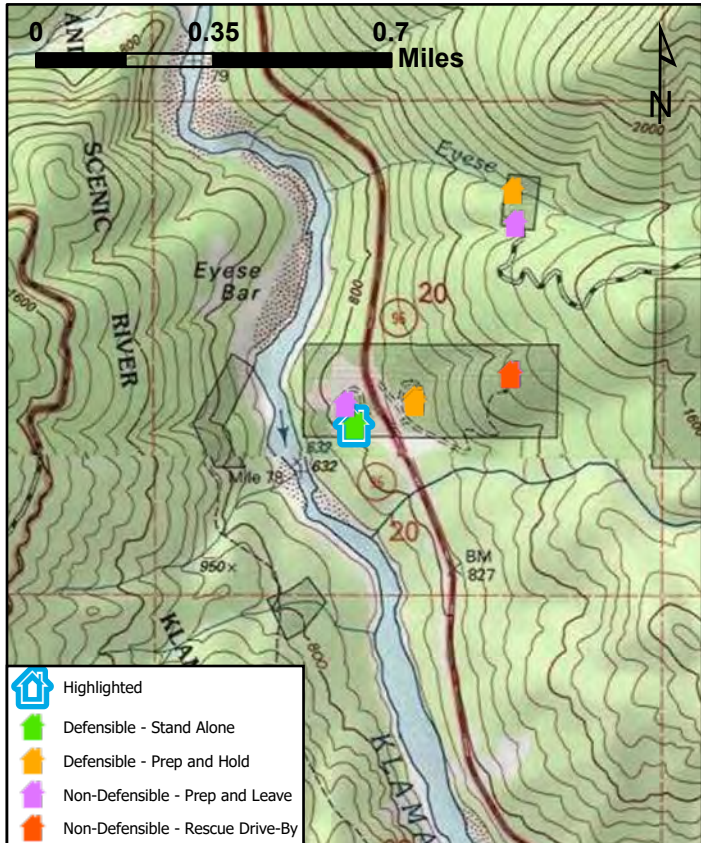
Area: Patterson
Address:
Assigned Structure Number: 175
Type of Structure: Residential
Primary Structures: 1
Outbuildings: 3
Is the building Occupied?: Yes
Coordinates (DDM): 41° 30.046' N, 123° 31.454' W

Roof Material:
Siding Material: Vinyl
Electrical Power: No
Gas to Structure: Yes
Comments: Orien and chastity Met with Gary (owner) he is weed eating a path to the neighbors swimming pool for water access. One sprinkler kit and a few hundred feet of trunk to reach swimming pool. Chain saw work around the road leading in to his house.

Safety Zone(s): No safety zone(s) in area
Comm With ICP: Yes
Water Supply: No reliable water source nearby
Fuel Type: Grass/tundra,northern hardwood litter
Defensible Space: 30 ft treated
Hazards:

Defensible, Stand Alone

Mitigation Time (in hours): 2
Mitigation Description: Prep around structure, setup tank, sprinklers

Resources Needed to Protect Structure: Crew to prep

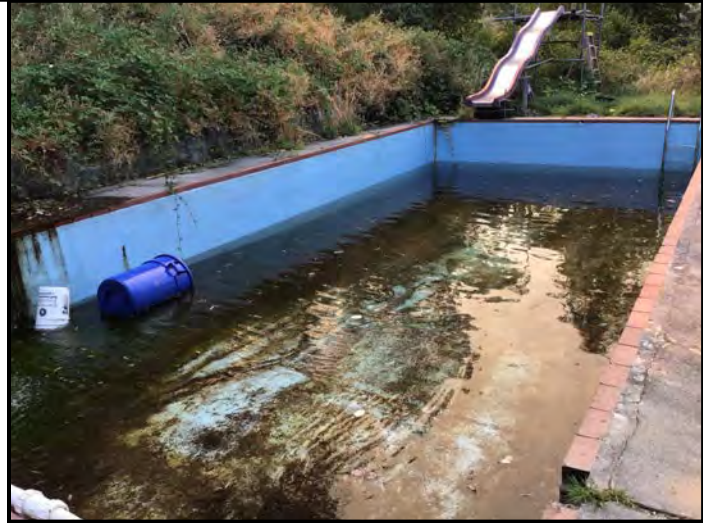
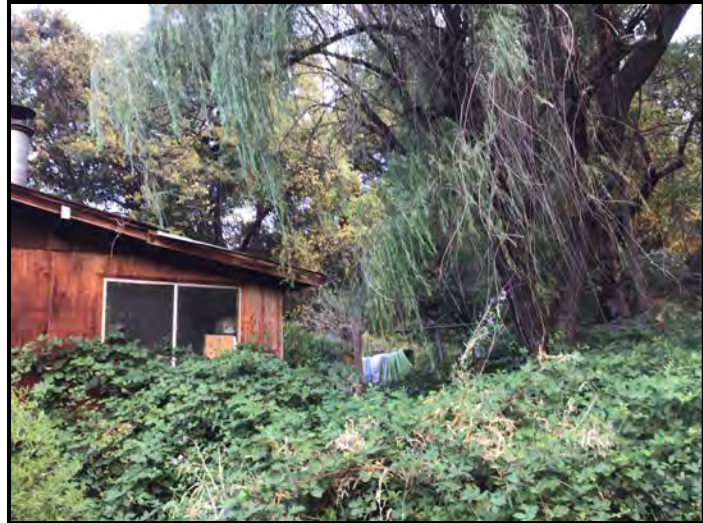
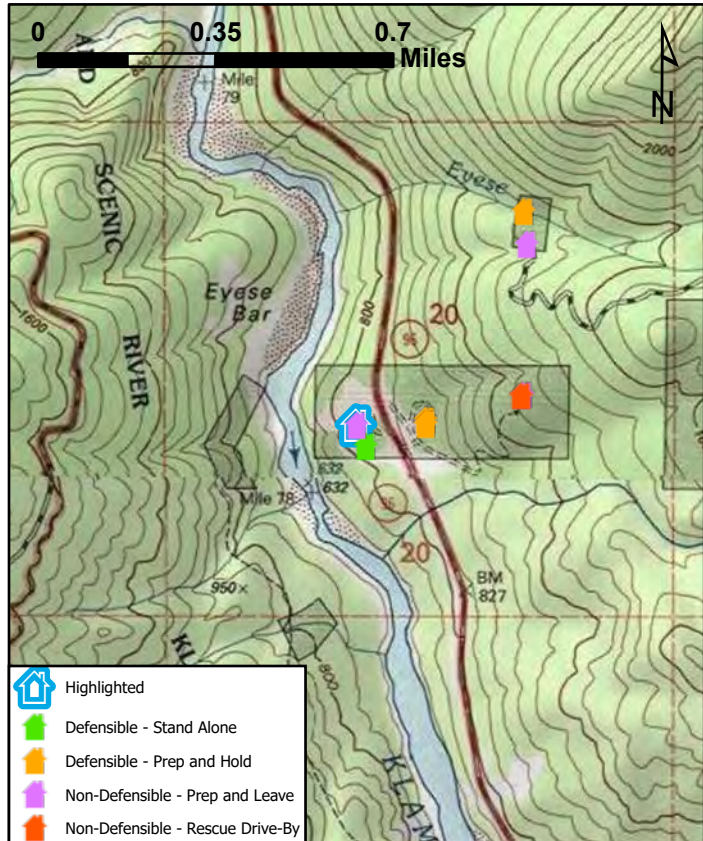
Area: Patterson
Address: 90121 hwy 96
Assigned Structure Number: 176
Type of Structure: Residential
Primary Structures: 1
Outbuildings: 3
Is the building Occupied?: Yes
Coordinates (DDM): 41° 30.082' N, 123° 31.475' W

Roof Material: Noncombustible or not applicable
Siding Material: Wood or open sided
Electrical Power: Yes
Gas to Structure: Yes
Comments: Richard Glasgow. Very little clearance but large swimming pool. Now structure has been brushed back min 25ft, two sprinkler kits and approx 400ft of hose with two lats rolled with nozzles for homeowner. Pump number is NWK-0148-1370 AND kit. There is a camper trailer that is occupied and has been brushed around and has

Safety Zone(s): Potential safety zone(s) in area
Comm With ICP: Yes
Water Supply: Reliable water source nearby
Fuel Type: Shrub or timber
Defensible Space: Less than 30 ft treated
Hazards: Propane

Non-Defensible, Prep and Leave

Mitigation Time (in hours): 3
Mitigation Description: Pump in pool, saw work, hose, sprinklers

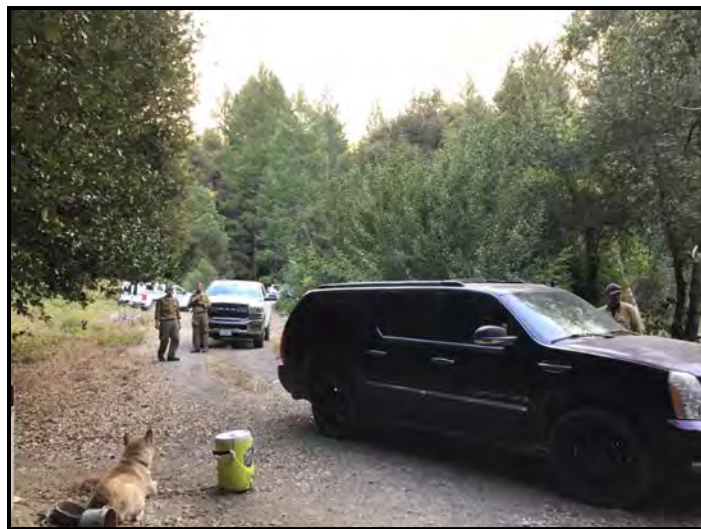
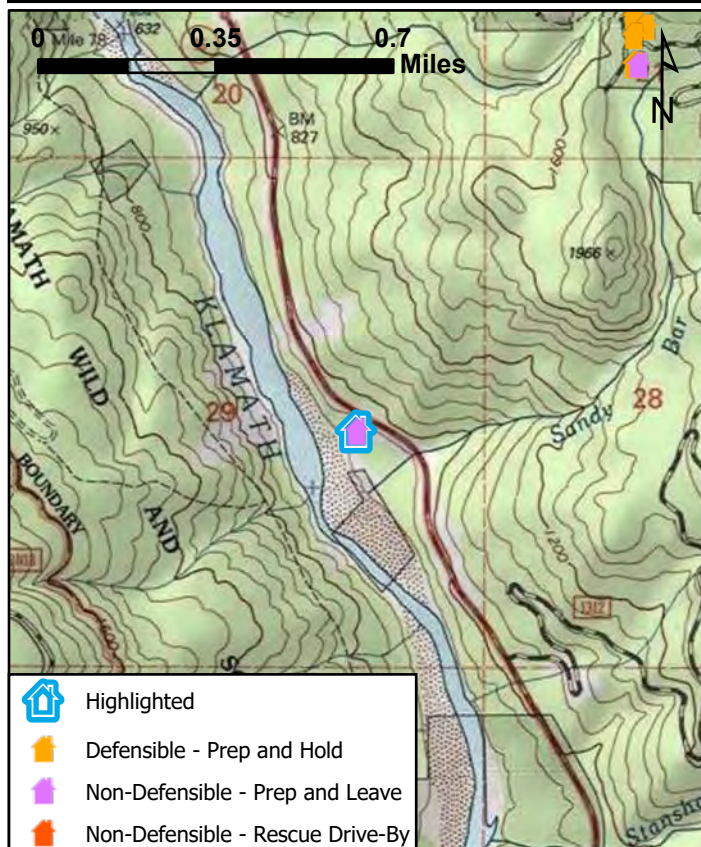
Area: Patterson
Address:
Assigned Structure Number: 184
Type of Structure: Other
Primary Structures: 1
Outbuildings: 1
Is the building Occupied?: No
Coordinates (DDM): 41° 29.288' N, 123° 31.040' W

Roof Material: Noncombustible or not applicable
Siding Material: Rock, concrete, metal
Electrical Power: No
Gas to Structure: No
Comments: Crispin

Safety Zone(s): No safety zone(s) in area
Comm With ICP: Yes
Water Supply: No reliable water source nearby
Fuel Type: Grass and shrub, hardwood litter
Defensible Space: 30 ft treated
Hazards: Terrain

Non-Defensible, Prep and Leave

Mitigation Time (in hours): 2
Mitigation Description: Brush around structure. Crews brushed around the structure and land owner was present.
