McCash Fire Structure Triage Assessment

CASRF000651
August 23, 2021

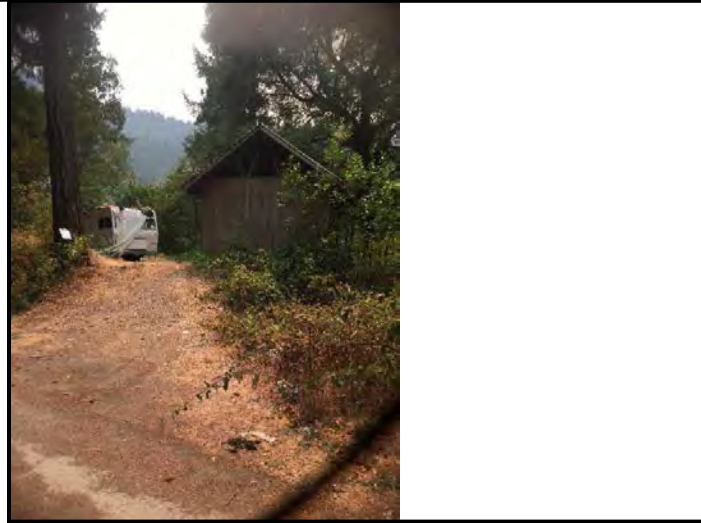
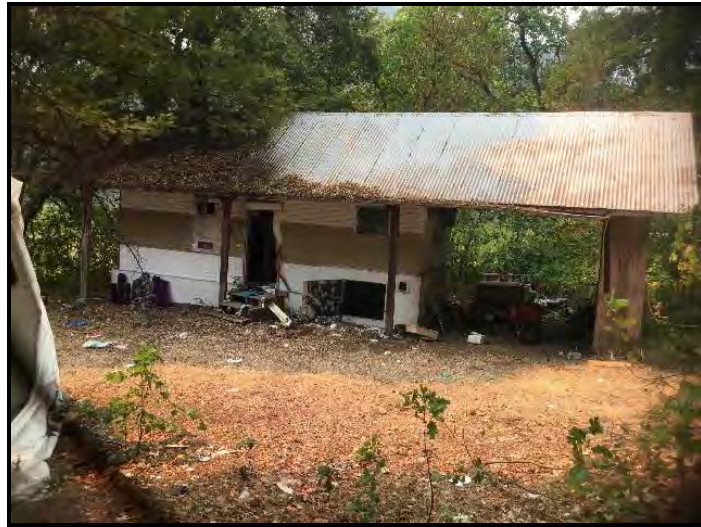
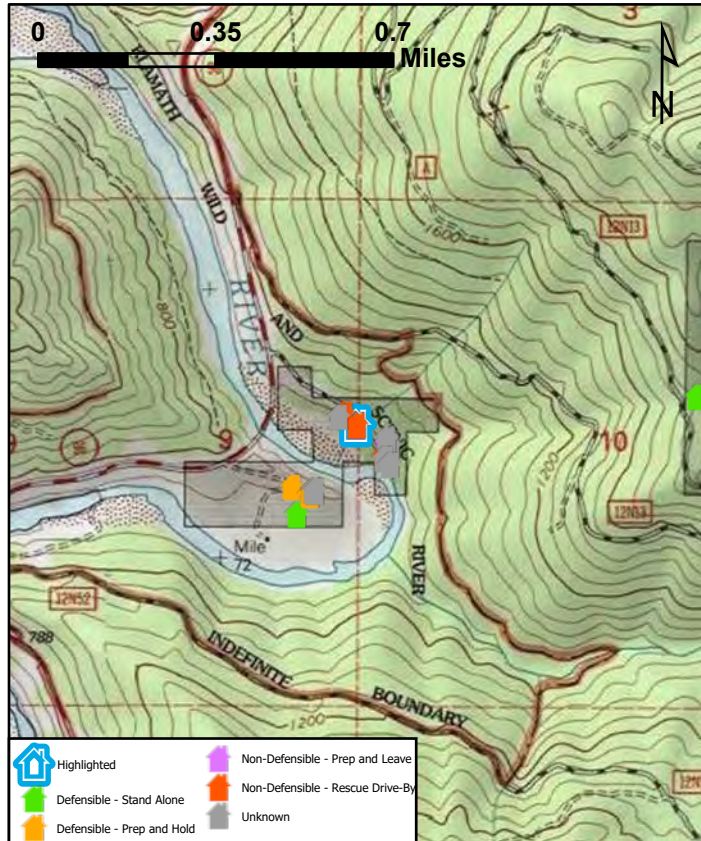
Roof Material: Combustible or no roof
Siding Material: Wood or open sided
Electrical Power: No
Gas to Structure: No
Comments: 3 travel trailers. Main one has wood roof over the top. All abandon

Safety Zone(s): No safety zone(s) in area
Comm With ICP: Yes
Water Supply: Reliable water source nearby
Fuel Type: Shrub or timber
Defensible Space: Less than 30 ft treated
Hazards: River bottom. Abandon vehicles and trash.

Non-Defensible, Rescue, Drive By

Mitigation Time (in hours): 2
Mitigation Description: Brush out and line structure

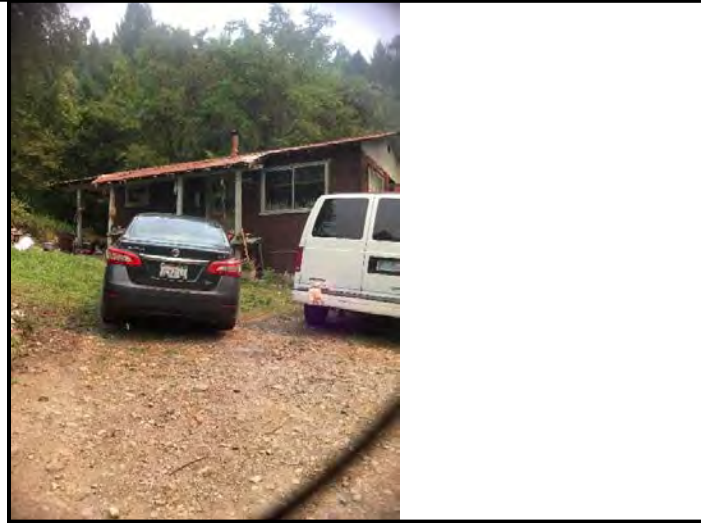
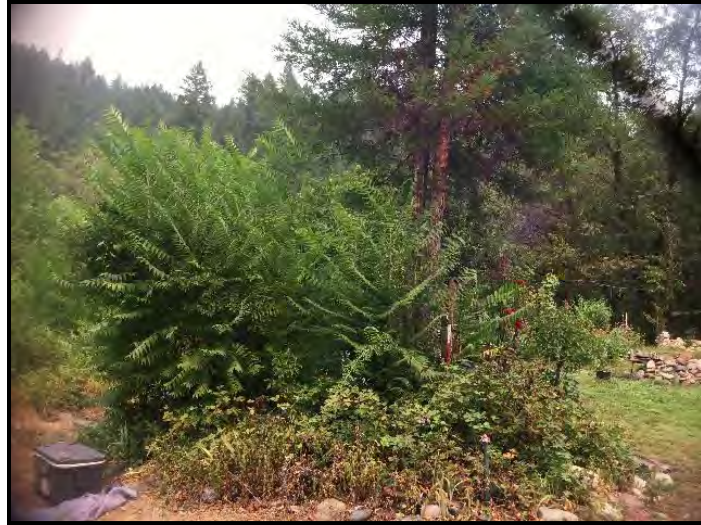
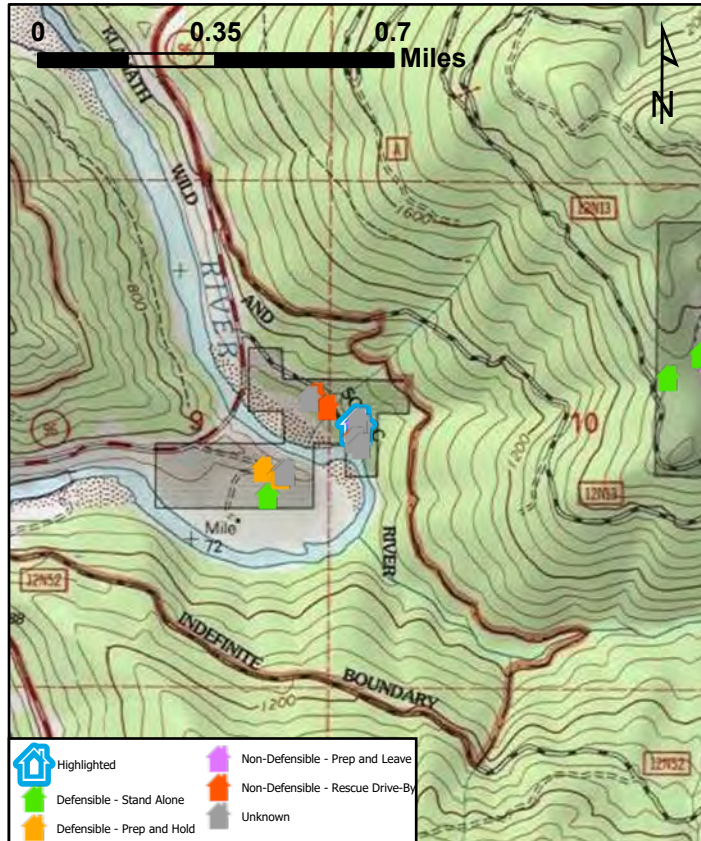
Roof Material: Noncombustible or not applicable
Siding Material: Wood or open sided
Electrical Power: No
Gas to Structure: No
Comments: 1500 gallon water tank uphill from the house.

Safety Zone(s): No safety zone(s) in area
Comm With ICP: Yes
Water Supply: Reliable water source nearby
Fuel Type: Shrub or timber
Defensible Space: Less than 30 ft treated
Hazards: Canyon/ river bottom

Non-Defensible, Prep and Leave

Mitigation Time (in hours): 2
Mitigation Description: Brush around the back of house and line the structure. Hose lay and several sprinklers

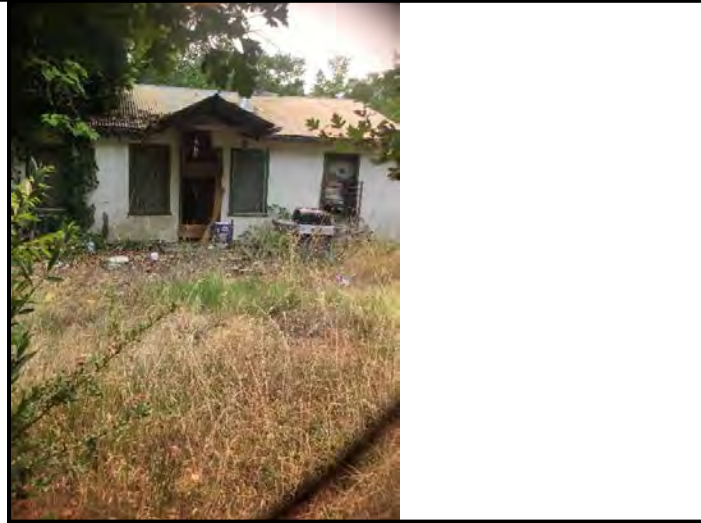
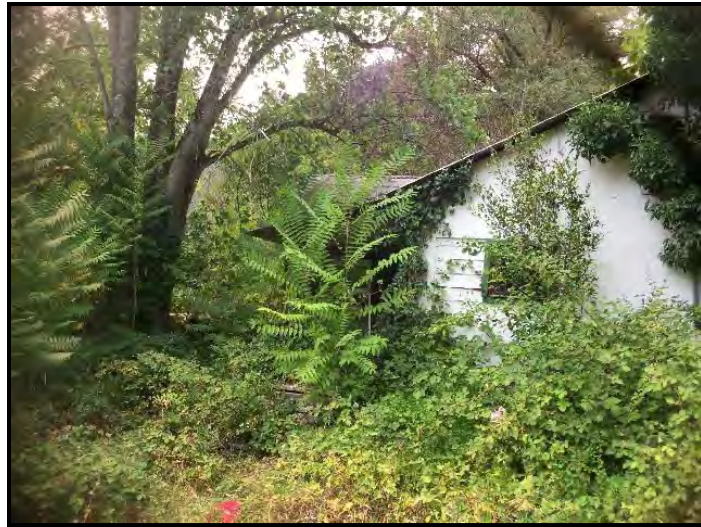
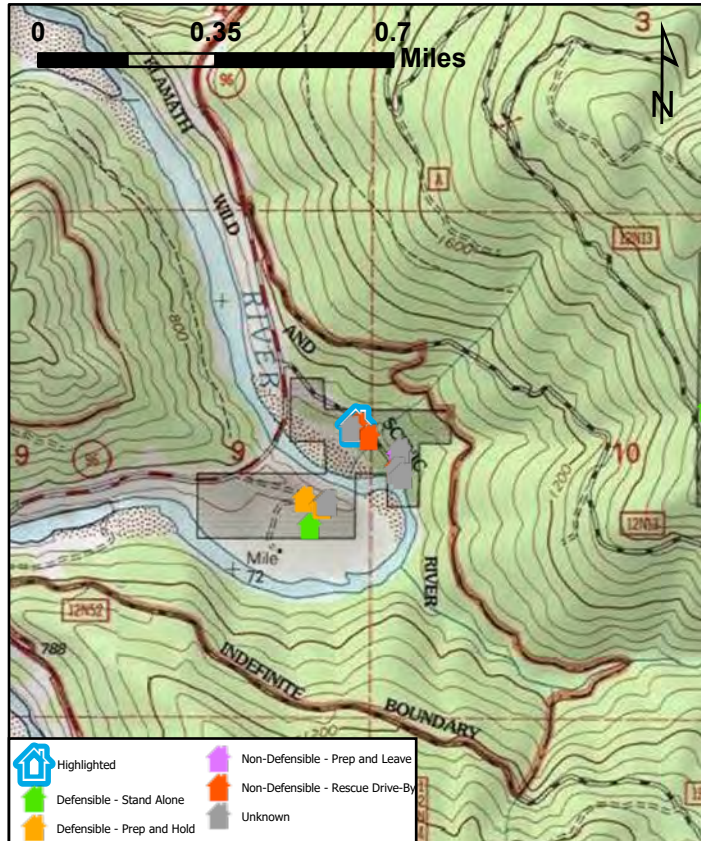
Roof Material: Noncombustible or not applicable
Siding Material: Rock, concrete, metal
Electrical Power: Unknown
Gas to Structure: Unknown
Comments: Abandon house no front door and broken windows.

Safety Zone(s): No safety zone(s) in area
Comm With ICP: Yes
Water Supply: Reliable water source nearby
Fuel Type: Shrub or timber
Defensible Space: Less than 30 ft treated
Hazards: River bottom. Hazardous waste and abandoned vehicles

Non-Defensible, Rescue, Drive By

Mitigation Time (in hours): 2
Mitigation Description: Brush out next to structure and set up sprinklers if needed

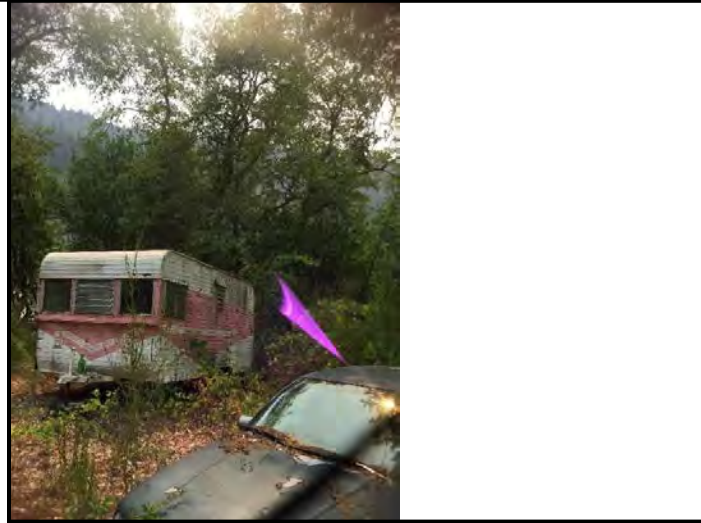
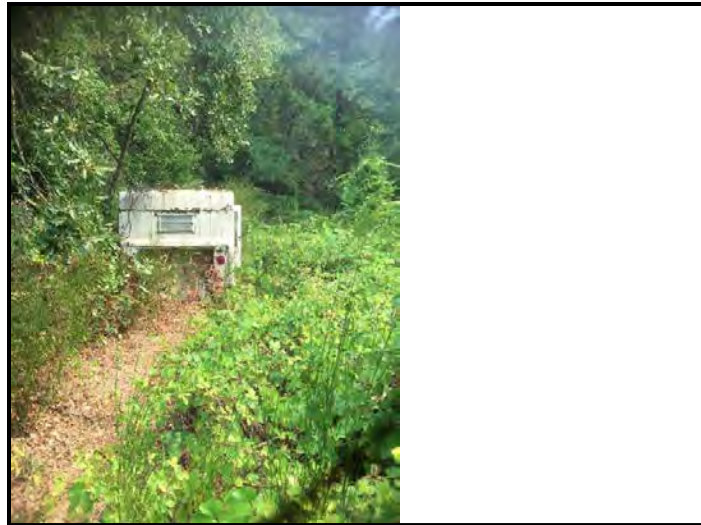
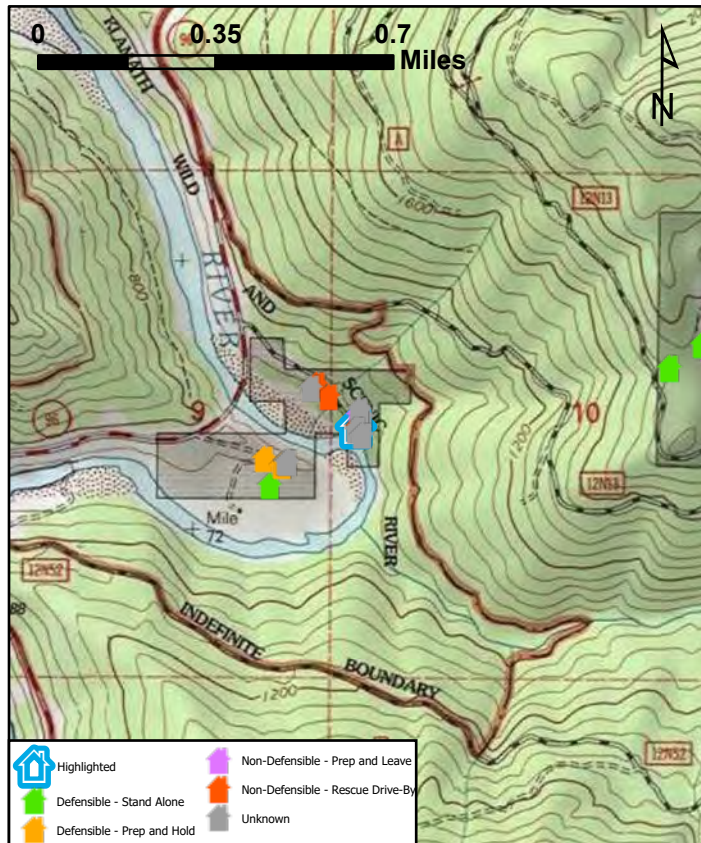
Access to Site: Handcrew
Describe Access: Broken down vehicles are blocking access. Must walk in from last house.

Roof Material: Noncombustible or not applicable
Siding Material: Rock, concrete, metal
Electrical Power: No
Gas to Structure: No
Comments: Abandon travel trailer. Out building is another old trailer 100 yards to the east.

Non-Defensible, Rescue, Drive By

Mitigation Time (in hours): 1
Mitigation Description: Brush out and rake

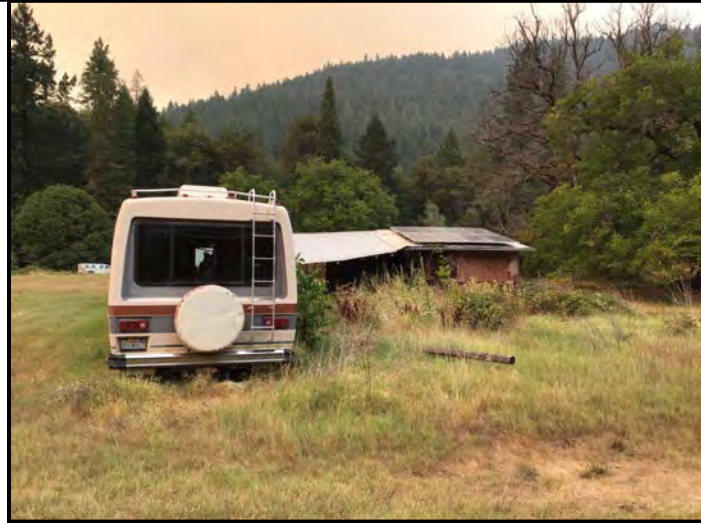
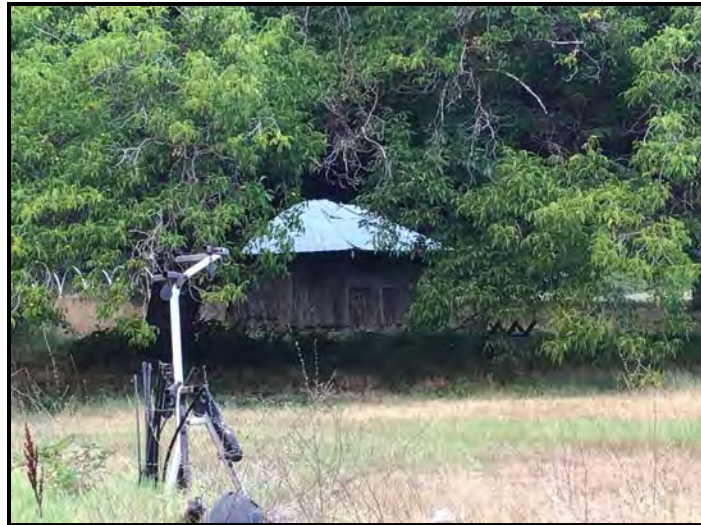
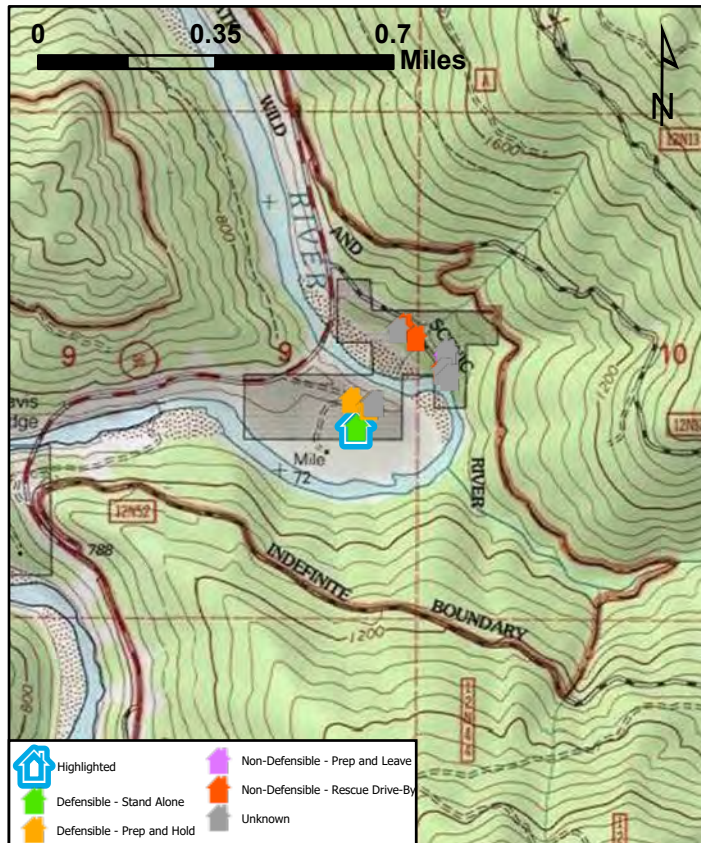
Roof Material: Noncombustible or not applicable
Siding Material:
Electrical Power: Yes
Gas to Structure: No
Comments: Solar station, round storage shed and dilapidated RV

Safety Zone(s): Potential safety zone(s) in area
Comm With ICP: Yes
Water Supply: No reliable water source nearby
Fuel Type: Grass/tundra, northern hardwood litter
Defensible Space: 30 ft treated
Hazards: Solar panel batteries

Defensible, Stand Alone

Mitigation Time (in hours): 2
Mitigation Description: Scrape line, pump, water tank, sprinklers. Main power source,

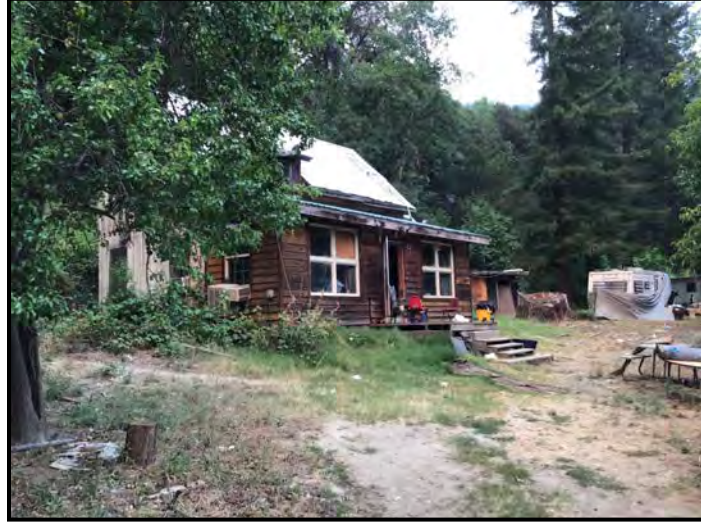
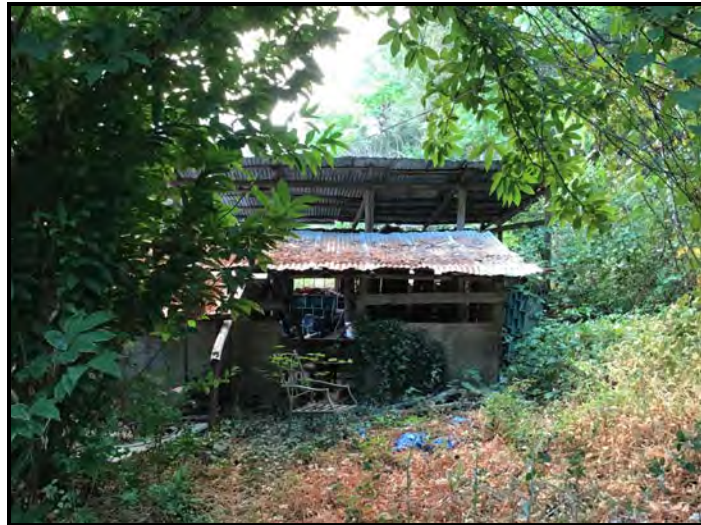
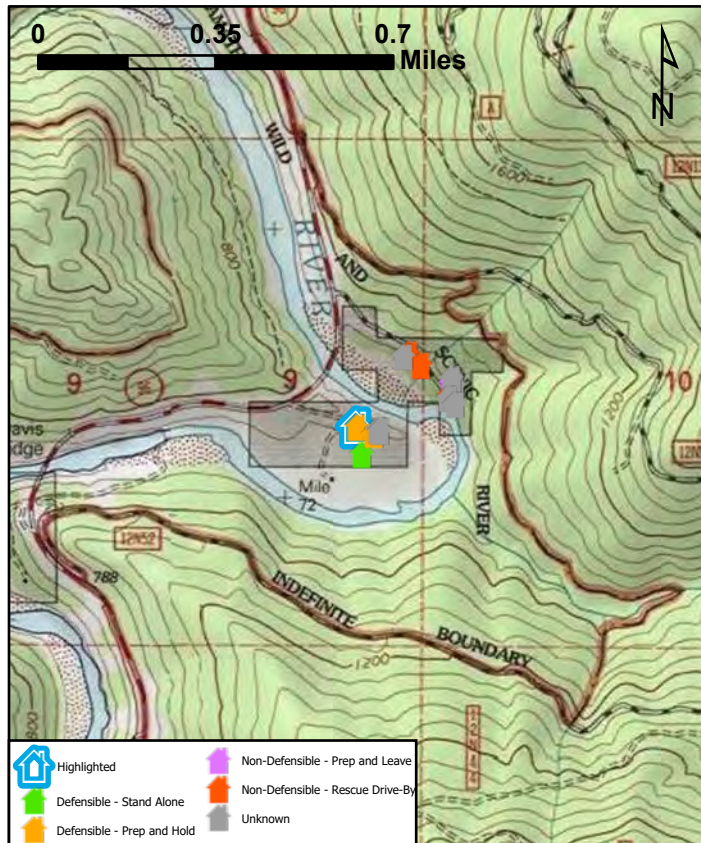
Roof Material: Noncombustible or not applicable
Siding Material: Wood or open sided
Electrical Power: Yes
Gas to Structure: Yes
Comments: On generator power, propane Asa Donahue+ kids

Safety Zone(s): Potential safety zone(s) in area
Comm With ICP: Yes
Water Supply: No reliable water source nearby
Fuel Type: Shrub or timber
Defensible Space: Less than 30 ft treated
Hazards:

Defensible, Prep and Hold

Mitigation Time (in hours): 3
Mitigation Description: Set up tank, pump, sprinklers, brush back of house

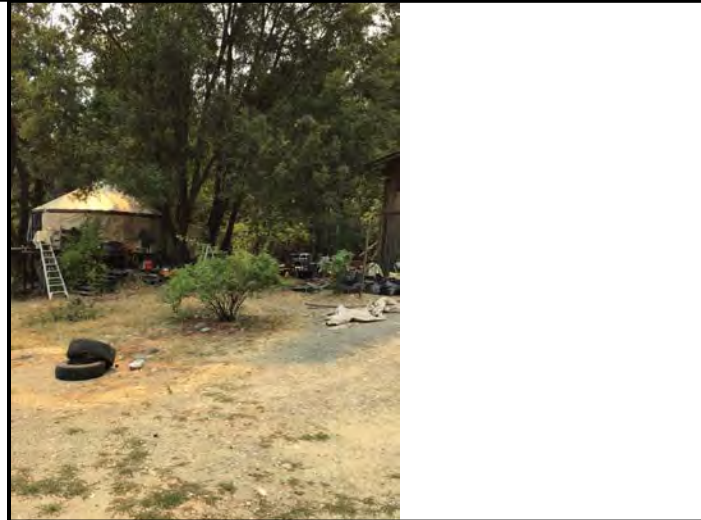
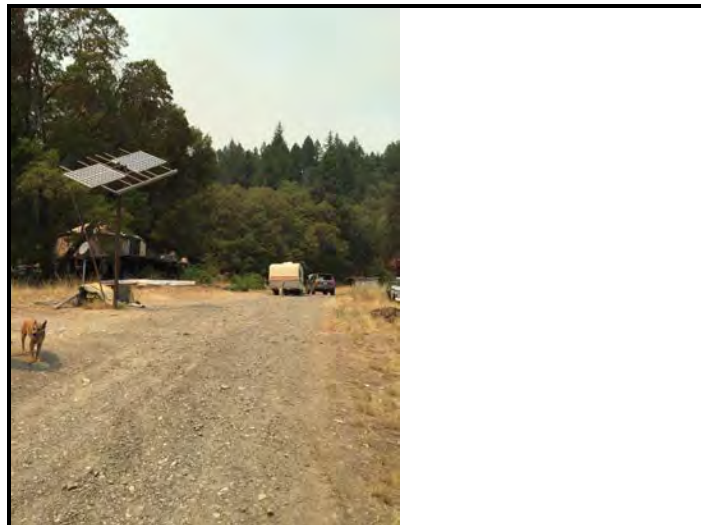
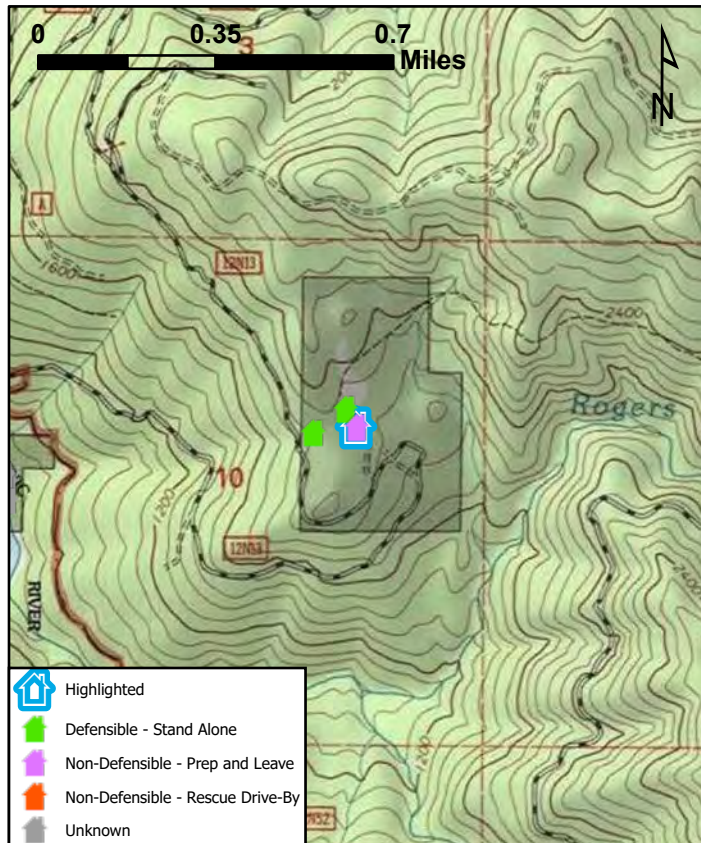
Roof Material: Combustible or no roof
Siding Material: Wood or open sided
Electrical Power: No
Gas to Structure: No
Comments: Building has small LP tank with solar electric Rudy Galindo

Safety Zone(s): Potential safety zone(s) in area
Comm With ICP: Yes
Water Supply: No reliable water source nearby
Fuel Type: Shrub or timber
Defensible Space: 30 ft treated
Hazards: General trash and debris, small LP tanks under yurt,

Non-Defensible, Prep and Leave

Mitigation Time (in hours): 4
Mitigation Description: Remove leaf litter, trash and debris, plumb with sprinkler kit and pumpkin

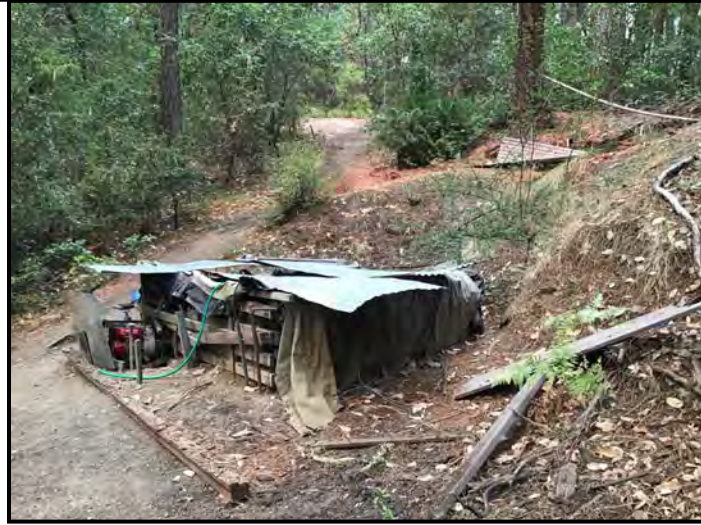
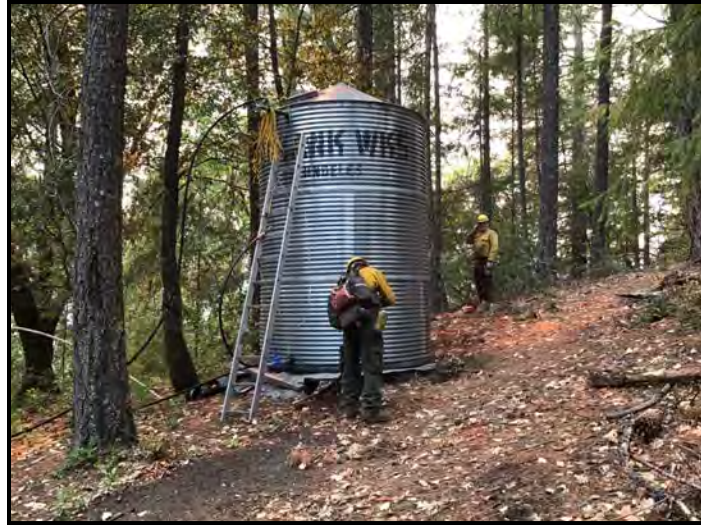
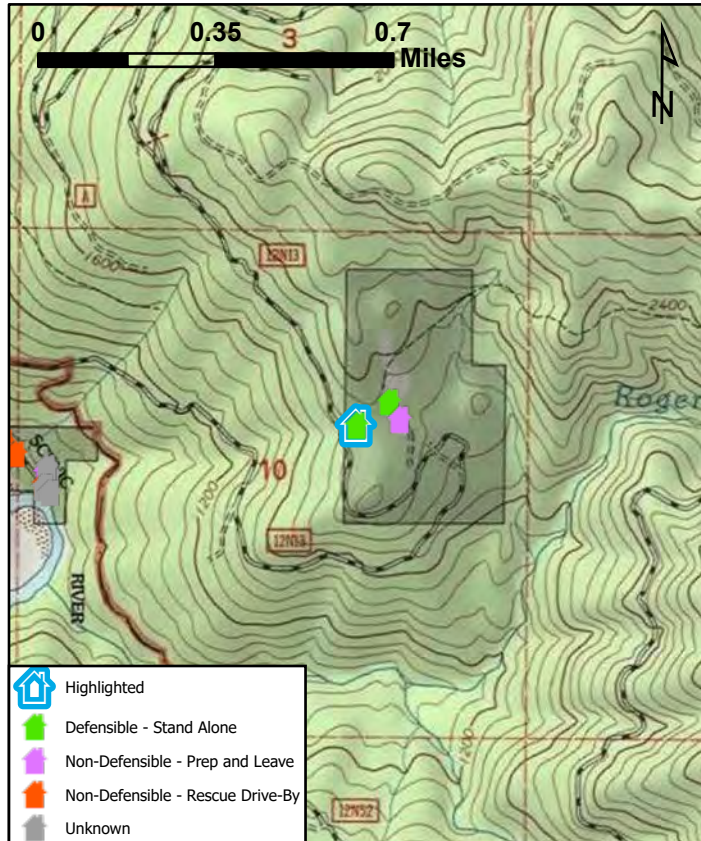
Access to Site: Handcrew
Describe Access: West of primary structures. Rudy's well that pumps water uphill along ridge to a 10000 gallon galvanized water tank

Roof Material: Noncombustible or not applicable
Siding Material: Wood or open sided
Electrical Power: No
Gas to Structure: No
Comments: Water well with pump

Defensible, Stand Alone

Mitigation Time (in hours): 1
Mitigation Description: Hand line
