McCash Fire Structure Triage Assessment

CASRF000651
August 23, 2021

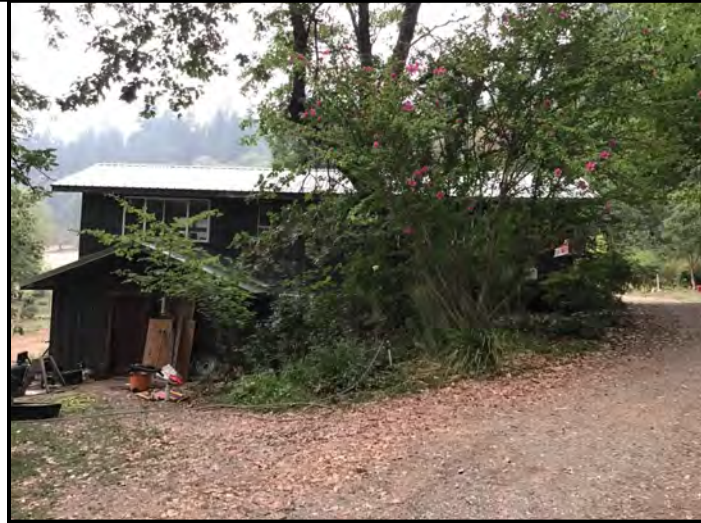
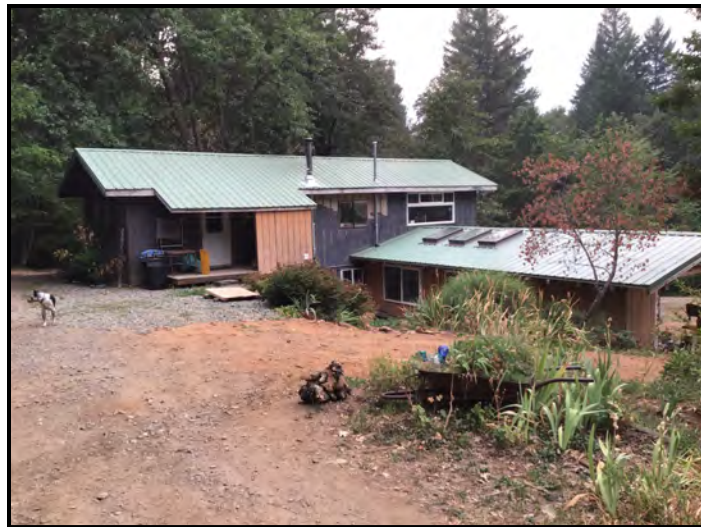
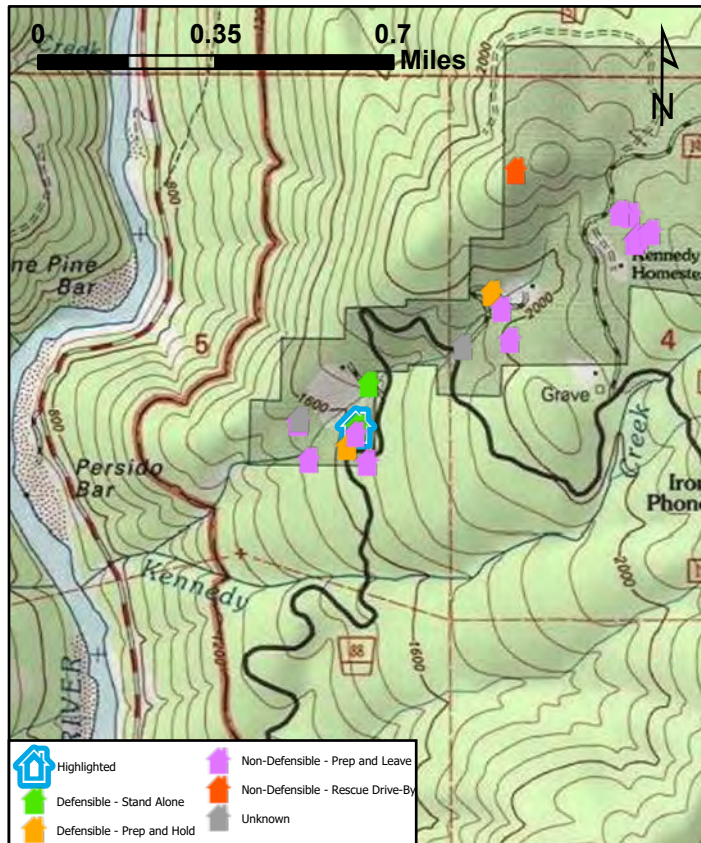
Roof Material: Noncombustible or not applicable
Siding Material: Wood or open sided
Electrical Power: Yes
Gas to Structure: Yes
Comments: Residence and enclosed work shop

Safety Zone(s): Potential safety zone(s) in area
Comm With ICP: Yes
Water Supply: Pressurized hydrant(s) or fixed sprinkler system
Fuel Type: Grass and shrub, hardwood litter
Defensible Space: 100 ft treated
Hazards: Propane tank 50 feet beyond structure

Defensible, Stand Alone

Mitigation Time (in hours): 1
Mitigation Description: Rake, remove materials from side of structure

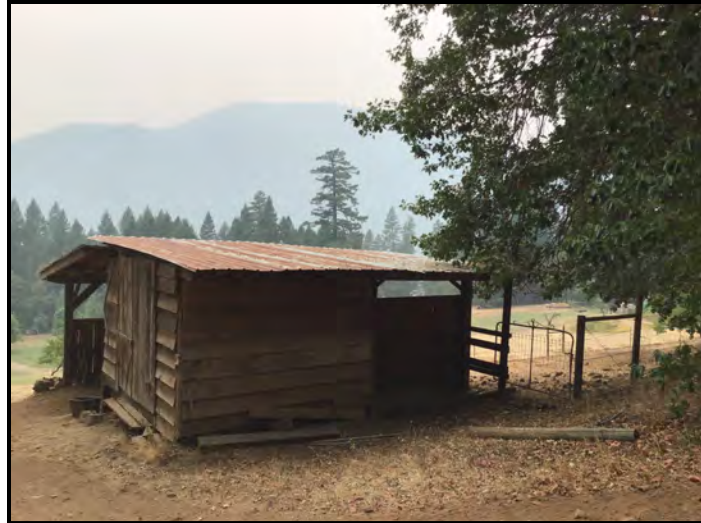
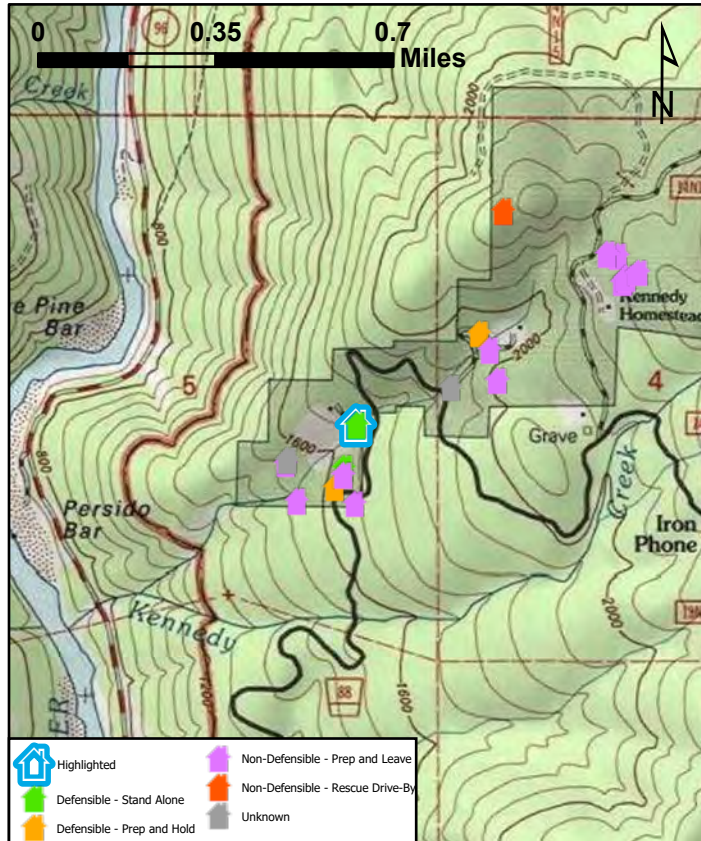
Roof Material: Noncombustible or not applicable
Siding Material: Wood or open sided
Electrical Power: No
Gas to Structure: No
Comments: Horse barn

Safety Zone(s): Potential safety zone(s) in area
Comm With ICP: Yes
Water Supply: No reliable water source nearby
Fuel Type: Grass and shrub, hardwood litter
Defensible Space: No defensible space
Hazards:

Defensible, Stand Alone

Mitigation Time (in hours): 1
Mitigation Description: Scratch line, low priority , small horse barn

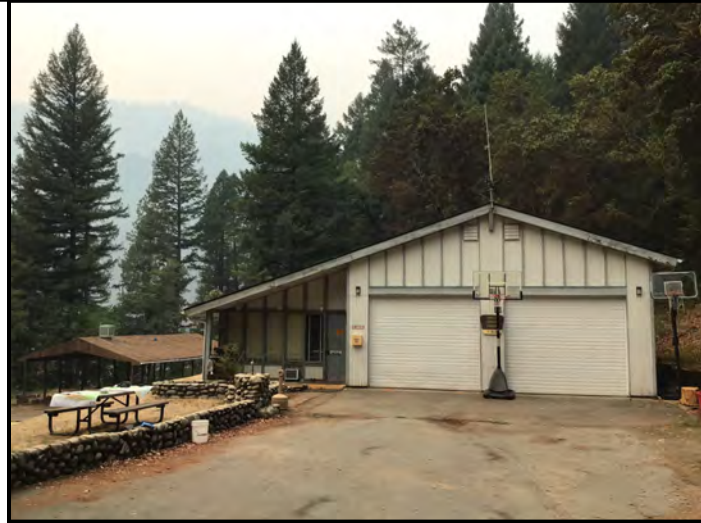
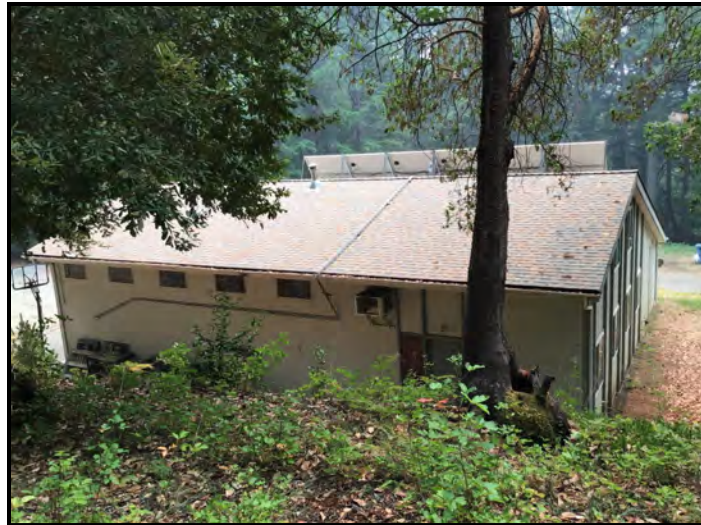
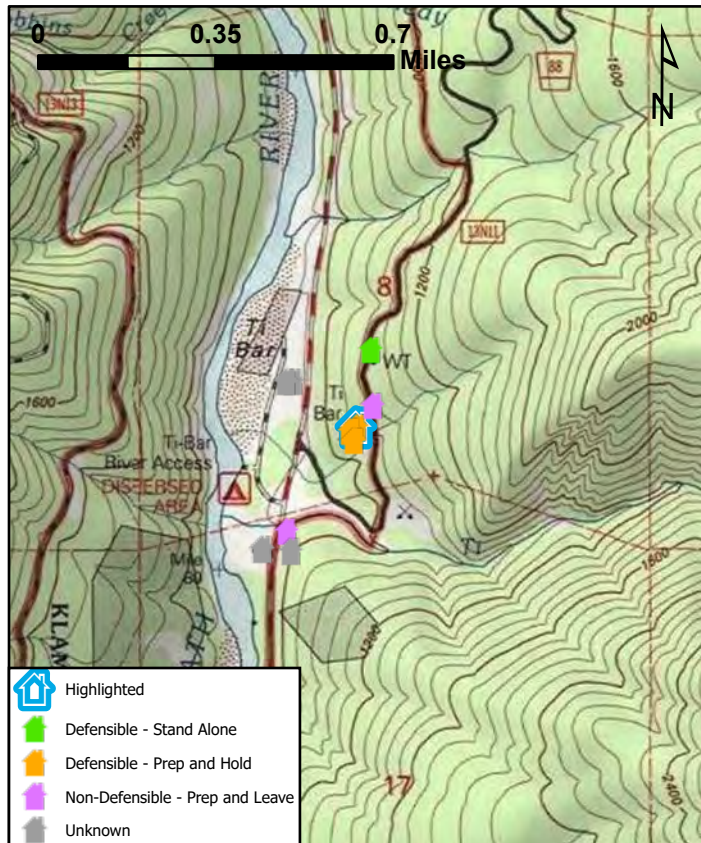
Roof Material: Combustible or no roof
Siding Material: Wood or open sided
Electrical Power: Yes
Gas to Structure: Yes
Comments: Ti Bar Station. Propane tank 100' up hill of station

Safety Zone(s): Potential safety zone(s) in area
Comm With ICP: Yes
Water Supply: Limited or dependent on electricity
Fuel Type: Shrub or timber
Defensible Space: 30 ft treated
Hazards: Fuel shed within 20' of building

Defensible, Prep and Hold

Mitigation Time (in hours): 3
Mitigation Description: Clear roof of leaf litter. Clear vegetation around structure and propane tank. Lay hose perimeter and set up sprinkler system

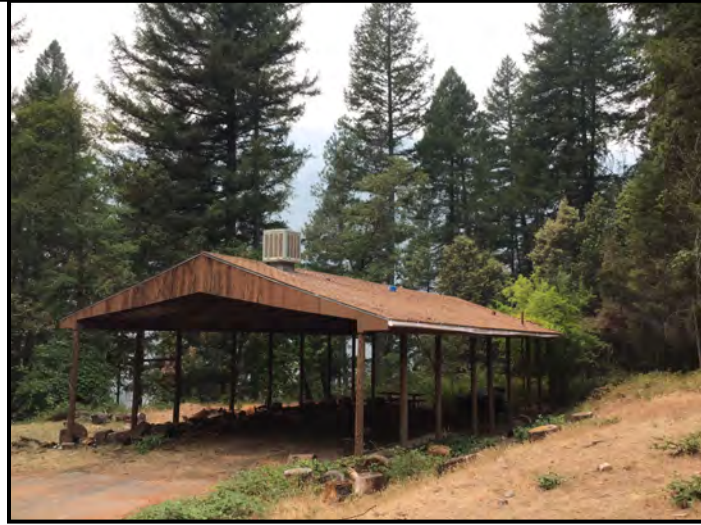
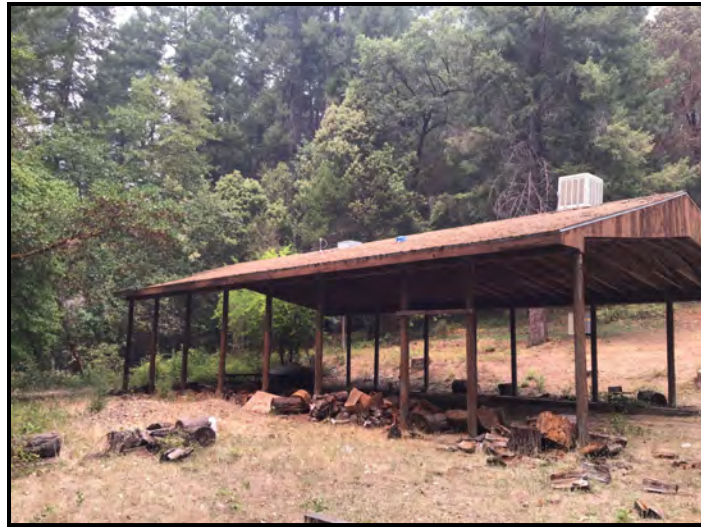
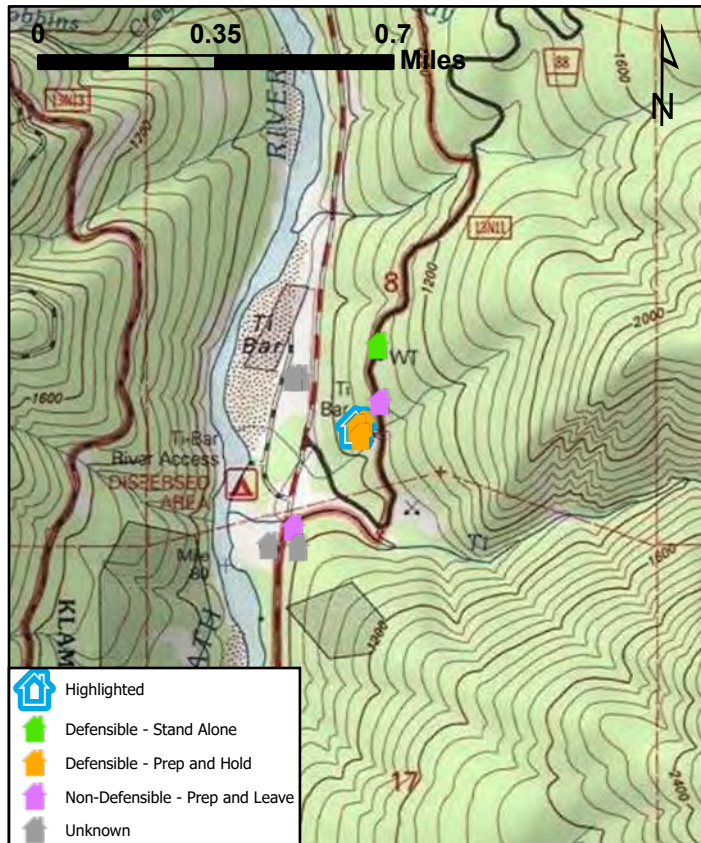
Roof Material: Combustible or no roof
Siding Material: Not applicable
Electrical Power: Yes
Gas to Structure: Yes
Comments: Open sided barn

Safety Zone(s): Potential safety zone(s) in area
Comm With ICP: Yes
Water Supply: Limited or dependent on electricity
Fuel Type: Shrub or timber
Defensible Space: Less than 30 ft treated
Hazards: None

Defensible, Prep and Hold

Mitigation Time (in hours): 3
Mitigation Description: Clear back vegetation, clean off roof, remove wood pile

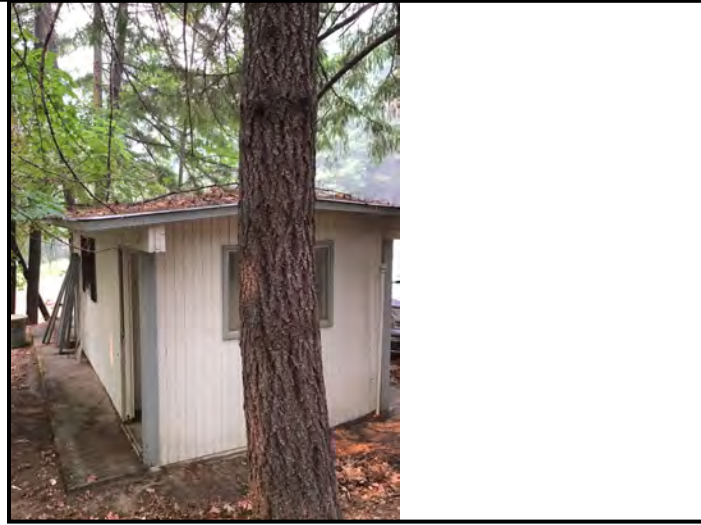
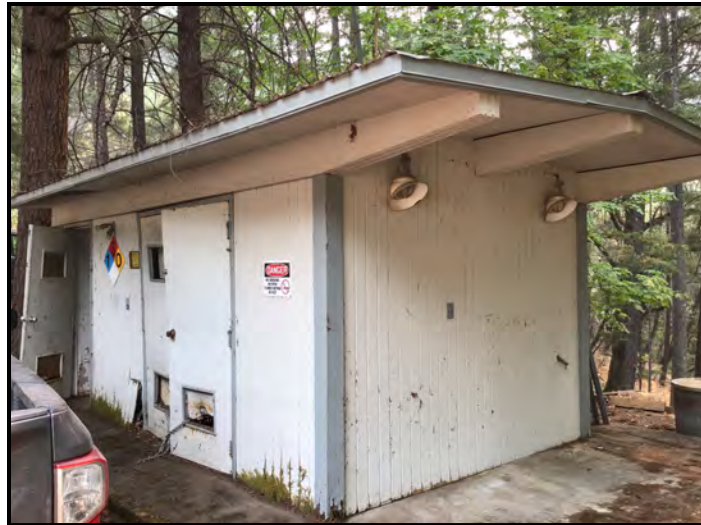
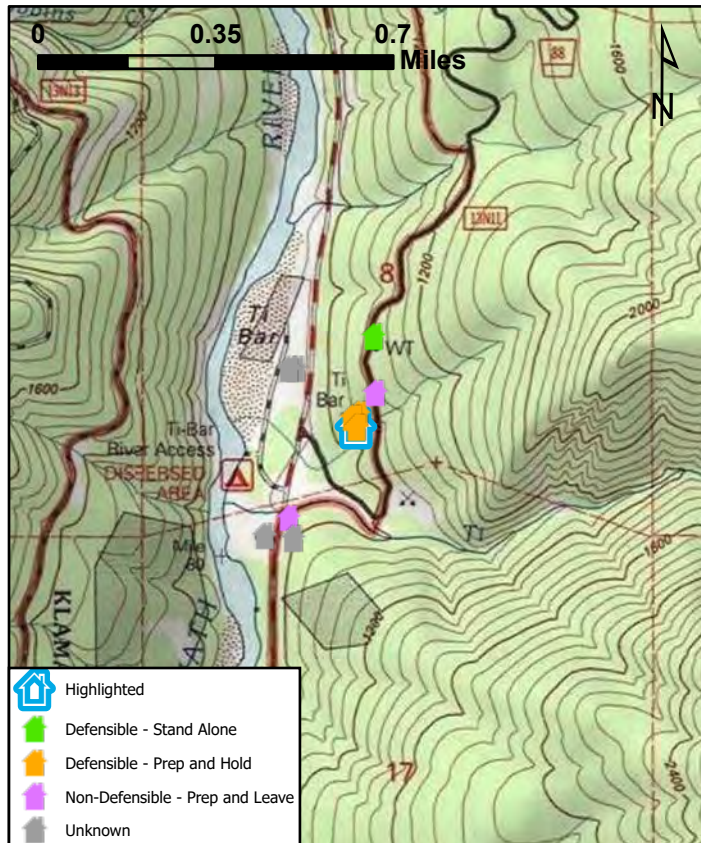
Roof Material: Noncombustible or not applicable
Siding Material: Wood or open sided
Electrical Power: Yes
Gas to Structure: No
Comments: Old gas house. Used as storage shed. Metal roof. Broken doors

Safety Zone(s): Potential safety zone(s) in area
Comm With ICP: Yes
Water Supply: Limited or dependent on electricity
Fuel Type: Shrub or timber
Defensible Space: Less than 30 ft treated
Hazards:

Defensible, Prep and Hold

Mitigation Time (in hours): 1
Mitigation Description: Clean off Roof leaf litter and from around shed. Seal broken doors with scrap plywood.

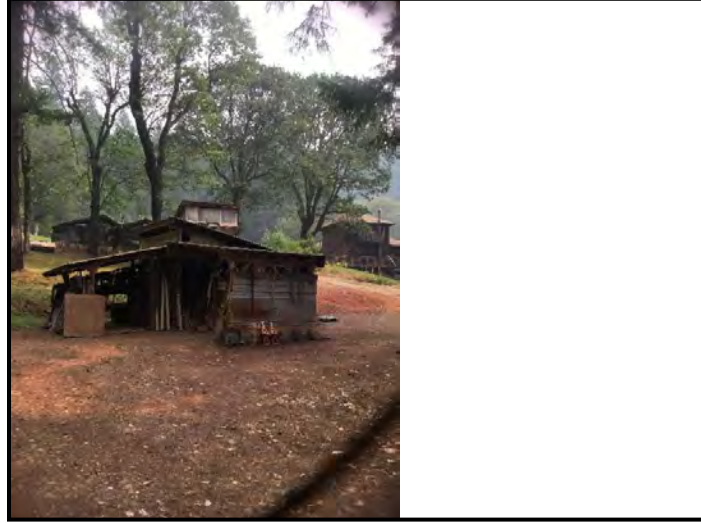
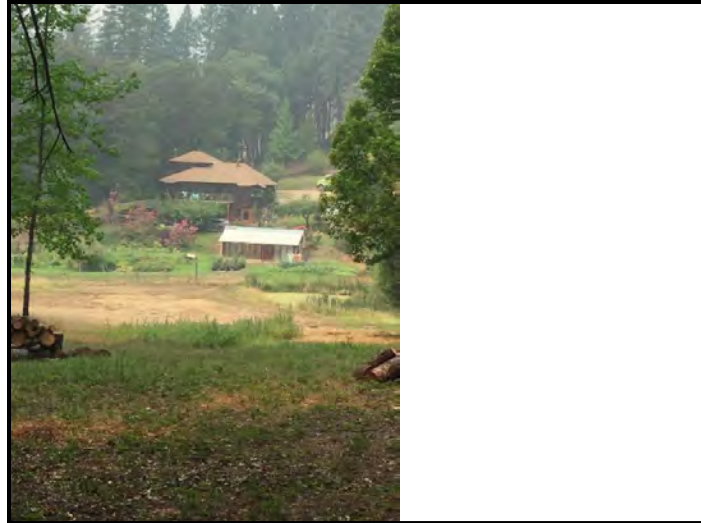
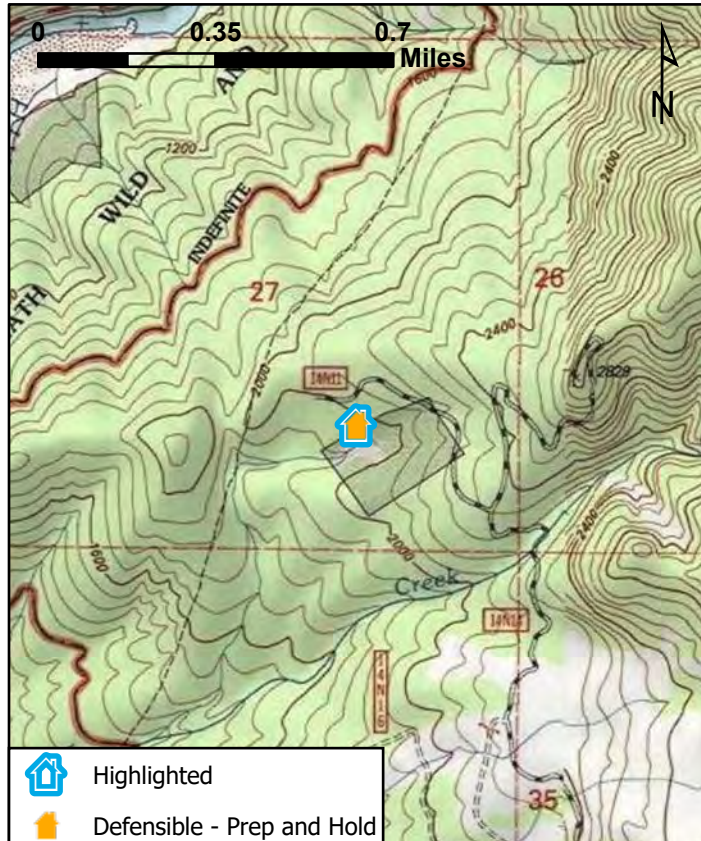
Roof Material: Noncombustible or not applicable
Siding Material: Wood or open sided
Electrical Power: Yes
Gas to Structure: Yes
Comments: Structure has new shingle roof and well maintained grounds with personal sprinkler system in place 1sprinkler on roof 1above ground propane tank (250 gallon) roughly 150' to the nw of main structure behind outbuilding

Safety Zone(s): Potential safety zone(s) in area
Comm With ICP: Yes
Water Supply: No reliable water source nearby
Fuel Type: Grass and shrub, hardwood litter
Defensible Space: 100 ft treated
Hazards: Fuel (diesel/gas) in one of outbuildings 250 gallon propane tank

Defensible, Prep and Hold

Mitigation Time (in hours): 1
Mitigation Description: Minimal mitigation no saw work

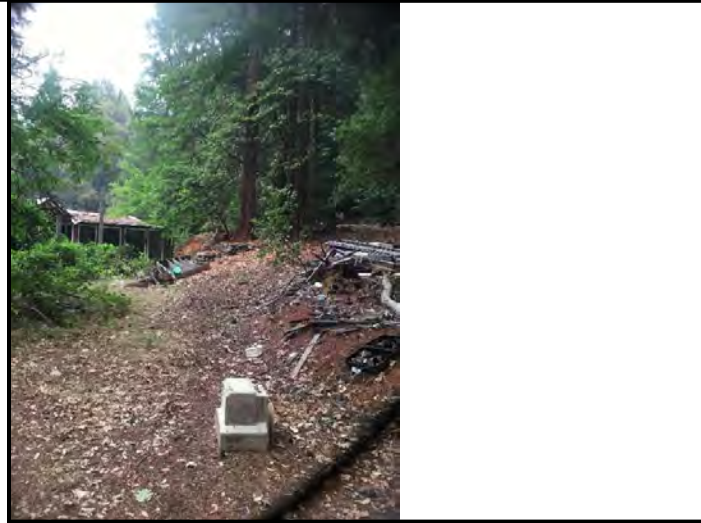
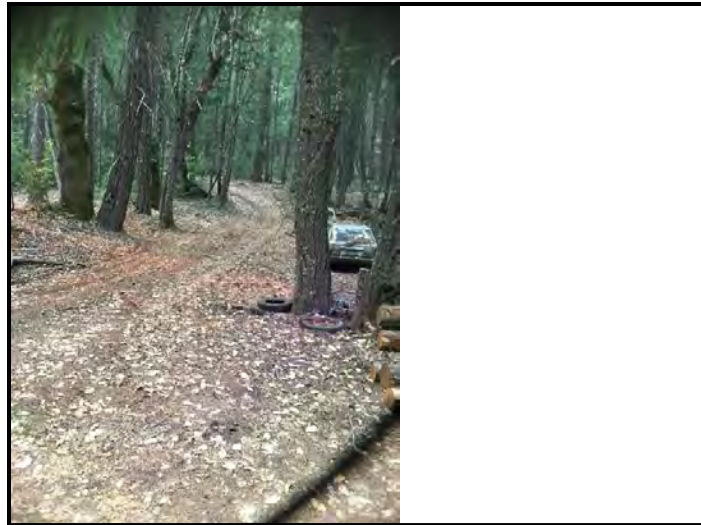
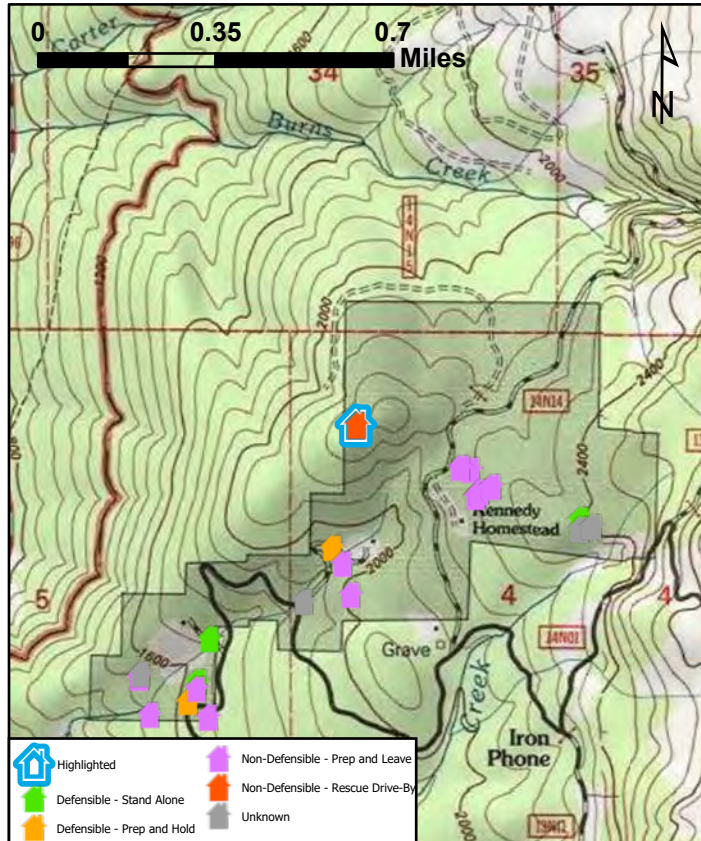
Roof Material: Combustible or no roof
Siding Material: Wood or open sided
Electrical Power: Unknown
Gas to Structure: Unknown
Comments: Non defensible

Safety Zone(s): No safety zone(s) in area
Comm With ICP: Yes
Water Supply: No reliable water source nearby
Fuel Type: Shrub or timber
Defensible Space: No defensible space
Hazards: Multiple hazards, including vehicles, structures, yard debris etc
1

Non-Defensible, Rescue, Drive By

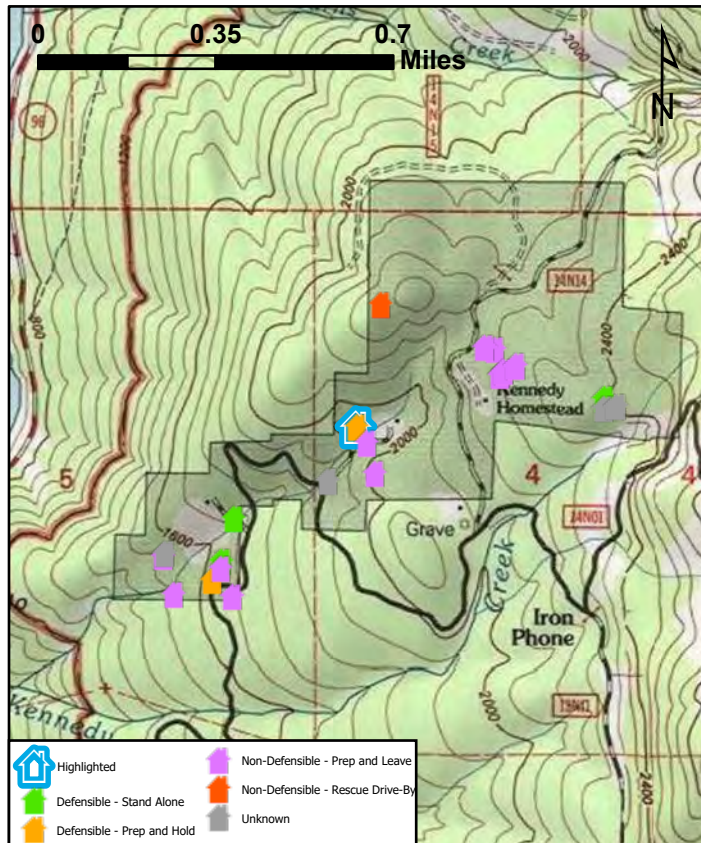
Roof Material: Noncombustible or not applicable
Siding Material: Wood or open sided
Electrical Power: Yes
Gas to Structure: Yes
Comments: Structure has above ground 250 gallon propane tank 50' to the east also a few hardwoods touching structure

Safety Zone(s): Potential safety zone(s) in area
Comm With ICP: Yes
Water Supply: Reliable water source nearby
Fuel Type: Shrub or timber
Defensible Space: 100 ft treated
Hazards: One way in/out

Defensible, Prep and Hold

Mitigation Time (in hours): 1
Mitigation Description: Possible lite saw work /hand tool work (rakes)

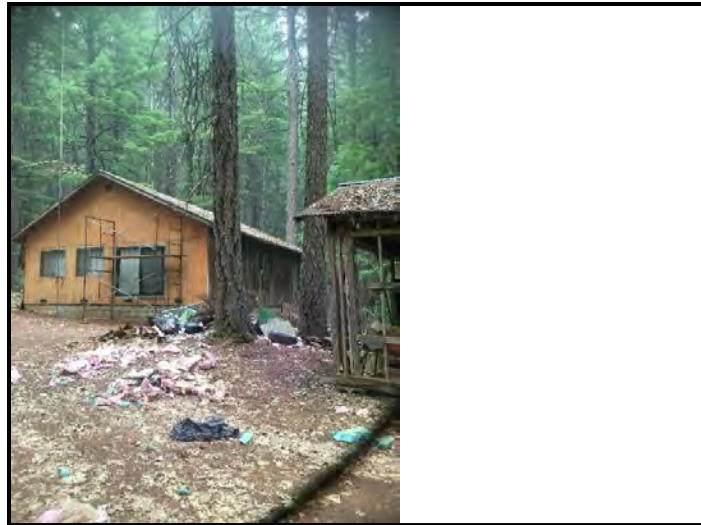
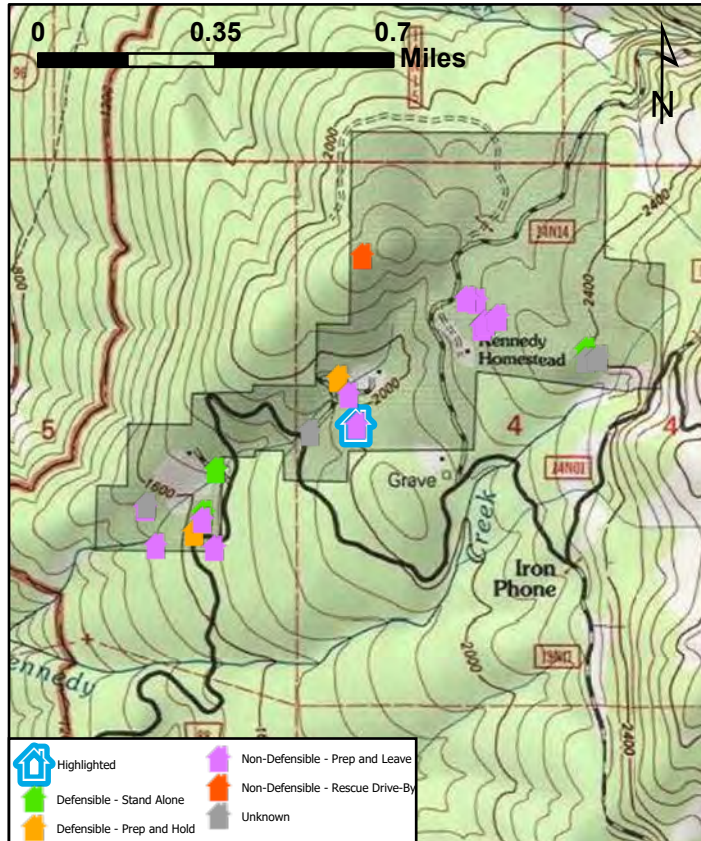
Roof Material: Noncombustible or not applicable
Siding Material: Wood or open sided
Electrical Power: Unknown
Gas to Structure: Unknown
Comments: Structure is above 2803 gene strouss residence

Safety Zone(s): No safety zone(s) in area
Comm With ICP: Yes
Water Supply: Reliable water source nearby
Fuel Type: Shrub or timber
Defensible Space: Less than 30 ft treated
Hazards: Yard debris/timber

Non-Defensible, Prep and Leave

Mitigation Time (in hours): 2
Mitigation Description: Brushing and limbing ladder fuels, move yard debris, cut hand line around structure/ prep and leave

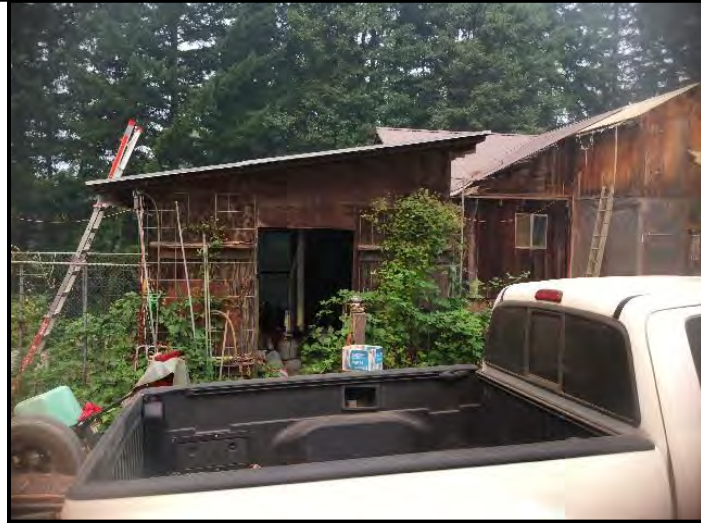
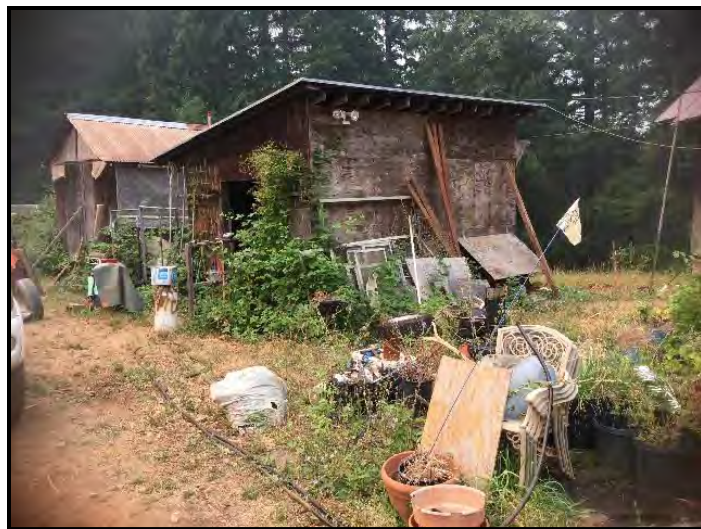
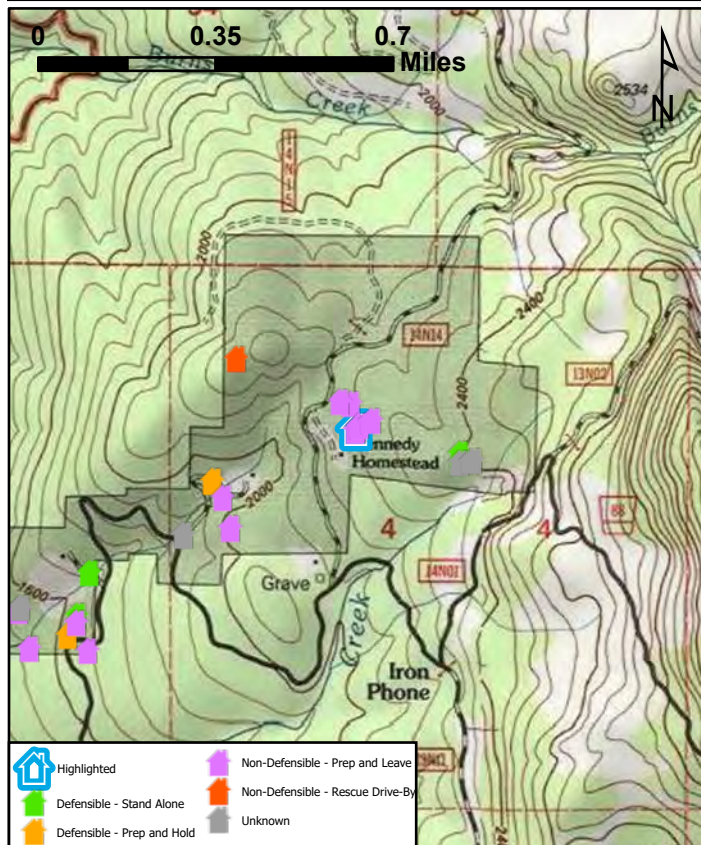
Roof Material: Combination of fire resistant and combustible
Siding Material: Wood or open sided
Electrical Power: Yes
Gas to Structure: No
Comments: Shed adjacent to primary residence

Safety Zone(s): No safety zone(s) in area
Comm With ICP: Yes
Water Supply: No reliable water source nearby
Fuel Type: Shrub or timber
Defensible Space: No defensible space
Hazards: Household and agricultural debris, LP tanks, fuel cans, household an agricultural chemicals

Non-Defensible, Prep and Leave

Mitigation Time (in hours): 2
Mitigation Description: Removal of debris

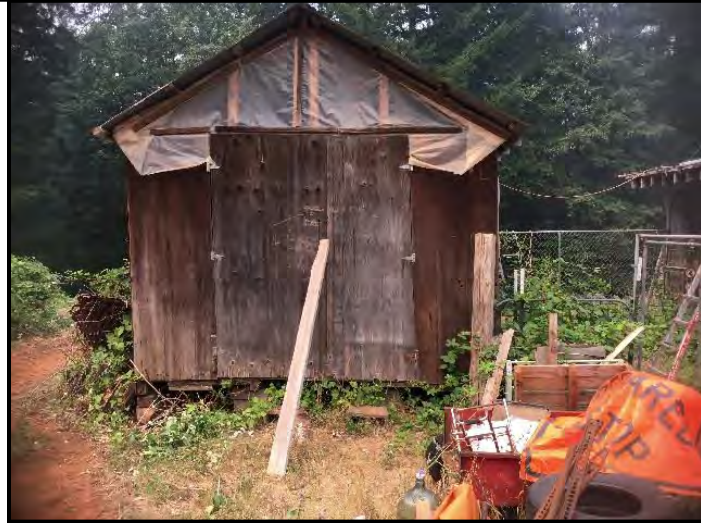
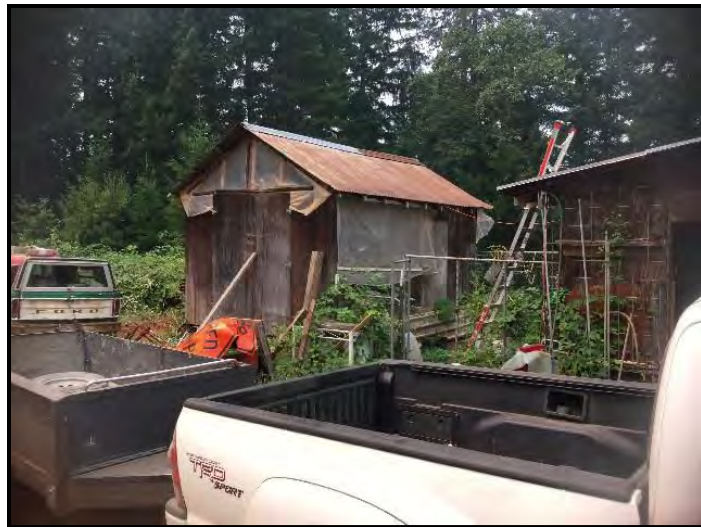
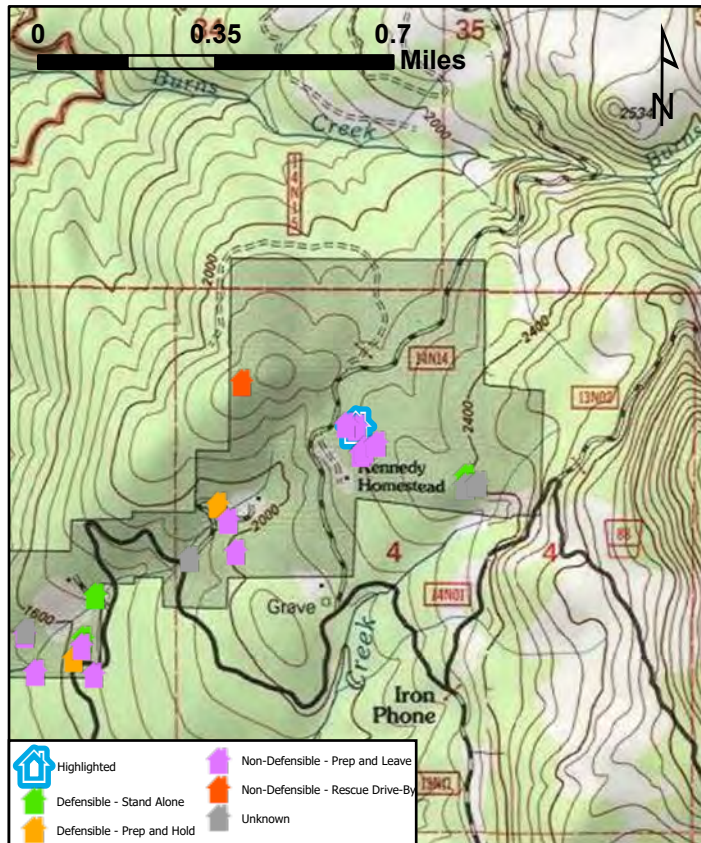
Roof Material: Combustible or no roof
Siding Material: Wood or open sided
Electrical Power: Yes
Gas to Structure: Unknown
Comments: Shed adjacent to primary structure

Safety Zone(s): No safety zone(s) in area
Comm With ICP: Yes
Water Supply: No reliable water source nearby
Fuel Type: Shrub or timber
Defensible Space: No defensible space
Hazards: Adjacent fuels containing tires content of structure unknown

Non-Defensible, Prep and Leave

Mitigation Time (in hours): 1
Mitigation Description: Remove all debris set up sprinkler

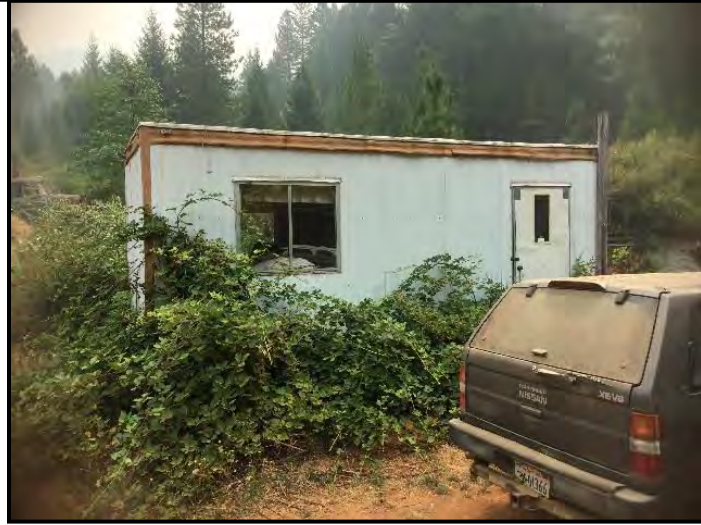
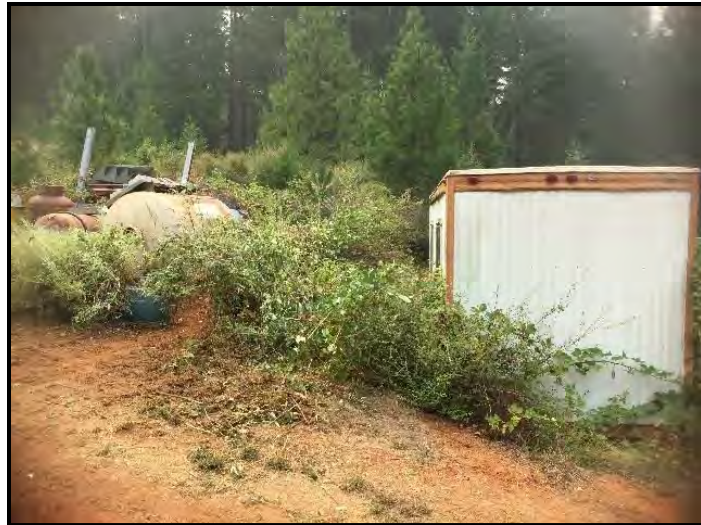
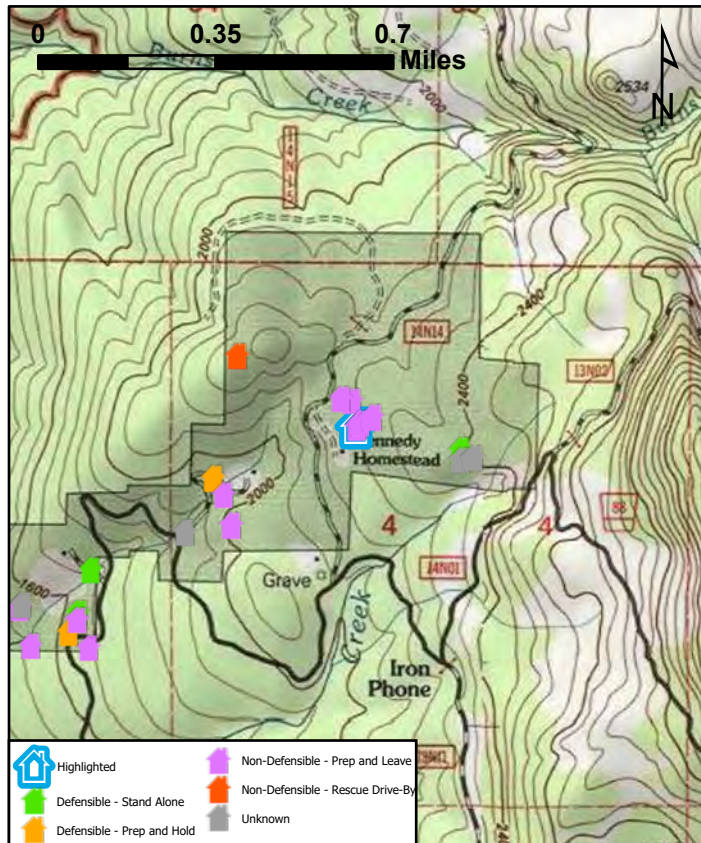
Roof Material: Combustible or no roof
Siding Material: Rock, concrete, metal
Electrical Power: Unknown
Gas to Structure: Unknown
Comments: Portable building across road from primary structure

Safety Zone(s): No safety zone(s) in area
Comm With ICP: Yes
Water Supply: No reliable water source nearby
Fuel Type: Grass and shrub, hardwood litter
Defensible Space: No defensible space
Hazards: Heavy fuel load, debris, LP tanks

Non-Defensible, Prep and Leave

Mitigation Time (in hours): 1
Mitigation Description: Remove fuel and debris set up sprinkler

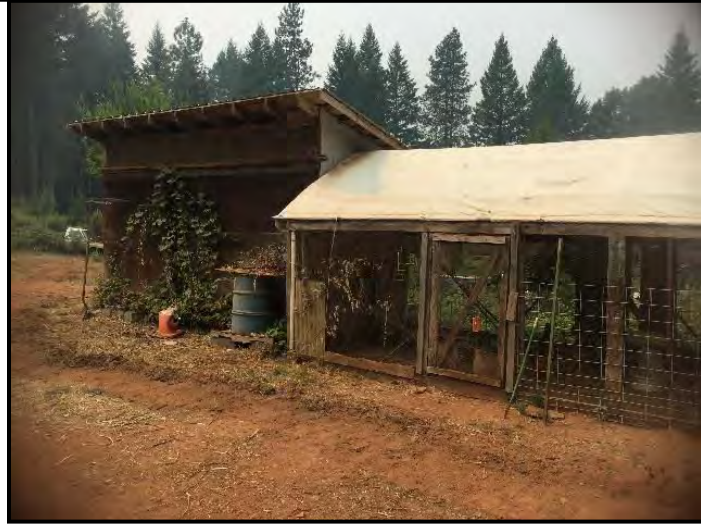
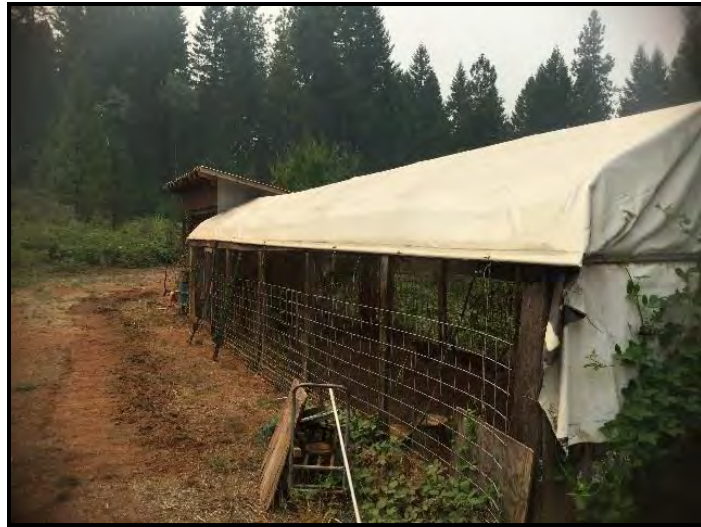
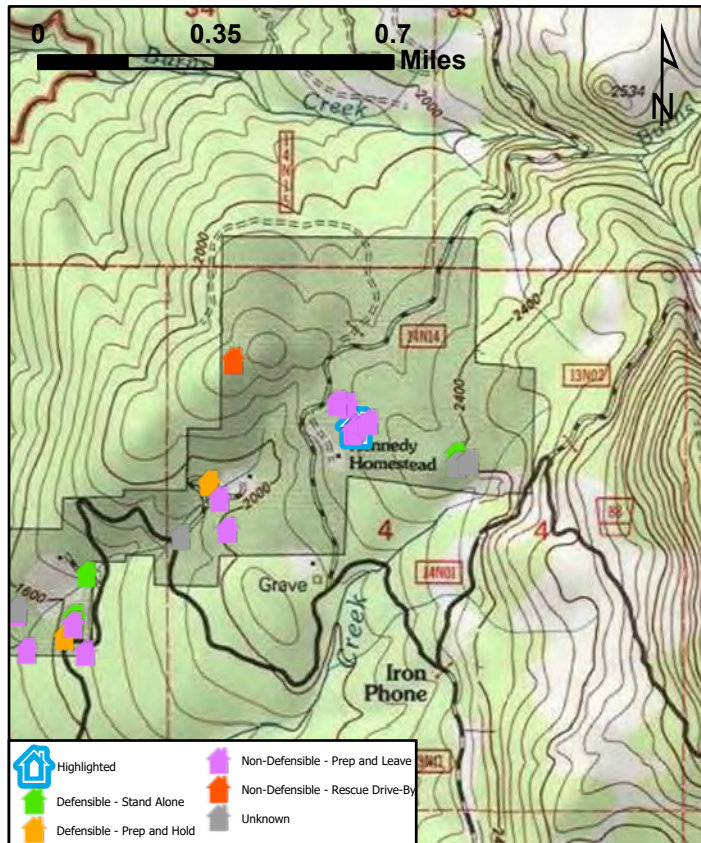
Roof Material: Combination of fire resistant and combustible
Siding Material: Wood or open sided
Electrical Power: No
Gas to Structure: No
Comments: Chicken coop up hill from primary structures.

Safety Zone(s): No safety zone(s) in area
Comm With ICP: Yes
Water Supply: No reliable water source nearby
Fuel Type: Grass and shrub, hardwood litter
Defensible Space: Less than 30 ft treated
Hazards: Fuel loading

Non-Defensible, Prep and Leave

Mitigation Time (in hours): 1
Mitigation Description: Clear adjacent fuel plum sprinkler

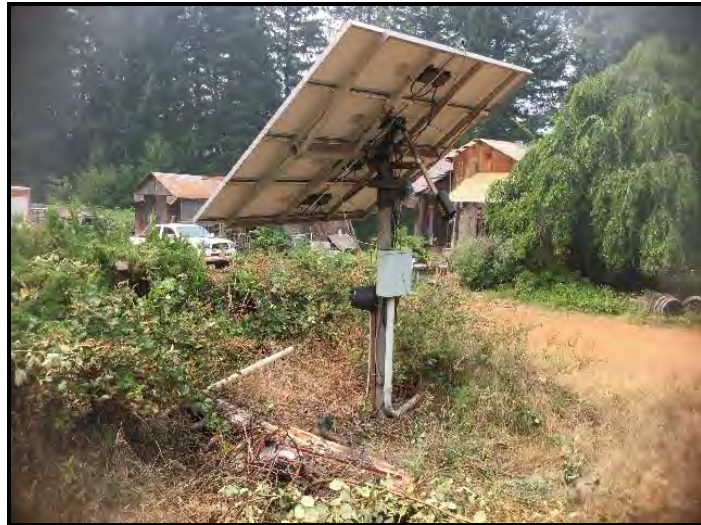
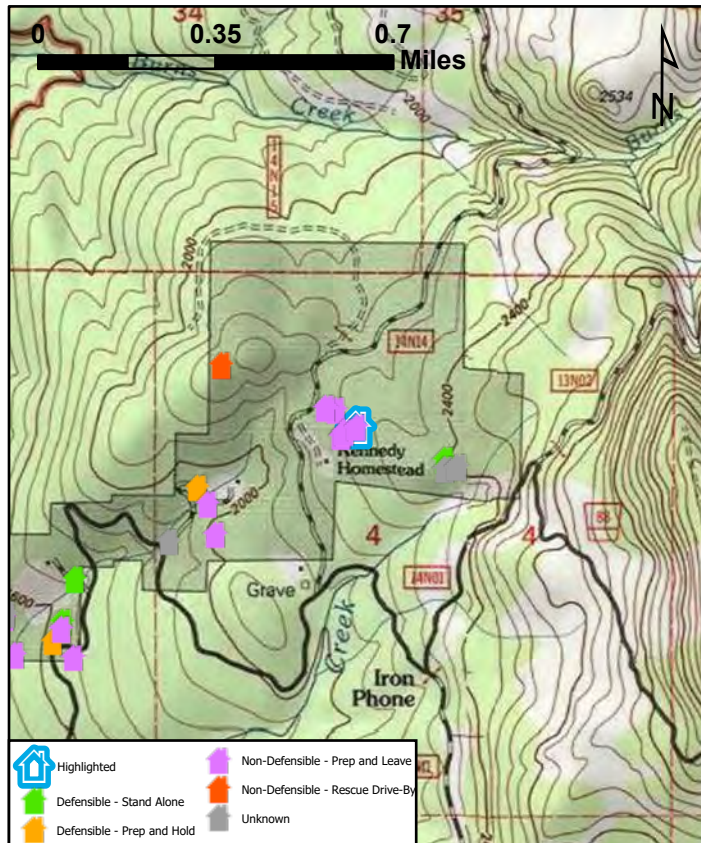
Roof Material: Noncombustible or not applicable
Siding Material: Not applicable
Electrical Power: Yes
Gas to Structure: No
Comments: Solar array

Safety Zone(s): No safety zone(s) in area
Comm With ICP: Yes
Water Supply: No reliable water source nearby
Fuel Type: Grass and shrub, hardwood litter
Defensible Space: Less than 30 ft treated
Hazards: Adjacent fuel

Non-Defensible, Prep and Leave

Mitigation Time (in hours): 1
Mitigation Description: Remove fuel and debris

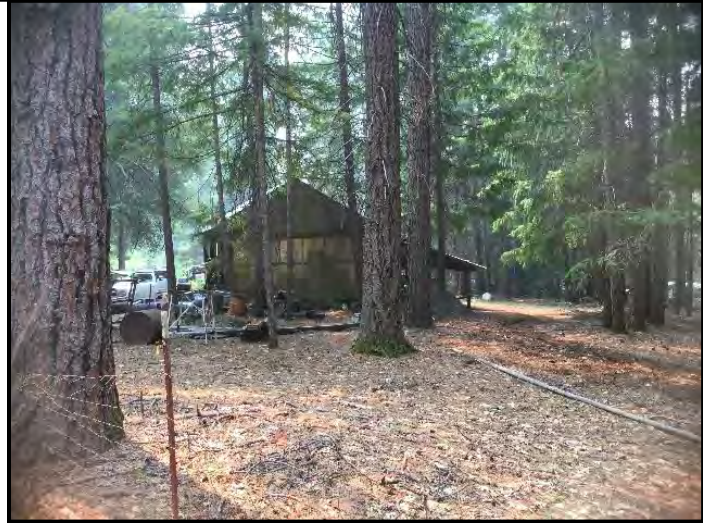
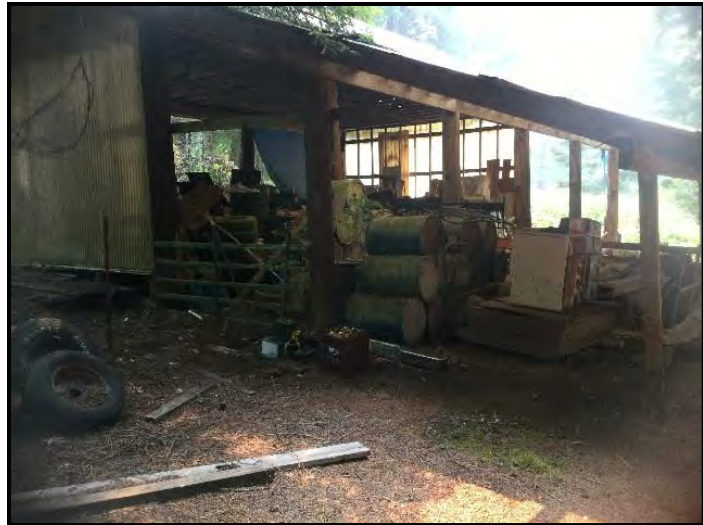
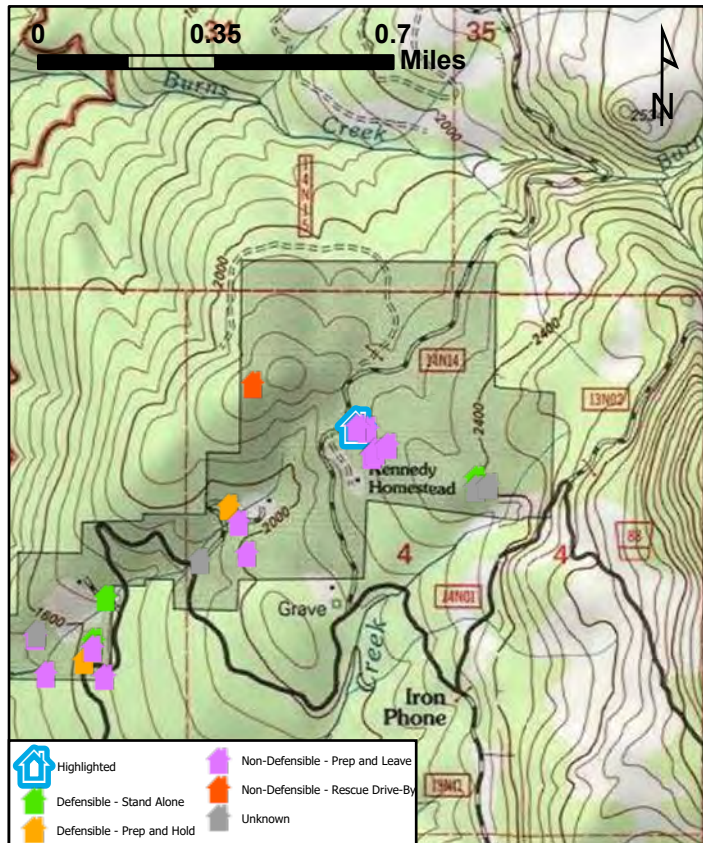
Roof Material: Combination of fire resistant and combustible
Siding Material: Wood or open sided
Electrical Power: No
Gas to Structure: No
Comments: Large open barn down hill from primary structure

Safety Zone(s): No safety zone(s) in area
Comm With ICP: Yes
Water Supply: No reliable water source nearby
Fuel Type: Shrub or timber
Defensible Space: Less than 30 ft treated
Hazards: Debris and contents of structure flammable

Non-Defensible, Prep and Leave
