## SPRING SUPPRESSION REPAIR

### Smith River Complex - Hiouchi Repair Area

94,639 acres as of 11/13/2023  
Map Date 05/17/2024

Smith River Complex  
CA-SRF-000968

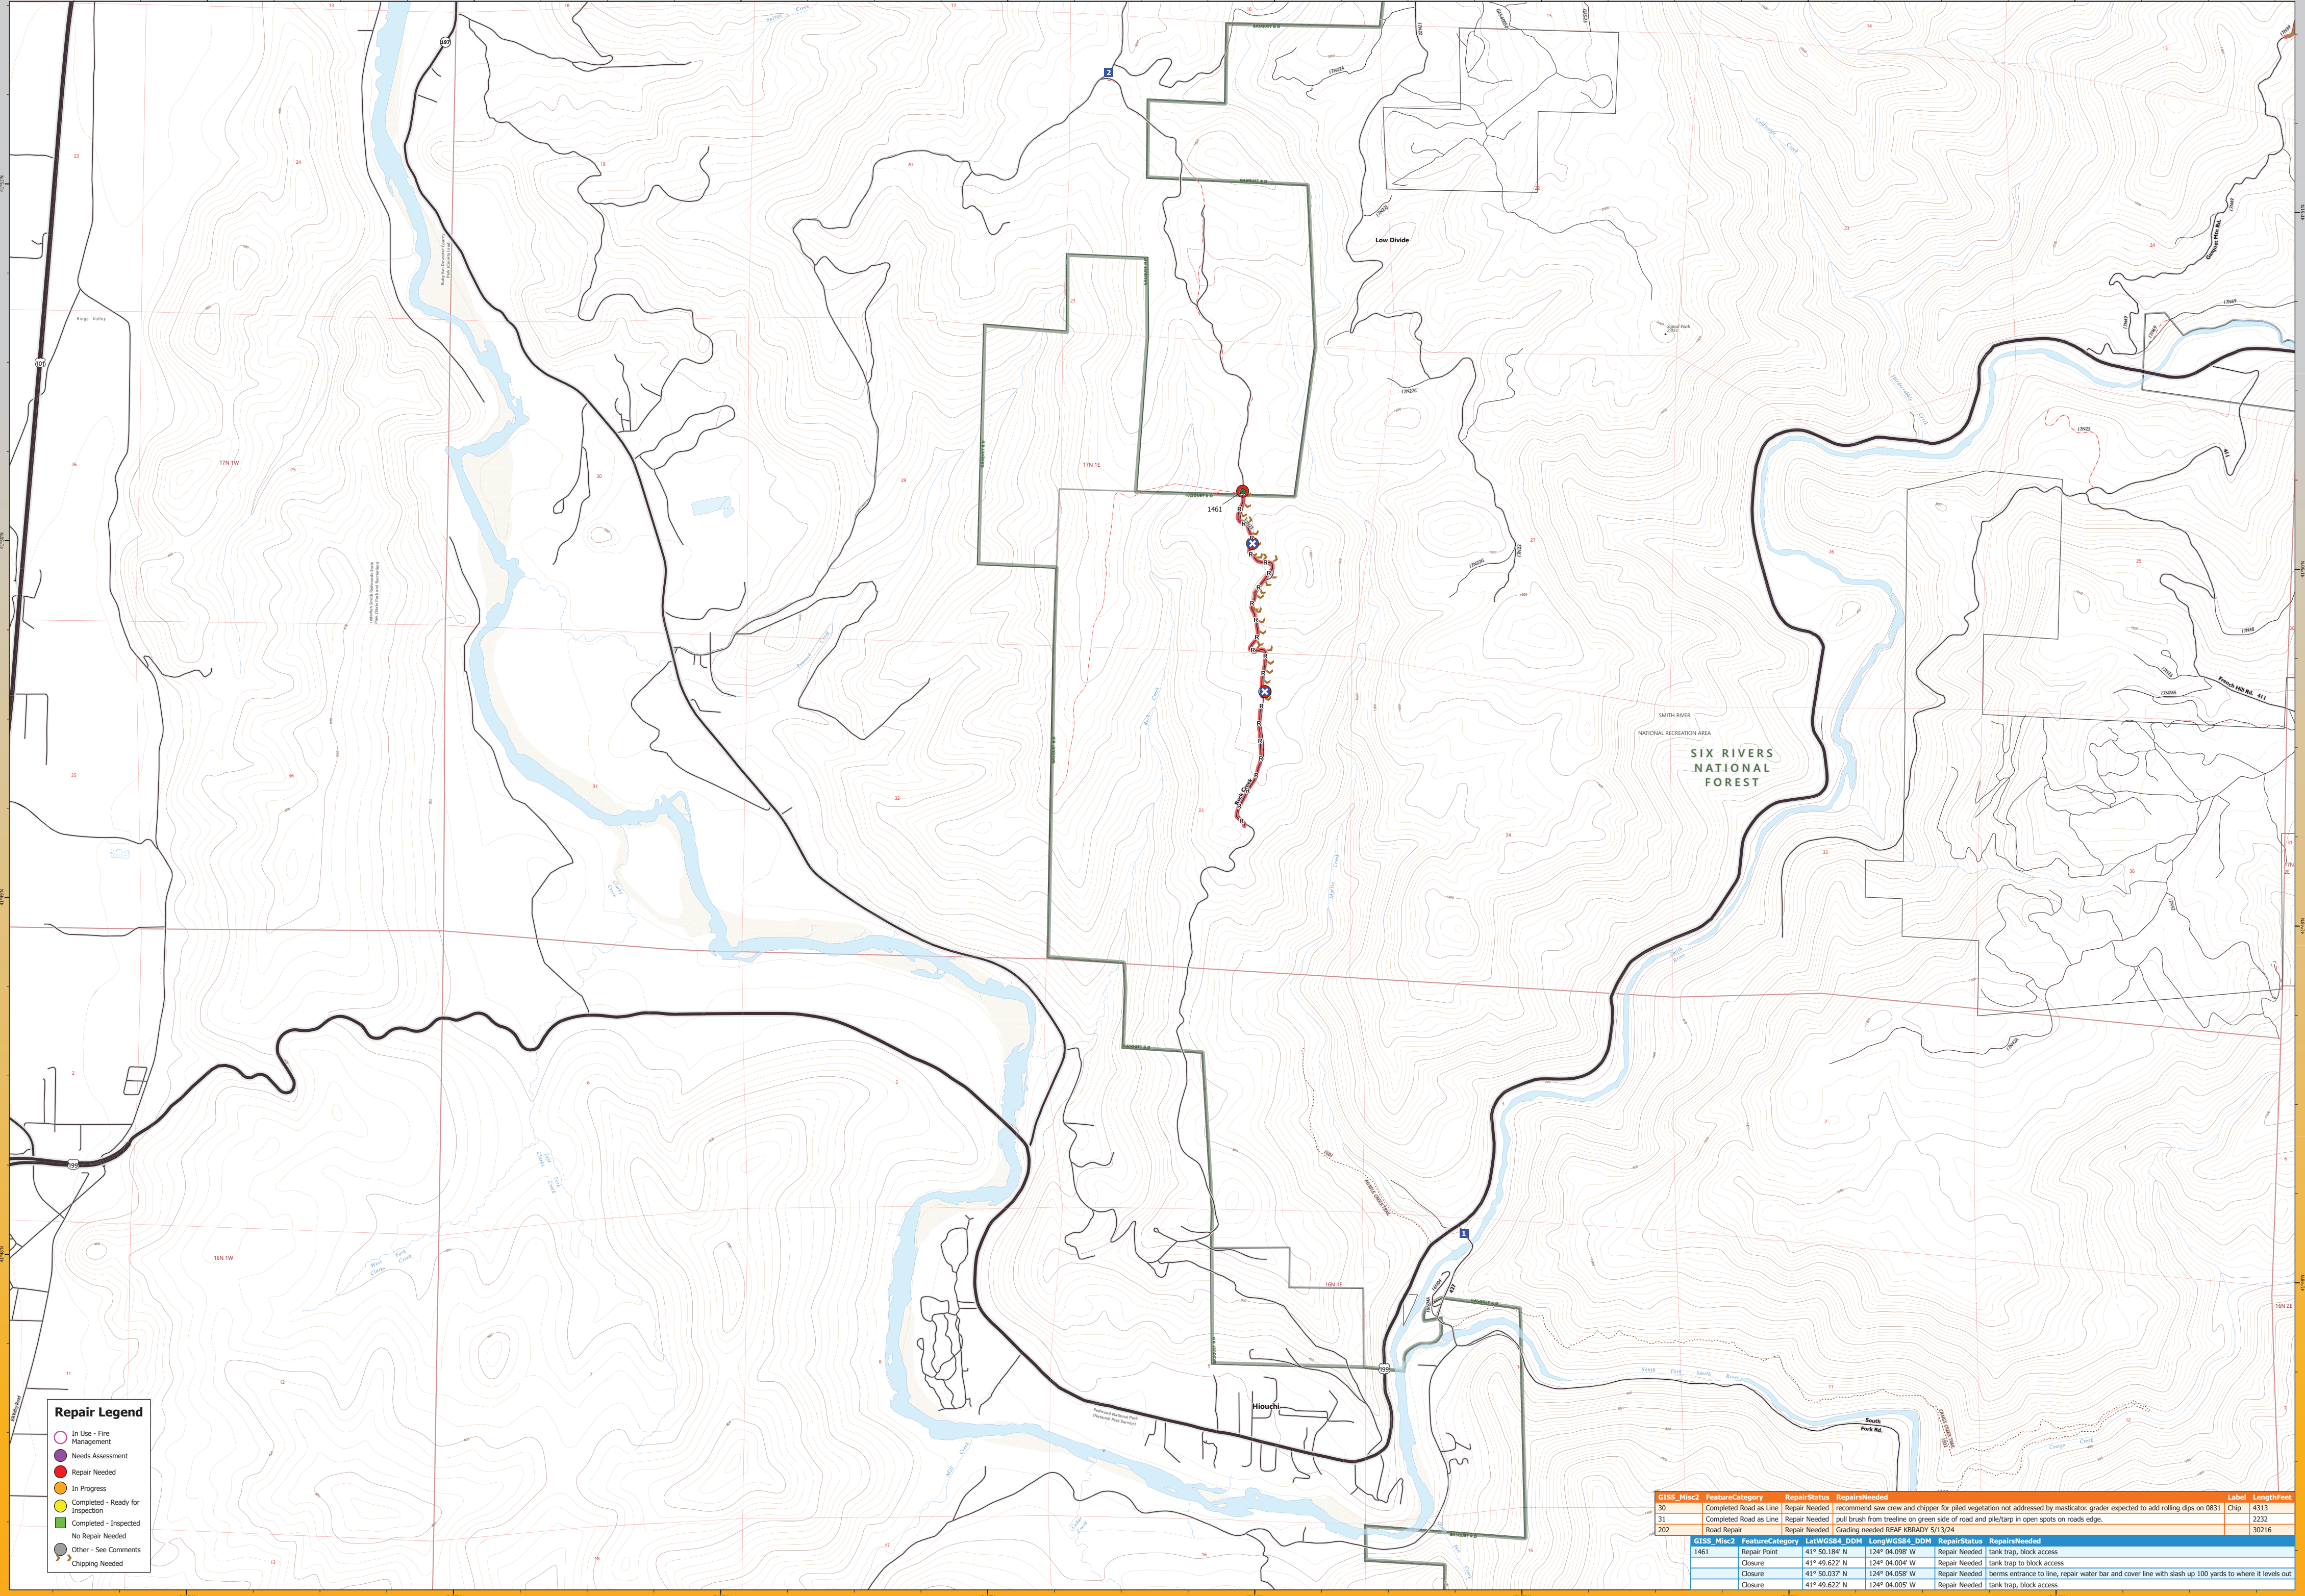
GISS_Misc2	FeatureCategory	RepairStatus	RepairsNeeded	Label	Length/Feet
30	Completed Road as Line	Repair Needed	recommend saw crew and chipper for piled vegetation not addressed by masticator; grader expected to add rolling dips on 0831	Chip	4313
31	Completed Road as Line	Repair Needed	pull brush from treeline on green side of road and pile/tarp in open spots on roads edge.		2232
202	Road Repair	Repair Needed	Grading needed REAF KBRADY 5/13/24		30216
GISS_Misc2	FeatureCategory	LatWGS84_DDM	LongWGS84_DDM	RepairStatus	RepairsNeeded
1461	Repair Point	41° 50.184' N	124° 04.098' W	Repair Needed	tank trap, block access
	Closure	41° 49.622' N	124° 04.094' W	Repair Needed	tank trap to block access
	Closure	41° 50.037' N	124° 04.058' W	Repair Needed	berms entrance to line, repair water bar and cover line with slash up 100 yards to where it levels out
	Closure	41° 49.622' N	124° 04.005' W	Repair Needed	tank trap, block access
