# SPRING SUPPRESSION REPAIR

## Smith River Complex - Jawbone Repair Area

94,639 acres as of 11/13/2023  
Map Date 05/17/2024

Smith River Complex  
CA-SRF-000968

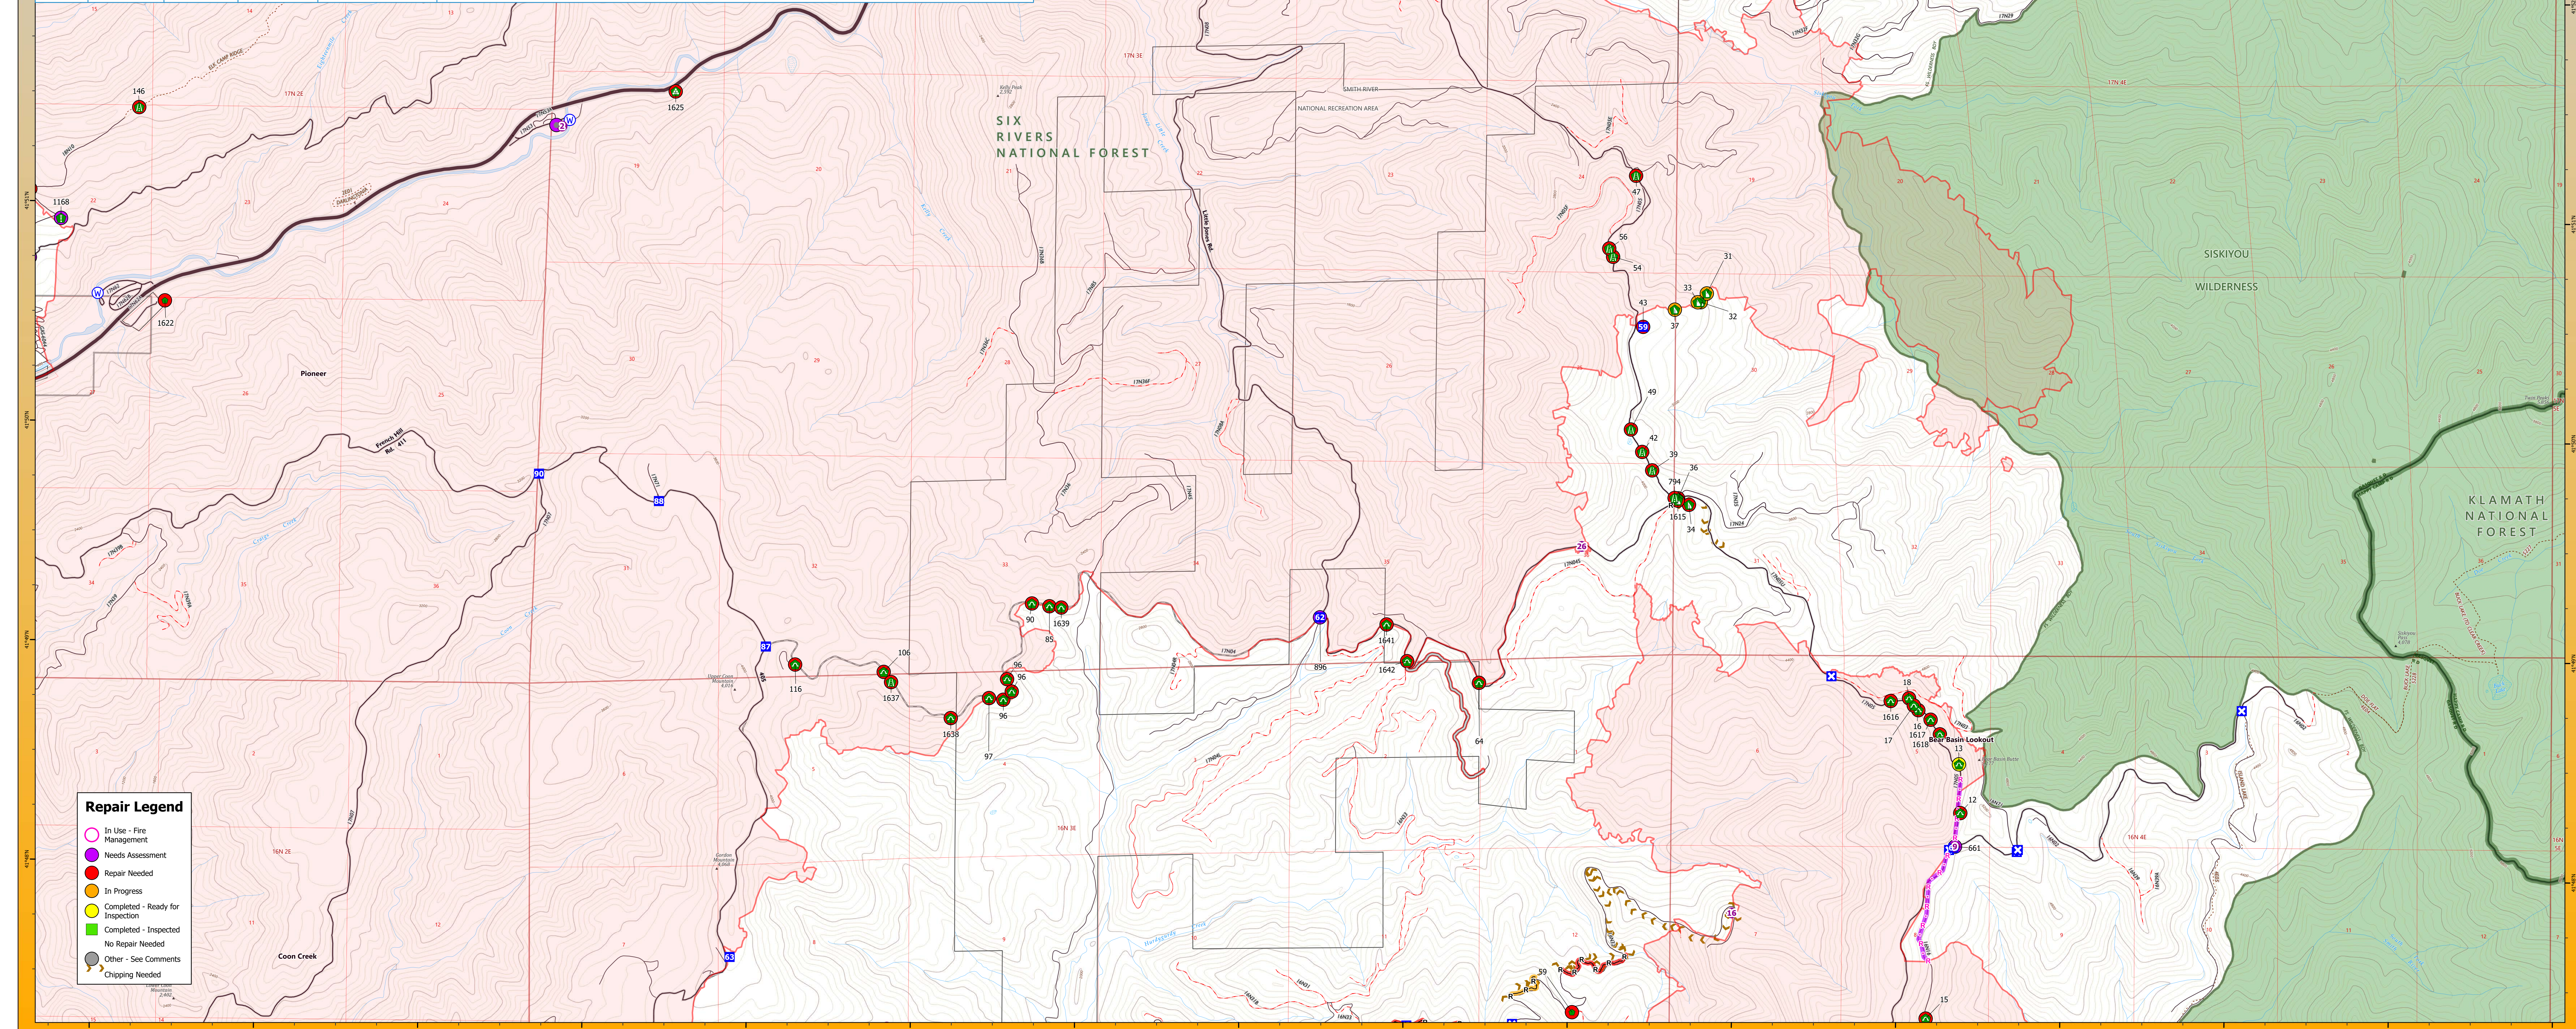
GISS_Misc2	FeatureCategory	LatWGS84_DDM	LongWGS84_DDM	RepairStatus	RepairsNeeded
896	Drop Point	41° 49.161' N	123° 48.529' W	Needs Assessment	Spot check needed by roads/hydro to assess if repair needed. Minor soil displacement from dozer tracks but no major damage.
43	Drop Point	41° 50.496' N	123° 46.576' W	Repair Needed	pull berms back, install barriers around edge of parking area. Spread seed and mulch around edges. SJ 4/19
661	Helispot	41° 48.143' N	123° 44.648' W	Needs Assessment	
36	Dozer Push	41° 49.718' N	123° 46.253' W	Repair Needed	decompact bladed area, pull berms back over area and slash. block ingress. Williams 9/8
1150	Road Repair	41° 51.054' N	123° 54.515' W	Repair Needed	Drainage needed, currently eroding road. Thels 9/1
989	Road Repair	41° 54.483' N	123° 51.748' W	Repair Needed	Burned roots likely, repair needed. Flagged. REAF Kovasi 4/26/24
1002	Road Repair	41° 52.439' N	123° 52.252' W	Repair Needed

37	Dozer Push	41° 50.578' N	123° 46.384' W	In Progress	FS CRITICAL REPAIR, recontour line to restore grade, salvage sod and replant in line. hand crew with excavator recommended Williams/Madera/Platte 9/7
32	Dozer Push	41° 50.613' N	123° 46.226' W	In Progress	pull berms and slash back over line. recontour. Williams 9/7
31	Dozer Push	41° 50.653' N	123° 46.150' W	In Progress	Pull berms and slash back, decompact, roughen surface, and seed. Williams/Madera/Platt 9/7
33	Dozer Push	41° 50.612' N	123° 46.232' W	In Progress	FS CRITICAL REPAIR, recontour drainage across line. Williams 9/7
992	Road Repair	41° 52.407' N	123° 52.014' W	Repair Needed	Replace sign
65	Repair Point	41° 53.362' N	123° 47.914' W	Repair Needed	haul logs out, remove brush and chip pile
34	Dozer Push	41° 49.690' N	123° 46.287' W	Repair Needed	pull berms in and recontour dirt piles. roughen surface (light potato patch for water run off)

42	Road Repair	41° 49.928' N	123° 46.575' W	Repair Needed	patch chip seal.
49	Road Repair	41° 50.030' N	123° 46.645' W	Repair Needed	patch chip seal
704	Road Repair	41° 49.720' N	123° 46.232' W	Repair Needed	patch chip seal
39	Road Repair	41° 49.845' N	123° 46.513' W	Repair Needed	patch chip seal
54	Road Repair	41° 50.816' N	123° 46.763' W	Repair Needed	patch chip seal
56	Road Repair	41° 50.854' N	123° 46.787' W	Repair Needed	patch chip seal
47	Road Repair	41° 51.186' N	123° 46.627' W	Repair Needed	patch chip seal
74	Road Repair	41° 52.625' N	123° 49.260' W	Repair Needed	patch chip seal
75	Road Repair	41° 52.664' N	123° 49.256' W	Repair Needed	patch chip seal
72	Repair Point	41° 52.728' N	123° 49.298' W	Repair Needed	chip small material. haul or buck up large material
13	Culvert	41° 48.518' N	123° 44.628' W	Completed - Ready for Inspection	CRITICAL REPAIR. Remove debris from culvert inlet. REAF_TONER 9/13

15	Culvert	41° 47.358' N	123° 44.818' W	Repair Needed	FS CRITICAL REPAIR. Remove woody debris from culvert and ditch leading to culvert... type 3 excavator recommended REAF_TONER 9/16
59	Repair Point	41° 47.373' N	123° 46.972' W	Repair Needed	re-install road block REAF_TONER 10/8
18	Culvert	41° 48.817' N	123° 44.536' W	Repair Needed	dig out inlet with small excavator and hand crew. REAF_TONER 10/1
16	Culvert	41° 48.763' N	123° 44.878' W	Repair Needed	clear inlet with hand crew REAF_TONER 10/1
17	Culvert	41° 48.784' N	123° 44.906' W	Repair Needed	clear inlet, half buried
12	Culvert	41° 48.296' N	123° 44.617' W	Repair Needed	
99	Repair Point	41° 52.550' N	123° 50.565' W	Repair Needed	Chipping and log bucking needed. 10/2 REAF Thels
146	Road Repair	41° 51.431' N	123° 55.756' W	Repair Needed	Replace road sign
116	Culvert	41° 48.923' N	123° 51.724' W	Repair Needed	the following is up to date RMD 4/26. critical repair. out outlet and clear pipe for adequate drainage from ditch REAF_TONER 10/4

106	Culvert	41° 48.894' N	123° 51.184' W	Repair Needed	critical repair. clear soil and rock from inlet and improve ditch REAF_TONER 10/4
97	Culvert	41° 48.779' N	123° 50.540' W	Repair Needed	CRITICAL REPAIR. remove debris from Culvert inlet REAF_TONER 9/13 remove material from culvert inlet REAF_KBRADY 5/13/24
96	Culvert	41° 48.772' N	123° 50.453' W	Repair Needed	CRITICAL REPAIR. remove debris from Culvert inlet REAF_TONER 10/4 remove material from ditch at inlet, create a more gradual slope of ditch grade line REAF_KBRADY 5/13/24
90	Culvert	41° 49.212' N	123° 50.285' W	Repair Needed	CRITICAL REPAIR. remove debris from Culvert inlet REAF_TONER 10/4
85	Culvert	41° 49.200' N	123° 50.178' W	Repair Needed	CRITICAL REPAIR. remove debris from Culvert inlet REAF_TONER 10/4
64	Culvert	41° 48.870' N	123° 47.556' W	Repair Needed	CRITICAL REPAIR. remove debris from Culvert inlet REAF_TONER 10/4
906	Repair Point	41° 52.496' N	123° 49.120' W	Needs Assessment	Monitor for effectiveness, shore up if needed

1168	Resource Location	41° 50.923' N	123° 56.226' W	Needs Assessment	Arch?
1615	Dozer Push	41° 49.707' N	123° 46.355' W	Repair Needed	Pull back berms 4-27-24 REAF Kovasi
1616	Culvert	41° 48.803' N	123° 45.047' W	Repair Needed	Culvert clogged with rock REAF Kovasi
1617	Culvert	41° 48.720' N	123° 44.803' W	Repair Needed	Culvert clogged with debris REAF Kovasi 4-27-24
1618	Culvert	41° 48.653' N	123° 44.745' W	Repair Needed	Clogged culvert with debris REAF Kovasi 4-27-24
1619	Road Repair	41° 53.570' N	123° 44.412' W	Repair Needed	Culvert repair pull out debris
1620	Road Repair	41° 53.577' N	123° 44.438' W	Repair Needed	Pull debris out of culvert
1622	Repair Point	41° 50.552' N	123° 55.586' W	Repair Needed	Use hand crew to remove bucked logs and cut brush from creek.
1637	Road Repair	41° 48.84749392' N	123° 51.13813435' W	Repair Needed	Clear out ditch
1638	Culvert	41° 48.68622380' N	123° 50.77237407' W	Repair Needed	Clear out ditch near culvert inlet

96	Culvert	41° 48.90626258' N	123° 50.40226026' W	Repair Needed	CRITICAL REPAIR. remove debris from Culvert inlet REAF_TONER 10/4 remove material from ditch at inlet, create a more gradual slope of ditch grade line REAF_KBRADY 5/13/24
96	Culvert	41° 48.86607541' N	123° 50.43170262' W	Repair Needed	CRITICAL REPAIR. remove debris from Culvert inlet REAF_TONER 10/4 remove material from ditch at inlet, create a more gradual slope of ditch grade line REAF_KBRADY 5/13/24
1639	Culvert	41° 49.19451119' N	123° 50.10562617' W	Repair Needed	Inlet riser cover burned, needs replacing
1641	Culvert	41° 49.13169852' N	123° 48.12279521' W	Repair Needed	Inlet covered
1642	Culvert	41° 48.96531374' N	123° 47.99536555' W	Repair Needed	Inlet covered
1623	Landing or Log Deck	41° 52.953' N	123° 49.127' W	Repair Needed	Consolidate slash at centralized location.
1624	Landing or Log Deck	41° 52.870' N	123° 49.650' W	Repair Needed	Consolidate slash at centralized location.

1625	Landing or Log Deck	41° 51.528' N	123° 52.486' W	Repair Needed	Consolidate slash at centralized location.
Other		41° 51.369' N	123° 53.211' W	Needs Assessment

GISS_Misc2	FeatureCategory	RepairStatus	RepairsNeeded	Label	Length/Foot
164	Planned Secondary Line	In Progress	Critical Repair - Remove debris from road ditch, pull out-slope berms	Chip	17654
167	Completed Road as Line	Repair Needed	Consult roads engineer to see if should be closed REAF Kovasi 4-27-24 Repair to standard - closed or decommissioned rd?	Chip	57
172	Planned Road as Line	Needs Assessment	Roadway needs grading due to ruts on the travel way. REAF BGOMEZ, 05/12/24		3529
74	Completed Road as Line	Repair Needed			16103
174	Planned Road as Line	Needs Assessment			1920
122	Completed Road as Line	In Progress	chip cut vegetation	Chip	1314
123	Completed Road as Line	Repair Needed	chip cut vegetation	Chip	481
124	Completed Road as Line	Repair Needed	chip cut vegetation	Chip	2241
156	Access or Improved Road	Repair Needed	pull berms, out slope road, install water bars, spread slash, block edge of road SJ 4/19	Chip	5696
