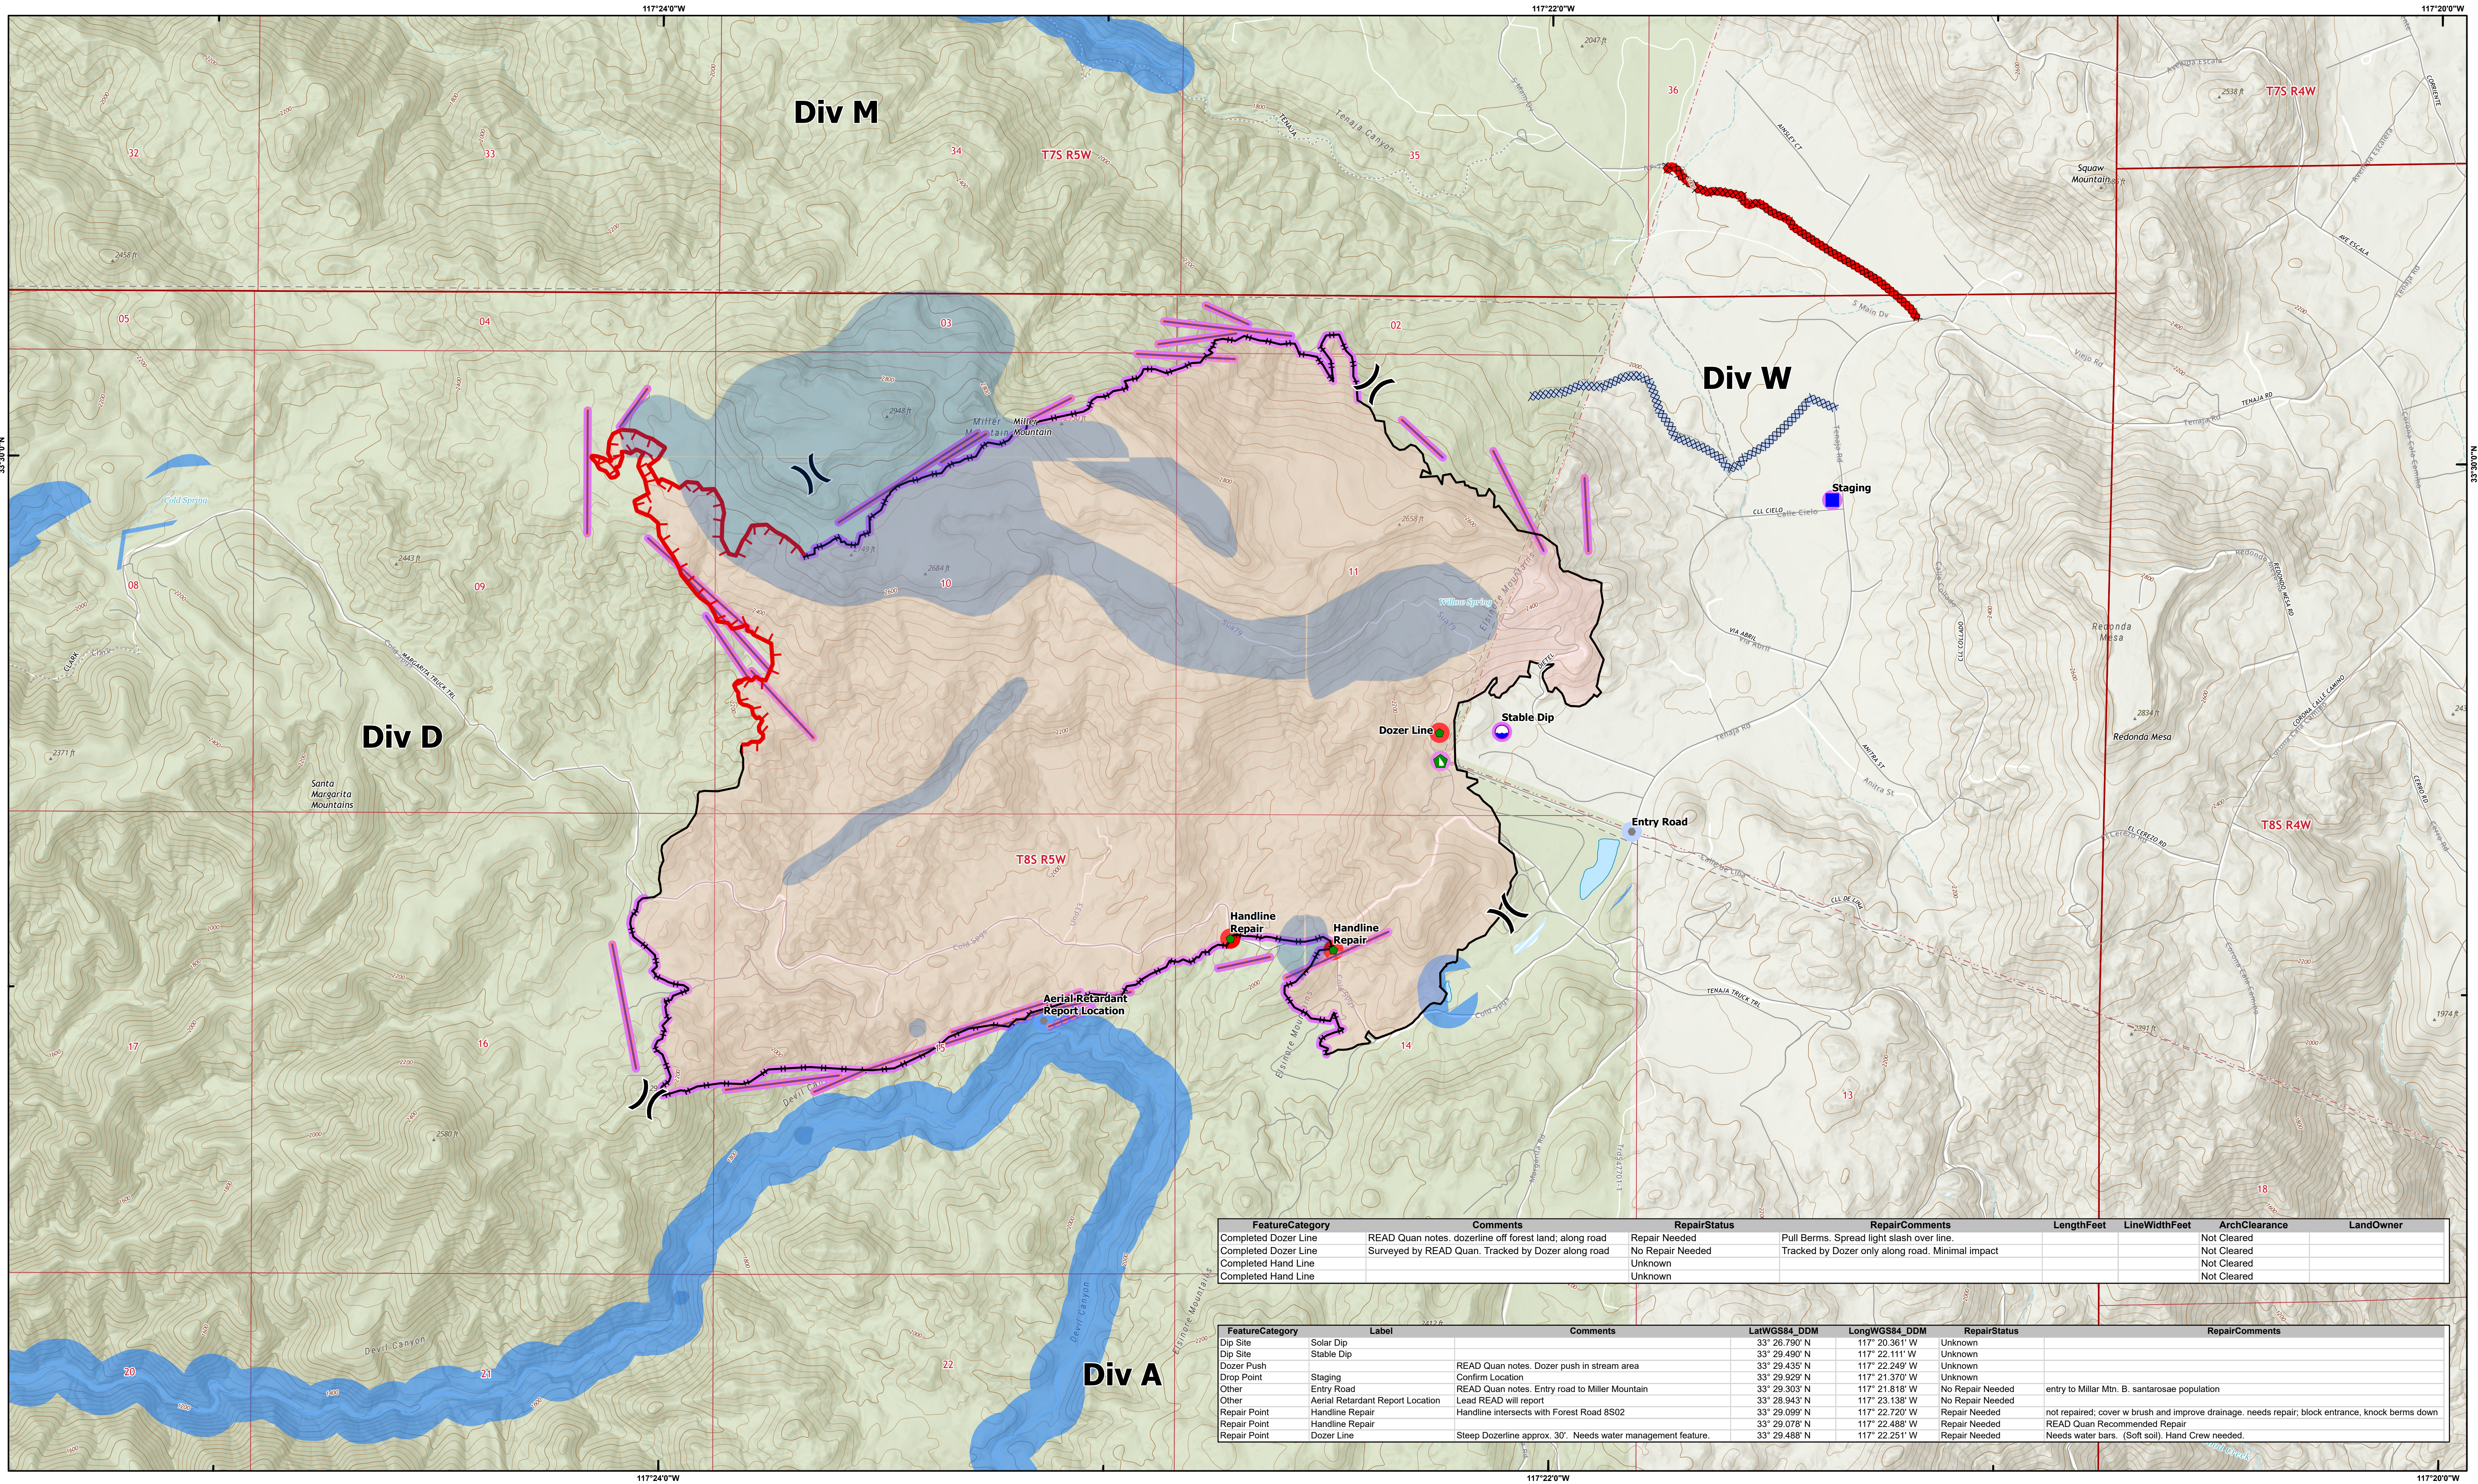
FeatureCategory	Comments	RepairStatus	RepairComments	LengthFeet	LineWidthFeet	ArchClearance	LandOwner
Completed Dozer Line	READ Quan notes. dozerline off forest land; along road	Repair Needed	Pull Berms. Spread light slash over line.			Not Cleared	
Completed Dozer Line	Surveyed by READ Quan. Tracked by Dozer along road	No Repair Needed	Tracked by Dozer only along road. Minimal impact			Not Cleared	
Completed Hand Line		Unknown				Not Cleared	
Completed Hand Line		Unknown				Not Cleared

FeatureCategory	Label	Comments	LatWGS84_DDM	LongWGS84_DDM	RepairStatus	RepairComments
Dip Site	Solar Dip		33° 26.790' N	117° 20.361' W	Unknown	
Dip Site	Stable Dip		33° 29.490' N	117° 22.111' W	Unknown	
Dozer Push		READ Quan notes. Dozer push in stream area	33° 29.435' N	117° 22.249' W	Unknown	
Drop Point	Staging	Confirm Location	33° 29.929' N	117° 21.370' W	Unknown	
Other	Entry Road	READ Quan notes. Entry road to Miller Mountain	33° 29.303' N	117° 21.818' W	No Repair Needed	entry to Miller Mtn. B. santarosae population
Other	Aerial Retardant Report Location	Lead READ will report	33° 28.943' N	117° 23.138' W	No Repair Needed	
Repair Point	Handline Repair	Handline intersects with Forest Road 8S02	33° 29.099' N	117° 22.720' W	Repair Needed	not repaired; cover w brush and improve drainage. needs repair; block entrance, knock berms down
Repair Point	Handline Repair		33° 29.078' N	117° 22.488' W	Repair Needed	READ Quan Recommended Repair

Repair Point	Dozer Line	Steep Dozerline approx. 30'. Needs water management feature.	33° 29.488' N	117° 22.251' W	Repair Needed	Needs water bars. (Soft soil). Hand Crew needed.
