Stream Reaches Surveyed For Hazard Analysis

10/2008

Big Sur River

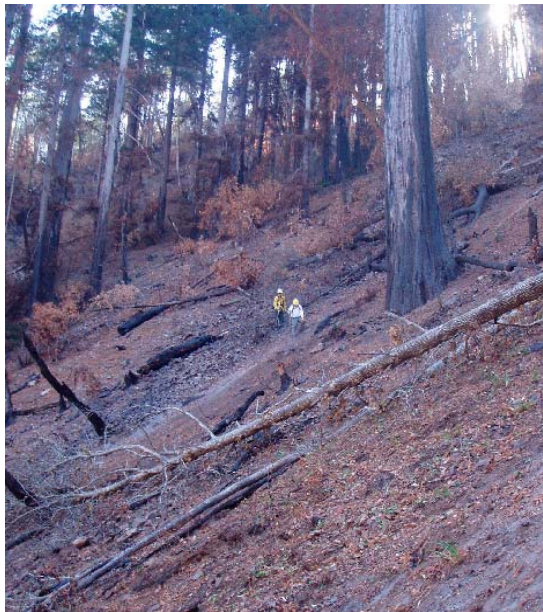
Photo 1: Side slopes dropping into survey reach at wilderness boundary off the Pine Ridge trail.

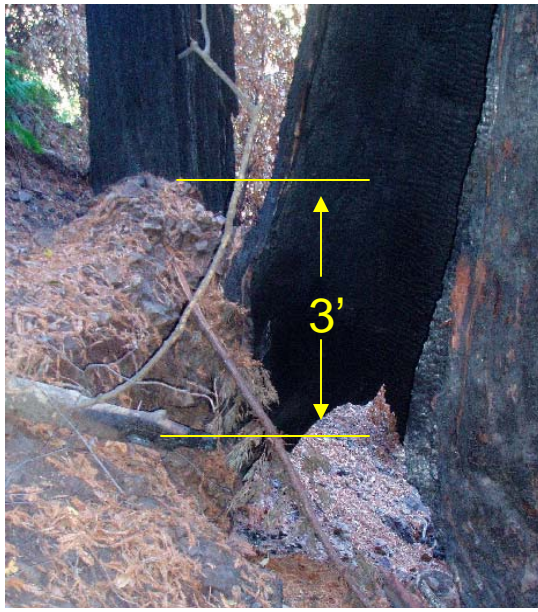
Photo 2: Example of dry ravel build up behind redwood tree. Approximately 3 feet. Numerous cat faced redwoods.

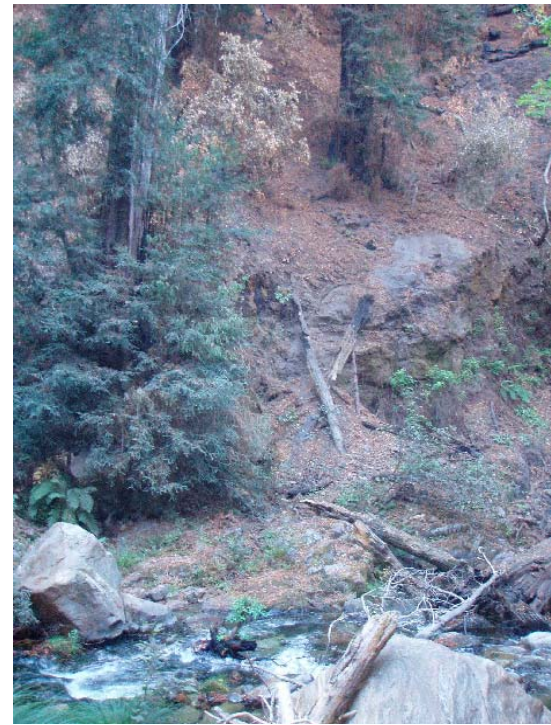
Photo 3: Dry ravel entering Big Sur River and constricting valley bottom. Valley width 100'.

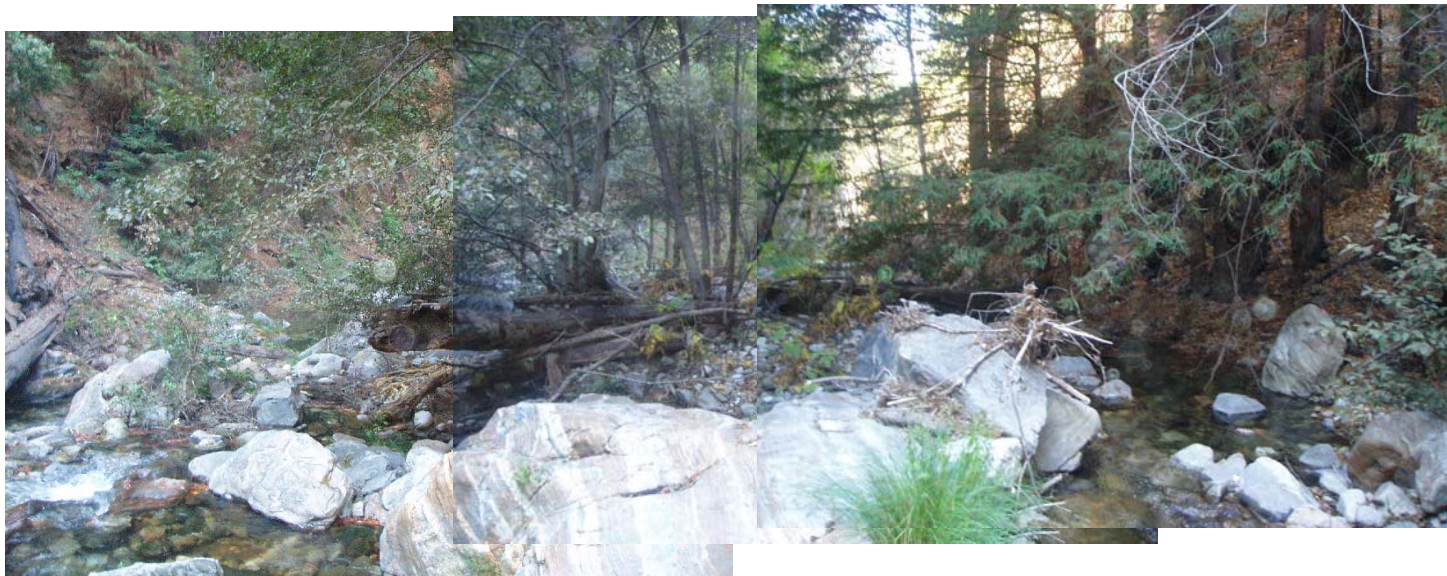
Photo 4: Composite of photos showing typical valley width. Photo take facing down stream from photo 3 location.

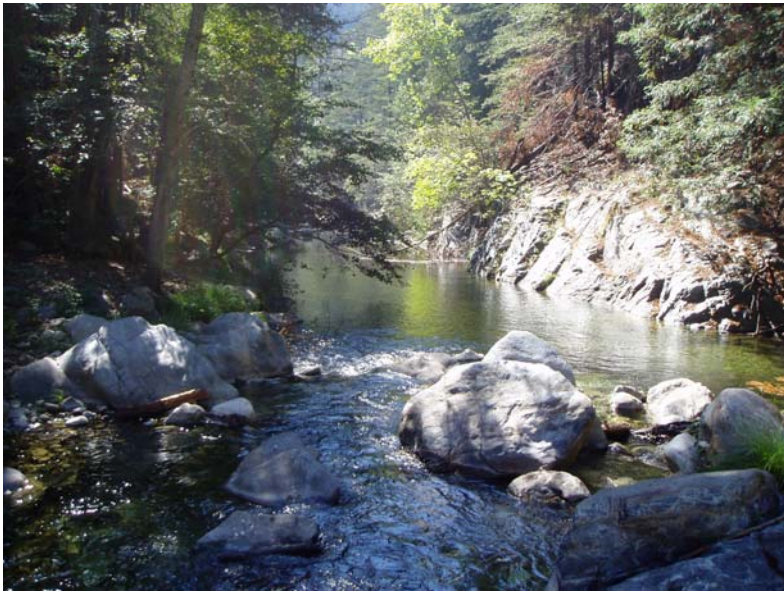
Photo 5: Typical valley facing downstream. Note bedrock constriction on Right Hand Bank

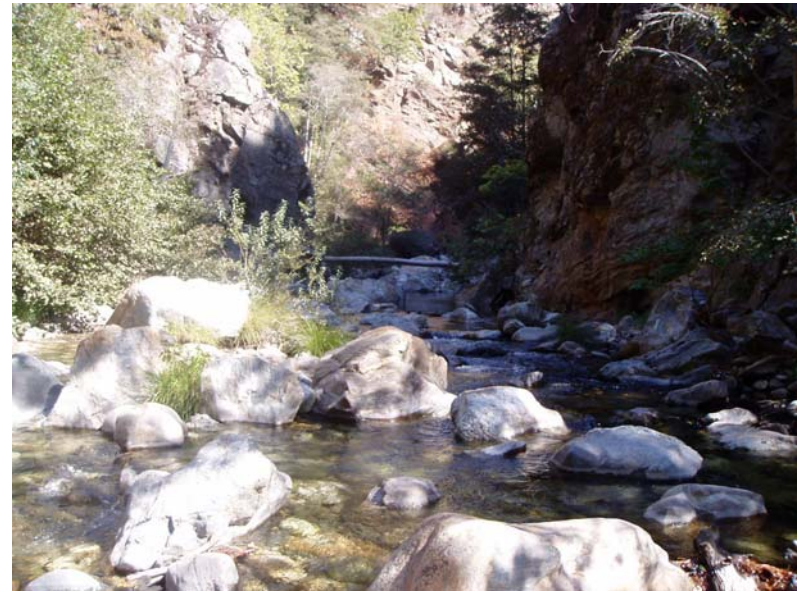
Photo 6: Turning and facing upstream from photo 5 a view of typical valley width, 50- 70 feet.

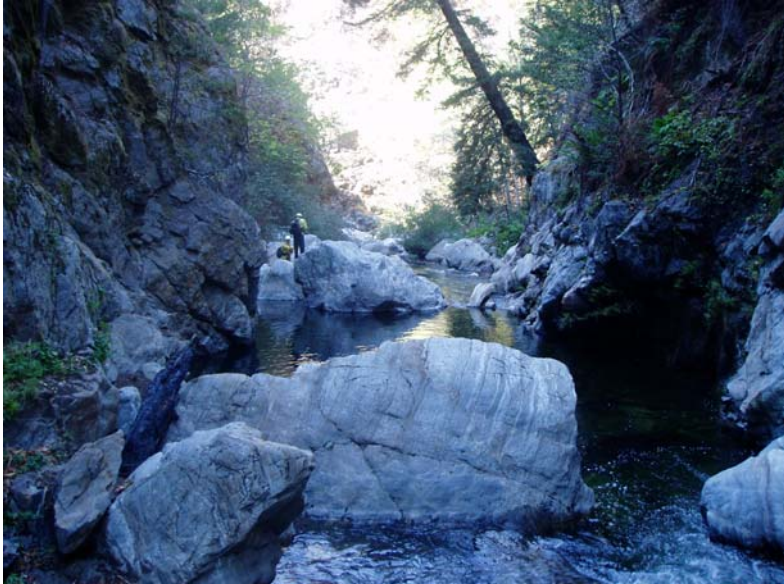
Photo 7: Valley constriction due to bedrock pinch point. Photo facing downstream. Valley width 30 feet

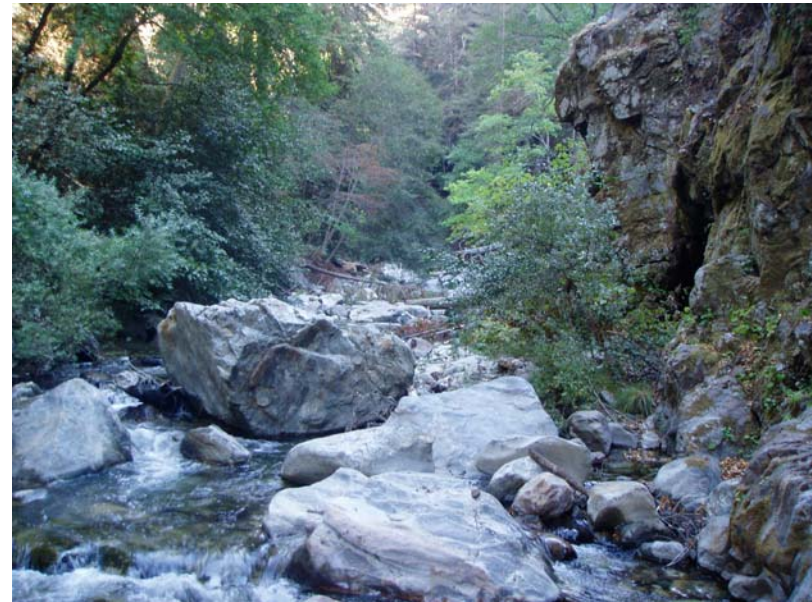
Photo 8: Valley constriction due to bedrock pinch point. Photo facing upstream. Valley width 50 feet.

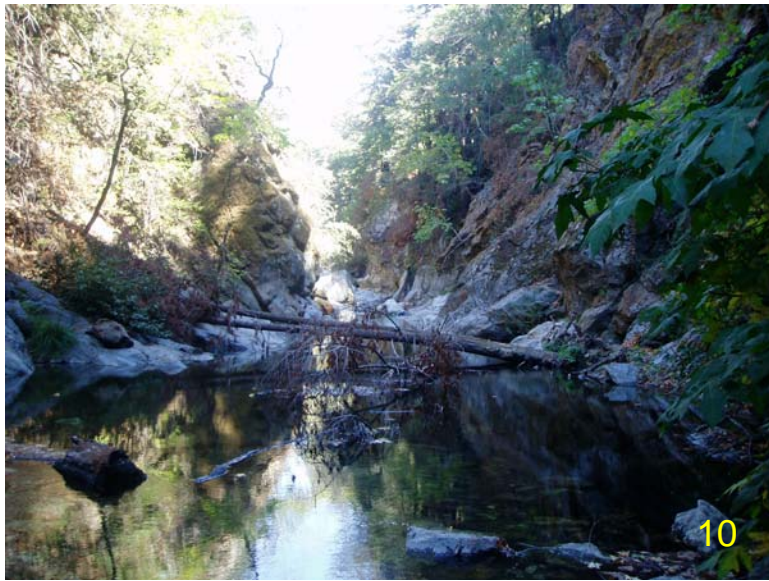
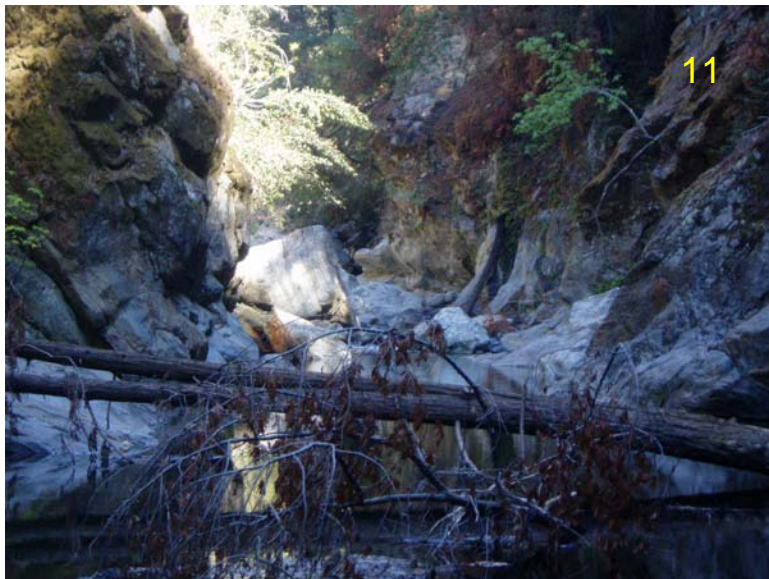
Photo 10 & 11: Continuation of narrow valley. Facing upstream. Valley less than 50 feet wide.

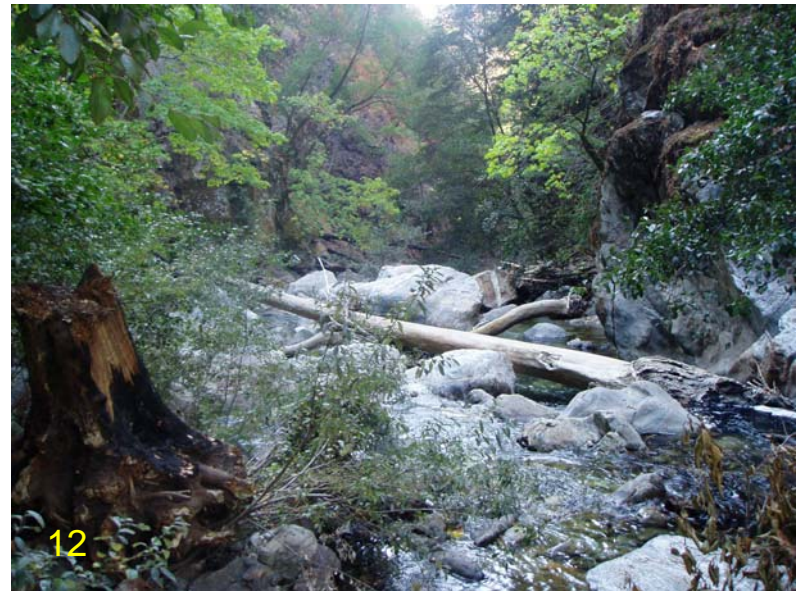
Photo 12: Facing downstream at photo 10 site.

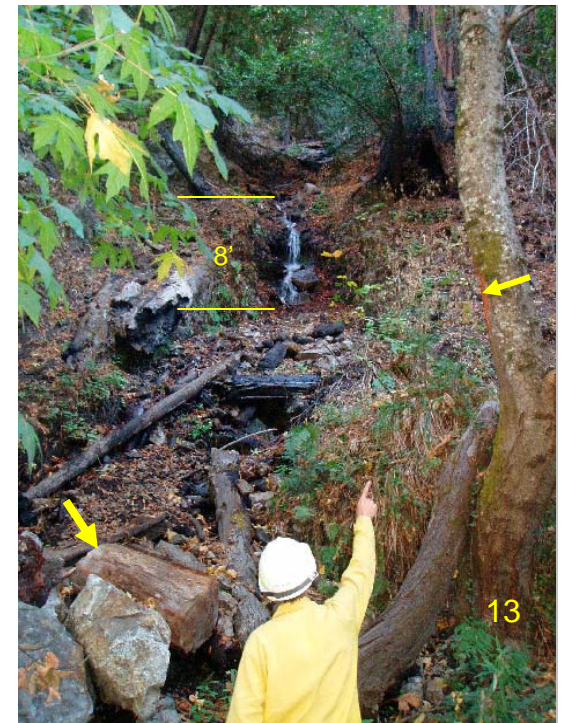
Photo 13: Tributary coming in on south side, left hand bank, of river. Channel gradient $> 40\%$. Steps are created by large wood holding back ravel. Note chunk of wood lower left of photo. Historic removal of wood has created a very mobile system. Scar in tree shows damage of riparian vegetation from raveling material

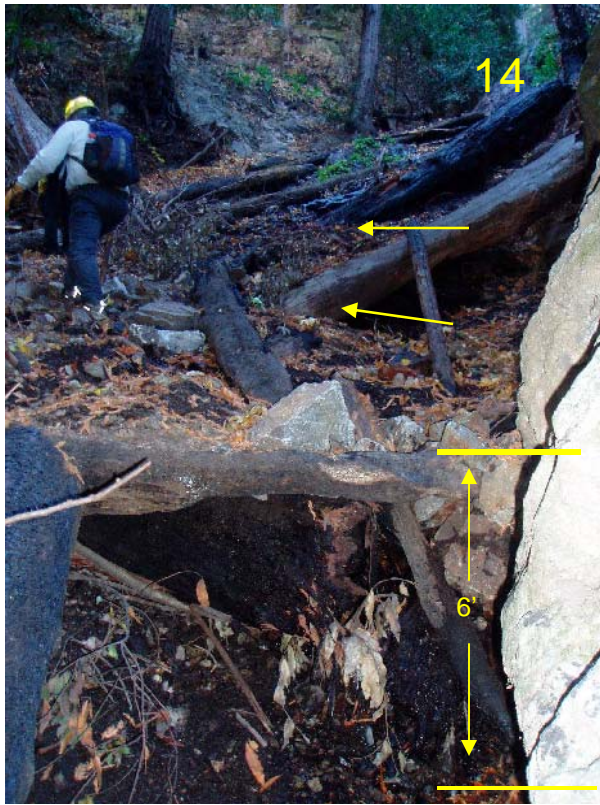
Photo 14: Wood steps along the channel have been burned and are susceptible to failure. Wood is being buried by slope ravel and could possibly fail due to loss of integrity from fire. One can see the lower ends of the logs that are buried as one progresses up channel. (arrows)

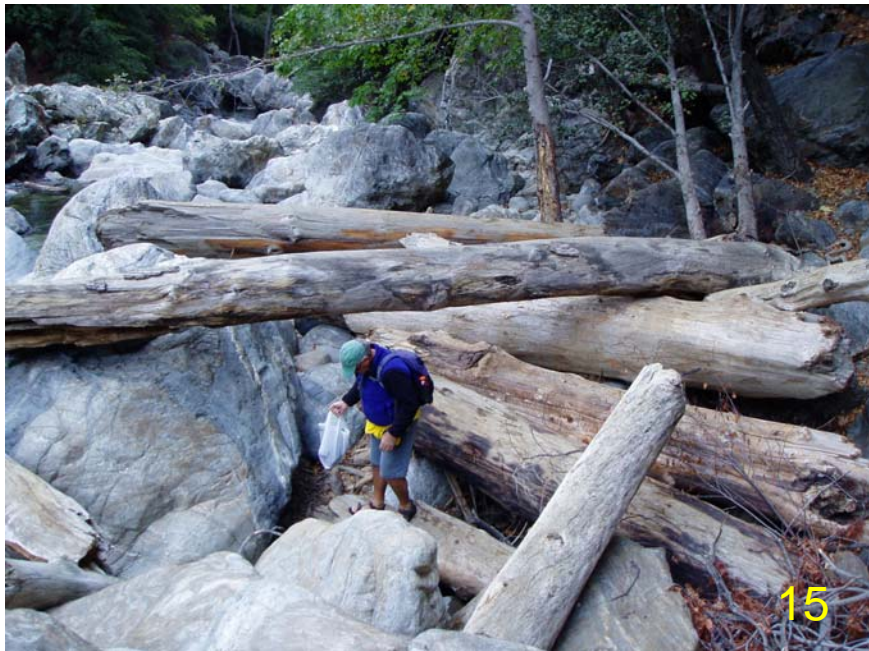
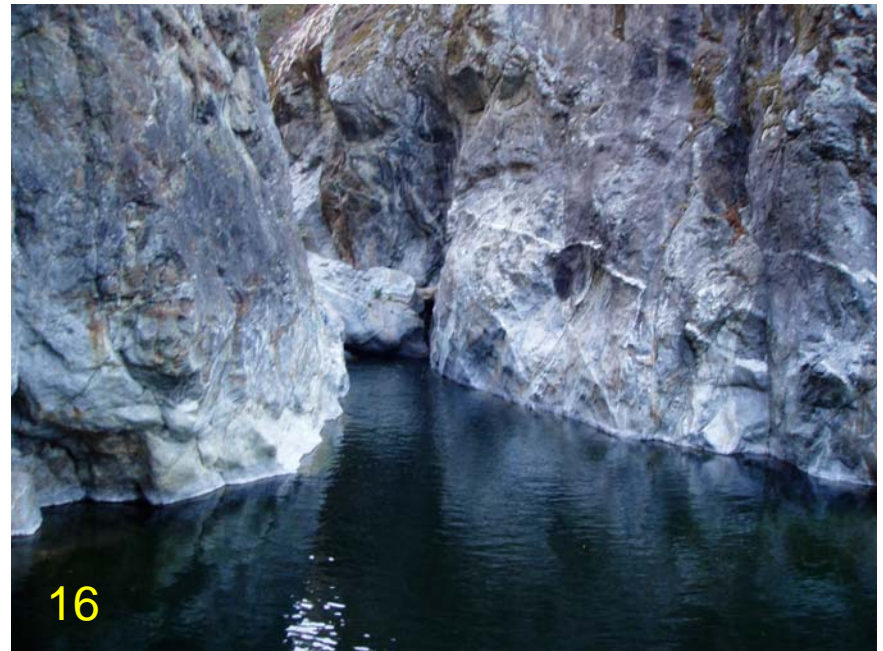
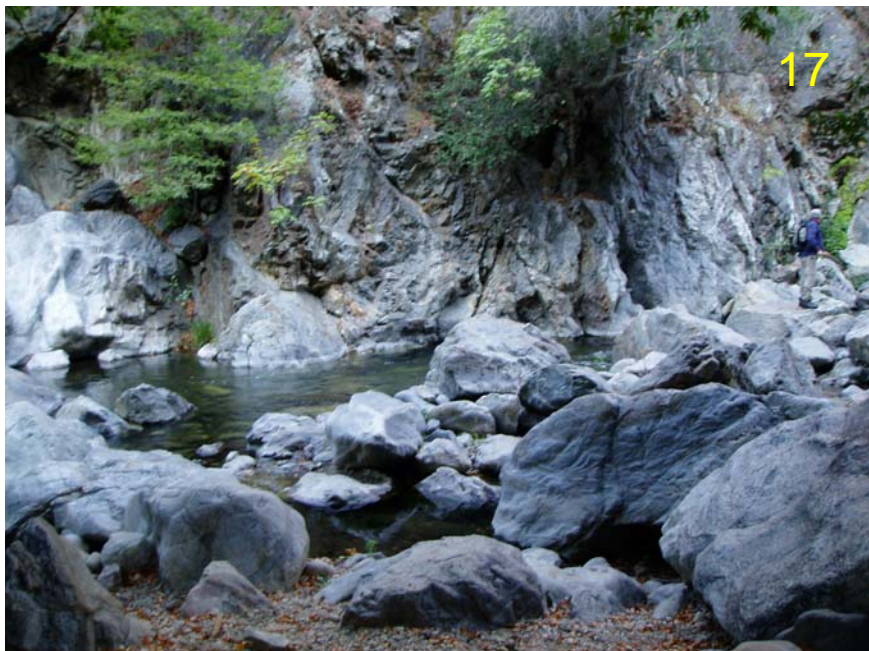
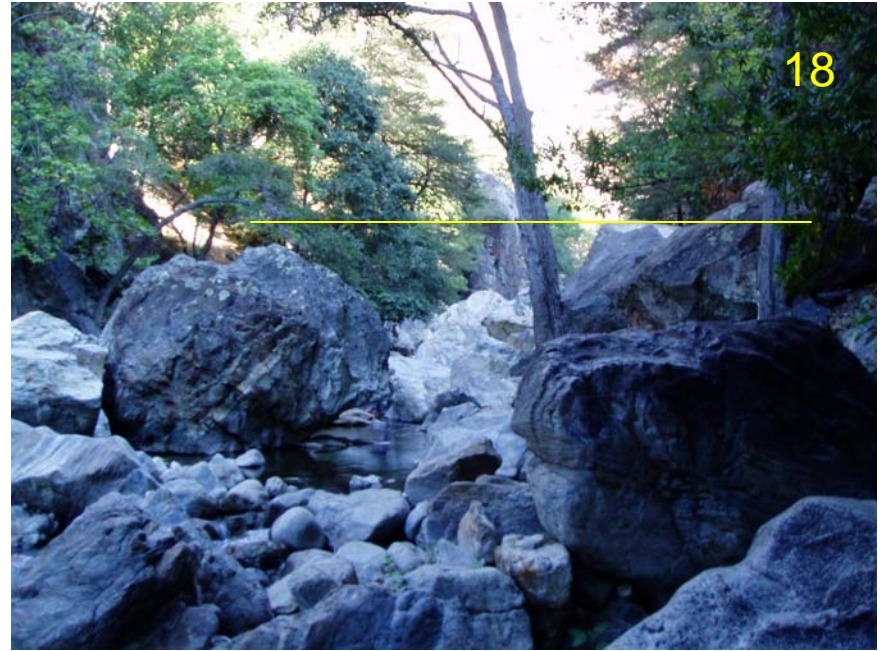
Photos 15- 18, following page, Show the narrow gorge are directly above the State park Campground. Unable to proceed upstream of photo 16 due to the sheer walls and the deep pool. Directly downstream of the pool, photo 15, a small accumulation of wood exists. A backwater area is formed as the water is forced through the narrow gorge and wood accumulates along the right hand bank as channel widens. Valley width 50-70 feet. Photo 17 and 18 show the channel character directly below, downstream, of the gorge. At yellow line valley opens and was historically part of an oxbow meander. This has in recent times been cut off and a berm exists to prevent the channel from accessing historic flood plain. This is all on State Park Lands.

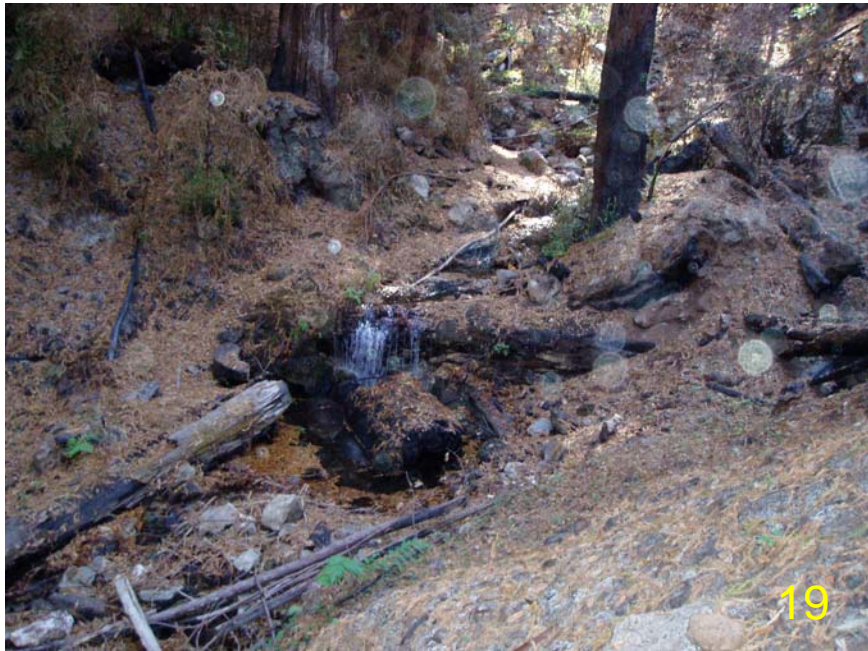
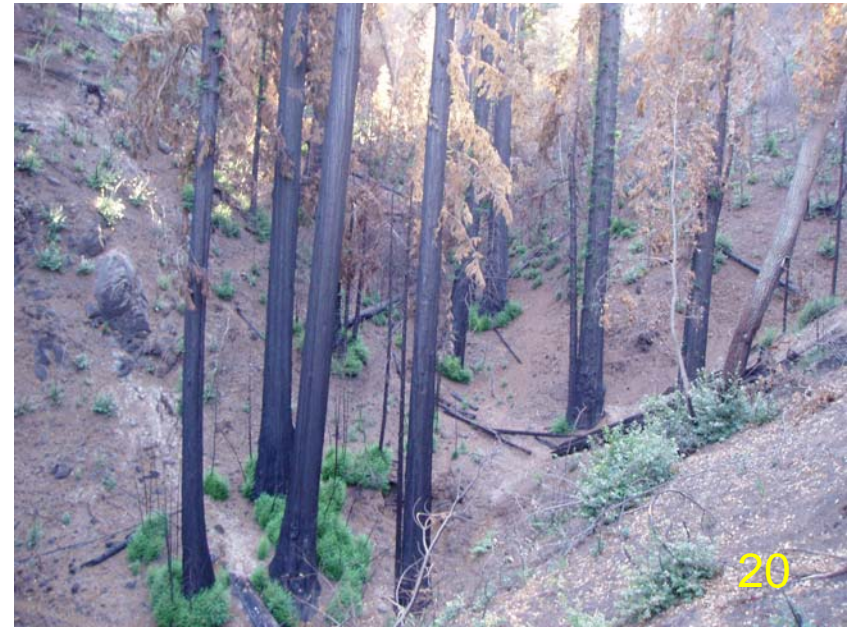
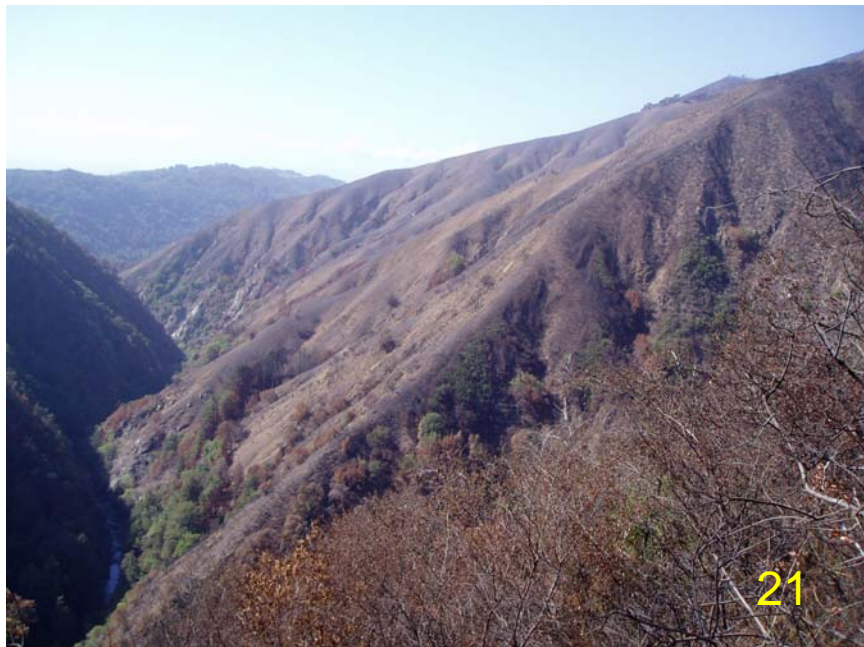
Photos 19-21 show some of the upland conditions of the upper slopes. Limited wood is being utilized in photo 19 and sprouting at based of tree and shrub species is occurring photo 20. Lack of vegetation of the southern aspect, photo 21, indicate higher risk to failure due to lack of root strength.

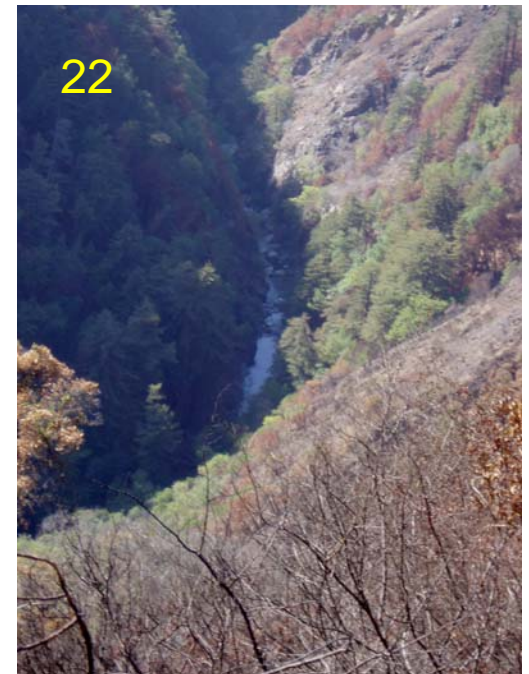
Photo 22 depicts a downstream view of the Big Sur River from the Pine Ridge trail.
