USDA Forest Service
Assessment of Juan Higuera Creek
Following the 2008 Basin Complex Fire
October 15, 2008

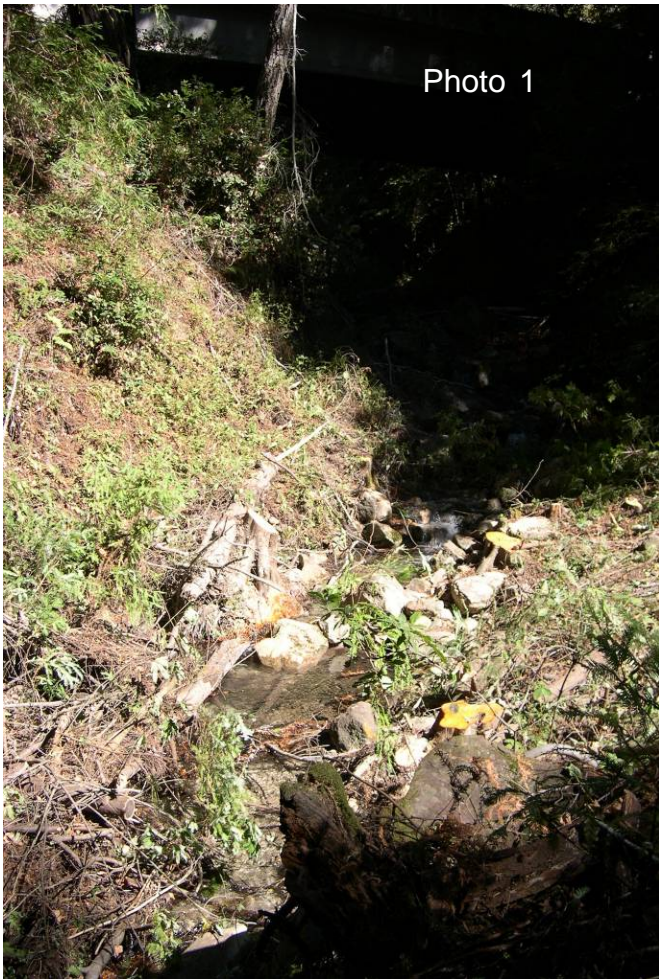
Photo 1

Photo 1: Upstream view of Juan Higuera Creek below Hwy. 1 bridge. Crews have recently removed large trees along this reach. As a result, debris and flood flows will move with increased velocity and could add to channel and bank instability. At moderate flows, water and sediment will tend to stay in channel and not move onto adjacent terraces.

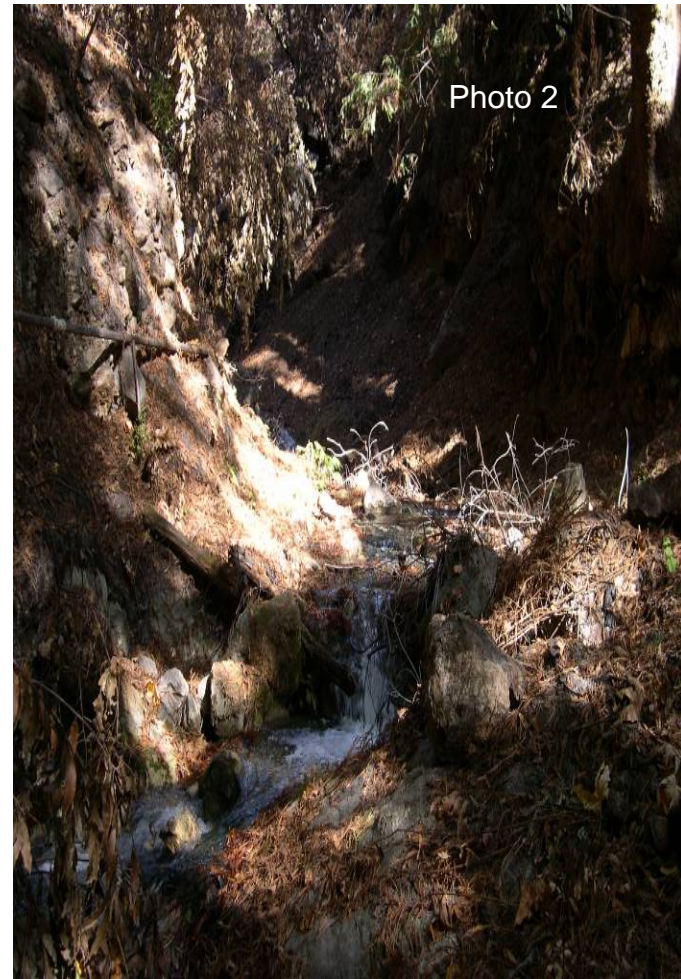
Photo 2

Photo 2: Upstream view of Juan Higuera Creek, 200 feet below the confluence of the main branch and southern branch. The channel is confined within a U-shaped valley with no floodplain. There are steep, narrow alluvial terraces from rotational failures. This reach has the lowest gradient of the survey reach at approximately 10%. Above and below this short segment channel slopes exceed 40% (estimated).

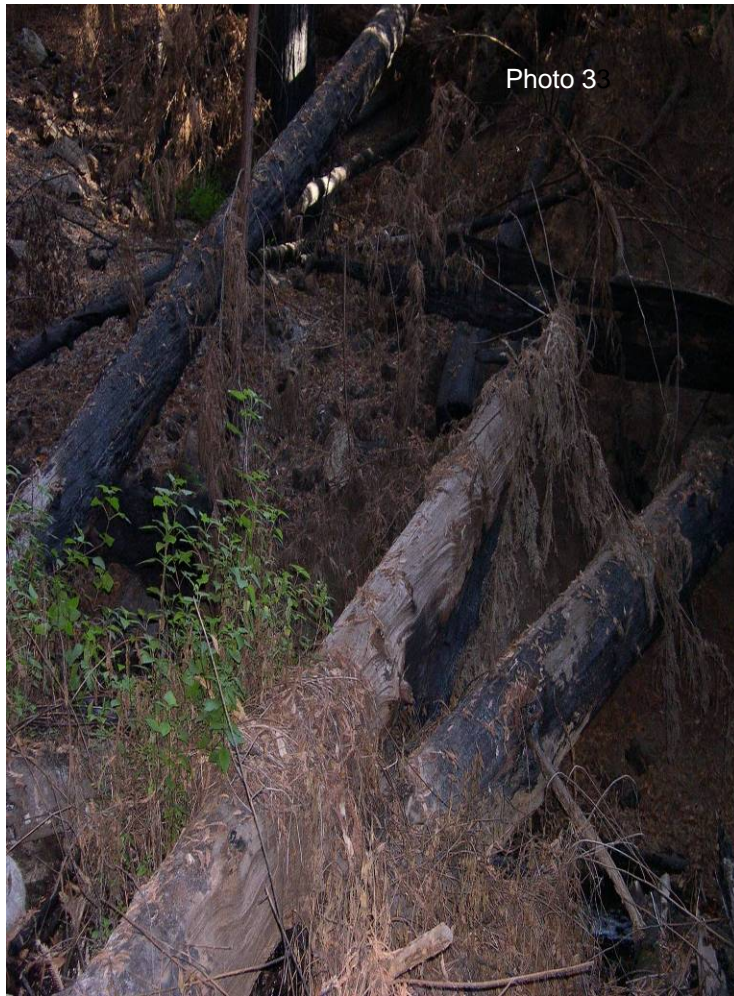
Photo 3

Photo 3: Embedded large wood (redwood) within Juan Higuera Creek below the confluence of the two branches. Large woody materials are stabilizing adjacent stream banks/valley walls and have potential to slow flood and debris flows. These trees protrude from an old debris deposit several hundred years old. Access to this site is down an embankment several hundred feet deep (approximately 80%). Overstory is mature redwood, making structure placement by helicopter difficult. Movement of existing downed wood, would destabilize valley walls.

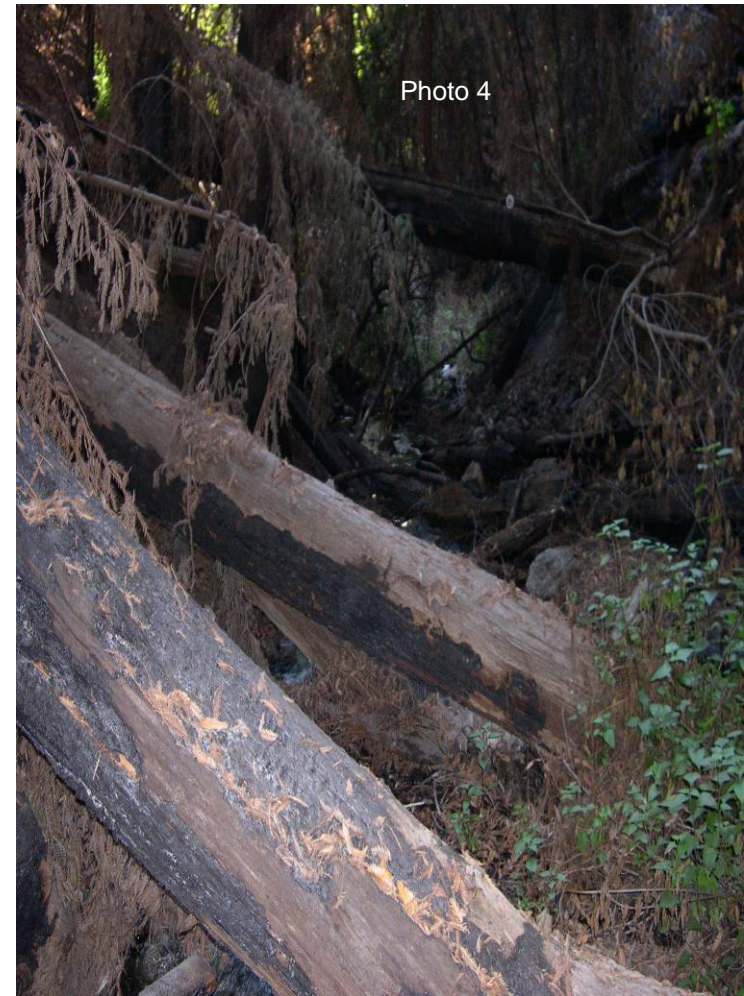
Photo 4

Photo 4: Juan Higuera Creek below confluence of main branch and southern branch. Bed material is armored by calcium carbonate deposits. Steep terrace banks along creek are comprised of mostly coarse landslide materials. Stream channel is confined within a deep, narrow valley.

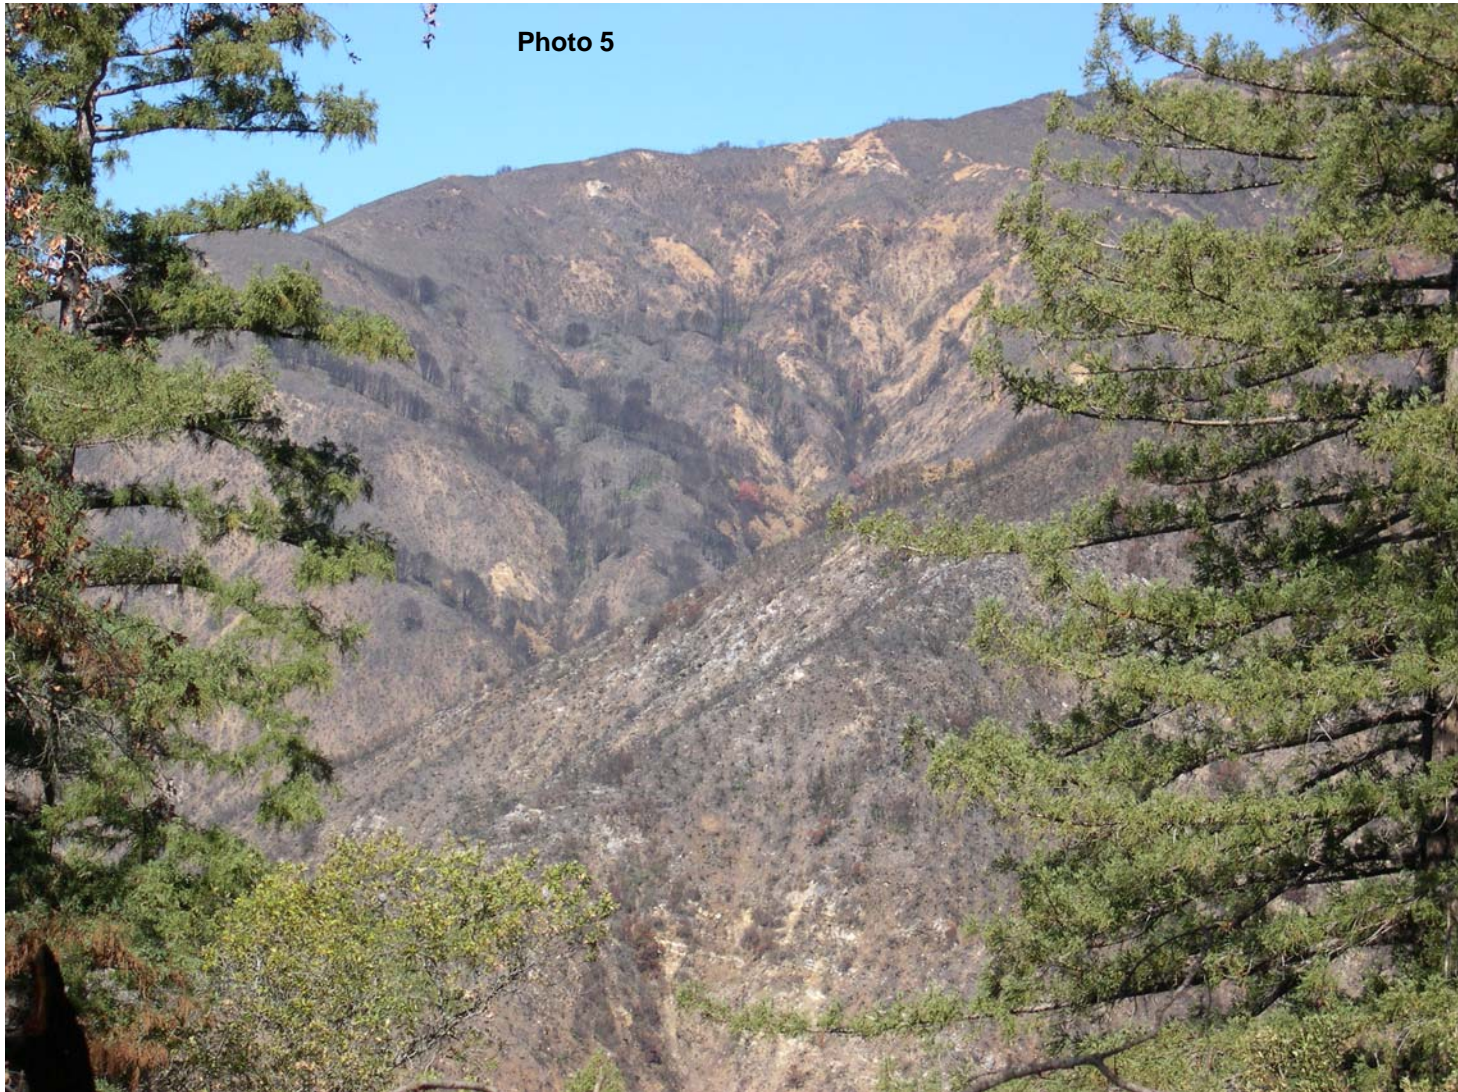
Photo 5

Photo 5: View of the upper Juan Higuera Creek drainage. Estimated channel gradients above the confluence of the two forks range from 20 to 40 percent and are almost entirely erosional channel types. The reach immediately below the confluence was selected for evaluation as this section was the most likely to have a depositional characteristic where channel grade lessened.
