**Little Sur River Survey Area- Large Woody Debris Threat
Assessment - Pico Blanco Boy Scout Camp Area and Downstream**

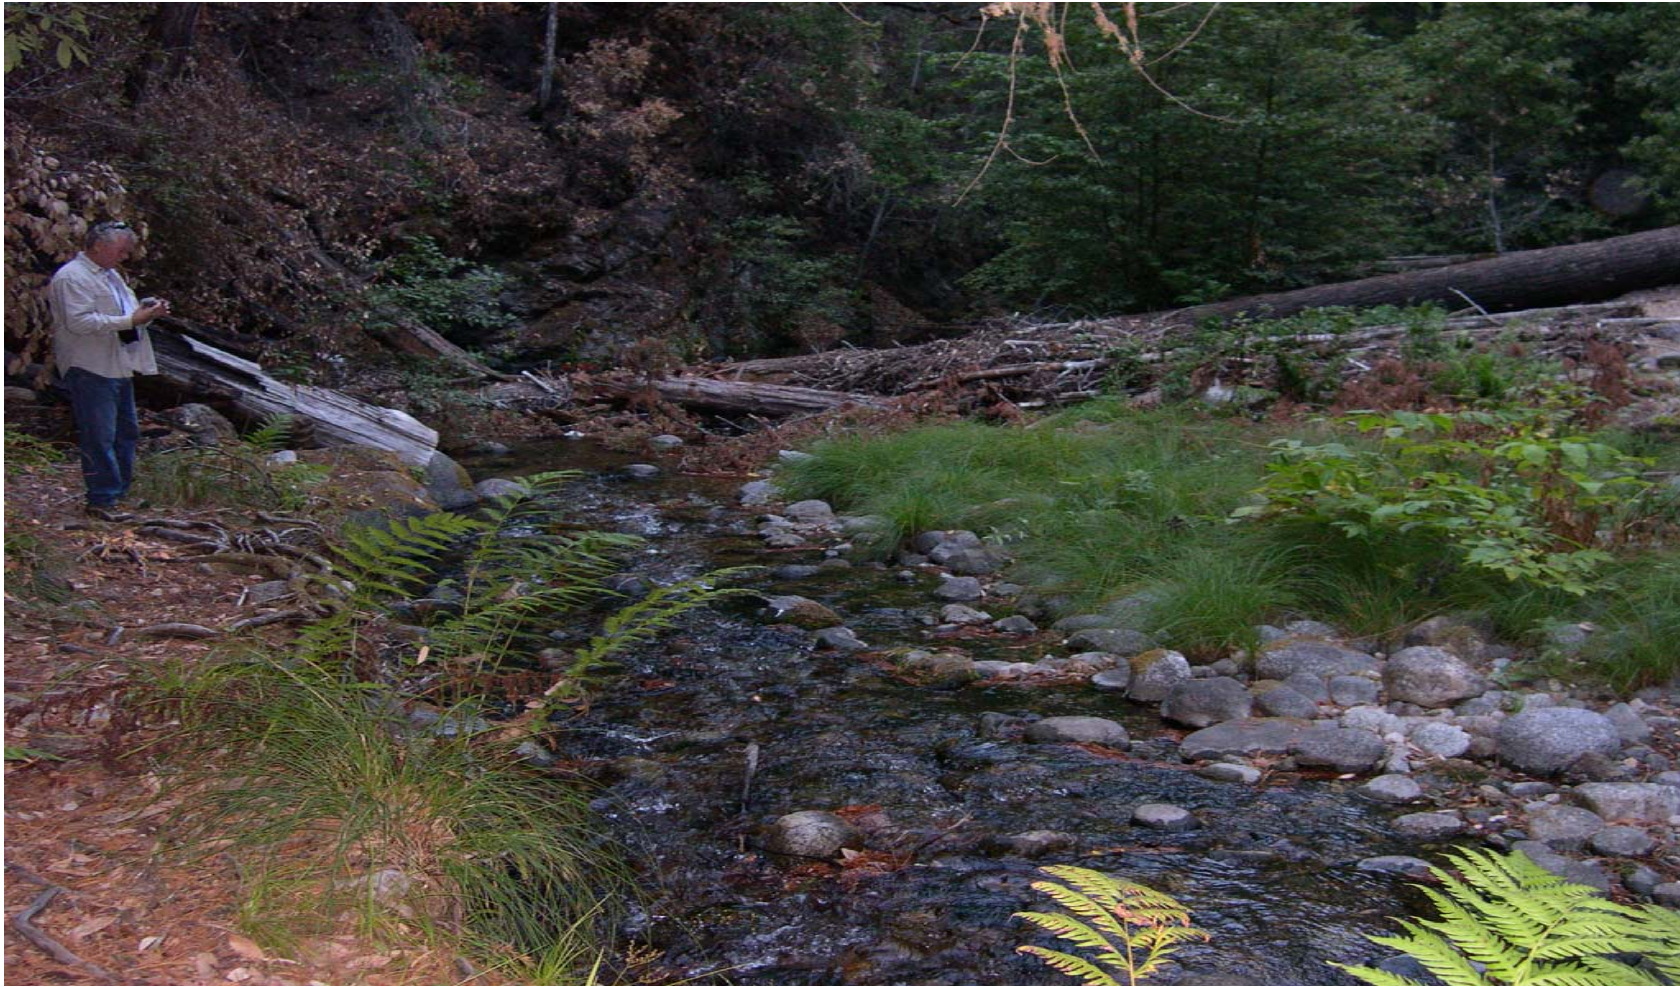
Figure 3: Little Sur River ½ mile upstream of the Pico Blanco Boy Scout Camp. Large fir tree that fell into channel shows minor congestion point for wood materials and sediment. Large wood is embedded in to stream banks and hold slope ravel. Sediment and debris can trap and slow behind this feature. Overall stream gradient in the reach surveyed was 2 to 5 % and moderately to highly confined, valley widths range from 40 feet to approximately 80 feet. Channel is moderately sinuous with several stream bends.

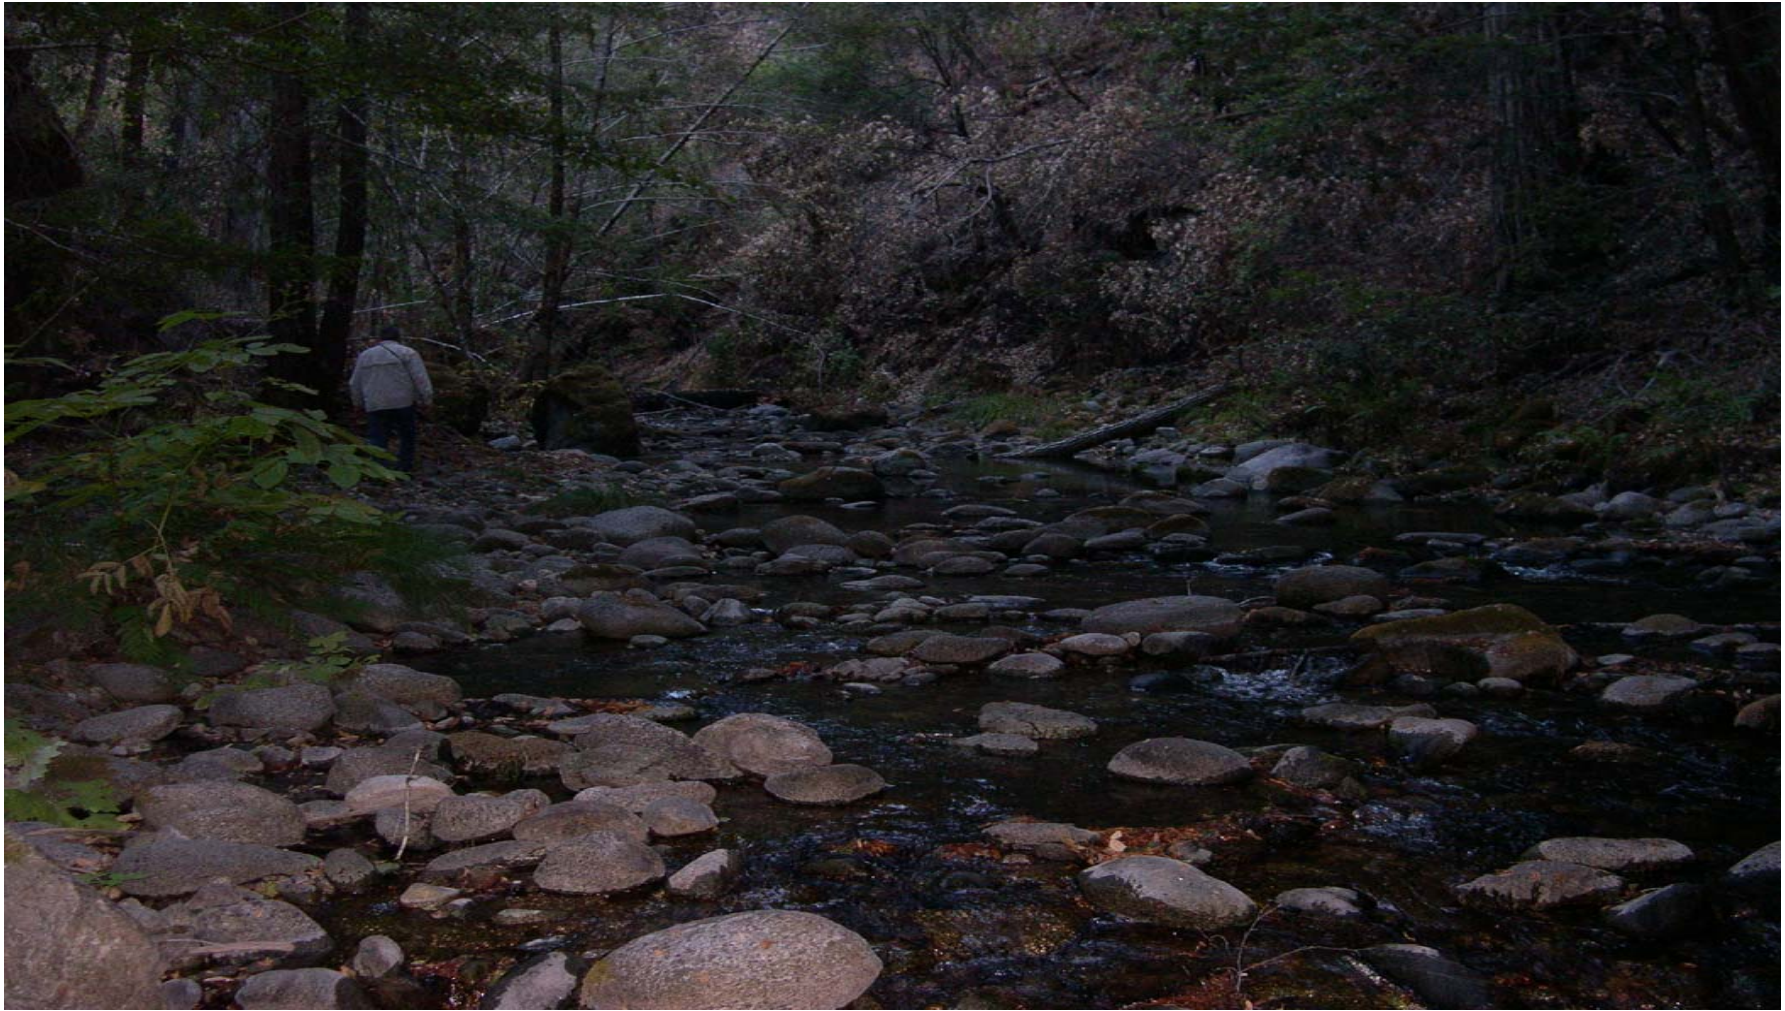
Figure 4: Little Sur River ½ mile above Pico Blanco Boy Scout Camp. Channel has narrow valley with large trees stabilizing stream banks and slope materials. Channel capable of moving large wood, large pieces were found entrained into stream banks and channel. The recent fire has contributed to additional amounts of downed wood that may be transported downstream. Large wood could gather and congest the channel in narrower, more constricted reaches of the channel. The fish ladder and back water pond at the Boy Scout Camp is susceptible to large amount of wood and sediment deposition that may transport out of the burn area during a flood this coming winter.

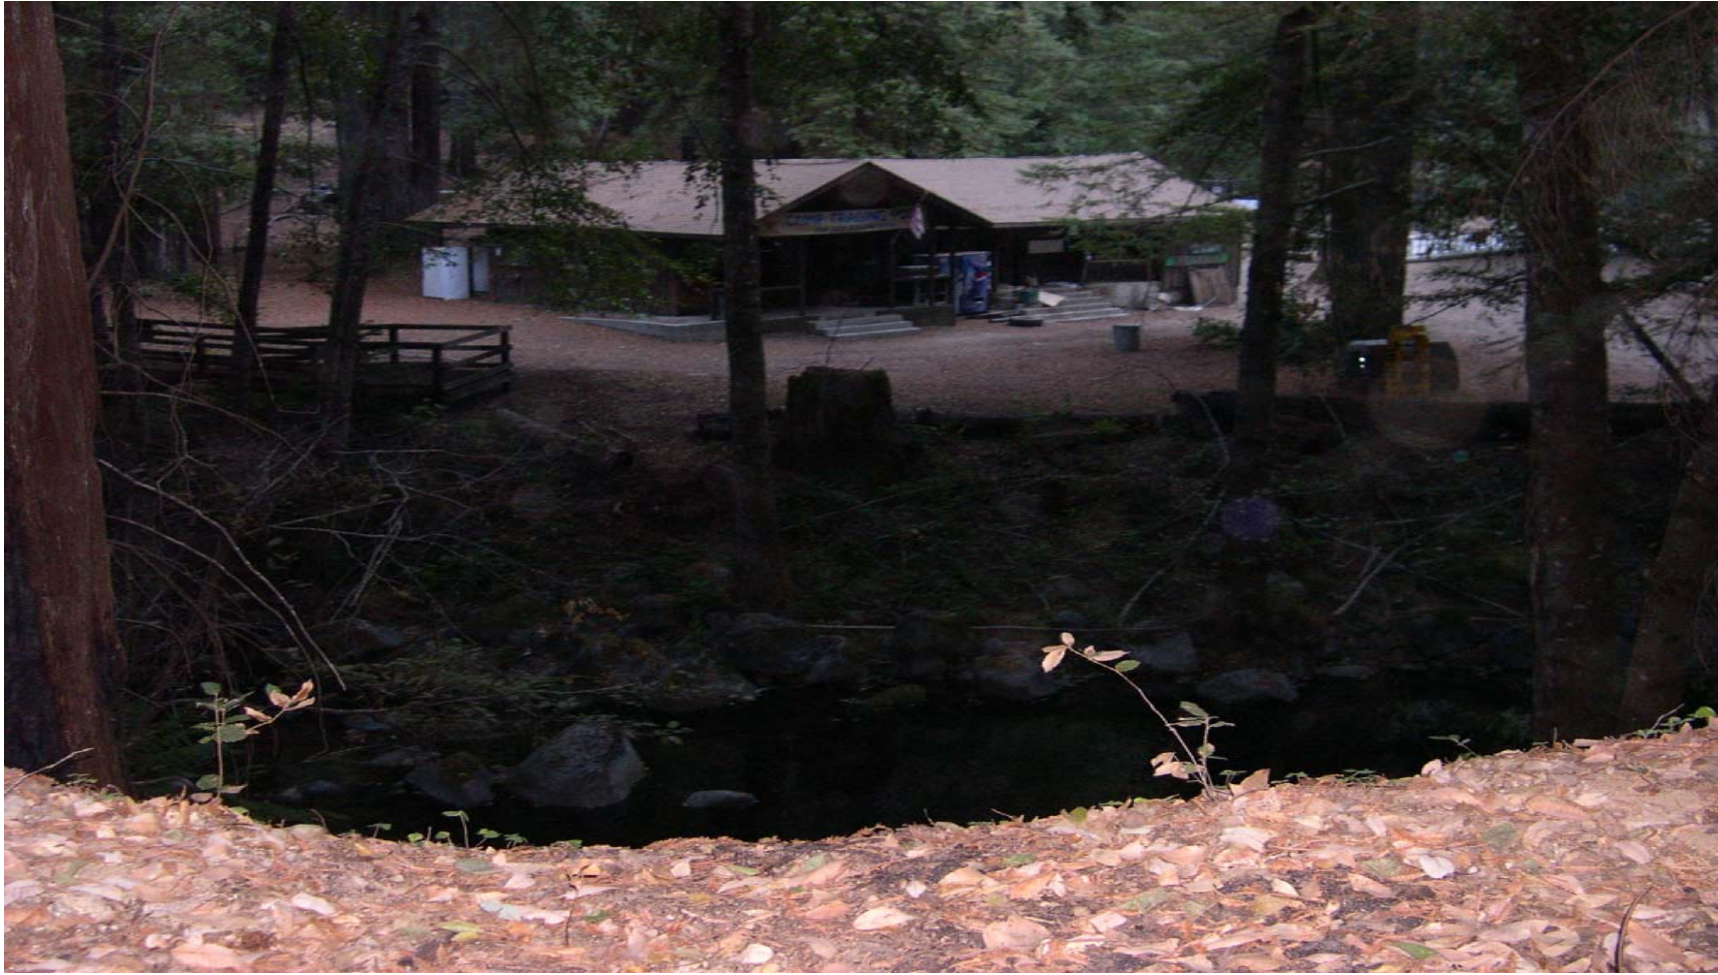
Figure 5: Pico Blanco Boy Scout Camp, camp outpost and store with Little Sur River channel in foreground. This building has the highest probability of flooding of all of the large structures in the camp. It is located on the inside of a short river bend and the bulk of flood energy is focused on the bank opposite of the building. The development of the camp has confined the channel along this reach, note the steep stream banks.

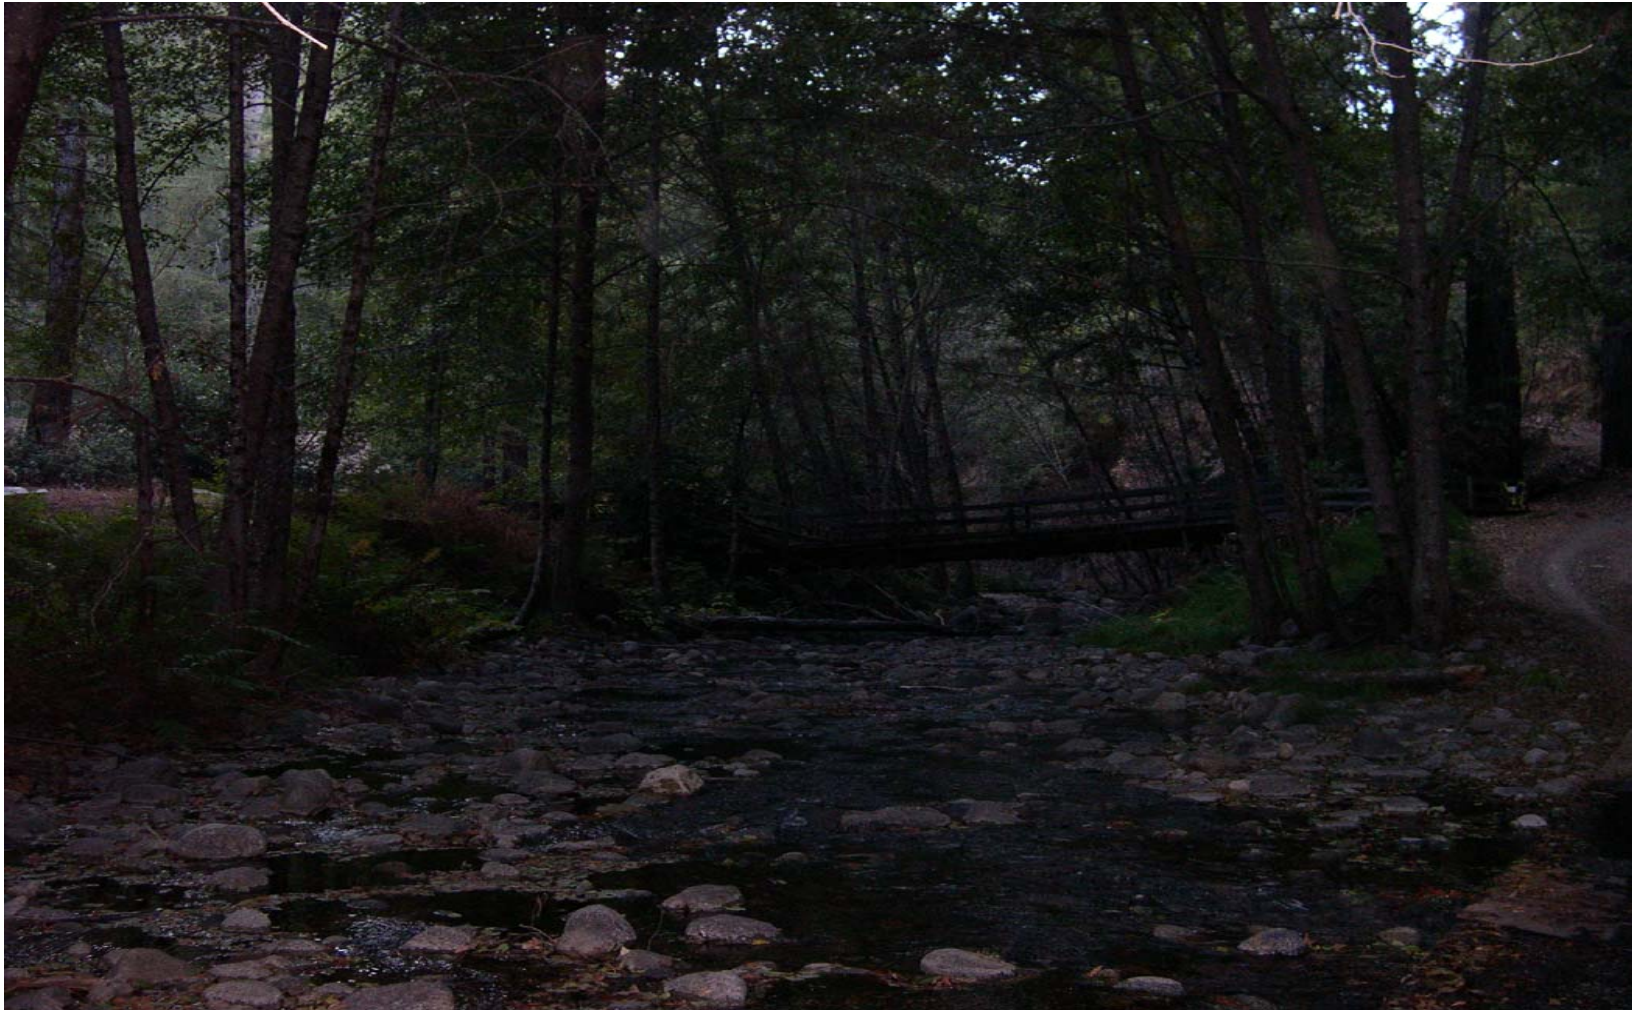
Figure 6: Little Sur River and camp foot bridge at Pico Blanco Boy Scout camp and access road low water ford. Bridge is a potential constriction point for large wood debris at bridge and may cause flows to flood terrace to the left of bridge. Building shown in Figure 5 (store) is to the left of the footbridge in photo. Channel banks have been built up as result of the camp development.

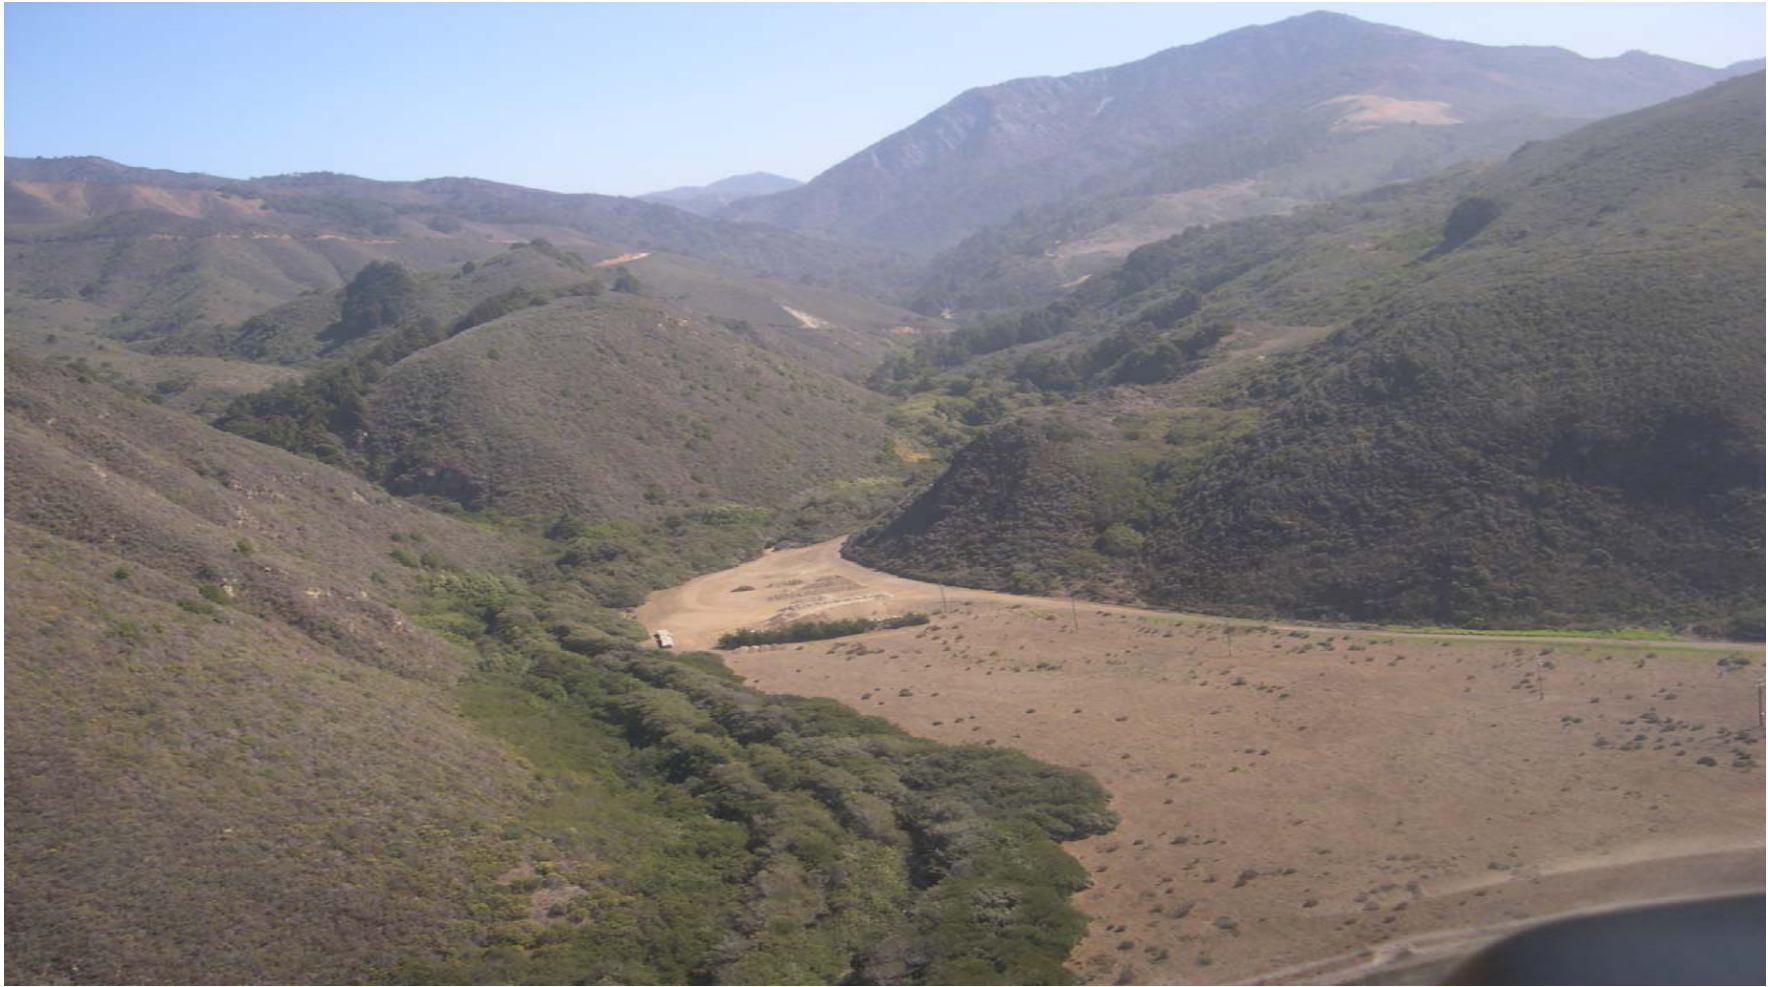
Figure 7: Lower Little Sur River valley just upstream of the Highway 1 Bridge from helicopter view. Wide valley above bridge is able to have flood water and debris settle on adjacent fill terrace. Valley at this point and upstream is wider and with a lower gradient with well developed stream side vegetation that should buffer high peak flows and allow the majority of floatable large wood and sediment to deposit and store over the valley reach. Threat of damage to Highway 1 Bridge over Little Sur River by large wood is unlikely.
