Stream
Reaches
Surveyed
For Hazard
Analysis

10/2008

BAER

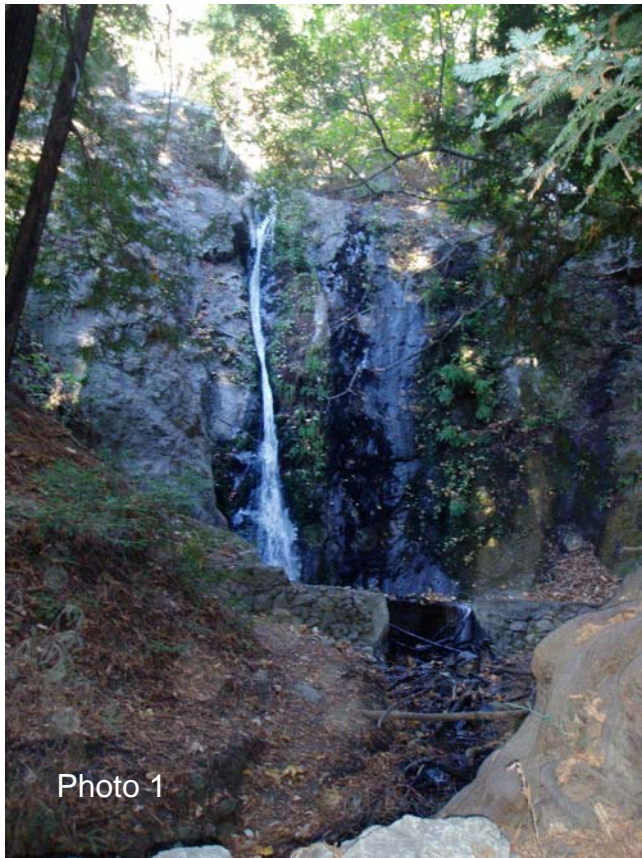
Photo 1

Photo 1: Pfeifer Falls. Found on State Park lands below Forest Service Boundary.

Channel area at Forest boundary. Large redwood in foreground spanning channel. This small 100 foot bench is found between two 40 foot falls.

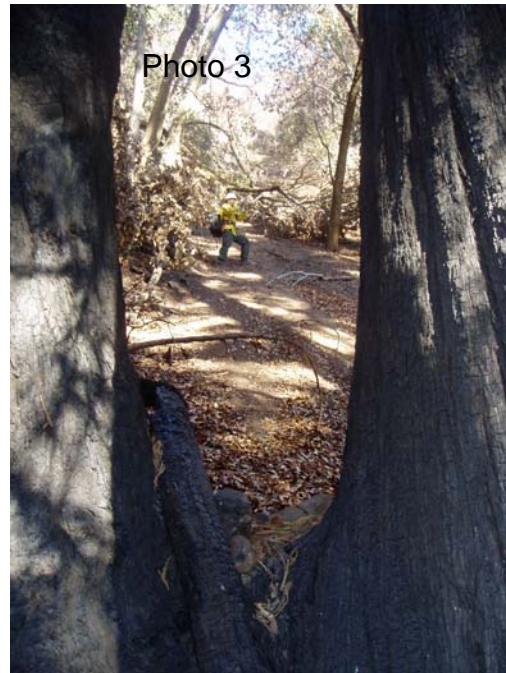
Photo 3

Photo 3: Steep gradient > 75%, entering channel. Slopes contain approximately 4-10" of ravel material covered with leaf litter.

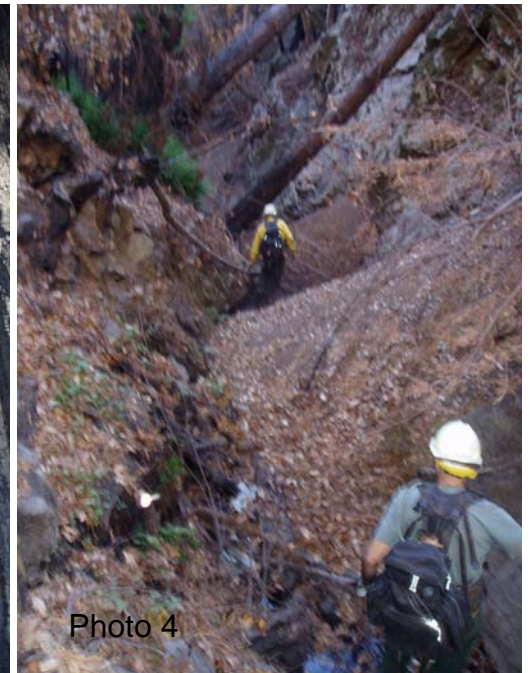
Photo 4

Photo 4: Channel bottom and valley width. Note ravel covering channel bottom material. Flow goes subsurface.

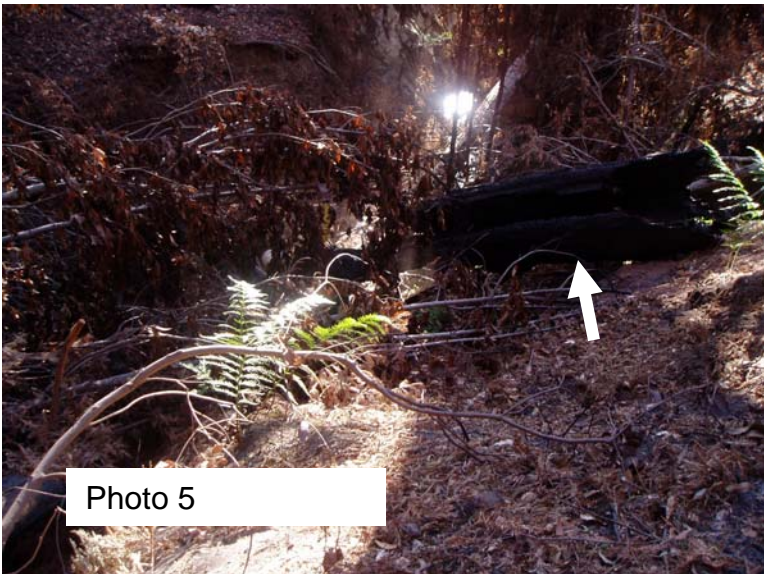
Photo 5

Photo 5: Large piece of redwood effectively storing ravel material behind, upslope.

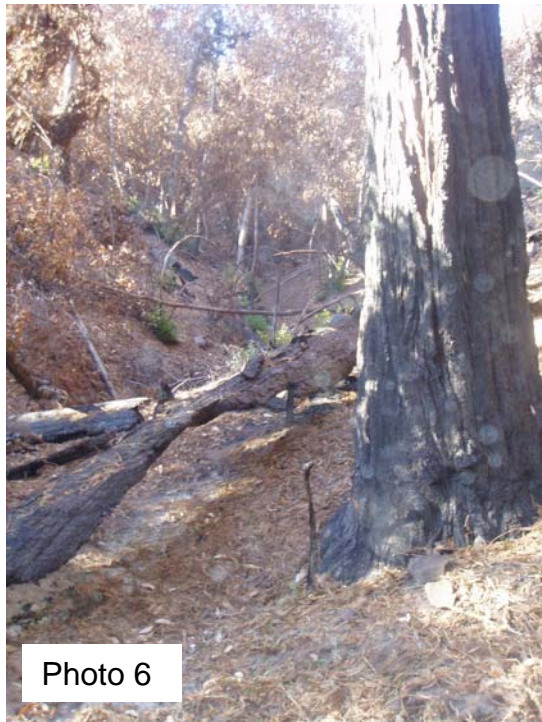
Photo 6

Photo 6: Downed wood partially consumed by fire and example of concentration of wood available. Minor amounts.

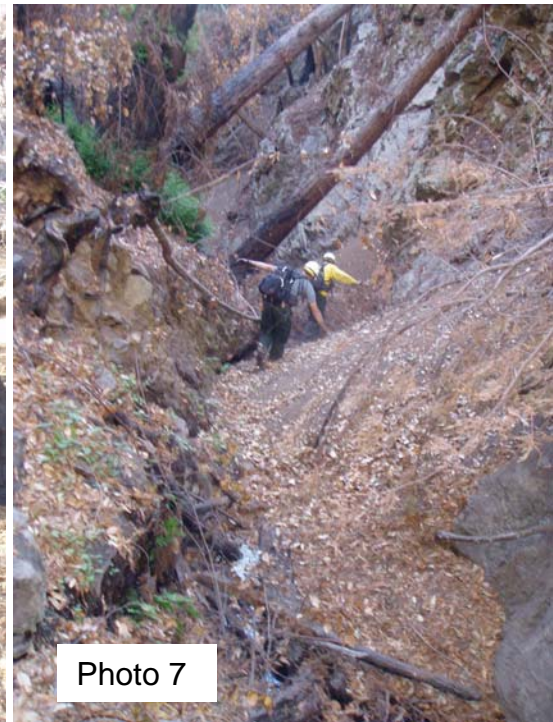
Photo 7

Photo 7: Different angle of photo 4, Note pinch point where ravel from both sides have pinched channel off and buried substrate. Ravel extend upslope >100 feet. Facing downstream.

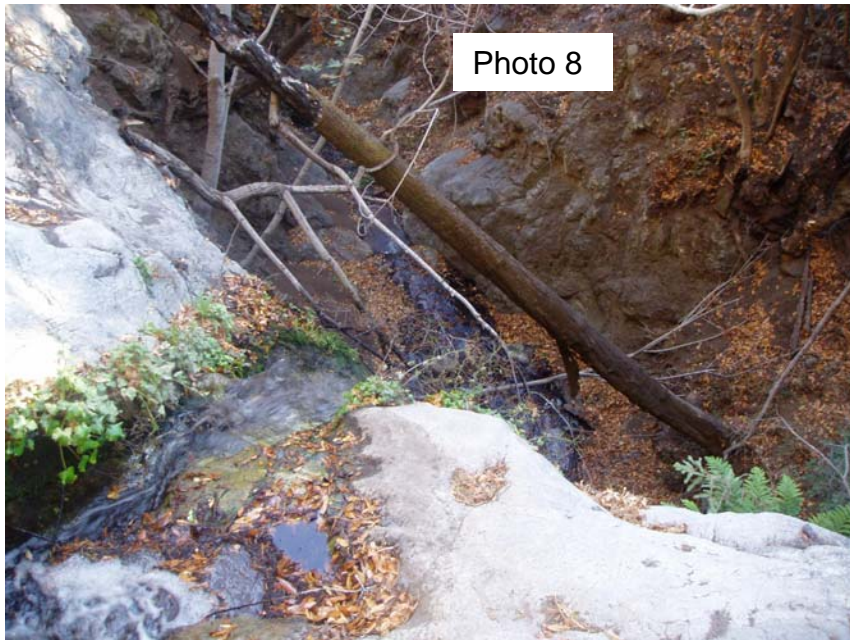
Photo 8

Photo 8: 3rd in a series of falls approximately 50 feet high. On Forest Service land. Looking over falls downstream.

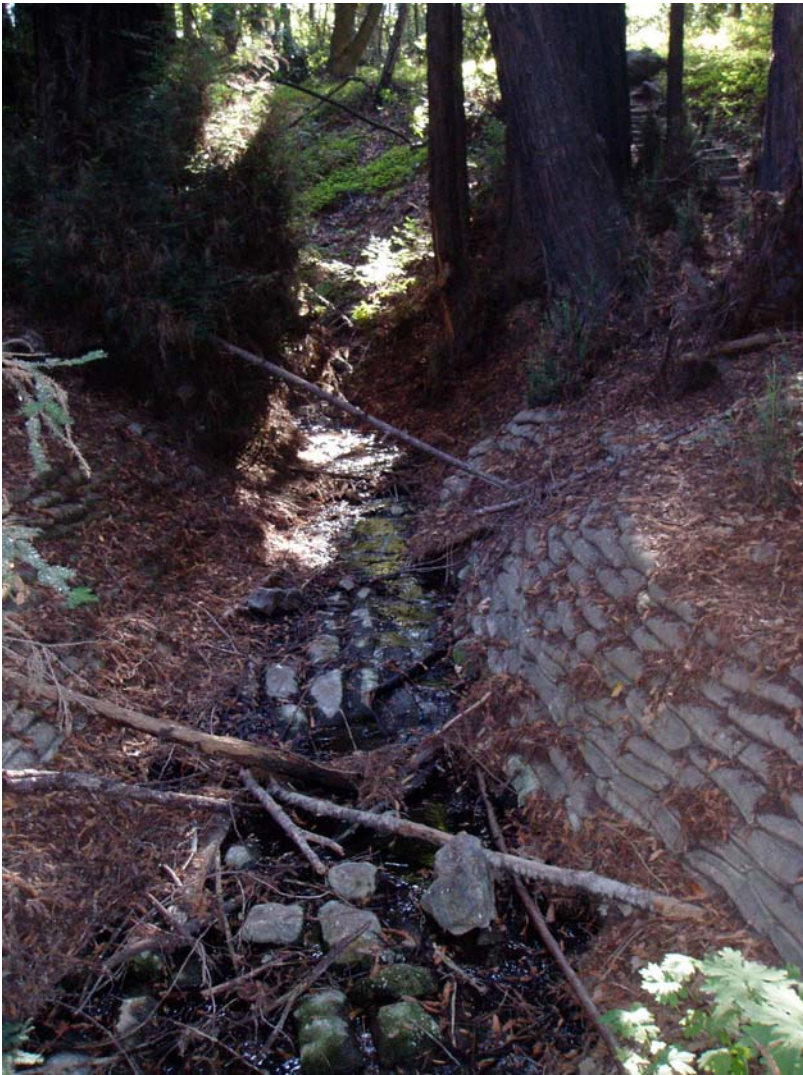
Photo 9: Within the State park channel facing upstream of a culvert. Channel has channel hardened and will create increased energy due to lack of structure and constraints.

NOTE: Entire State Park facility is located on a alluvial outwash deposit from historic past failures. Historic and current efforts set the stream channel up to not allow energy regulation through utilization of historic flood prone area. Wood has been removed and channels hardened which allow increase in stream energy as one travels down slope. To minimize effects of failures upslope efforts should be taken to reduce energy by adding complexity in the channel and pushing flow out onto its historic flood plain. This flood prone area is off Forest Service land and on State and Private Lands.

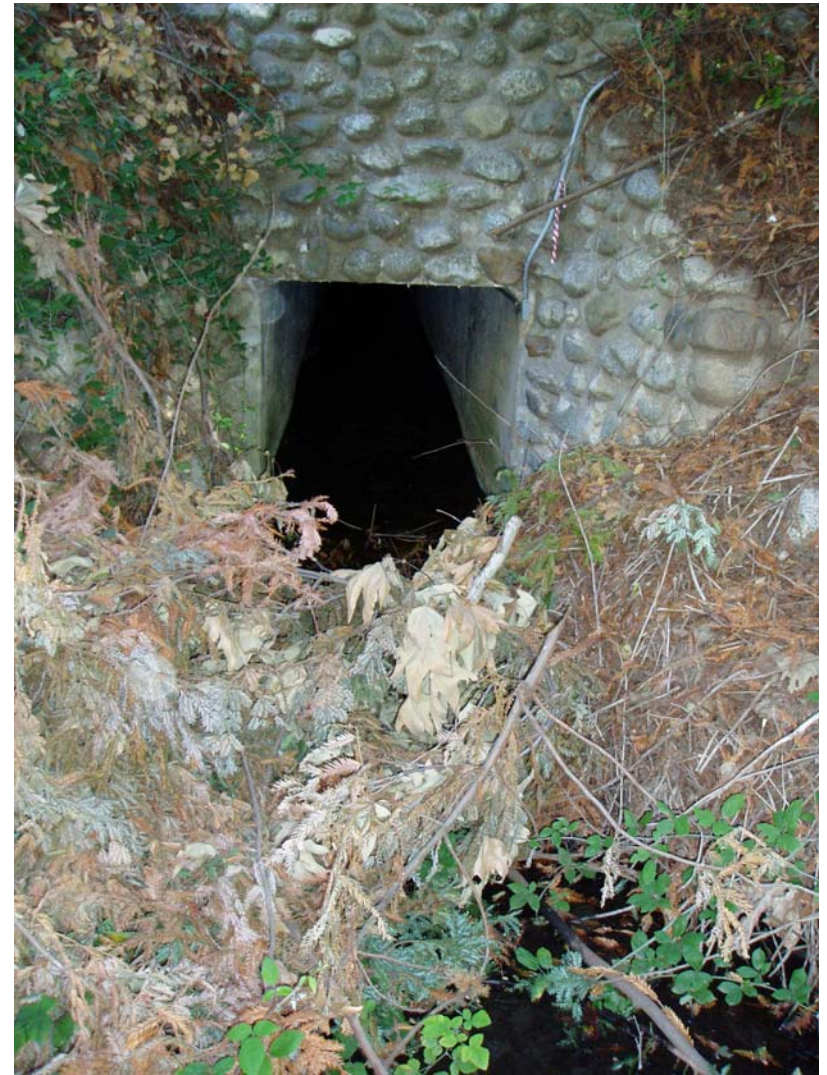
Photo 10: Small box culvert drains channel and is not capable of passing bedload or flow given a > 10 year event with upslope conditions.
