Stream
Reaches
Surveyed
For Hazard
Analysis

10/2008

BAER

Phenegar Creek

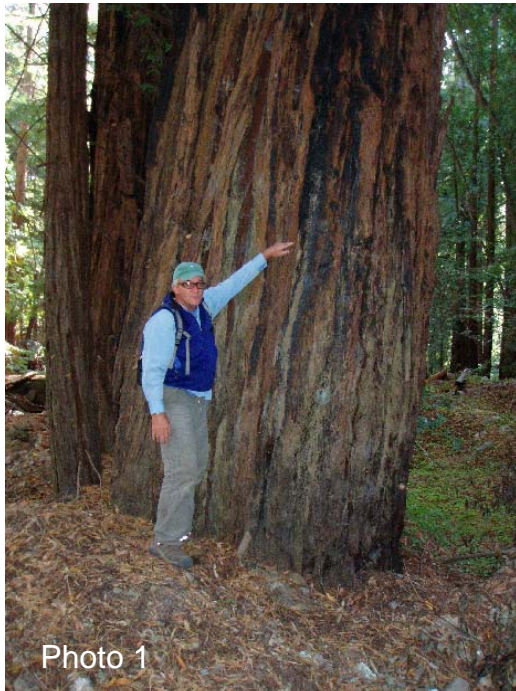
Photo 1

Photo 1: Sediment line from previous fluid flow through area (top of hand). Deposition on uphill side of tree. *Private Land*

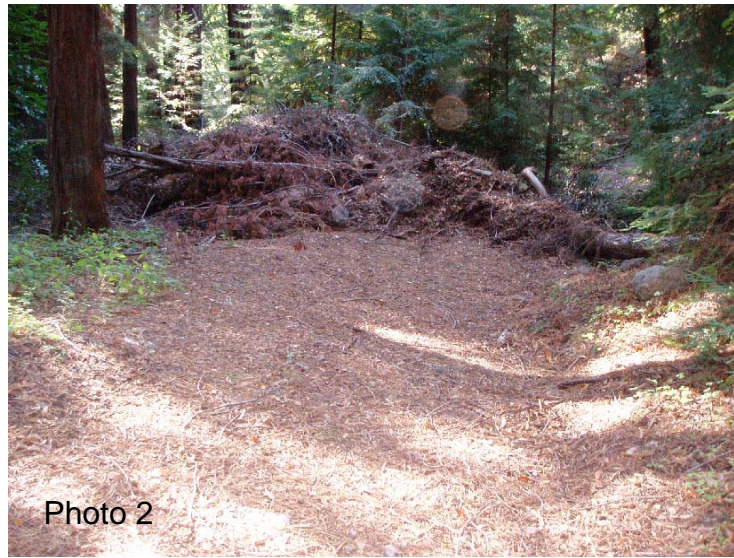
Photo 2

Photo 2: Landowner has piled slash < 50 feet from creek on terrace from previous failure.

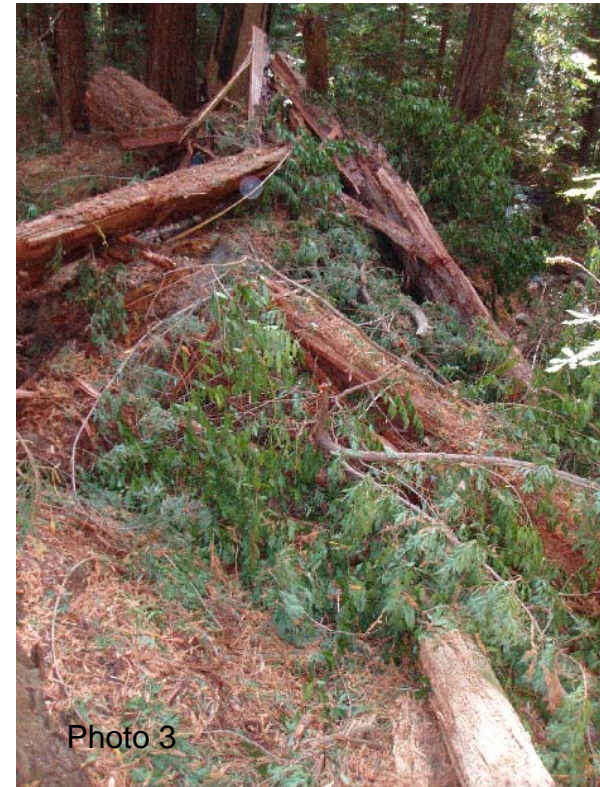
Photo 3

Photo 3: Logs have been placed on channel banks along with slash. Placed on the outside margins of the flood terrace.

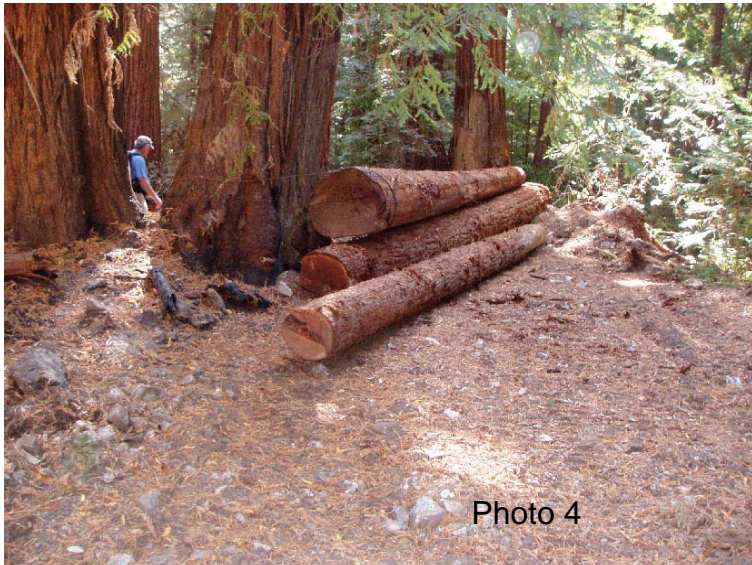
Photo 4

Redwood tree felled and placed on terrace above the creek. Top log is cable with a single strand of 1/2 inch cable. Creek is at the end of the logs below stump.

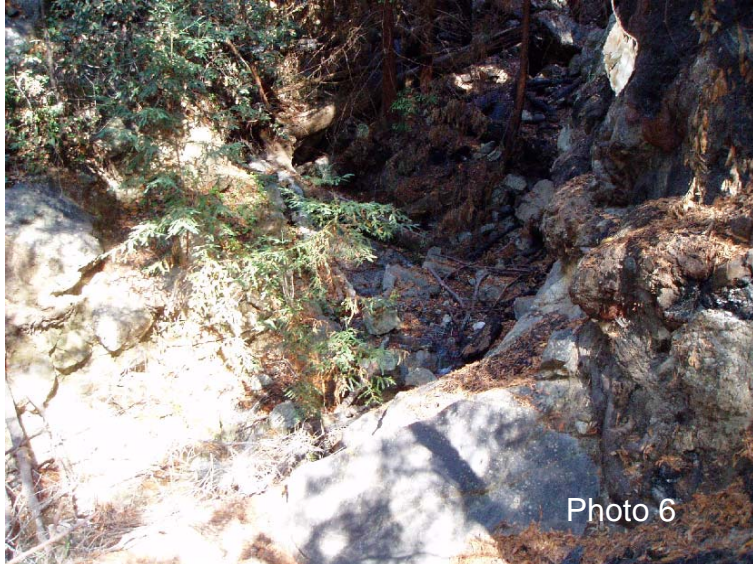
Photo 6

Photo 6: Private road pulls away from stream channel and heads east to old homestead. Channel upstream is 40 feet across at old terrace heights and 12 feet deep. Confluence exists to the right facing upstream. (Photo taken facing upstream). Channel banks are vertical to 100 % slope. Bottom width is 15 feet on the average. Channel gradient 30%. Wood presence is 2 pieces per 100 feet and is redwood dominated. Margins of channel contain standing Redwood with Ca. Laurel understory.

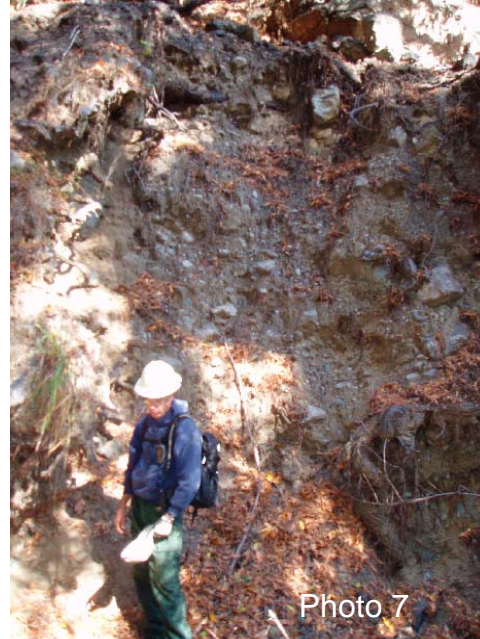
Photo 7

Photo 7: Depth of channel depicted by person. (person is 6'3" tall). Gully nature of channel is eroded alluvial deposits from previous failures and colluvial deposits from dry ravel. Substrate material is cemented together by what appears to be calcium carbonate. Once dry ravel is wetted it sets up to firm footing and slope stability.

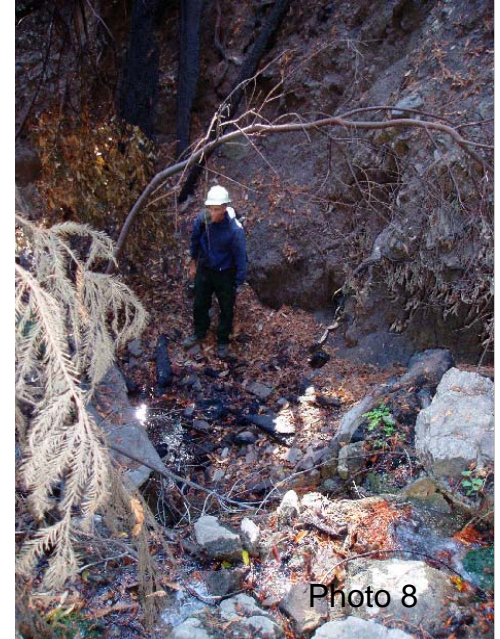
Photo 8

Photo 8: Standing at the top of a 8' headcut and looking down stream. Cut is currently stabilized by embedded Redwood logs. Material has been weakened by fire. 30 % of material burned.

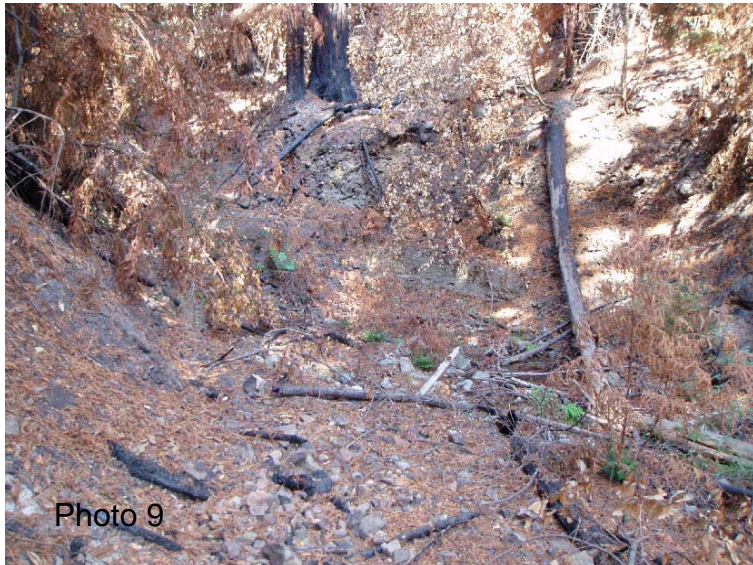
Photo 9

Photo 9: Standing on old terrace on RHB, (west side) and looking upstream. Deposits are maintained due to a gully plug of large wood downstream. Deposits are available for movement due to wood being weakened from the fire. 30-45% wood consumed.

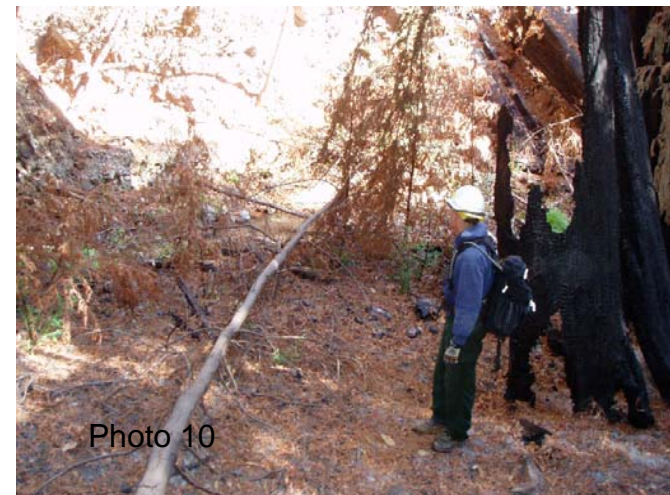
Photo 10

Photo 10: Center of old rotation slide. Toe is being removed by flow. Channel right, west side.

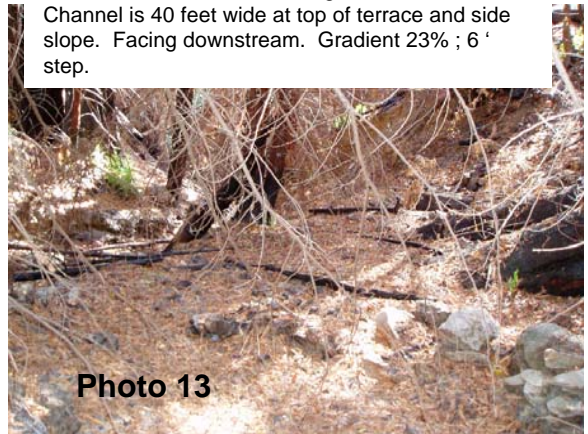
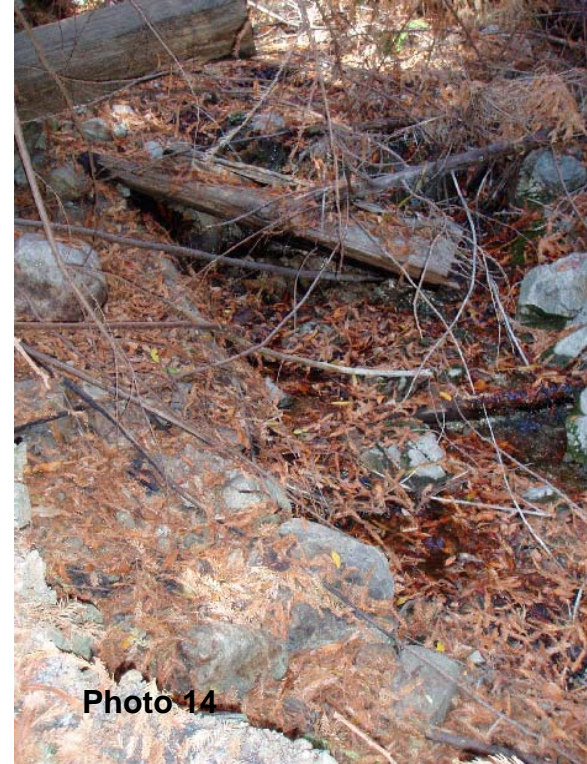
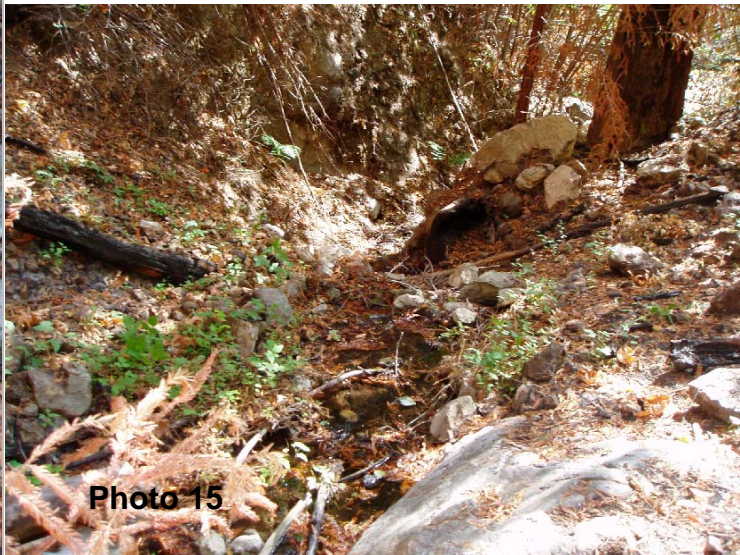
Photos 14, 15, and 16; represent the steep, 28% channel gradient and the steps that occur within this reach. Stored sediment occurs behind all structure but is easily mobilized due to gradient. Wood is being buried and storing sediments nicely.

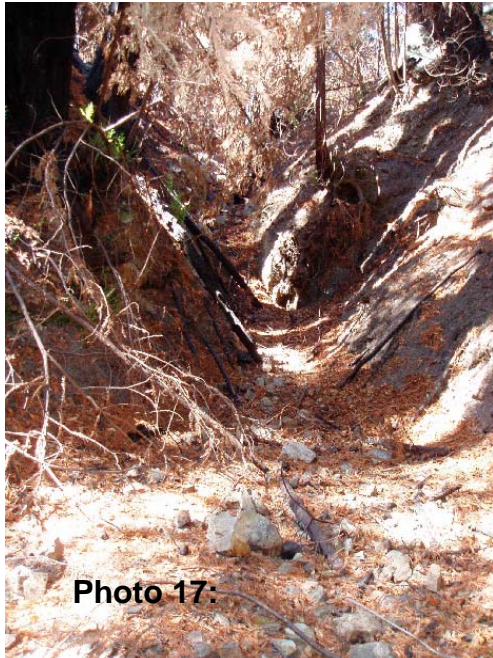
Photo 17:

Photos 17 and 18; Example of v shape of channel on Forest Service and stored sediment related to boulder constrictions within the channel. Valley width is 15- 20 feet and bottom material is dominated by colluviums.

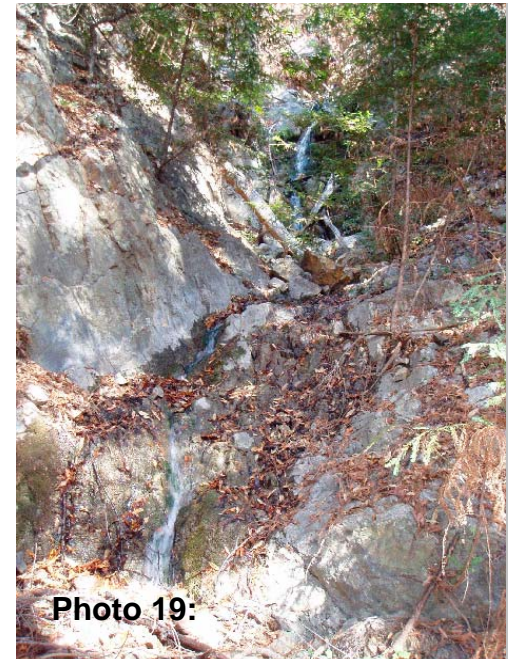
Photo 19:

Photos 19,20, and 21; Gradient change to water falls. > 70% gradient

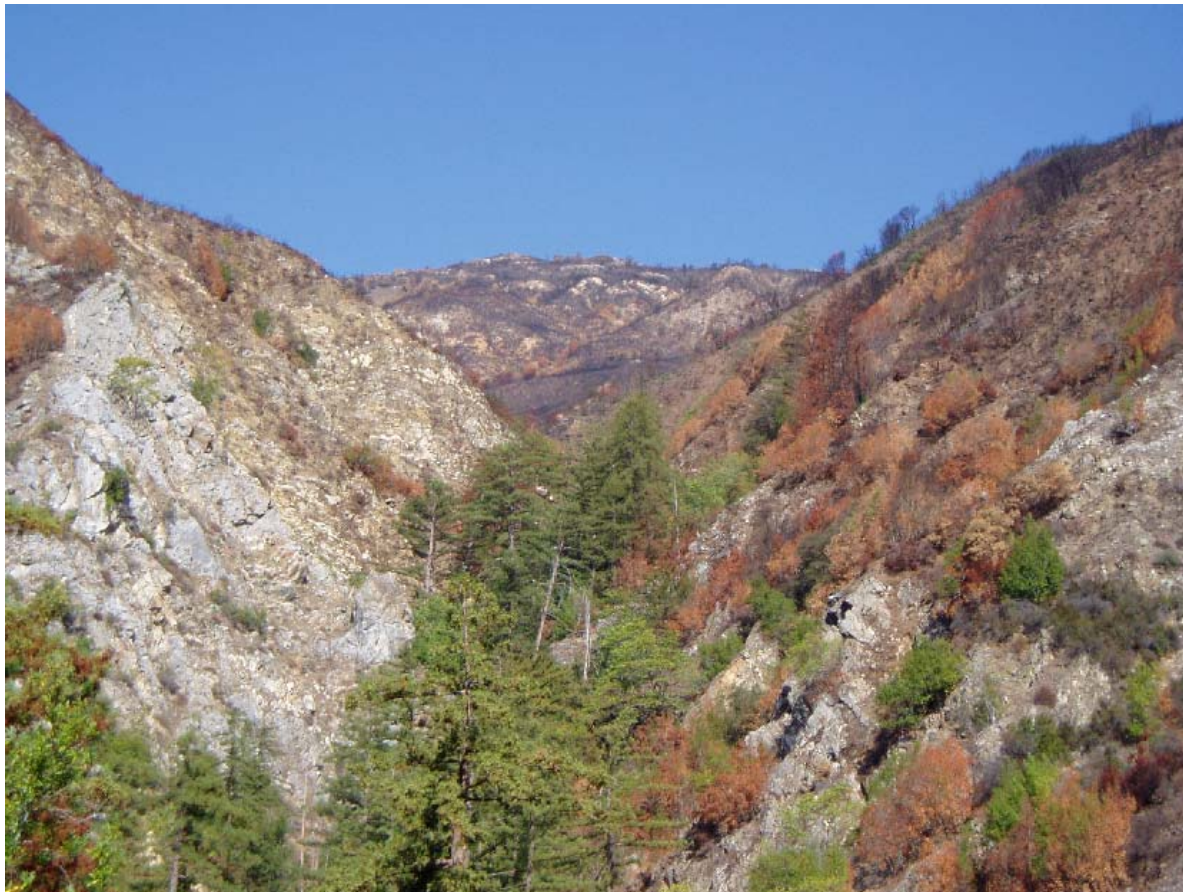
Photo 22/23:

Photo is taken from the road that access Michael Curtis property. Facing north one can see the inner gorge nature of the channel and the rock cliffs within the channel. End of survey.
