2022 Owl Fire (ID-SCF-022248) Structure Triage

Collected By: Owl Fire 2022 BR 32/ Div A

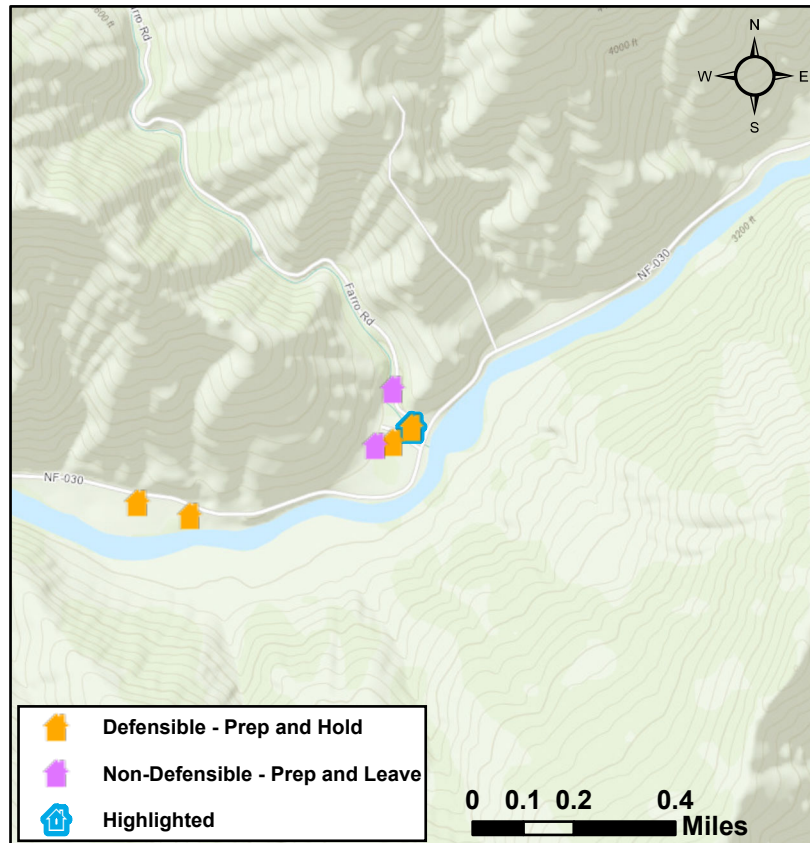
Triage Category: Defensible, Prep and Hold
FIRESCOPE Triage Category:
Structure Number: 4
Collected Date/Time: 9/11/2022 4:51:09 PM
Collected By: Owl Fire 2022 BR 32/ Div A
Inspector's Position:
Type of Structure: Residential
Primary Structures: 1
Is the building Occupied?: Yes
Outbuildings: 6
Fuel Surrounding Structure: Grass and shrub, hardwood litter
Defensible Space: 30 ft treated
Roof Material: Noncombustible or not applicable
Siding Material: Wood or open sided
Electrical Power: Unknown
Gas to Structure: Yes
Hazards: Propane, Septic
Access to Site: T1 Engine
Describe Access:
Comm With ICP: Yes
Water Source: Pressurized hydrant(s) or fixed sprinkler system
Safety Zone Present:
Mitigation Time (in hours): 1
Mitigation Description:
Resources Needed to Protect Structure:
FIRESCOPE Tactics:
Notes:

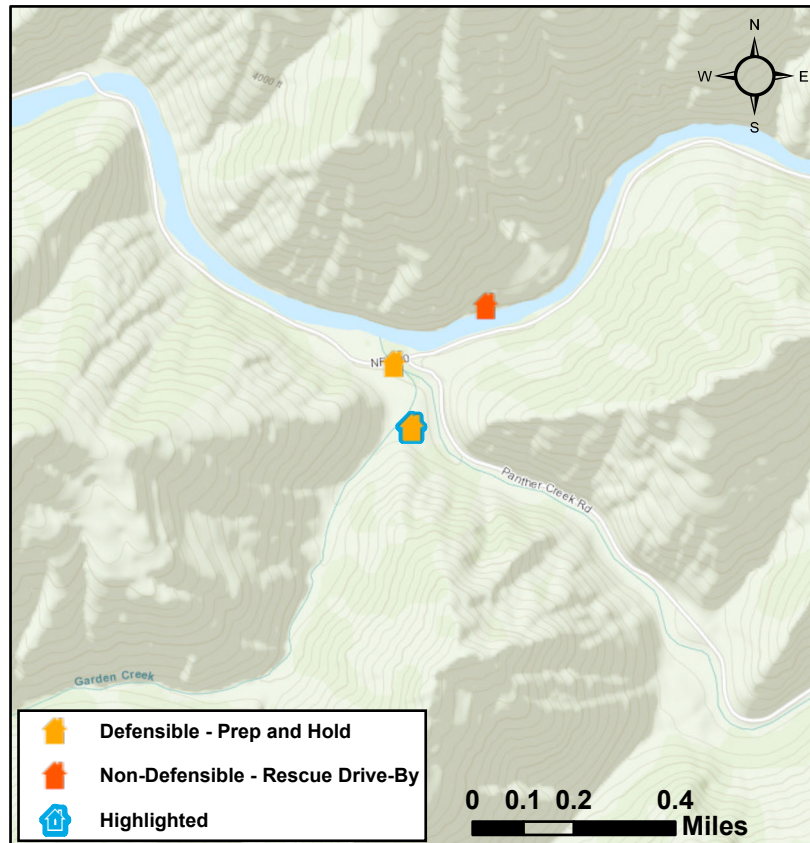
Triage Category: Defensible, Prep and Hold
FIRESCOPE Triage Category:
Structure Number: 7
Collected Date/Time: 9/11/2022 6:29:13 PM
Collected By: Oak Fire 2022 BR 32/ Div A
Inspector's Position:
Type of Structure: Residential
Primary Structures: 2
Is the building Occupied?: Yes
Outbuildings: 4
Fuel Surrounding Structure: Grass and shrub, hardwood litter
Defensible Space: 30 ft treated
Roof Material: Noncombustible or not applicable
Siding Material: Wood or open sided
Electrical Power: Yes
Gas to Structure: Yes
Hazards: Propane, Septic
Access to Site: T6 Engine
Describe Access:
Comm With ICP: Yes
Water Source: Pressurized hydrant(s) or fixed sprinkler system
Safety Zone Present:
Mitigation Time (in hours): 2
Mitigation Description:
Resources Needed to Protect Structure:
FIRESCOPE Tactics:
Notes: After Crossing Bridge - there are additional structures

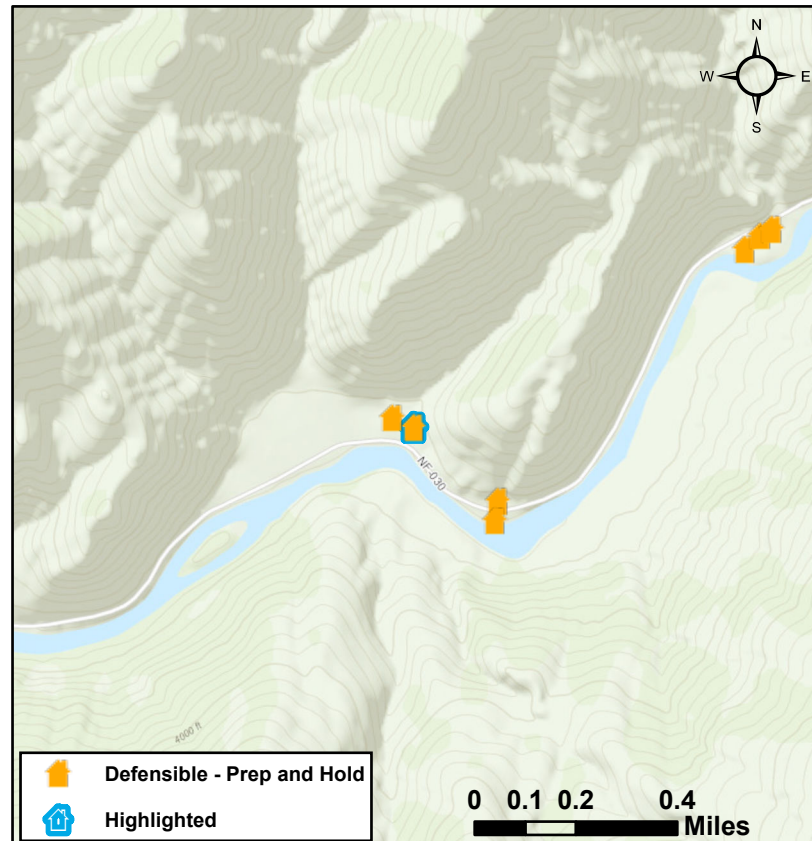
Triage Category: Defensible, Prep and Hold
FIRESCOPE Triage Category:
Structure Number: 15
Collected Date/Time: 9/11/2022 11:05:23 PM
Collected By: Owl Fire 2022 BR 32/ Div A
Inspector's Position:
Type of Structure: Residential
Primary Structures: 1
Is the building Occupied?: Yes
Outbuildings: 4
Fuel Surrounding Structure: Grass and shrub, hardwood litter
Defensible Space: 30 ft treated
Roof Material: Noncombustible or not applicable
Siding Material: Log construction
Electrical Power: Yes
Gas to Structure: Yes
Hazards: Propane, Fuel Cell
Access to Site: T6 Engine
Describe Access:
Comm With ICP: Yes
Water Source: Pressurized hydrant(s) or fixed sprinkler system
Safety Zone Present:
Mitigation Time (in hours): 1
Mitigation Description:
Resources Needed to Protect Structure:
FIRESCOPE Tactics:
Notes: Resident is actively prepping home

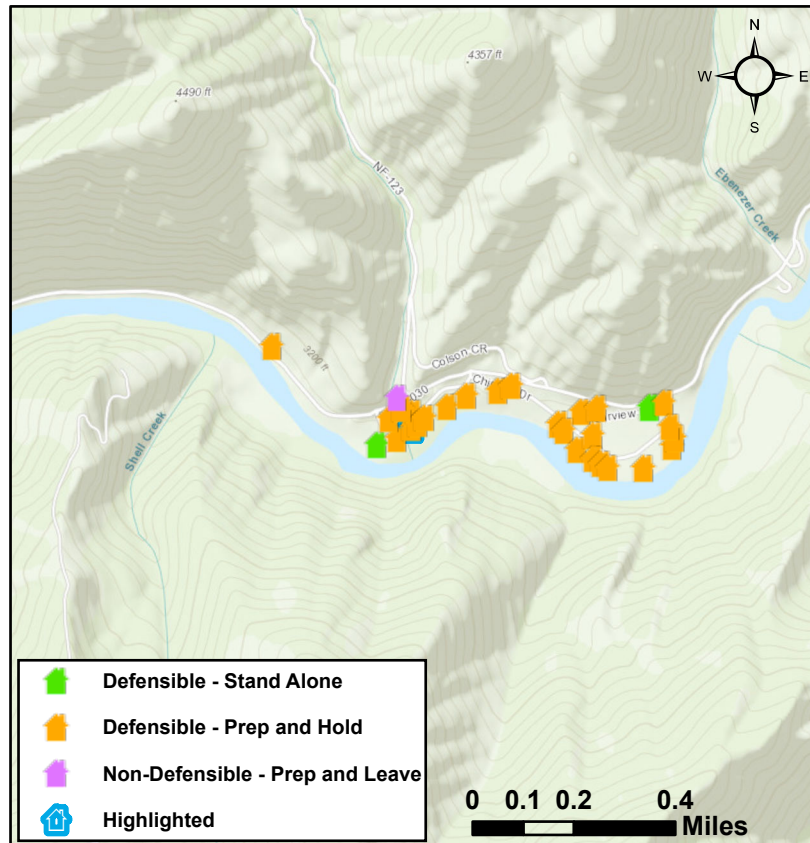
Triage Category: Defensible, Prep and Hold
FIRESCOPE Triage Category:
Structure Number: 20
Collected Date/Time: 9/12/2022 6:16:14 PM
Collected By: Owl Fire 2022 BR 32/ Div A
Inspector's Position:
Type of Structure: Residential
Primary Structures: 1
Is the building Occupied?: Yes
Outbuildings: 2
Fuel Surrounding Structure: Grass and shrub, hardwood litter
Defensible Space: 30 ft treated
Roof Material: Noncombustible or not applicable
Siding Material: Wood or open sided
Electrical Power: Yes
Gas to Structure: Yes
Hazards: Propane, Septic, Fuel Tank
Access to Site: T6 Engine
Describe Access: Narrow Access T6 only
Comm With ICP: Yes
Water Source: Pressurized hydrant(s) or fixed sprinkler system
Safety Zone Present:
Mitigation Time (in hours): 1
Mitigation Description: Trim and limb bushes
Resources Needed to Protect Structure:
FIRESCOPE Tactics:
Notes: Well Defendable

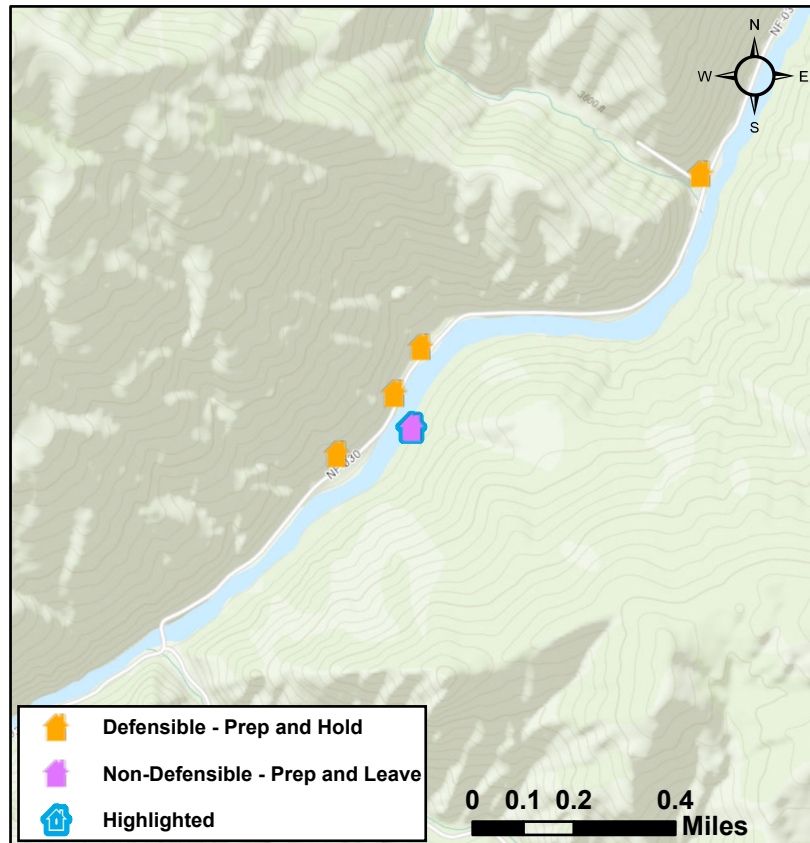
Hazards: Rolling rock, access across river

Notes: Fuel Type: Timber, grass, brush; Defensible Space: 3050Feet; Roof: Wood; Siding: Wood; Heat Traps: No Concrete foundation; Notes: 1 portable high pressure pump, one kit, 2 sprinkler kits, 600 feet of inch and a half hose, 400 feet of one inch hose, one chainsaw.

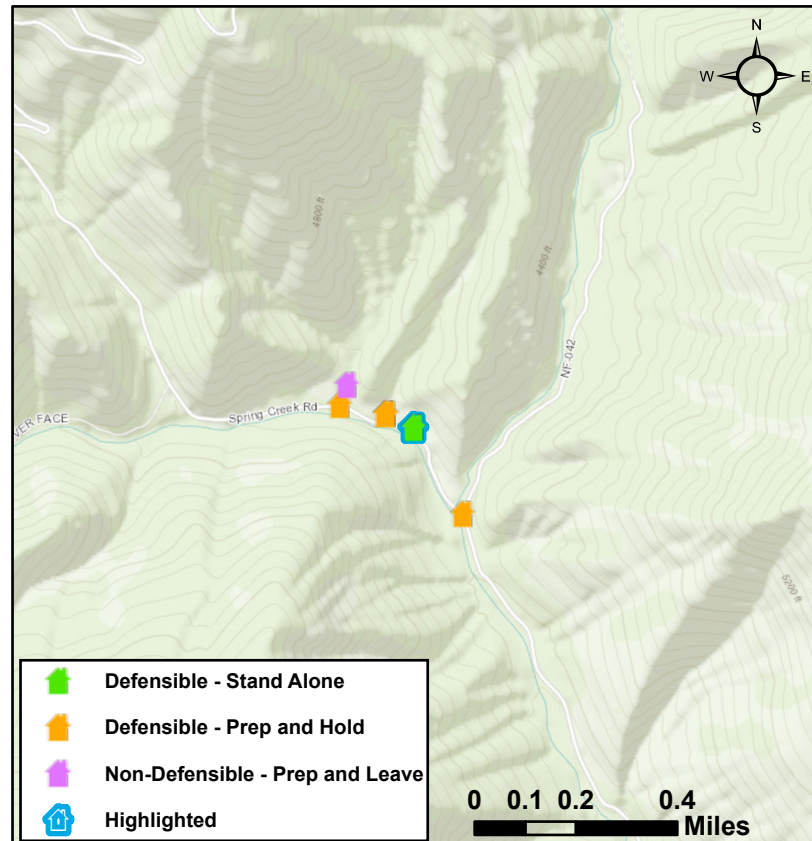
Triage Category: Defensible, Stand Alone
FIRESCOPE Triage Category:
Structure Number: 2
Collected Date/Time: 9/12/2022 10:36:00 PM
Collected By: Gary Hobbs
Inspector's Position: Division
Type of Structure: Residential
Primary Structures: 1
Is the building Occupied?: Yes
Outbuildings: 4
Fuel Surrounding Structure: Shrub or timber
Defensible Space: More than 100ft treated
Roof Material: Noncombustible or not applicable
Siding Material: Log construction
Electrical Power: Unknown
Gas to Structure: Yes
Hazards: Timber behind house. Propane tank
Access to Site: T3/4 Engine
Describe Access: Gravel driveway with turn around in yard
Comm With ICP: Yes
Water Source: Reliable water source nearby
Safety Zone Present:
Mitigation Time (in hours): 8
Mitigation Description: Set sprinklers and hose lay
Resources Needed to Protect Structure: 4 sprinkler kits one engine crew
FIRESCOPE Tactics:
Notes: Solar power ,has wood shed. Green grass in yard ..Pump and hose crosses road already established by homeowner

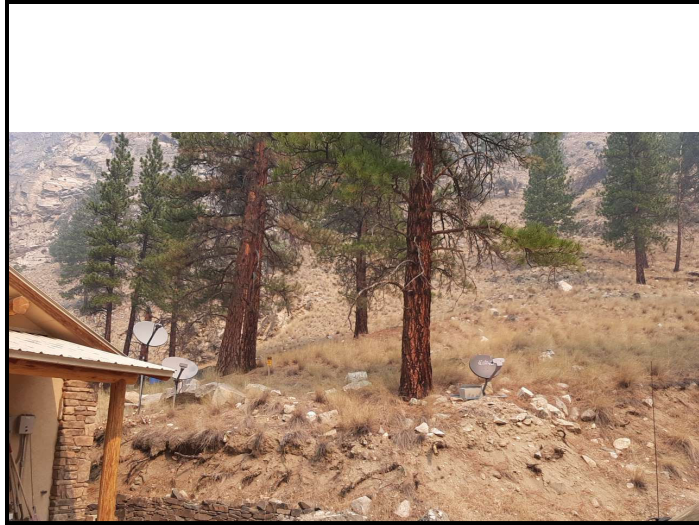
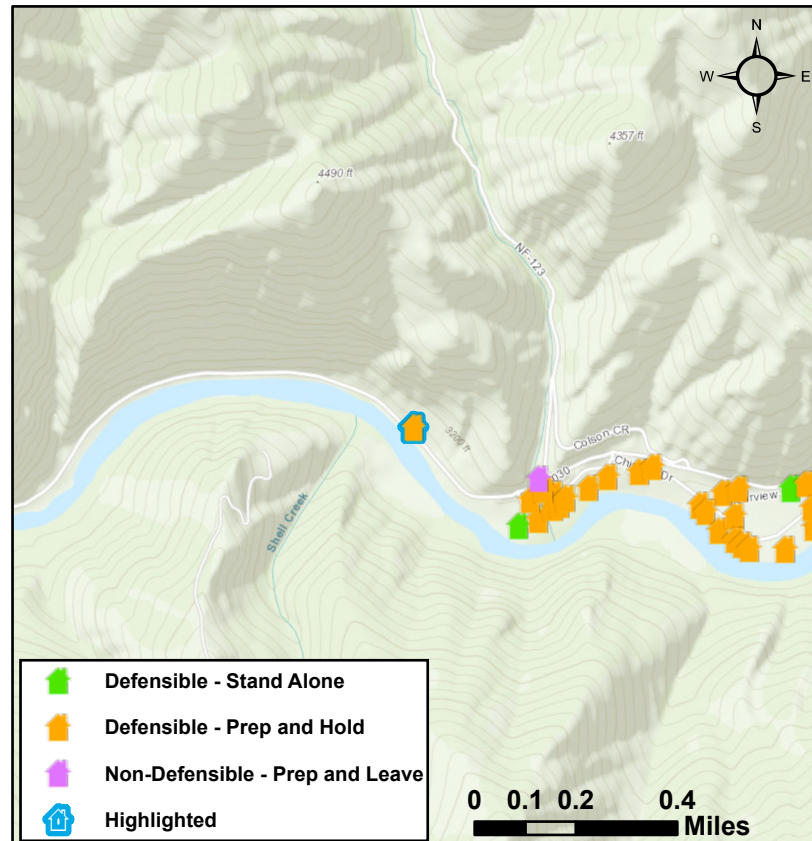
Triage Category: Defensible, Prep and Hold
FIRESCOPE Triage Category:
Structure Number: 1A
Collected Date/Time: 9/11/2022 6:18:00 PM
Collected By: Gary Hobbs
Inspector's Position: Division Alpha
Type of Structure: Residential
Primary Structures: 1
Is the building Occupied?: Unknown
Outbuildings: 1
Fuel Surrounding Structure: Shrub or timber
Defensible Space: No defensible space
Roof Material: Noncombustible or not applicable
Siding Material: Rock, concrete, metal
Electrical Power: Yes
Gas to Structure: Yes
Hazards: Located on slope river below
Access to Site: T6 Engine
Describe Access: Single lane road up to structure
Comm With ICP: Unknown
Water Source: Reliable water source nearby
Safety Zone Present:
Mitigation Time (in hours): 1
Mitigation Description: Needle raking from structure.
Sprinkler set up.
Resources Needed to Protect Structure: Sprinklers 1
type 6 engine or Type 4
FIRESCOPE Tactics:
Notes: Propane storage shed 500' east of structure

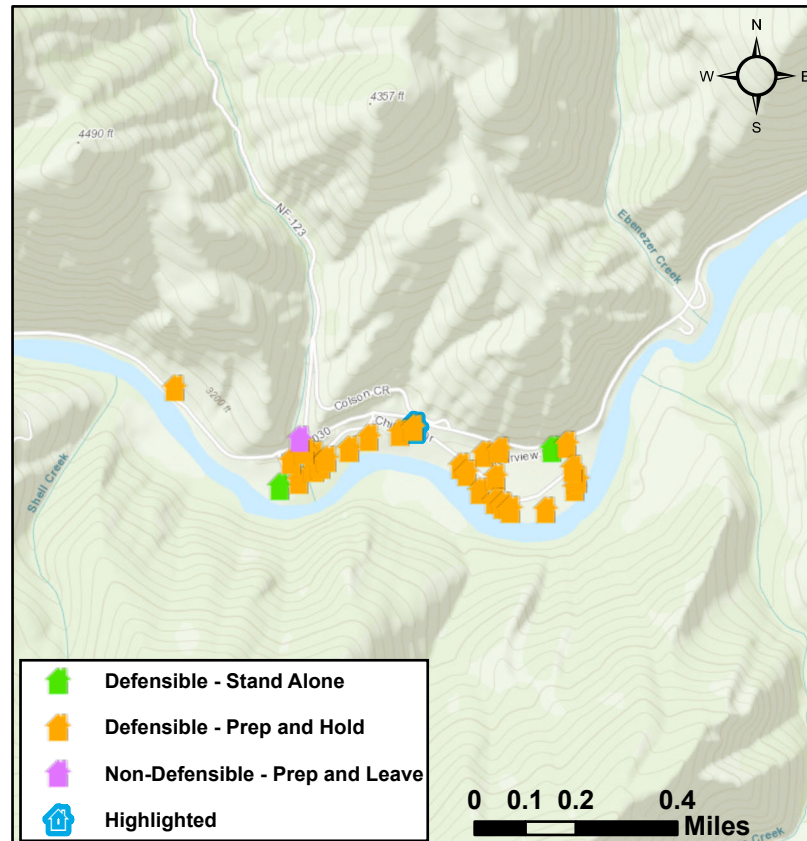
Triage Category: Defensible, Prep and Hold
FIRESCOPE Triage Category:
Structure Number: 27
Collected Date/Time: 9/12/2022 6:56:19 PM
Collected By: Owl Fire 2022 BR 32/ Div A
Inspector's Position:
Type of Structure: Residential
Primary Structures: 1
Is the building Occupied?: Unknown
Outbuildings: 30
Fuel Surrounding Structure: Grass and shrub, hardwood litter
Defensible Space: Less than 30 ft treated
Roof Material: Combustible or no roof
Siding Material: Vinyl
Electrical Power: Yes
Gas to Structure: Yes
Hazards: Fuel Tanks, propane, various automobiles
Access to Site: T6 Engine
Describe Access: Overgrown and littered with "antique" items
Comm With ICP: Yes
Water Source: Reliable water source nearby
Safety Zone Present:
Mitigation Time (in hours): 3
Mitigation Description: Remove grass and brush - scatter junk piles
Resources Needed to Protect Structure:
FIRESCOPE Tactics:
Notes: Trailers Long Term Parking - Over grown and left for a long time.

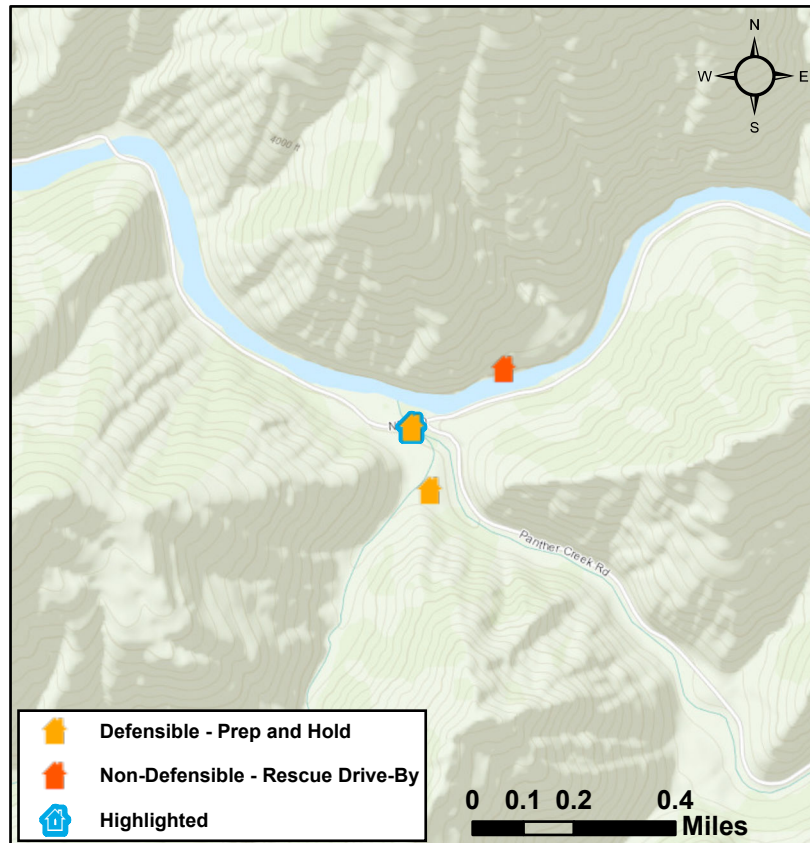
Triage Category: Defensible, Prep and Hold
FIRESCOPE Triage Category:
Structure Number: 6
Collected Date/Time: 9/11/2022 6:20:20 PM
Collected By: Owl Fire 2022 BR 32/ Div A
Inspector's Position:
Type of Structure: Residential
Primary Structures: 2
Is the building Occupied?: Yes
Outbuildings: 18
Fuel Surrounding Structure: Grass and shrub, hardwood litter
Defensible Space: 30 ft treated
Roof Material: Noncombustible or not applicable
Siding Material: Wood or open sided
Electrical Power: Yes
Gas to Structure: Yes
Hazards: Fuels,SepticTank
Access to Site: T1 Engine
Describe Access: River Road
Comm With ICP: Yes
Water Source: Pressurized hydrant(s) or fixed sprinkler system
Safety Zone Present:
Mitigation Time (in hours): 3
Mitigation Description: Cleaning up trees along river edge
Resources Needed to Protect Structure:
FIRESCOPE Tactics:
Notes: Fuel Type: Grass,Shrub,Timber; Defensible Space: 3050Feet; Roof: Metal; Siding: Wood; Heat Traps: ; Notes: May be called Ram's Horn?
