Suppression Repair Branch I

Burnt Peak MT-KNF-000167

8/11 Day

3,583 acres at 8/08/2021 2125 hrs

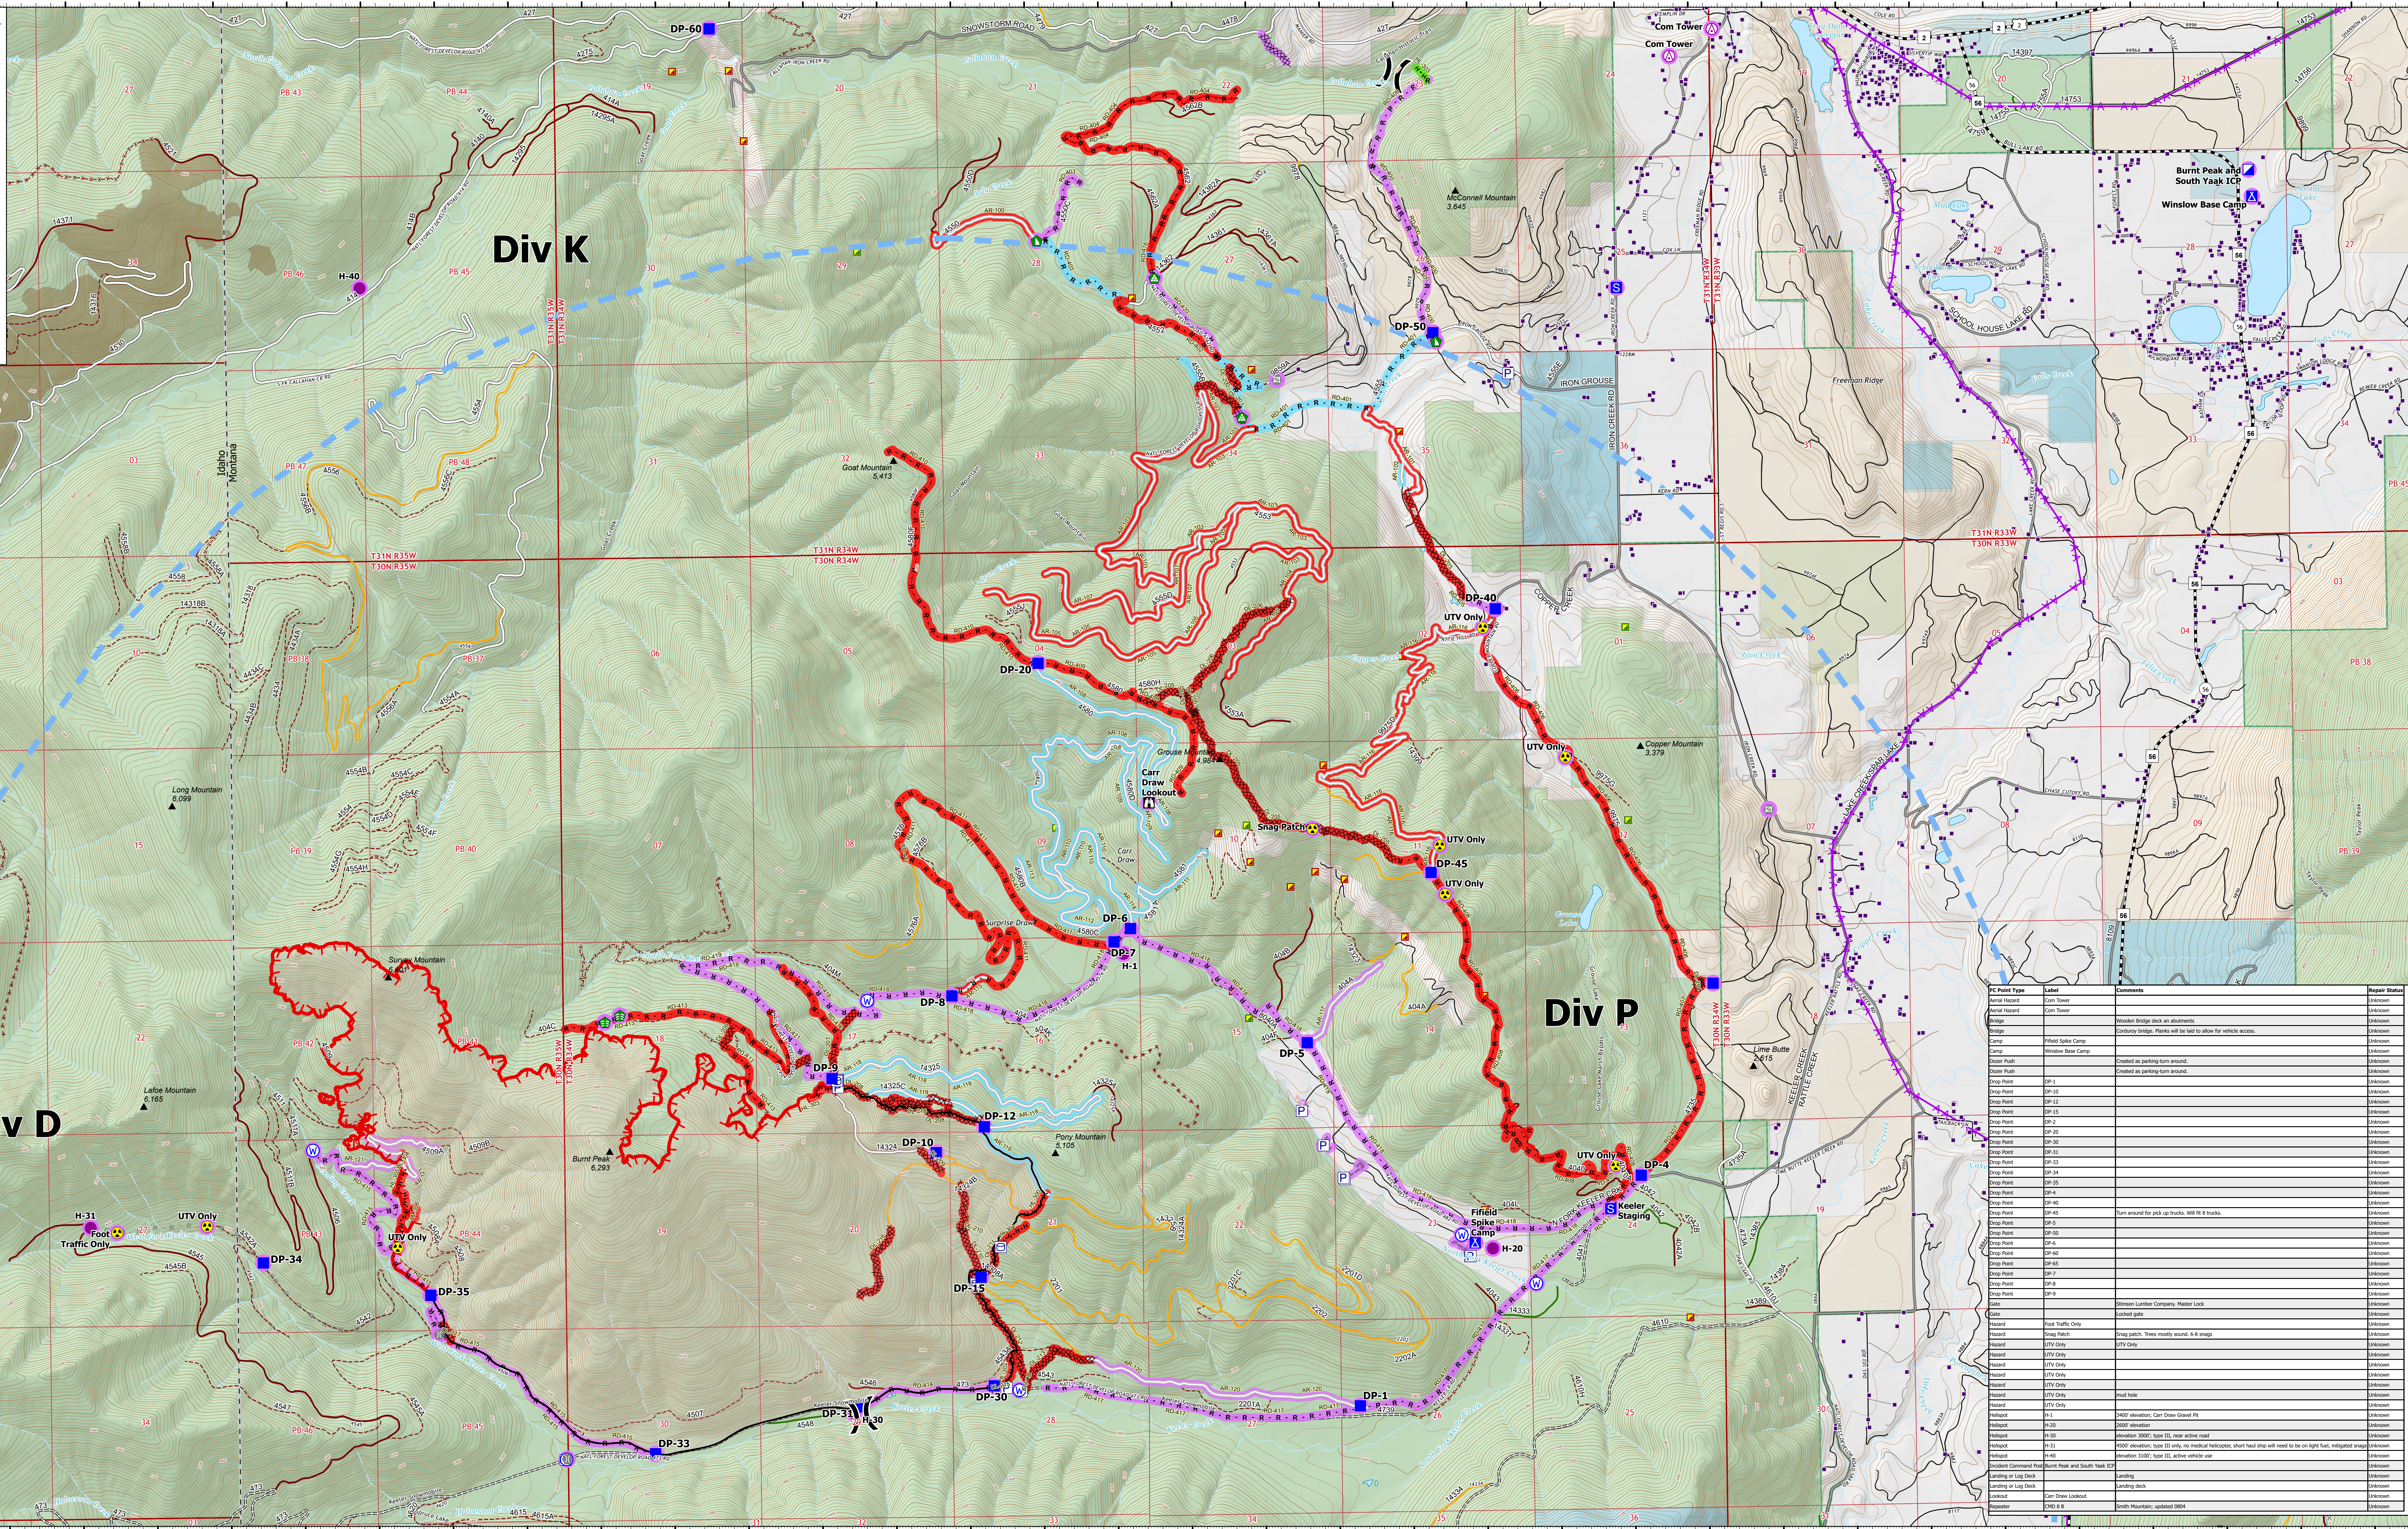
FC Point Type	Label	Comments	Repair Status
Access Road	AR-100	Existing road, mastication both sides 30'	Repair Needed
Access Road	AR-101	Existing road, mastication both sides 30'	Repair Needed
Access Road	AR-102	Existing road, mastication both sides 30'	Repair Needed
Access Road	AR-103	Existing road, mastication both sides 30'	Repair Needed
Access Road	AR-104	Existing road, mastication both sides 30'	Repair Needed
Access Road	AR-105	Existing road, mastication both sides 30'	Repair Needed
Access Road	AR-106	Existing road, mastication both sides 30'	Repair Needed
Access Road	AR-107	Existing road, mastication both sides 30'	Repair Needed
Access Road	AR-108	Existing road, mastication both sides 30'	Repair Needed
Access Road	AR-109	Existing road, mastication both sides 30'	Repair Needed
Access Road	AR-110	Existing road, mastication both sides 30'	Repair Needed
Access Road	AR-111	Existing road, mastication both sides 30'	Repair Needed

Access Road	AR-112	Existing road, mastication both sides 30'	Repair Needed
Access Road	AR-113	Existing road, mastication both sides 30'	Repair Needed
Completed Dozer Line	DL-204	One blade wide with 30-foot mastication	Repair Needed
Completed Dozer Line	DL-205	New dozer line	Repair Needed
Completed Dozer Line	DL-206	single blade, mastication	Repair Needed
Completed Dozer Line	DL-207	one blade, mastication 30'	Repair Needed
Completed Dozer Line	DL-208	New dozer line	Repair Needed
Completed Dozer Line	DL-209	New dozer line	Repair Needed
Completed Dozer Line	DL-209	New dozer line	Repair Needed
Completed Dozer Line	DL-210	New dozer line	Repair Needed
Completed Dozer Line	DL-211	New dozer line	Repair Needed
Completed Dozer Line	DL-212	New dozer line	Repair Needed
Completed Dozer Line	DL-213	dozer line on previously closed road	Repair Needed
Completed Dozer Line	DL-214	New dozer line	Repair Needed
Completed Dozer Line	DL-215	New dozer line	Repair Needed

Completed Dozer Line	DL-216	dozer line on previously closed road	Repair Needed
Completed Dozer Line	DL-200	Newly constructed dozer line, mastication both sides 30'	Repair Needed
Completed Dozer Line	DL-201	Newly constructed dozer line, mastication both sides 30'	Repair Needed
Completed Dozer Line	DL-203	One blade new dozer, then masticated on the west side 30'	Repair Needed
Completed Road as Line	RD-403	Existing logging road, opened with mastication. Only the roadbed is cleared. No black doze, mastication 30'	Unknown
Completed Road as Line	RD-404	Existing logging road, opened with mastication. Only the roadbed is cleared. No black doze, mastication 30'	Repair Needed
Completed Road as Line	RD-405	One blade on existing private road, then masticated on the west side one boom length.	Unknown
Completed Road as Line	RD-406	some sections previously closed road, some sections private, mastication both sides 30'	Repair Needed

Completed Road as Line	RD-407	mastication both sides of road 30'	Repair Needed
Completed Road as Line	RD-408	previously closed road, Road between DP-45, Southeast to new DP accessible by prep up truck, 1/4 only downhill from there, c.	Repair Needed
Completed Road as Line	RD-409	previously closed road opened with dozer, prep road	Repair Needed
Completed Road as Line	RD-410	previously closed road, single blade doze, mastication 30'	Repair Needed
Completed Road as Line	RD-411	single blade doze, previously closed road; Line completed 7/19/21	Repair Needed
Completed Road as Line	RD-412	single blade doze, previously closed road; Line completed 7/19/21	Repair Needed
Completed Road as Line	RD-413	single blade doze, mastication both sides, previously closed road	Repair Needed
Completed Road as Line	RD-413	2 wide blade dozer line, previously closed road	Repair Needed
Completed Road as Line	RD-413	Repair Needed	Repair Needed

FC Line Type	Label	Repair Status	Comments	Repair Comments
Access or Improved Road	AR-100	Repair Needed	Masticated existing road (overgrown). Heavily masticated. Small berm in spots from masticated tracks on south side of road.	
Access or Improved Road	AR-101	Repair Needed	Existing private road that was improved with mastication.	Existing private road that was improved with mastication. No dozer blades dropped on this section. No repair needed.
Access or Improved Road	AR-102	No Repair Needed	No blade dropped, opened an existing private road with some limbing work.	Existing road opened with some limbing work.
Access or Improved Road	AR-103	Repair Needed	existing road, mastication both sides 30'	
Access or Improved Road	AR-104	Repair Needed	existing road, mastication both sides 30'	
Access or Improved Road	AR-105	Repair Needed	existing road, mastication both sides 30'	
Access or Improved Road	AR-107	Repair Needed	existing road but overgrown, not drivable even after heavy mastication both sides 30'

Access or Improved Road	AR-108	No Repair Needed	for transportation reference, no suppression impacts	
Access or Improved Road	AR-109	No Repair Needed	for transportation reference, no suppression impacts	
Access or Improved Road	AR-110	No Repair Needed	for transportation reference, no suppression impacts	
Access or Improved Road	AR-111	No Repair Needed	for transportation reference, no suppression impacts	
Access or Improved Road	AR-112	No Repair Needed	for transportation reference, no suppression impacts	
Access or Improved Road	AR-113	No Repair Needed	for transportation reference, no suppression impacts

FC Line Type	Label	Repair Status	Comments	Repair Comments
Access or Improved Road	AR-114	No Repair Needed	for transportation reference, no suppression impacts	
Access or Improved Road	AR-115	Unknown		
Access or Improved Road	AR-116	Repair Needed	Masticated to be open access only. Road is very narrow with few turn arounds.	
Access or Improved Road	AR-117	Unknown		
Access or Improved Road	AR-118	No Repair Needed	for transportation reference, no suppression impacts	
Access or Improved Road	AR-119	No Repair Needed	for transportation reference, no suppression impacts	
Access or Improved Road	AR-120	Unknown		
Access or Improved Road	AR-121	Unknown		
Completed Dozer Line	DL-200	Repair Needed	Standard dozer line rehab	
Completed Dozer Line	DL-201	Unknown		
Completed Dozer Line	DL-203	Repair Needed	Standard dozer line rehab with excavator that material bank over line, seat, and water at as needed. Dozer work needed where line hits up to area.

Completed Dozer Line	DL-203	Repair Needed	One blade new dozer, then masticated on the west side 30'

FC Line Type	Label	Repair Status	Comments	Repair Comments
Completed Dozer Line	DL-204	Repair Needed	One blade wide with 30-foot mastication	
Completed Dozer Line	DL-205	Repair Needed	New dozer line	
Completed Dozer Line	DL-206	Repair Needed	single blade, mastication	
Completed Dozer Line	DL-207	Repair Needed	one blade, mastication 30'	
Completed Dozer Line	DL-208	Repair Needed	New dozer line	
Completed Dozer Line	DL-209	Repair Needed	New dozer line	
Completed Dozer Line	DL-209	Repair Needed	New dozer line	
Completed Dozer Line	DL-210	Repair Needed	New dozer line	
Completed Dozer Line	DL-211	Repair Needed	New dozer line	
Completed Dozer Line	DL-212	Repair Needed	New dozer line	
Completed Dozer Line	DL-213	Repair Needed	dozer line on previously closed road	
Completed Dozer Line	DL-214	Repair Needed	New dozer line	
Completed Dozer Line	DL-215	Repair Needed	New dozer line	
Completed Dozer Line	DL-216	Repair Needed	dozer line on previously closed road

FC Line Type	Label	Repair Status	Comments	Repair Comments
Completed Dozer Line	DL-217	Repair Needed	New dozer line	
Completed Dozer Line	DL-218	Repair Needed	New dozer line	
Completed Hand Line	HL-300	Repair Needed	Line is plumbed with a hose	
Completed Hand Line	HL-301	Repair Needed		
Completed Hand Line	HL-302	Repair Needed		
Completed Hand Line	HL-303	Repair Needed		
Completed Hand Line	HL-303	Completed - Inspected	30' saw cut with 2' scrape	
Completed Hand Line	HL-304	Repair Needed		
Completed Hand Line	HL-305	Repair Needed		
Completed Hand Line	HL-306	Repair Needed		
Completed Road as Line	RD-400	Unknown	Existing logging road, dozed and masticated 30 feet both sides	
Completed Road as Line	RD-401	No Repair Needed	County Road, mastication	
Completed Road as Line	RD-402	Repair Needed	previously closed road, single blade doze, mastication both sides 30'	
Completed Road as Line	RD-403	No Repair Needed	Existing logging road, dozed and masticated 30 feet both sides

FC Line Type	Label	Repair Status	Comments	Repair Comments
Completed Road as Line	RD-414	Unknown		
Completed Road as Line	RD-415	Unknown		
Completed Road as Line	RD-416	Repair Needed	previously closed road, single blade doze, mastication both sides 30'	
Completed Road as Line	RD-417	Unknown	Existing road with 30' masticator prep.	
Completed Road as Line	RD-418	Unknown	Existing road with 30' masticator prep.	
Completed Road as Line	RD-419	Unknown	Road with 20' masticator prep.	
Completed Road as Line	RD-420	Unknown	Road with 30' masticator prep.	
Completed Road as Line	RD-421	Unknown	Road with 20' masticator prep.	
Other		Unknown	Hose lay and Sprinkler kit set up	
Other		Unknown	Hose lay and Sprinkler kit set up	
Other		Unknown	Hose lay and Sprinkler kit set up	
Other		Unknown	Hose lay and Sprinkler kit set up	
Other		Unknown	Hose lay and Sprinkler kit set up	
Other		No Repair Needed	Cleared vegetation from a green-existing access road. No black work, undesirable: narrow with no ability to turn around.
