**Copper King IAP Map**  
**MT-LNF-005092**  
**Sep 16, 2016**

**Page 7**

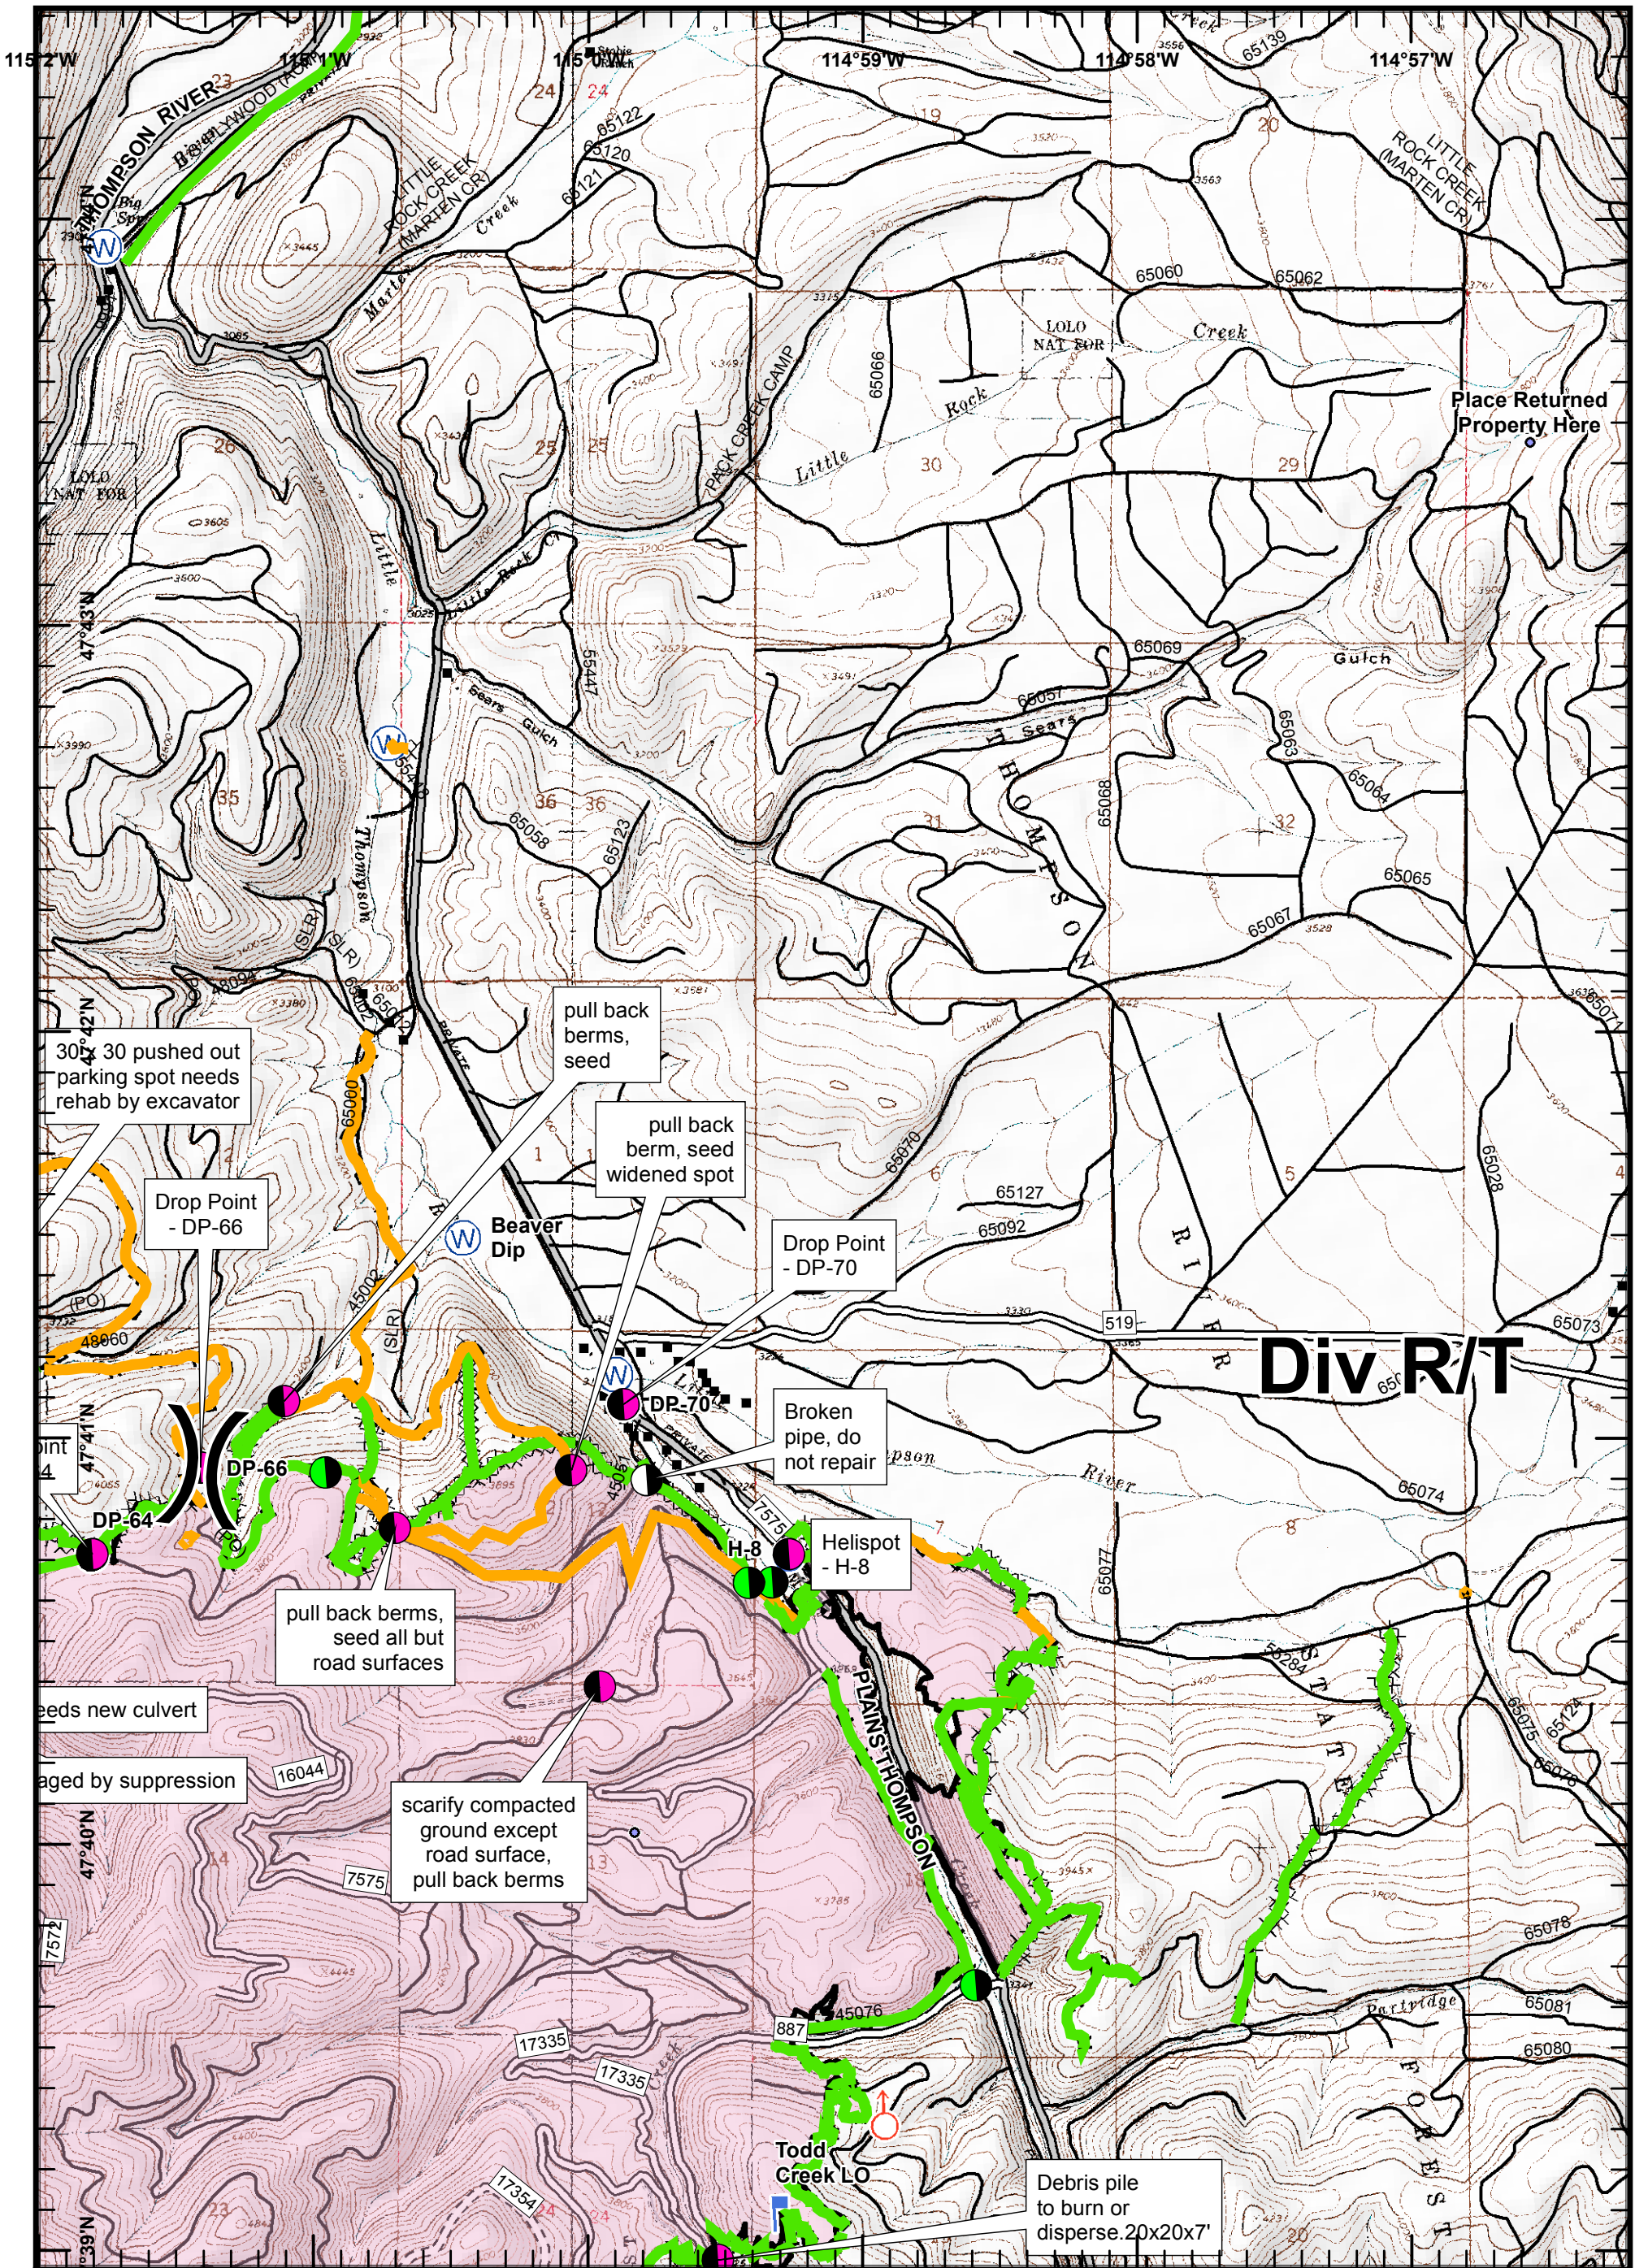
30x30 pushed out parking spot needs rehab by excavator

Broken pipe, do not repair

needs new culvert

aged by suppression

Debris pile to burn or disperse. 20x20x7'

pull back berms, seed

pull back berm, seed widened spot

pull back berms, seed all but road surfaces

scarify compacted ground except road surface, pull back berms
