STRUCTURE
PROTECTION PLAN
FOR
ELK CREEK BLOCK
07/27/2017

Structure Protection Plan

OZ Ranch

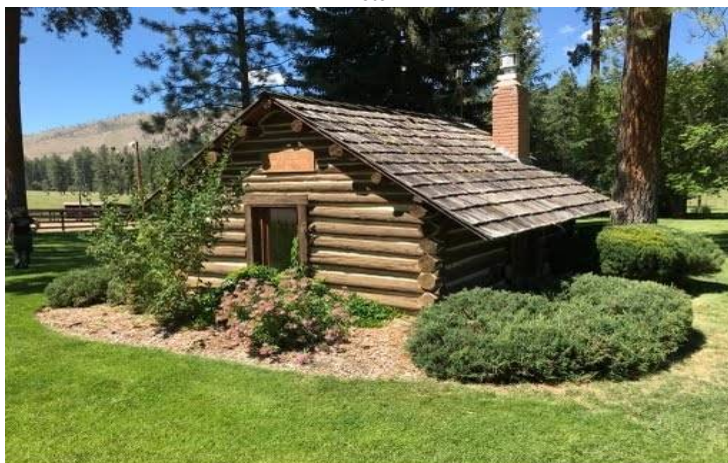
Structure Number: 3789
Structure Name: Office - 4th structure on the right of egress
SubDivision: OZ Ranch
GPS Location, Lat. 46 45.25998
GPS Location, Long. 114 15.56814
Safety Zone Present: Yes **Where is Safety Zone:** Large arena and pasture to the west of structure.
Type of Structure: Mixed Use **Primary Structures:** 1 **Outbuildings:** 0
Surrounding Fuels: Grass, Timber **Defensible Space:** 30-50 Feet
Structure Triage Category: Defensible, Prep and Hold
Roof Material: Wood **Siding Material:** Wood
Heat Traps: **Gas to Structure:** None
Electrical Power: Underground
Hazards: Fuels
Hazard Notes: Old wood shingled roof with needle cast on top.
Access to Site: T1 Engine **Best Access From:** HWY 12, OZ Ranch driveway.
Comm with ICP: Radio
Water Source: Large Pond, Creek
Mitigation Time: Less Than An Hour
Collected By: E 27 Florence Fire **Collected Date/Time:** 07/23/2017 15:05:08
Photo 1 Photo 2

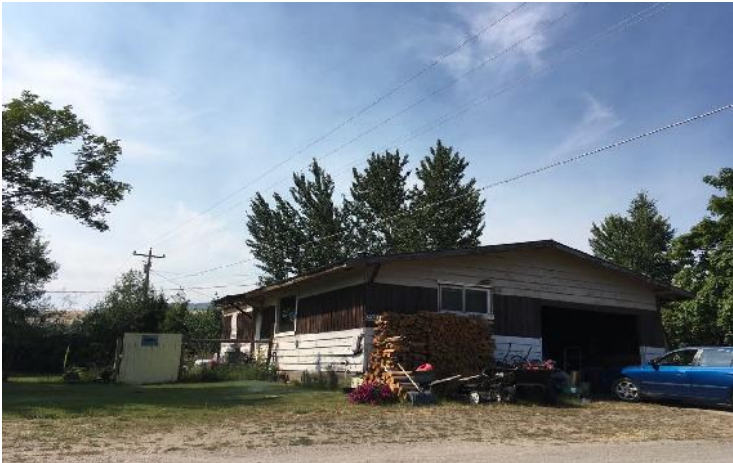
Structure Number: 4688
Structure Name: 12037 Pleasant Meadows lane
SubDivision: Travelers Rest
GPS Location, Lat. 46 45.31626
GPS Location, Long. 114 6.10788
Safety Zone Present: No **Where is Safety Zone:** Easy travel to Hwy 12
Type of Structure: Residential **Primary Structures:** **Outbuildings:**
Surrounding Fuels: Timber **Defensible Space:** 30-50 Feet
Structure Triage Category: Non-Defensible, Prep and Leave
Roof Material: Composite **Siding Material:** Wood
Heat Traps: Open Eaves, Wood Deck, Other Receptor
Electrical Power: Overhead **Gas to Structure:**
Hazards:
Access to Site: T3/4 Engine **Best Access From:** Hwy 12
Comm with ICP: Radio, Cell Service
Water Source: Faucet / Hose
Mitigation Time: 1-2 Hours
Collected By: E-27 Florence **Collected Date/Time:** 07/29/2017 14:46:47
Photo 1 Photo 2

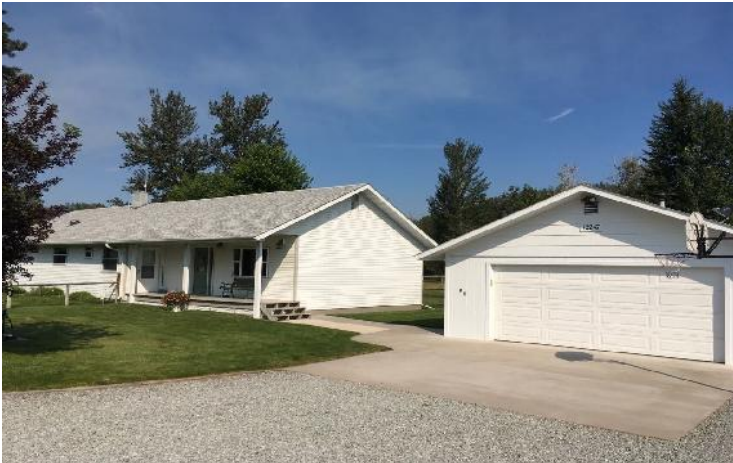
Structure Number: 4762
Structure Name: 12247 Pleasant Meadows lane
SubDivision: Travelers Rest
GPS Location, Lat. 46 45.26286
GPS Location, Long. 114 6.1311
Safety Zone Present: No **Where is Safety Zone:** Easy travel back to Hwy 12
Type of Structure: Residential **Primary Structures:** **Outbuildings:**
Surrounding Fuels: Grass **Defensible Space:** 50-100 Feet
Structure Triage Category: Defensible, Prep and Hold
Roof Material: Composite **Siding Material:** Vinyl
Heat Traps: Open Eaves, Wood Deck, Rain Gutters
Electrical Power: Overhead **Gas to Structure:**
Hazards:
Access to Site: T1 Engine **Best Access From:** Hwy 12
Comm with ICP: Radio, Cell Service
Water Source: Faucet / Hose, Hydrant
Mitigation Time: Less Than An Hour
Collected By: E-27 Florence **Collected Date/Time:** 07/29/2017 14:48:10
Photo 1 Photo 2

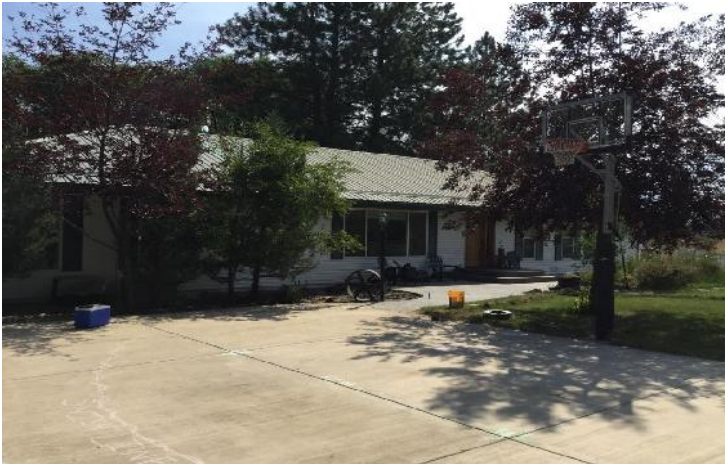
Structure Number: 4751
Structure Name: 7105 HWY 12
SubDivision: Travelers Rest
GPS Location, Lat. 46 45.3432
GPS Location, Long. 114 5.73462
Safety Zone Present: Yes **Where is Safety Zone:** In front of house, parking lot near business and hwy.
Type of Structure: Mixed Use **Primary Structures:** **Outbuildings:**
Surrounding Fuels: Grass, Timber **Defensible Space:** >100 Feet
Structure Triage Category: Defensible, Stand Alone
Roof Material: Metal **Siding Material:** Vinyl
Heat Traps: Rain Gutters
Electrical Power: Overhead, Underground **Gas to Structure:** Aboveground
Hazards: Septic Tank, HazMat
Access to Site: T1 Engine **Best Access From:** Off HWY 12
Comm with ICP: Radio, Cell Service
Water Source: Faucet / Hose, Porta-Tank/Pumpkin
Mitigation Time: None Needed
Other Resources Needed to Protect: None
Notes: Owner is in process of building new home 6921 HWY 12. Owners own various contract wild land engines. A-1 Fire services. Currently weed wash station.

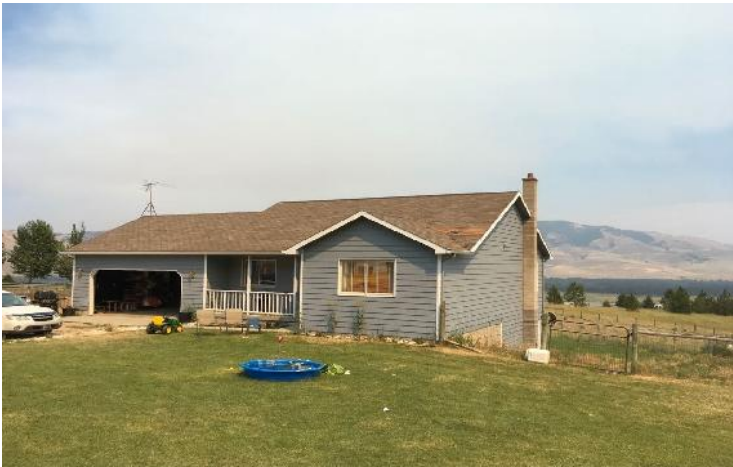
Structure Number:
Structure Name: 16335 Highland Dr
SubDivision: Macintosh Manor
GPS Location, Lat. 46 42.89646
GPS Location, Long. 114 5.99922
Safety Zone Present: No
Type of Structure: Residential
Surrounding Fuels: Grass
Structure Triage Category: Defensible, Prep and Hold
Roof Material: Composite
Heat Traps: Rain Gutters
Electrical Power: Underground
Hazards:
Access to Site: T3/4 Engine
Comm with ICP: Radio, Cell Service
Water Source: Faucet / Hose
Mitigation Time: Less Than An Hour
Other Resources Needed to Protect: Pumpkin and sprinklers
Collected By: E-27 Florence
Photo 1

Where is Safety Zone: Five to seven minute escape back to Hwy 93
Primary Structures:
Defensible Space: 50-100 Feet
Outbuildings:
Siding Material: Wood
Gas to Structure:
Best Access From: Highland drive...one way drive with turn around
Collected Date/Time: 07/29/2017 16:28:06
Photo 2

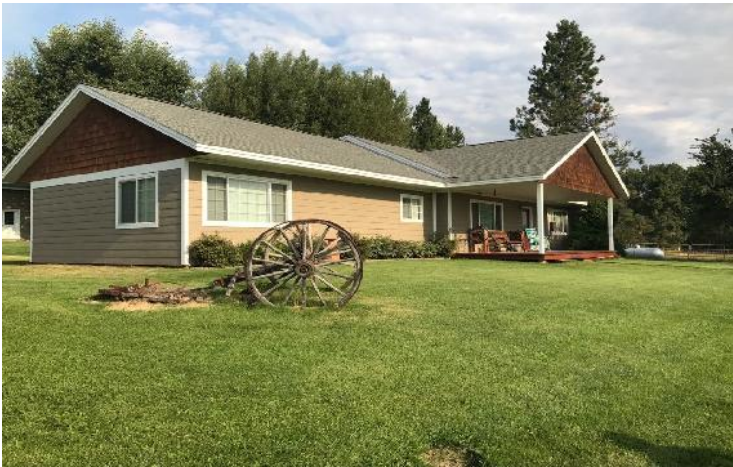
Structure Number:
Structure Name: 21405 Tiger Ln
SubDivision: Carlton
GPS Location, Lat. 46 40.12146
GPS Location, Long. 114 4.84938
Safety Zone Present: Yes
Type of Structure: Residential
Surrounding Fuels: Grass
Structure Triage Category: Defensible, Prep and Hold
Roof Material: Composite
Heat Traps: Rain Gutters
Electrical Power: Overhead
Hazards: Septic Tank
Access to Site: T1 Engine
Comm with ICP: Radio, Cell Service
Water Source: Faucet / Hose
Mitigation Time: Less Than An Hour
Other Resources Needed to Protect: An engine crew to do a little bit of prep. May need a few trees limbed up n some grass cut.
Collected By: COCO 482
Photo 1

Where is Safety Zone: Field in front of house
Primary Structures:
Defensible Space: 50-100 Feet
Outbuildings:
Siding Material: Wood
Gas to Structure: Aboveground
Best Access From: Out to old highway 93 then to highway 93
Collected Date/Time: 07/29/2017 20:07:01
Photo 2

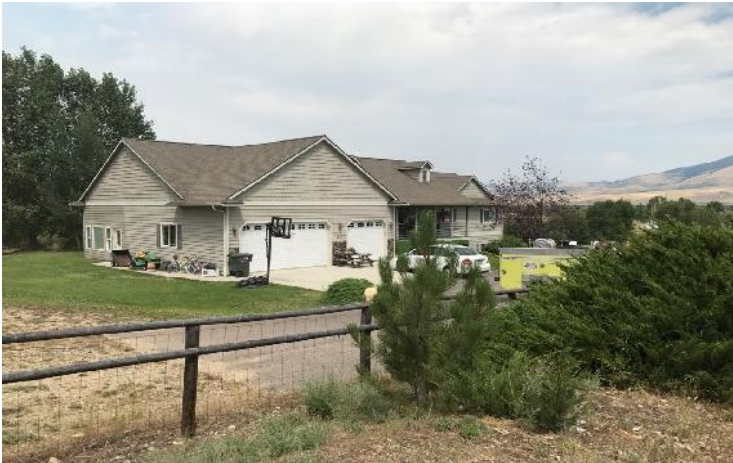
Structure Number:
Structure Name: 230 Mountain Shadow Trail
SubDivision: Tie Chute
GPS Location, Lat. 46 39.15642
GPS Location, Long. 114 4.82238
Safety Zone Present: Yes **Where is Safety Zone:** Old Highway 93
Type of Structure: Residential **Primary Structures:** **Outbuildings:**
Surrounding Fuels: Grass,Shrub **Defensible Space:** 30-50 Feet
Structure Triage Category: Defensible, Stand Alone
Roof Material: Composite **Siding Material:** Masonry
Heat Traps: Open Eaves,Rain Gutters,Other Receptor
Electrical Power: Underground **Gas to Structure:** Underground
Hazards:
Access to Site: T3/4 Engine **Best Access From:** Old Highway 93
Comm with ICP: Radio,Cell Service
Water Source: Faucet / Hose,Creek
Mitigation Time: None Needed
Collected By: E-96 Corvallis **Collected Date/Time:** 07/30/2017 08:58:23
Photo 1 Photo 2

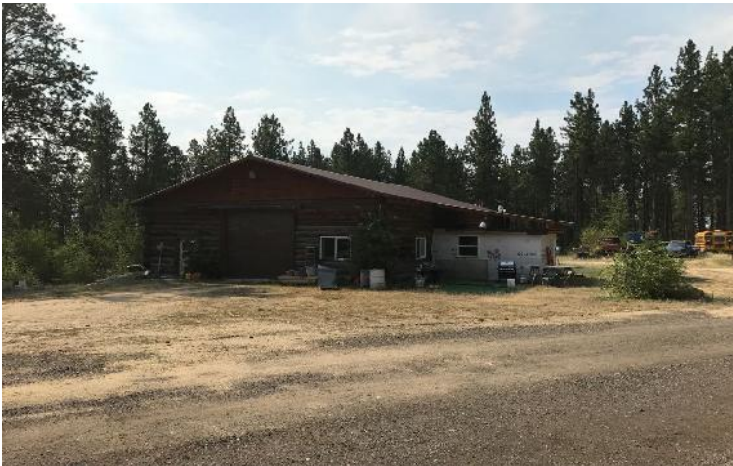
Structure Number:
Structure Name: 442 Yarrow Dr.
SubDivision: Tie Chute
GPS Location, Lat. 46 39.28968
GPS Location, Long. 114 6.17724
Safety Zone Present: No **Where is Safety Zone:** Highway 93
Type of Structure: Mixed Use **Primary Structures:** **Outbuildings:**
Surrounding Fuels: Grass,Shrub,Timber,Slash **Defensible Space:** 30-50 Feet
Structure Triage Category: Defensible, Prep and Hold
Roof Material: Metal **Siding Material:** Wood
Heat Traps: Open Eaves,Other Receptor
Electrical Power: Overhead,Underground **Gas to Structure:** Aboveground
Hazards: Septic Tank
Access to Site: T1 Engine **Best Access From:** Old Highway 93 to Wagner Lane. Take to Jones Road. To West County Line Road. To Yarrow Dr.
Comm with ICP: Radio,Cell Service
Water Source: Faucet / Hose,Large Pond
Mitigation Time: 1-2 Hours
Other Resources Needed to Protect: Mark 3 pump. Approximately 600 feet of inch and a half hose. Two sprinkler kits with appliances.

Notes: Multiple vehicles and trailers scatter property. Scrap metal all over property.
Large pond to the South East.
Multiple heavy equipment
Contact info Steve Jones # 406-880-6230
Collected By: E-96 Corvallis **Collected Date/Time:** 07/30/2017 08:58:26
Photo 1 Photo 2

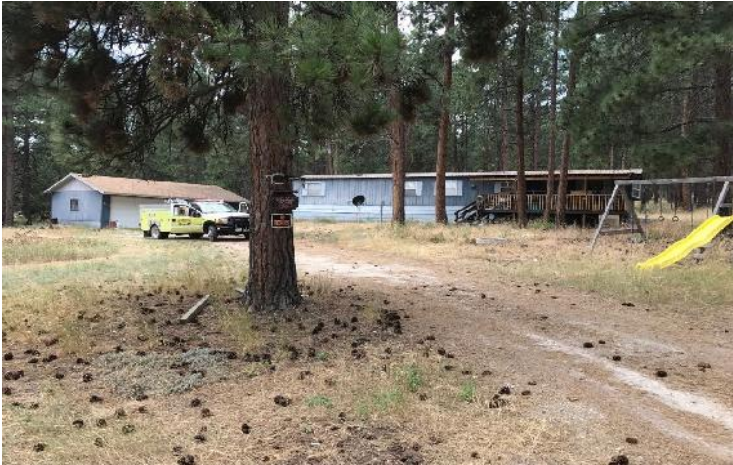
Structure Number:
Structure Name: 461 West County Line Rd
SubDivision: Tie Chute
GPS Location, Lat. 46 39.61134
GPS Location, Long. 114 5.93358
Safety Zone Present: No **Where is Safety Zone:** Hwy 93
Type of Structure: Residential **Primary Structures:** **Outbuildings:**
Surrounding Fuels: Grass,Shrub,Timber **Defensible Space:** None
Structure Triage Category: Defensible, Prep and Hold
Roof Material: Metal **Siding Material:** Wood
Heat Traps: Wood Deck,Other Receptor
Electrical Power: Overhead,Underground **Gas to Structure:** Underground
Hazards: Fuels,Animals
Access to Site: T1 Engine **Best Access From:** Old Hwy 93, to Wagner Ln. To Jones Rd. To West County Line Rd.
Comm with ICP: Radio,Cell Service
Water Source: Faucet / Hose
Mitigation Time: 1-2 Hours
Other Resources Needed to Protect: Pumpkin, mark 3 pump, 1000' 11/2" hose, and sprinkler kits to do this structure and the structure at 455 West County Line Rd.

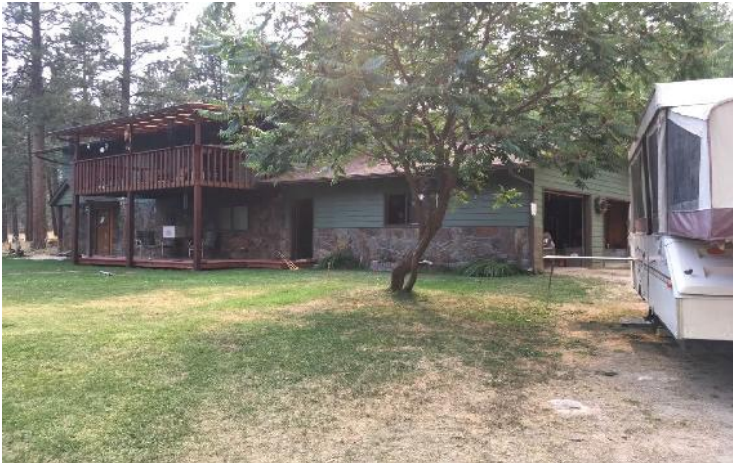
Structure Number:
Structure Name: 5751 Daisy Lane
SubDivision: Tie Chute
GPS Location, Lat. 46 39.41676
GPS Location, Long. 114 6.27852
Safety Zone Present: No **Where is Safety Zone:** Down to Old Hwy 93, 7-10 minutes travel
Type of Structure: Residential **Primary Structures:** **Outbuildings:**
Surrounding Fuels: Timber **Defensible Space:** 30-50 Feet
Structure Triage Category: Non-Defensible, Prep and Leave
Roof Material: Composite **Siding Material:** Wood
Heat Traps: Open Eaves, Wood Deck, Rain Gutters
Electrical Power: Overhead **Gas to Structure:** Aboveground
Hazards: Terrain, Fuels, No Turn Around, Animals
Access to Site: T6 Engine **Best Access From:** Wagner Road to Jones Road to West County Line
Comm with ICP: Radio, Cell Service
Water Source: Faucet / Hose
Mitigation Time: 3-4 Hours
Collected By: E-27 Florence **Collected Date/Time:** 07/30/2017 08:58:03
Photo 1 Photo 2

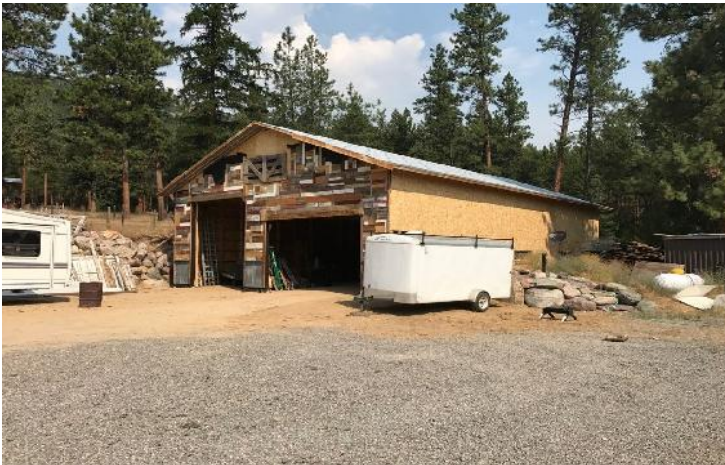
Structure Number:
Structure Name: 600 Tie Chute Ln
SubDivision: Tie Chute
GPS Location, Lat. 46 38.5665
GPS Location, Long. 114 6.94938
Safety Zone Present: No **Where is Safety Zone:** Tie Chute to Old Hwy 93
Type of Structure: Residential **Primary Structures:** **Outbuildings:**
Surrounding Fuels: Grass, Timber **Defensible Space:** 30-50 Feet
Structure Triage Category: Non-Defensible, Prep and Leave
Roof Material: Composite **Siding Material:** Wood
Heat Traps: Open Eaves, Wood Deck, Rain Gutters
Electrical Power: Underground **Gas to Structure:** Aboveground
Hazards:
Access to Site: T3/4 Engine **Best Access From:** Tie Chute
Comm with ICP: Radio, Cell Service
Water Source: Faucet / Hose
Mitigation Time: 2-3 Hours
Other Resources Needed to Protect: Type 6 crew for extra hands.
Collected By: AZ-TNF 1265 **Collected Date/Time:** 07/30/2017 08:57:44
Photo 1 Photo 2

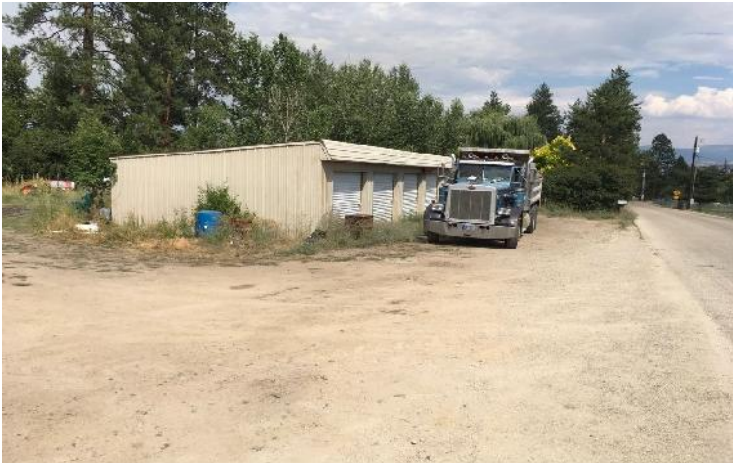
Structure Number:
Structure Name: Storage unit next to Brown's Septic Service
SubDivision: Tie Chute
GPS Location, Lat. 46 38.55234
GPS Location, Long. 114 4.85838
Safety Zone Present: No **Where is Safety Zone:** Two minute drive to ICP
Type of Structure: Commercial **Primary Structures:** **Outbuildings:**
Surrounding Fuels: Timber **Defensible Space:** 30-50 Feet
Structure Triage
Category: Defensible, Prep and Hold
Roof Material: Metal **Siding Material:** Metal
Heat Traps:
Electrical Power: Overhead **Gas to Structure:**
Hazards: Septic Tank
Access to Site: T1 Engine **Best Access From:** Tie Chute lane
Comm with ICP: Radio, Cell Service
Water Source: Faucet / Hose
Mitigation Time: Less Than An Hour
Collected By: E-27 Florence **Collected Date/Time:** 07/30/2017 08:58:18
Photo 1 Photo 2

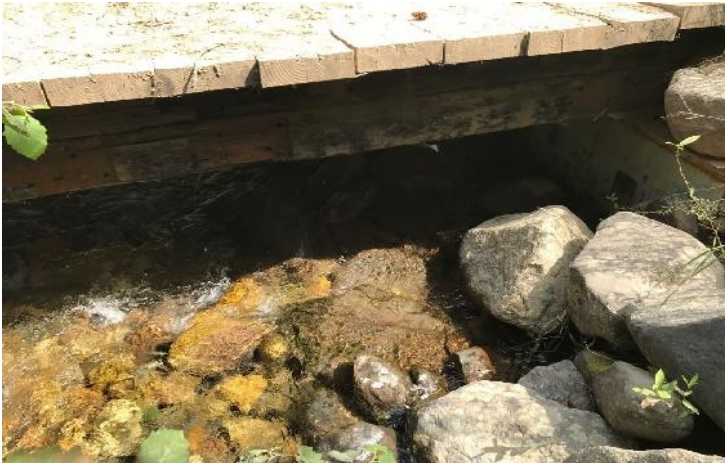
Structure Number:
Structure Name: Wood Bridge--Tie Chute Ln
SubDivision: Tie Chute
GPS Location, Lat. 46 38.56968
GPS Location, Long. 114 6.78444
Safety Zone Present: No **Where is Safety Zone:** No safety zone.
Type of Structure: Other **Primary Structures:**
Other Type of Structure: Wooden bridge **Outbuildings:**
Surrounding Fuels: Grass,Shrub,Timber **Defensible Space:** None
Structure Triage Category: Defensible, Stand Alone
Roof Material: Wood **Siding Material:** Wood
Heat Traps:
Electrical Power: **Gas to Structure:**
Hazards: Fuels,Bridge Load Limits,No Turn Around
Access to Site: T3/4 Engine **Best Access From:** Old highway 93 to Tie shoots Rd
Comm with ICP: Radio,Cell Service
Water Source: Creek
Mitigation Time: 1-2 Hours
Other Resources Needed to Protect: Engine crew could prep bridge by cutting back brush and put sprinklers in.
Collected By: COCO 482 **Collected Date/Time:** 07/30/2017 08:58:21

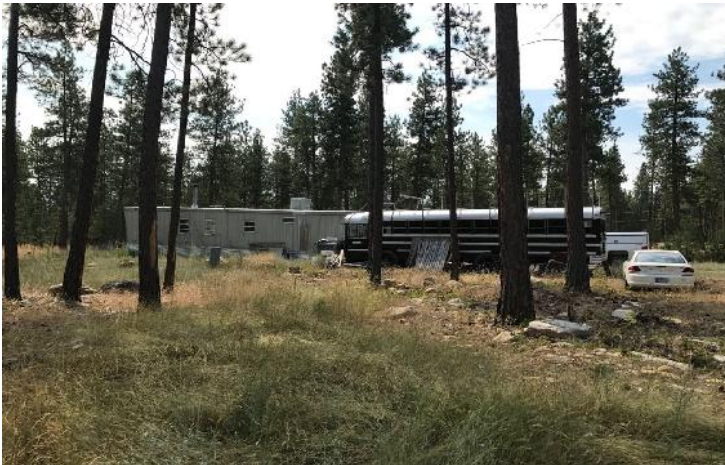
Structure Number:
Structure Name: 510 Trenk way
SubDivision: One Horse
GPS Location, Lat. 46 38.24298
GPS Location, Long. 114 6.0096
Safety Zone Present: Yes **Where is Safety Zone:** Field 100 yds south of structures
Type of Structure: Residential **Primary Structures:** **Outbuildings:**
Surrounding Fuels: Grass, Timber **Defensible Space:** None
Structure Triage Category: Defensible, Prep and Hold
Roof Material: Metal **Siding Material:** Metal
Heat Traps: Rain Gutters, Other Receptor
Electrical Power: Underground **Gas to Structure:** Aboveground
Hazards: Septic Tank, HazMat
Access to Site: T1 Engine **Best Access From:** 93 to Holloway to Trenk way
Comm with ICP: Radio, Cell Service
Water Source: Faucet / Hose
Mitigation Time: 2-3 Hours
Other Resources Needed to Protect: Brush hog
Collected By: Lolo 632 **Collected Date/Time:** 07/30/2017 10:08:49

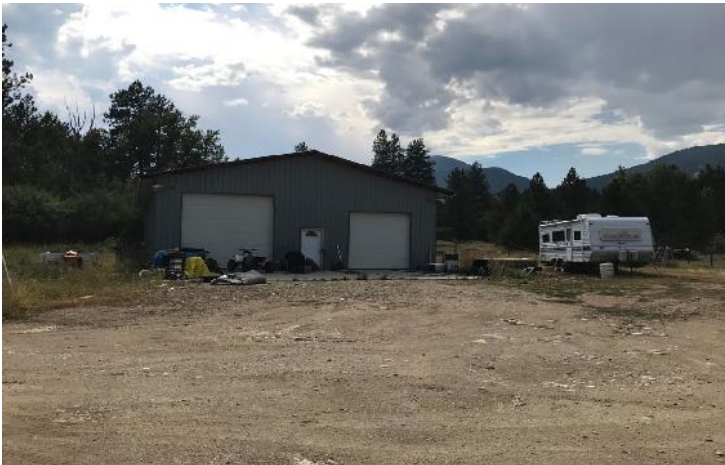
Structure Number:
Structure Name: 422 Sweeney Creek Loop
SubDivision: Sweeny
GPS Location, Lat. 46 36.63024
GPS Location, Long. 114 5.52408
Safety Zone Present: Yes **Where is Safety Zone:** 100yds to 93
Type of Structure: Residential **Primary Structures:** **Outbuildings:**
Surrounding Fuels: Grass,Shrub,Timber **Defensible Space:** 30-50 Feet
Structure Triage Category: Defensible, Prep and Hold
Roof Material: Composite **Siding Material:** Wood
Heat Traps: Open Eaves,Wood Deck,Rain Gutters,Other Receptor
Electrical Power: Underground **Gas to Structure:** Underground
Hazards: Animals,HazMat
Access to Site: T1 Engine **Best Access From:** 93 to Sweeney loop
Comm with ICP: Radio,Cell Service
Water Source: Faucet / Hose
Mitigation Time: 3-4 Hours
Other Resources Needed to Protect: Hand crew
Collected By: Lolo 632 **Collected Date/Time:** 07/30/2017 11:28:22

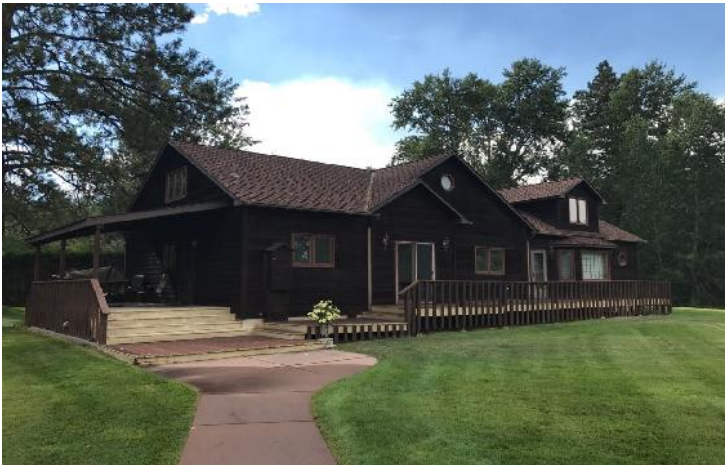
Structure Number:
Structure Name: 465 Sweeney Creek Loop
SubDivision: Sweeny
GPS Location, Lat. 46 36.5616
GPS Location, Long. 114 5.77224
Safety Zone Present: Yes **Where is Safety Zone:** 100yds to 93, very large irrigated meadows
Type of Structure: Residential **Primary Structures:** **Outbuildings:**
Surrounding Fuels: Grass,Shrub,Timber **Defensible Space:** 30-50 Feet
Structure Triage Category: Defensible, Prep and Hold
Roof Material: Composite **Siding Material:** Wood
Heat Traps: Wood Deck,Rain Gutters
Electrical Power: Underground **Gas to Structure:** Aboveground
Hazards: Bridge Load Limits,Animals,HazMat
Access to Site: T1 Engine **Best Access From:** 93 to Sweeney loop
Comm with ICP: Radio,Cell Service
Water Source: Faucet / Hose,Creek
Mitigation Time: Less Than An Hour
Other Resources Needed to Protect: 3 Type 6 engines
Collected By: Lolo 632 **Collected Date/Time:** 07/30/2017 11:28:57

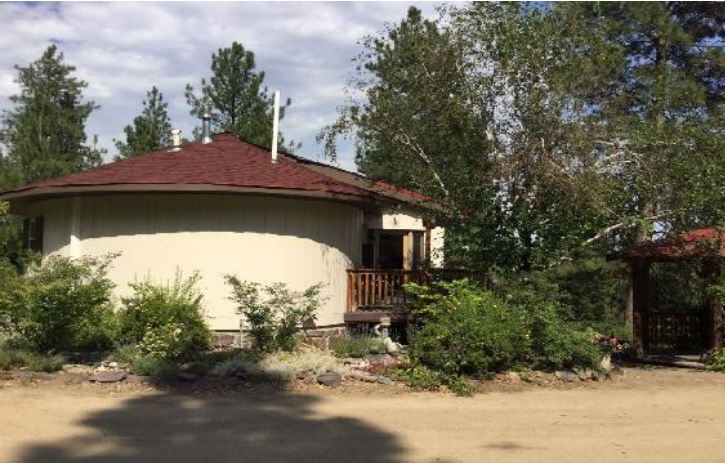
Structure Number:
Structure Name: 860 Upper Sweeney Creek Loop
SubDivision: Sweeny
GPS Location, Lat. 46 36.80106
GPS Location, Long. 114 7.28532
Safety Zone Present: Yes **Where is Safety Zone:** Field by smith fork road
Type of Structure: Residential **Primary Structures:** **Outbuildings:**
Surrounding Fuels: Grass, Timber **Defensible Space:** 30-50 Feet
Structure Triage Category: Non-Defensible, Prep and Leave
Roof Material: Composite **Siding Material:** Wood
Heat Traps: Wood Deck **Gas to Structure:** Aboveground
Electrical Power: Overhead, Underground
Hazards: Fuels
Access to Site: T3/4 Engine **Best Access From:** Upper Sweeney Creek Loop
Comm with ICP: Radio, Cell Service
Water Source: Faucet / Hose
Mitigation Time: 2-3 Hours
Other Resources Needed to Protect: Engine module, clear brush and wood piles near structures. Clear around propane tank
Collected By: Engine 951 **Collected Date/Time:** 07/30/2017 11:28:44

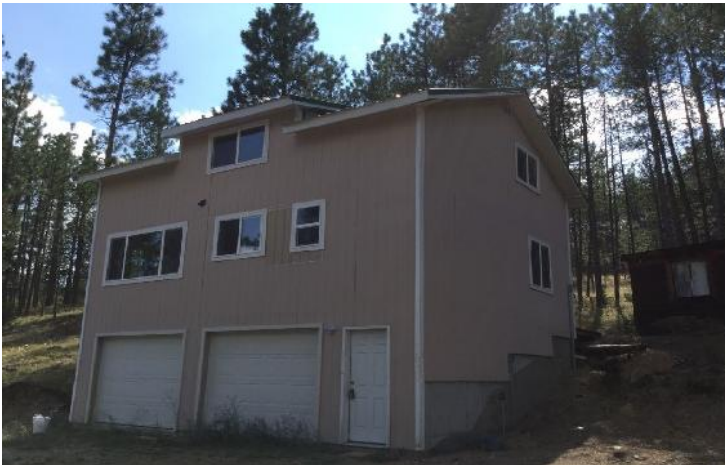
Structure Number:
Structure Name: 861 Upper Sweeney Creek Loop
SubDivision: Sweeny
GPS Location, Lat. 46 36.7938
GPS Location, Long. 114 7.34904
Safety Zone Present: Yes **Where is Safety Zone:** Field by smith fork road
Type of Structure: Residential **Primary Structures:** **Outbuildings:**
Surrounding Fuels: Grass, Timber **Defensible Space:** 30-50 Feet
Structure Triage Category: Non-Defensible, Prep and Leave
Roof Material: Wood **Siding Material:** Metal
Heat Traps: Wood Deck **Gas to Structure:**
Electrical Power:
Hazards:
Access to Site: T6 Engine **Best Access From:** Upper Sweeney Creek Loop
Comm with ICP: Radio, Cell Service
Water Source: Faucet / Hose
Mitigation Time: 2-3 Hours
Other Resources Needed to Protect: Engine module, dig line around house
Collected By: Engine 951 **Collected Date/Time:** 07/30/2017 11:28:52

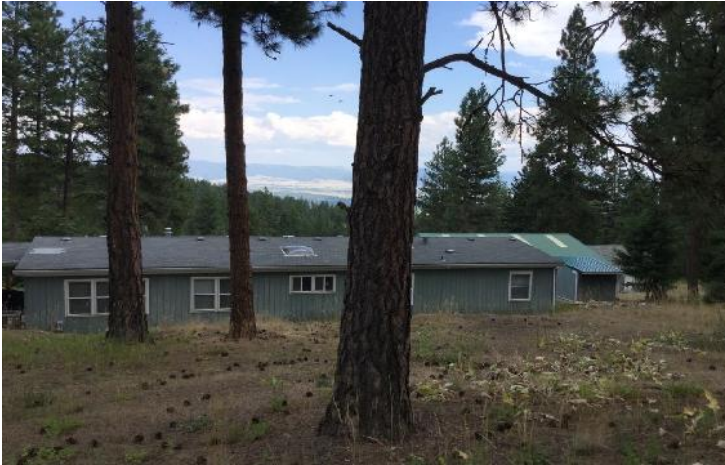
Structure Number:
Structure Name: 872 Upper Sweeney Creek Loop
SubDivision: Sweeny
GPS Location, Lat. 46 36.8673
GPS Location, Long. 114 7.2861
Safety Zone Present: Yes **Where is Safety Zone:** Field by smith fork road
Type of Structure: Residential **Primary Structures:** **Outbuildings:**
Surrounding Fuels: Grass, Timber **Defensible Space:** 30-50 Feet
Structure Triage Category: Non-Defensible, Prep and Leave
Roof Material: Composite **Siding Material:** Wood
Heat Traps: Wood Deck, Rain Gutters
Electrical Power: Overhead, Underground **Gas to Structure:** Aboveground
Hazards:
Access to Site: T3/4 Engine **Best Access From:** Upper Sweeney Creek Loop
Comm with ICP: Radio, Cell Service
Water Source: Faucet / Hose
Mitigation Time: 1-2 Hours
Other Resources Needed to Protect: Engine module, scratch line and weedwack around garage and propane tank
Collected By: Engine 951 **Collected Date/Time:** 07/30/2017 11:28:36

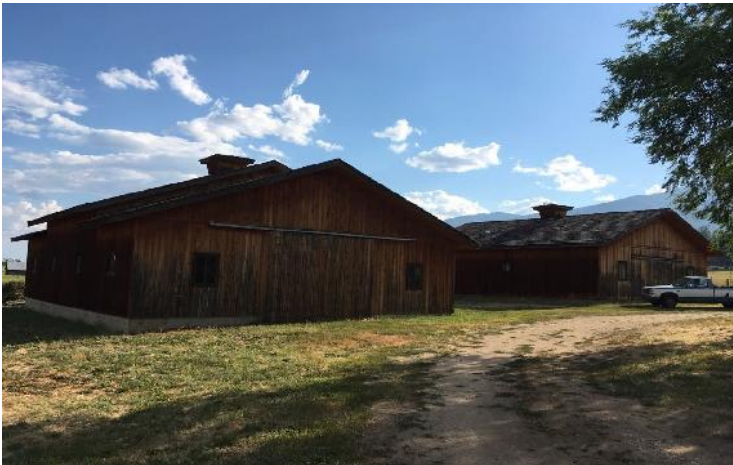
Structure Number:
Structure Name: 763 Sweeney Creek Loop
SubDivision: Larry Creek
GPS Location, Lat. 46 35.78982
GPS Location, Long. 114 6.62418
Safety Zone Present: Yes
Type of Structure: Mixed Use
Surrounding Fuels: Grass
Structure Triage Category: Defensible, Prep and Hold
Roof Material: Wood
Heat Traps: Open Eaves
Electrical Power: Overhead,Underground
Hazards:
Access to Site: T1 Engine
Comm with ICP: Radio,Cell Service
Water Source: Faucet / Hose,Creek
Mitigation Time: 1-2 Hours
Other Resources Needed to Protect: Sprinklers for wood shake shingles...creek at entrance of driveway...easy to dam and about 50 gpm...possible irrigation ditch...
Collected By: E-27 Florence
Photo 1

Where is Safety Zone: Large green short grass field south
Primary Structures:
Defensible Space: >100 Feet
Outbuildings:
Siding Material: Wood
Gas to Structure:
Best Access From: Sweeney Creek loop
Collected Date/Time: 07/30/2017 12:23:59
Photo 2
