ACCIDENT PREVENTION BULLETIN

No. IA APB 12-01

Subject: Wind Effects on Idling Rotorcraft

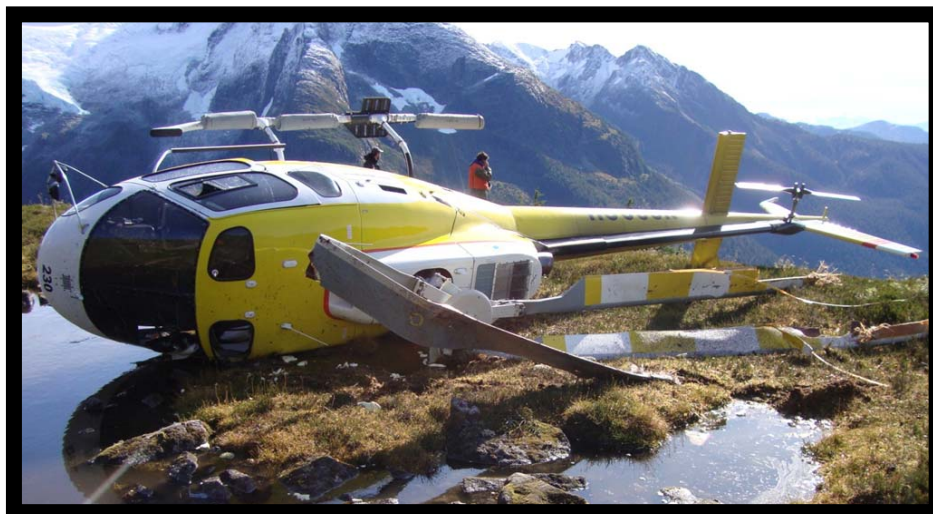
Discussion: In September, 2011 a Eurocopter AS-350BA sustained substantial damage after winds caused the aircraft to lift up and roll over on a ridgeline despite the engine operating at idle RPM ([NTSB # ANCI11LA108](#)). The aircraft had landed on the top edge of a steep slope where winds were forecast to be strong and erratic due to an arriving low pressure system over the area. The National Weather Service (NWS) forecasted the surface winds at 35 – 45 knots however, NWS hourly observations from 3 different observation locations indicated maximum velocities ranging from 10 - 29 knots.
