Davis Structure Assessment #1

Collected Date/Time: 8/25/2018 9:24:01 PM, Collected By: Eric J Kurtz STPS Incident Number: MT-KNF-000161

Location: 28933 Yaak River Road (Hwy 508) , Yaak

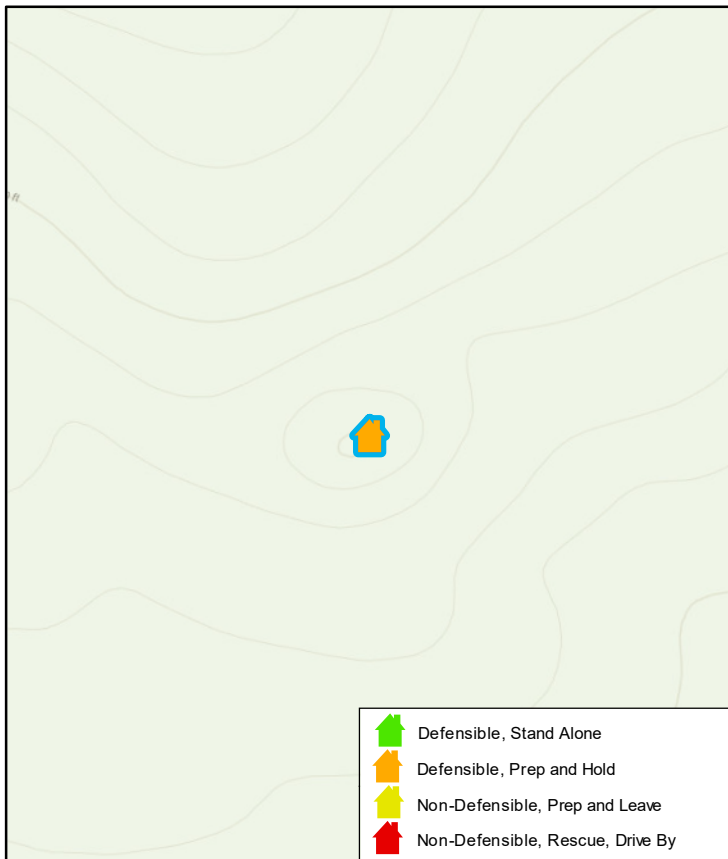
Davis Structure Assessment #2

Hazard Notes: Large ammo cache in primary structure . Large covered woodpiles next to residence. Very long narrow switchback driveway with deep water bars to structures. Lots of building materials piled on

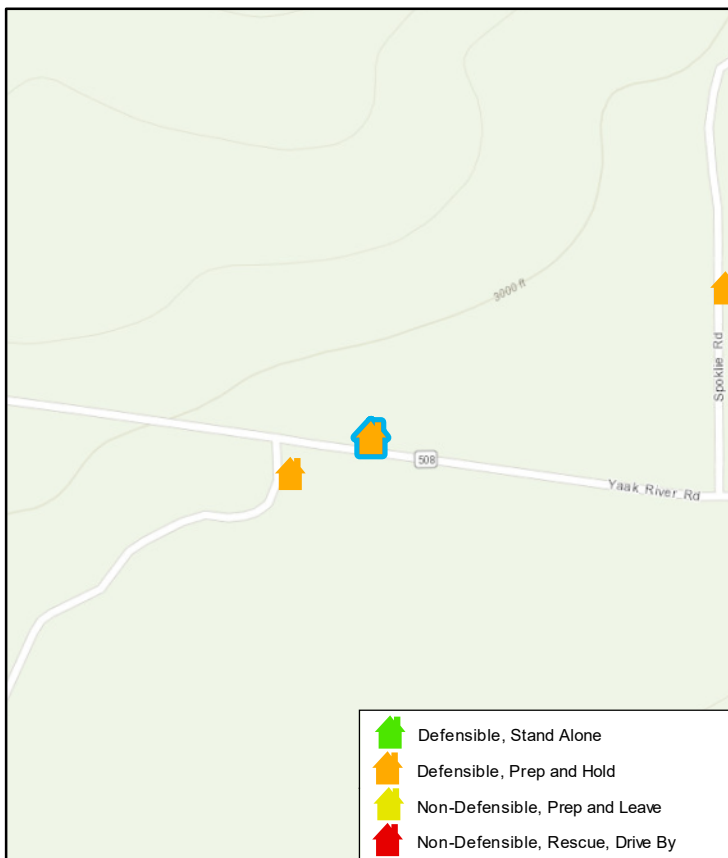
Davis Structure Assessment #4

Hazard Notes: Lots of miscellaneous vehicles in front of residence and shop building. Firewood pile within 30 feet of residence. Large cache of firearms and ammunition. Tire pile and abandoned vehicles

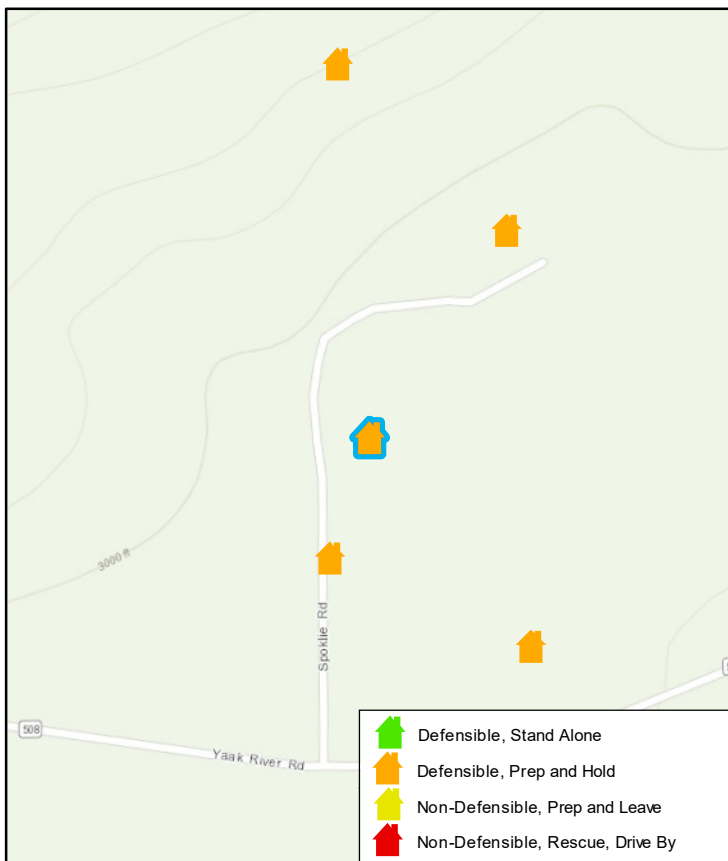
Davis Structure Assessment #5

Hazard Notes: Shop twenty feet from residence with primary woodpile. 300 long woodshed 35 cords of split firewood 200 feet away from front of residence.

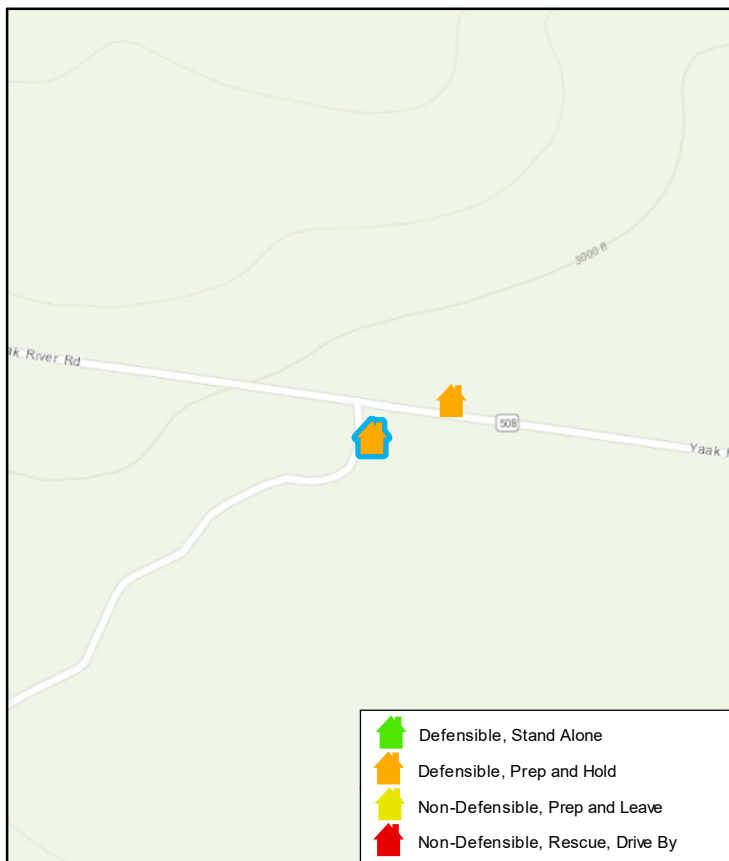
Davis Structure Assessment #6

Hazard Notes: Lots of miscellaneous vehicles in front of residence. Firewood pile within 30 feet of residence.

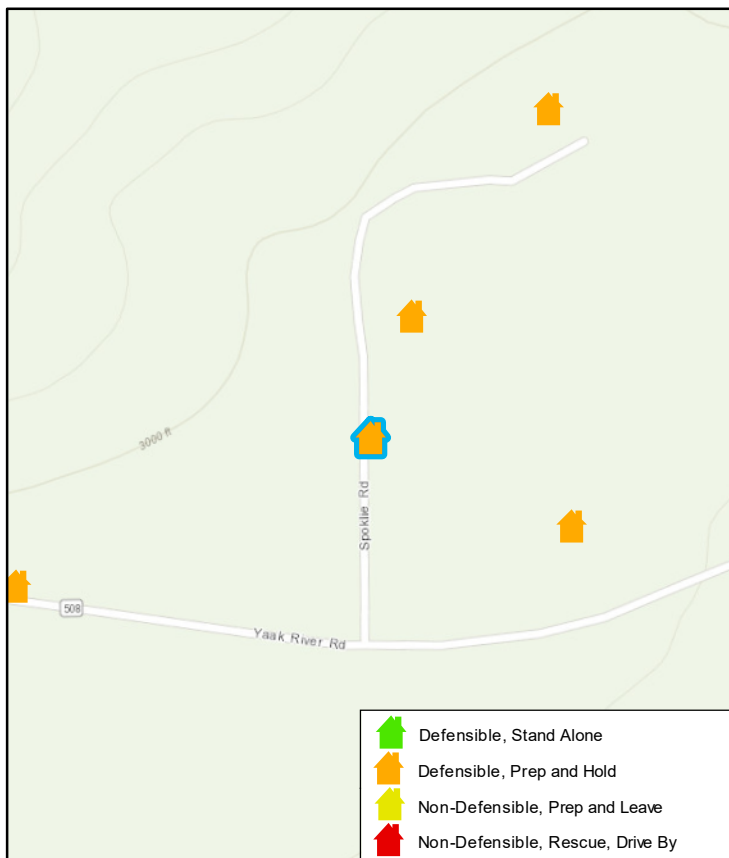
Davis Structure Assessment #7

Hazard Notes: Large woodpiles behind the primary residence. Numerous building materials and gardens within 30 feet of residence

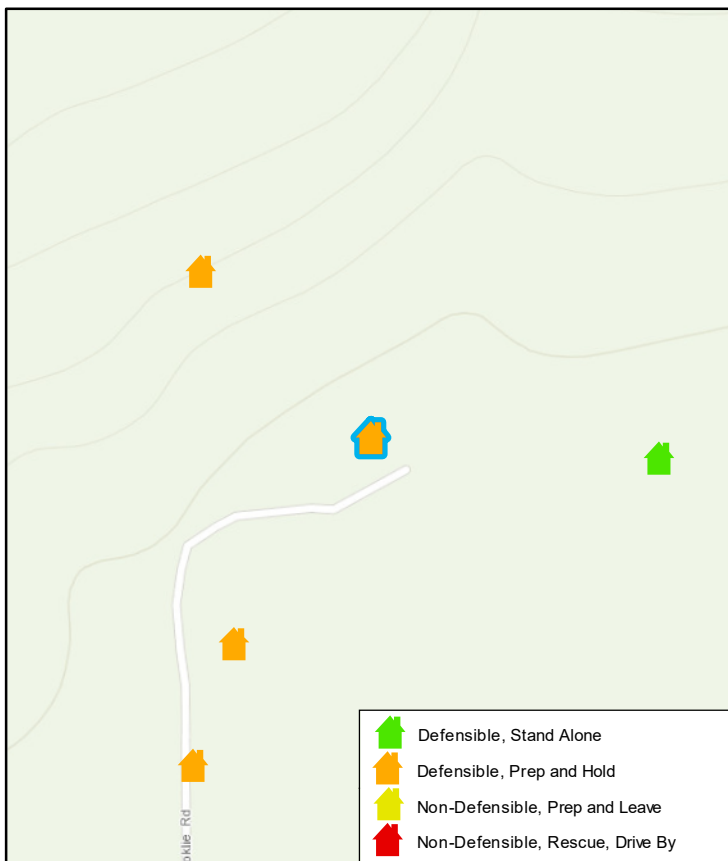
Davis Structure Assessment #9

Hazard Notes: Open faced garage/woodshed 30 feet from primary residence. Abandoned delapidated wood framed greenhouse on south side primary residence Empty log cabin 300 feet from primary

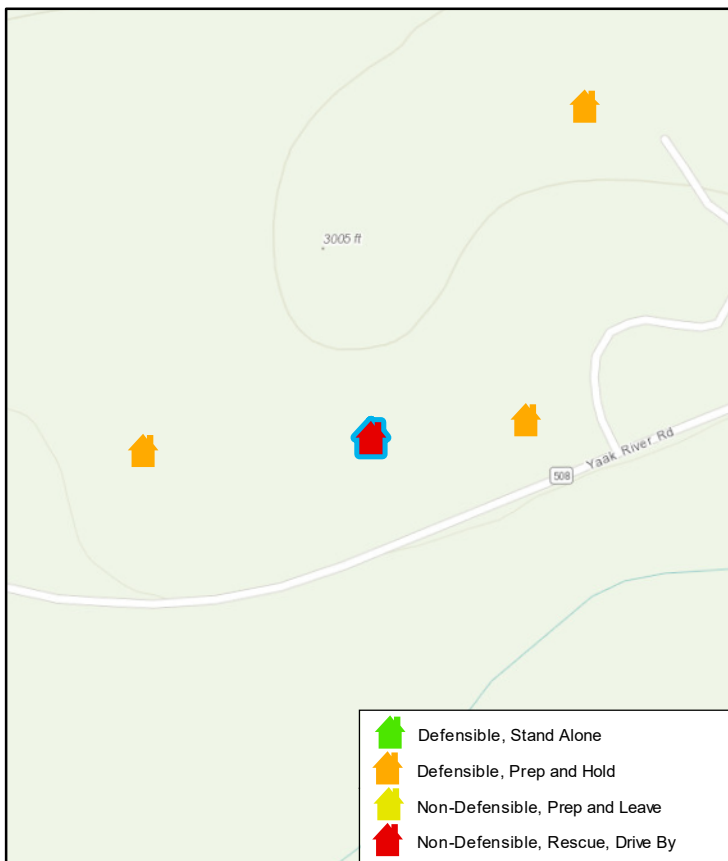
Davis Structure Assessment #14

Hazard Notes: Houses are partially built with a travel camper too. Numerous yard hazards. Little defensible space. Hazardous materials and yard debris all over site.

Notes: Dangerous site. Do not over commit

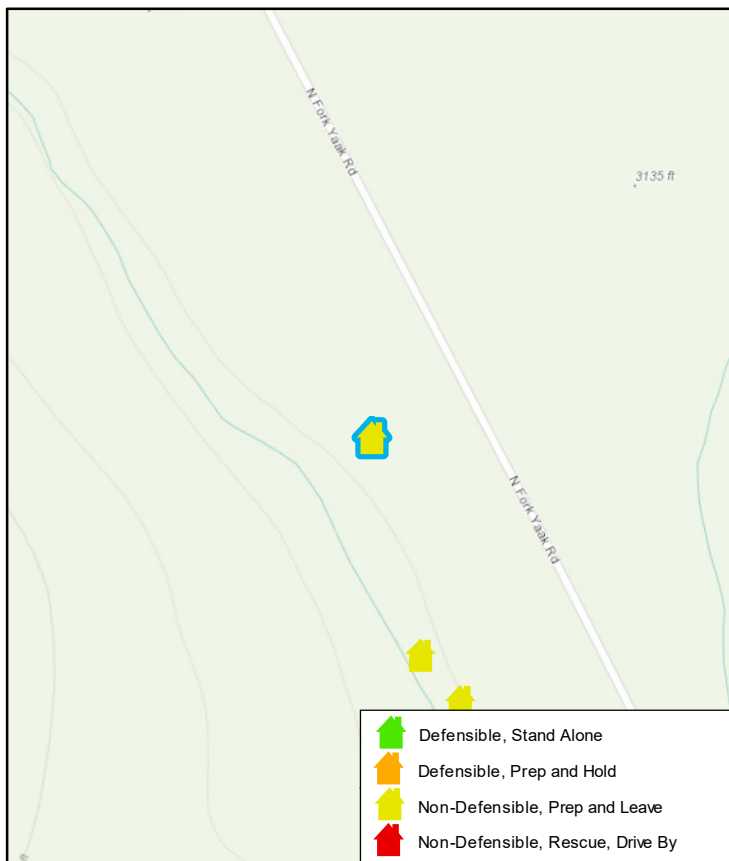
Davis Structure Assessment #47

Hazard Notes: Isolated old hunting cabin. Large snag 50 feet from cabin. Unmowed grassey fuels around cabin. Woodpiles under cabin eaves

Resources Needed to Protect Structure: Class C Faller to drop 18 " DBH snag. Mark 3 Pump kit 500 x 1.5" hose and Sprinkler Kit, Weedeater or Dozer

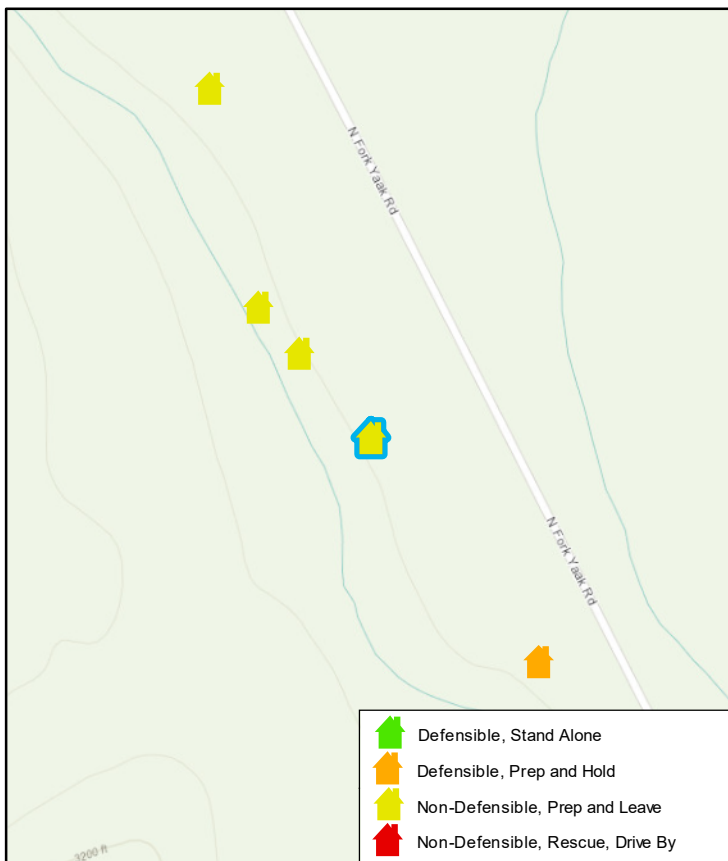
Davis Structure Assessment #52

Hazard Notes: Ancient hunt and fishing cabin with poor shake roof. Woodshed within 20 feet of cabin. Tall Unmowed grass. Some yard clutter

**Resources Needed to Protect Structure: Mark 3 Pump kit
with 500 feet 1.5 hose and Sprinkler kit Falling Team**

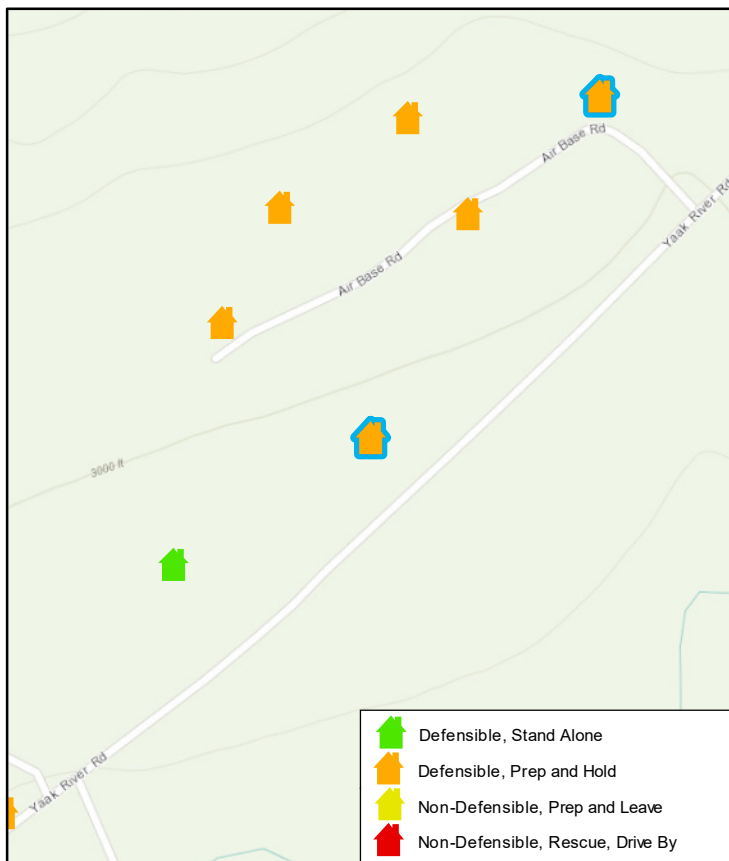
Davis Structure Assessment #56

Hazard Notes: **Large wood pile in carport. Tall snag within 20 feet of structure should be felled**
