# Davis Structure Assessment #1

Collected Date/Time: 8/25/2018 9:24:01 PM, Collected By: Eric J Kurtz STPS Incident Number: MT-KNF-000161

**Location: 28933 Yaak River Road (Hwy 508) , Yaak**

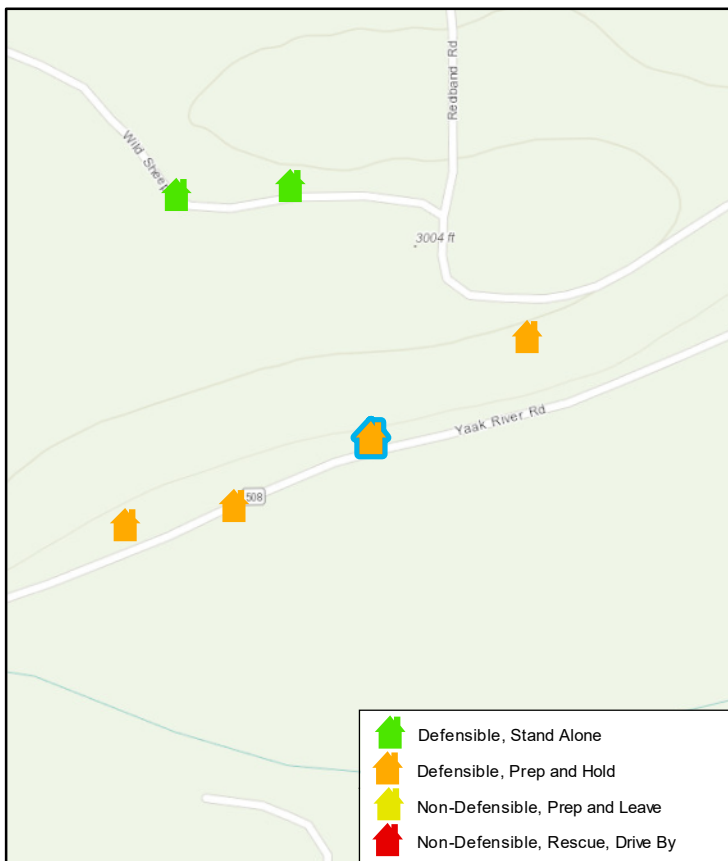
**Hazard Notes: Wood pile within 20 feet front door. Rear porch exposed to hillside**

**Notes: Large pond directly across the road for portable pump or helicopter bucket dip site. Maybe shallow during drought years**

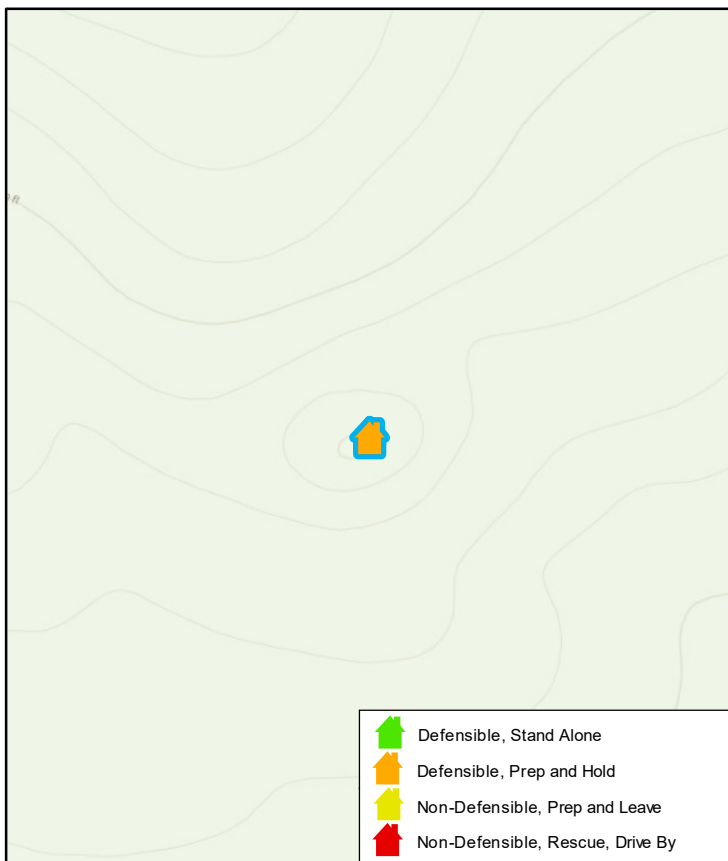
## Davis Structure Assessment #2

**Hazard Notes: Large ammo cache in primary structure . Large covered woodpiles next to residence. Very long narrow switchback driveway with deep water bars to structures. Lots of building materials piled on**

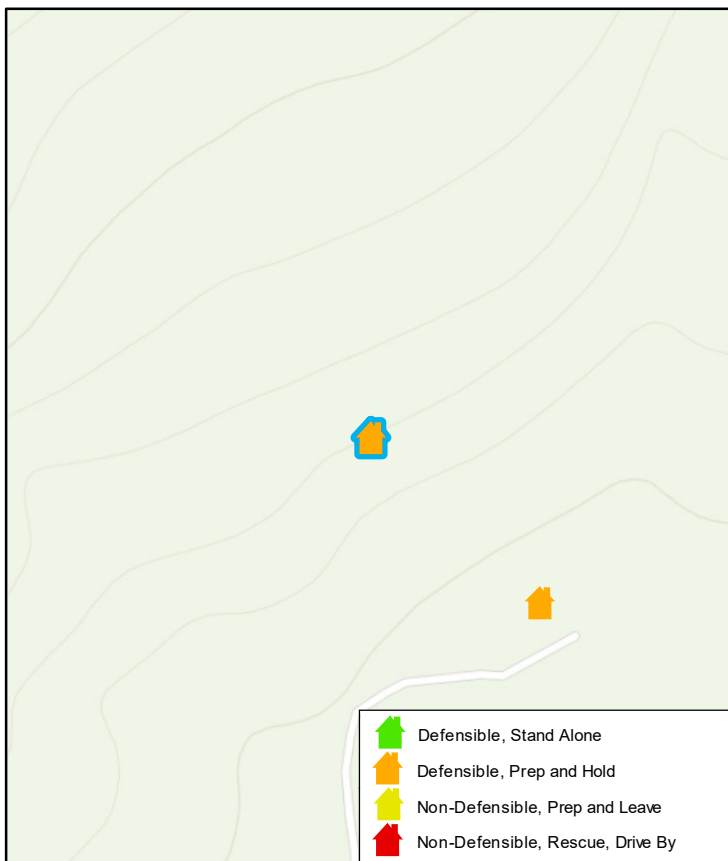
### Davis Structure Assessment #3

**Hazard Notes: Large woodshed 30 feet north side of home. Dry irrigation ditch behind residence. Generator in well house front yard exit to well head. Open shed with vehicles. Partial above ground**

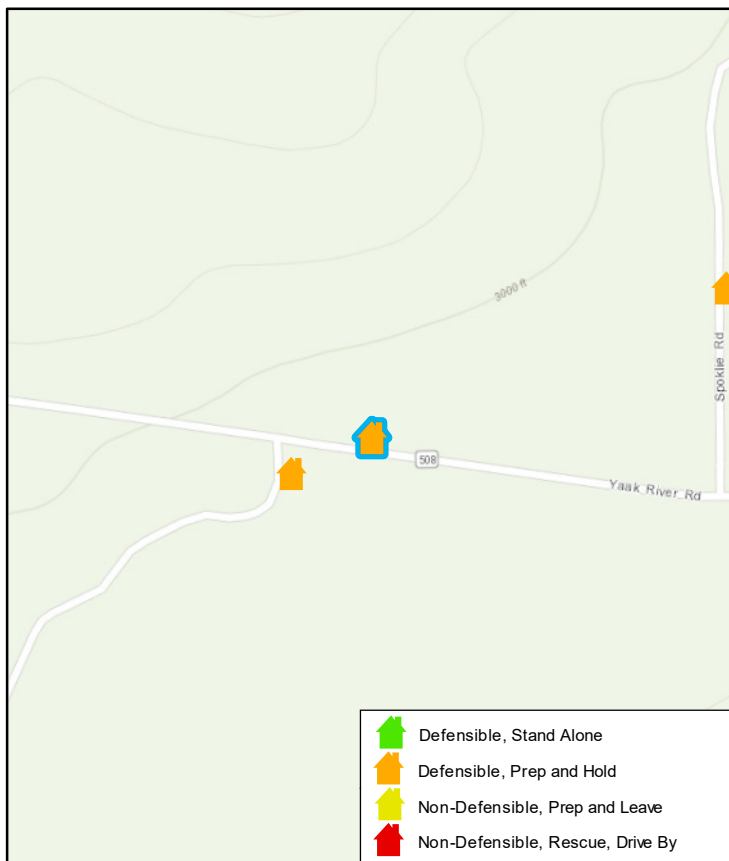
# Davis Structure Assessment #4

**Hazard Notes: Lots of miscellaneous vehicles in front of residence and shop building. Firewood pile within 30 feet of residence. Large cache of firearms and ammunition. Tire pile and abandoned vehicles**

**Resources Needed to Protect Structure: Type 2 Water Tender**

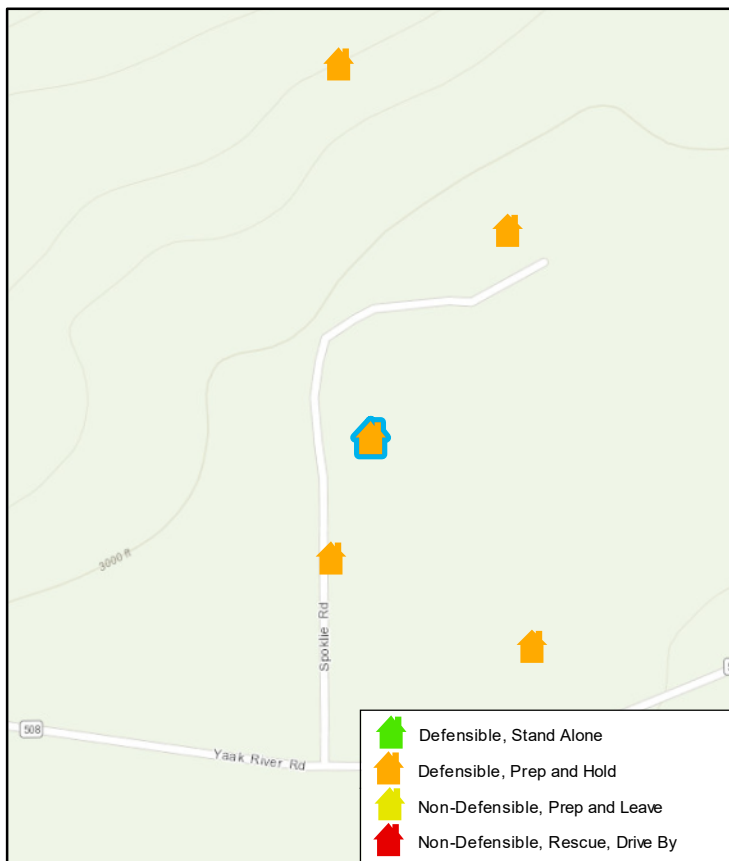
# Davis Structure Assessment #5

**Hazard Notes: Shop twenty feet from residence with primary woodpile. 300 long woodshed 35 cords of split firewood 200 feet away from front of residence.**

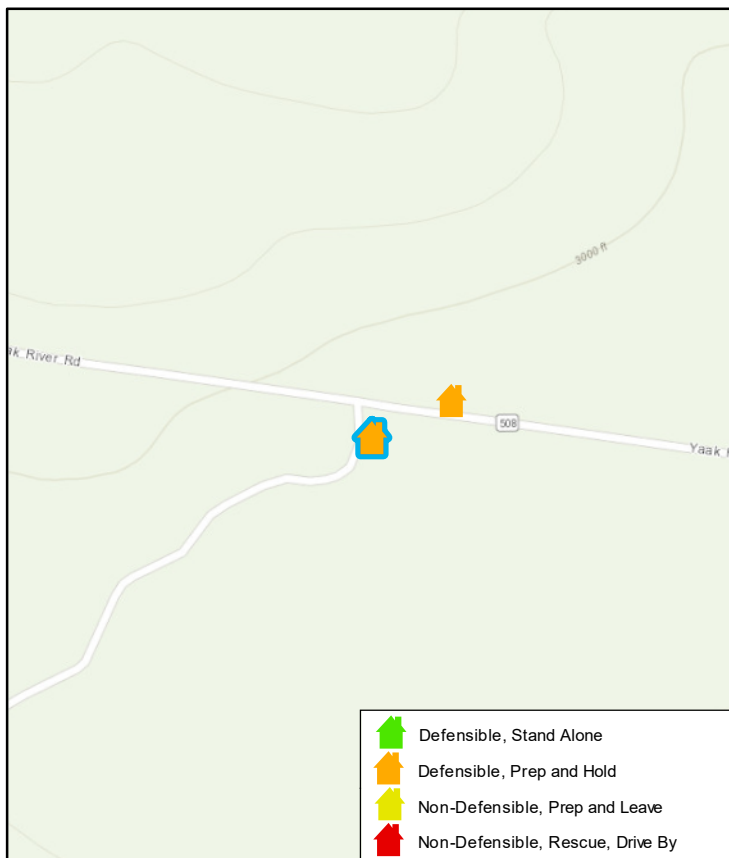
## Davis Structure Assessment #6

**Hazard Notes: Lots of miscellaneous vehicles in front of residence. Firewood pile within 30 feet of residence.**

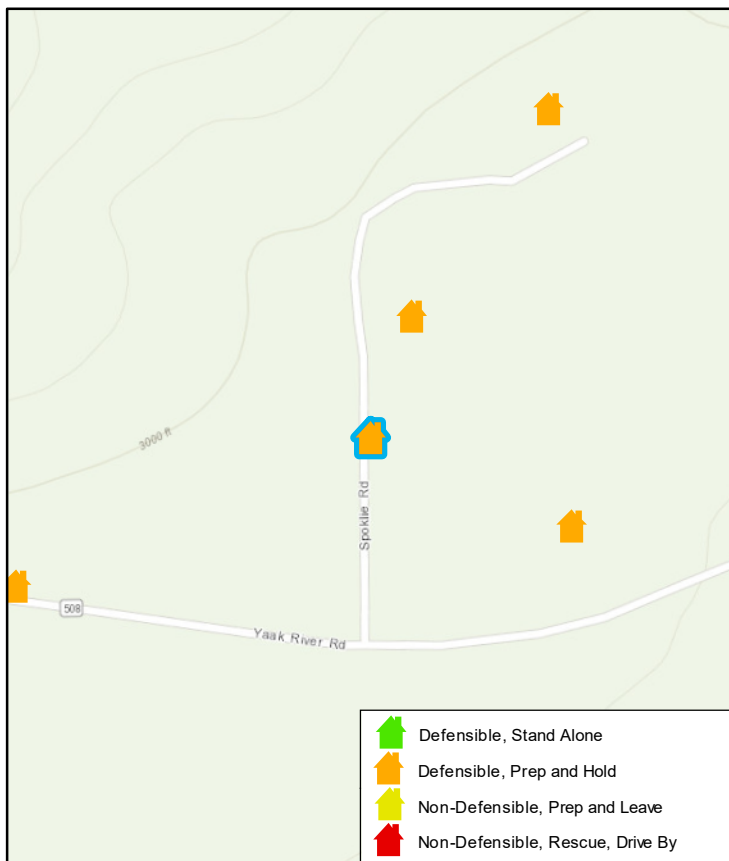
# Davis Structure Assessment #7

**Hazard Notes: Large woodpiles behind the primary residence. Numerous building materials and gardens within 30 feet of residence**

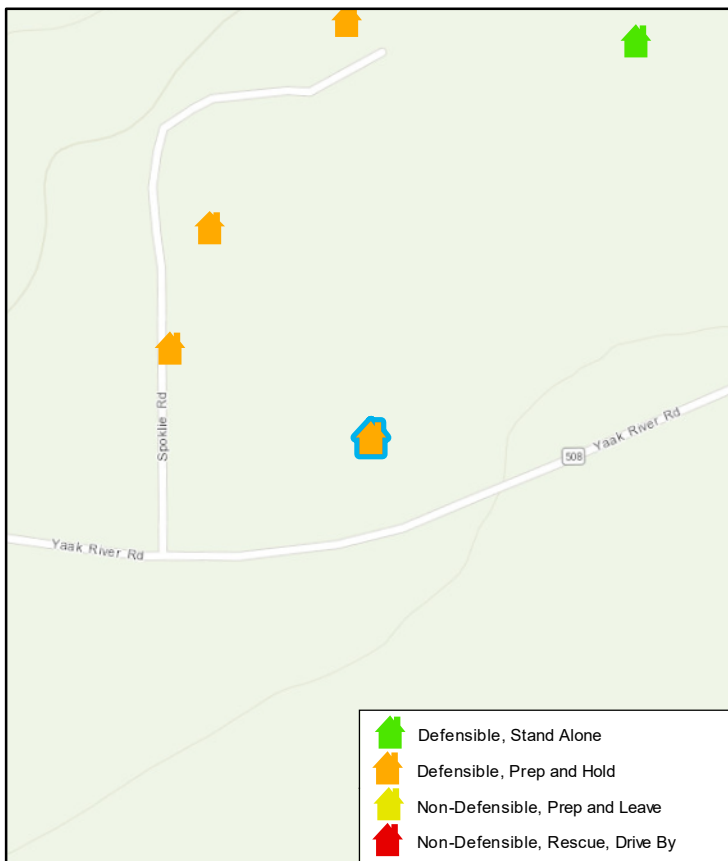
## Davis Structure Assessment #8

**Hazard Notes: Slash pile and small woodpiles 30 feet from primary residence above Church Some yard debris directly behind residence**

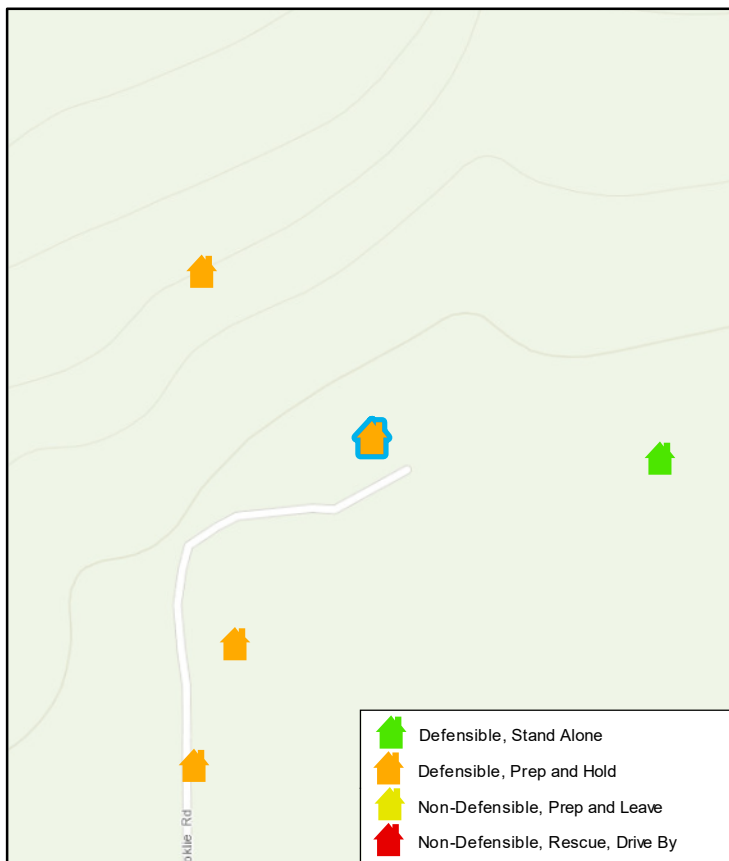
# Davis Structure Assessment #9

**Hazard Notes: Open faced garage/woodshed 30 feet from primary residence. Abandoned delapidated wood framed greenhouse on south side primary residence Empty log cabin 300 feet from primary**

**Resources Needed to Protect Structure: Short handcrew with weed eaters**

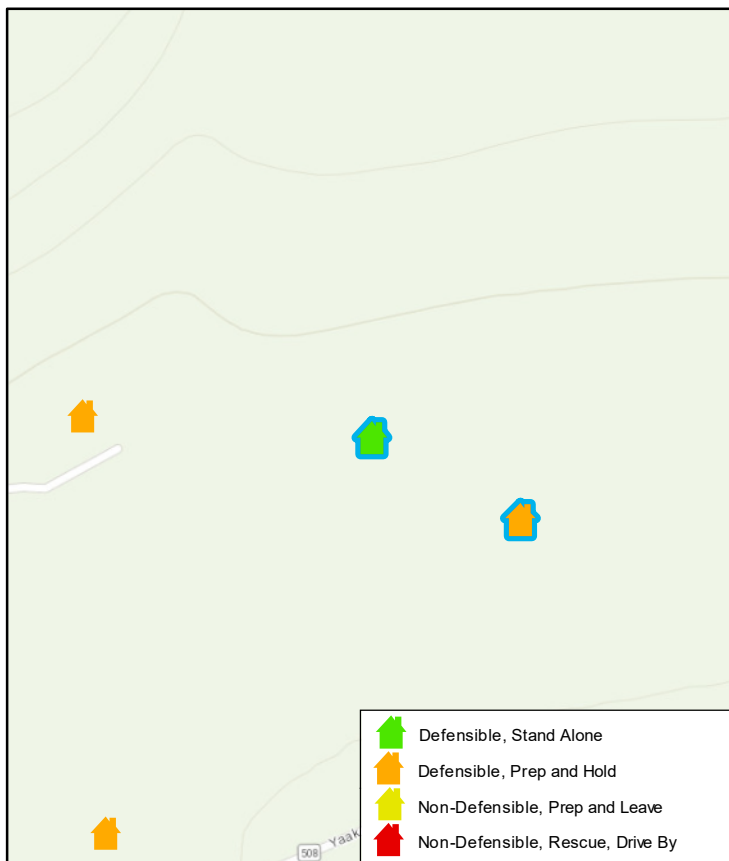
# Davis Structure Assessment #10

**Hazard Notes: Currently has dozer piles and red slash within 50 feet of primary residence from Defensible Space mitigation work past few months. Some miscellaneous yard debris Woodshed is 30 feet in front**

**Resources Needed to Protect Structure: None once the slash and dozer piles are burned after 2018 fall rains. John Deere tractor backhoe on site too**

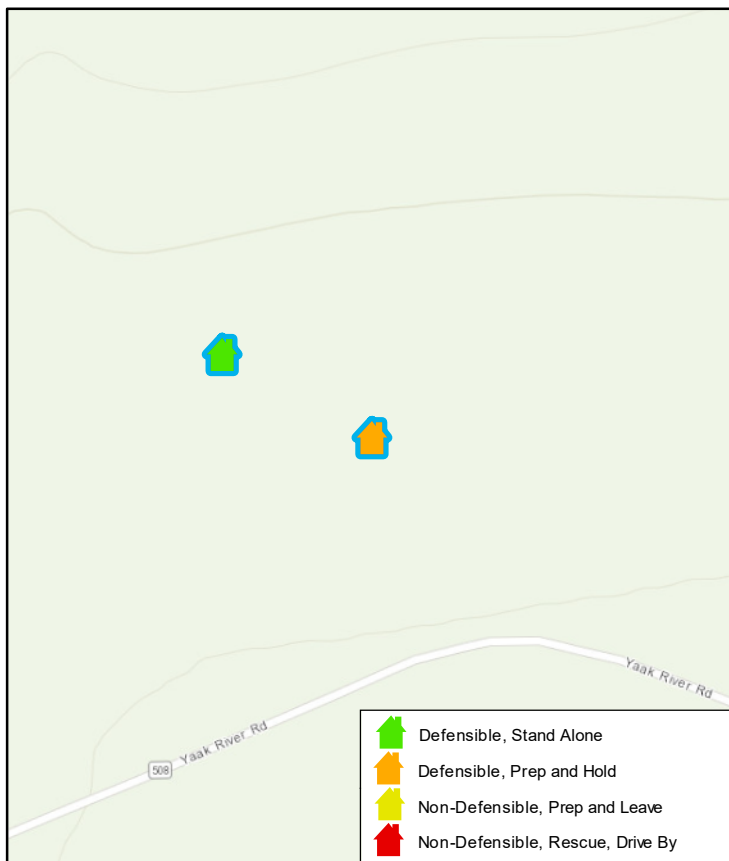
# Davis Structure Assessment #12

**Hazard Notes: Four cords of wood stacked on residence porch. Woodshed within 30 feet of residence. Tall uncut grass and weeds all around structure. Partially brushed in tight narrow driveway access**

**Resources Needed to Protect Structure: Short Handcrew with weed eaters**

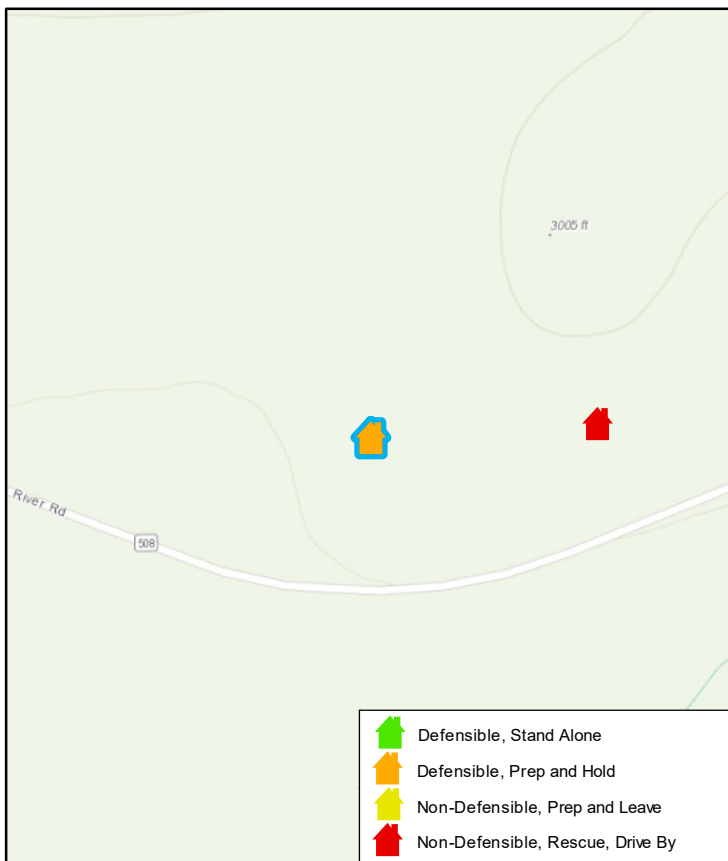
# Davis Structure Assessment #13

**Hazard Notes: Recently logged 20 acres seed tree cut. Scattered Dozer piled red slash and decked logs. Skidder and excavator on site. Feed straw and hay stacked within 30 feet of residence. Hogs in pen next**

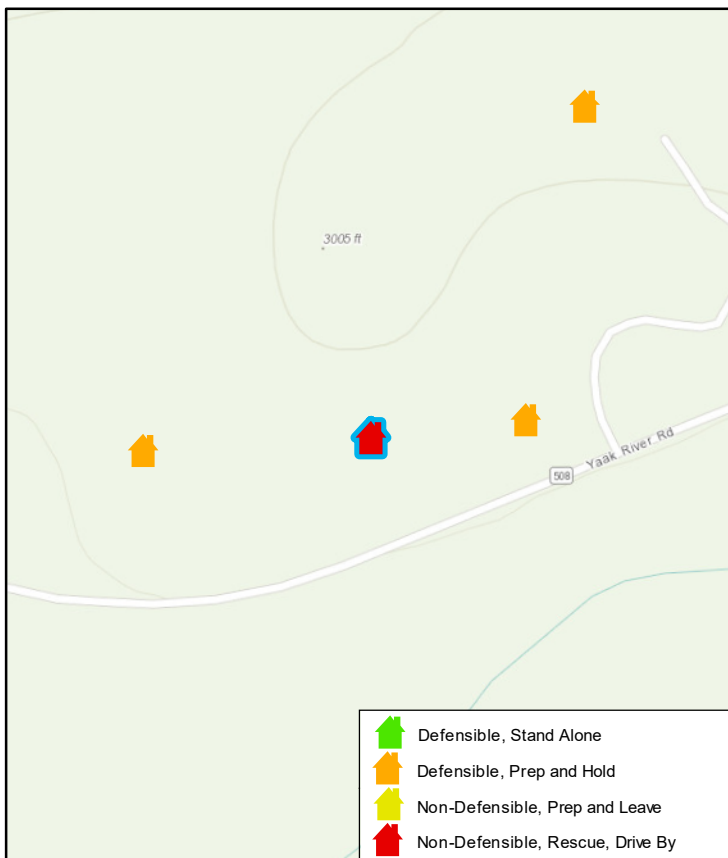
# Davis Structure Assessment #14

**Hazard Notes: Houses are partially built with a travel camper too. Numerous yard hazards. Little defensible space. Hazardous materials and yard debris all over site.**

**Notes: Dangerous site. Do not over commit**

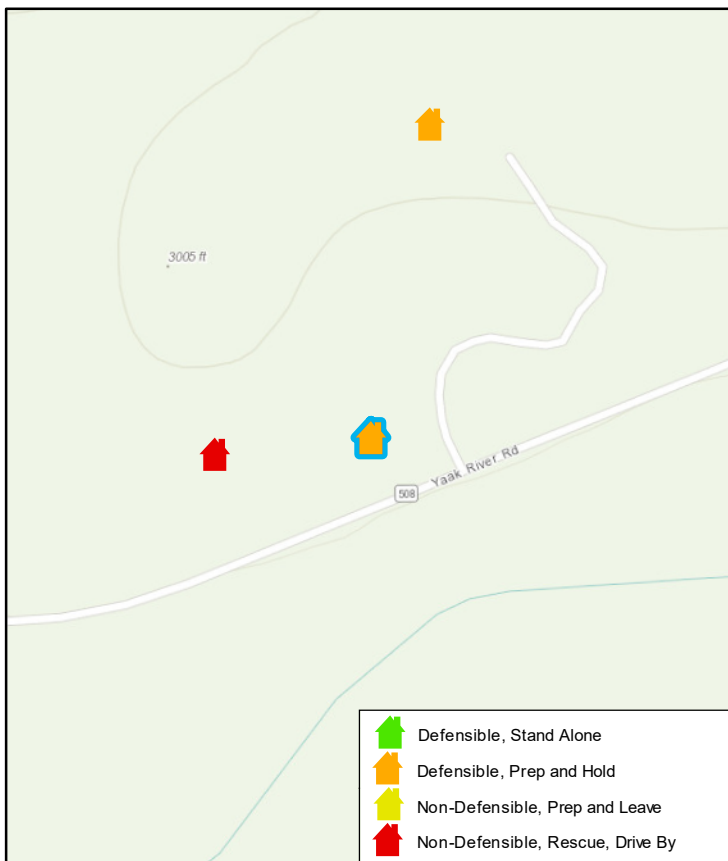
# Davis Structure Assessment #15

**Hazard Notes: Large woodshed 10 feet from shop and house. Wood walk way from house to shop**

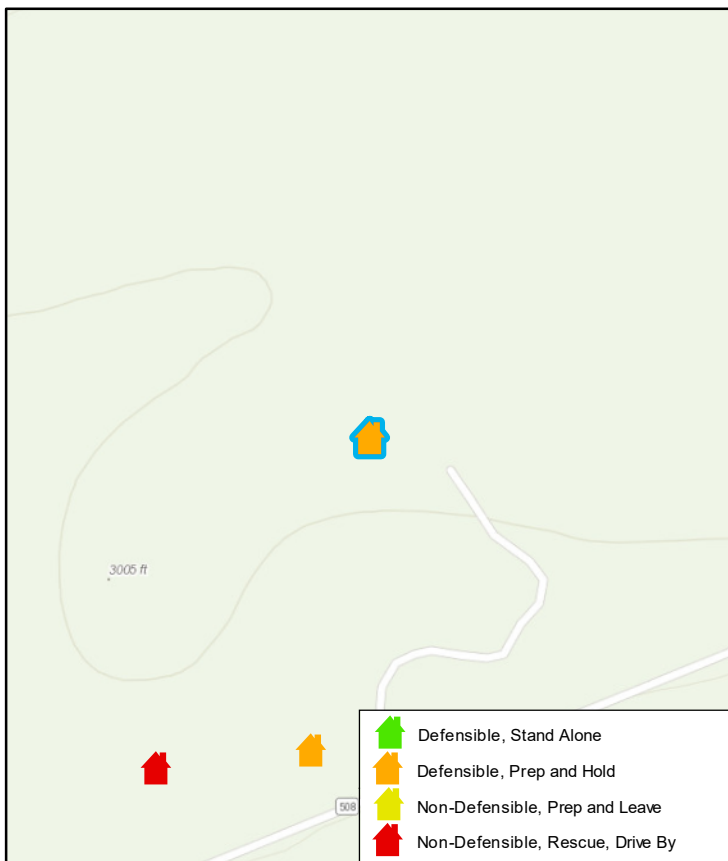
# Davis Structure Assessment #16

**Hazard Notes: Tall amature radio antenna on site. Red slash and dozer piles within 100 feet of primary residence and garage shop SW adjacent property.**

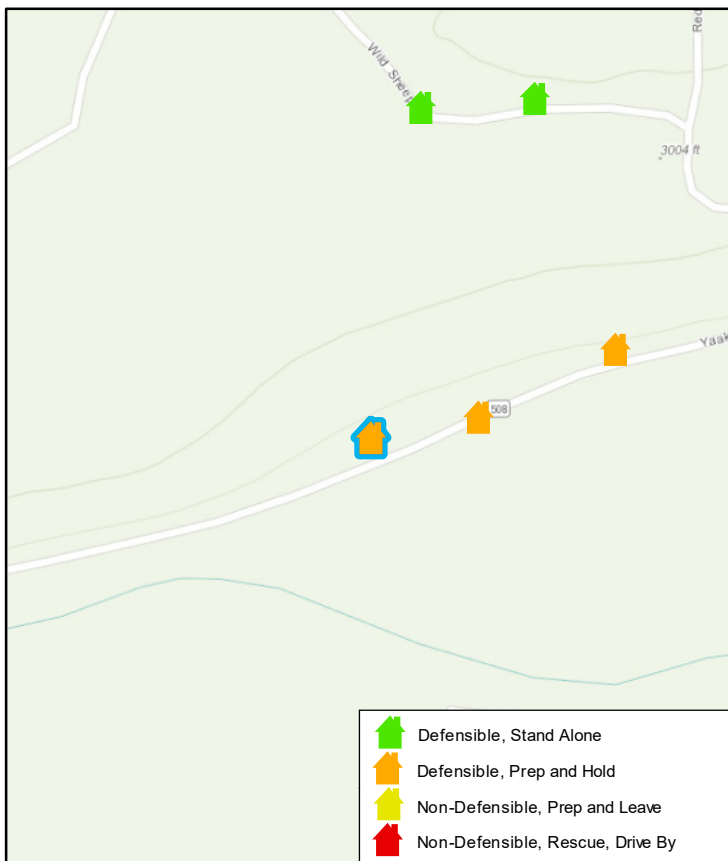
# Davis Structure Assessment #17

**Hazard Notes: Timber within 20 feet rear of residences. Large larch trees in front of residences  
Unmowed grass upto back door**

**Resources Needed to Protect Structure: Set up  
sprinklers behind rear of primary residence**

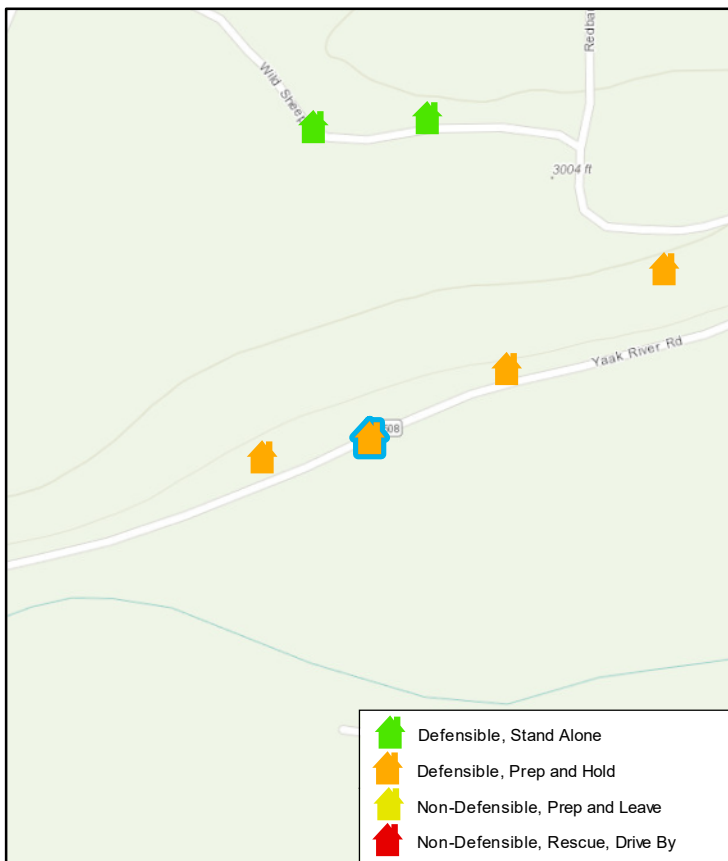
# Davis Structure Assessment #18

**Hazard Notes: Large woodpiles under open car shed leanto**

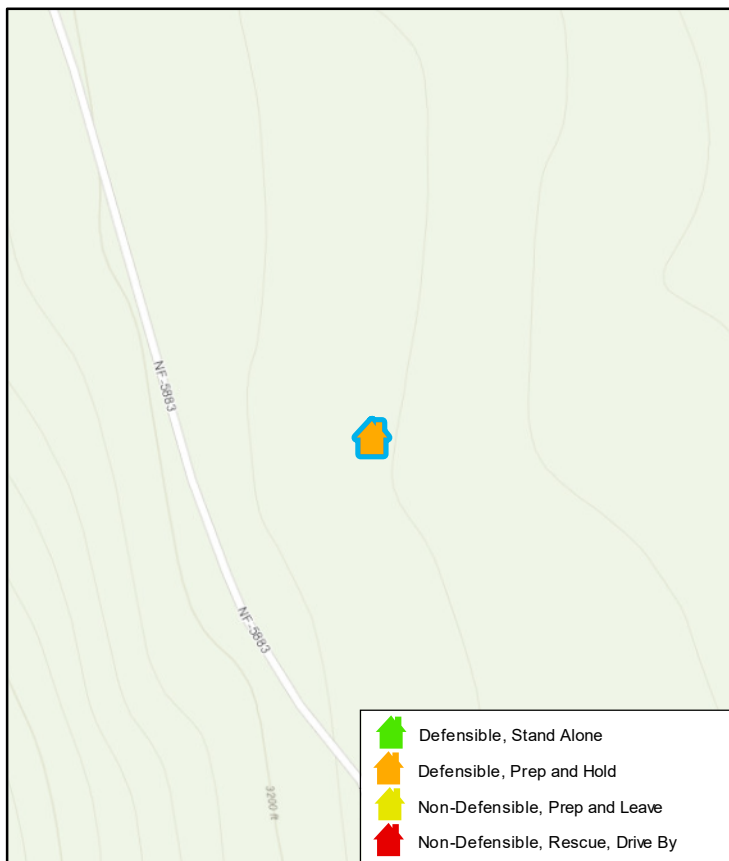
# Davis Structure Assessment #19

**Hazard Notes: Septic tank on south side of house. Woodshed within 10 feet of residence Propane BBQs and spare bottles**

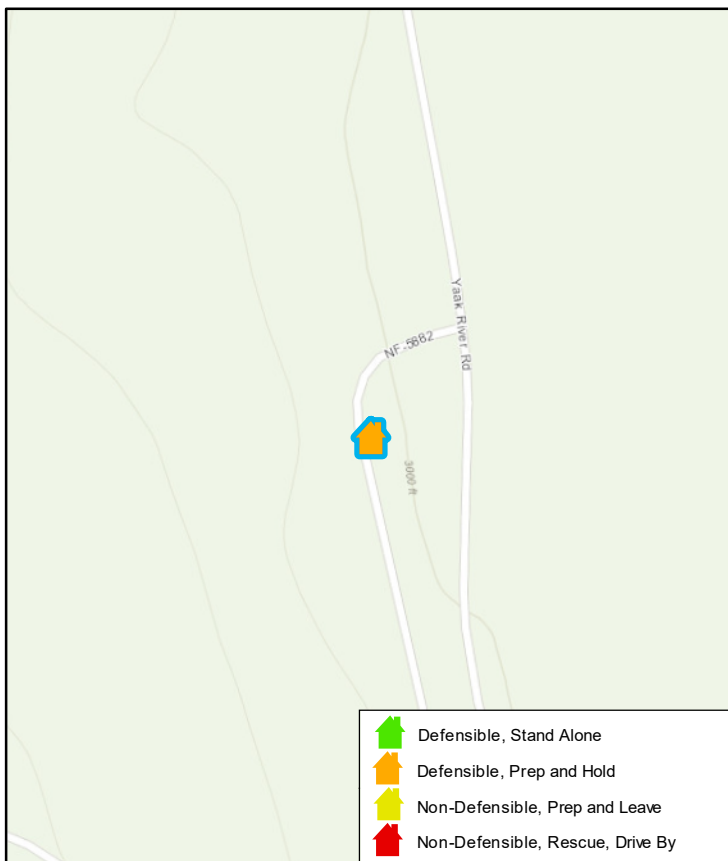
# Davis Structure Assessment #20

**Hazard Notes: Heavily brushed in access road and limited turnaround Two Unburned brush piles below rear of structure**

**Resources Needed to Protect Structure: Saw team with hand crew or feller buncher with skidder to increase Defesible Space**

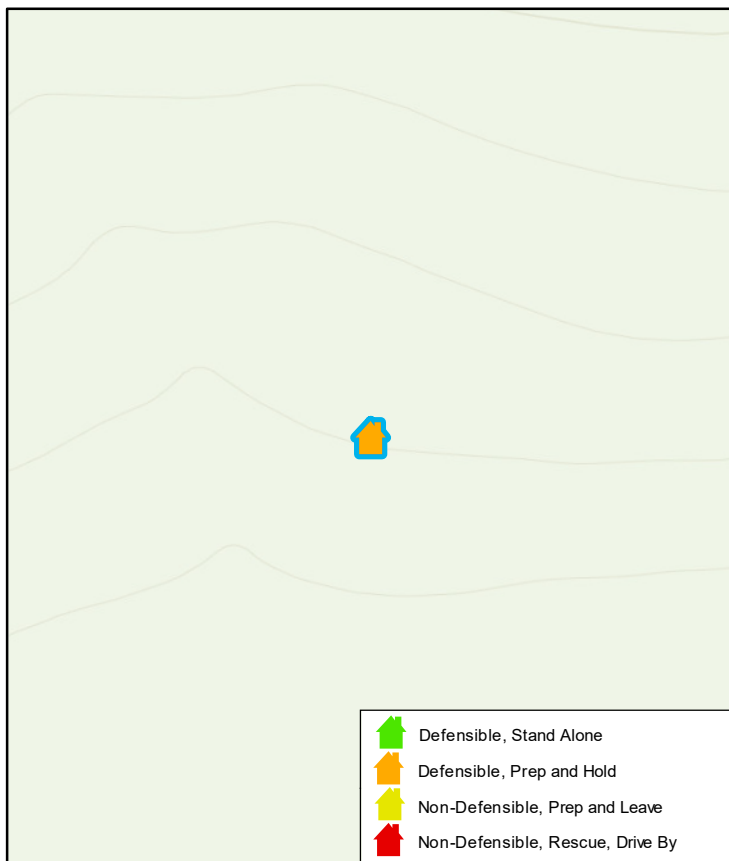
# Davis Structure Assessment #21

**Hazard Notes: Huge pile of exposed firewood. Large dead snag within 20 feet of residence. Scattered yard debri and hazmat materials. Working on creating Defesible Space.**

**Resources Needed to Protect Structure: Sprinklers set up around residence. May have to set up a folda-tank with Mark 3 pump to supply sprinklers**

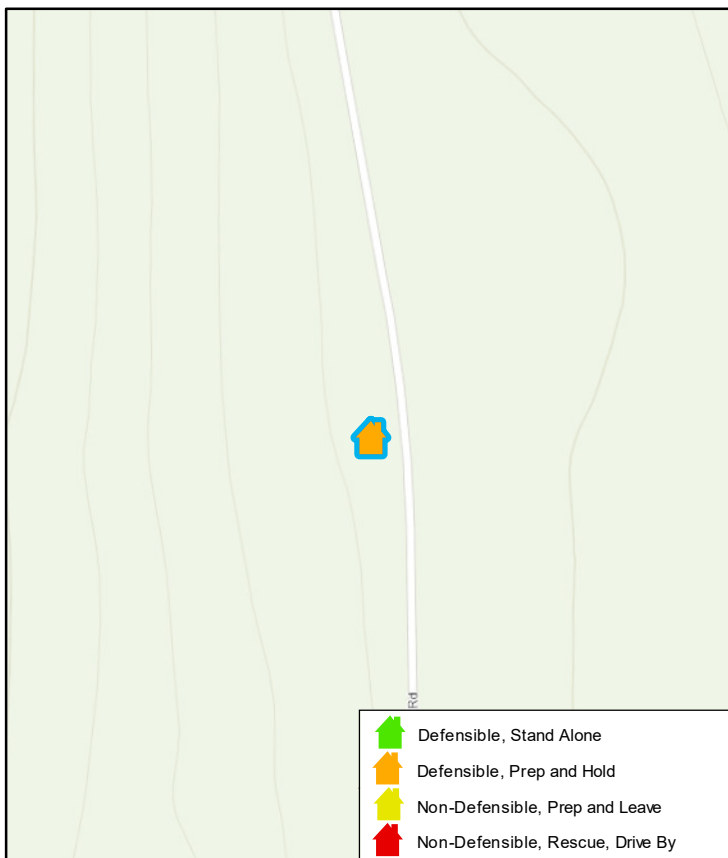
## Davis Structure Assessment #22

**Hazard Notes: Attached rear woodshed full**

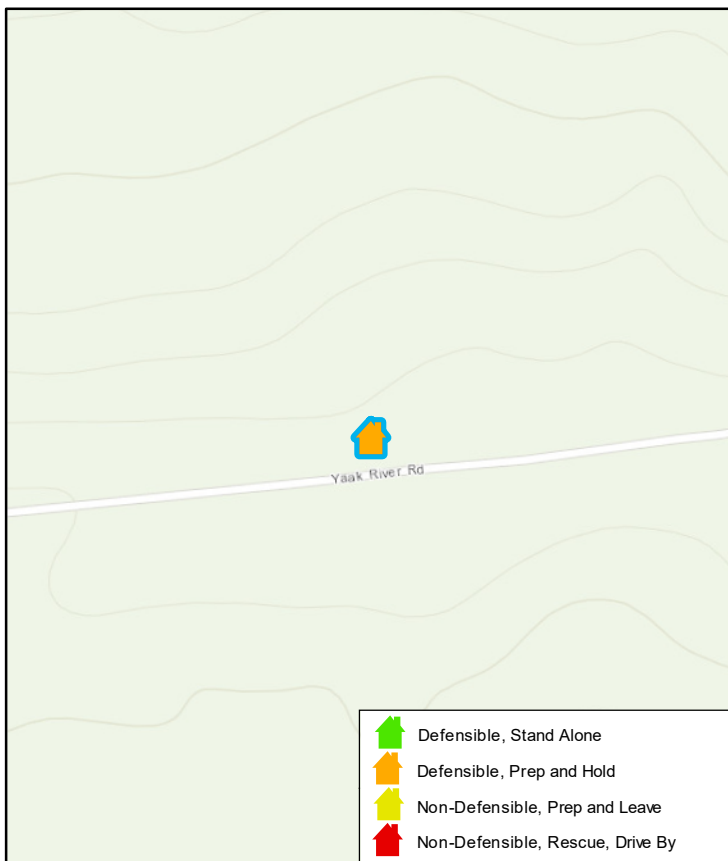
# Davis Structure Assessment #23

**Hazard Notes: Steep driveway approach. Woodpile within 10 feet of cabin**

**Notes: Could park Type 1 Engine at base of driveway hill instead of parking a Type 3 at structure**

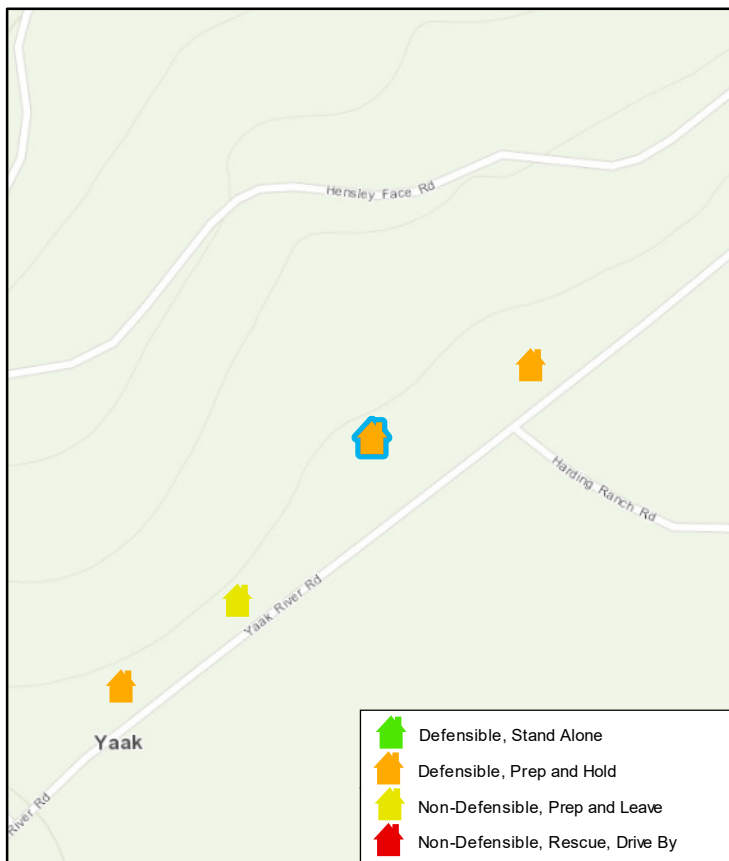
# Davis Structure Assessment #24

Hazard Notes: **Fabric covered Yurt. (Pirate's Place). Woodpiles within 30 feet of Yurt. Tight canopied lodgepole stand surrounding yurt**

Resources Needed to Protect Structure: **Saw crew**

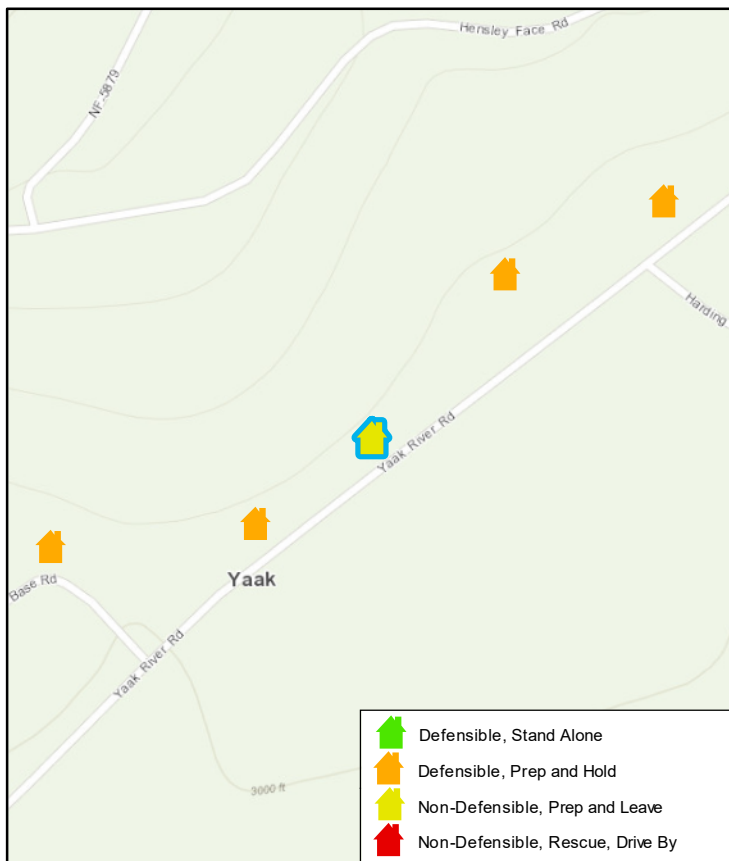
## Davis Structure Assessment #25

**Hazard Notes: Uncut grass surrounding cabins. Limited Defensible Space**

**Resources Needed to Protect Structure: Short hand crew with chainsaws and weed eater**

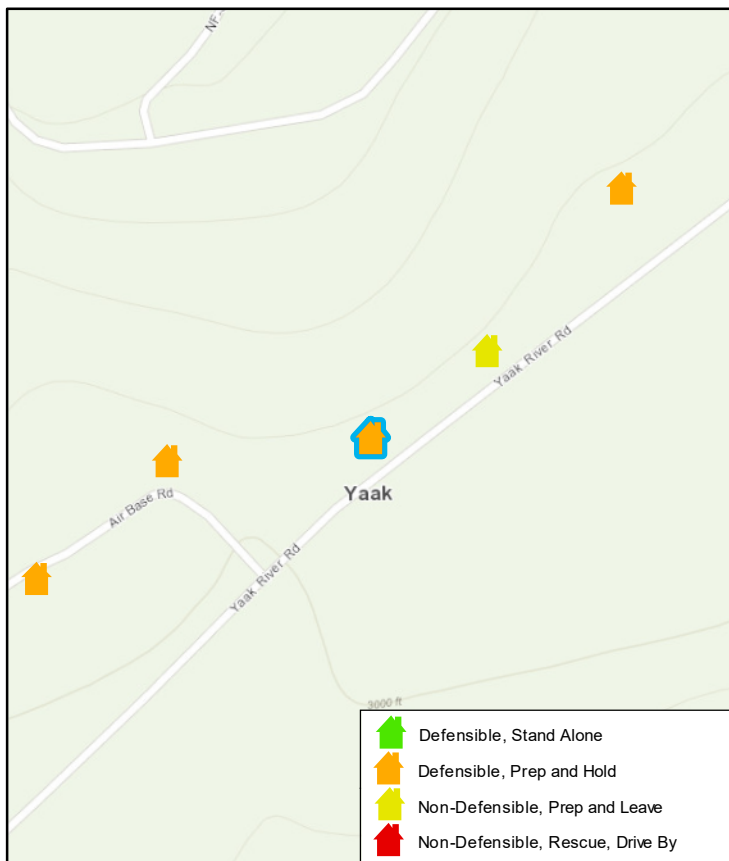
## Davis Structure Assessment #26

**Hazard Notes: Lots of yard clutter and vehicles on site BBQ Propane tanks on front porch. Open car port and shop area. Large unburied slash pile on hill above house. Large woodshed connected to rear of**

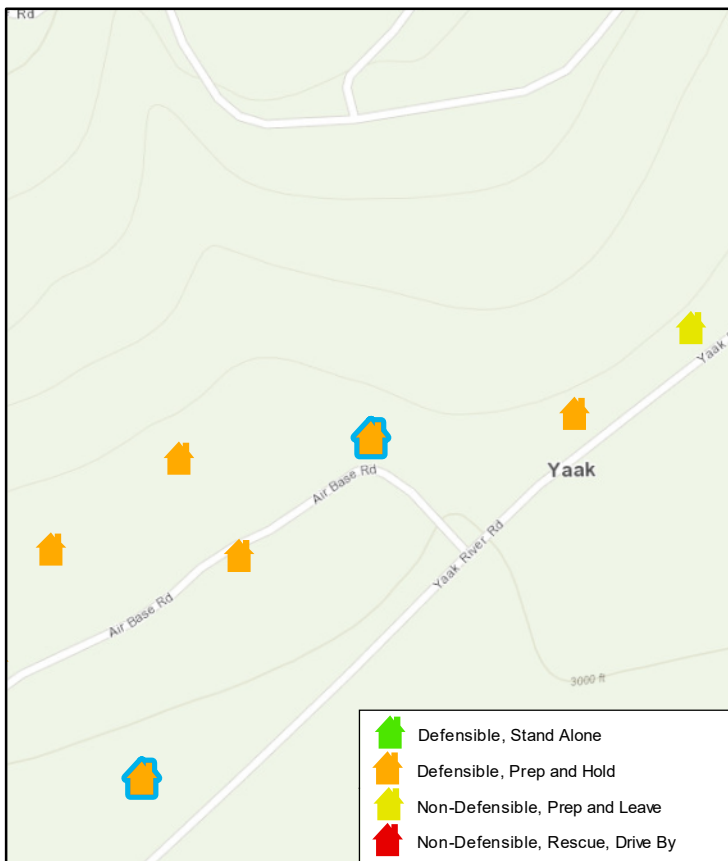
## Davis Structure Assessment #27

**Hazard Notes: Dog kennel full Two tall snags twenty feet from residence Woodpiles on side of garage/dog kennels**

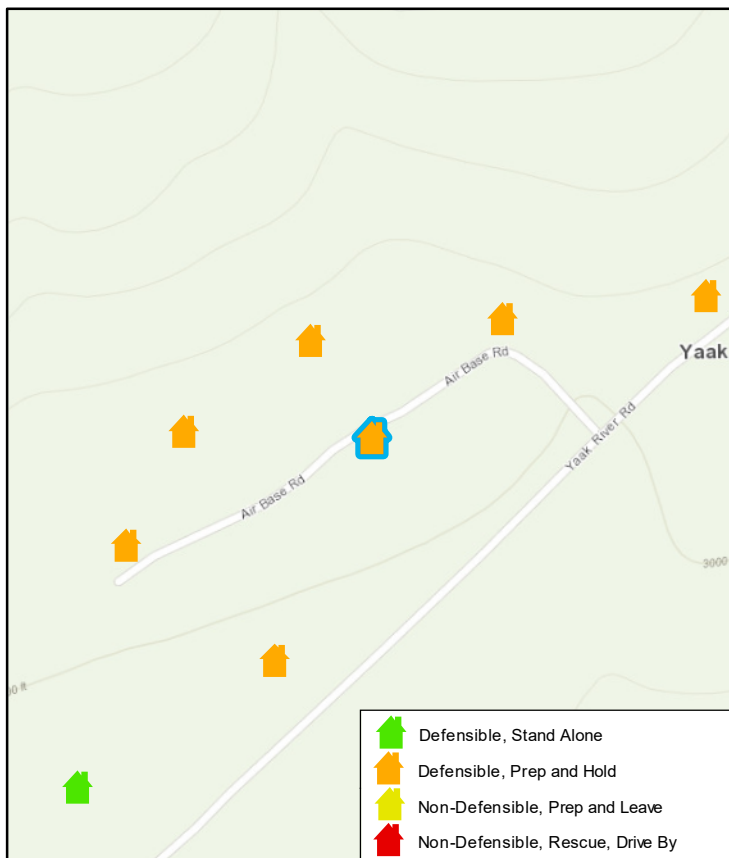
## Davis Structure Assessment #28

**Hazard Notes: Large woodpiles within 30 feet of structure. Combination shop and living quarters under construction. Cluttered yard area**

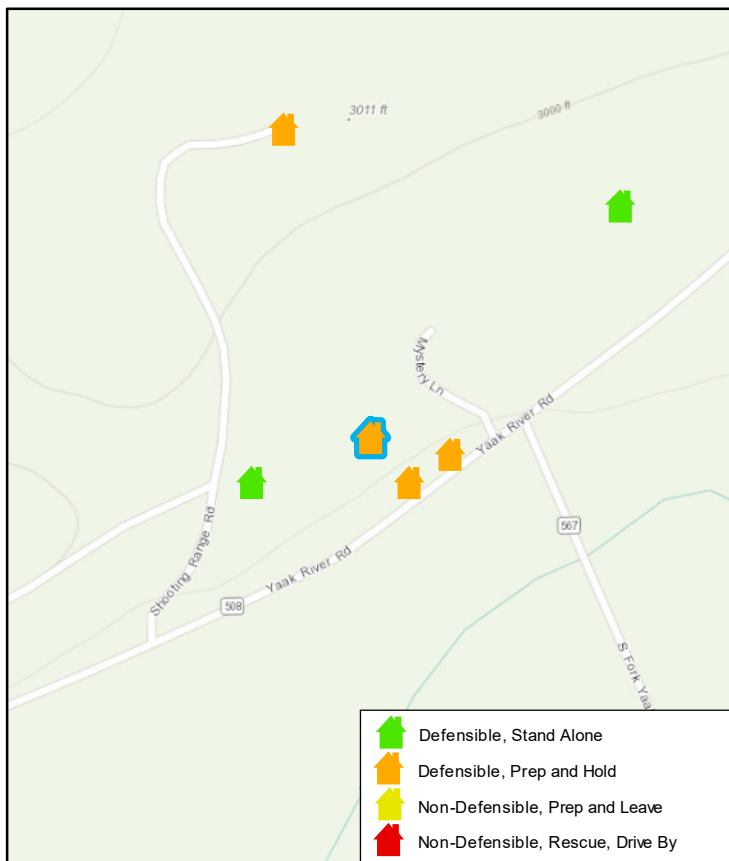
# Davis Structure Assessment #29

**Hazard Notes: Cabin rental site with a few year round residences. Seasonal RV parked too Many vehicles and yard debris on site. Crowded. High grass and knapweed needs to be weed whacked.**

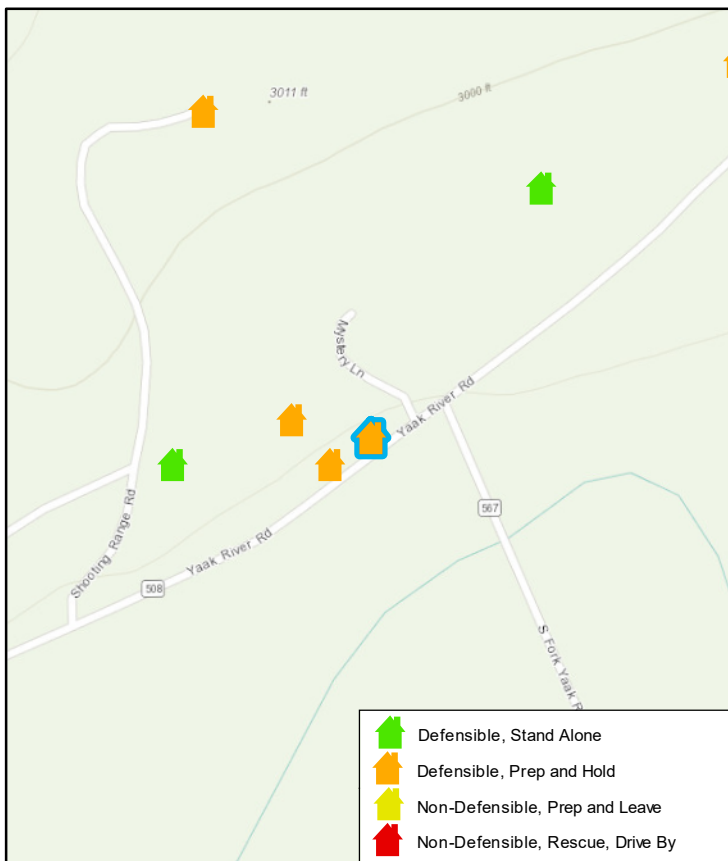
# Davis Structure Assessment #30

**Hazard Notes: Above ground 1500 Unleaded commercial fuel tank. Commercial cage of twenty 5 lb LPG tanks for sale in front of store. Large woodshed within 30 feet of store. Open aired wood band stage and**

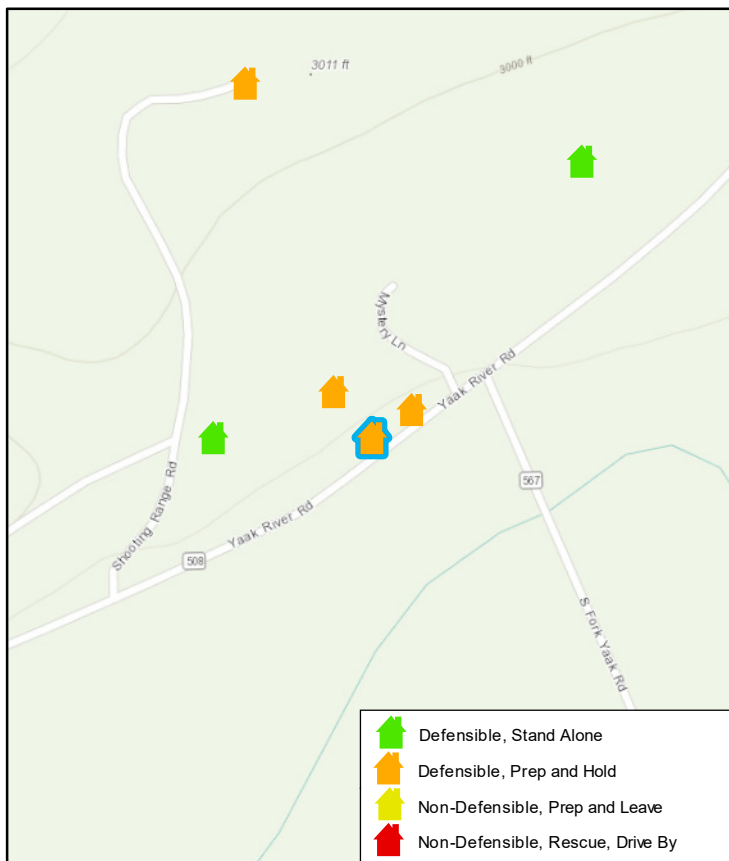
# Davis Structure Assessment #31

**Hazard Notes: 1000 gallon concrete Convault fuel cell empty. Partial shake roof. Yard debris, abandon vehicles and campers. Grassy uncut slope up against rear of buildings. Wild and crazy locals bar!!**

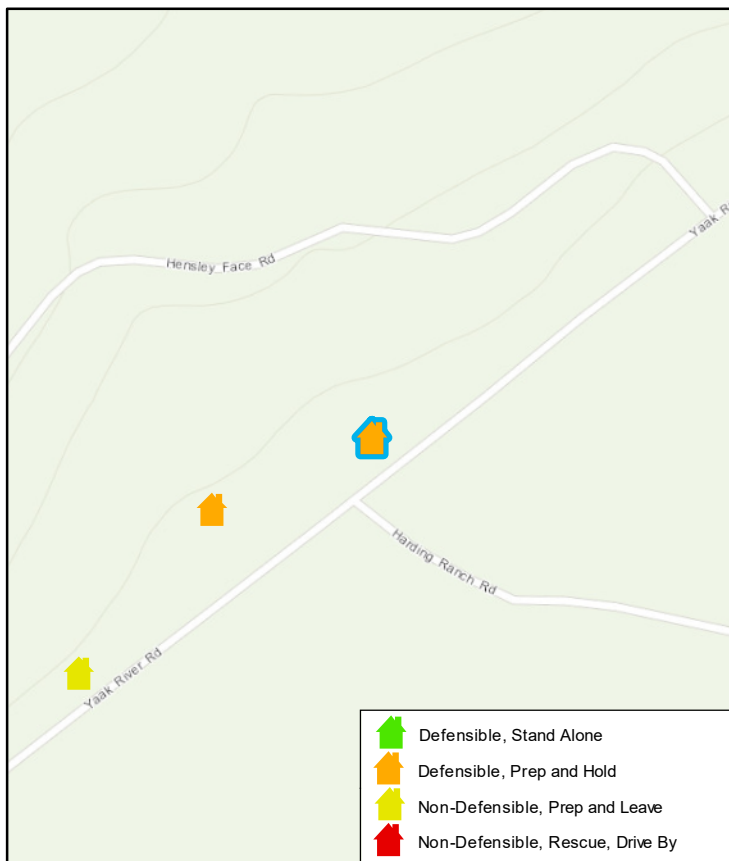
# Davis Structure Assessment #32

**Hazard Notes: Wood piles on rear deck and within 30 feet of school buildings Residence is occupied by a separate family, not the resident teacher**

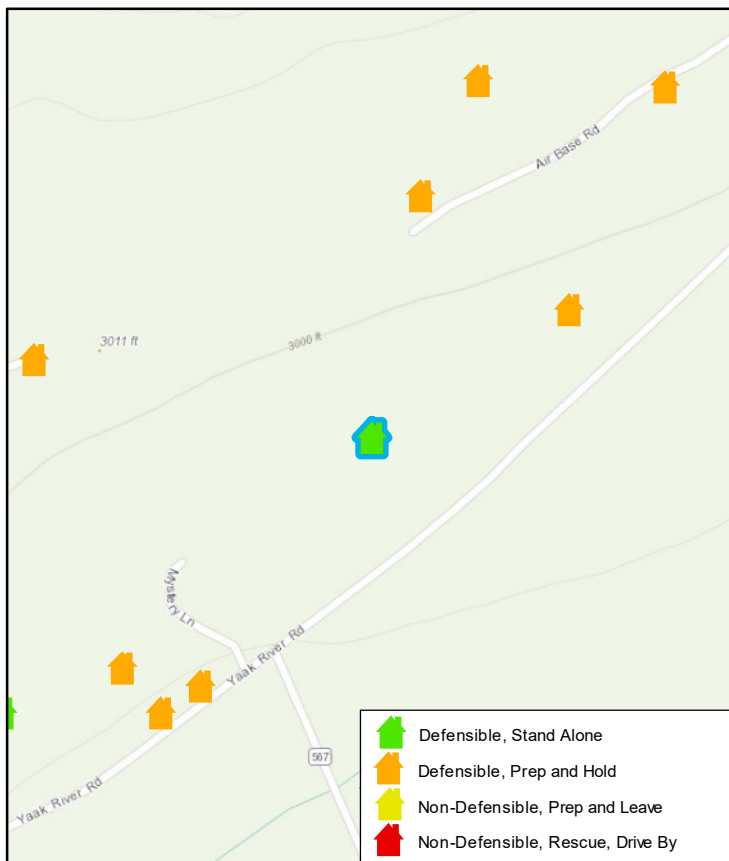
# Davis Structure Assessment #34

**Hazard Notes: Large woodshed with 30 feet of residence. Open car port area**

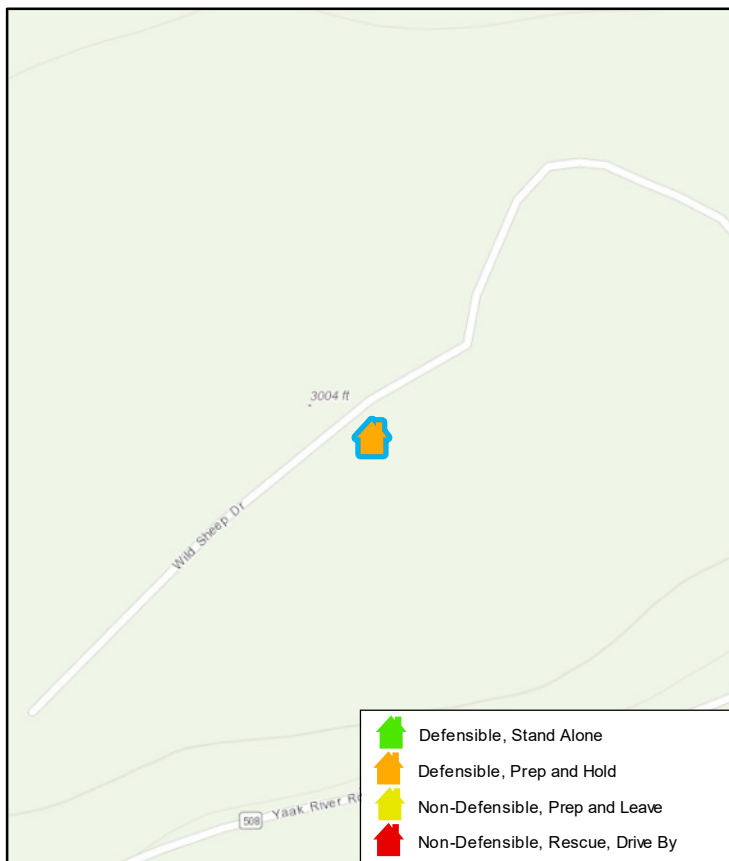
# Davis Structure Assessment #36

**Hazard Notes: Firewood piles stacked in carport, decks and two large wood sheds within 30 feet of residence. Very narrow driveway entrance steel gate**
