# Davis Structure Assessment #1

Collected Date/Time: 8/25/2018 9:24:01 PM, Collected By: Eric J Kurtz STPS Incident Number: MT-KNF-000161

**Location: 28933 Yaak River Road (Hwy 508) , Yaak**

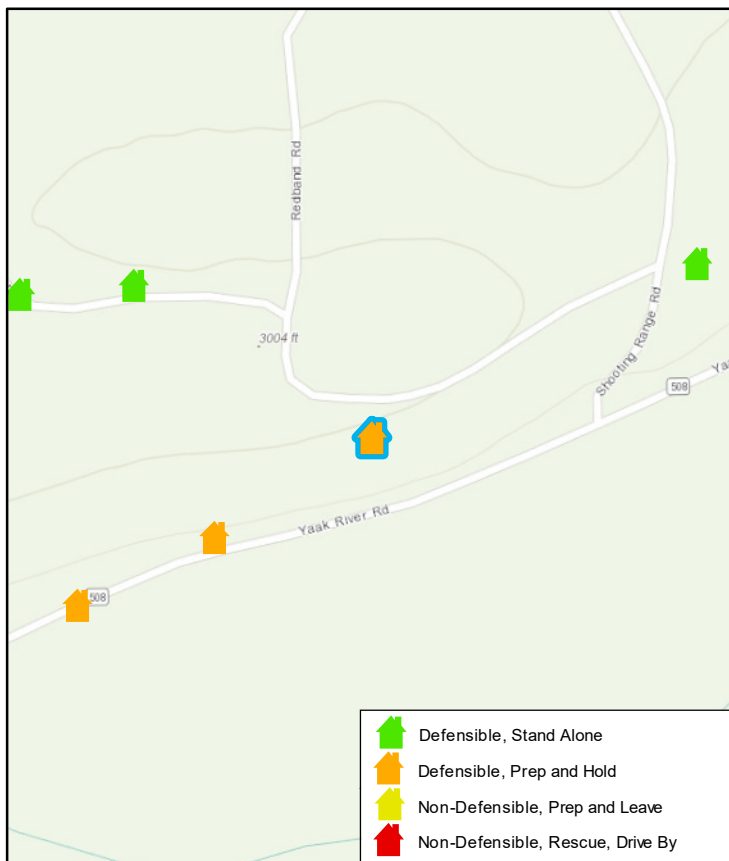
# Davis Structure Assessment #39

**Hazard Notes: Small woodpile below the deck. Woodpile street side of structure 70 percent slope open grass and weed covered leads up to rear deck. Unscreened crawl space vents ember traps**

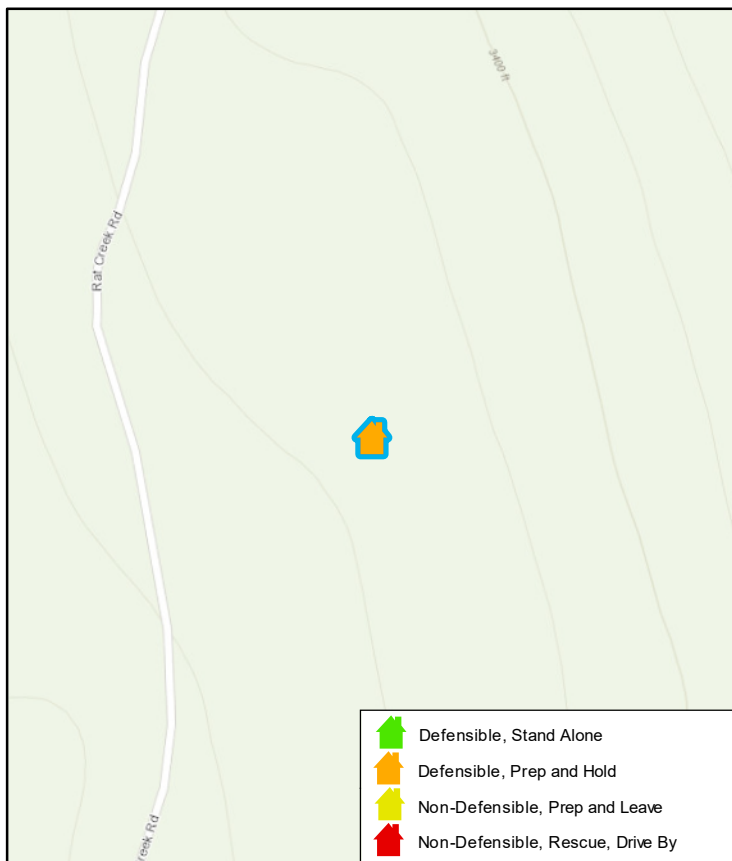
# Davis Structure Assessment #40

**Hazard Notes: Large woodpiles on decks and woodsheds Tractors on site**

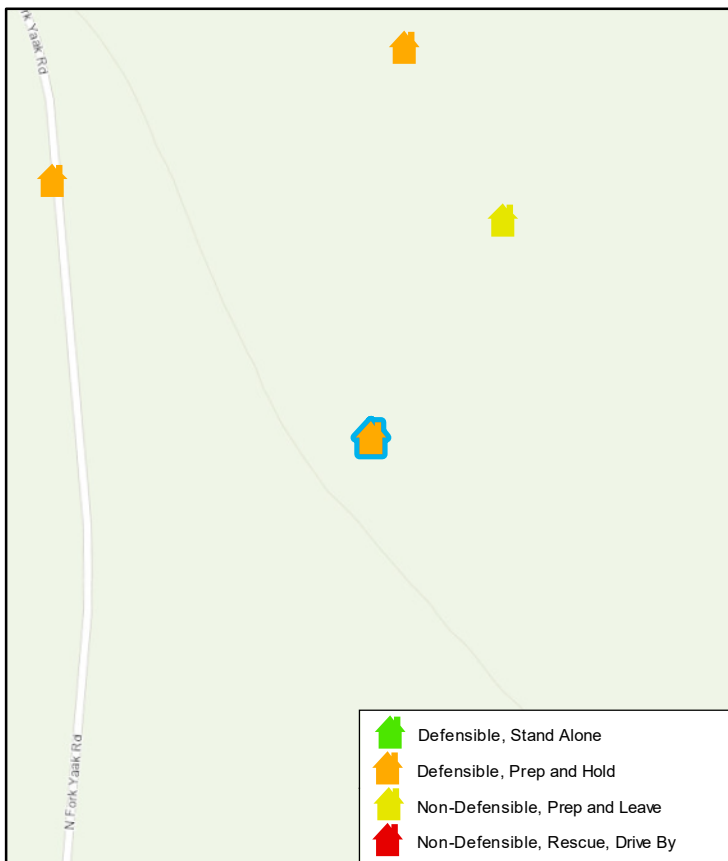
# Davis Structure Assessment #41

**Hazard Notes: Abandoned residence and 3 bay metal garage wiith unknown contents. Abandoned trucks, tractor and other vehicles. Woodpile on front porch BBQ. Unmowed grass and weeds**

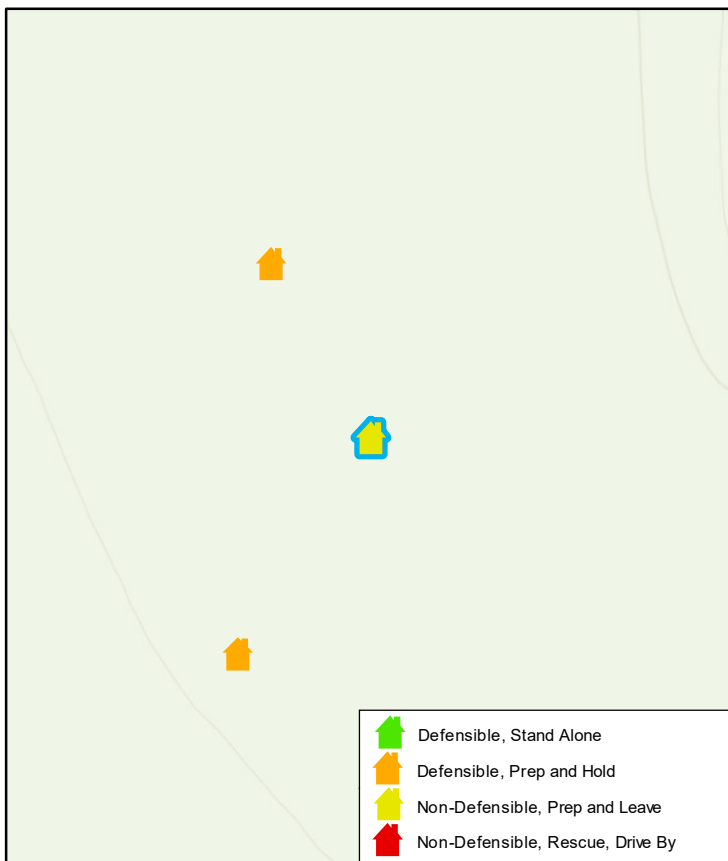
# Davis Structure Assessment #42

**Hazard Notes: Empty newly built garage with loft apartment unoccupied plus unoccupied original cabin. Unknown haz mat inside garage and surrounding structures. Old wood pile with 30 feet of structures.**

**Notes: Risk vs Gain assessment. Prep only if ample time to do so**

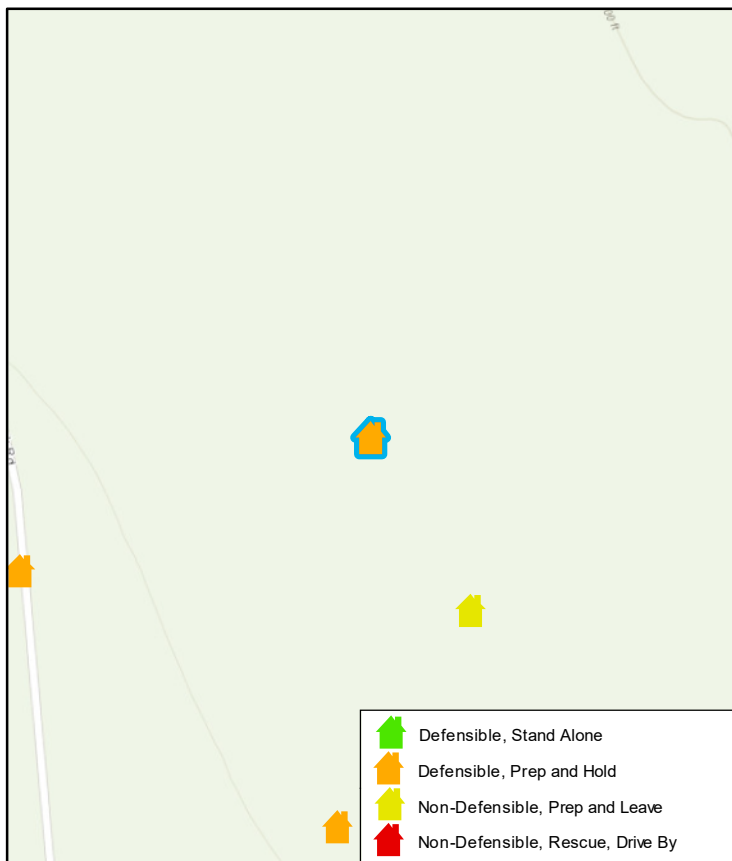
# Davis Structure Assessment #43

**Hazard Notes: Congested area around residence. Numerous woodpiles and woodshed within 30 feet of primary residence. Sapling sized pine reproduction will sustain crown fire Open block style foundation**

**Resources Needed to Protect Structure: Handcrew, Dozer, or Feller Buncher to increase Defensible Space in the pine plantation**

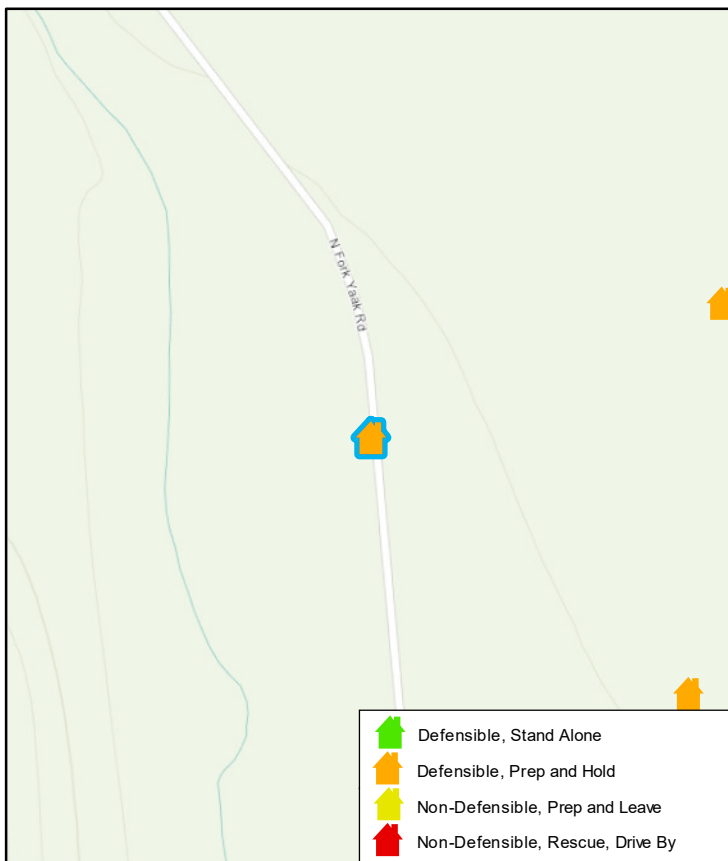
# Davis Structure Assessment #44

**Hazard Notes: Woodpiles on front porch and within 30 feet of primary residence**

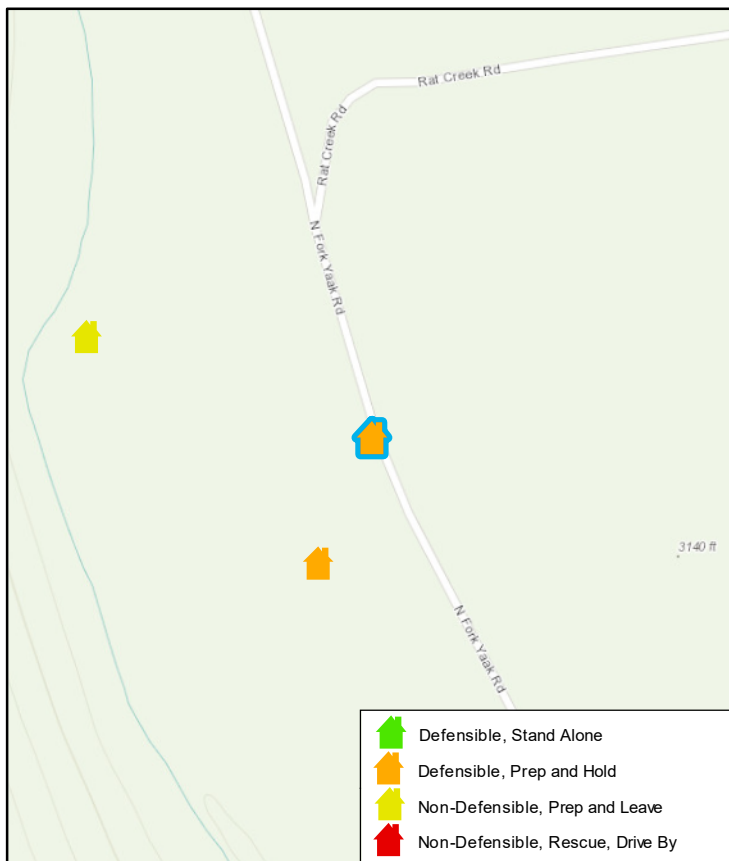
# Davis Structure Assessment #45

**Hazard Notes: Clutter in yard. Open carports with vehicles and firewood. New structure under construction**

**Resources Needed to Protect Structure: Mark 3 Pump Kit with 500 feet 1.5 hose and Sprinkler Kit**

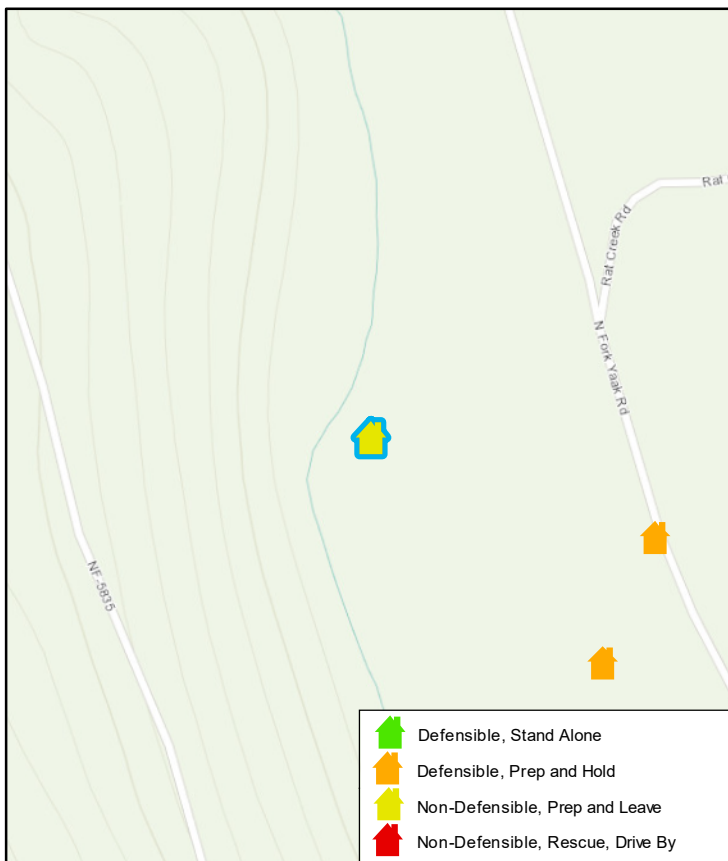
# Davis Structure Assessment #46

**Hazard Notes: Narrow canyon timber choked location but Yaak River only 50 feet from cabin. Firewood on deck. Open block stilt construction foundation**

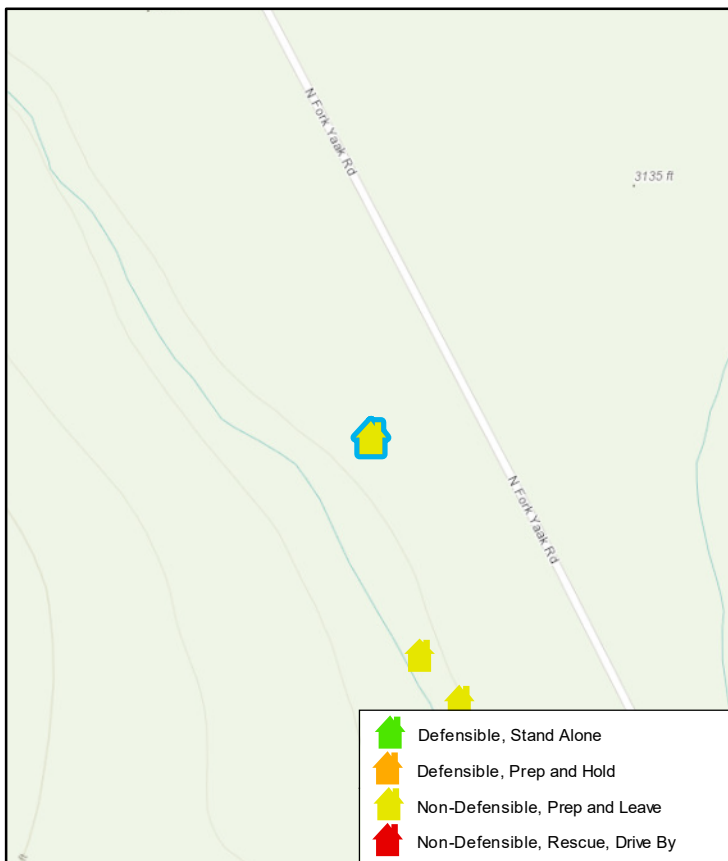
# Davis Structure Assessment #47

**Hazard Notes: Isolated old hunting cabin. Large snag 50 feet from cabin. Unmowed grassey fuels around cabin. Woodpiles under cabin eaves**

**Resources Needed to Protect Structure: Class C Faller to drop 18 “ DBH snag. Mark 3 Pump kit 500 x 1.5” hose and Sprinkler Kit, Weedeater or Dozer**

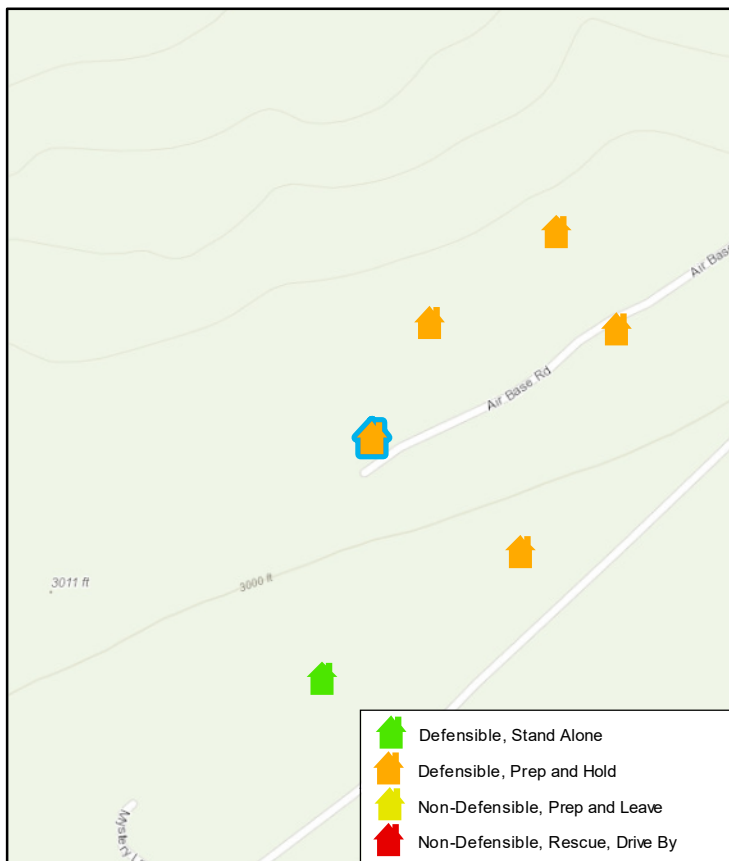
# Davis Structure Assessment #48

**Hazard Notes: Unfinished structure siding. Woodpiles in carport area. Friendly dog on site**

**Resources Needed to Protect Structure: Possible Water Tender staged on Airbase Road to support Type 1 engines protecting all structures within Airbase Road subdivision**

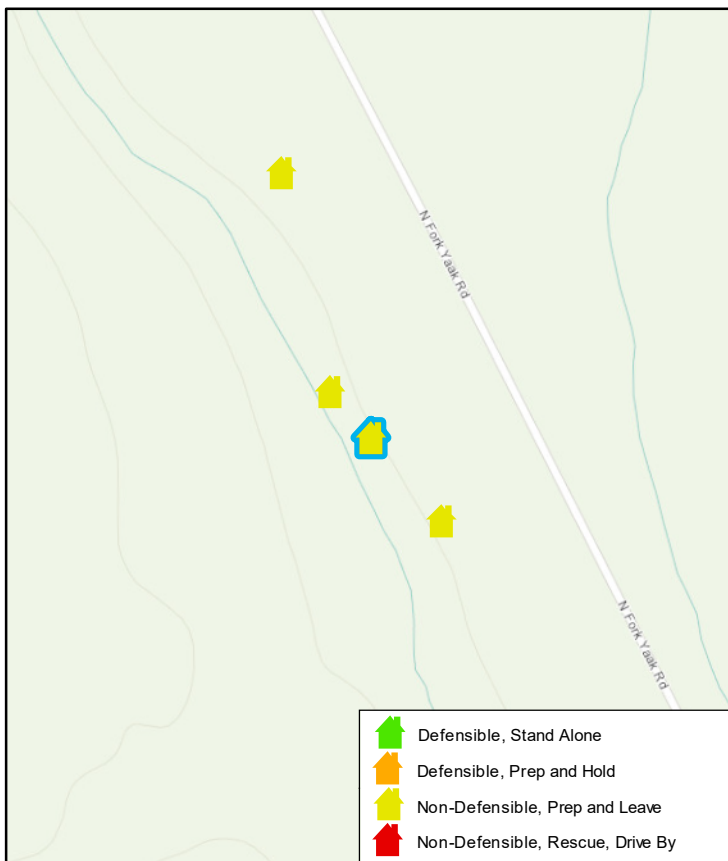
# Davis Structure Assessment #49

**Hazard Notes: Isolated seasonal cabin 300 feet west from the North Fork of the Yaak River. Limited access. Woodpiles within 30 feet of cabin**

**Resources Needed to Protect Structure: Falling team. Mark 3 Pump kit 700 x 1.5" hose plus Sprinkler kit**

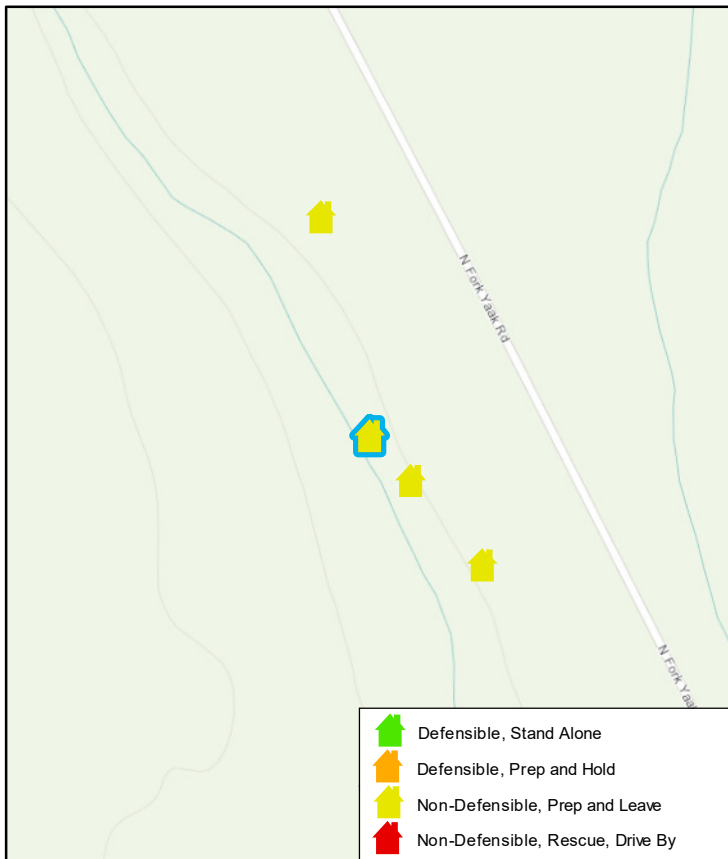
# Davis Structure Assessment #50

**Hazard Notes: No driveable access. Heavy blown down timber on site**

**Notes: Boarded up abandoned cabin. Low priority for mitigation work. Risk vs Gain based on Current and Expected Fire Behavior**

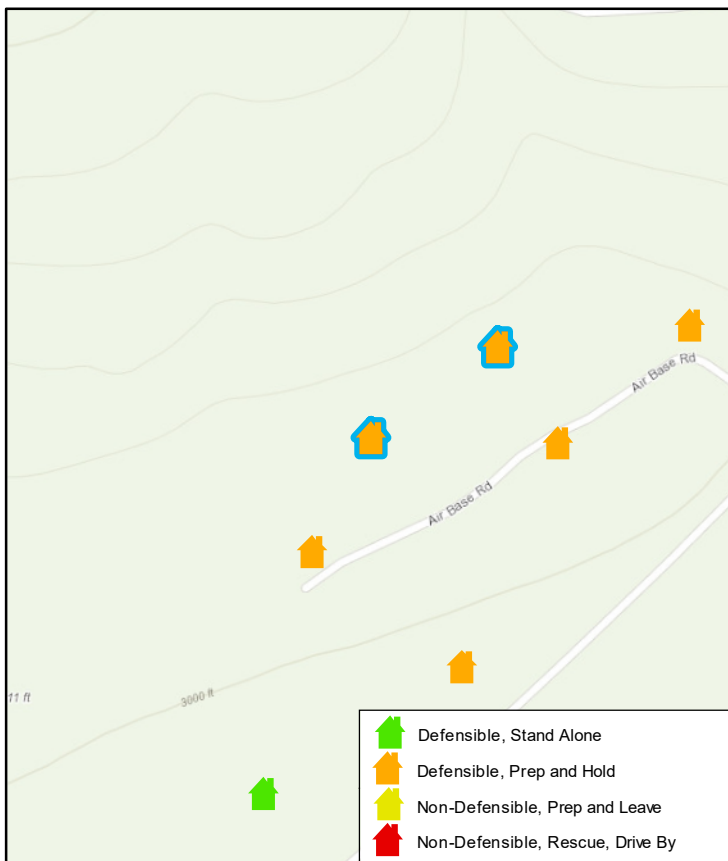
# Davis Structure Assessment #51

**Hazard Notes: Unfinished primary residence. Cluttered rear deck with woodpiles**

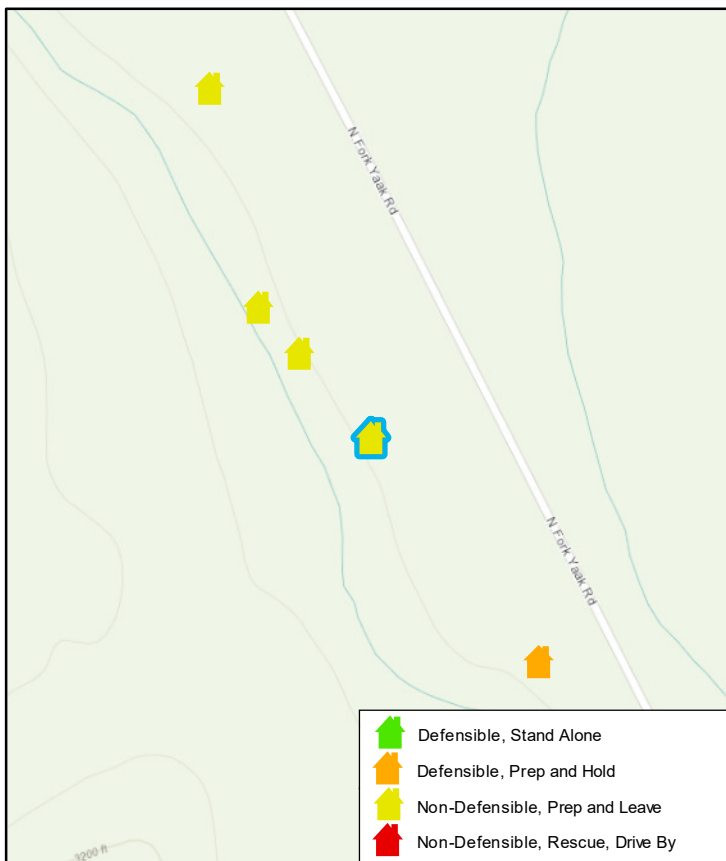
# Davis Structure Assessment #52

**Hazard Notes: Ancient hunt and fishing cabin with poor shake roof. Woodshed within 20 feet of cabin. Tall Unmowed grass. Some yard clutter**

**Resources Needed to Protect Structure: Mark 3 Pump kit  
with 500 feet 1.5 hose and Sprinkler kit Falling Team**

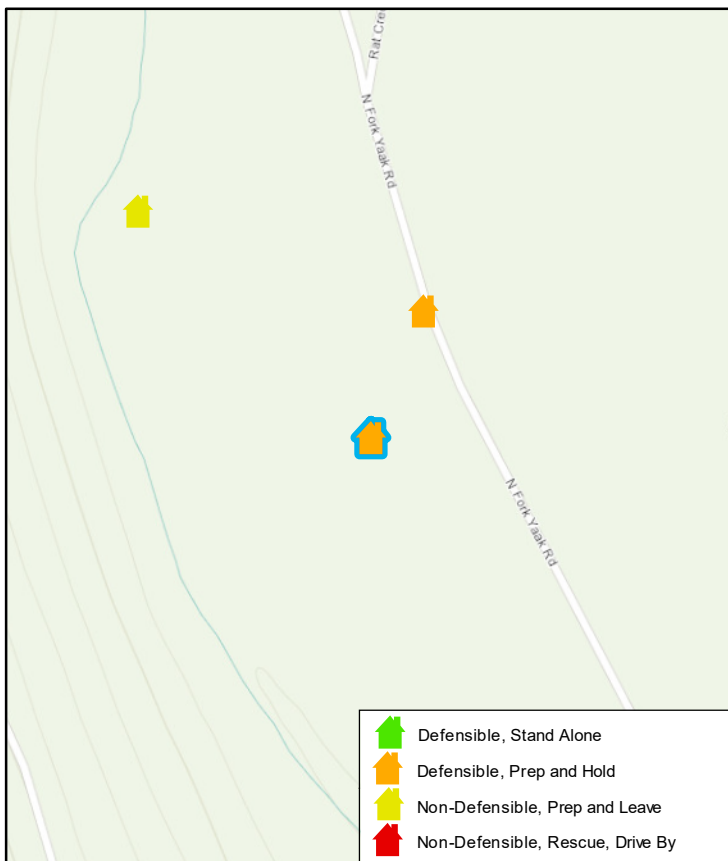
# Davis Structure Assessment #53

**Hazard Notes: Angry Dave the landowner very bitter. Do not enter property without a LEO. Woodpile under car port wood coral back of primary residence**

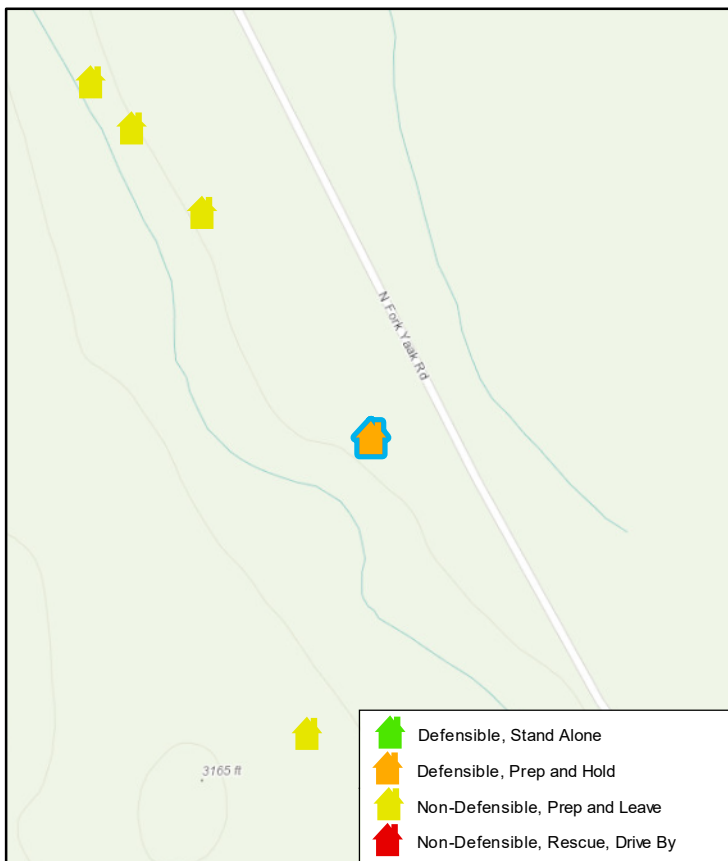
# Davis Structure Assessment #54

**Notes: Five delapated old homestead ranch buildings plus occupied primary residence and rental cabin wiith very flammable dry grass growing in and around all structures. Easy flat access. Grassy Meadow an excellent Spike Camp, Staging Area or helispot locaton as well**
