# Interagency Aviation Lessons Learned

No. IALL 15-01

**Subject: Helicopter Load Management**

**Area of Concern: Helicopter Operations**

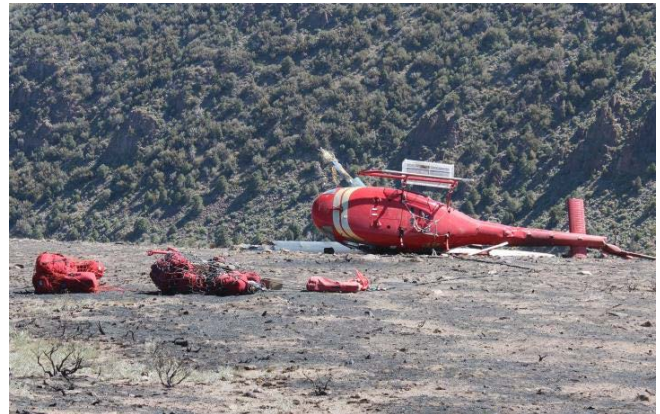
**Discussion:** Last summer, a contracted helicopter was destroyed when the pilot lost control of the aircraft while conducting external load operations in support of wildland fire operations. Fortunately, neither the pilot nor the firefighters who were in close proximity of the aircraft were injured. The investigation revealed the accident involved several links in that famous chain and lined up all the holes in the Swiss cheese model that contributed to the accident. In other words, it took a village.

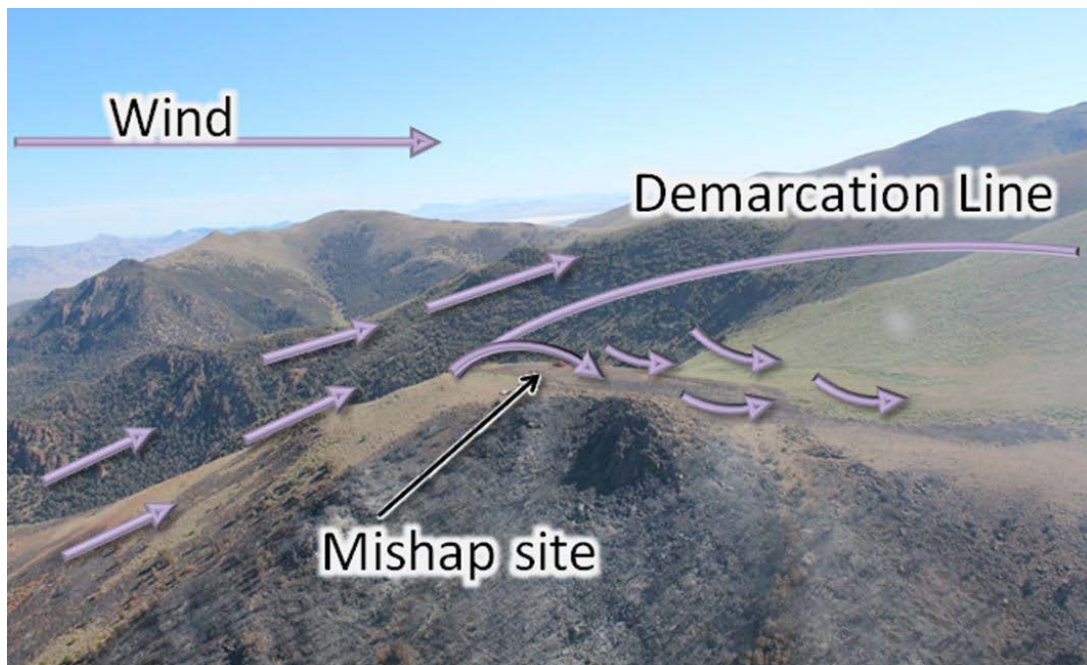
zone was on top of the ridge at an elevation of approximately 9000 feet. The requested landing zone moved the landing area below the ridge where winds were likely to travel downslope. Operating a helicopter with a long line places the helicopter in the environment that is conducive to Loss of Tail Rotor Effectiveness (LTE) due to increased weight and the requirement to HOGE. The pilot was likely experiencing turbulent wind conditions due to the rising terrain in this area. The unstable air mass and surface heating caused moderate winds (10-20 knots) that were measured at the surface. These winds were flowing up over and around the hilltop near the landing area creating updrafts on the windward side of the ridge and downdrafts and turbulence on the leeward side. A demarcation line, or the point that separates the up flow air from the turbulent down flow air, forms at the mountains highest point and extends diagonally upward. The velocity of the wind and slope gradient determines the demarcation line. The higher the wind speed and the steeper the terrain, the steeper the demarcation line angle is and the closer it forms near the crest. This would likely create the turbulent wind conditions near the location that the mishap aircraft would be hovering out of ground effect (HOGE). It's highly conceivable that the down flowing air reduced performance thus increasing the power required which in conjunction with directional winds, contributed to the onset of LTE. As the aircraft slowed to a hover to deliver the sling load, it began to rotate to the left. The pilot attempted to maintain control and to jettison the load, but was unable. The aircraft rotated several times, lost altitude, and impacted the ground.

Figure 1 Wind flow over mountainous terrain contributed to increased performance requirements and the onset of LTE.

The goal in recovery is to gain airspeed without increasing power. Decreasing collective (reducing power) also decreases the power required for antitorque. The problem is that these recovery actions will also result in a substantial loss of altitude which may not be an option when operating in close proximity to the ground. Prudent pilot planning should include a clear escape route in these types of conditions/operations. Although it is not included in the AS350 B3e Rotorcraft Flight Manual, jettisoning the load will reduce weight and subsequently reduce the power required. This action should have been accomplished simultaneously along with the other procedures.
