Structure Number:	169		FED TEAM
Structure Name:	FS #2		2 1-17-10-2
SubDivision:	<b>Cottonwood Guard Station</b>		S. LL VE
GPS Location, Lat.	48 1.25178		
GPS Location, Long.	120 38.45526		ANAGE
Safety Zone Present:	No	Where is Safety Zone: No safety zone present.	
Type of Structure:	Other	Primary Structures: 1	Outbuildings: 4
Other Type of	Government Building		
Surrounding Fuels:	Shrub,Timber,Slash	Defensible Space	e: 50-100 Feet
Structure Triage			
Category:	Non-Defensible, Prep and Le	ave	
Roof Material:	Metal	Siding Materia	I: Wood
Heat Traps:	Wood Deck, Other Receptor		
Electrical Power:	Solar/Wind	Gas to Structure	e: Aboveground
Hazards:	Terrain, Fuels, Haz Mat		
Hazard Notes:	500 gal LPG tank on site, no	safety zone.	
Access to Site:	T3/4 Engine	Best Access From: Located at the end of E	ntiat River Road MP 37.5 on left.
Comm with ICP:	Radio		
Water Source:	Faucet / Hose,Creek		
Mitigation Time:	1-2 Hours

Structure Number:	144		FED TLAN
Structure Name:	PH #4-2		2 000000
SubDivision:	Pope Summer Homes		S. LL P
GPS Location, Lat.	47 58.56648		
GPS Location, Long.	120 33.70884		24NAGE
Safety Zone Present:	No	Where is Safety Zone: Safety zone is located 7	miles south on Entiat Ri

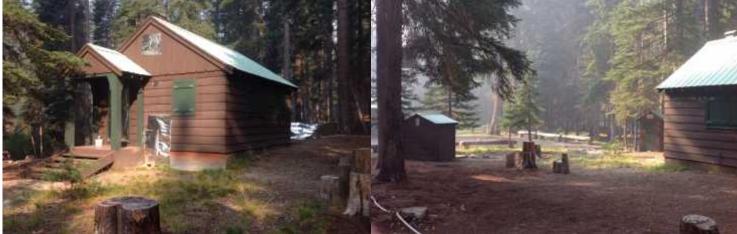
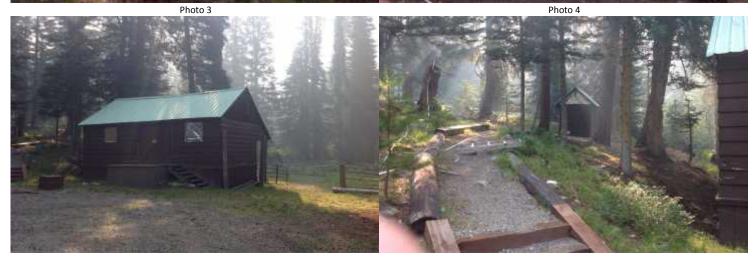
Other Resources			
Needed to Protect:	Hose lay with sprinkler kits, s	scratch line around all structures, use structure	e wrap where needed.
Notes:	debris and all heat traps have bee buildings have hand line scratched	n covered with structure wrap. There is also a large ba I around them and have been structure wrapped wher	with a clean metal roof and wood siding. Roof is clear of rn and tac shop on site with three other misc outbuildings. All re necessary. All structures in the compound have been
	nroximity to established safety zo		prep and leave due to lack of safety zones and distance in
Collected By:	Jay Walter Photo 1	Collected Date/Time:	08/03/2014 07:03:47 GMT-07:00 Photo 2

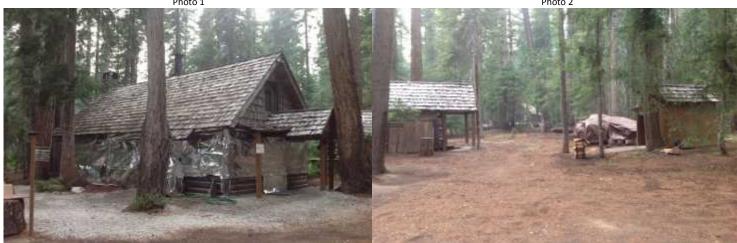
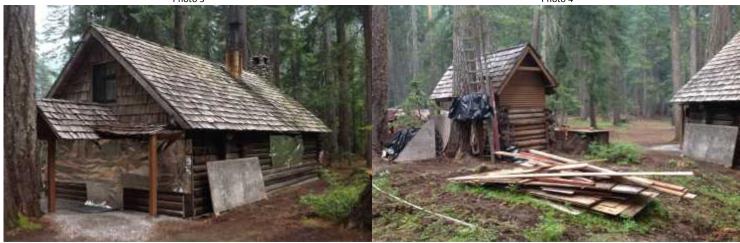
Needed to Protect:	Hose lay with sprinkler kits,	scratch line around structure, use structure wr	ap where needed .
Notes:	comprised wood siding with a dire	ty wood roof. Heat traps and decks are present but clear able driveway located off of main roadway in a small gro	Summer Homes. Structure's primary building construction is ar of debris and combustible materials. Access to the oup of structures. Structure 4-2 is non-defendable prep and
Collected By:	Jay Walter Photo 1	Collected Date/Time:	08/03/2014 08:18:07 GMT-07:00 Photo 2

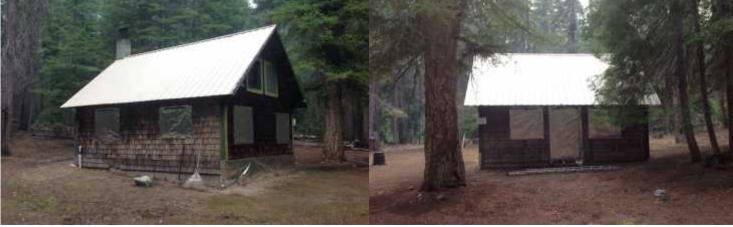
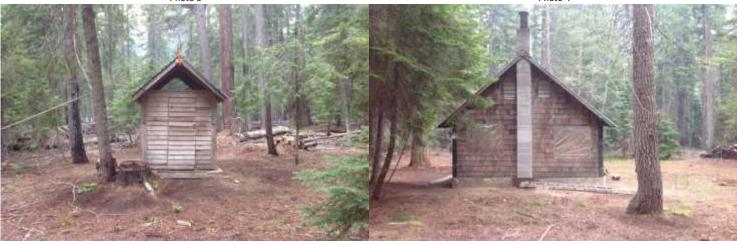
Structure Number:	161	FED TLAN . 2
Structure Name:	PH #5-1	2 Dorthoga
SubDivision:	Pope Summer Homes	ST. EL VE
GPS Location, Lat.	47 58.60398	
GPS Location, Long.	120 33.7347	**ANAGE***
Safety Zone Present:	No	Where is Safety Zone: Safety zone is located 7 miles south on Entiat River Road.
Type of Structure:	Residential	Primary Structures: 1 Outbuildings: 1
Other Type of		
Surrounding Fuels:	Shrub,Timber,Slash	Defensible Space: 50-100 Feet
Structure Triage		
Category:	Non-Defensible, Prep and Le	ave
Roof Material:	Metal	Siding Material: Wood
Heat Traps:	Open Eaves, Other Receptor	
Electrical Power:	Generator	Gas to Structure: Aboveground
Hazards:	Fuels, Haz Mat	
Hazard Notes:	25 gal LPG tank on site.	
Access to Site:	T3/4 Engine	Best Access From: West on unnamed driveway marked #5 west of Entiat River Road.
Comm with ICP:	Radio	
Water Source:	Creek	
Mitigation Time:	1-2 Hours	
Other Resources		
Needed to Protect:	His lay with sprinkler kits, scr	atch line around structure, use structure wrap where needed.

Notes:	wood siding with a clean metal ro	e located along the Entiat River in the Pope Summer Homes. Structure's primary building construction is comprised of. Heat traps and decks are present but clear of debris and combustible materials. Access to the structure is by a ated off of main roadway in a small group of structures. Structure 5-1 is non-defendable prep and leave due to lack
Collected By:	Jay Walter	Collected Date/Time: 08/03/2014 07:06:40 GMT-07:00
	Photo 1	Photo 2
AN OWNER STREET

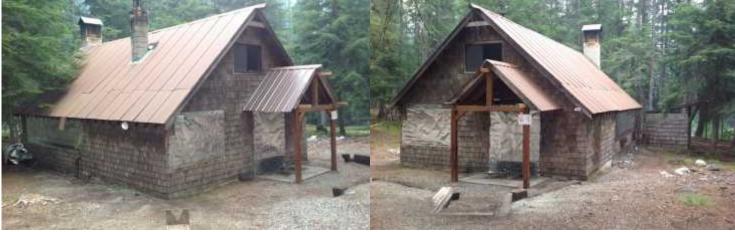
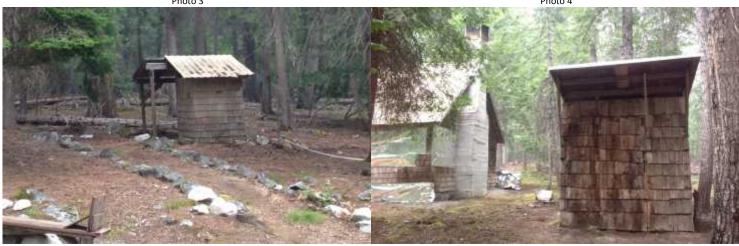
Structure Number:	142		FED TIAN
Structure Name:	PH #6-1		a Contrata
SubDivision:	Pope Summer Homes		St. B-LE
GPS Location, Lat.	47 58.64838		
GPS Location, Long.	120 33.79032		24NAG2
Safety Zone Present:	No	Where is Safety Zone: Safety zone is located 7	miles south on Entiat River Road.
Type of Structure:	Residential	Primary Structures: 1	Outbuildings: 2
Other Type of			
Surrounding Fuels:	Shrub, Timber, Slash	Defensible Space	e: 30-50 Feet
Structure Triage			
Category:	Non-Defensible, Prep and Le	ave	
Roof Material:	Metal	Siding Materia	I: Wood
Heat Traps:	Open Eaves, Other Receptor		
Electrical Power:	Generator	Gas to Structure	e: Aboveground
Hazards:	Fuels, Haz Mat		
Hazard Notes:	250 gal LPG tank on site.		
Access to Site:	T3/4 Engine	Best Access From: West on unnamed drive	eway marked #6 west of Entiat River Road.
Comm with ICP:	Radio		
Water Source:	Creek		
Mitigation Time:	1-2 Hours		
Other Resources

Needed to Protect:	Hose lay with sprinkler kit, se	cratch line around structure, use structure wra	p where needed.
Notes:	wood siding with a clean metal ro	of. Heat traps and decks are present but clear of debris	omes. Structure's primary building construction is comprised and combustible materials. Access to the structure is by a s. Structure 4-1 is non-defendable prep and leave due to lack
Collected By:	Jay Walter Photo 1	Collected Date/Time:	08/03/2014 08:18:51 GMT-07:00 Photo 2

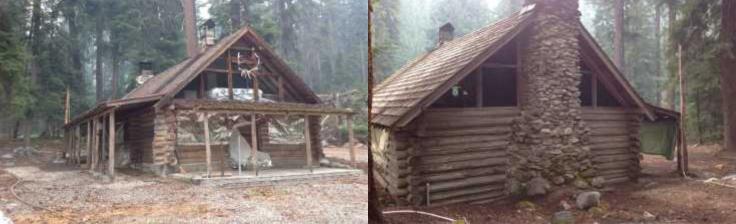
Structure Number:	141		FED TLAN	
Structure Name:	PH #7-1		2 000000	
SubDivision:	Pope Summer Homes		ST. EP. S	
GPS Location, Lat.	47 58.64994			
GPS Location, Long.	120 33.8577		**ANAGE**	
Safety Zone Present:	No	Where is Safety Zone: Safety zone is located 7	miles south on the Entiat River Road.	
Type of Structure:	Residential	Primary Structures: 1	Outbuildings: 1	
Other Type of				
Surrounding Fuels:	Shrub, Timber, Slash	Defensible Space	e: 30-50 Feet	
Structure Triage				
Category:	Non-Defensible, Prep and	Leave		
Roof Material:	Metal	Siding Materia	I: Wood	
Heat Traps:	Open Eaves,Wood Deck,O	Open Eaves,Wood Deck,Other Receptor		
Electrical Power:	Generator	Gas to Structure	e: Aboveground	
Hazards:	Fuels, Haz Mat			
Hazard Notes:	250 gal LPG tank on site.			
Access to Site:	T3/4 Engine	Best Access From: West on unnamed drive	eway marked #7 west of Entiat River Road.	
Comm with ICP:	Radio			
Water Source:	Creek

Mitigation Time:	1-2 Hours			
Other Resources				
Needed to Protect:	Hose lay with sprinkler kit	s, scratch line around structure, use structure wr	ap where needed.	
Notes:	wood siding with a clean wood	roof. Heat traps and decks are present but clear of debris	omes. Structure's primary building construction is comprised and combustible materials. Access to the structure is by a s. Structure 7-1 is non-defendable prep and leave due to lack	
Collected By:	Jay Walter	Collected Date/Time:	08/03/2014 08:19:10 GMT-07:00	
	Photo 1		Photo 2	
	201

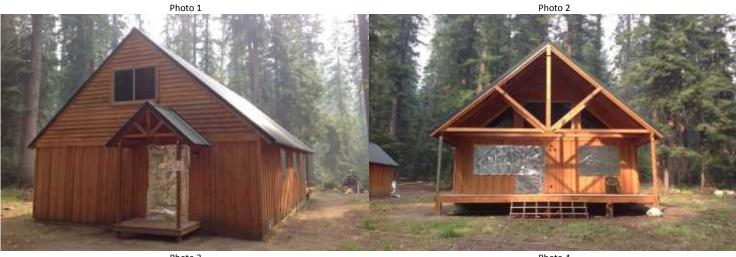
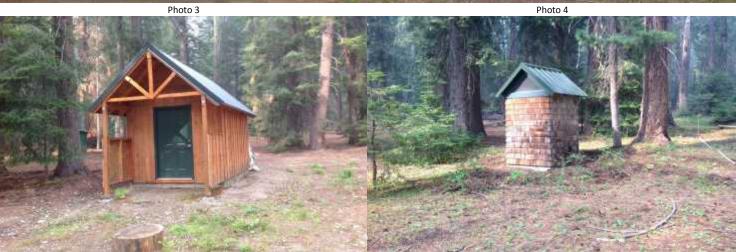
Structure Number:	164		FED TLAN
Structure Name:	PH #7-2		S I COME
SubDivision:	Pope Summer Homes		S. BHAR
GPS Location, Lat.	47 5.86668		
GPS Location, Long.	120 33.92604		TANAGE
Safety Zone Present:	No	Where is Safety Zone: Safety zone is located 7	miles south on Entiat River Road.
Type of Structure:	Residential	Primary Structures: 1	Outbuildings: 2
Other Type of			
Surrounding Fuels:	Shrub, Timber, Slash	Defensible Space	: 30-50 Feet
Structure Triage			
Category:	Non-Defensible, Prep and Le	ave	
Roof Material:	Metal	Siding Material	: Wood
Heat Traps:	Wood Deck, Other Receptor		
Electrical Power:	Generator	Gas to Structure	: Aboveground
Hazards:	Fuels, Haz Mat		
Hazard Notes:	500 gal LPG tank on site.		
Access to Site:	T3/4 Engine	Best Access From: West on unnamed drive	way marked with #7 west of Entiat River Road.
Comm with ICP:	Radio		
Water Source:	Creek		
Mitigation Time:	1-2 Hours		
Other Resources			
Needed to Protect:	Hose lay with sprinkler kits, s	cratch line around structure, use structure wra	ap where needed.

Notes:	comprised wood siding with a clea	in metal roof. Heat traps and decks are present but clea ble driveway located off of main roadway in a small gro	Immer Homes. Structure's primary building construction is ar of debris and combustible materials. Access to the pup of structures. Structure 7-2 is non-defendable prep and
Collected By:	Jay Walter	Collected Date/Time:	08/03/2014 07:05:45 GMT-07:00

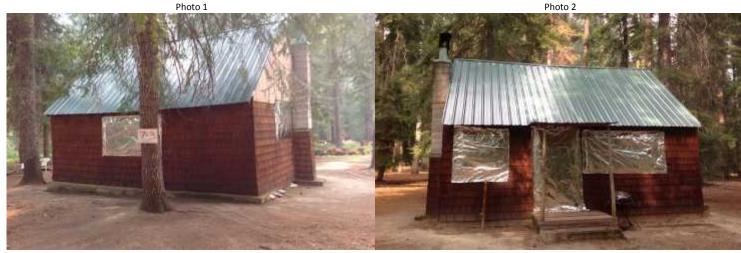
Structure Number:	139		FED TLAN
Structure Name:	PH #7-3		2 0000003
SubDivision:	Pope Summer Homes		S. EL S
GPS Location, Lat.	47 58.66398		
GPS Location, Long.	120 33.94302		24NAGE
Safety Zone Present:	No	Where is Safety Zone: Safety zone is located 7	miles south on entiate River Road.
Type of Structure:	Residential	Primary Structures: 1	Outbuildings: 2
Other Type of			
Surrounding Fuels:	Shrub, Timber, Slash	Defensible Space	:: 30-50 Feet
Structure Triage			
Category:	Non-Defensible, Prep and Le	ave	
Roof Material:	Metal	Siding Material	l: Wood
Heat Traps:	Open Eaves, Other Receptor		
Electrical Power:	Generator	Gas to Structure	e: Aboveground
Hazards:	Fuels, Haz Mat		
Hazard Notes:	25 gal LPG tank on site.		
Access to Site:	T3/4 Engine	Best Access From: West on unnamed drive	way marked #7 west of Entiat River Road.
Comm with ICP:	Radio		
Water Source:	Creek		
Mitigation Time:	1-2 Hours		
Other Resources

Needed to Protect: Notes:	Structure is a single story structure wood siding with a clean metal room	of. Heat traps and decks are present but clear of debris	ap where needed. omes. Structure's primary building construction is comprised and combustible materials. Access to the structure is by a . Structure 7-3 is non-defendable prep and leave due to lack
Collected By:	Jay Walter Photo 1	Collected Date/Time:	08/03/2014 08:19:50 GMT-07:00 Photo 2

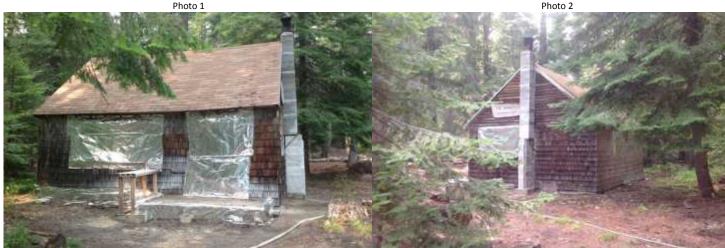
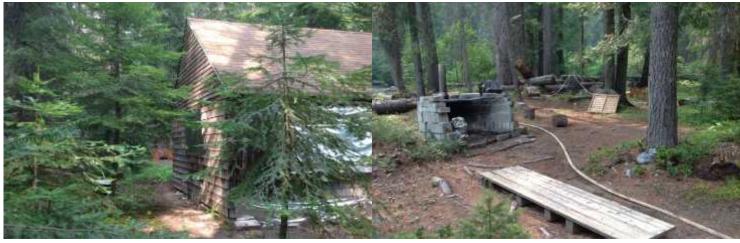
Heat Traps:       Open Eaves, Wood Deck, Other Receptor         Electrical Power:       Generator         Generator:       Gas to Structure: Aboveground         Hazards:       Fuels, HazMat         Hazard Notes:       5 gal LPG tank on site.         Access to Site:       T3/4 Engine         Best Access From: West on unnamed driveway marked #7 west of Entiat River Road.         Comm with ICP:       Radio         Water Source:       Creek         Mitigation Time:       1-2 Hours         Other Resources       Fuelay with sprinkler kits, scratch line around structure, use structure wrap where needed.         Notes:       Structure is a single story structure located along the Entiat River in the Pope Summer Homes. Structure's primary building construction is comprised wood siding with a clean asphalt shingle roof. Heat traps and decks are present but clear of debris and combustible materials. Access to the structure is by a narrow but passable driveway located off of main roadway in a small group of structures. Structure 7-5 is non-defendable prep and leave due to lack of safety zone present on site.         Collected By:       Jay Walter       Collected Date/Time: 08/03/2014 08:20:27 GMT-07:00	Category:	Non-Defensible, Prep and	Leave

<ul> <li>wood siding with a clean asphalt shingle roof. Heat traps and decks are present but clear of debris and combustible materials. Access to the structure is by a narrow but passable driveway located off of main roadway in a small group of structures. Structure 7-5 is non-defendable prep and leave due to lack of safety zone present on site.</li> <li>Collected By: Jay Walter Collected Date/Time: 08/03/2014 08:20:27 GMT-07:00</li> </ul>	Needed to Protect:	Hose lay with sprinkler kits	s, scratch line around structure, use structure wra	ap where needed.
	Notes:	wood siding with a clean aspha is by a narrow but passable driv	It shingle roof. Heat traps and decks are present but clear reway located off of main roadway in a small group of stru	of debris and combustible materials. Access to the structure
Photo 1 Photo 2	Collected By:	Jay Walter	Collected Date/Time:	08/03/2014 08:20:27 GMT-07:00

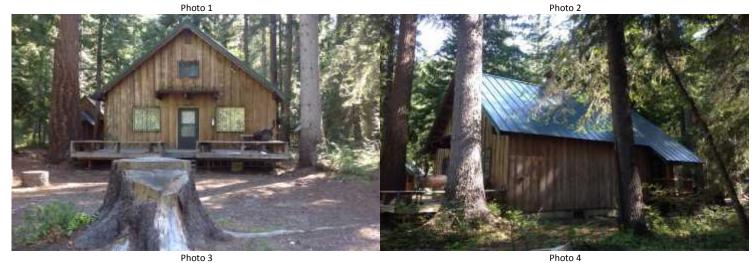
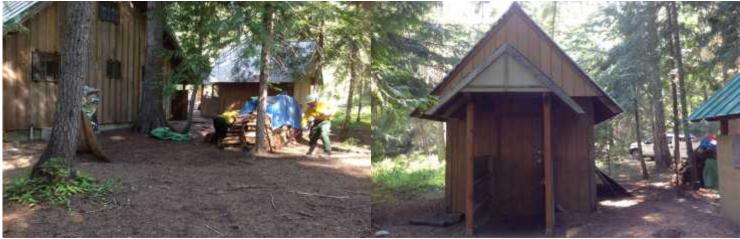
Structure Number:	153		FED TLAW
Structure Name:	RH #1-2		a Donations
SubDivision:	<b>Riverside Summer Homes</b>		ST. ELLAS
GPS Location, Lat.	47 5.81442		
GPS Location, Long.	120 33.18258		ANAGE
Safety Zone Present:	No	Where is Safety Zone: Down Entiat River Road	approx 8 miles
Type of Structure:	Residential	Primary Structures: 1	Outbuildings: 2
Other Type of			
Surrounding Fuels:	Shrub,Timber,Slash	Defensible Space	e: 30-50 Feet
Structure Triage			
Category:	Non-Defensible, Prep and Le	ave	
Roof Material:	Metal	Siding Materia	I: Wood
Heat Traps:	Wood Deck,Other Receptor		
Electrical Power:	Generator	Gas to Structure	e: Aboveground
Hazards:	Fuels, Haz Mat		
Hazard Notes:	LPG tank on site		
Access to Site:	T3/4 Engine	Best Access From: Entiat River Road & stru	icture group road 1
Comm with ICP:	Radio		
Water Source:	Creek		
Mitigation Time:	1-2 Hours		
Other Resources			
Needed to Protect:	Sprinkler kits set up with pur	np and hose lay in place. Scratch line around s	tructures and light fuels removal.

Notes:	comprised of a metal roof with we by a passable driveway located of	ood siding. Heat traps and decks are present but clear o	Summer Homes. Structure's primary building construction is of debris and combustible materials. Access to the structure is ructure 1-2 is non-defendable prep and leave due to lack of
	safety zone present on site.		
Collected By:	Jay Walter	Collected Date/Time:	08/03/2014 08:14:20 GMT-07:00

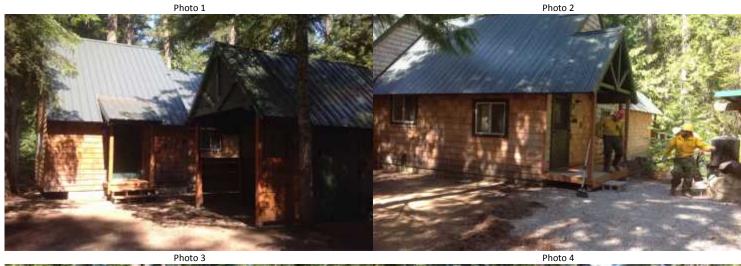
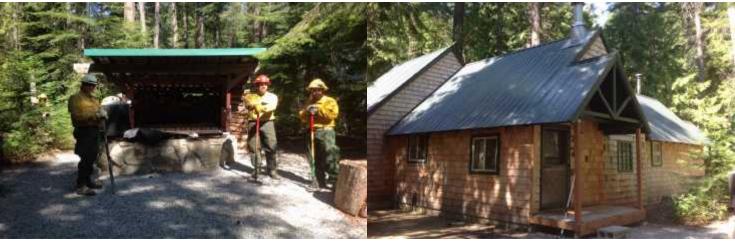
Structure Number:	151	PED TLAN
Structure Name:	RH #1-3	E THE
SubDivision:	<b>Riverside Summer Homes</b>	St. LL VE
GPS Location, Lat.	47 58.12854	
GPS Location, Long.	120 0.03318	A HAGE AND
Safety Zone Present:	No	Where is Safety Zone: Down Entiat River Road approx 8 miles.
Type of Structure:	Residential	Primary Structures: 1 Outbuildings: 2
Other Type of		
Surrounding Fuels:	Shrub, Timber, Slash	Defensible Space: 30-50 Feet
Structure Triage		
Category:	Non-Defensible, Prep and Le	ave
Roof Material:	Metal	Siding Material: Wood
Heat Traps:	Wood Deck,Other Receptor	
Electrical Power:	Generator	Gas to Structure: Aboveground
Hazards:	Fuels, Haz Mat	
Hazard Notes:	250 gal LPG tank on site	
Access to Site:	T3/4 Engine	Best Access From: Entiat River Road & Riverside Structure road 1
Comm with ICP:	Radio	
Water Source:	Creek	
Mitigation Time:	2-3 Hours	
Other Resources	Pump with hose lay and spri	nklers will need to be present on site. Scratch line will need to line the exterior perimeter of the

Needed to Protect:	structure.	
Notes:	construction is comprised wood s	e with a loft located along the Entiat River in the Riverside Summer Homes. Structure's primary building iding with a clean metal roof. Heat traps and decks are present but clear of debris and combustible materials. Access t passable driveway located off of main roadway in a group of three structures. Structure 1-3 is non-defendable prep ne present on site.
Collected By:	Jay Walter	Collected Date/Time: 08/03/2014 08:15:11 GMT-07:00

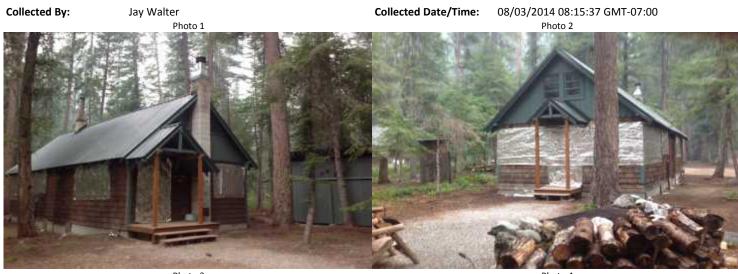
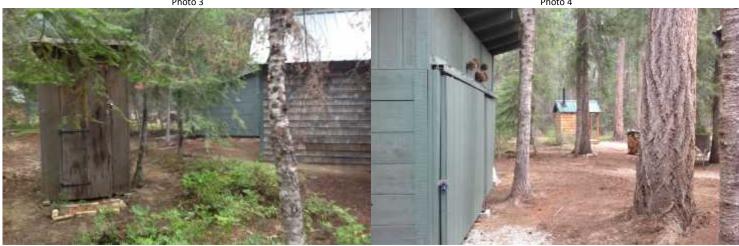
Structure Number:	150		FED TEAM
Structure Name:	RH #2-1		a Contracta
SubDivision:	<b>Riverside Summer Homes</b>		EL CE
GPS Location, Lat.	47 58.15704		
GPS Location, Long.	120 33.16716		24NAGE
Safety Zone Present:	No	Where is Safety Zone: Safety zone is located 6	miles south on Entiat River Road.
Type of Structure:	Residential	Primary Structures: 1	Outbuildings: 4
Other Type of			
Surrounding Fuels:	Shrub, Timber, Slash	Defensible Space	e: 30-50 Feet
Structure Triage			
Category:	Non-Defensible, Prep and Le	ave	
Roof Material:	Metal	Siding Materia	I: Wood
Heat Traps:	Open Eaves,Wood Deck,Oth	er Receptor	
Electrical Power:	Generator	Gas to Structure	e: Aboveground
Hazards:	Fuels, Haz Mat		
Hazard Notes:	500 gal. LPG tank on site.		
Access to Site:	T3/4 Engine	Best Access From: Unnamed but marked d	riveway 2 west of Entiat River Road.
Comm with ICP:	Radio		
Water Source:	Creek		
Mitigation Time:	1-2 Hours		
Other Resources

Needed to Protect:	One type 6 or larger engine of	on site.	
Notes:	construction is comprised wood s	t passable driveway located off of main roadway in a g	ide Summer Homes. Structure's primary building present but clear of debris and combustible materials. Access roup of structures. Structure 2-1 is non-defendable prep and
Collected By:	Jay Walter	Collected Date/Time:	08/03/2014 08:15:37 GMT-07:00

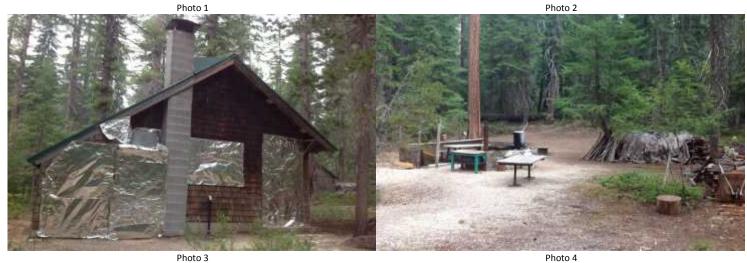
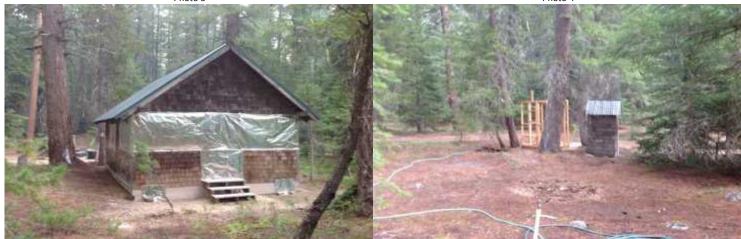
Structure Number:	149	FED TLAN	
Structure Name:	RH #3-1	= TIFE	
SubDivision:	<b>Riverside Summer Homes</b>	St. EH. P.	
GPS Location, Lat.	47 58.15146		
GPS Location, Long.	120 33.16518	24NAGE***	
Safety Zone Present:	No	Vhere is Safety Zone: Safety zone is located 6 miles south on Entiat River Road.	
Type of Structure:	Residential	Primary Structures: 1 Outbuildings: 1	
Other Type of			
Surrounding Fuels:	Shrub, Timber, Slash	Defensible Space: 30-50 Feet	
Structure Triage			
Category:	Non-Defensible, Prep and Lea	ave	
Roof Material:	Metal	Siding Material: Wood	
Heat Traps:	Open Eaves,Wood Deck,Other Receptor		
Electrical Power:	Generator	Gas to Structure: Aboveground	
Hazards:	Fuels,HazMat		
Hazard Notes:	25 LPG tank on site.		
Access to Site:	T3/4 Engine	Best Access From: Unnamed driveway but marked #3 west of Entiat River Road.	
Comm with ICP:	Radio		
Water Source:	Creek		
Mitigation Time:	1-2 Hours		
Other Resources

Needed to Protect:	Type 6 or larger engine on sit	e.	
Notes:	comprised wood siding with a clea	e located along the Entiat River in the Riverside Summer Homes. Structure's primary building construction is n metal roof. Heat traps and decks are present but clear of debris and combustible materials. Access to the ble driveway located off of main roadway in a group of three structures. Structure 3-1 is non-defendable prep and esent on site.	
Collected By:	lav Walter	Collected Date/Time: 08/03/2014 08:15:57 GMT-07:00

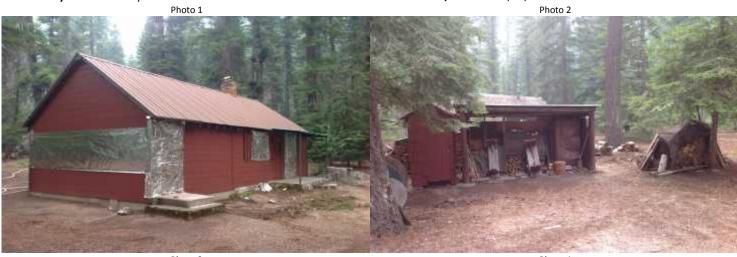
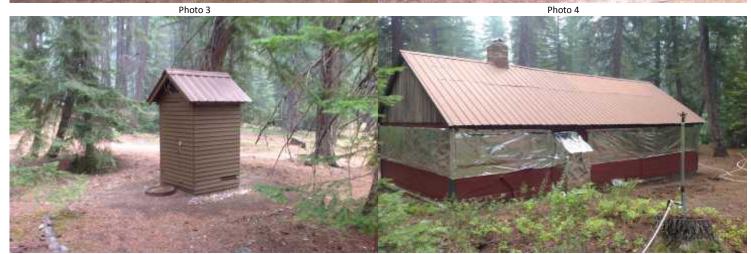
Structure Number:	147	FED TTAN A
Structure Name:	RH #3-3	a Dortana
SubDivision:	<b>Riverside Summer Homes</b>	S. LL S
GPS Location, Lat.	47 0.58188	
GPS Location, Long.	120 33.19068	47ANA GEN
Safety Zone Present:	No	Where is Safety Zone: Safety zone is located 6 miles south down Entiat River Road.
Type of Structure:	Residential	Primary Structures: 1 Outbuildings: 2
Other Type of		
Surrounding Fuels:	Shrub, Timber, Slash	Defensible Space: 50-100 Feet
Structure Triage		
Category:	Non-Defensible, Prep and L	eave
Roof Material:	Metal	Siding Material: Wood
Heat Traps:	Open Eaves,Wood Deck,Oth	ner Receptor
Electrical Power:	Generator	Gas to Structure: Aboveground
Hazards:	Fuels, Haz Mat	
Hazard Notes:	250 LPG tank on site.	
Access to Site:	T3/4 Engine	Best Access From: West on unnamed driveway marked #3 west of Entiat River Road.
Comm with ICP:	Radio	
Water Source:	Creek	
Mitigation Time:	1-2 Hours	
Other Resources

Needed to Protect:	Hose lay with sprinkler kits,	scatch line around wrap on structure.
Notes:	comprised wood siding with a clo	are located along the Entiat River in the Riverside Summer Homes. Structure's primary building construction is ean metal roof. Heat traps and decks are present but clear of debris and combustible materials. Access to the able driveway located off of main roadway in a group of three structures. Structure 3-3 is non-defendable prep and present on site.
Collected By:	Jay Walter	Collected Date/Time: 08/03/2014 08:16:35 GMT-07:00

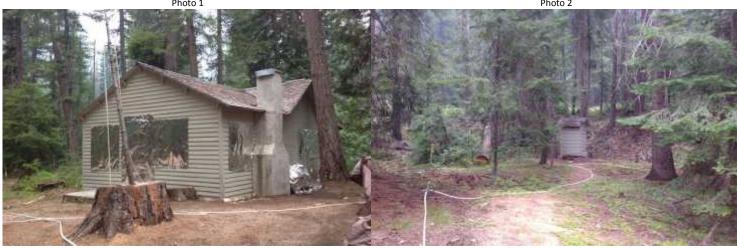
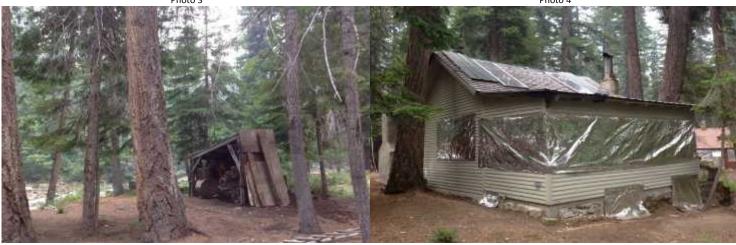
Structure Number:	158		FED TLAN
Structure Name:	RH #3-4		2 Donates
SubDivision:	<b>Riverside Summer Homes</b>		ST. LL E
GPS Location, Lat.	47 58.21704		
GPS Location, Long.	120 33.19182		**ANAGE**
Safety Zone Present:	No	Where is Safety Zone: Safety zone is located 6	miles south on the Entiat River Road.
Type of Structure:	Residential	Primary Structures: 1	Outbuildings: 2
Other Type of			
Surrounding Fuels:	Shrub, Timber, Slash	Defensible Space	: 50-100 Feet
Structure Triage			
Category:	Non-Defensible, Prep and Lo	eave	
Roof Material:	Wood	Siding Material	: Wood
Heat Traps:	Open Eaves,Wood Deck,Oth	ner Receptor	
Electrical Power:	Solar/Wind,Generator	Gas to Structure	: Aboveground
Hazards:	Fuels, Haz Mat		
Hazard Notes:	250 gal LPG tank on site.		
Access to Site:	T3/4 Engine	Best Access From: West on unnamed drive	way marked #3 west of Entiat River Road.
Comm with ICP:	Radio		
Water Source:	Creek		
Mitigation Time:	1-2 Hours

Other Resources			
Needed to Protect:	Hose lay with sprinkler kits,	scratch line around and wrap structure.	
Notes:	comprised wood siding with a cle	, , , , ,	
Collected By:	Jay walter	Collected Date/Time:	08/03/2014 07:07:46 GMT-07:00

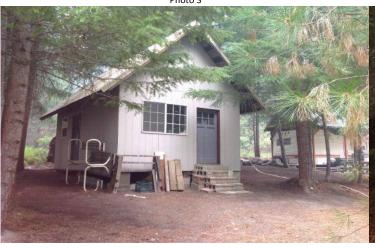
Structure Number: Structure Name: SubDivision: GPS Location, Lat.	279 P9W Preston / Fox 47 54.13236		+ TODENT TEAM
GPS Location, Long.	120 28.2537		
Safety Zone Present:		Where is Safety Zone: .5 miles south on Entiat River Ro	
Type of Structure:	Residential	Primary Structures: 1	Outbuildings: 5
Other Type of			
Surrounding Fuels:	Grass,Shrub,Timber,Slash	Defensible Space: 30-50	Feet
Structure Triage			
Category:	Defensible, Prep and Hold		
Roof Material:	Metal	Siding Material: Wood	
Heat Traps:	Wood Deck, Other Receptor		
Electrical Power:	Overhead	Gas to Structure: Above	ground
Hazards:			
Hazard Notes:	Overhead power lines over t	op of driveway.	
Access to Site:	T3/4 Engine	Best Access From: Entiat River Road	
Comm with ICP:	Radio		
Water Source:	Faucet / Hose,Creek		
Mitigation Time:	1-2 Hours		
Other Resources			
Needed to Protect:	Hose lay with sprinkler kits,	vegetation removal from immediate proximity to struc	tures. Scratch line around all structures.

Notes:	under a constructed cover. Struct	story structure with a metal roof and wood siding. There are 5 ac ure has a roof clear of debris and vegetation has been brushed b Structures are in close proximity to safety zones and are uninhal	ack from the structures. Scratch line has been

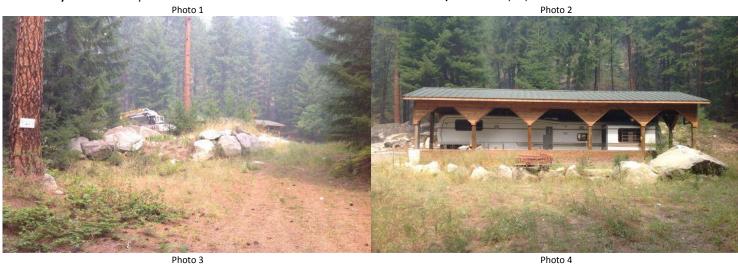
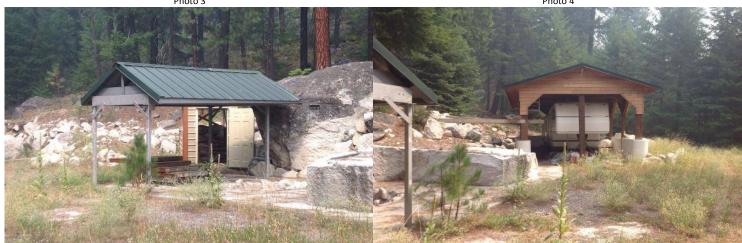
Structure Triage Informa	tion
Structure Number:	275		
Structure Name:	P10E		
SubDivision:	Preston / Fox		
GPS Location, Lat.	47 5.40858		
GPS Location, Long.	120 27.81768		ENT
Safety Zone Present:	Yes	Where is Safety Zone: .2 miles sout	n on Entiat River Road.
Type of Structure:	Residential	Primary Structures: 1	Outbuildings: 1
Other Type of			
Surrounding Fuels:	Grass, Shrub, Timber	Defen	sible Space: 30-50 Feet
Structure Triage			
Category:	Defensible, Prep and Hold		
Roof Material:	Metal	Sidir	g Material: Metal
Heat Traps:	Open Eaves,Wood Deck,Ra	in Gutters, Other Receptor	
Electrical Power:	Generator	Gas t	o Structure: Aboveground
Hazards:	Terrain, Fuels		
Hazard Notes:	10 gal LPG tank on site.		
Access to Site:	T3/4 Engine	Best Access From: Entiat River F	oad
Comm with ICP:	Radio		
Water Source:	Faucet / Hose,Creek		
Mitigation Time:	1-2 Hours		
Other Resources			
Needed to Protect:	Hose lay with sprinkler kits	, light removal of vegetation from arc	und structures. Scratch hand line around all structures.

Notes:	Structure is a large fifth wheel th	avel trailer under a wood frame constructed	awning with a clean metal roof. Open eves are present with other
	ignition receptive sources under	neath the awning. Sprinkler and fuels reduc	tion in place.

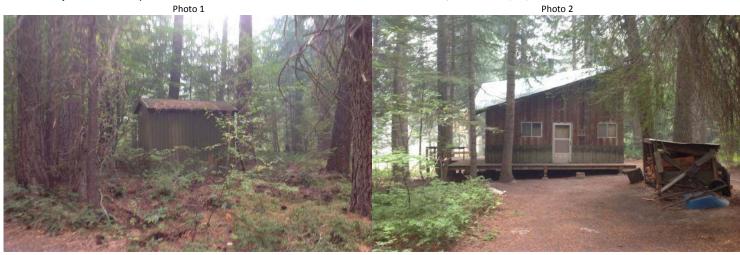
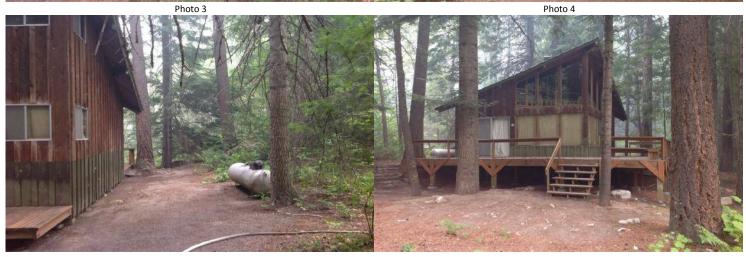
Structure Number: Structure Name: SubDivision:	278 P10W Preston / Fox			
GPS Location, Lat.	47 5.40972		TEAM 2	
GPS Location, Long.	120 28.2435		OENT TE	
Safety Zone Present:		Where is Safety Zone: .5 miles south on Entiat River	Road.	
Type of Structure:	Residential	Primary Structures: 1	Outbuildings: 1	
Other Type of			C C	
Surrounding Fuels:	Grass,Shrub,Timber	Defensible Space: 30-50 Feet		
Structure Triage				
Category:	Defensible, Prep and Hold			
Roof Material:	Metal	Siding Material: Woo	bc	
Heat Traps:	Wood Deck,Other Receptor			
Electrical Power:	Underground	Gas to Structure: Abo	veground	
Hazards:	Terrain, Fuels			
Hazard Notes:	500 gal LPG tank on site.			
Access to Site:	T3/4 Engine	Best Access From: Entiat a River Road.		
Comm with ICP:	Radio			
Water Source:	Faucet / Hose,Creek			
Mitigation Time:	1-2 Hours			
Other Resources	Hose lay with sprinkler kits,	scratch line around all structures and remove any ve	getation that is in direct proximity to the

Needed to Protect:	structure.			
Notes:		story structure with a metal roof and wood siding. Structure h s. Structures are in close proximity to safety zones and are unir	•

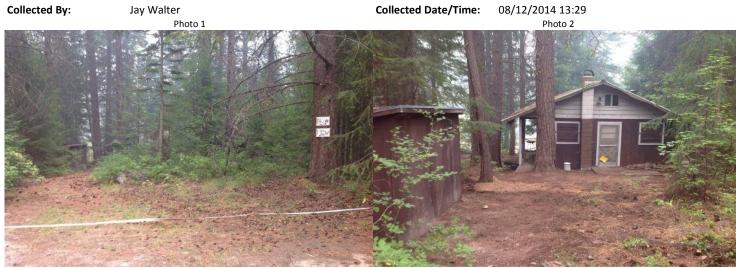
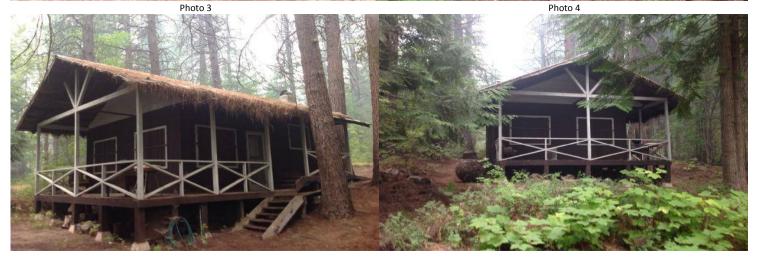
Structure Number: Structure Name: SubDivision: GPS Location, Lat.	276 P11W Preston / Fox 47 54.11754 120 28.20108			+ TODENT TEN
GPS Location, Long.		Where is Safety 7ana, E miles south	on Entiat Divor Doad	
Safety Zone Present:		Where is Safety Zone: .5 miles south of		Outhuildings 1
Type of Structure:	Residential	Primary Structures: 1		Outbuildings: 1
Other Type of		Defensil	hla <b>C</b> urana, 20 E0 Eant	
Surrounding Fuels:	Grass,Shrub,Timber	Defensio	ble Space: 30-50 Feet	
Structure Triage				
Category:	Defensible, Prep and Hold		<b>NA</b> - <b>N</b> -	
Roof Material:	Metal	•	Material: Wood	
Heat Traps:	Open Eaves, Wood Deck, Rair			
Electrical Power:	Overhead, Generator	Gas to S	Structure: Abovegrou	nd
Hazards:	Terrain, Fuels			
Hazard Notes:	250 gal LPG tank on site.			
Access to Site:	T3/4 Engine	Best Access From: Entiat River Roa	ad	
Comm with ICP:	Radio			
Water Source:	Faucet / Hose,Creek			
Mitigation Time:	1-2 Hours

Other Resources				
Needed to Protect: Notes:	Structure is a single family single	scratch line around all structures and n story structure with a metal roof and wood si k from the structures and scratch line has be time.	iding. Structure has a roof	with large amounts of debris on top of it.

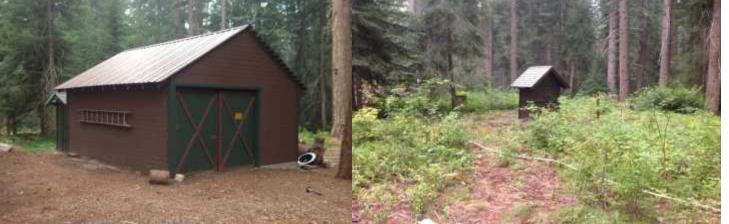
Structure Number: Structure Name: SubDivision: GPS Location, Lat. GPS Location, Long. Safety Zone Present: Type of Structure: Other Type of	170 FS #1 Silver Falls Guard Station 47 57.48888 120 32.13216 No Other Government building	Where is Safety Zone: Safety zones are located Primary Structures: 1	I south of guard station location approx 4 miles. Outbuildings: 3
Surrounding Fuels: Structure Triage	Timber,Slash	Defensible Space	: 30-50 Feet
Category:	Non-Defensible, Prep and L	_eave	
Roof Material:	Wood	Siding Material	: Wood
Heat Traps:	Open Eaves, Wood Deck, Ot	her Receptor	
Electrical Power:	Solar/Wind	Gas to Structure	: Aboveground
Hazards:	Fuels,HazMat		
Hazard Notes:		n site. Bulk fuel storage in outbuilding.	
Access to Site: Comm with ICP:	T1 Engine	Best Access From: Silver Falls Guard Station	n is located at the Silver Falls Trail along Entiat River
Water Source:	Radio Faucet / Hose,Porta-Tank/F	Pumpkin Crook

Mitigation Time:	1-2 Hours	unphil, cleek	
Other Resources	1 1 100.0		
Needed to Protect:	Hose lay with sprinkler kits,	, scratch line around structure, use structure wra	ap as needed on structure.
Notes:	clean shake shingle roof with wo compound have had hand line so	bod siding. there is one medium size garage on site and tw	buildings. Primary structure is a single level structure with a wo smaller misc outbuildings. All buildings in the Silver Falls lay and sprinkler system. Structure wrap was used where n established safety zones.
Collected By:	Jay Walter Photo 1	Collected Date/Time:	08/03/2014 07:03:22 GMT-07:00 Photo 2
Contraction of the second second	Photo 3		Photo 4
