JONES FIRE
 BRANCH I
 OR-WIF-170191
 Repair Status Map
 Datum: North American 1983
 09/29/2017
 Day Shift
 Perimeter as of: 09/27/17
 Approx: 10,114ac

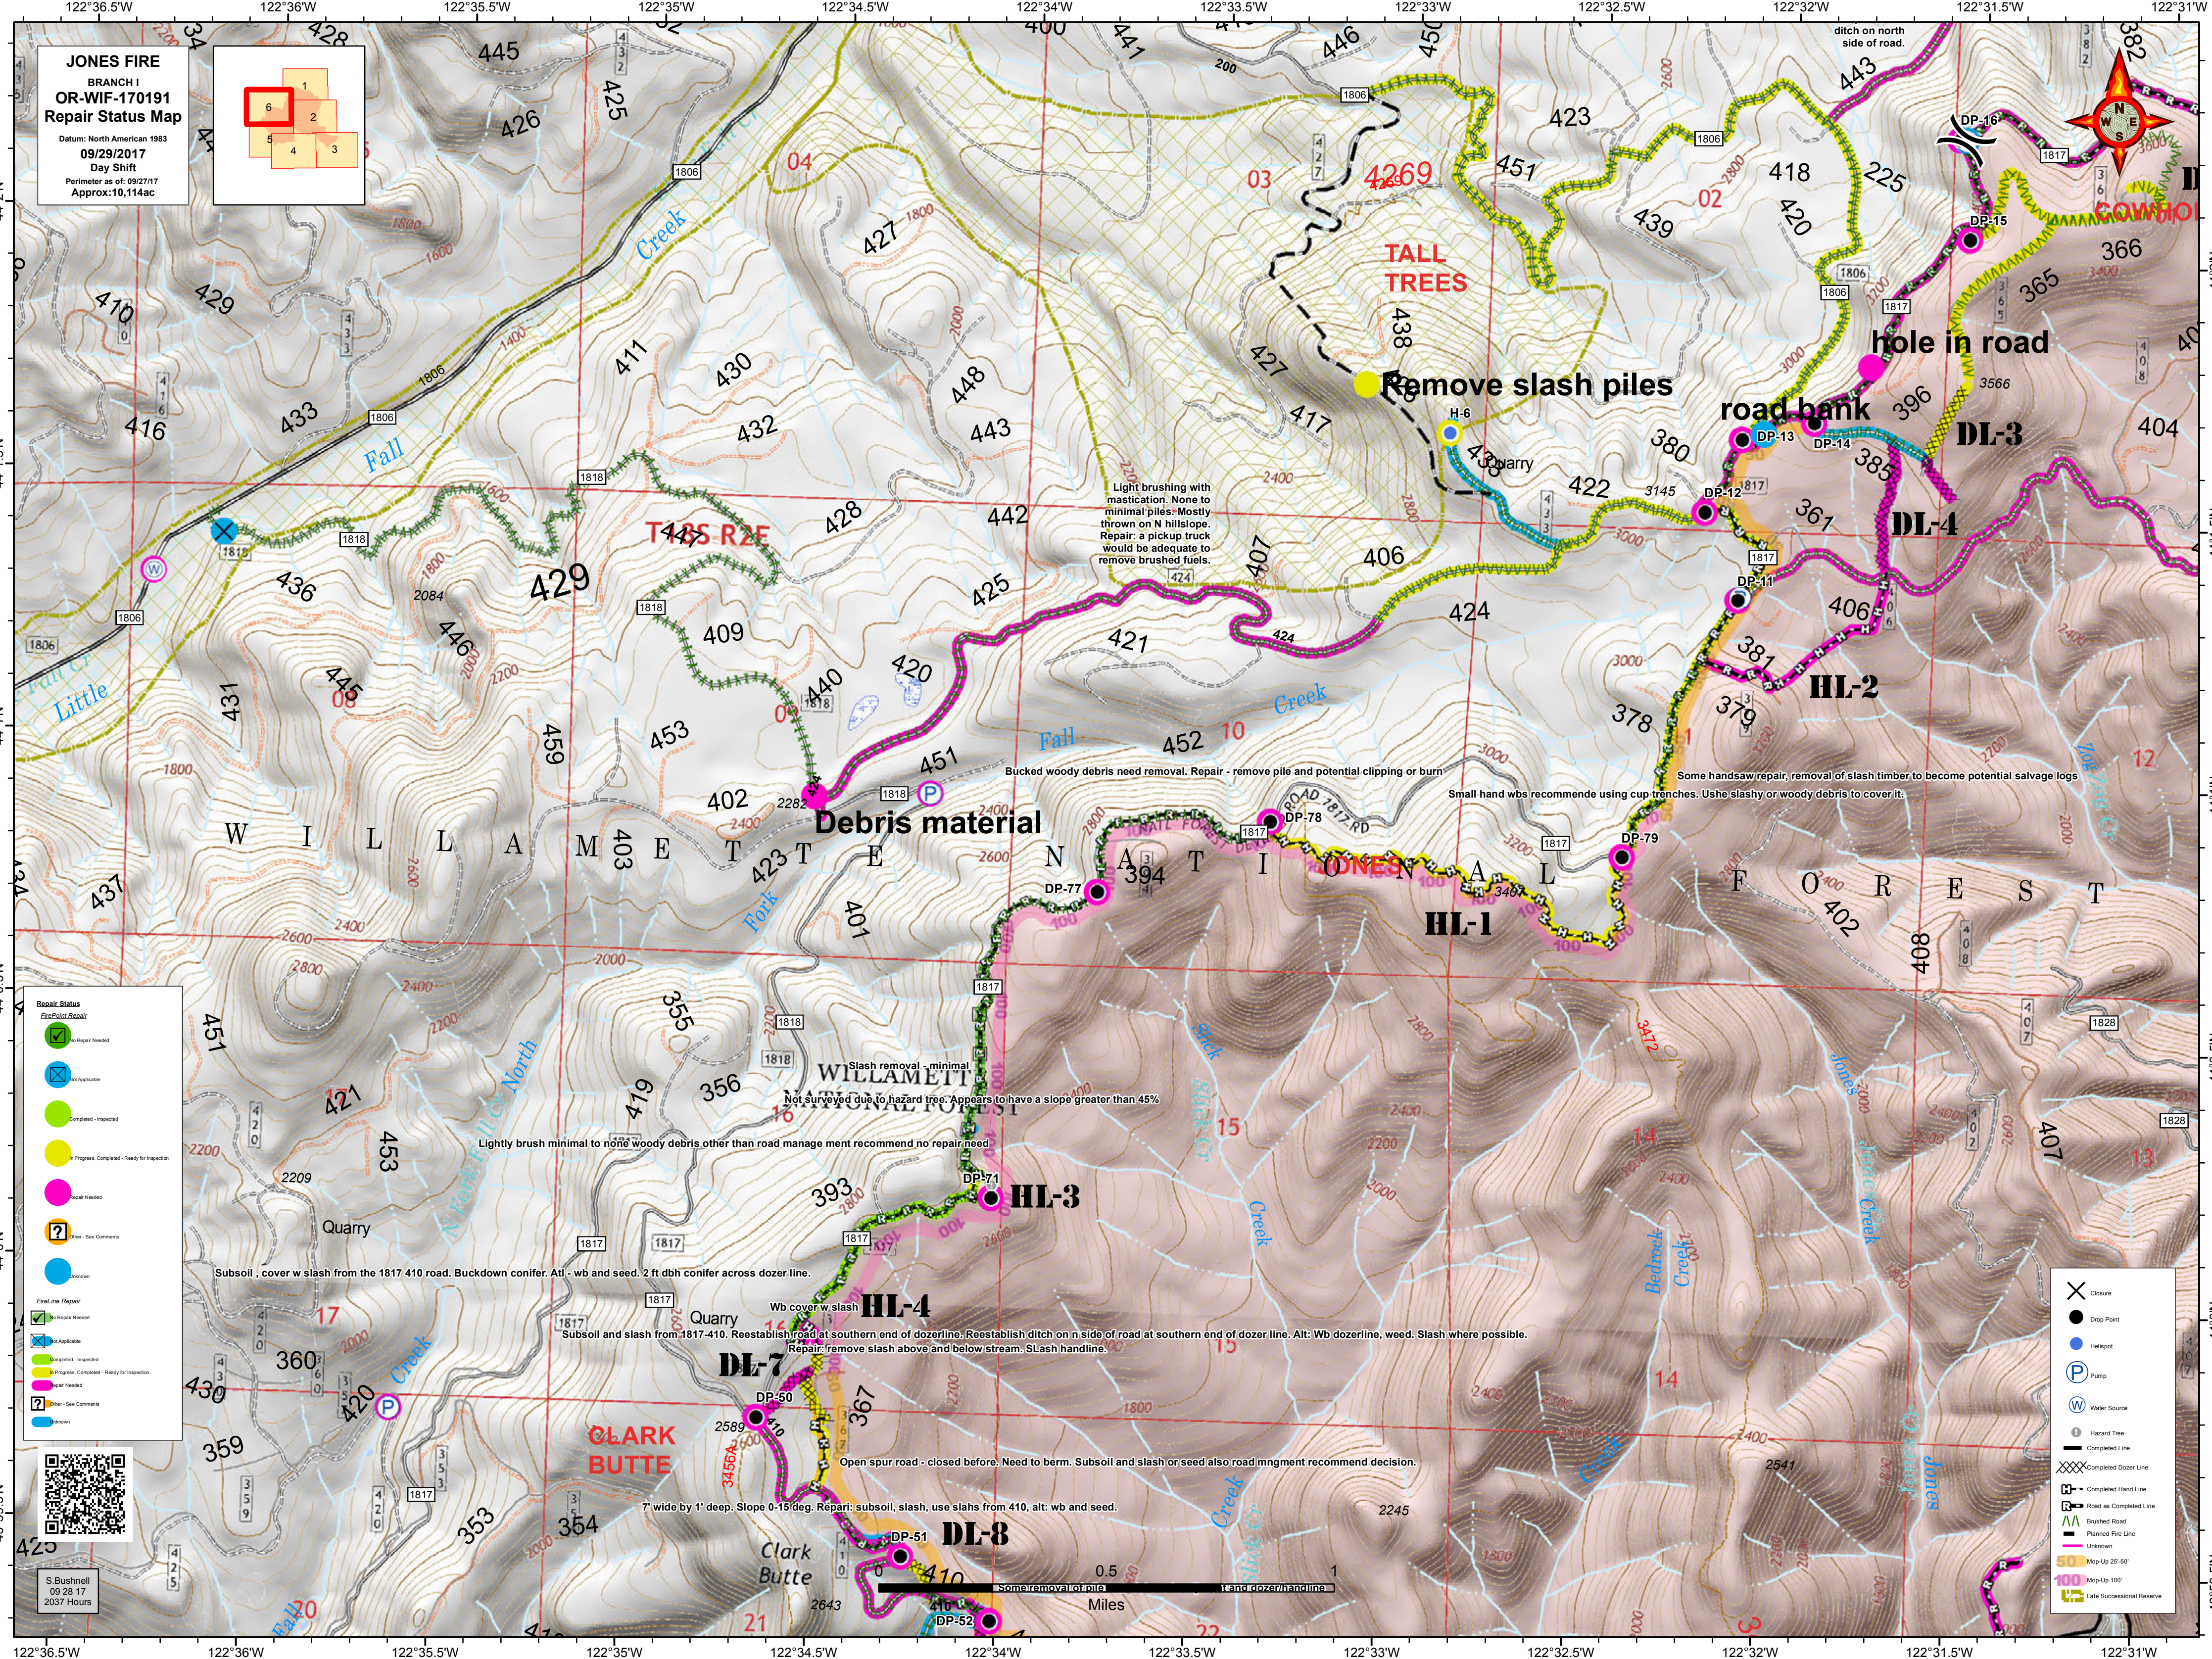
Light brushing with mastication. None to minimal piles - Mostly thrown on N hillslope. Repair: a pickup truck would be adequate to remove brushed fuels.

Bucked woody debris need removal. Repair - remove pile and potential clipping or burn

Some handsaw repair, removal of slash timber to become potential salvage logs

Slash removal - minimal
 Not surveyed due to hazard tree. Appears to have a slope greater than 45%

Lightly brush minimal to none woody debris other than road management recommend no repair need

Subsoil, cover w slash from the 1817 410 road. Buckdown conifer. Alt - wb and seed. 2 ft dbh conifer across dozer line.

Subsoil and slash from 1817-410. Reestablish road at southern end of dozerline. Reestablish ditch on n side of road at southern end of dozer line. Alt: Wb dozerline, weed. Slash where possible. Repair: remove slash above and below stream. SLASH handline.

Open spur road - closed before. Need to berm. Subsoil and slash or seed also road mgmt recommend decision.

7' wide by 1' deep. Slope 0-15 deg. Repair: subsoil, slash, use slash from 410, alt: wb and seed.
