Natchez Fire 2018

Incident Number: OR-RSF-000348

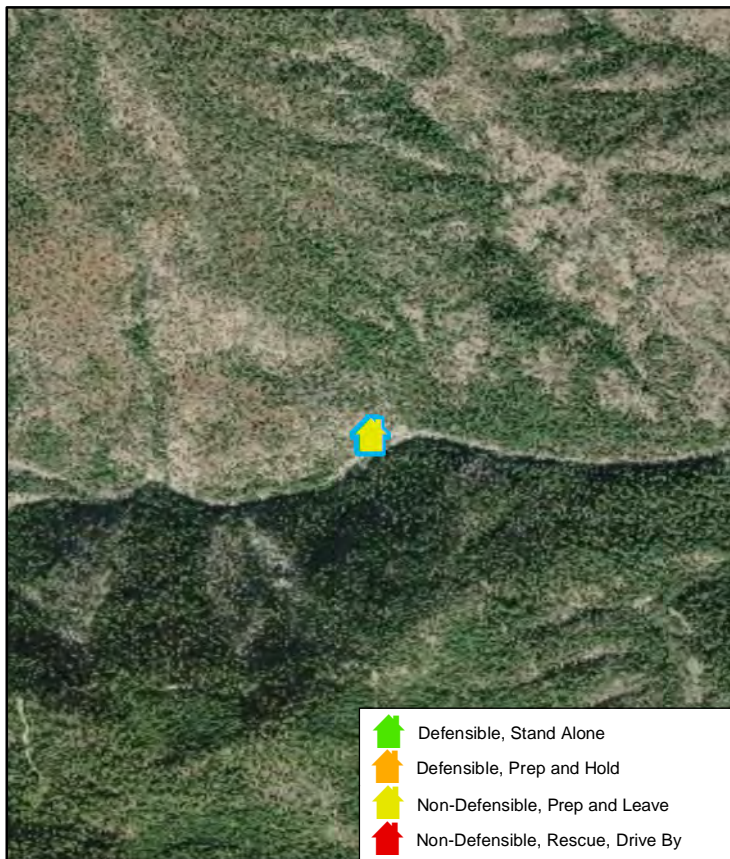
Location: South fork of Indian creek ,
Structure Triage: Non-Defensible, Prep and Leave
Coordinates, DDM: 41°52.213, 123°30.71
Safety Zone Present: No

Heat Traps: WoodDeck,OpenEaves

Fuel Surrounding Structure: Timber

Defensible Space: None

Hazards: Terrain,NoTurnAround,Other

Hazard Notes: Very steep. Utv vehicle access only.

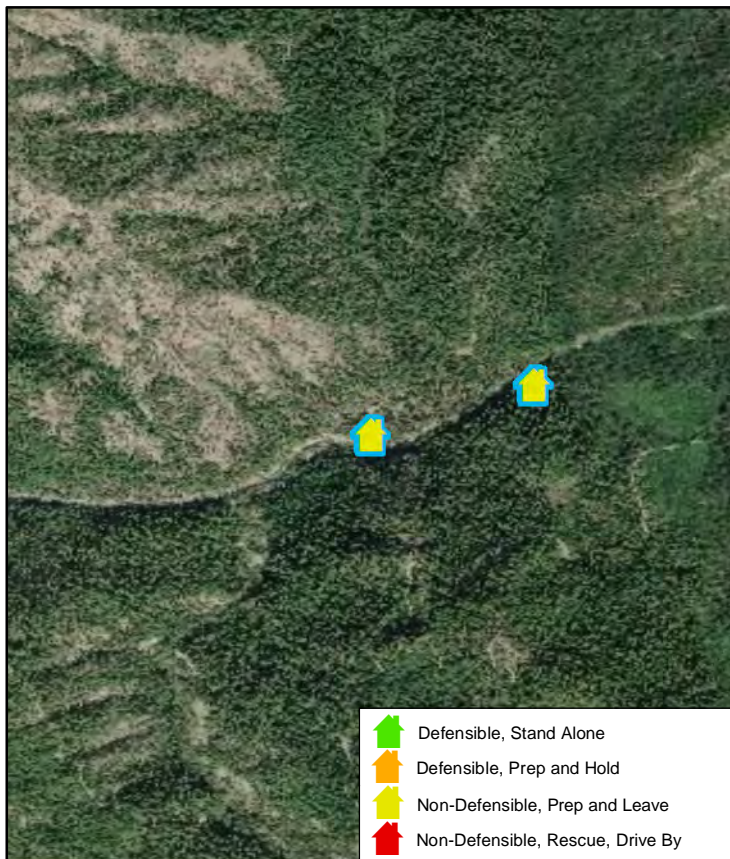
Location: South fork of Indian creek ,
Structure Triage: Non-Defensible, Prep and Leave
Coordinates, DDM: 41°52.293, 123°29.767
Safety Zone Present: No

Heat Traps: Numerous

Gas to Structure: Aboveground

Notes: 4 20 lb propane tanks under traile

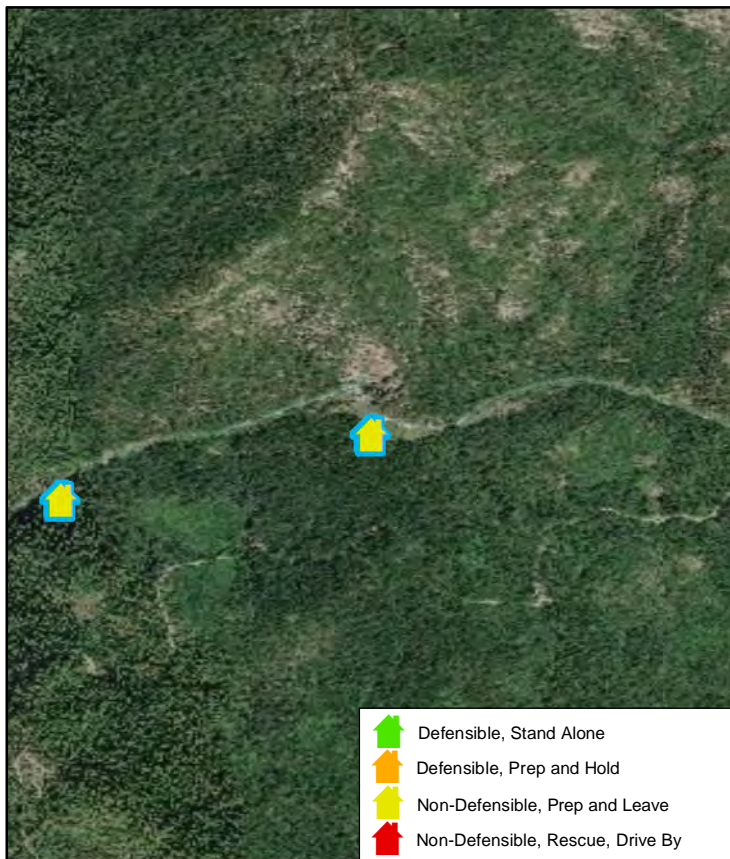
Location: South fork of Indian creek ,
Structure Triage: Non-Defensible, Prep and Leave
Coordinates, DDM: 41°52.514, 123°28.864
Safety Zone Present: No

Heat Traps: WoodDeck

Defensible Space: 0-30 Feet

Resources Needed to Protect Structure: Historical USFS cabin with 2 out buildings. Wrapped and prepped.

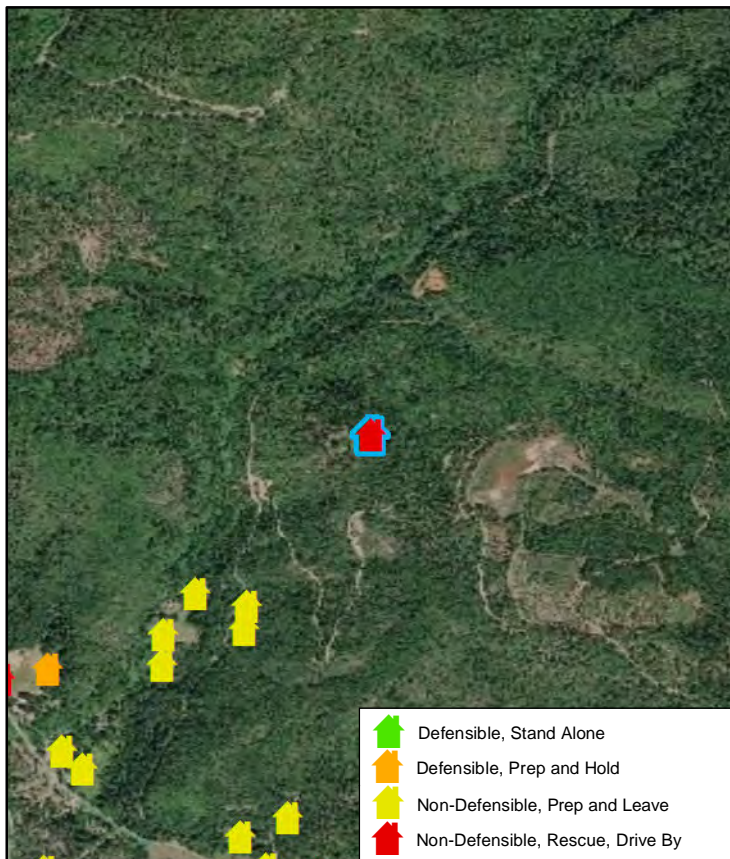
Location: Davis home East Fork of Indian Creek , NA

Heat Traps: **OpenEaves,WoodDeck**

Resources Needed to Protect Structure: **Due to bad access with narrow, heavily timbered driveway it would be difficult to defend.**

Hazards: **Terrain,NoTurnAround**

Hazard Notes: **Narrow heavily timbered driveway down to home.**

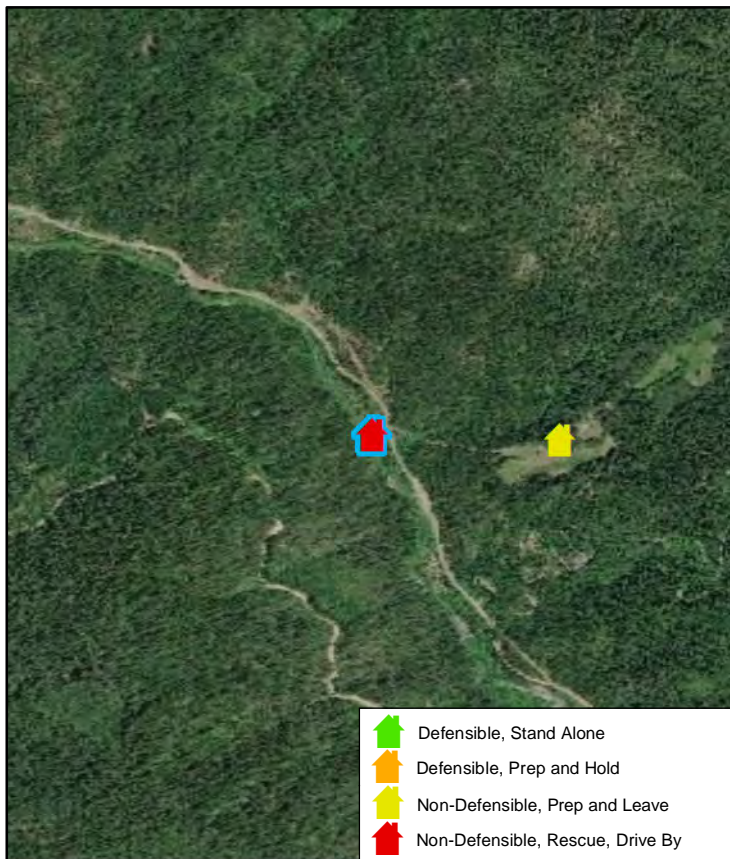
Location: 9591 Indian Creek , Abandoned

Defensible Space: **None**

Hazards: **Yard art**

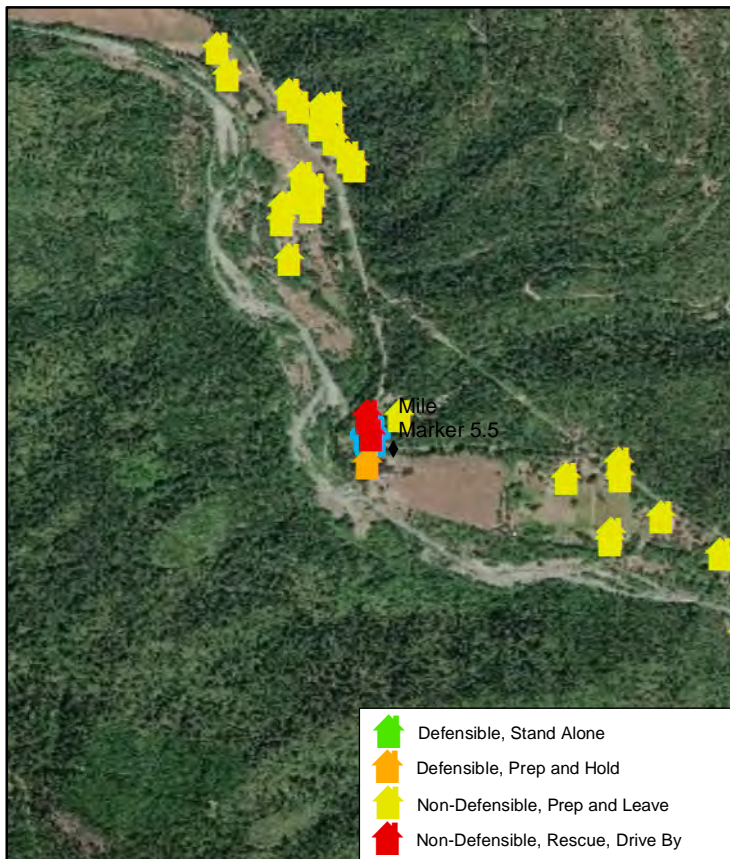
Hazards: **Asbestos siding**

Notes: **Abandoned**

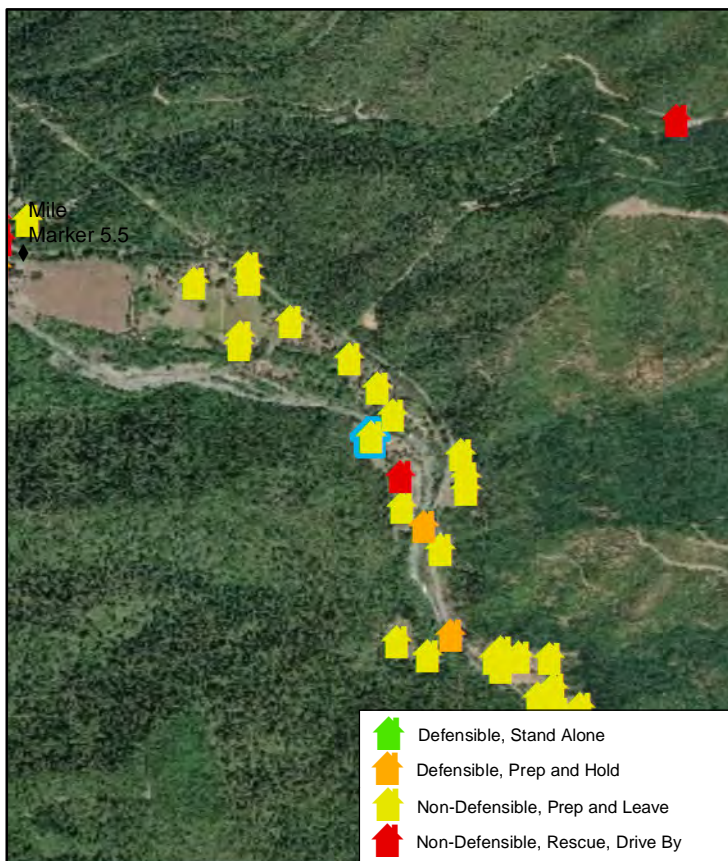
Hazards: **Bridge load limits, Yard art**

Notes: **Bridge is insufficient for engine traffic**

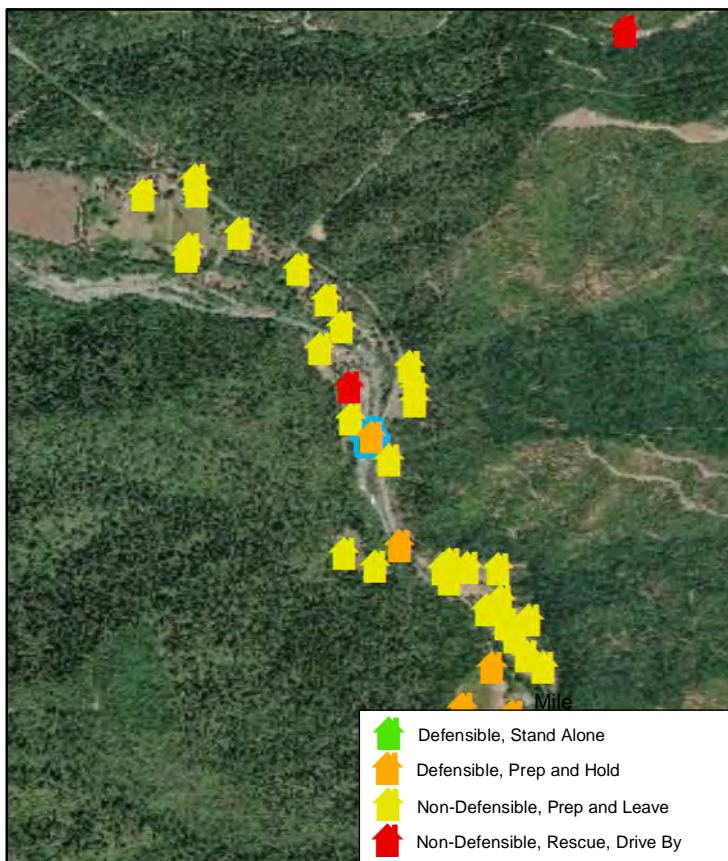
Hazards: **Operator use extreme caution crossing bridge**

Notes: **Bridge is significantly insufficient, pickup only, walk it out first**

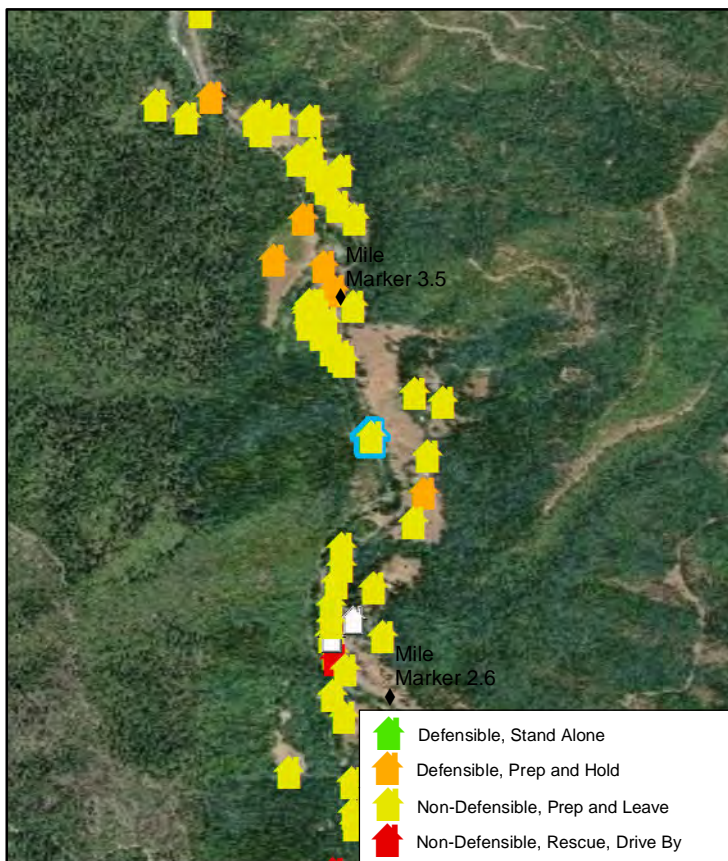
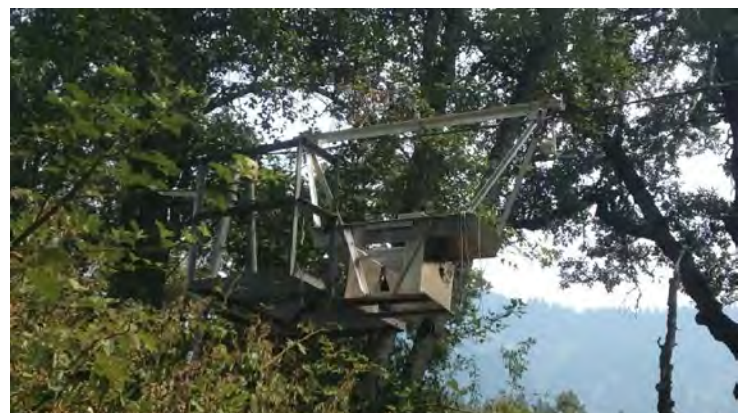
Notes: This a zip line is for access over Indian creek. The shed must provide power to operate cable pulley, etc. The zip line/ carrier is metal and should withstand any fire damage, however this person transport indicates there is most likely a cabin on the west side of Indian Creek near this location.

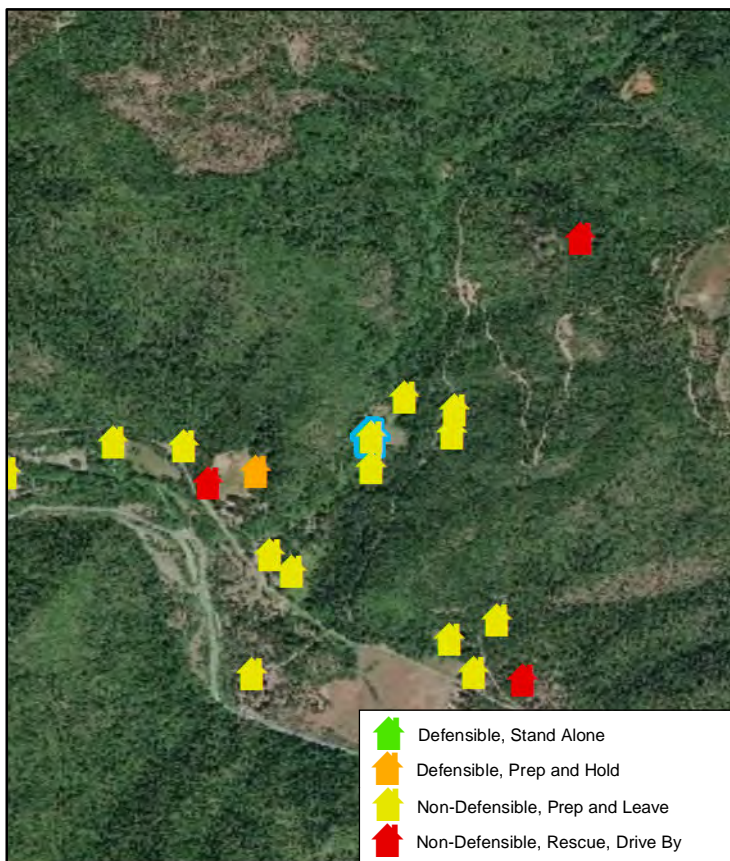
Hazards: Fuels

Hazard Notes: 80 lb propane tank.

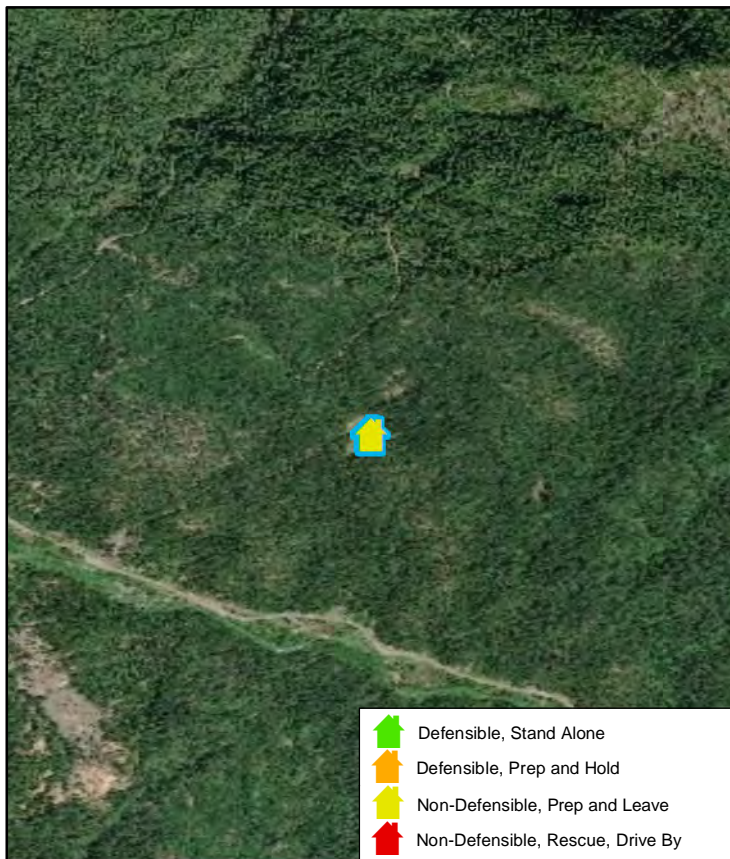
Hazards: **Other**

Hazard Notes: **Access. Steep narrow road down into property with heavy timber**

Notes: **Large house with one large shop and shed. Large irrigated grass field in front of house. There is a two thousand gallon well located outside the yard at the end of the grape vines. (There is also a hydrant in the backyard by the end of the bricks. Renters are Patrick and Shuana Mayfield, 707-346-0171 or 707-**

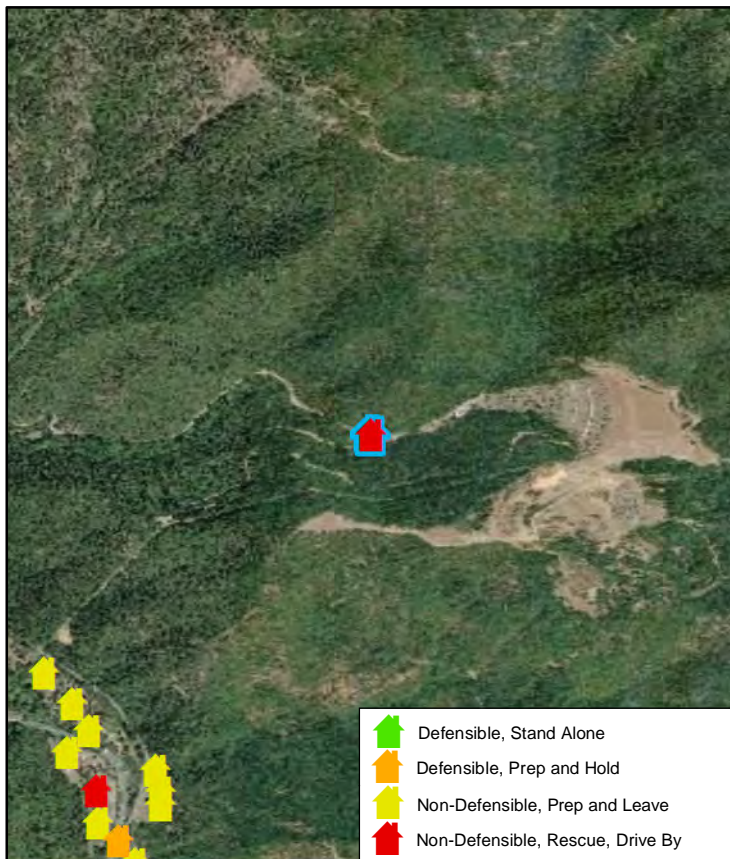
Hazards: **HazMat**

Hazard Notes: **Mining site, sodium chloride tank present in addition to diesel tank. Maybe other hazardous materials associated with mining industry present.**

Notes: **Mobile retardant site is up steep narrow road from mine entrance.**
