Suppression Repair

Beachie Creek
ORWIF-200299
Riverside
ORMHF-000859
10/02/20
Page: 15

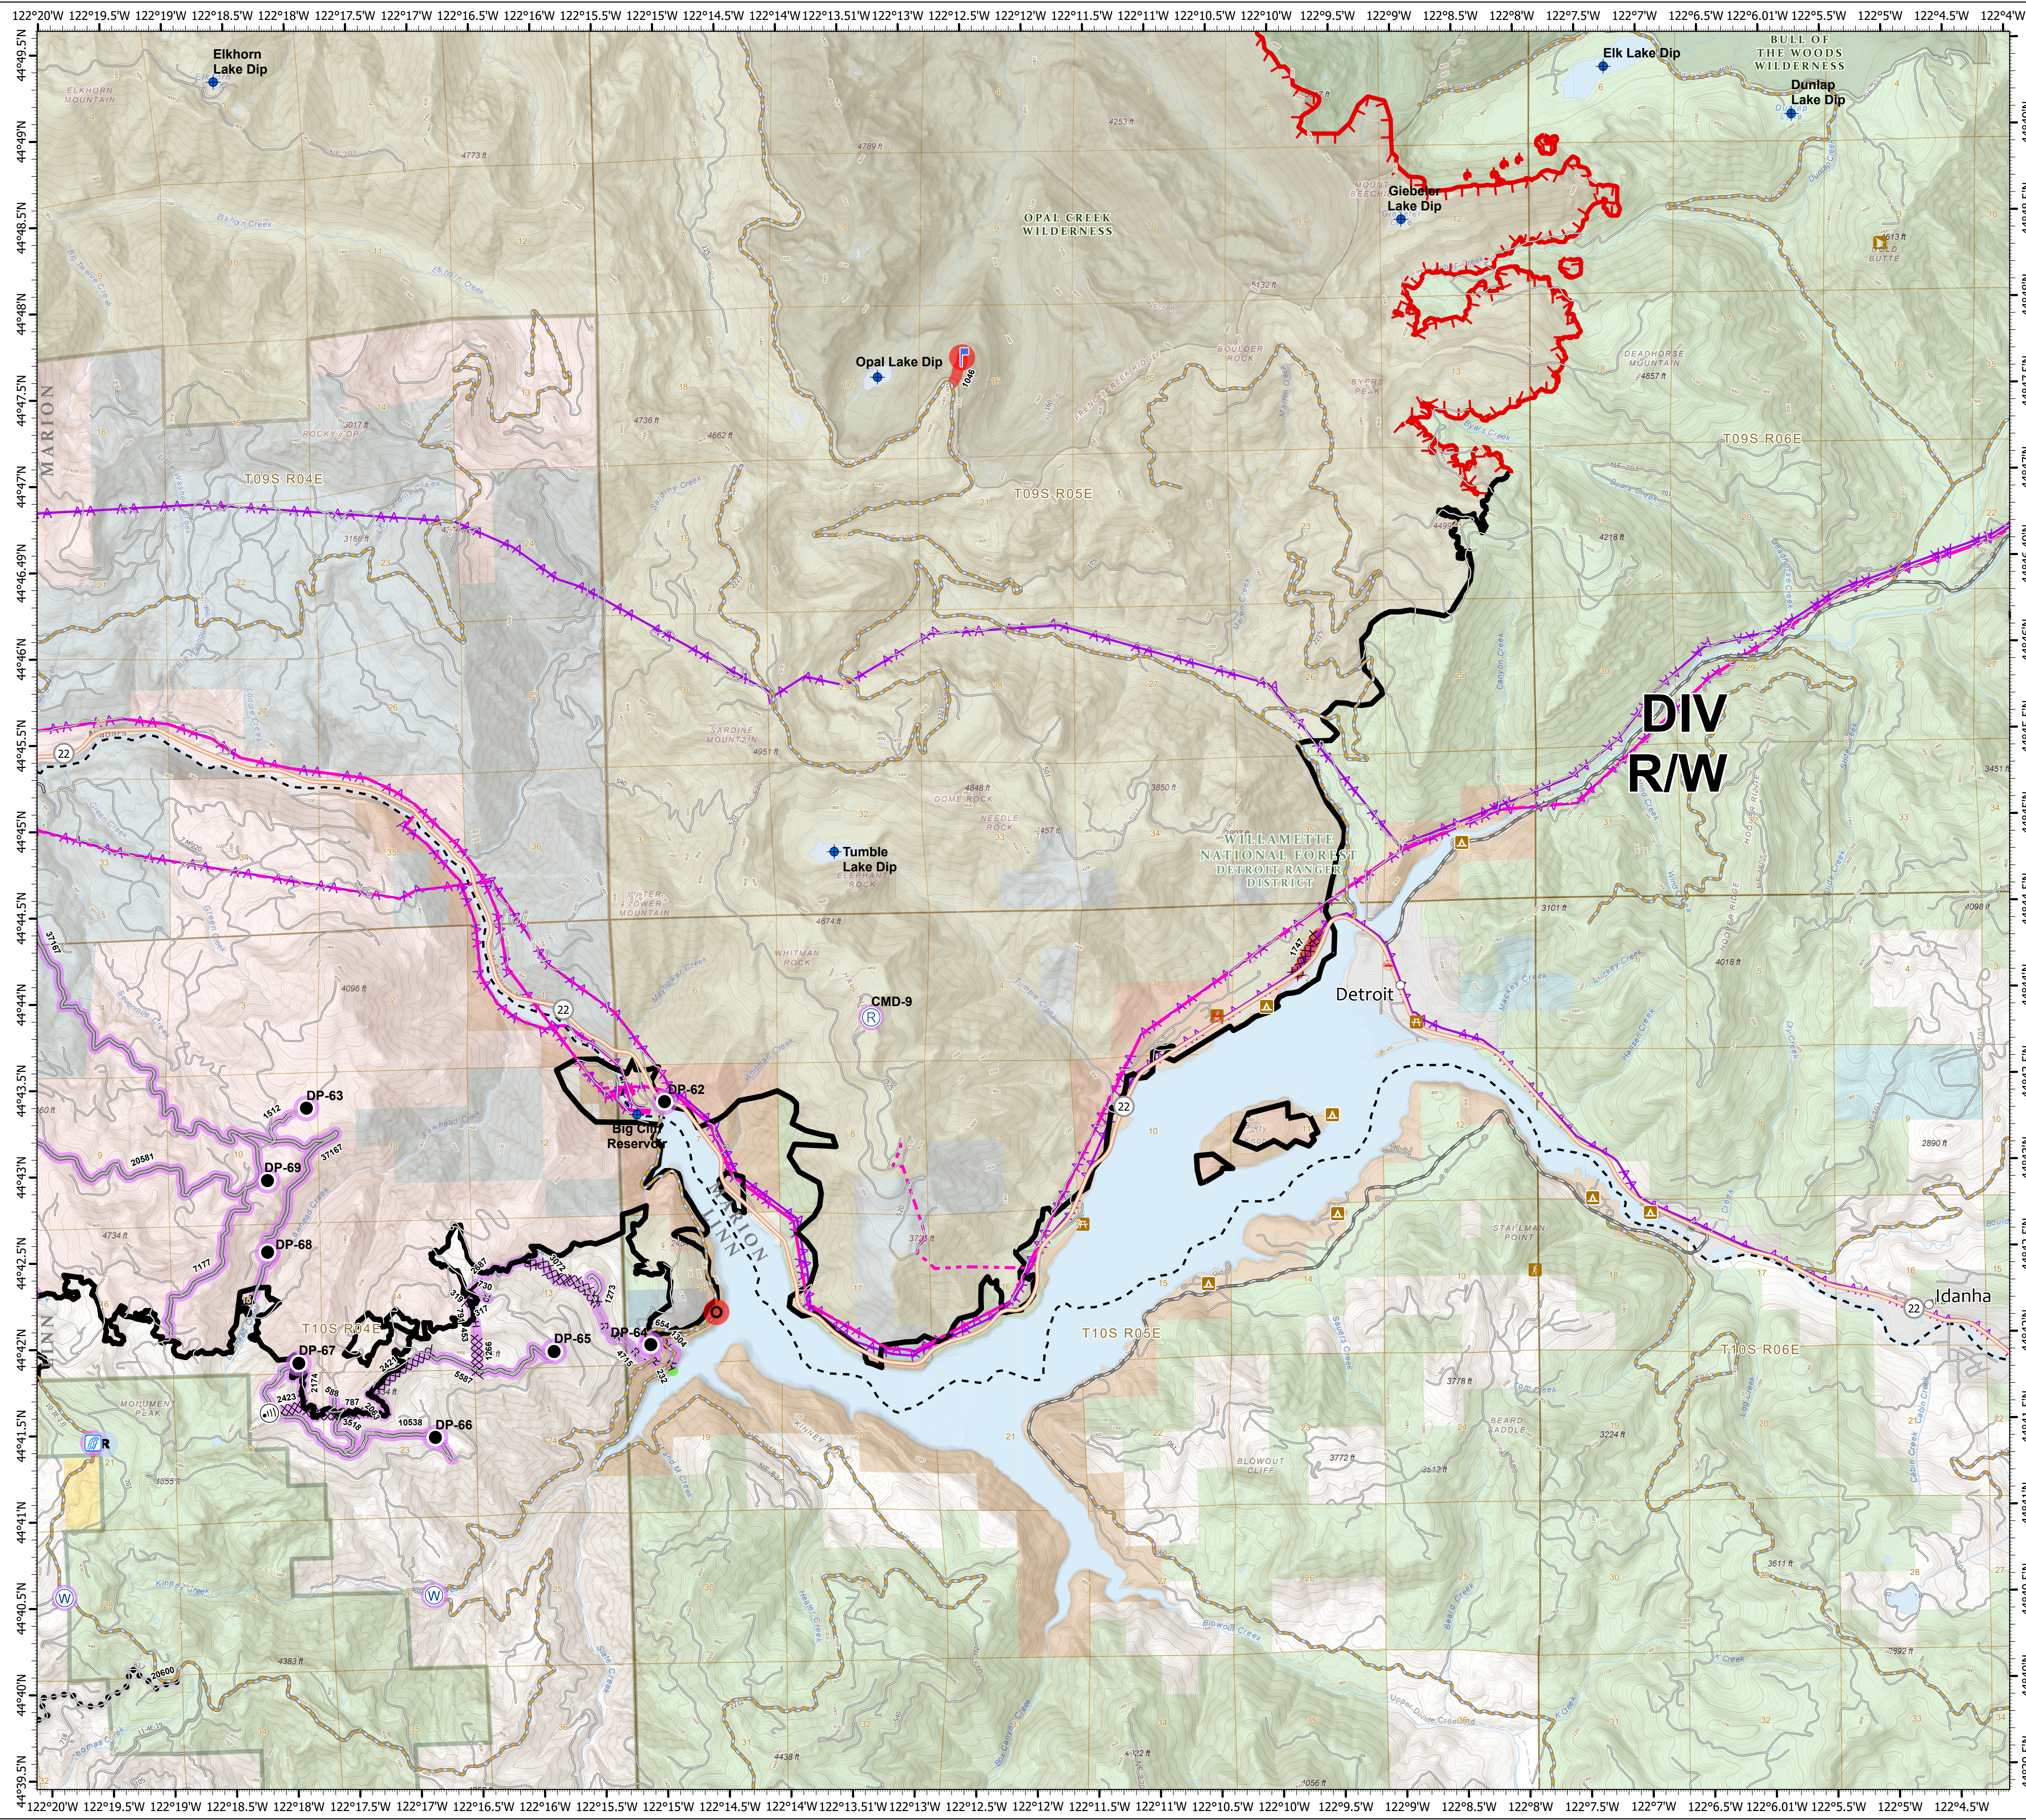
FC Point Type	Repair Status	Repair Comments	Label
Culvert	Repair Needed	BAER Alert: burnt out plastic culvert. 24" x 36" replacement needed. Asphalt surfacing. 10 CY aggregate	
Drop Point	Unknown		DP-62
Drop Point	Unknown		DP-63
Drop Point	Unknown		DP-64
Drop Point	Unknown		DP-65
Drop Point	Unknown		DP-66
Drop Point	Unknown		DP-67
Drop Point	Unknown		DP-68
Drop Point	Unknown		DP-69
Lookout	Repair Needed		
Repeater	Unknown		CMD-9
Resource Location	No Repair Needed		
Stream Crossing	Unknown		
Water Development or Draft Site	Unknown		
Water Source	Unknown		
Water Source	Unknown

FC Line Type	Repair Status	Repair Comments	Length Feet
Access or Improved Road	Unknown		1273
Access or Improved Road	Unknown		1512
Access or Improved Road	Unknown		3518
Access or Improved Road	Unknown		5387
Access or Improved Road	Unknown		7177
Access or Improved Road	Unknown		10538
Access or Improved Road	Unknown		20581
Access or Improved Road	Unknown		37167
Completed Dozer Line	Repair Needed	Waterbar as appropriate and seed roads, cut banks and entrances off of Hwy 22. Approximately 15 water bars will be needed. Recommend mini or medium sized excavator. Trash left behind by CFI including old telephone poles, insulators, wire, beverage bottles, food wrappers, etc.	317
Completed Dozer Line	Unknown		787
Completed Dozer Line	Unknown		1266
Completed Dozer Line	Unknown		2421
Completed Dozer Line	Unknown		2423
Completed Dozer Line	Unknown		3072
Completed Hand Line	Completed - Inspected	waterbars installed on 9/22 by Richardson and Haganan	232

Completed Hand Line	Unknown		319
Completed Hand Line	Unknown		453
Completed Hand Line	Unknown		588
Completed Hand Line	Unknown		654
Completed Hand Line	Unknown		2063
Completed Hand Line	Unknown		2174
Other	Repair Needed	Cover with brush. Pull flagging	1046
Planned Fire Line	Unknown		2687
Road as Completed Line	Unknown		730
Road as Completed Line	Unknown		791
Road as Completed Line	Unknown		1304
Road as Completed Line	Unknown		4715
