Suppression Repair

Beachie Creek
ORWIF-200299
Riverside 2
10/02/20
Page: 2

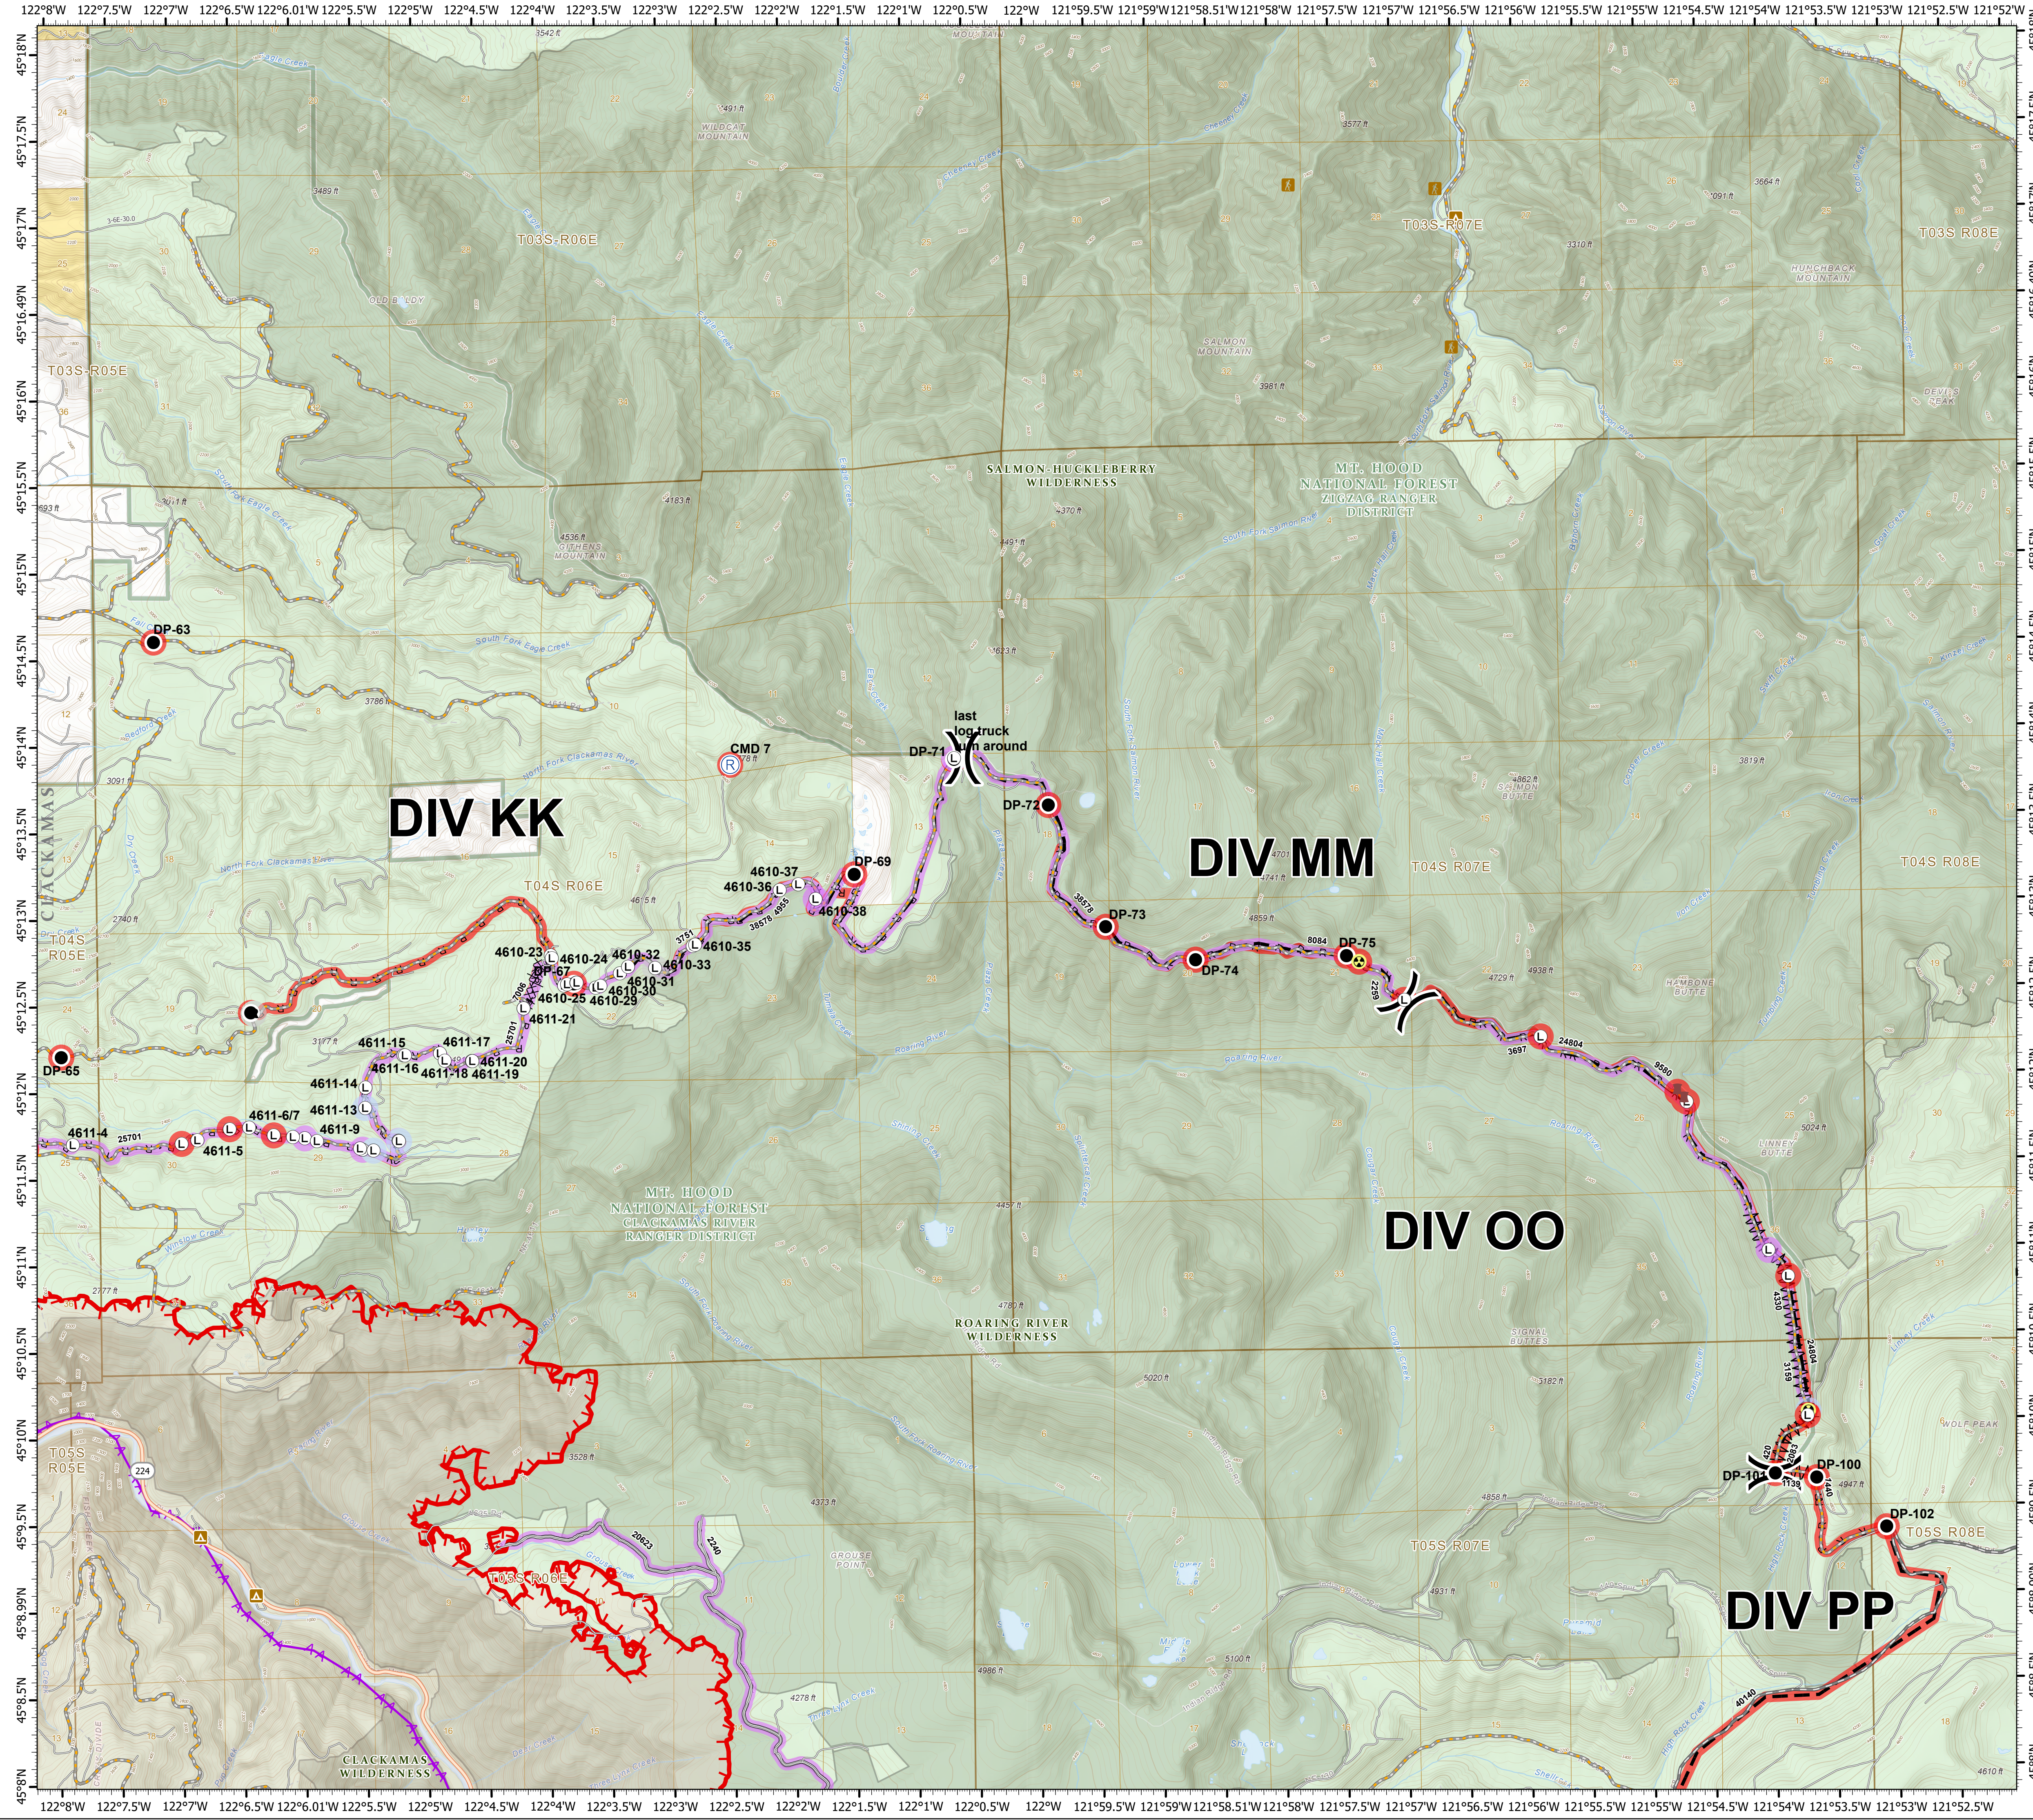
FC Point Type	Repair Status	Repair Comments	Label	FC Point Type	Repair Status	Repair Comments	Label
Dozer Push	Repair Needed			Landing or Log Deck			4610-27
Dozer Push	Repair Needed			Landing or Log Deck			4610-28
Drop Point	Repair Needed		DP-101	Landing or Log Deck			4610-29
Drop Point	Repair Needed		DP-101	Landing or Log Deck			4610-30
Drop Point	Repair Needed		DP-102	Landing or Log Deck			4610-31
Drop Point	Repair Needed		DP-63	Landing or Log Deck			4610-32
Drop Point	Repair Needed		DP-64	Landing or Log Deck			4610-33
Drop Point	Repair Needed		DP-65	Landing or Log Deck			4610-34
Drop Point	Repair Needed		DP-66	Landing or Log Deck			4610-35
Drop Point	Repair Needed		DP-67	Landing or Log Deck			4610-36
Drop Point	Repair Needed		DP-69	Landing or Log Deck			4610-37
Drop Point	Repair Needed		DP-71	Landing or Log Deck			4610-38
Drop Point	Repair Needed		DP-72	Landing or Log Deck			4610-39
Drop Point	Repair Needed		DP-73	Landing or Log Deck			4610-40

Drop Point	Repair Needed		DP-74	Landing or Log Deck			4610-41
Drop Point	Repair Needed		DP-75	Landing or Log Deck			4610-42
Hazard	No Repair Needed	One way road. No turnaround. Contact Div O before proceeding.		Landing or Log Deck			4611-10
Hazard	Repair Needed	Waterbar and divert sweep away from failure. cutbank releveling.		Landing or Log Deck			4611-11
Landing or Log Deck				Landing or Log Deck			4611-12
Landing or Log Deck			4610-23	Landing or Log Deck			4611-13
Landing or Log Deck			4610-24	Landing or Log Deck			4611-14
Landing or Log Deck			4610-25	Landing or Log Deck	No Repair Needed		4611-15

FC Line Type	Repair Status	Repair Comments	Length Feet
Access or Improved Road	Unknown		2240
Access or Improved Road	Unknown		20623
Completed Dozer Line	Repair Needed	Dozer line needs significant repair. Follow decom with slash and water bars.	
Completed Dozer Line	Repair Needed	Pull in berms, may not be needed until log deck is removed.	
Completed Dozer Line	Repair Needed	Light chipping and sweeping needed.	1139
Line Break Completed	Repair Needed	Logs in ditch need to be removed. Chip smaller material. Berms need to be knocked down. Rocky debris behind shoulder needs additional repair.	2083
Line Break Completed	Unknown		3159
Line Break Completed	Unknown		4330
Planned Fire Line	Repair Needed	Road grading, remove berms, repair cut and fill slopes (marked separately), and chipping -Suing.	24804
Planned Fire Line	Repair Needed	Chipping needed throughout NF 58 and entry to NF 5830 and NF 150. Crews needed to sweep debris.	40140

Planned Fire Line	Unknown		8084
Planned Fire Line	Unknown		38578
Road as Completed Line	Repair Needed		
Road as Completed Line	Repair Needed	Road grading, remove berms, repair cut and fill slopes (marked separately), and chipping -Suing.	
Road as Completed Line	Repair Needed	Bladed and water bars	
Road as Completed Line	Repair Needed	Sweeping of debris and light chipping need at intersection of DP 102	
Road as Completed Line	Repair Needed	The road needs drainage. excavator work, too narrow for grader on out-sloped road, remove slash from road, road has little surfacing and very bony.	
Road as Completed Line	Repair Needed	Begin grading to remove berm on roadside from tracked equipment, begin slash removal from drainage features, barricade light grading, road prism needs brushed, ditches pulled and graded to remove ruts and have proper drainage. Will require spot rock, starts at 150 spur, this segment has worst rutting.

Road as Completed Line	Repair Needed	Light chipping needed	420
Road as Completed Line	Repair Needed	Sweeping of debris	1440
Road as Completed Line	Repair Needed		3751
Road as Completed Line	Repair Needed	Needs grading of berm caused by dozer. Masticated edge needs follow up hand cutting (stems were cut too long).	4955
Road as Completed Line	Unknown		2259
Road as Completed Line	Unknown		3697
Road as Completed Line	Unknown		7006
Road as Completed Line	Unknown		9580
Road as Completed Line	Unknown		25701
