# Suppression Repair

Beachie Creek  
ORWIF-200299  
Riverside  
ORMHF-000859  
10/06/20  
Page: 2

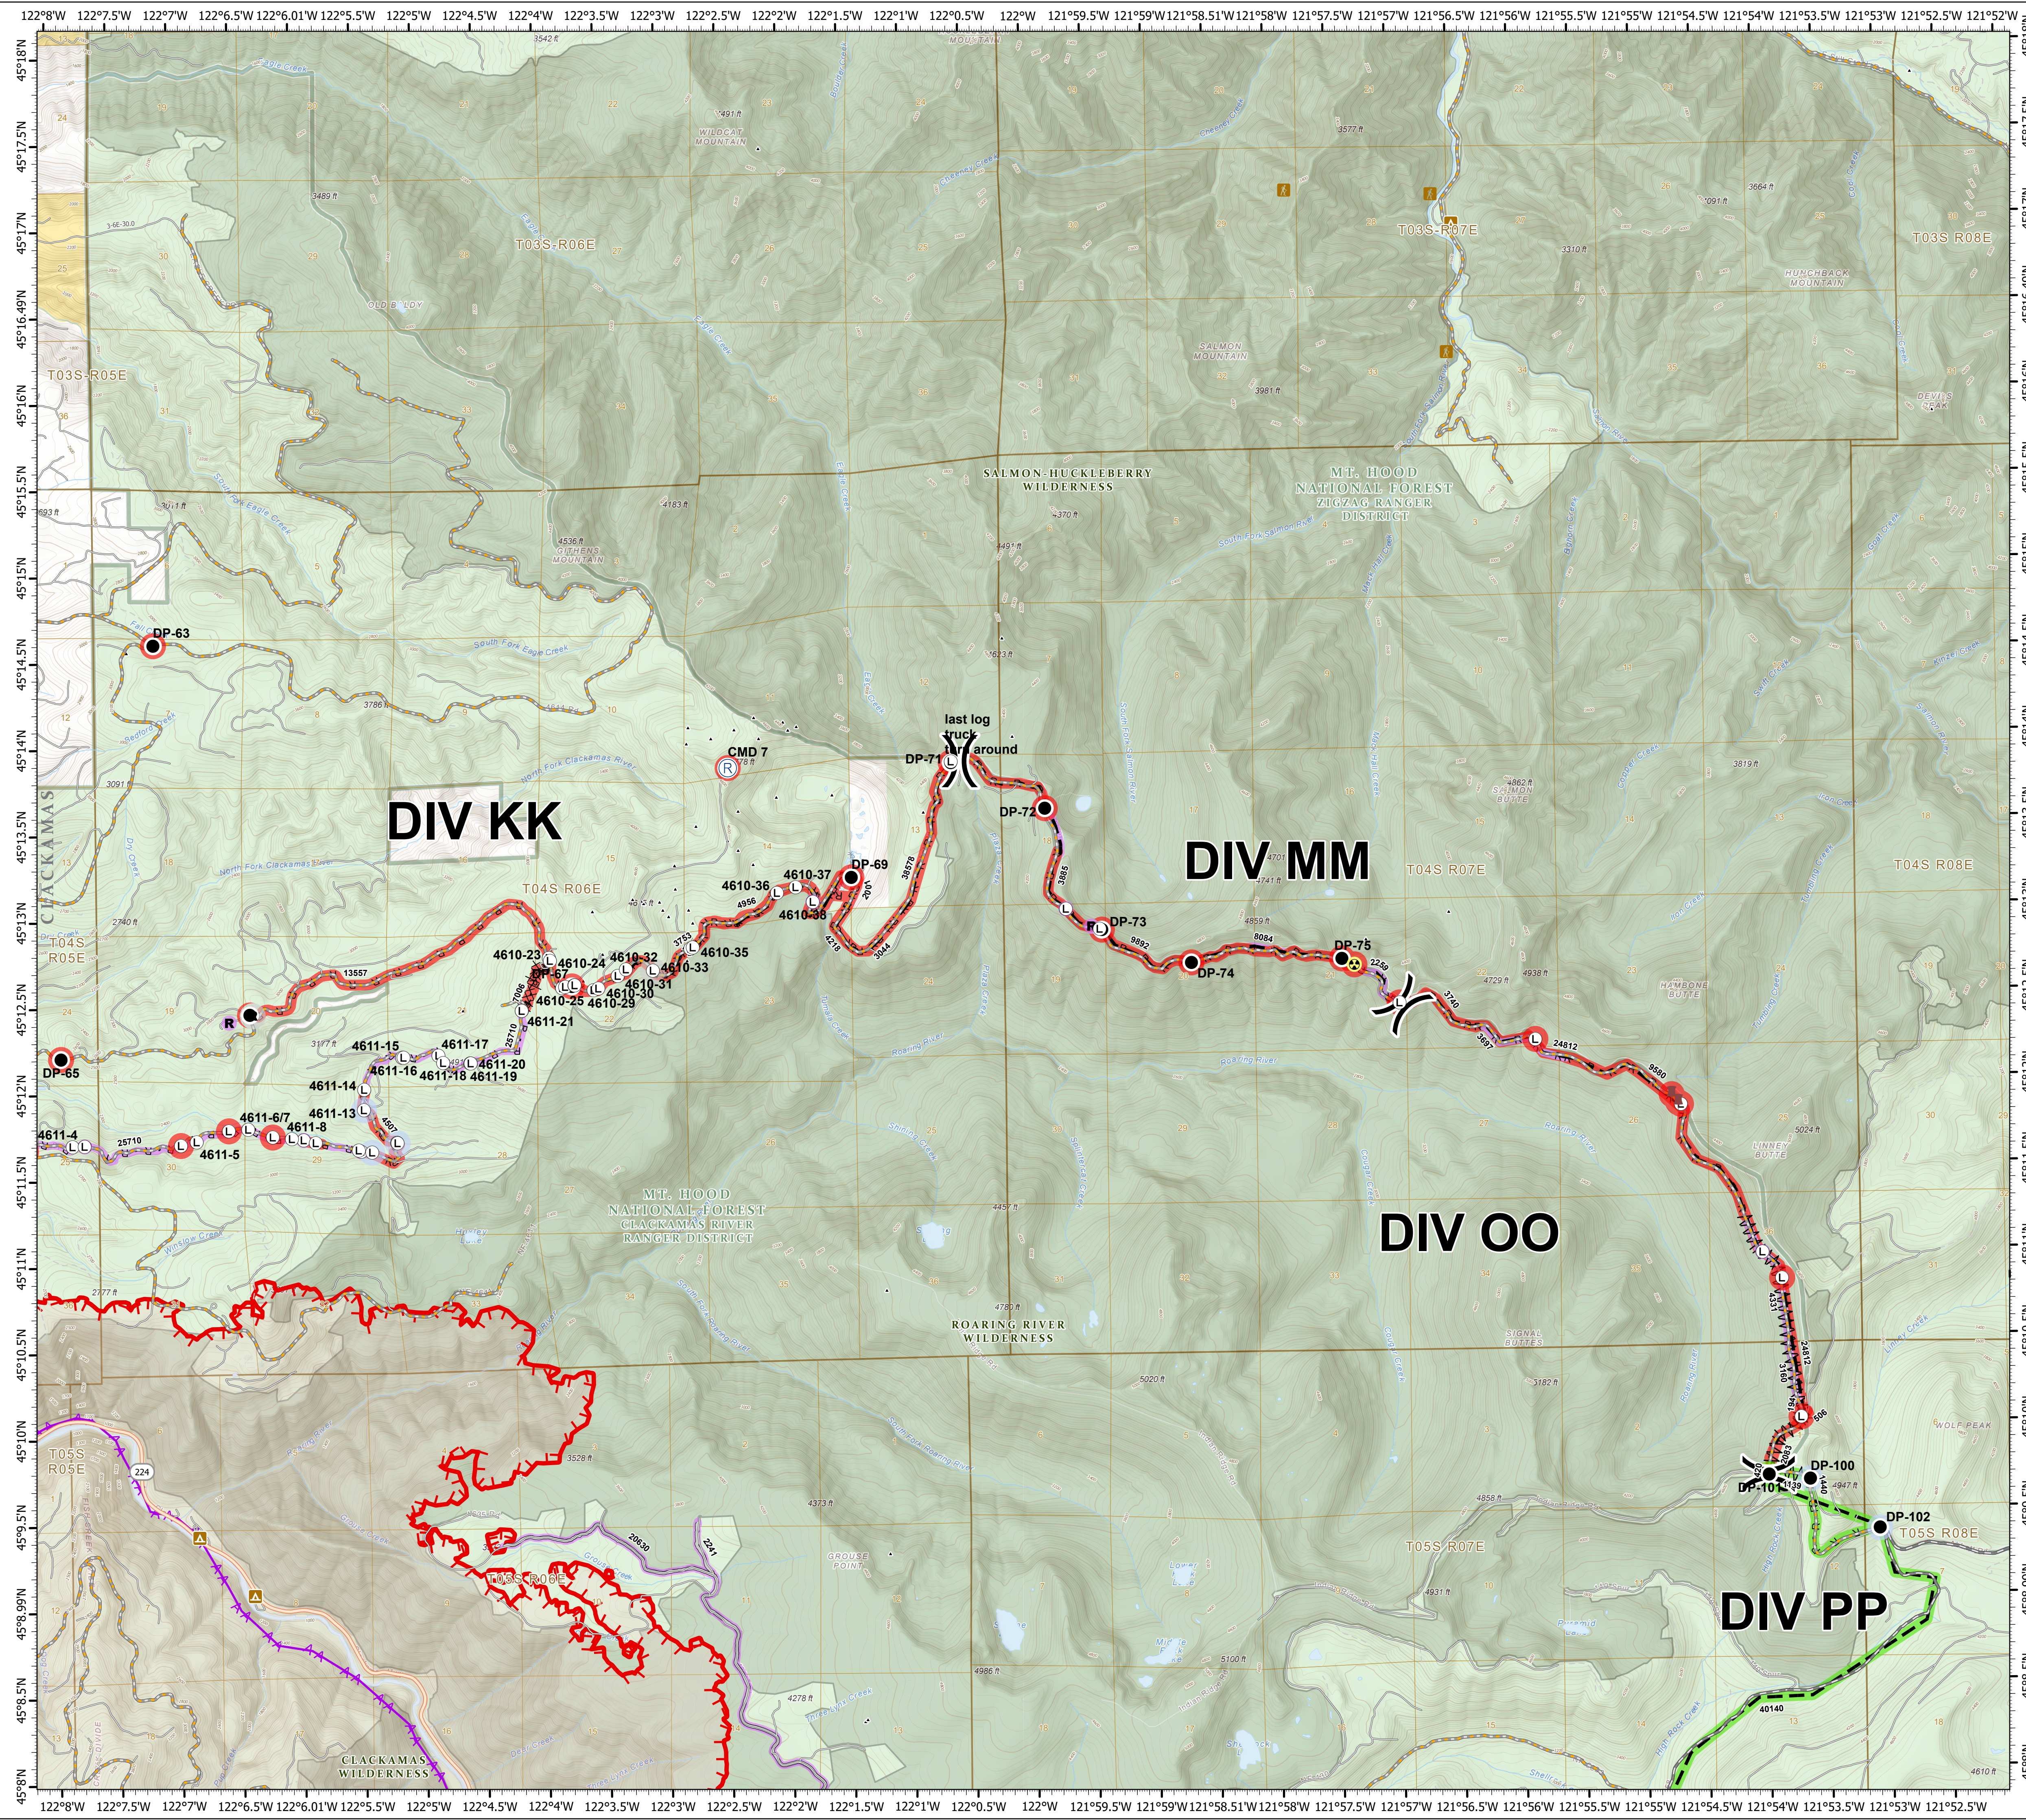
FC Point Type	Repair Status	Repair Comments	Label
Dozer Push	Repair Needed	18 inch thick slash lightly scattered here where soil is exposed. - Lin kyan	4610-25
Dozer Push	Repair Needed	18 inch thick slash scattered slash on top of exposed soil. In kyan 10/3/20	4610-27
Drop Point	Completed - Inspected		4610-29
Drop Point	No Repair Needed		4610-30
Drop Point	Repair Needed		4610-31
Drop Point	Repair Needed		4610-32
Drop Point	Repair Needed		4610-36
Drop Point	Repair Needed		4610-37
Drop Point	Repair Needed		4610-38
Drop Point	Repair Needed		4611-14
Drop Point	Repair Needed		4611-15
Drop Point	Repair Needed		4611-16
Drop Point	Repair Needed		4611-17
Drop Point	Repair Needed		4611-18
Drop Point	Repair Needed		4611-19
Drop Point	Repair Needed		4611-20
Drop Point	Repair Needed		4611-21
Drop Point	Repair Needed	waterbar and divert sweep away from failure. cutbank reworking.	4611-4
Landing or Log Deck			4611-8
Landing or Log Deck			4611-9

Landing or Log Deck			4610-23
Landing or Log Deck			4610-24

FC Line Type	Repair Status	Repair Comments	Length Feet
Road as Completed Line	Unknown		2259
Road as Completed Line	Unknown		3044
Road as Completed Line	Unknown		3097
Road as Completed Line	Unknown		25710
Road as Completed Line	Repair Needed	remove masticator debris from ditches and culvert, grade road for drainage. remove berm on shoulder scatter large slash accumulation	
Road as Completed Line	Repair Needed	Light chipping needed	420
Road as Completed Line	Repair Needed		2001
Road as Completed Line	Repair Needed	Road grading, remove berms, repair cut and fill slopes (marked separately), and chipping -Sung	3740
Road as Completed Line	Repair Needed		3753
Road as Completed Line	Repair Needed	4610 segment 4 - excavator work, too narrow for grader on outskipped road. remove slash from roadstead, road has little surfacing and very bony-R. Sanders	3885
Road as Completed Line	Repair Needed		4218
Road as Completed Line	Repair Needed	Bladed and water bars	4507

Road as Completed Line	Repair Needed	Needs grading of berm caused by dozer. Masticator edge needs follow up hand cutting (stems were cut too long).	4956
Road as Completed Line	Repair Needed	repair notes in comments	7005
Road as Completed Line	Repair Needed		9580
Road as Completed Line	Repair Needed	The road needs drainage.	9892
Road as Completed Line	Repair Needed	4610 segment 2 - Begin grading to remove berm on roadside from tracked equipment. begin slash removal from drainage features. barricade? light grading. 4610 brushing and ruts - road prism needs brushing, ditches pulled and graded to remove ruts and have proper drainage. Will require spot rock. starts at 150 spur. this segment has worst rutting	13557

FC Line Type	Repair Status	Repair Comments	Length Feet
Road as Completed Line	Completed - Inspected	Sweeping of debris and light chipping need at intersection of DP 102	1440
Road as Completed Line	Completed - Inspected	Sweeping of debris	8084
Planned Fire Line	Unknown		38578
Planned Fire Line	Repair Needed	Road grading, remove berms, repair cut and fill slopes (marked separately), and chipping -Sung	24812
Planned Fire Line	Completed - Inspected	Chipping needed throughout NF 58 and entry to NF 5830 and NF 150. Crews needed to sweep debris.	40140
Other	Repair Needed	Remove slash in ditch roadside.	3160
Line Break Completed	Unknown		4331
Line Break Completed	Repair Needed	Logs in ditch need to be removed. Chip smaller material. Berms need to be knocked down. Rocky debris behind shoulder needs additional repair	2083
Line Break Completed	Completed - Inspected	Light chipping and sweeping needed	1139
Completed Dozer Line	Repair Needed	Dozer line needs significant repair. Follow decom with slash and water bars.

Completed Dozer Line	Repair Needed	rehab reestablish foot trail	194
Completed Dozer Line	Repair Needed	Pull in berms, may not be needed until log deck is removed	506
Access or Improved Road	Unknown		2241
Access or Improved Road	Unknown		20630
