Suppression Repair

Beachie Creek
ORWIF-200299
Riverside
ORMHF-000859
10/07/20
Page: 5

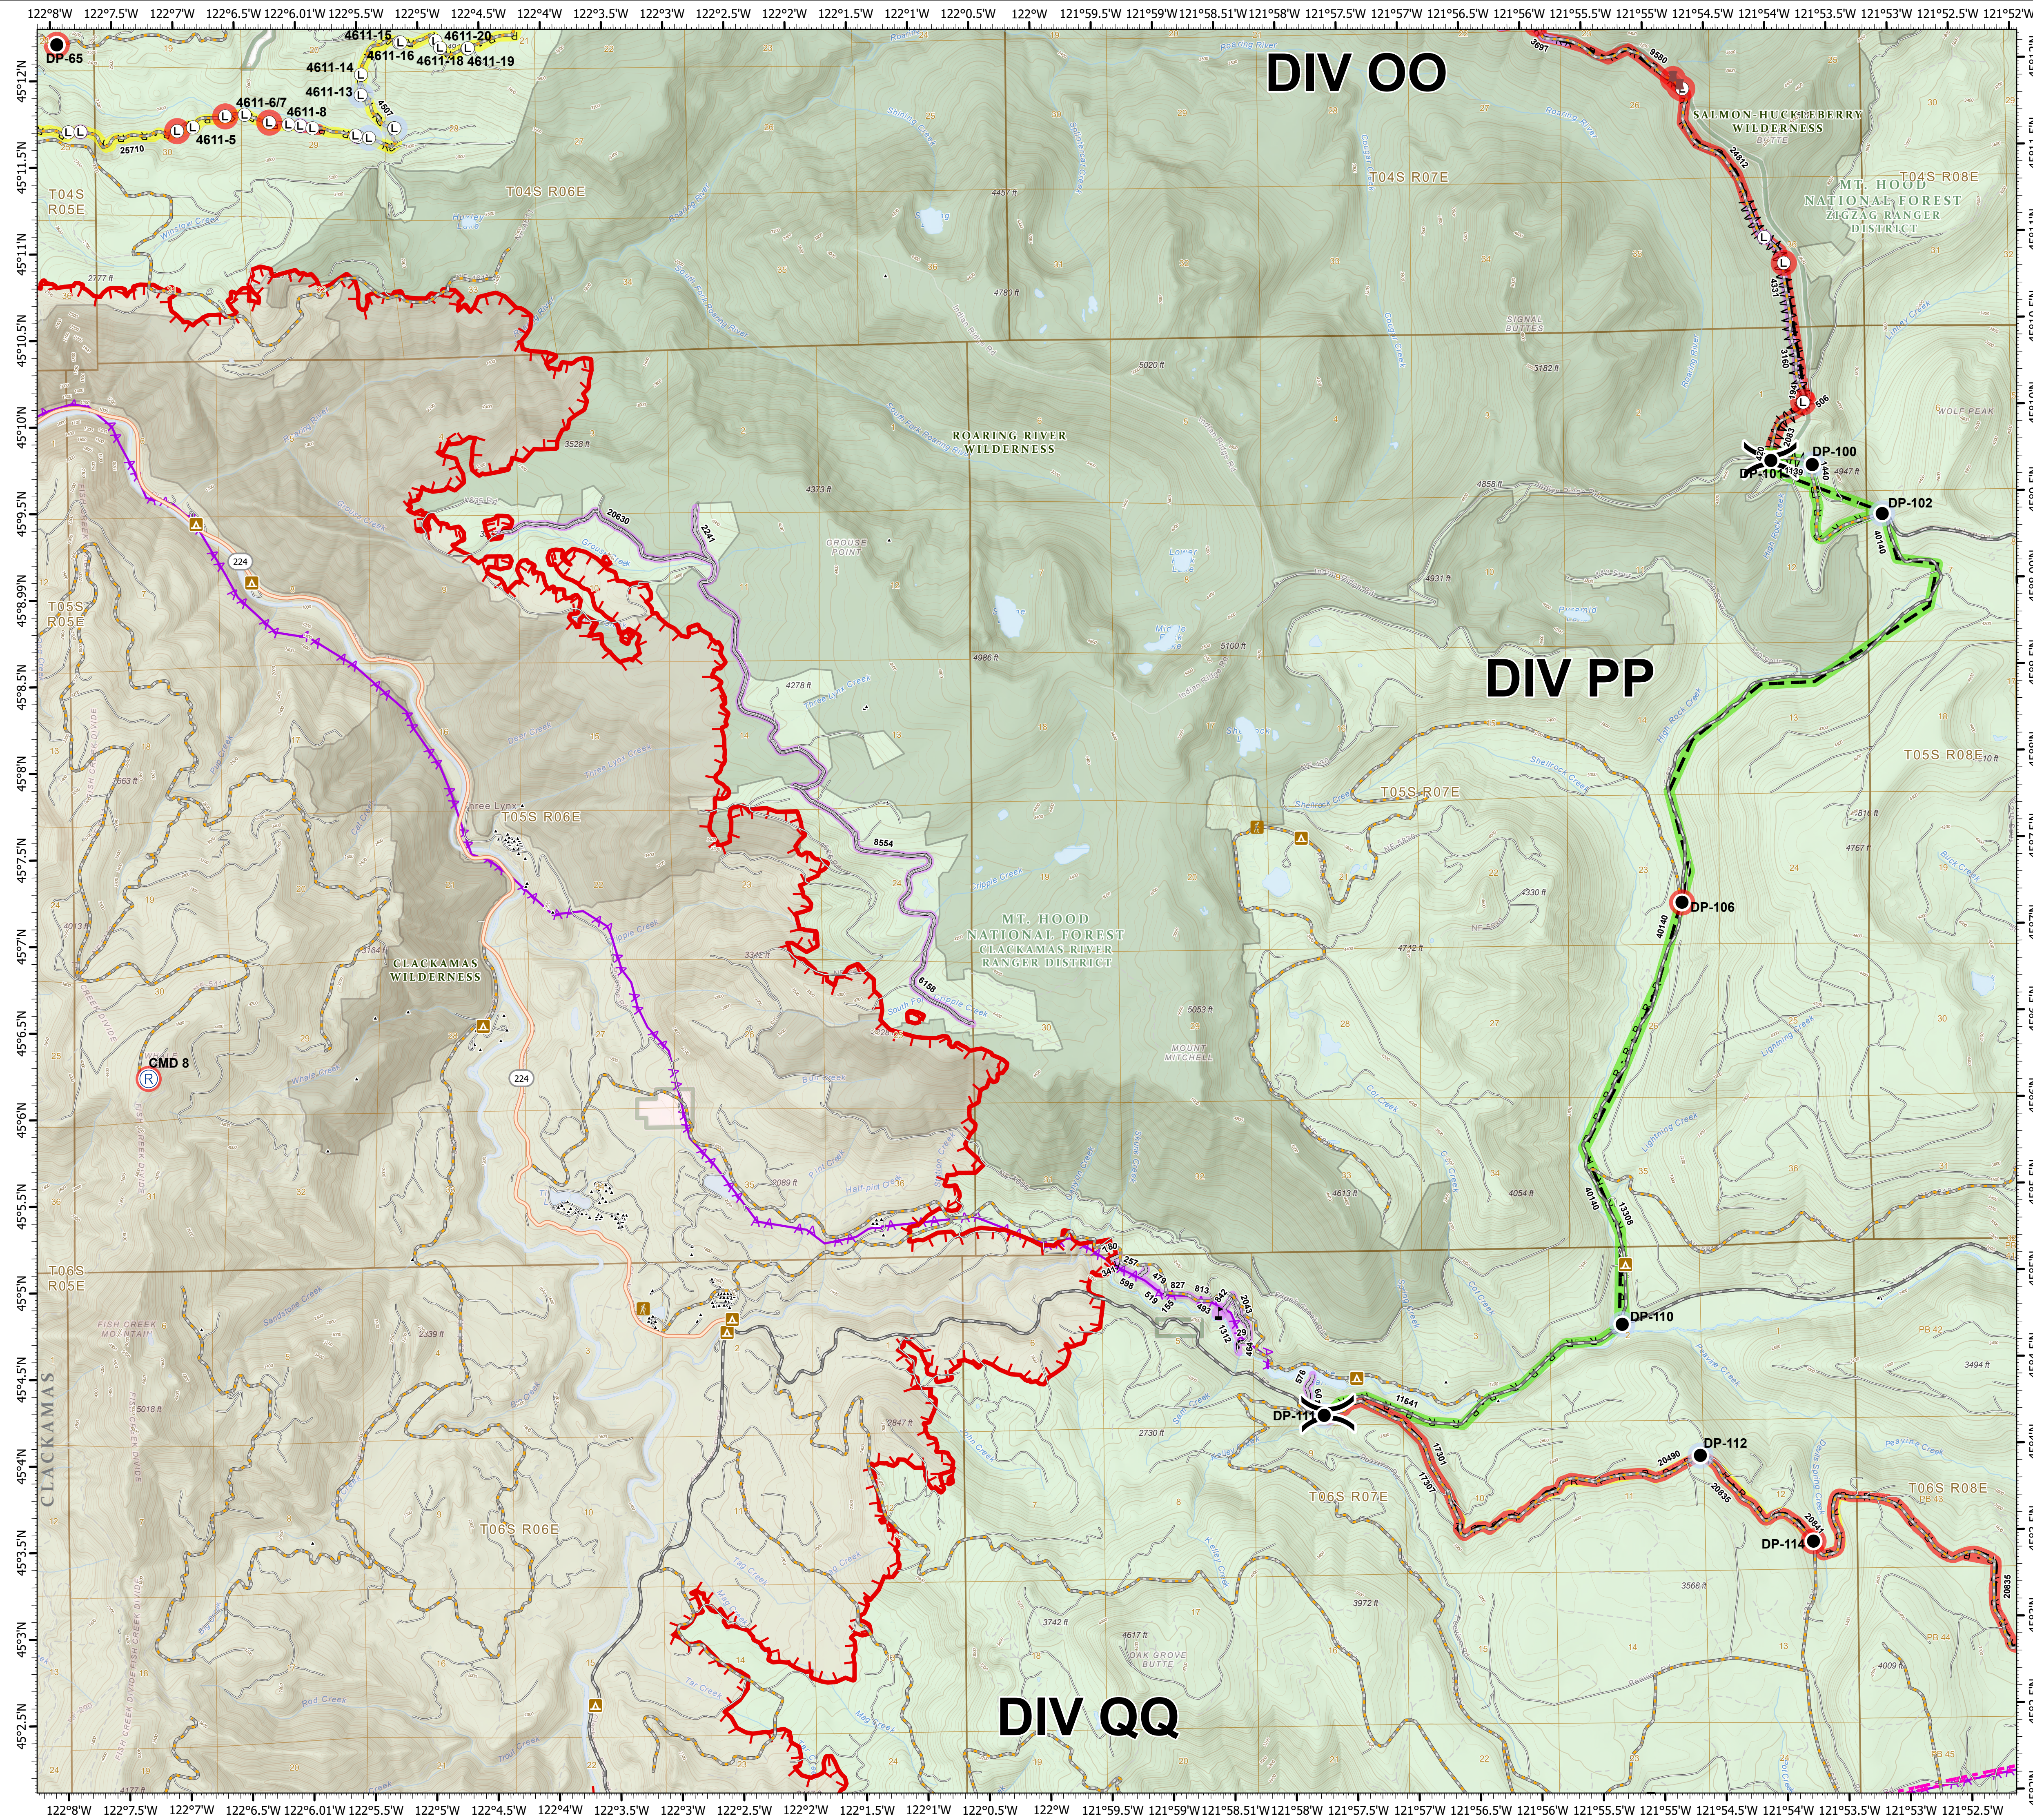
FC Point Type	Repair Status	Repair Comments	Label
Dozer Push	Repair Needed	18 inch thick slash highly scattered here where soil is exposed. -Lin kyan	4611-67
Dozer Push	Repair Needed	18 inch thick slash highly scattered slash on top of exposed soil. In kyan 10-3-20	4611-8
Drop Point	Completed - Inspected		DP-101
Drop Point	No Repair Needed		DP-100
Drop Point	No Repair Needed		DP-102
Drop Point	No Repair Needed		DP-110
Drop Point	No Repair Needed		DP-111
Drop Point	No Repair Needed		DP-112
Drop Point	Repair Needed		DP-106
Drop Point	Repair Needed		DP-114
Drop Point	Repair Needed		DP-65
Landing or Log Deck	Repair Needed		4611-10
Landing or Log Deck	Unknown		4611-14
Landing or Log Deck	Unknown		4611-15
Landing or Log Deck	Unknown		4611-16
Landing or Log Deck	Unknown		4611-17
Landing or Log Deck	Unknown		4611-18
Landing or Log Deck	Unknown		4611-19
Landing or Log Deck	Repair Needed		4611-20
Landing or Log Deck	Unknown		4611-4

FC Line Type	Repair Status	Repair Comments	Length Feet
Road as Completed Line	Unknown		780
Road as Completed Line	Repair Needed	Significant morch. Slash piles will need to be disposed of. Flush cut purges and stumps where needed. Chipping needed.	
Road as Completed Line	Repair Needed	Chipper needed after fire-M. DeAngelis Sep 15, 2020. Equipment currently masticating (9/28). Crews may be needed to break up and spread highly concentrated material in the ditch	420
Road as Completed Line	In Progress	Chipping needed	20496
Road as Completed Line	Completed - Inspected	Sweeping of debris and light chipping need at intersection of DP 102	1440
Road as Completed Line	Completed - Inspected	Chipping needed to clear ditches	11641
Road as Completed Line	Completed - Inspected	Chipping needed north of Shellock Campground	13308
Planned Fire Line	Unknown		464
Planned Fire Line	Repair Needed	Equipment currently masticating (9/28). Crews may be needed to break up and spread highly concentrated material in the ditch	17307

Planned Fire Line	Repair Needed	Chipping needed	20841
Planned Fire Line	Repair Needed	Road grading, remove berms, repair cut and fill slopes (marked separately), and chipping - Sung	24812
Planned Fire Line	In Progress	Chipping needed	20835
Planned Fire Line	Completed - Inspected	Equipment currently masticating (9/28). Crews may be needed to break up and spread highly concentrated material in the ditch	17301
Planned Fire Line	Completed - Inspected	Chipping needed throughout NF 58 and entry to NF 5830 and NF 150. Crews needed to sweep debris.	40140
Other	Unknown		257
Other	Unknown		479
Other	Unknown		493
Other	Unknown		519
Other	Unknown		598
