Structures Map

Bulldog Mountain
WACOF-2348
8/26/2021 Day

Bulldog_Mountain

WACOF-002348

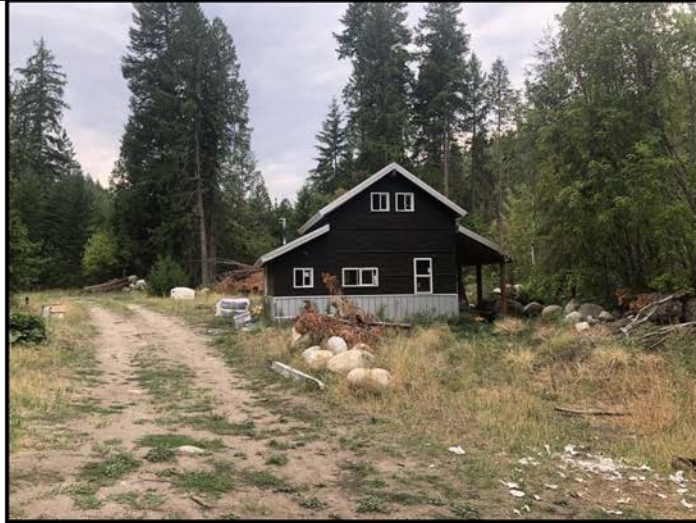
Triage Category: Defensible, Prep and Hold
FIRESCOPE Triage Category:
Structure Number: 1
Collected Date/Time:
Collected By:
Inspector's Position: Division
Type of Structure: Residential
Primary Structures: 1
Is the building Occupied?: Unknown
Outbuildings: 1
Fuel Surrounding Structure: Shrub or timber
Defensible Space: 30 ft treated
Roof Material: Noncombustible or not applicable
Siding Material: Wood or open sided
Electrical Power: Yes
Gas to Structure: Unknown
Hazards: Power lines
Access to Site:
Describe Access:
Comm With ICP: Yes
Water Source: Reliable water source nearby
Safety Zone Present:
Mitigation Time (in hours): 2
Mitigation Description: Brush out, scratch line, porta tanks
Resources Needed to Protect Structure: x1 Type 6 Engine, x1 20 Person Crew
FIRESCOPE Tactics:
Notes: Horse Barn with two horses

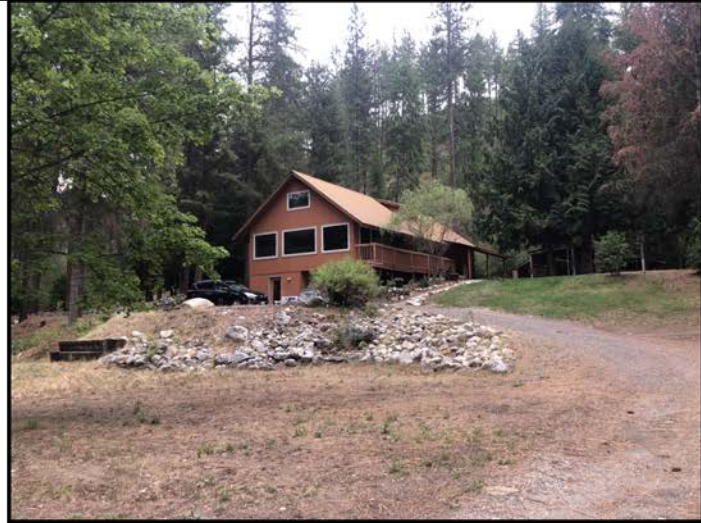
Triage Category: Defensible, Prep and Hold
FIRESCOPE Triage Category:
Structure Number: 10
Collected Date/Time:
Collected By:
Inspector's Position: Division
Type of Structure: Residential
Primary Structures: 1
Is the building Occupied?: Yes
Outbuildings:
Fuel Surrounding Structure: Shrub or timber
Defensible Space: 100 ft treated
Roof Material: Noncombustible or not applicable
Siding Material: Wood or open sided
Electrical Power: Yes
Gas to Structure: Unknown
Hazards:
Access to Site:
Describe Access:
Comm With ICP: Yes
Water Source: Reliable water source nearby
Safety Zone Present:
Mitigation Time (in hours): 2
Mitigation Description: Removal of lateral fuels, Scratch line, possible dozer line, porta tanks
Resources Needed to Protect Structure: x1 Type 6 Engine, x1 20 Person Hand Crew
FIRESCOPE Tactics:
Notes:

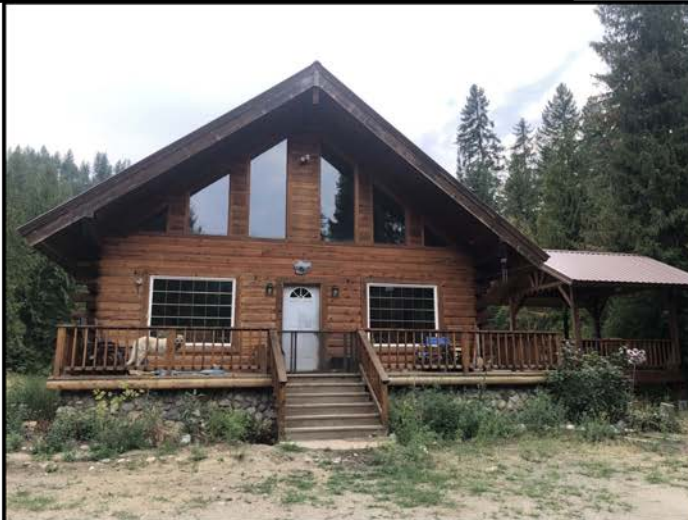
Structure Number: 11

Triage Category: Non-Defensible, Prep and Leave

Defensible Space: 100 ft treated

Siding Material: Wood or open sided

Mitigation Description: Removal of lateral fuels, scratch line, possible dozer line, porta tanks

Resources Needed to Protect Structure: x1 Type 6

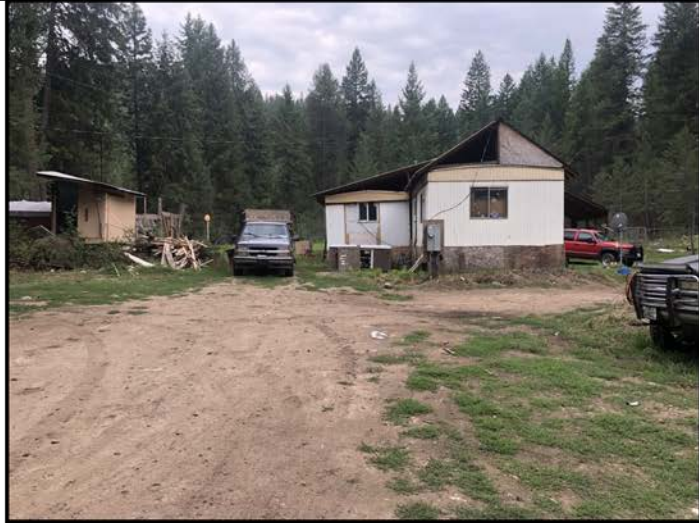
Triage Category: Defensible, Prep and Hold
FIRESCOPE Triage Category:
Structure Number: 13
Collected Date/Time:
Collected By:
Inspector's Position: Division
Type of Structure: Residential
Primary Structures: 1
Is the building Occupied?: Yes
Outbuildings: 3
Fuel Surrounding Structure: Shrub or timber
Defensible Space: 100 ft treated
Roof Material: Noncombustible or not applicable
Siding Material: Wood or open sided
Electrical Power: Yes
Gas to Structure: Unknown
Hazards:
Access to Site:
Describe Access:
Comm With ICP: Yes
Water Source: Reliable water source nearby
Safety Zone Present:
Mitigation Time (in hours): 4
Mitigation Description: Removal of lateral fuels, scratch line, brush out, possible dozer line, porta tanks
Resources Needed to Protect Structure: x1 Type 6 Engine, x1 20 Person Hand Crew
FIRESCOPE Tactics:
Notes:

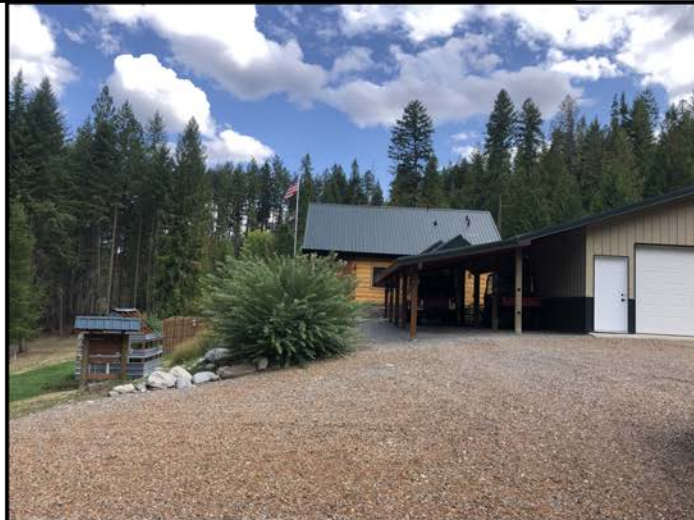
Triage Category: Defensible, Prep and Hold
FIRESCOPE Triage Category:
Structure Number: 2
Collected Date/Time:
Collected By:
Inspector's Position: Division
Type of Structure: Residential
Primary Structures: 2
Is the building Occupied?: Yes
Outbuildings: 3
Fuel Surrounding Structure: Shrub or timber
Defensible Space: 100 ft treated
Roof Material: Noncombustible or not applicable
Siding Material: Log construction
Electrical Power: Yes
Gas to Structure: Unknown
Hazards:
Access to Site: T1 Engine
Describe Access:
Comm With ICP: Yes
Water Source: Reliable water source nearby
Safety Zone Present:
Mitigation Time (in hours): 2
Mitigation Description: Sprinkle system, porta tank, scratch line
Resources Needed to Protect Structure: x2 Type 6 Engine, x1 20 Person Crew
FIRESCOPE Tactics:
Notes:

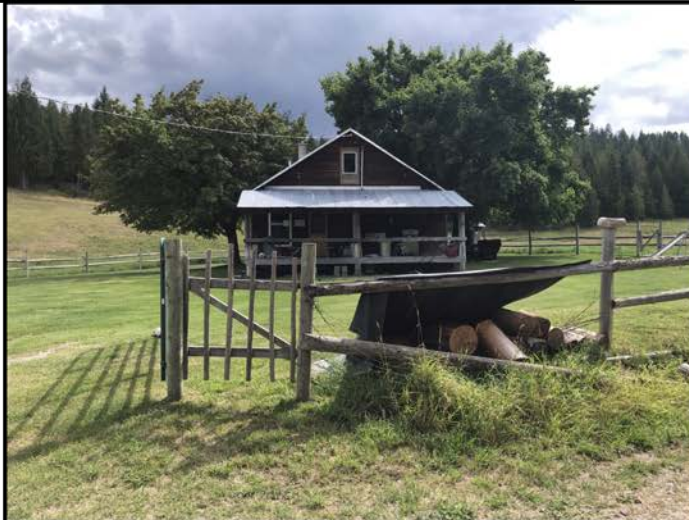
Triage Category: Defensible, Prep and Hold
FIRESCOPE Triage Category:
Structure Number: 3
Collected Date/Time:
Collected By:
Inspector's Position: Division
Type of Structure: Residential
Primary Structures: 1
Is the building Occupied?: Yes
Outbuildings: 4
Fuel Surrounding Structure: Shrub or timber
Defensible Space: 100 ft treated
Roof Material: Noncombustible or not applicable
Siding Material: Wood or open sided
Electrical Power: Yes
Gas to Structure: Unknown
Hazards: Power lines
Access to Site:
Describe Access:
Comm With ICP: Yes
Water Source: Reliable water source nearby
Safety Zone Present:
Mitigation Time (in hours): 2
Mitigation Description: Brush out, tree felling, scratch line, possible dozer line
Resources Needed to Protect Structure: x1 Type 6 Engine, x1 20 Person Hand Crew
FIRESCOPE Tactics:
Notes: Hay Barn across road

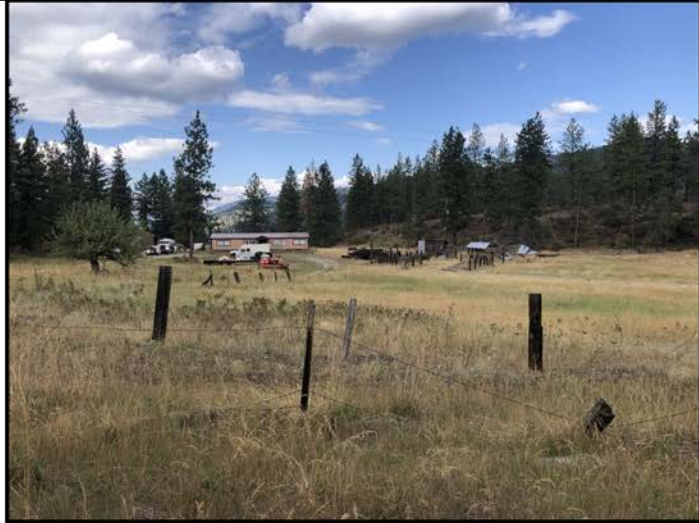
Triage Category: Defensible, Prep and Hold
FIRESCOPE Triage Category:
Structure Number: 4
Collected Date/Time:
Collected By:
Inspector's Position: Division
Type of Structure: Residential
Primary Structures: 1
Is the building Occupied?: Yes
Outbuildings: 4
Fuel Surrounding Structure: Shrub or timber
Defensible Space: 30 ft treated
Roof Material: Noncombustible or not applicable
Siding Material: Wood or open sided
Electrical Power: Yes
Gas to Structure: Unknown
Hazards: Power lines
Access to Site:
Describe Access:
Comm With ICP: Yes
Water Source: Reliable water source nearby
Safety Zone Present:
Mitigation Time (in hours): 4
Mitigation Description: Brush out, lateral fuels, possible dozer line, scratch line, porta tanks
Resources Needed to Protect Structure: x2 Type 6 Engines, x1 20 Person Crew
FIRESCOPE Tactics:
Notes:

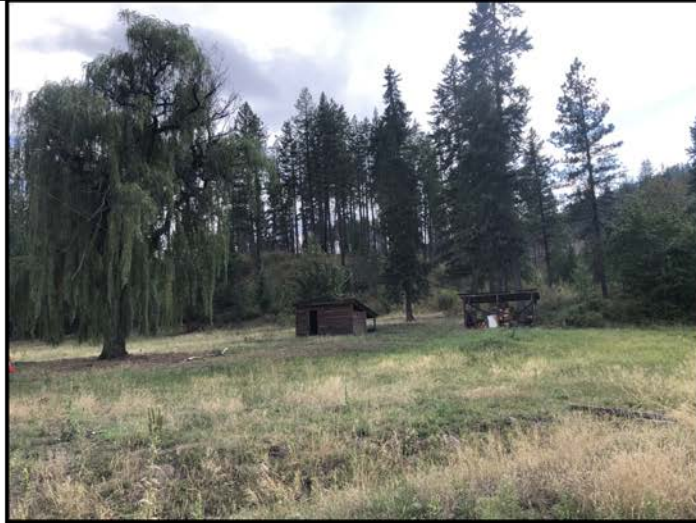
Triage Category: Defensible, Prep and Hold
FIRESCOPE Triage Category:
Structure Number: 6
Collected Date/Time: 8/23/2021 10:22:10 PM
Collected By:
Inspector's Position: Division
Type of Structure: Residential
Primary Structures:
Is the building Occupied?: No
Outbuildings: 2
Fuel Surrounding Structure: Shrub or timber
Defensible Space: Less than 30 ft treated
Roof Material: Noncombustible or not applicable
Siding Material: Wood or open sided
Electrical Power: Yes
Gas to Structure: Unknown
Hazards: Power lines
Access to Site:
Describe Access:
Comm With ICP: Yes
Water Source: No reliable water source nearby
Safety Zone Present:
Mitigation Time (in hours): 2
Mitigation Description: Brush out, scratch line, possible dozer line
Resources Needed to Protect Structure: Engine
FIRESCOPE Tactics:
Notes:

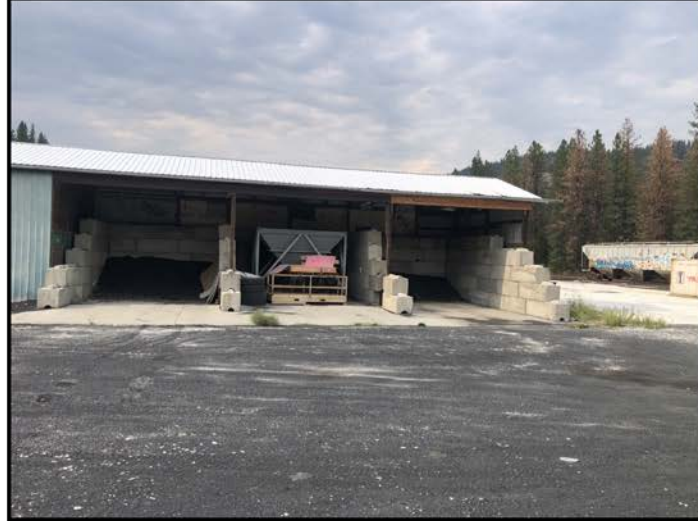
Triage Category: Defensible, Stand Alone
FIRESCOPE Triage Category:
Structure Number: 7
Collected Date/Time:
Collected By:
Inspector's Position: Division
Type of Structure: Residential
Primary Structures:
Is the building Occupied?: No
Outbuildings:
Fuel Surrounding Structure: Shrub or timber
Defensible Space: More than 100ft treated
Roof Material: Noncombustible or not applicable
Siding Material:
Electrical Power: Unknown
Gas to Structure:
Hazards: Rail Line
Access to Site:
Describe Access:
Comm With ICP: Yes
Water Source: Reliable water source nearby
Safety Zone Present:
Mitigation Time (in hours):
Mitigation Description:
Resources Needed to Protect Structure:
FIRESCOPE Tactics:
Notes:

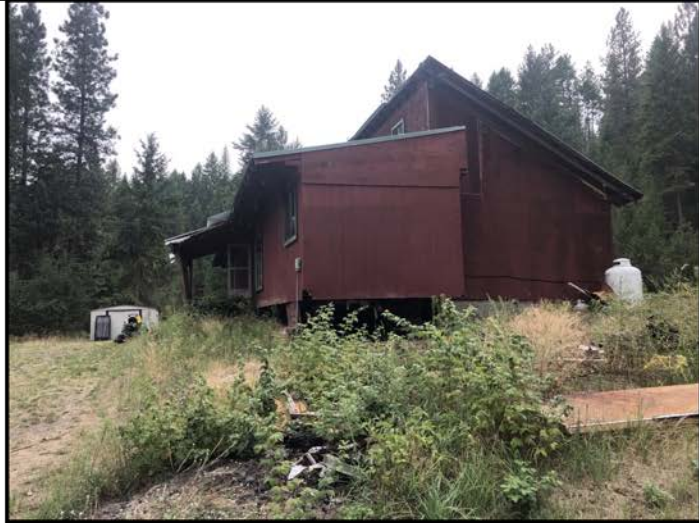
Structure Number: 8

Triage Category: Non-Defensible, Prep and Leave

Defensible Space: Less than 30 ft treated

Siding Material: Wood or open sided

Mitigation Description: Removal of lateral fuels, Brush out, Scratch Line, Possible dozer line, porta tanks

Resources Needed to Protect Structure: x1 Type 6 Engine, x1 20 Person Hand Crew

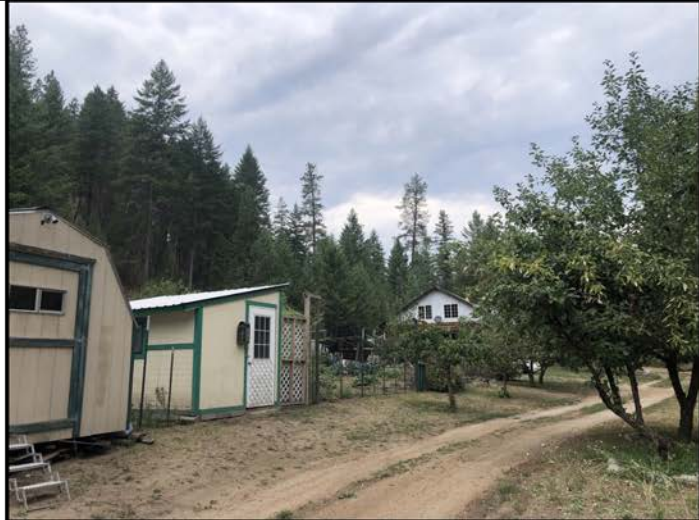
Structure Number: 9

Triage Category: Non-Defensible, Prep and Leave

Defensible Space: 100 ft treated

Siding Material: Wood or open sided

Mitigation Description: Removal of lateral fuels, Brush out, Scratch line, possible dozer line, porta tanks

Resources Needed to Protect Structure: x1 Type 6 Engine, x1 20 Person Hand Crew
