# Suppression Repair Tiles

Cedar Creek  
OR-WF-220180  
10/21/2022 24 Hour  
126,800 acres as of 10/19/2022 @ 1948  
1:1,100,000

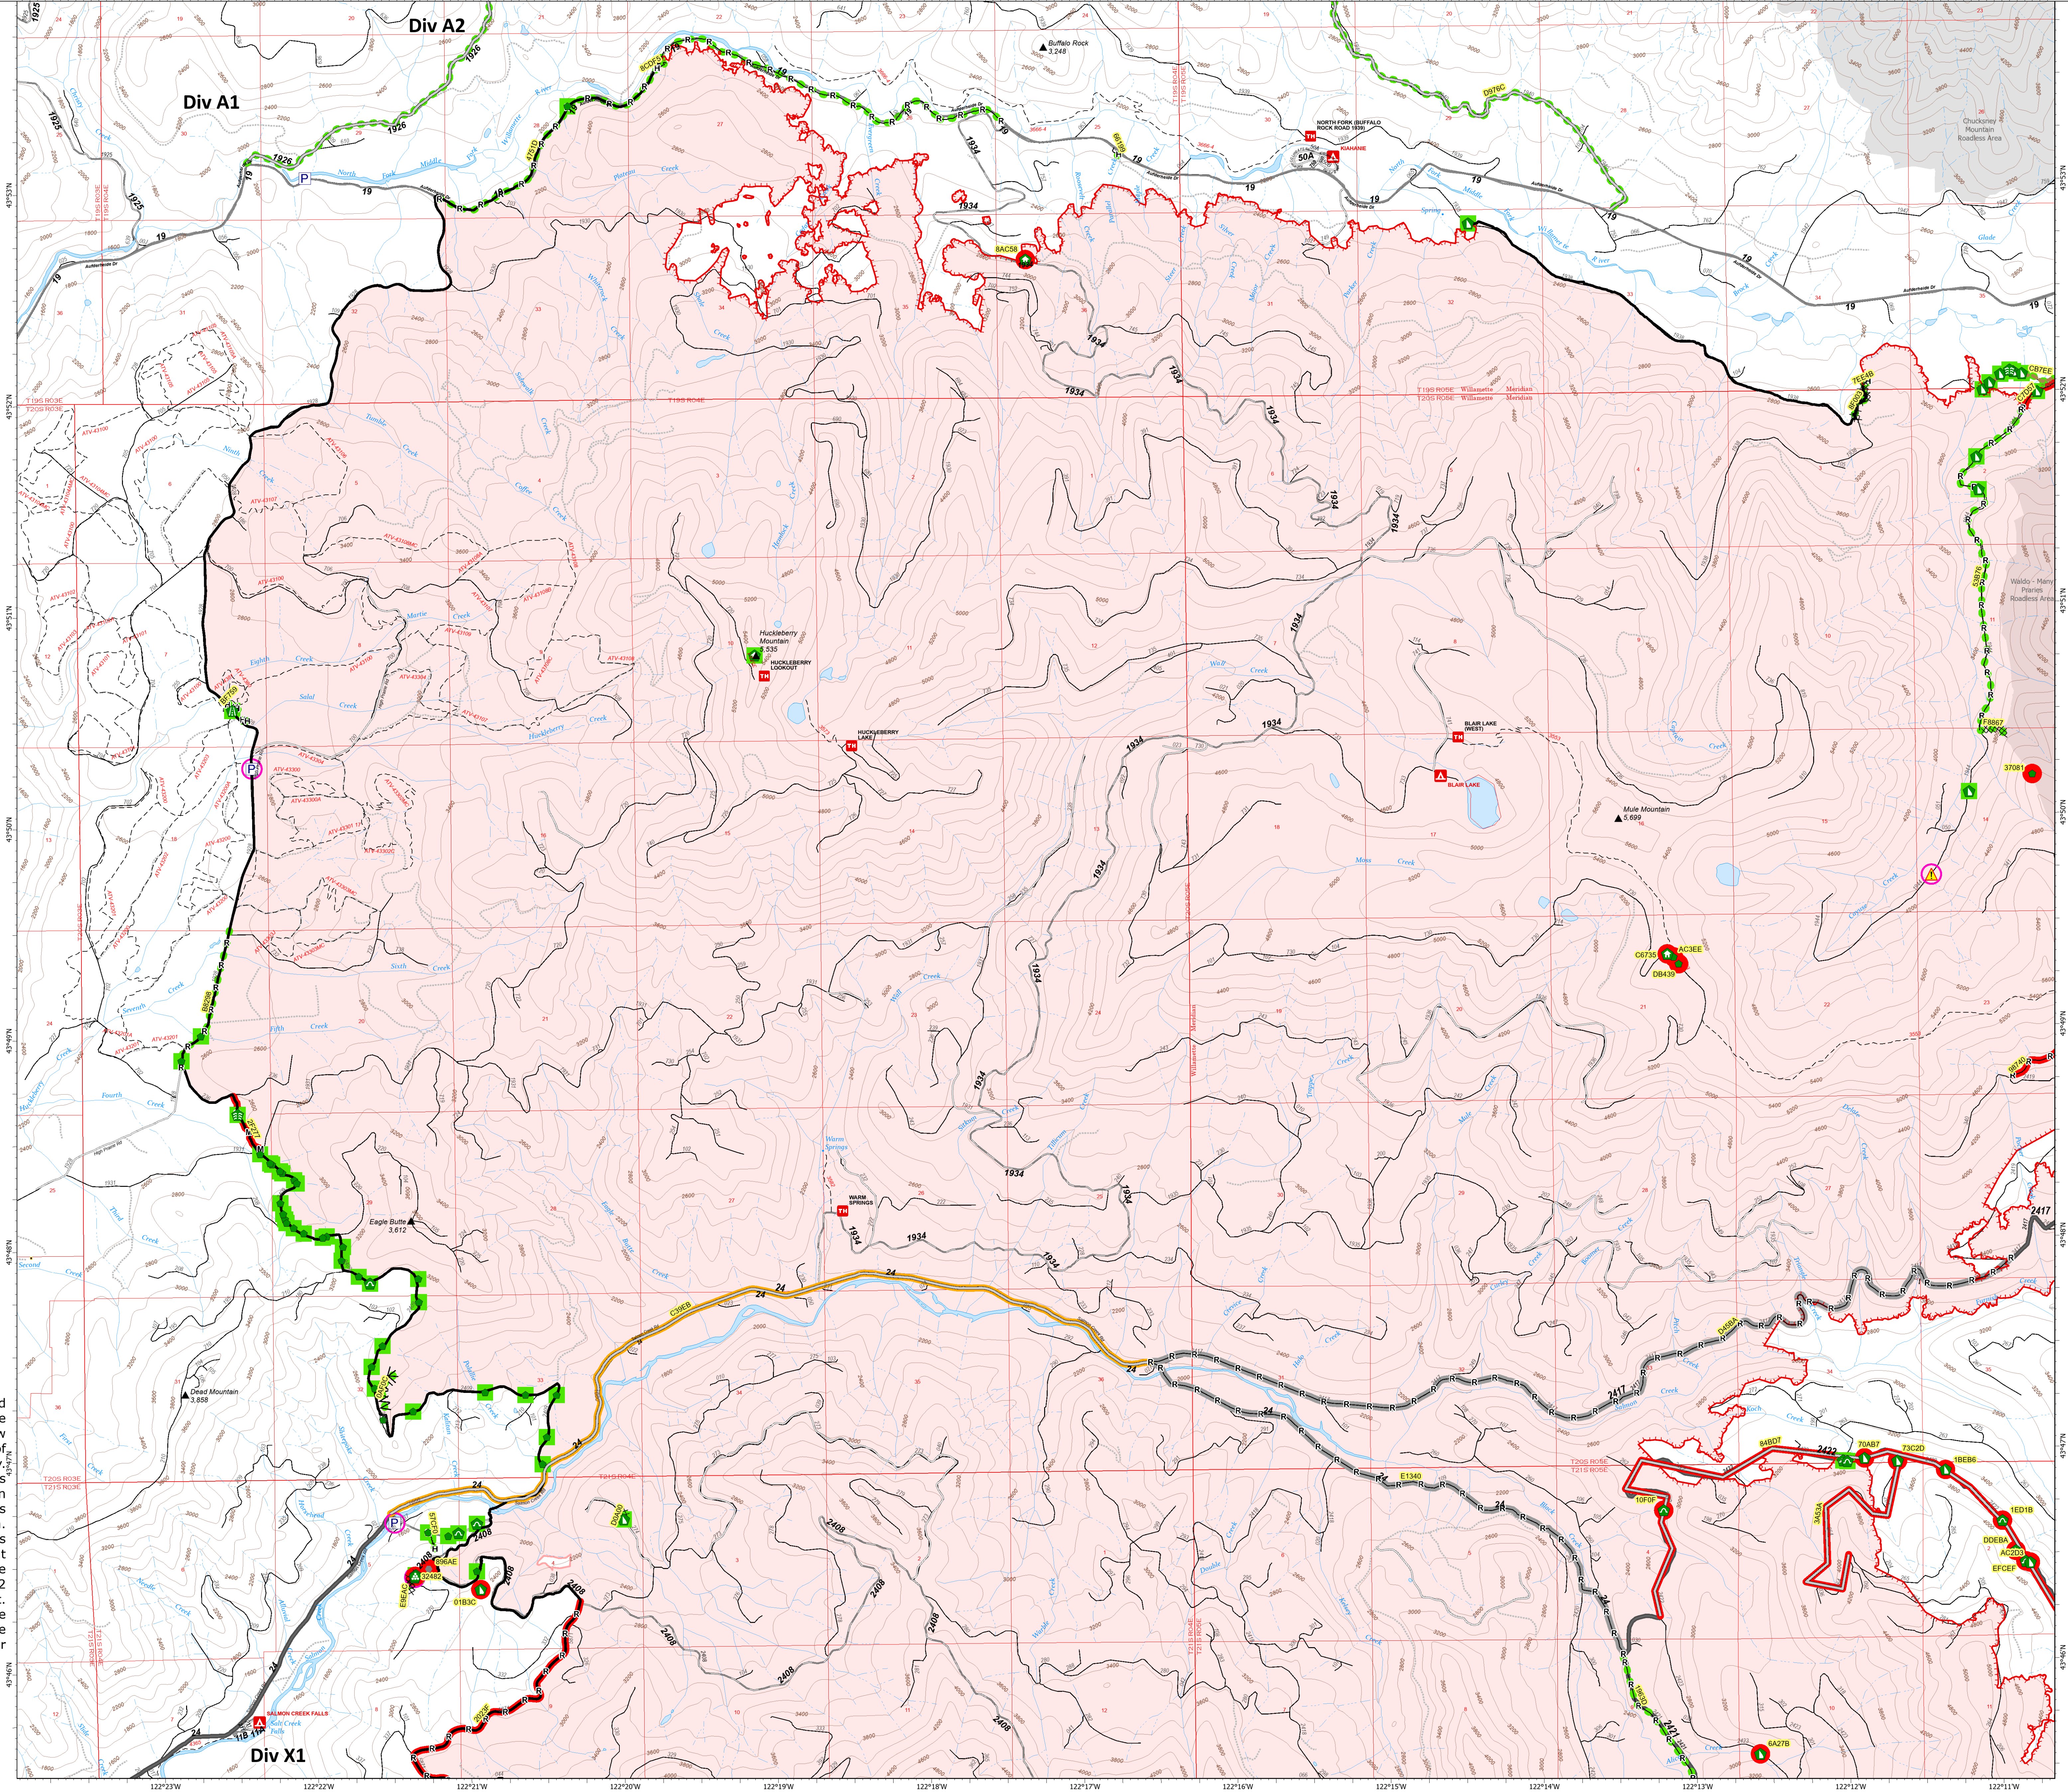
| Repair ID | Priority | Point Type | Status | Repairs Needed | Repair Comments | Latitude | Longitude |
|---|---|---|---|--|--|---|---|
| 1810P | High | Culvert | Repair Needed | Clear catch basin | | 42°46.250' N | 122°15.000' W |
| 1810F | High | Culvert | Repair Needed | Clear catch basin | | 42°46.218' N | 122°15.000' W |
| 1810K | High | Landing or Log Deck | Repair Needed | Fix, work, level and shore dislodged area. Use riprap or stone to back up to creek. Inspect 200' up the creek to see if riprap is needed. 10/19/2022 | | 42°46.452' N | 122°15.000' W |
| 1810L | High | Other | Repair Needed | Reconstruct stream | | 42°46.367' N | 122°15.072' W |
| 1810M | High | Road Point | Repair Needed | Reconstruct stream | Salvage BMP. Road for present during season | 42°46.367' N | 122°15.072' W |
| 1810N | High | Road Point | Repair Needed | Reconstruct stream | Reconstruct stream | 42°46.248' N | 122°15.072' W |
| 1810O | High | Structure Wash | Repair Needed | Remove debris along bank, make paths to remove debris, bring in fuel and riprap to back up to creek. 10/19/2022 | 4 riprap piles to back up creek, 100' riprap | 42°46.348' N | 122°15.000' W |
| 1810P | High | Structure Wash | Repair Needed | Remove debris | | 42°46.348' N | 122°15.000' W |
