# Suppression Repair Tiles

Cedar Creek  
OR-WF-220180  
10/21/2022 24 Hour  
126,890 acres as of 10/19/2022 © 1948  
1:1,100,000

## Div S

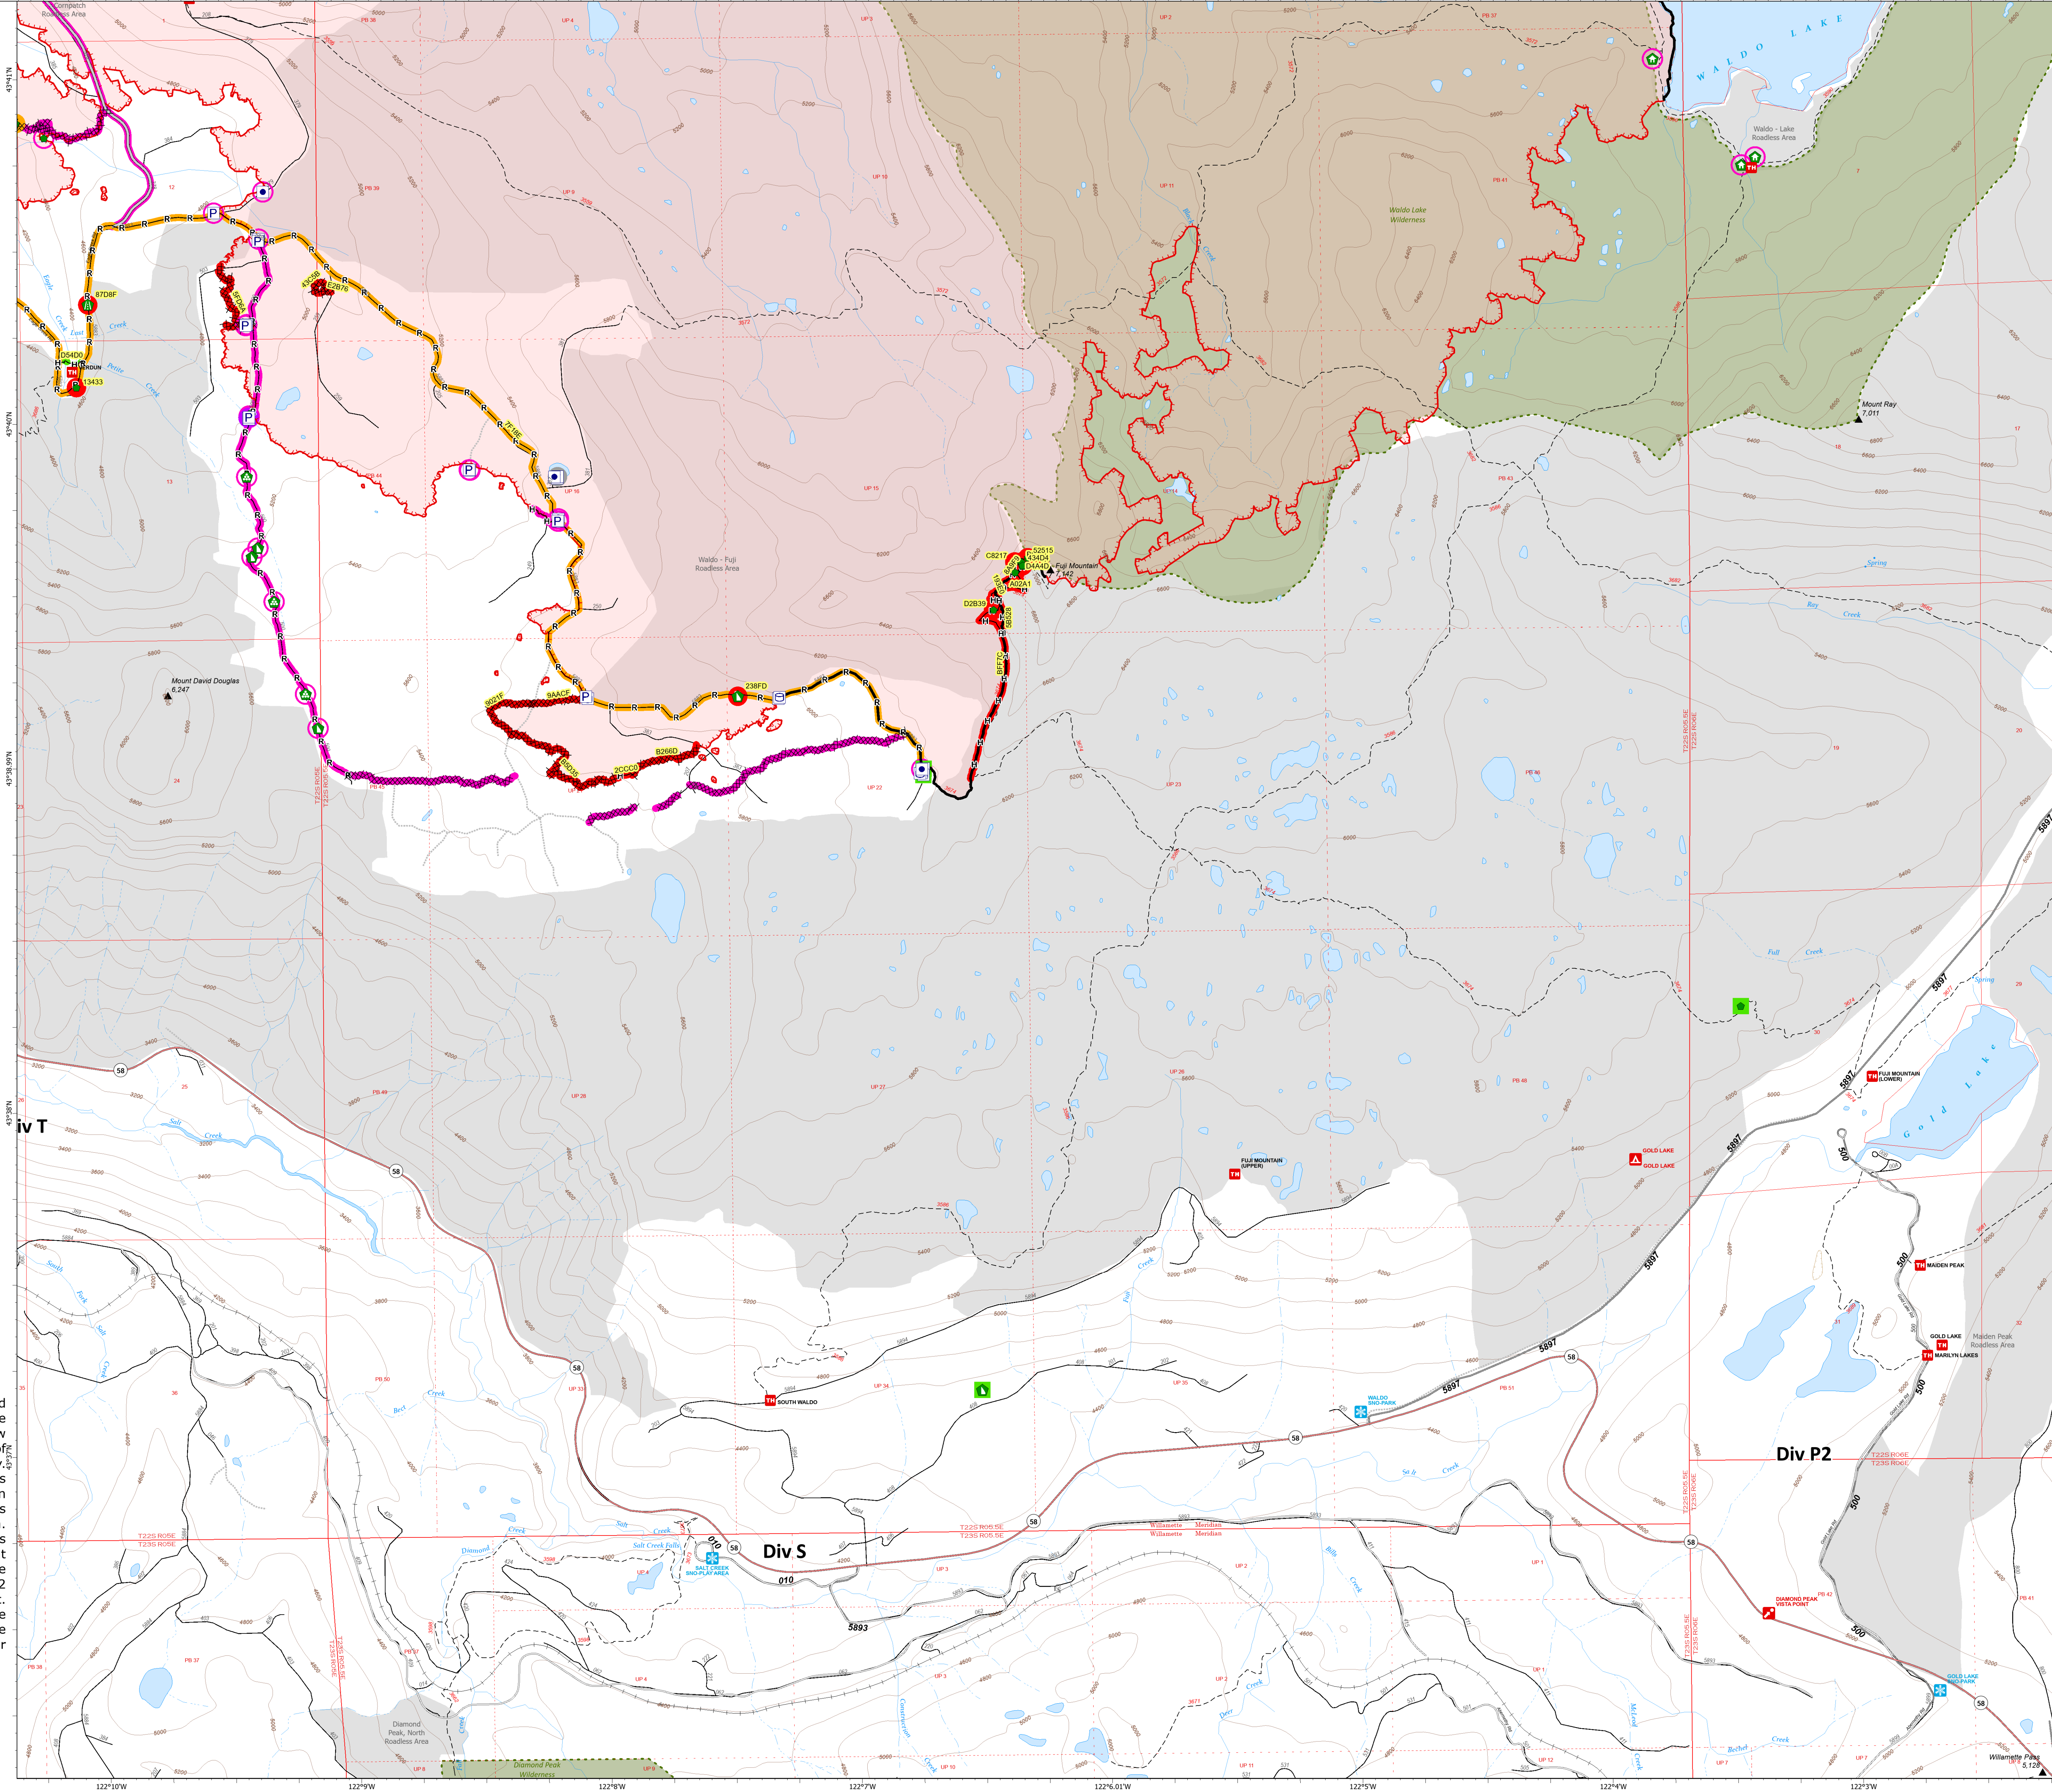
Repair ID	Priority	Point Type	Status	Repairs Needed	Repair Comments	Latitude	Longitude
AD04	High	Repair Point	Repair Needed	Full in berms, fill berms, dig out entrances, cover with slash, water bar as needed		43° 36' 54.1" N	122° 06' 23" W
AD05	High	Repair Point	Repair Needed	Full in berms, cover in slash, dig out entrances (200' observation 107)		43° 36' 51.7" N	122° 06' 24" W
AD06	High	Repair Point	Repair Needed	Full in berms, fill in berms, cover in slash, dig out entrances, water bar as needed (100' observation 107)		43° 36' 54.8" N	122° 06' 24" W
AD07	High	Repair Point	Repair Needed	Full in berms, fill in berms, cover in slash, dig out entrances, water bar as needed (100' observation 107)		43° 36' 58.2" N	122° 06' 23" W
AD08	High	Repair Point	Repair Needed	Full in berms, fill in berms, cover in slash, dig out entrances, water bar as needed (100' observation 107)		43° 36' 52.2" N	122° 06' 23" W

AD09	Medium	Dozer Run	Repair Needed		Full in berms, fill in berms, cover in slash, dig out entrances, water bar as needed. Run available (100' observation 107)	43° 36' 58.8" N	122° 07' 45.2" W
AD10	Medium	Repair Point	Repair Needed	100' observation 107	Run back berms to trail and water bar.	43° 36' 57.1" N	122° 06' 21" W
AD11	Medium	Repair Point	Repair Needed	Full in berms, cover in slash, dig out entrances (200' observation 107)		43° 36' 52.7" N	122° 06' 24" W
AD12	Medium	Repair Point	Repair Needed	Full in berms, cover in slash, dig out entrances, water bar as needed (100' observation 107)		43° 36' 52.0" N	122° 06' 24" W
AD13	Medium	Road Repair	Repair Needed	100' observation 107		43° 36' 52.0" N	122° 06' 24" W

Divs ID	Priority	Line Type	Status	Repairs Needed	Repair Comments	Len (ft)
1236	High	Completed Dozer Line	Repair Needed	F141 107438	Full in berms into contact, water bar and slash 30' (100' obs)	272
1237	High	Completed Dozer Line	Repair Needed	F141 107438	Full in berms into contact, water bar and slash 30' (100' obs)	427
1238	High	Completed Dozer Line	Repair Needed	F141 107438	Full in berms into contact, water bar and slash 30' (100' obs)	1140
1239	High	Completed Dozer Line	Repair Needed	F141 107438		108
1240	High	Completed Dozer Line	Repair Needed	F141 107438		1140
1241	High	Completed Dozer Line	Repair Needed	F141 107438		1140
1242	High	Completed Dozer Line	Completed - Inspected	100' observation 107		362
1243	High	Completed Dozer Line	Repair Needed	100' observation 107	100' observation 107	660
1244	High	Completed Dozer Line	Repair Needed	F141 107438	Full in berms, fill in berms, cover with slash, dig out entrances, water bar as needed	410

1245	High	Completed Dozer Line	Repair Needed	F141 107438	Full in berms, fill in berms, cover with slash, dig out entrances, water bar as needed	221
1246	High	Completed Dozer Line	Repair Needed	F141 107438	Full in berms, fill in berms, cover with slash, dig out entrances, water bar as needed	496
1247	High	Completed Dozer Line	Repair Needed	F141 107438	Full in berms, fill in berms, cover with slash, dig out entrances, water bar as needed	362
1248	Medium	Completed Dozer Line	Repair Needed	F141 107438	Full in berms, fill in berms, cover with slash, dig out entrances, water bar as needed	1144
1249	Medium	Completed Dozer Line	Repair Needed	F141 107438	Full in berms, fill in berms, cover with slash, dig out entrances, water bar as needed	1144
1250	Medium	Completed Dozer Line	In Progress	None		1144
