Incident: Cow Canyon

Subdivision: Wenas Road

Triage Category

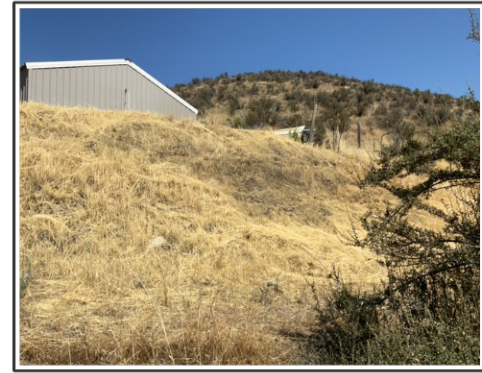
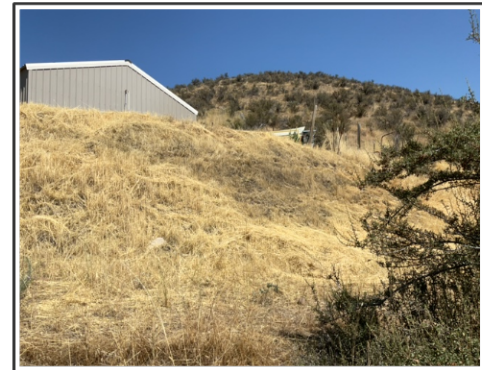
Address: 571 Audubon
Lat: 46°52.736'N Long: 120°46.922'W
Collected Date: 8/8/2022 9:21:00 PM

Hazards: Large propane and fuel tanks 25' from house

Defensible space: No defensible space
Fuel type: Shrub or timber
Water supply: No reliable water source nearby
Mitigation time: 3 Hr(s)
Mitigation resource: 1 Type 1 engine. Sprinkler kits can be used with porta tanks.

Non-Defensible, Prep and Leave

Mitigation description: Remove ground fuels from around house and out buildings.
