Incident: Cow Canyon
Subdivision: Wenas Road

Incident: Cow Canyon

Subdivision: Wenas Valley

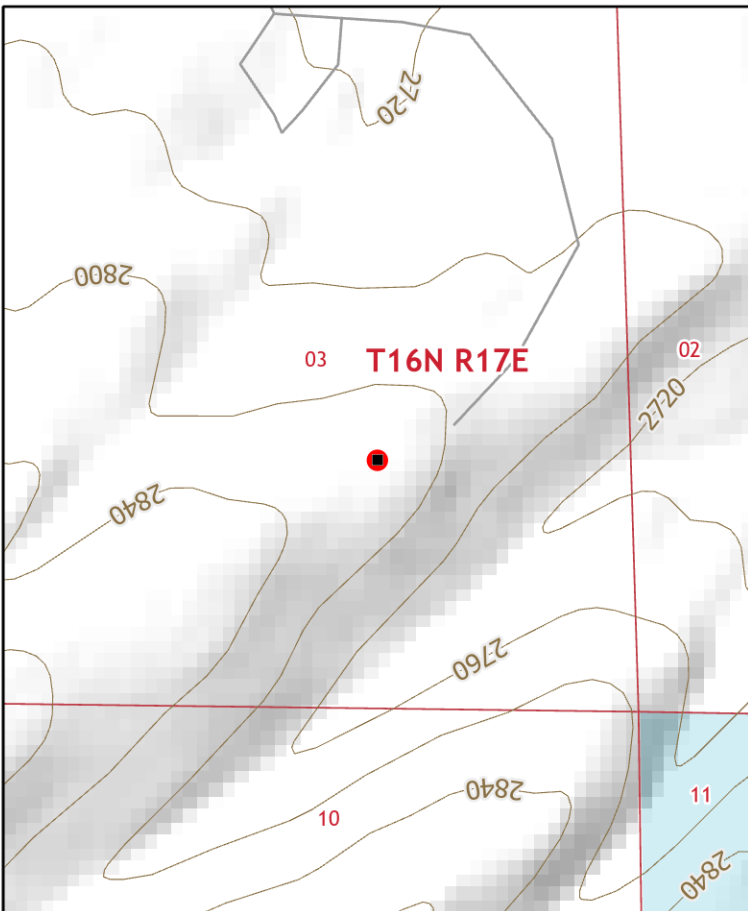
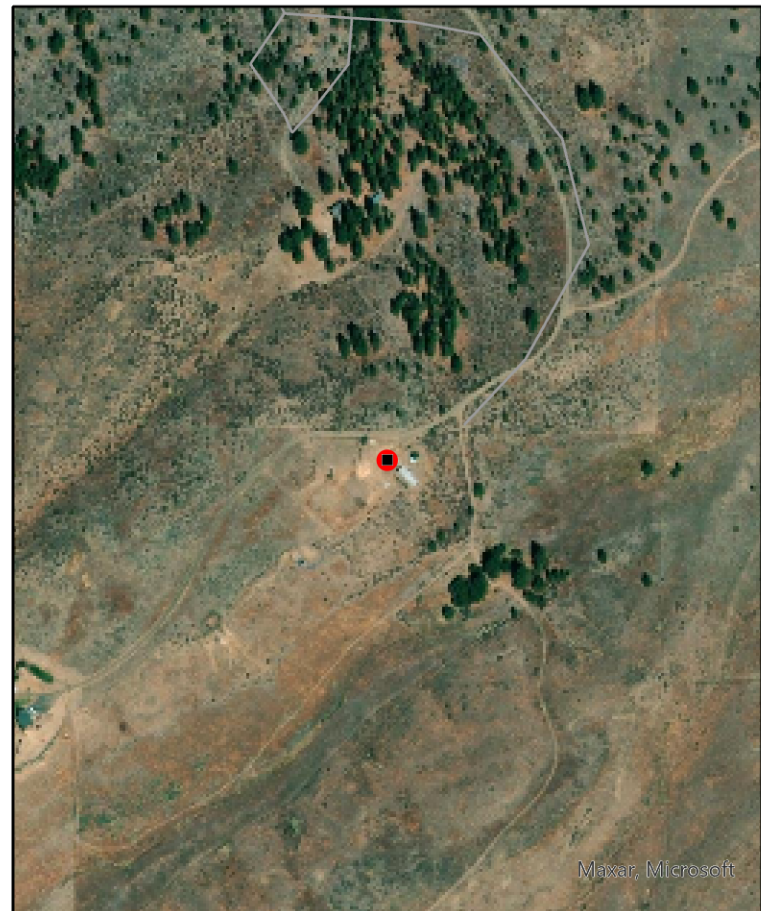
Structure comments: LOST STRUCTURE;
Possibly lost. Only the foundation remains;

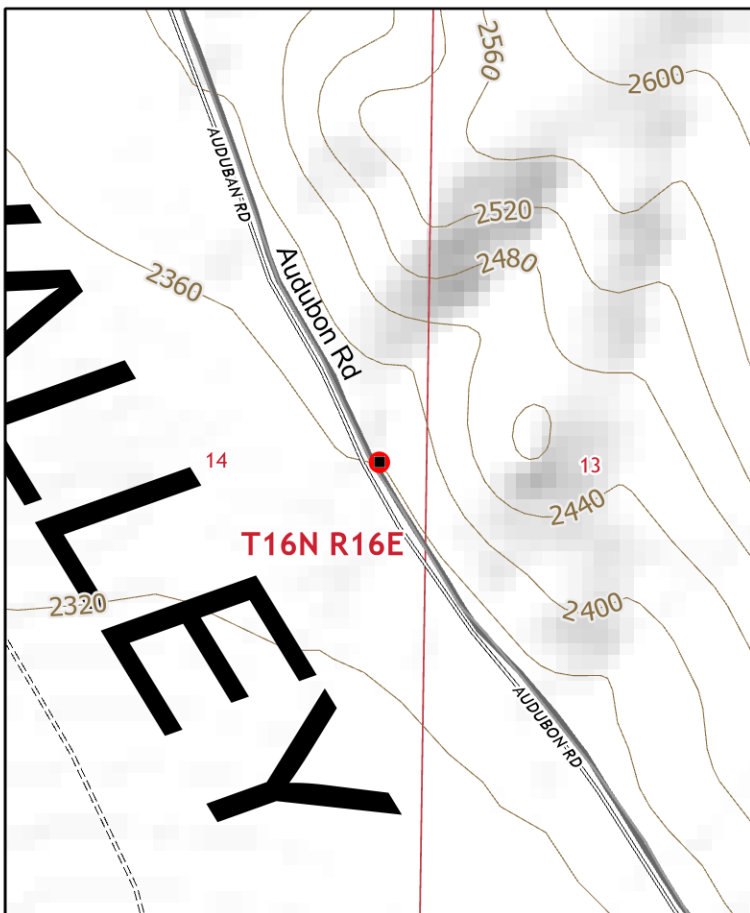
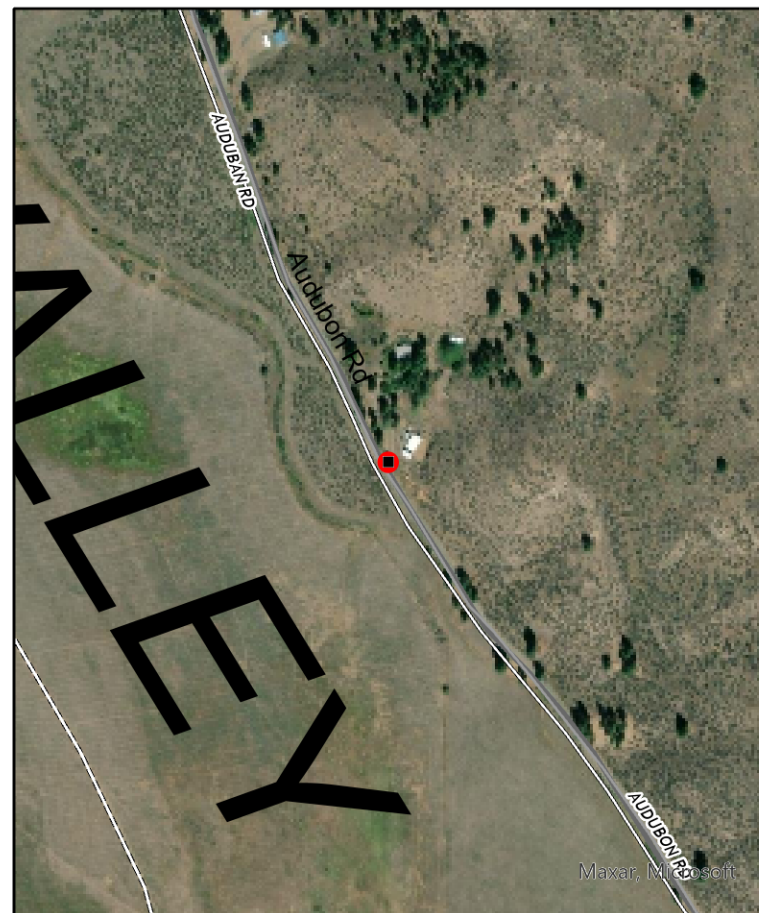
Hazards: Propane and fuel tanks 25 feet from house.

Defensible space: No defensible space
Fuel type: Shrub or timber
Water supply: Reliable water source nearby
Mitigation time: Hr(s)
Mitigation resource:

Structure comments: Numerous combustible materials around house.

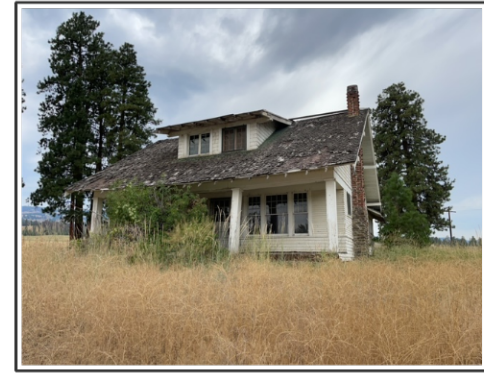
Structure comments: Vacant house in decaying stages
