Methodist East Structure Assessment

Structure ID: 30

Collected Date/Time: 9/26/2019 12:08:00 AM
Collected By: Chris Masson
Inspector's Position: Divs

Location: 5210 east highway 50,

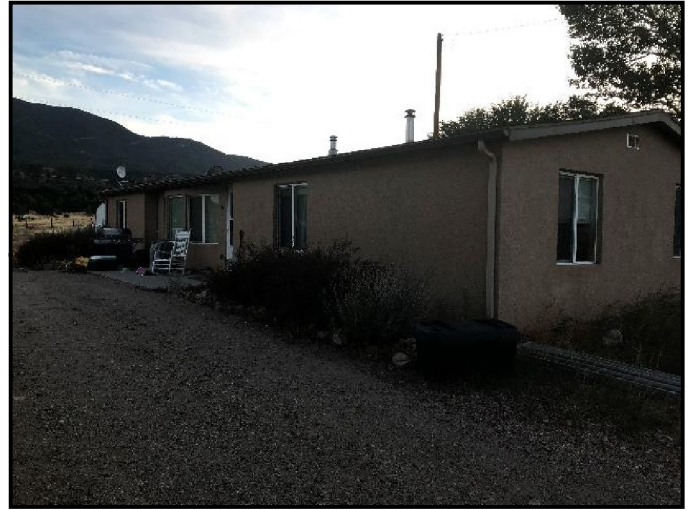
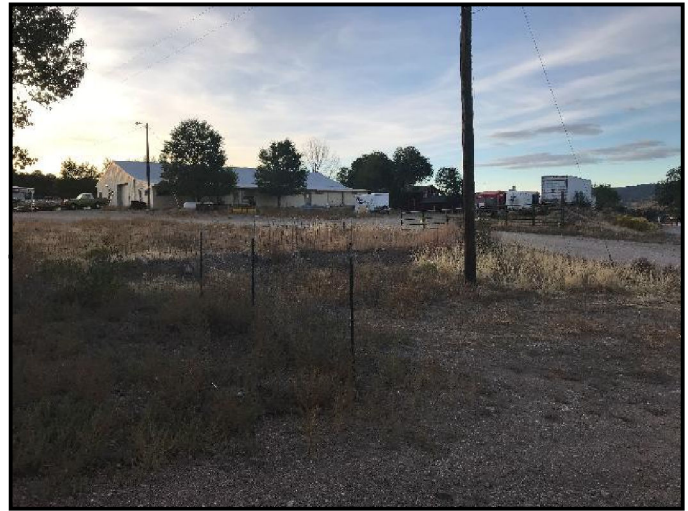
Collected Date/Time: 9/26/2019 12:45:00 AM
Collected By: Chris Masson
Inspector's Position: Divs

Notes: On flat area off highway 50, tall grass fuel models, debris, sign on door indicating "pets inside, please rescue", power pole

Mitigation Time (in hours): 4
Mitigation Description: Saw work and weed whacking

Type 1 engine

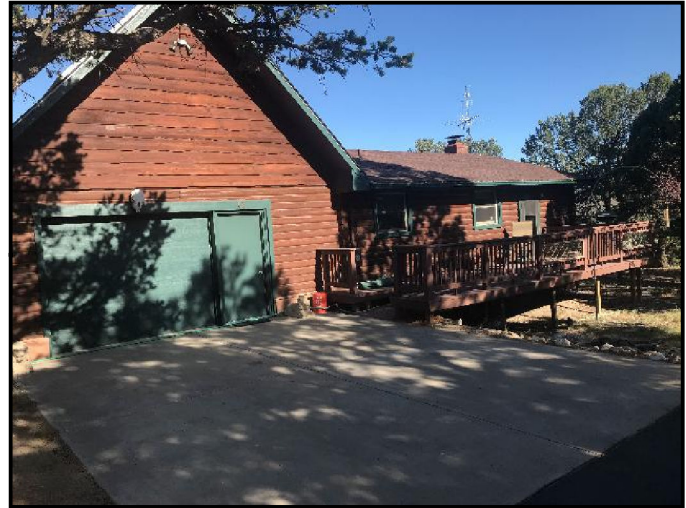
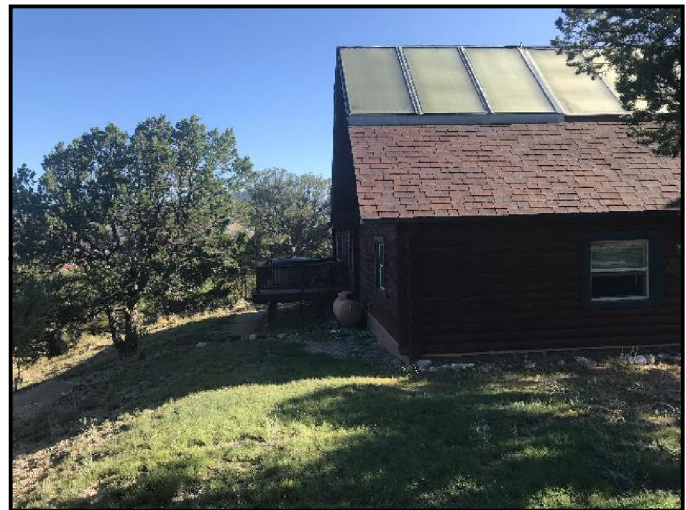
Collected Date/Time: 9/21/2019 3:06:00 PM
Collected By: Chris Masson
Inspector's Position: Divs

Notes: Fuel loading below residence, wooden deck on front and back

Mitigation Time (in hours): 6

Mitigation Description: Thinning

Type 6 engine

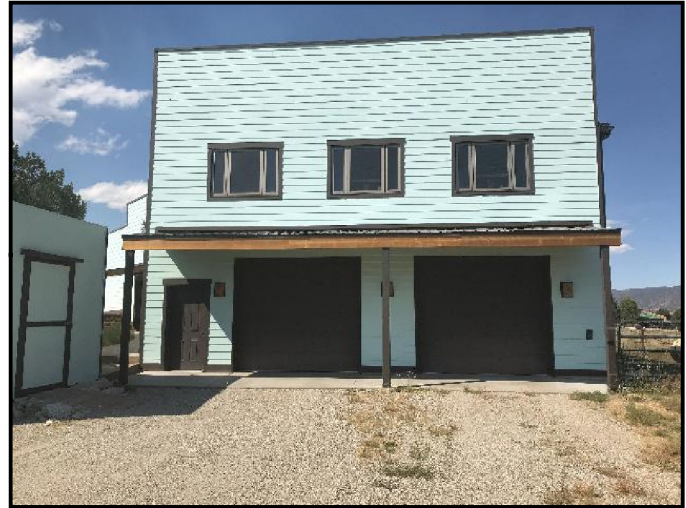
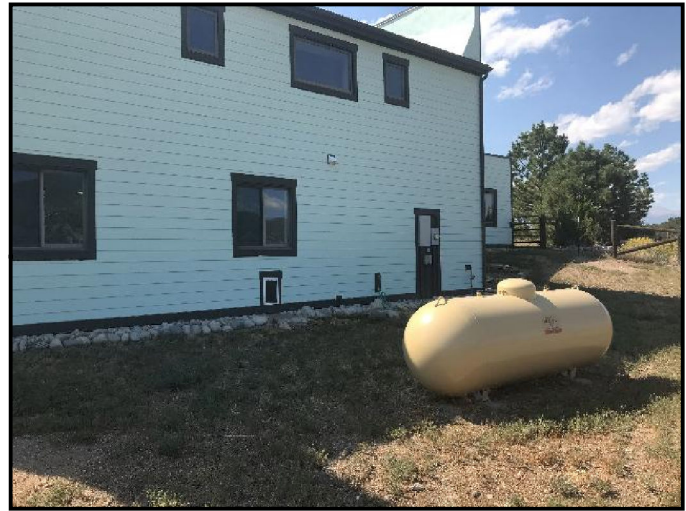
Triage Category: Defensible, Prep and Hold
Type of Structure: Residential
Primary Structures:
Is the building Occupied?: Yes
Outbuildings: 1
Fuel Surrounding Structure: Shrub or timber
Defensible Space: Less Than 30 ft treated
Roof Material: Noncombustible or not applicable
Siding Material: Wood or open sided
Electrical Power: Yes
Gas to Structure: Yes
Hazards: Fuels below structure
Access to Site: T6 Engine
Describe Access: One way in and out
Comm With ICP: No
Water Source: Limited or dependent on electricity
Safety Zone Present: Potential safety zone(s) in area

Mitigation Time (in hours): 4

Mitigation Description: Thinning

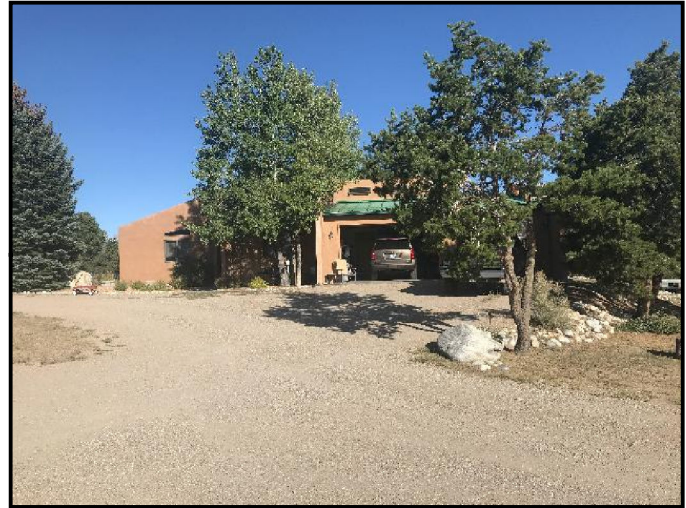
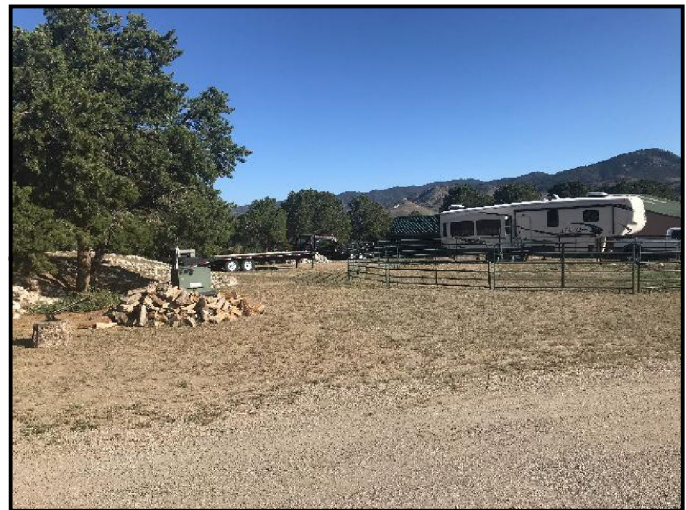
Triage Category: Defensible, Prep and Hold
Type of Structure: Residential
Primary Structures:
Is the building Occupied?: Yes
Outbuildings: 4
Fuel Surrounding Structure: Shrub or timber
Defensible Space: Less Than 30 ft treated
Roof Material: Noncombustible or not applicable
Siding Material: Rock, concrete, metal
Electrical Power: Yes
Gas to Structure: Yes
Hazards: Fuels below structure
Access to Site: T6 Engine
Describe Access: One way in and out
Comm With ICP: No
Water Source: Limited or dependent on electricity
Safety Zone Present: Potential safety zone(s) in area

Mitigation Time (in hours): 6

Mitigation Description: Thinning

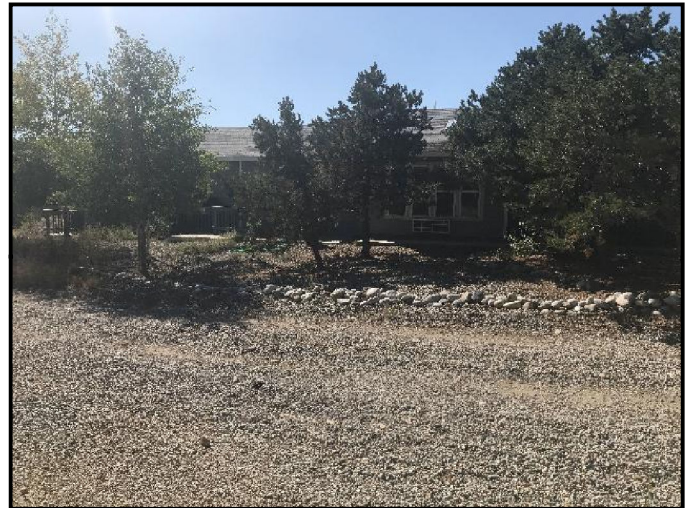
Triage Category: Defensible, Prep and Hold
Type of Structure: Residential
Primary Structures:
Is the building Occupied?: Yes
Outbuildings: 2
Fuel Surrounding Structure: Shrub or timber
Defensible Space: Less Than 30 ft treated
Roof Material: Fire resistant- tar, rubberized
Siding Material: Rock, concrete, metal
Electrical Power: Yes
Gas to Structure: Yes
Hazards: Fuels below structure
Access to Site: T6 Engine
Describe Access: One way in and out
Comm With ICP: No
Water Source: Limited or dependent on electricity
Safety Zone Present: Potential safety zone(s) in area

Mitigation Time (in hours): 6

Mitigation Description: Thinning

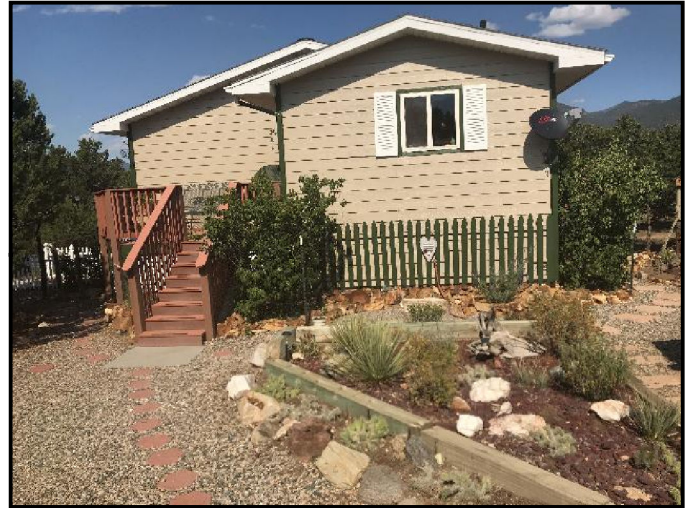
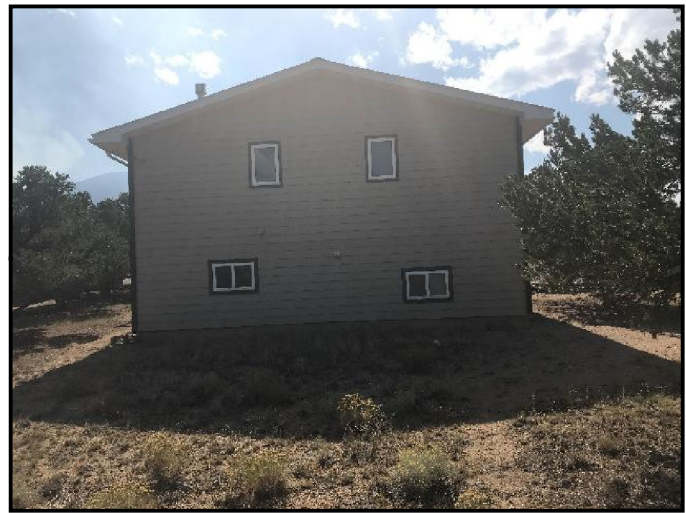
Triage Category: Defensible, Prep and Hold
Type of Structure: Residential
Primary Structures:
Is the building Occupied?: Yes
Outbuildings: 1
Fuel Surrounding Structure: Shrub or timber
Defensible Space: Less Than 30 ft treated
Roof Material: Fire resistant- tar,rubberized
Siding Material: Rock, concrete, metal
Electrical Power: Yes
Gas to Structure: Yes
Hazards: Fuels around structure
Access to Site: T6 Engine
Describe Access: One way in and out
Comm With ICP: No
Water Source: Limited or dependent on electricity
Safety Zone Present: Potential safety zone(s) in area

Mitigation Time (in hours): 6

Mitigation Description: Thinning

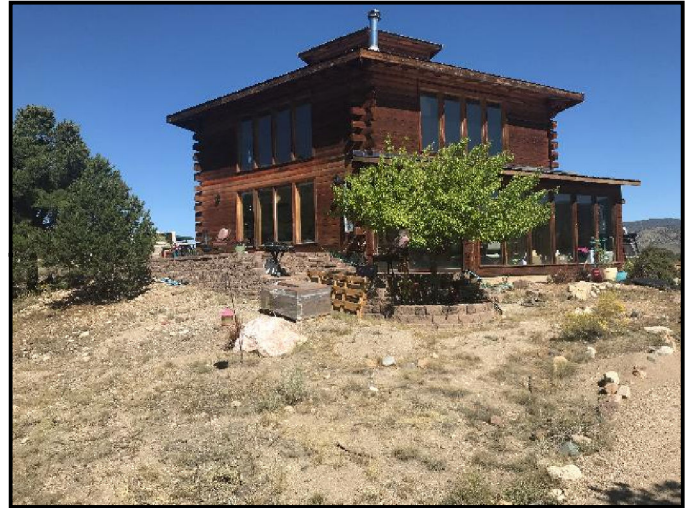
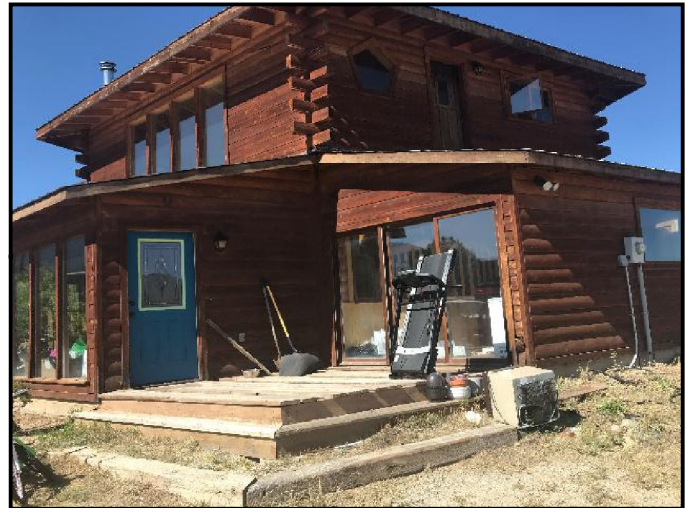
Triage Category: Defensible, Prep and Hold
Type of Structure: Residential
Primary Structures:
Is the building Occupied?: Yes
Outbuildings: 2
Fuel Surrounding Structure: Shrub or timber
Defensible Space: Less Than 30 ft treated
Roof Material: Noncombustible or not applicable
Siding Material: Log construction
Electrical Power: Yes
Gas to Structure: Yes
Hazards: Fuels below structure
Access to Site: T6 Engine
Describe Access: One way in and out
Comm With ICP: No
Water Source: Limited or dependent on electricity
Safety Zone Present: Potential safety zone(s) in area

Mitigation Time (in hours): 6

Mitigation Description: Thinning

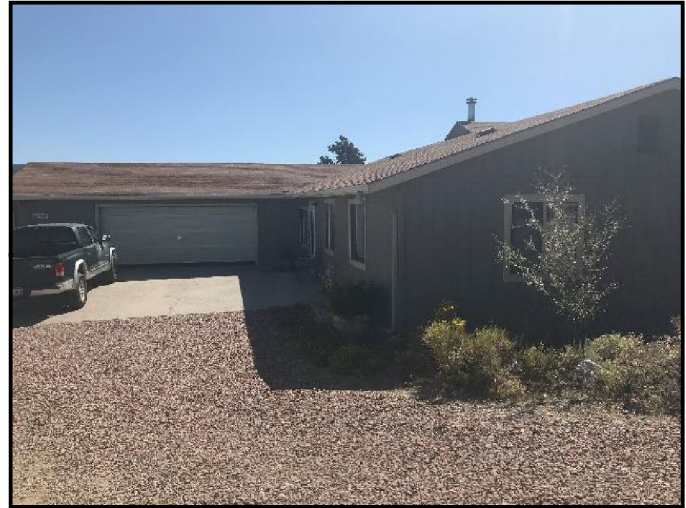
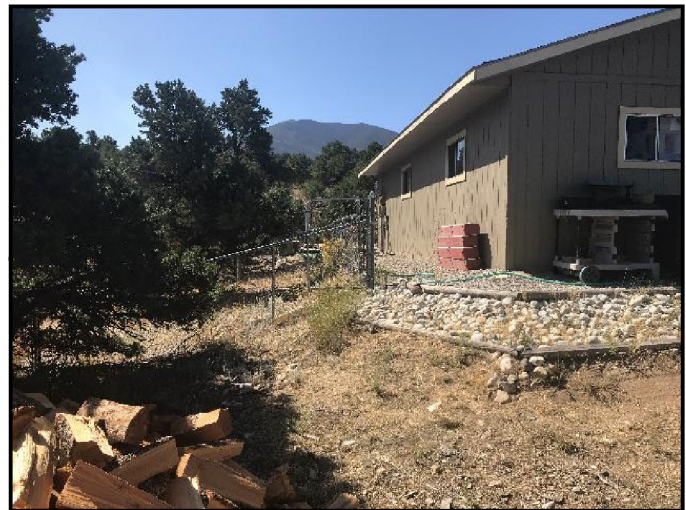
Triage Category: Defensible, Prep and Hold
Type of Structure: Residential
Primary Structures:
Is the building Occupied?: Yes
Outbuildings: 1
Fuel Surrounding Structure: Shrub or timber
Defensible Space: Less Than 30 ft treated
Roof Material: Fire resistant- tar, rubberized
Siding Material: Wood or open sided
Electrical Power: Yes
Gas to Structure: Yes
Hazards: Fuels above structure
Access to Site: T6 Engine
Describe Access: One way in and out
Comm With ICP: No
Water Source: Limited or dependent on electricity
Safety Zone Present: Potential safety zone(s) in area

Mitigation Time (in hours): 6

Mitigation Description: Thinning

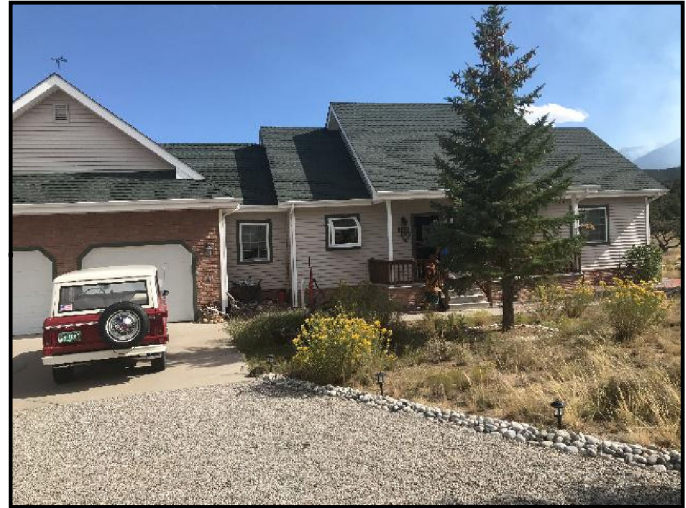
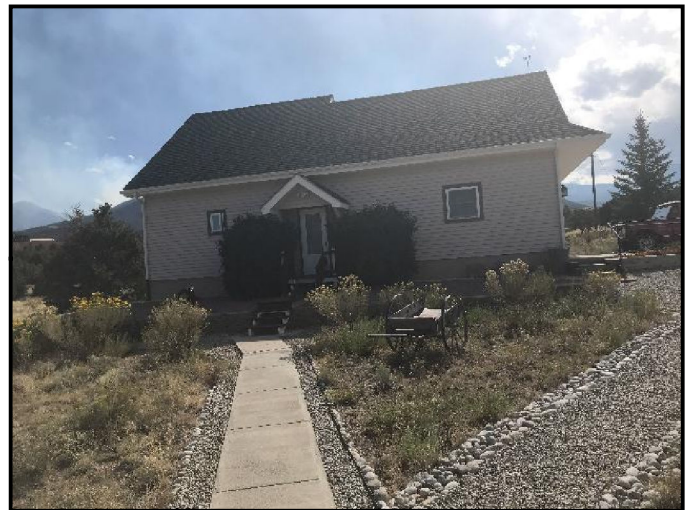
Triage Category: Defensible, Prep and Hold
Type of Structure: Residential
Primary Structures:
Is the building Occupied?: Yes
Outbuildings: 1
Fuel Surrounding Structure: Shrub or timber
Defensible Space: Less Than 30 ft treated
Roof Material: Fire resistant- tar, rubberized
Siding Material: Vinyl
Electrical Power: Yes
Gas to Structure: Yes
Hazards: Fuels fm1 in front yard
Access to Site: T6 Engine
Describe Access: One way in and out
Comm With ICP: No
Water Source: Limited or dependent on electricity
Safety Zone Present: Potential safety zone(s) in area

Mitigation Time (in hours):

Mitigation Description: Weed whacking

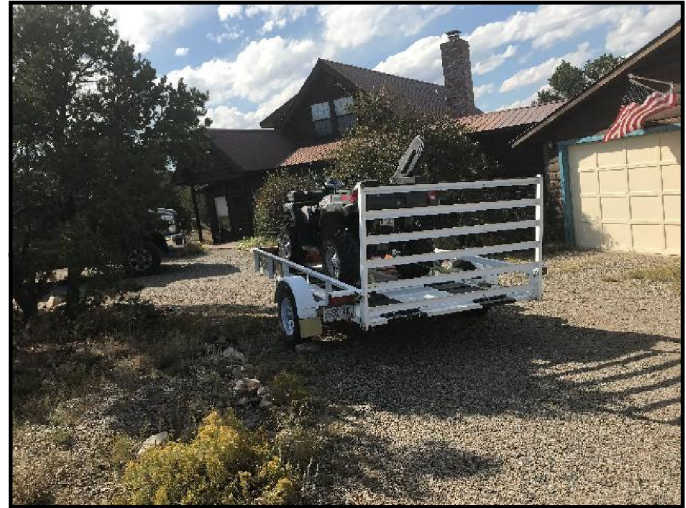
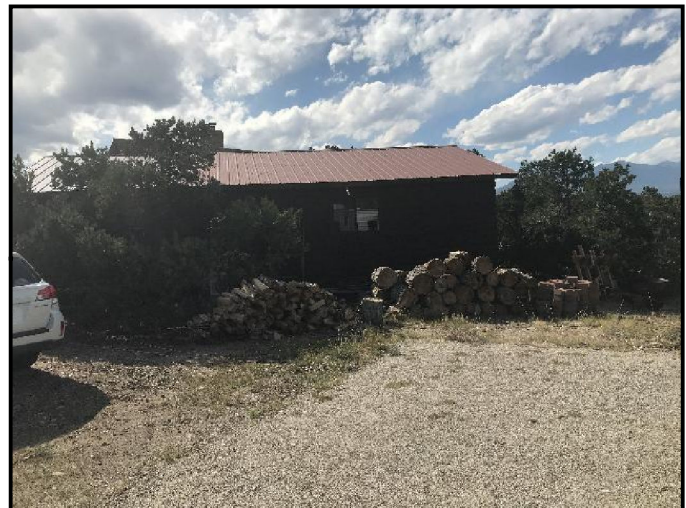
Triage Category: Defensible, Prep and Hold
Type of Structure: Residential
Primary Structures:
Is the building Occupied?: Yes
Outbuildings: 0
Fuel Surrounding Structure: Shrub or timber
Defensible Space: Less Than 30 ft treated
Roof Material: Noncombustible or not applicable
Siding Material: Log construction
Electrical Power: Yes
Gas to Structure: Yes
Hazards: Fuels below structure
Access to Site: T6 Engine
Describe Access: One way in and out
Comm With ICP: No
Water Source: Limited or dependent on electricity
Safety Zone Present: Potential safety zone(s) in area

Mitigation Time (in hours): 6

Mitigation Description: Thinning

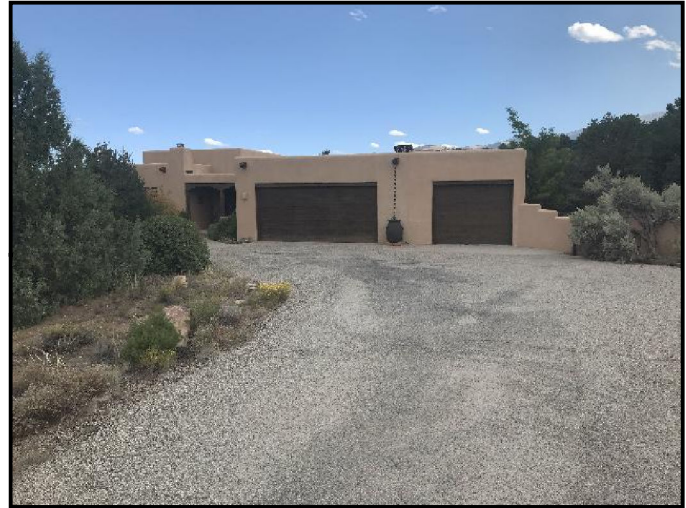
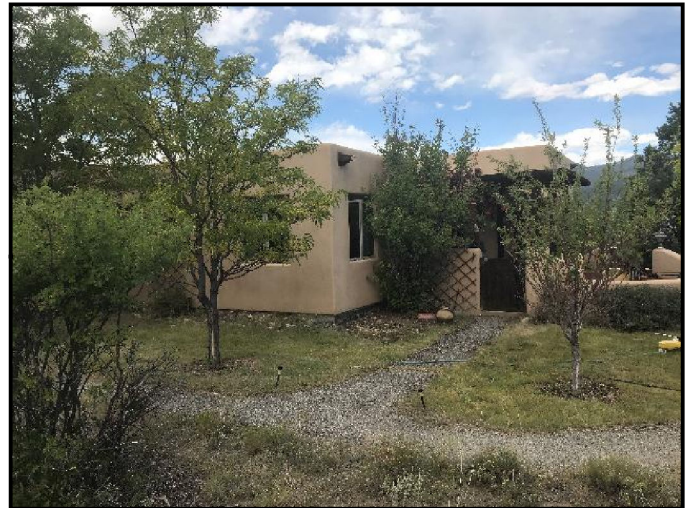
Triage Category: Defensible, Prep and Hold
Type of Structure: Residential
Primary Structures:
Is the building Occupied?: Yes
Outbuildings: 0
Fuel Surrounding Structure: Shrub or timber
Defensible Space: Less Than 30 ft treated
Roof Material: Noncombustible or not applicable
Siding Material: Rock, concrete, metal
Electrical Power: Yes
Gas to Structure: Yes
Hazards: Fuels around structure
Access to Site: T6 Engine
Describe Access: One way in and out
Comm With ICP: No
Water Source: Limited or dependent on electricity
Safety Zone Present: Potential safety zone(s) in area

Mitigation Time (in hours): 6
Mitigation Description: Thinning and weed whacking

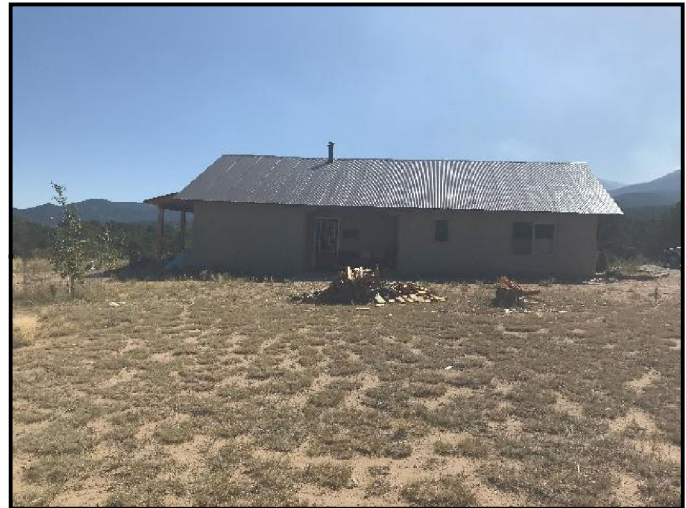
Triage Category: Defensible, Prep and Hold
Type of Structure: Residential
Primary Structures:
Is the building Occupied?: Yes
Outbuildings: 0
Fuel Surrounding Structure: Shrub or timber
Defensible Space: Less Than 30 ft treated
Roof Material: Noncombustible or not applicable
Siding Material: Rock, concrete, metal
Electrical Power: Yes
Gas to Structure: Yes
Hazards: Fuels below structure
Access to Site: T6 Engine
Describe Access: One way in and out
Comm With ICP: No
Water Source: Limited or dependent on electricity
Safety Zone Present: Potential safety zone(s) in area

Mitigation Time (in hours): 6

Mitigation Description: Thinning

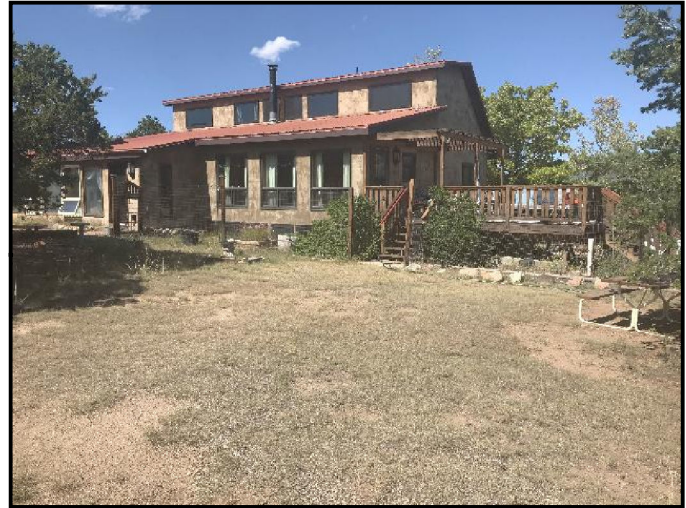
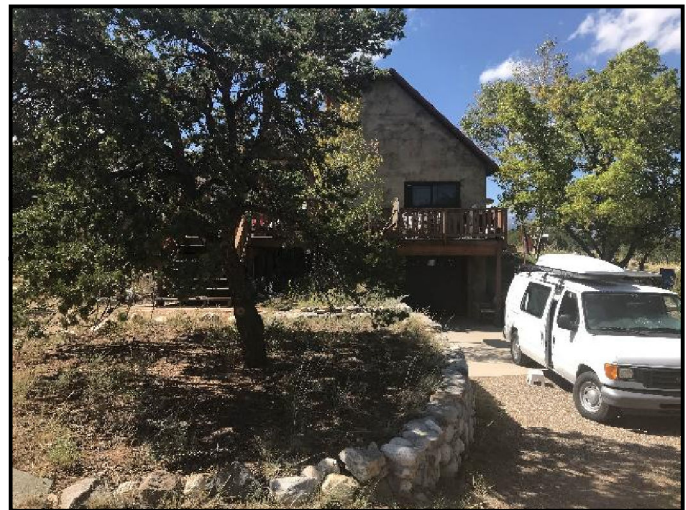
Triage Category: Defensible, Prep and Hold
Type of Structure: Residential
Primary Structures:
Is the building Occupied?: Yes
Outbuildings: 0
Fuel Surrounding Structure: Shrub or timber
Defensible Space: Less Than 30 ft treated
Roof Material: Noncombustible or not applicable
Siding Material: Rock, concrete, metal
Electrical Power: Yes
Gas to Structure: Yes
Hazards: Fuels below structure
Access to Site: T6 Engine
Describe Access: One way in and out
Comm With ICP: No
Water Source: Limited or dependent on electricity
Safety Zone Present: Potential safety zone(s) in area

Mitigation Time (in hours): 6

Mitigation Description: Thinning

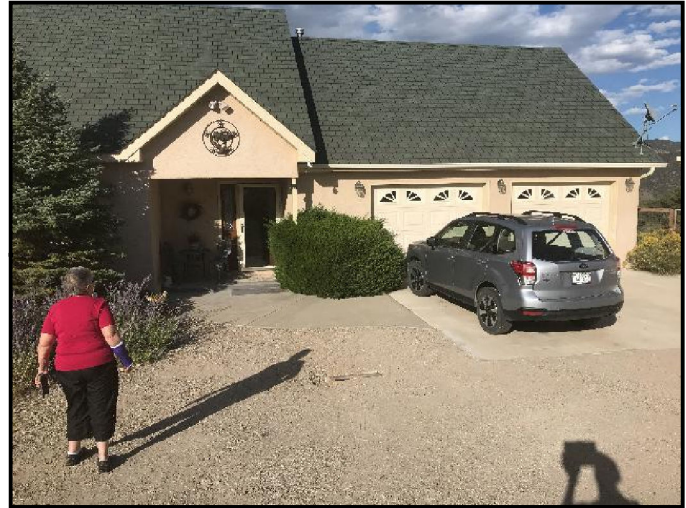
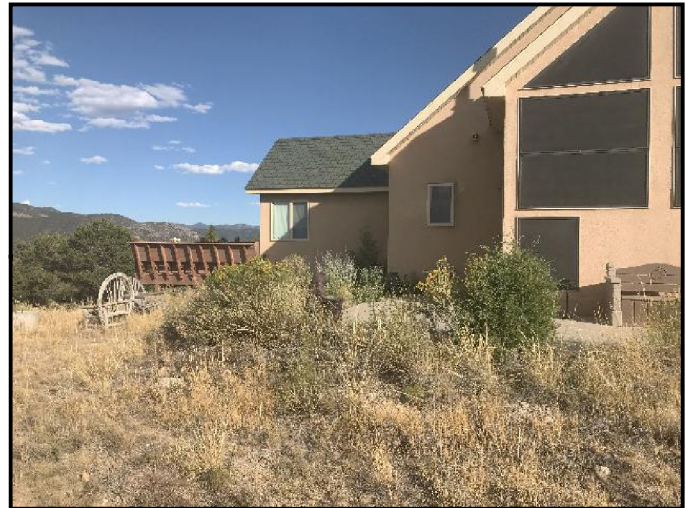
Triage Category: Defensible, Prep and Hold
Type of Structure: Residential
Primary Structures:
Is the building Occupied?: Yes
Outbuildings: 1
Fuel Surrounding Structure: Shrub or timber
Defensible Space: Less Than 30 ft treated
Roof Material: Fire resistant- tar, rubberized
Siding Material: Rock, concrete, metal
Electrical Power: Yes
Gas to Structure: Yes
Hazards: Fuels below structure
Access to Site: T6 Engine
Describe Access: One way in and out
Comm With ICP: No
Water Source: Limited or dependent on electricity
Safety Zone Present: Potential safety zone(s) in area

Mitigation Time (in hours): 6
Mitigation Description: Thinning and weed whacking Broken window
