# Bear Creek & Silver Heels Structure Assessment

Structure ID: 1

**Location:** 1612 CR 101/49, Bear creek

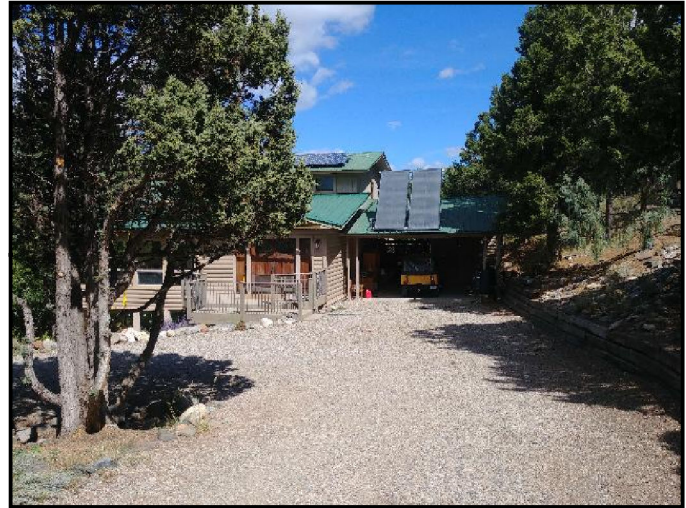
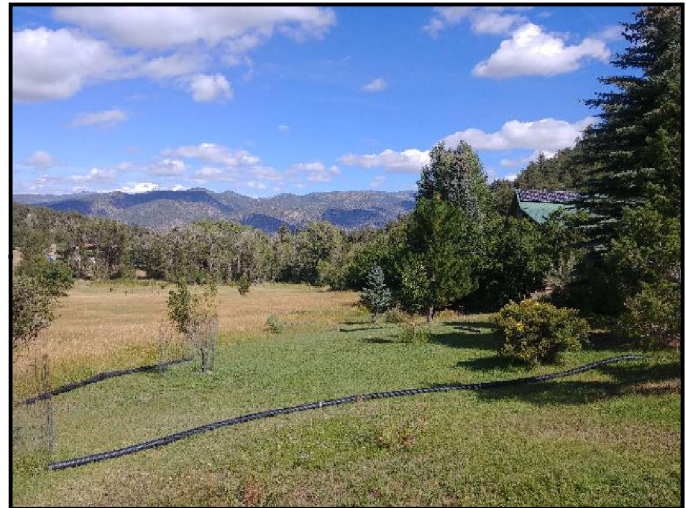
**Notes:** Well maintained structure and landscaping, need trash and lumber removed from around structure

**Mitigation Description:** Light brush and weed eater sprinkler. Pumpkin, pump# RMK-0148-92

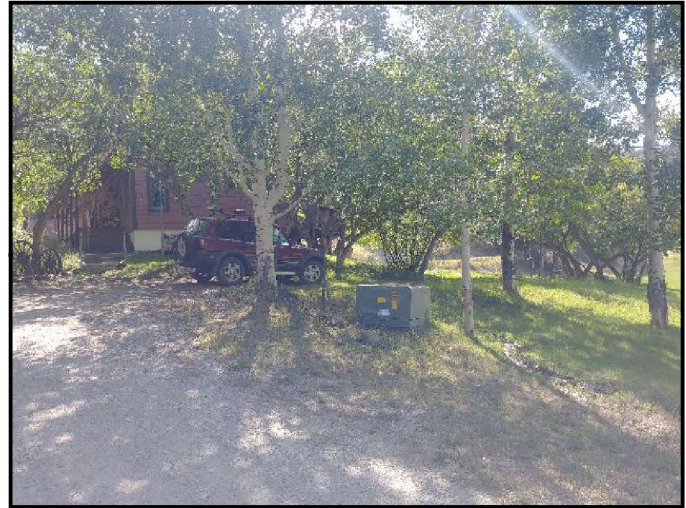
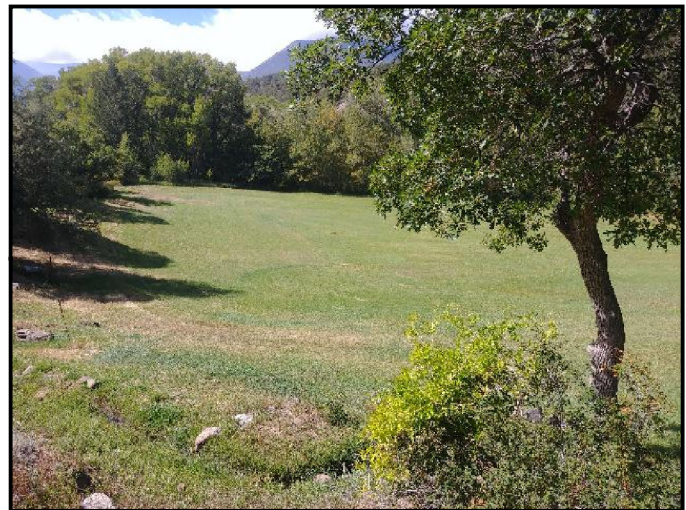
**Notes:** Well maintained structure and landscaping

**Mitigation Description:** Light brush and weed eater

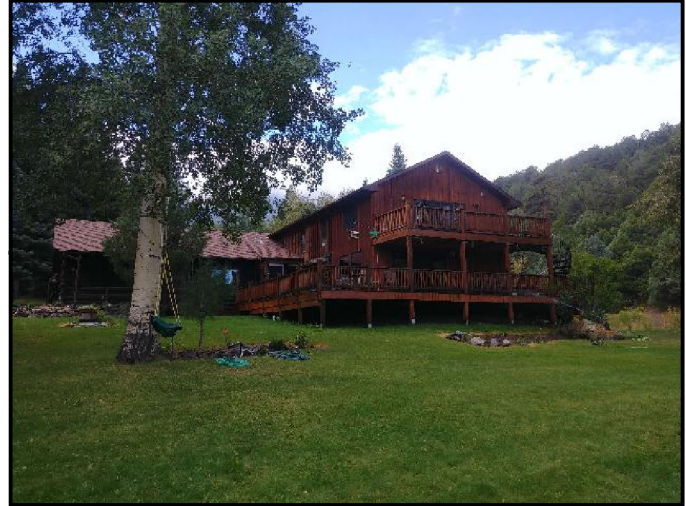
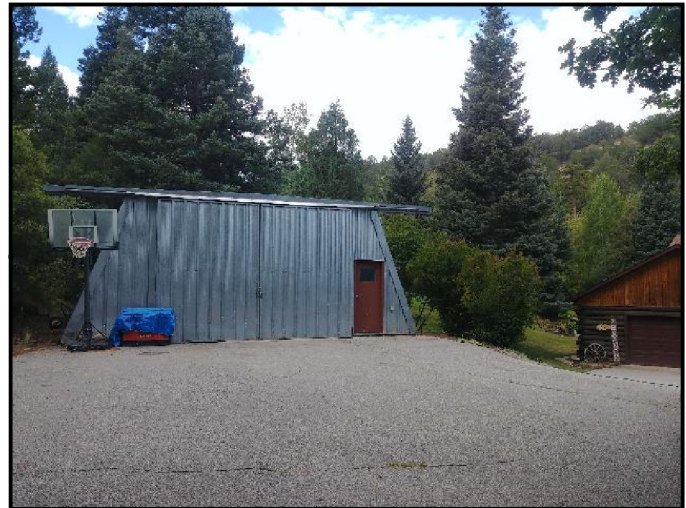
**Notes:** Well maintained structure and landscaping

**Mitigation Description:** Light brush and weed eater

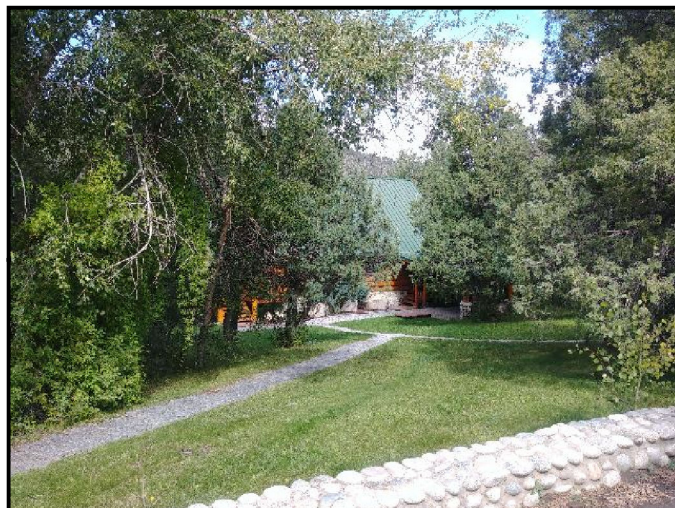
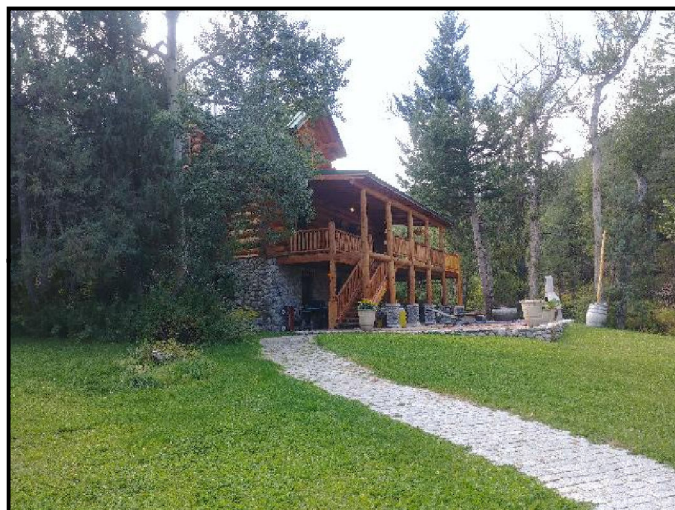
**Hazards:** Egress one way one lane road, fuels well maintained but to close to structure, bridge of unknown capacity

**Notes:** Well maintained structure and landscaping heavy fuels to close to structure

**Mitigation Description:** Heavy brush removal from surrounding area

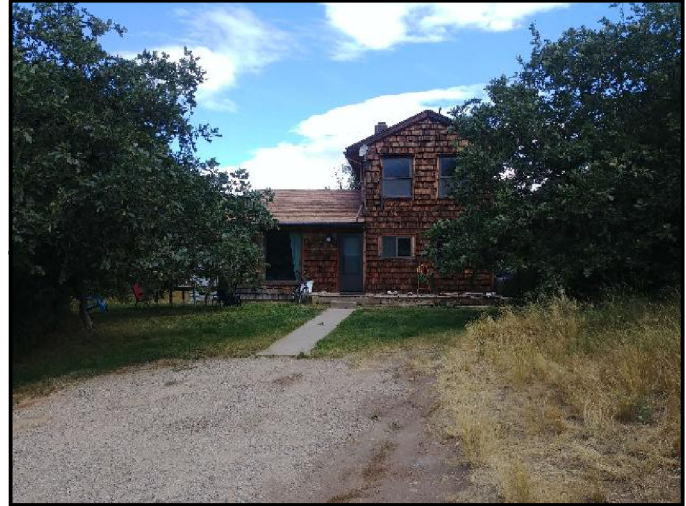
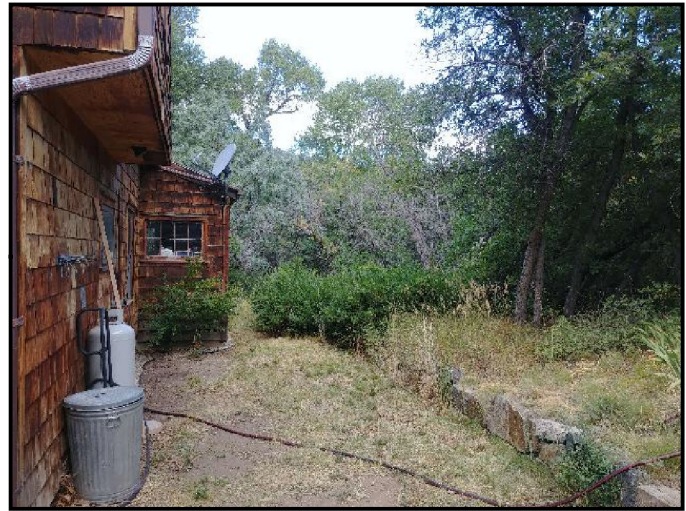
**Notes:** Shake single sided structure, light and heavy fuels at structure

**Mitigation Description:** Too much fuel reduction to be completed by fire resources

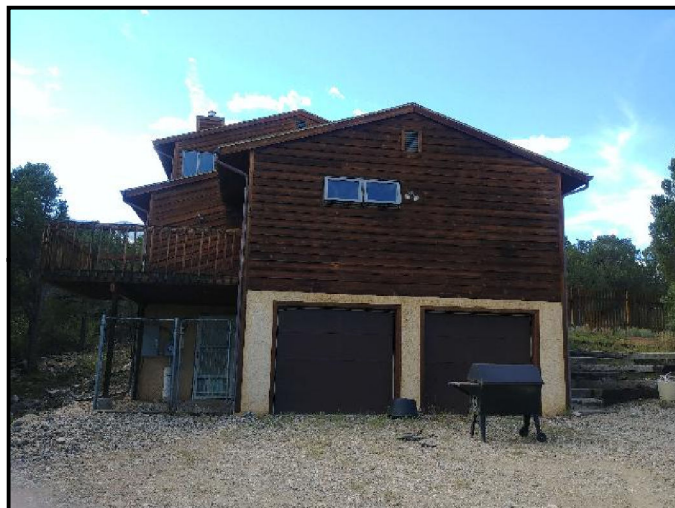
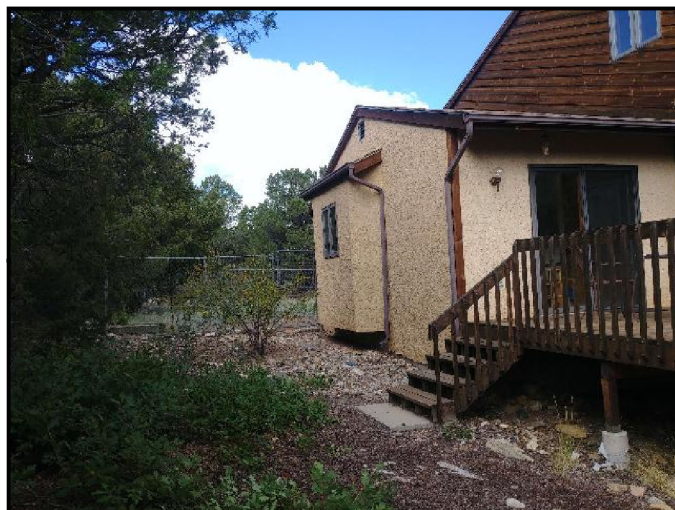
**Notes:** Heavy fuels upto structure, steep slope on south side

**Mitigation Description:** Heavy fuels work in PJ

prep and install sprinkler, check after fire front passage

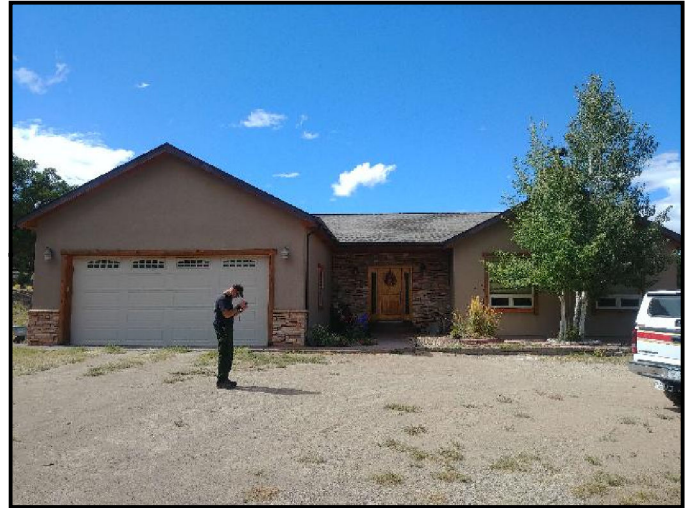
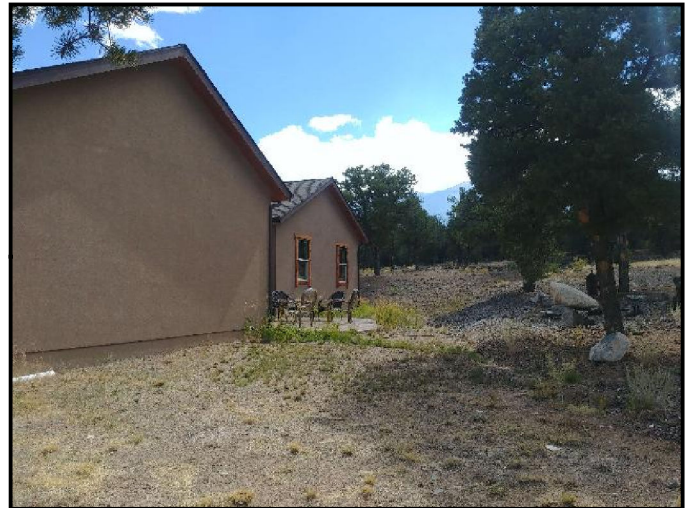
**Notes:** Well maintained structure and landscaping

**Mitigation Description:** Light brush and weed eater

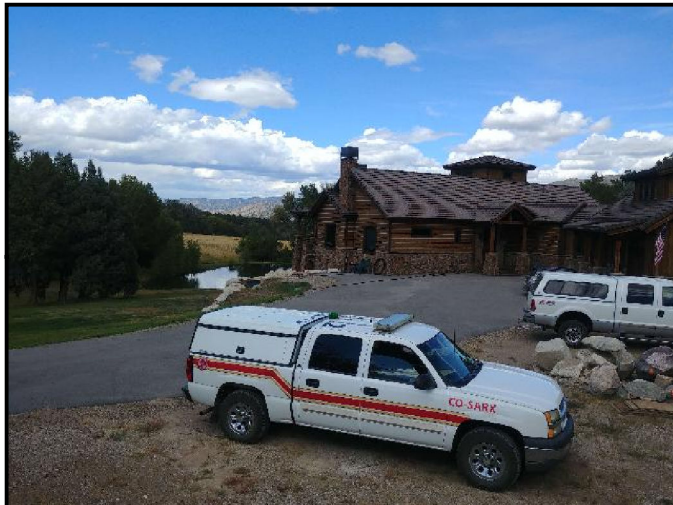
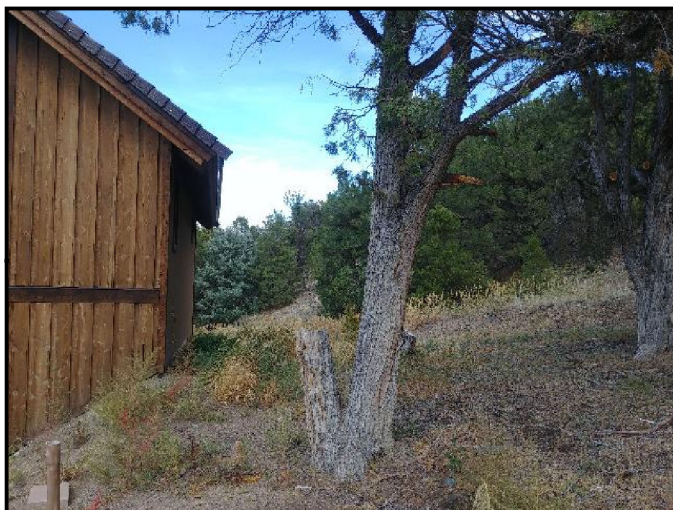
**Notes:** Well maintained structure and landscaping

**Mitigation Description:** Light brush and weed eater

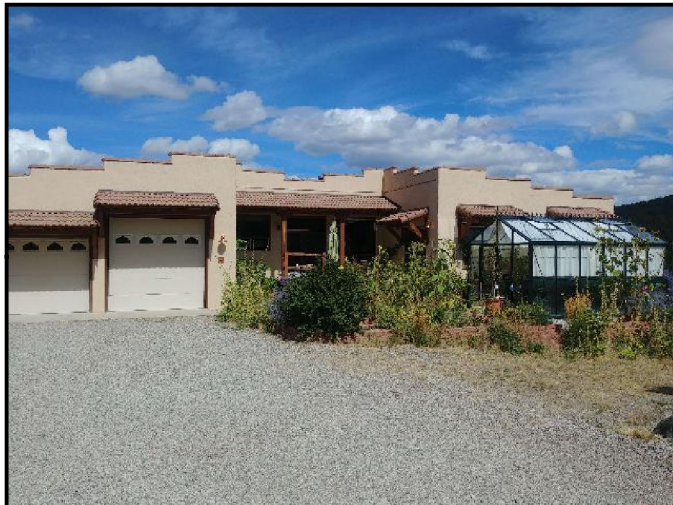
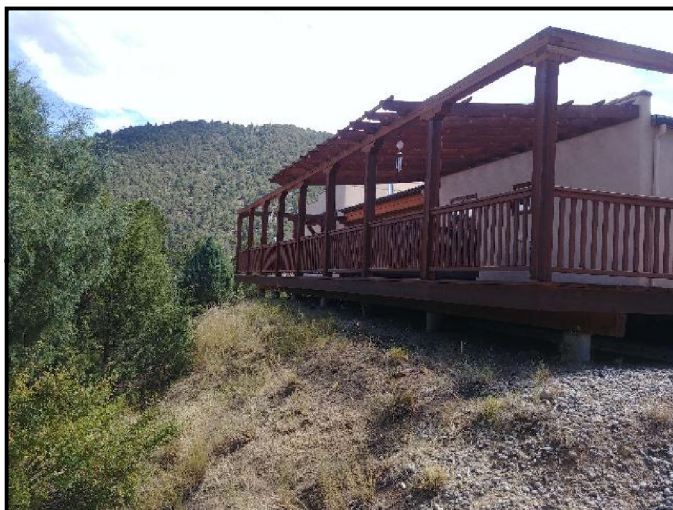
**Notes:** Well maintained structure and landscaping

**Mitigation Description:** Light brush and weed eater

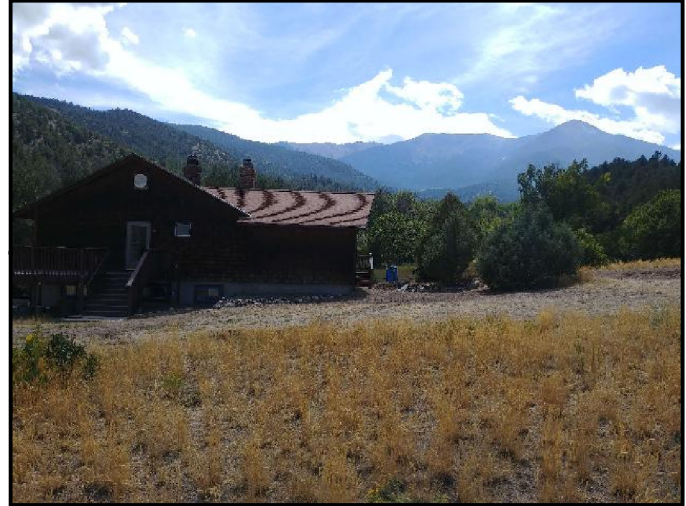
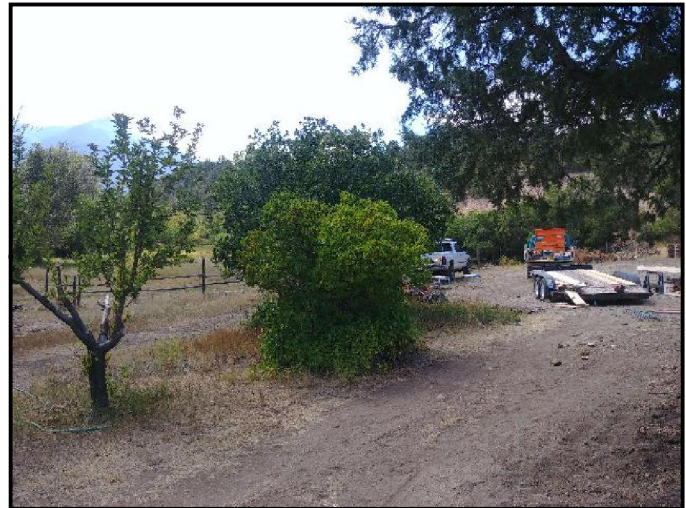
**Notes:** Under construction, shake siding

**Mitigation Description:** Light brush and weed eater

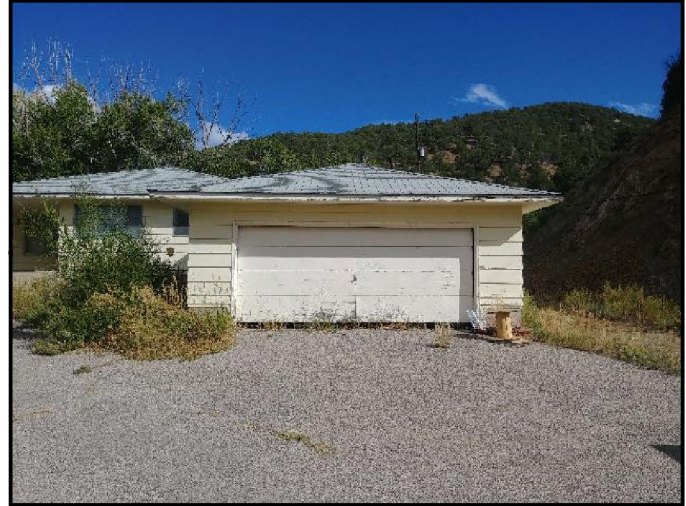
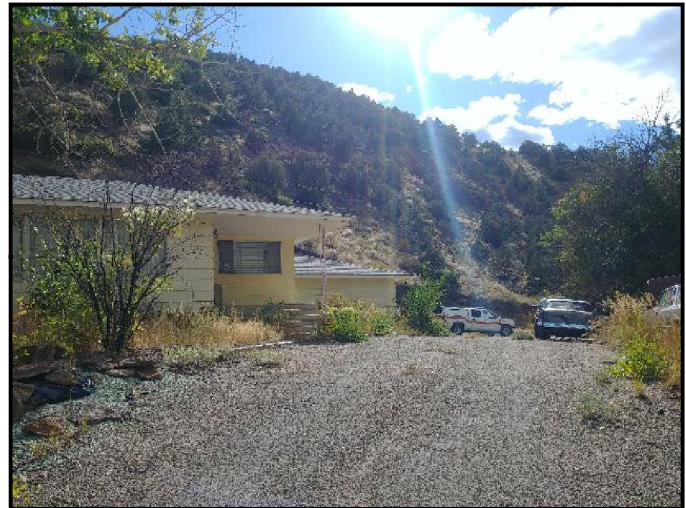
**Notes:** Heavy grass and brush up to structure, lots of yard debris

**Mitigation Description:** Heavy weed eater and brush clearing

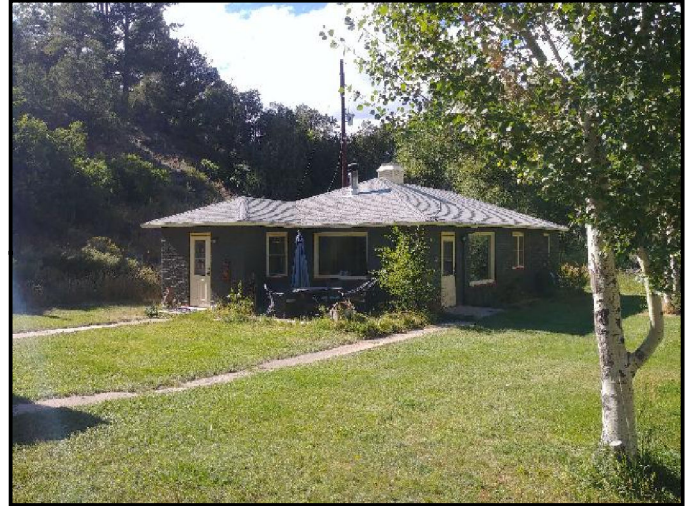
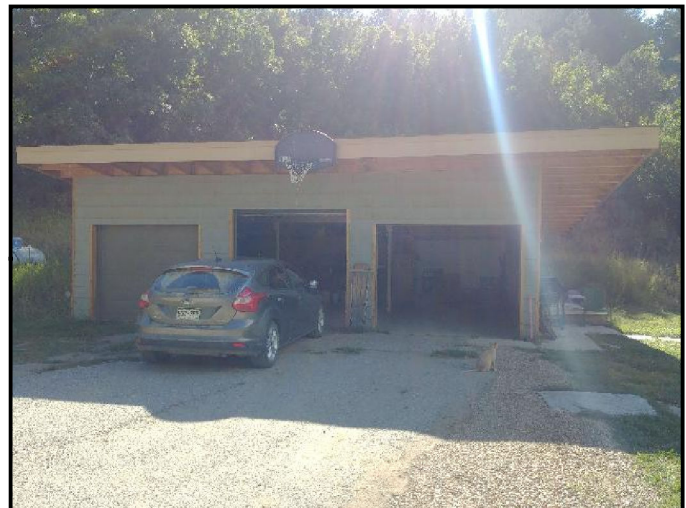
**Notes:** Grass and brush within 10' on west and south side of house and garage

**Mitigation Description:** Heavy weed eater and light saw work

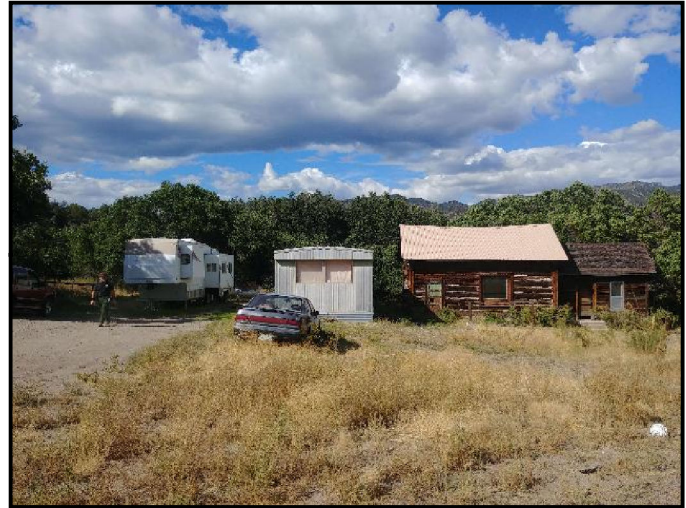
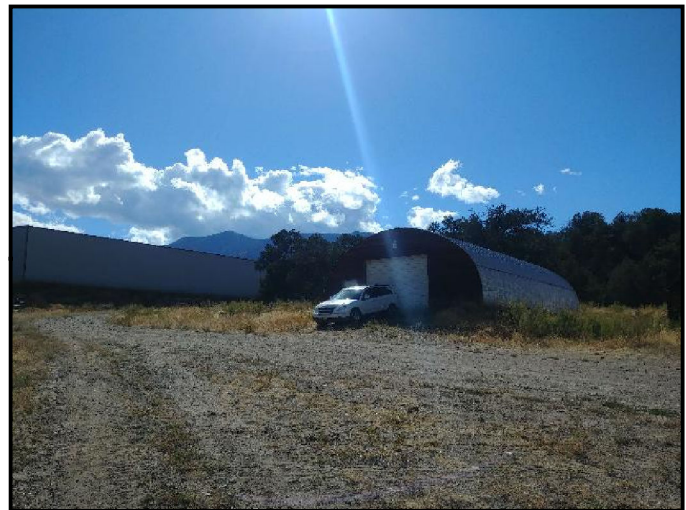
**Hazards:** Historic cabin with mobile home next door

**Notes:** Skirted mobile home next to very flammable historic cabin

**Mitigation Description:** Saw work in heavy brush on north side of both structures

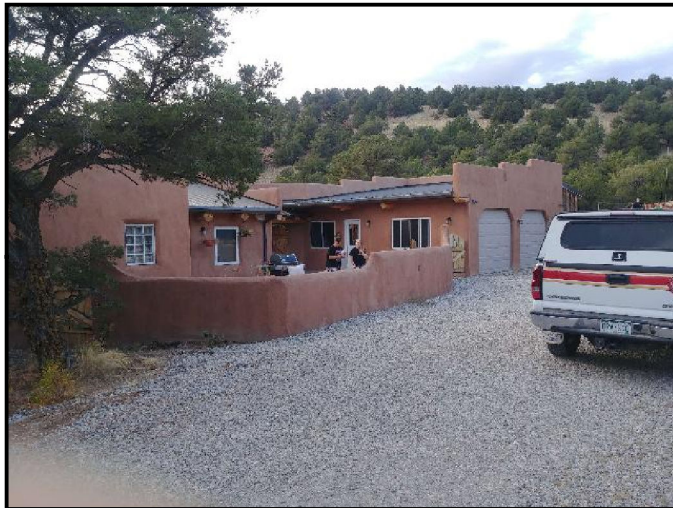
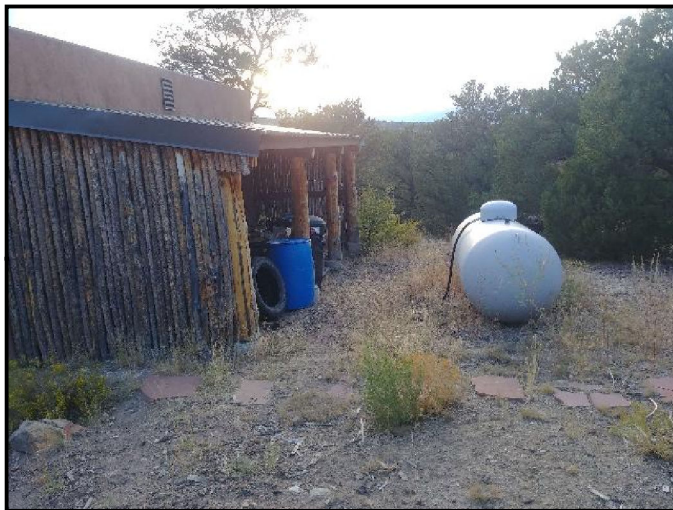
**Notes:** Stucco with both light and heavy fuels at structure

**Mitigation Description:** Moderate brush and weed eater

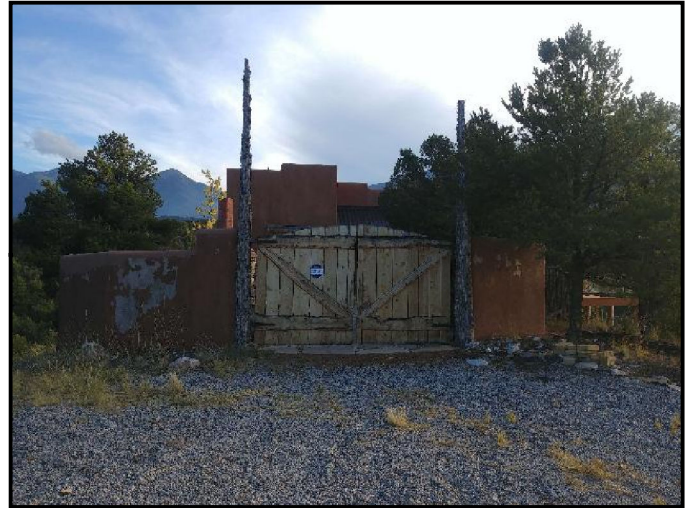
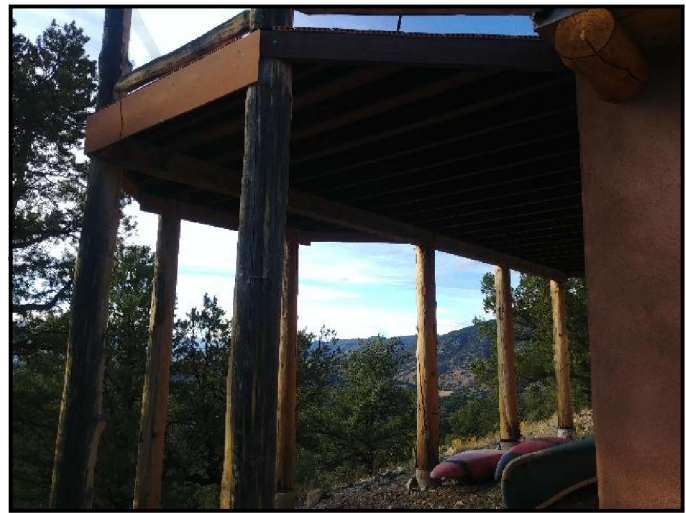
**Notes:** Lots of flammable heavies attached to or adjacent to the structure

**Mitigation Description:** Light brush and weed eater and heavy saw work House has steep slopes on 3 sides

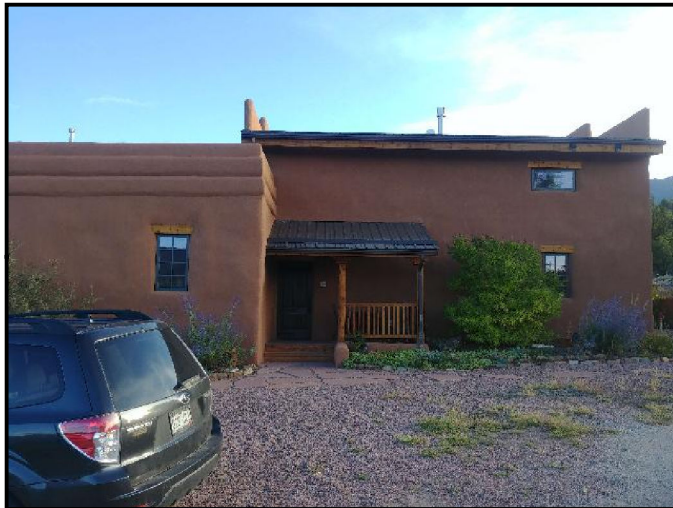
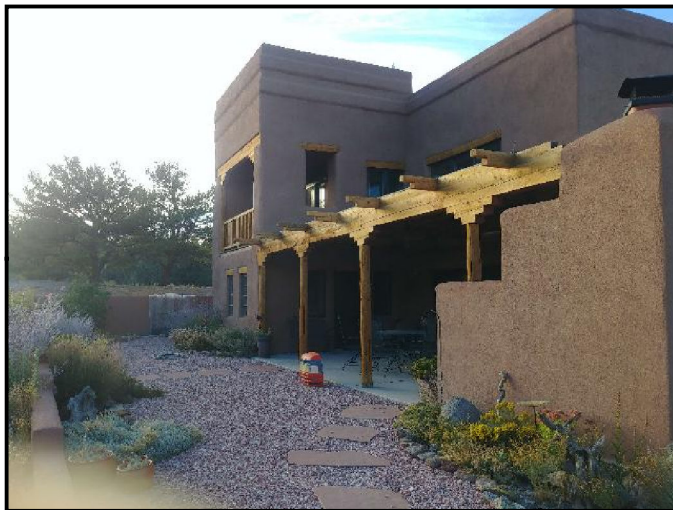
**Notes:** Well maintained structure and landscaping

**Mitigation Description:** Light brush and weed eater some saw work on east side

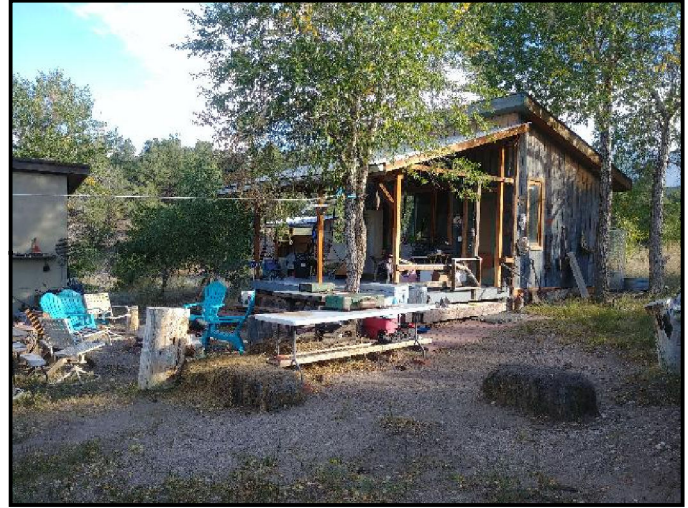
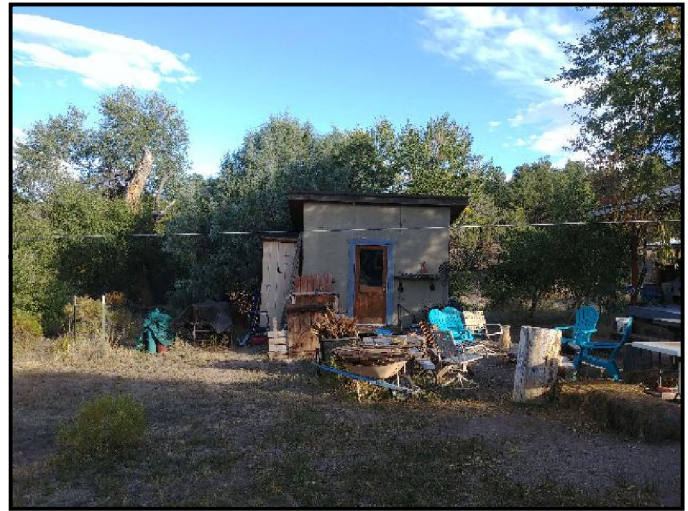
**Notes:** Fuels upto structure and lots of yard debris

**Mitigation Description:** Heavy brush and weed eater

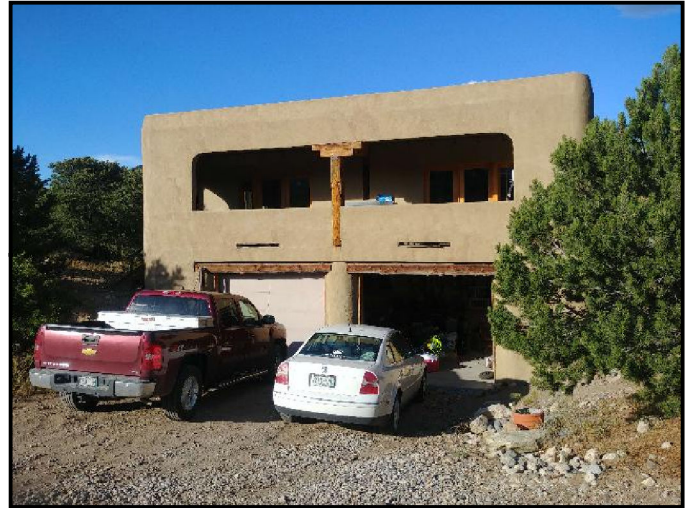
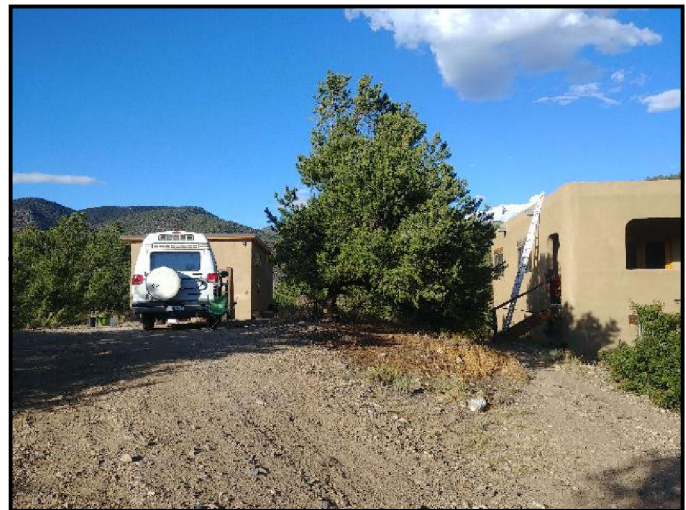
**Notes:** Stucco with brush right up to structure

**Mitigation Description:** Heavy brush and weed eater

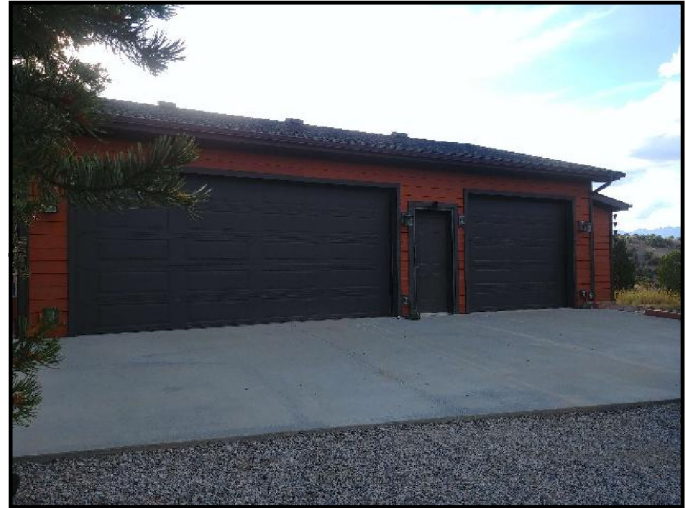
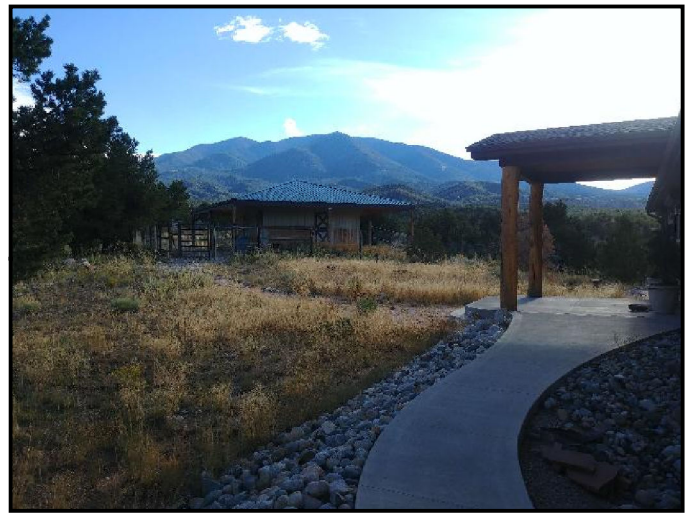
**Notes:** Well maintained structure and landscaping

**Mitigation Description:** Light brush and weed eater

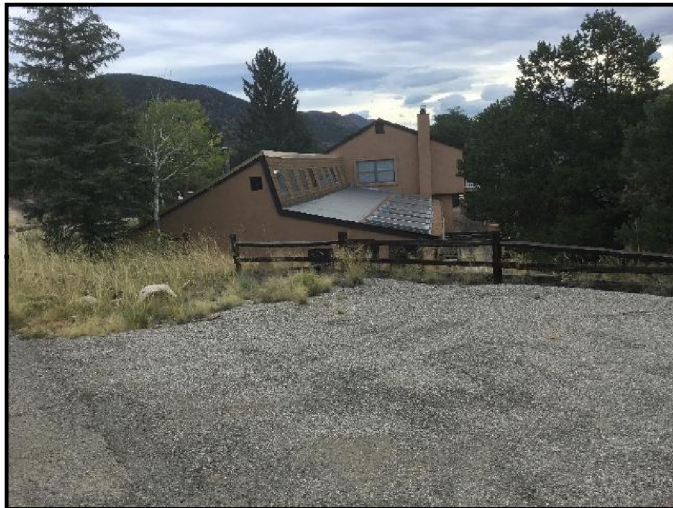
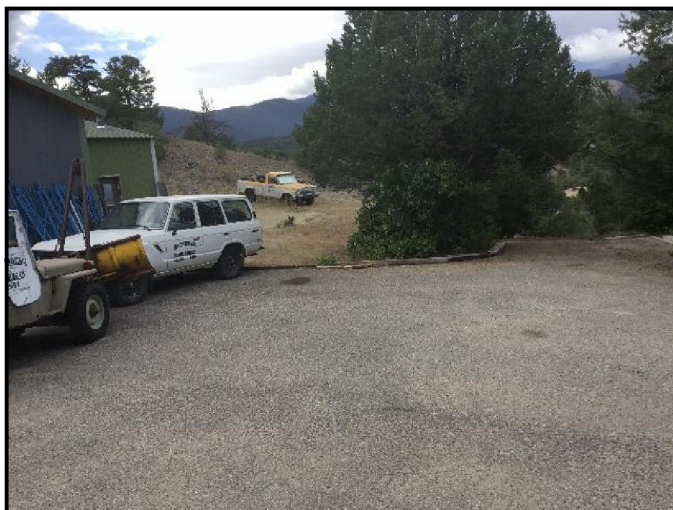
**Hazards:** Hazards include the following: moderate to high fuel loading surrounding structure, tar base shingles on 2/3 of roof main residence, mid slope, steep terrain.

**Notes:** Structure tucked into hillside w/ abundant fuels present.

**Mitigation Description:** Tree and brush removal. Wood pile removal.

Sprinkler set up with dedicated water source. Heavy fuels removal would require 10 to 20 person crew. Type 4/3 engine. Pump #RMK-0148-313

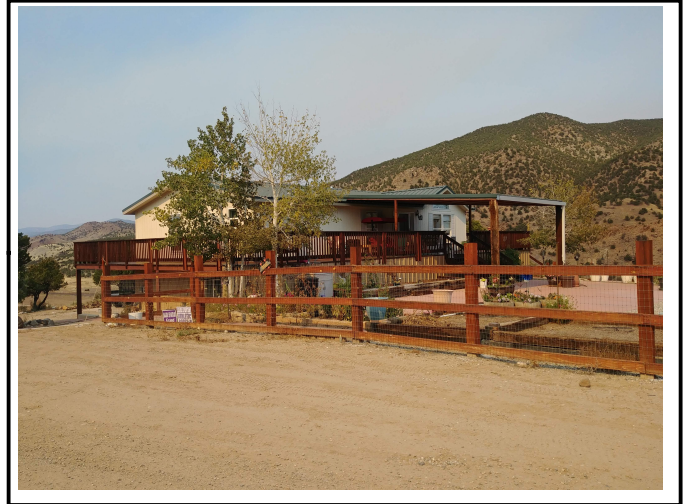
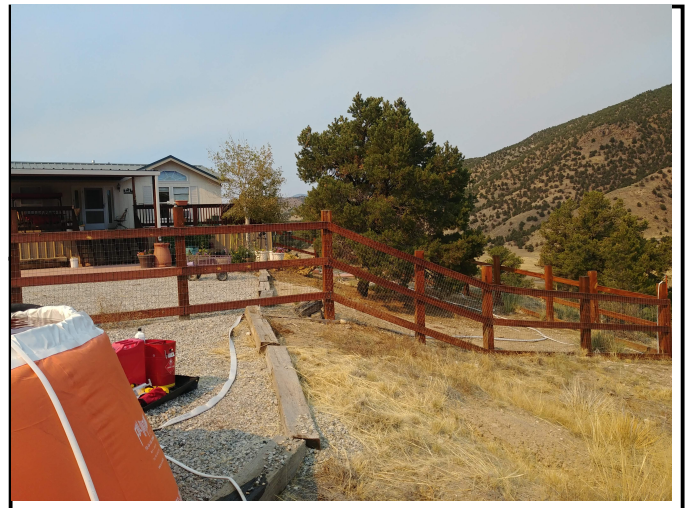
**Notes:** stucco home flat roof attached wood deck.

**Mitigation Description:** limb pj on slope  
weed eat around structures and sprinklers

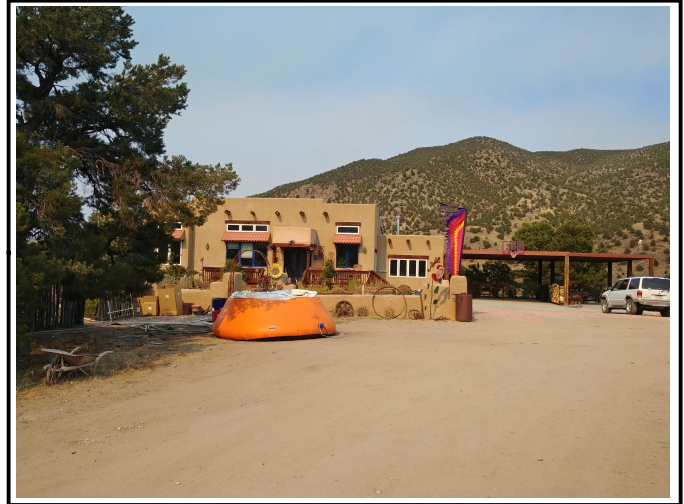
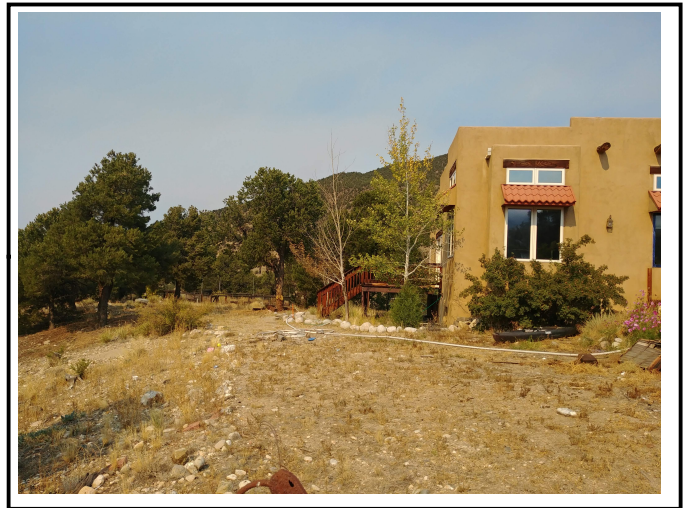
**Hazards:** access road, steep slopes north of house

**Notes:** well maintained, good mitigation, wooden deck

**Mitigation Description:** limbing and brushing
