Howard West Structure Assessment

Structure ID: 281

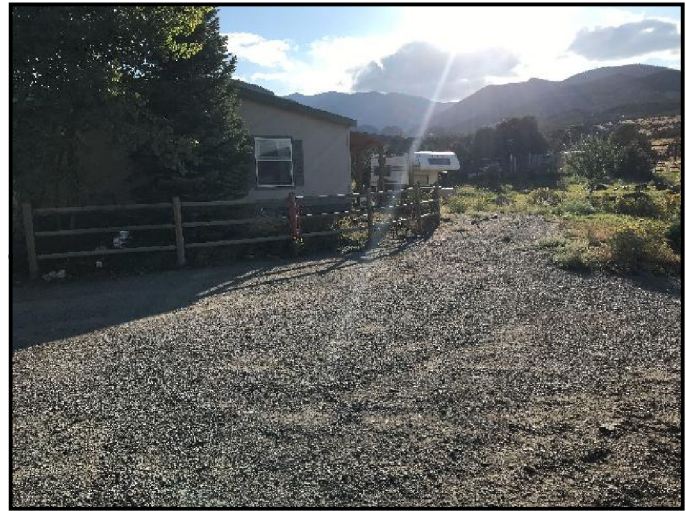
Hazards: Some surrounding fuels including shrubs and grass

Notes: Double wide type structure, lots of debris and misc. equipment

Mitigation Description: Weed whacking and general clean -up

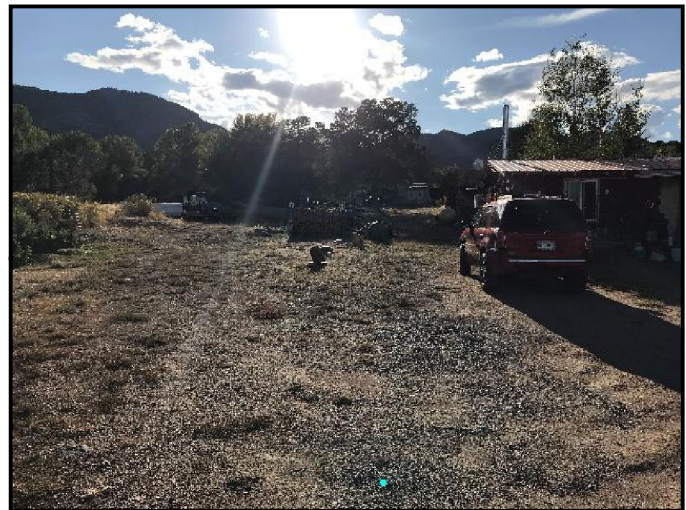
Structure ID: 282

Hazards: Grass fuel models against residence

Notes: Multiple structures, yard debris and wood piles, equipment and abandon vehicles present

Mitigation Description: Weed whacking and general clean-up

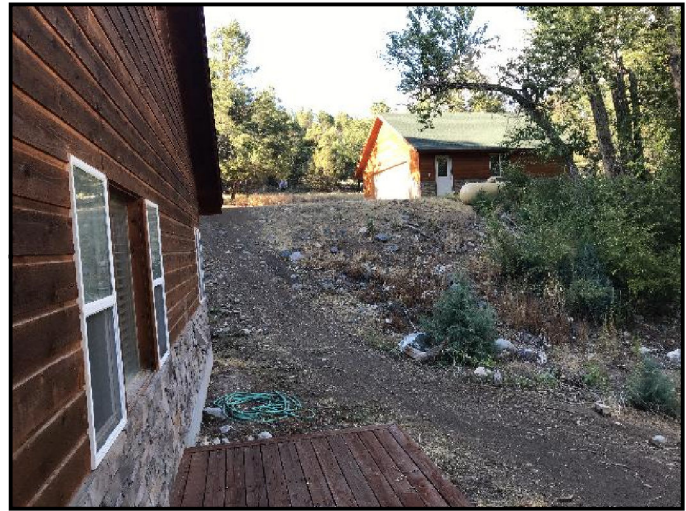
Structure ID: 287

Hazards: Fuel loading adjacent

Notes: Structure well maintained, some clearance with adjacent creek.

Mitigation Description: Brushing and weed whacking

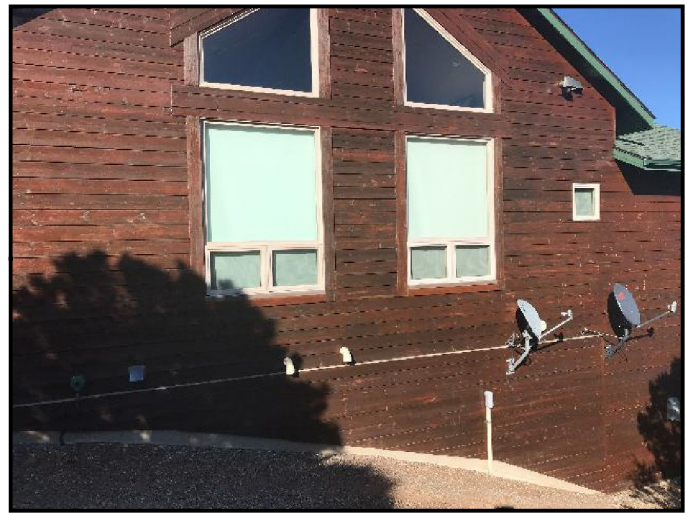
Structure ID: 288

Hazards: Fuels near structure, steep slope below house, gravel around entire perimeter of house

Notes: Wood deck

Mitigation Description: Thinning and brushing around house needed

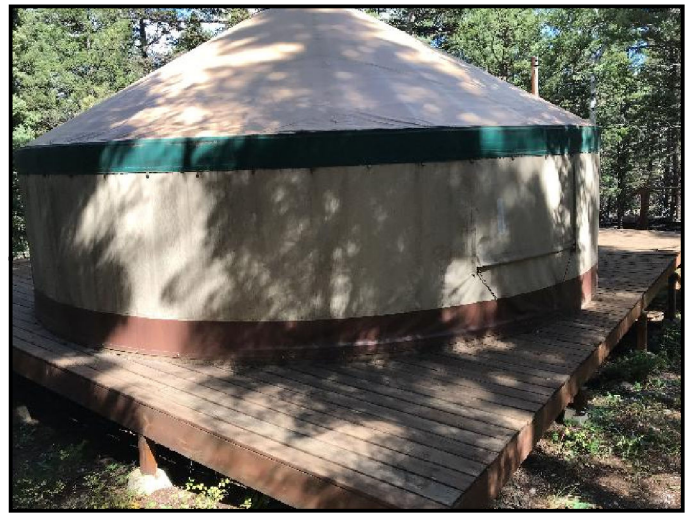
Structure ID: 289

Hazards: Yurt construction of flammable material, large amount of horizontal piles of timber

Notes: Yurt construction, large deck w/ material underneath

Mitigation Description: Removal of large wood piles and thinning of brush

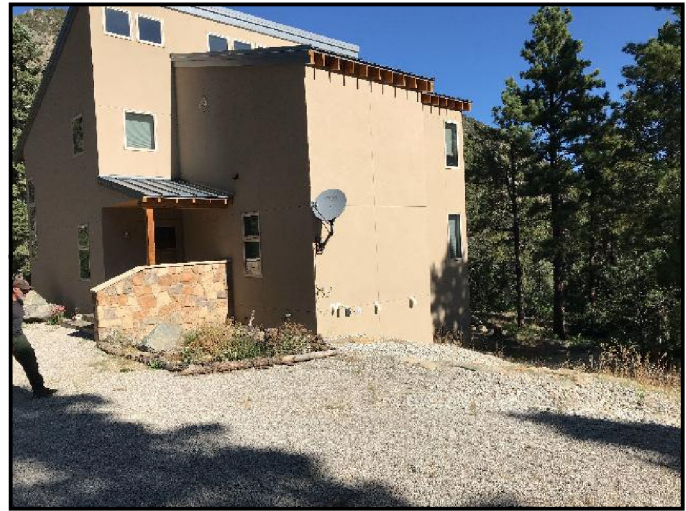
Structure ID: 290

Hazards: Fuel loading, semi canyon

Notes: Stucco, some clearance around structure with gravel in driveway.

Mitigation Description: Tree thinning and brush removal

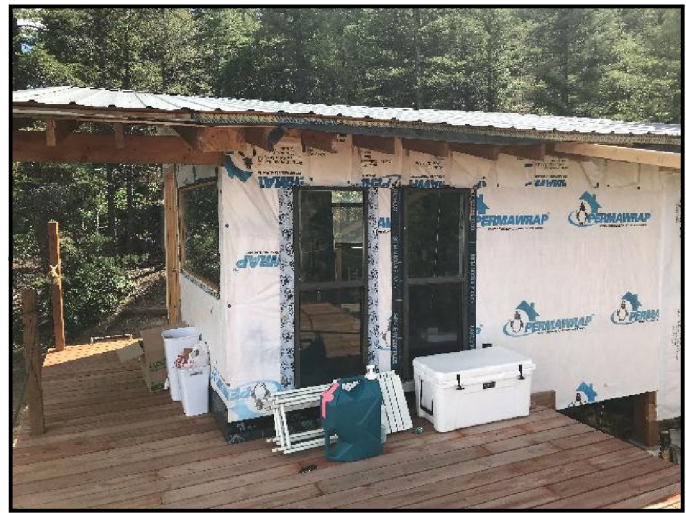
Structure ID: 291

Hazards: Heavy fuel loading around residence , some slope

Notes: Still under construction but livable .
Wood deck

Mitigation Description: Tree and brush removal

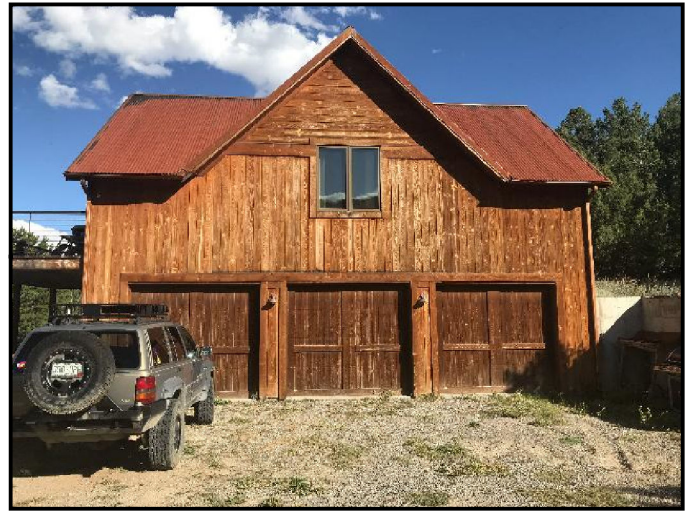
Structure ID: 292

Hazards: Fuels around structure

Notes: All wood w/ wood deck limited turn around area in driveway

Mitigation Description: Brushing and weed whacking

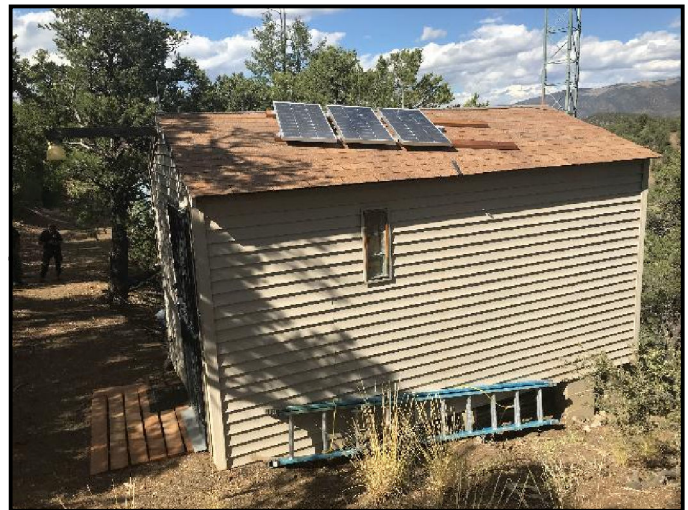
Structure ID: 296

Hazards: Surrounded by fuels and stacked wood under structure

Notes: Small shed like structure

Mitigation Description: Tree removal and brushing around structure

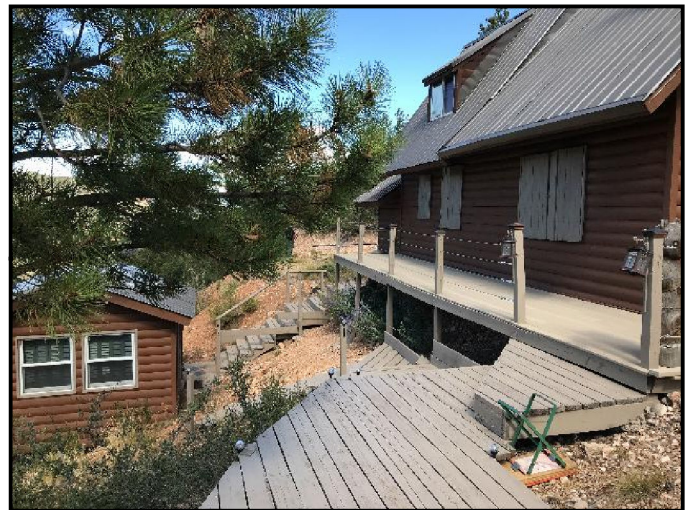
Hazards: Position on slope and fuel loading adjacent

Notes: Decks, portable propane, yard debris

Mitigation Description: Tree felling and brushing, some weed whacking around structure.

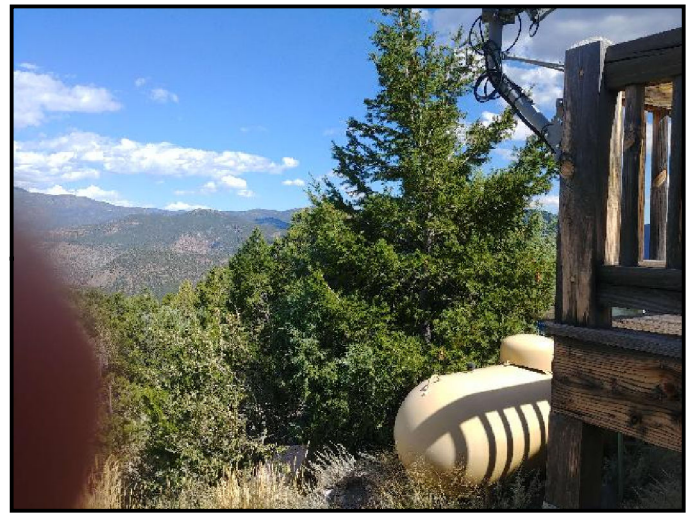
Structure ID: 298

Hazards: Long one way access road on top of a ridge steep slopes 3 sides

Notes: Lots of fuel at or near structure with overhanging deck and steep slopes

Mitigation Description: Lots of saw and weed eater work

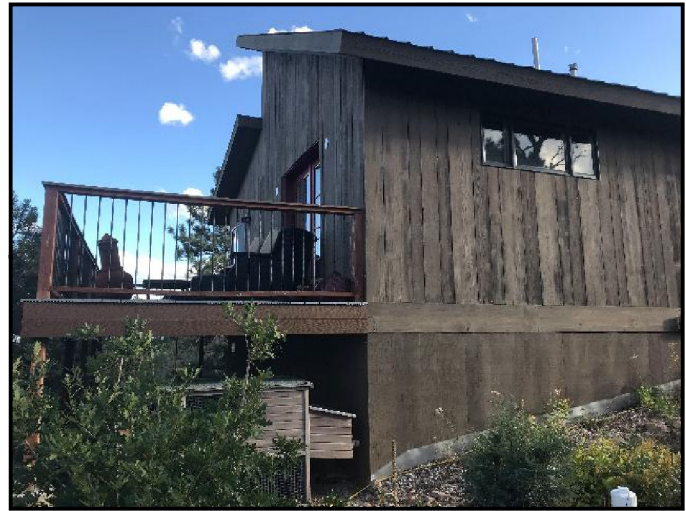
Hazards: Fuels, slope

Notes: Wooden decks front and back, wood pile, fuels close to structure

Mitigation Description: Saw work, weed whacking

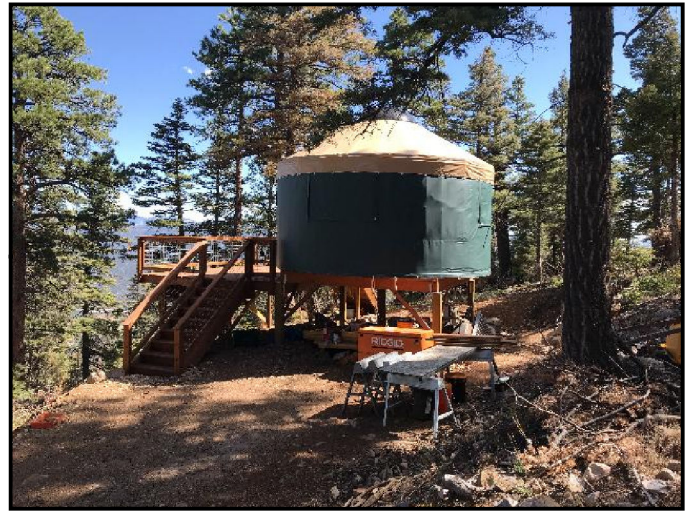
Hazards: Fuel loading surrounding structure.

Notes: Yurt construction, plastic materials on sides and roof. Materials under structure. Deck.

Mitigation Description: Tree felling and removal brush removal

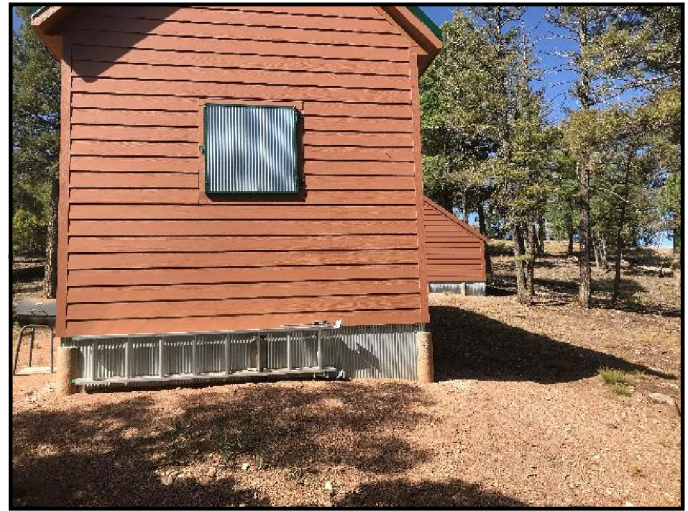
Hazards: Surrounding slope

Notes: Well constructed w/ fire resistant materials

Mitigation Description: Some tree work/removal

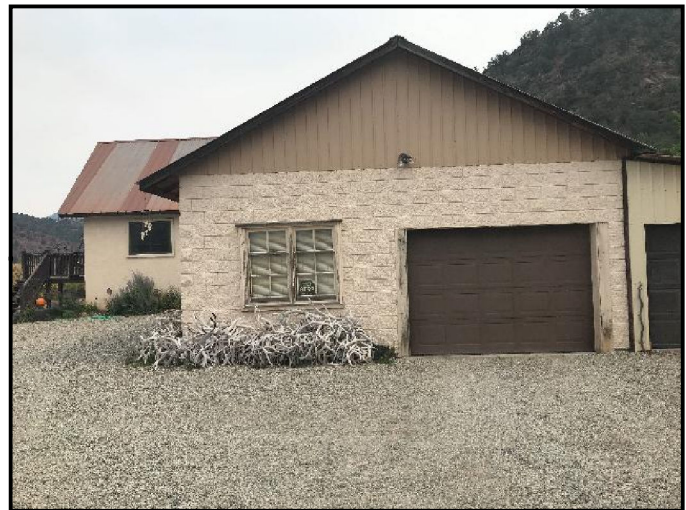
Structure ID: 306

Hazards: Fuels, slope behind structures

Notes: Wooden deck, large gravel driveway, wood piles

Mitigation Description: Weed whacking

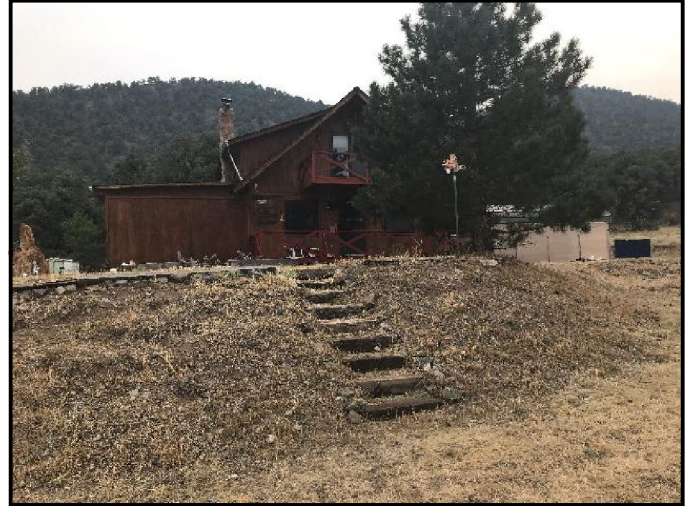
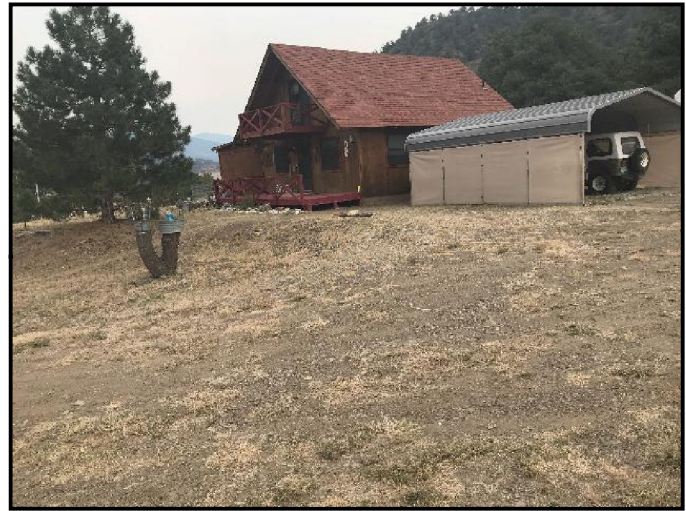
Structure ID: 307

Notes: Wooden decks, large wood pile, some debris, vehicles

Mitigation Time (in hours): 6
Mitigation Description: Tree thinning and brushing, weed whacking

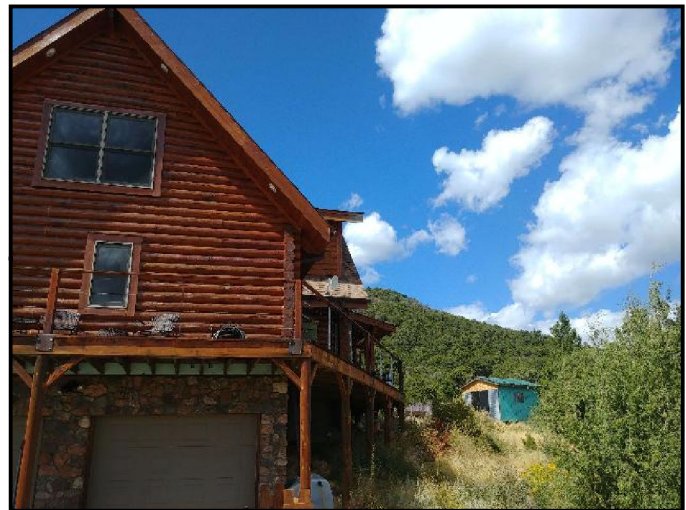
Hazards: Long one way access road on top of a ridge steep slopes 3 sides

Notes: Lots of fuel at or near structure with overhanging deck and steep slopes

Mitigation Description: Lots of saw and weed eater work

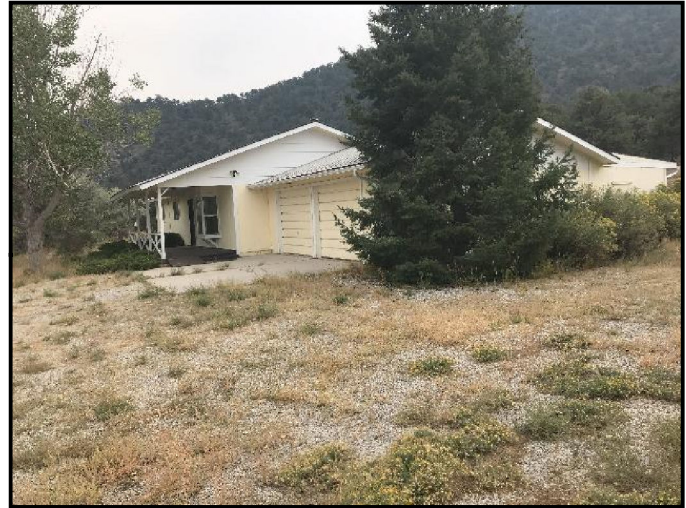
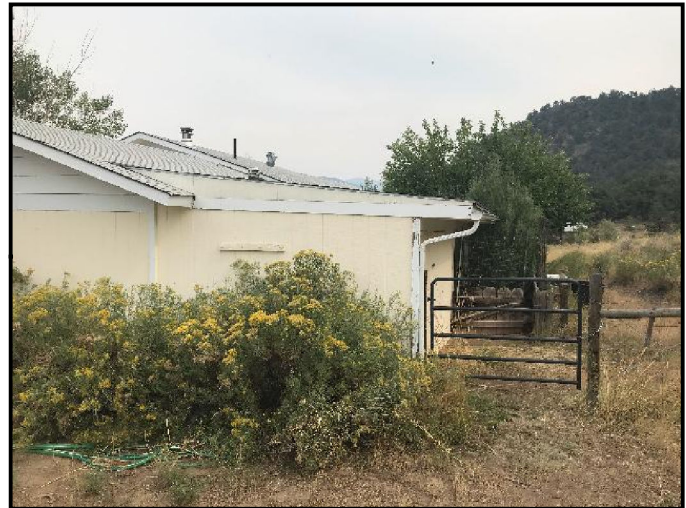
Notes: Grass fuel model in front of house, shrub model behind house, fuels up to house perimeter

Mitigation Time (in hours): 5
Mitigation Description: Tree thinning and brushing, weed whacking

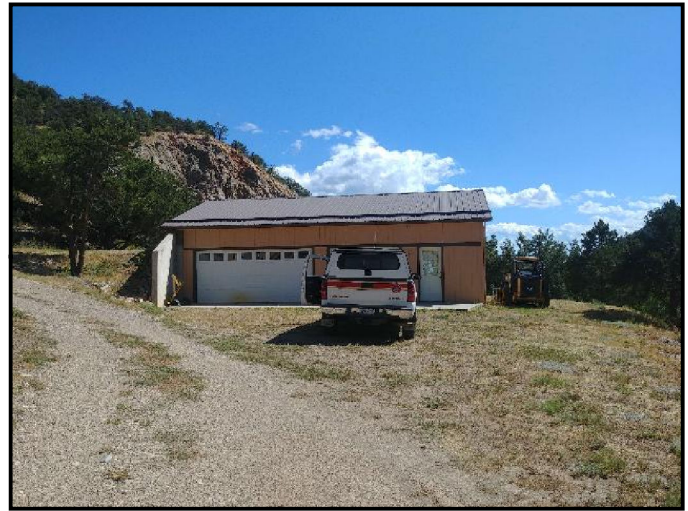
Structure ID: 312

Hazards: Long one way access road

Notes: Single family home with 3 garages
good clearances

Mitigation Description: Very little

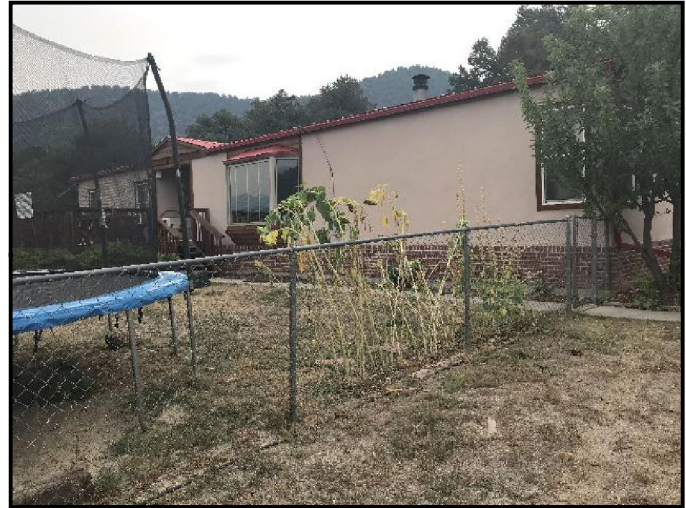
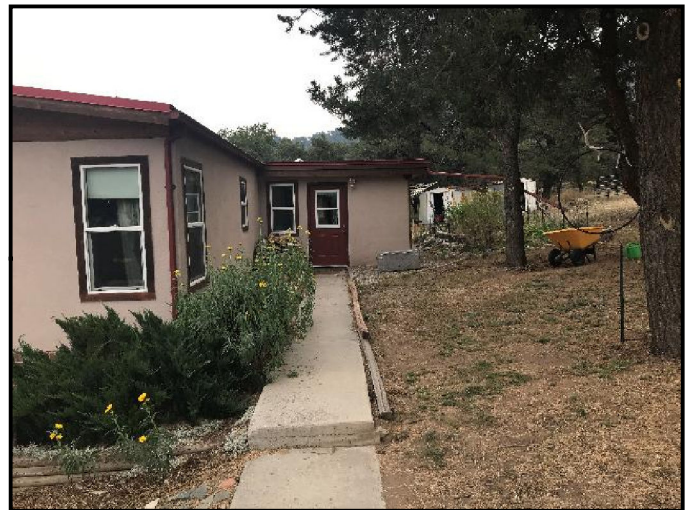
Notes: Wooden decks, gravel driveway, wood piles near structure

Mitigation Time (in hours): 4
Mitigation Description: Tree thinning and brushing, weed whacking

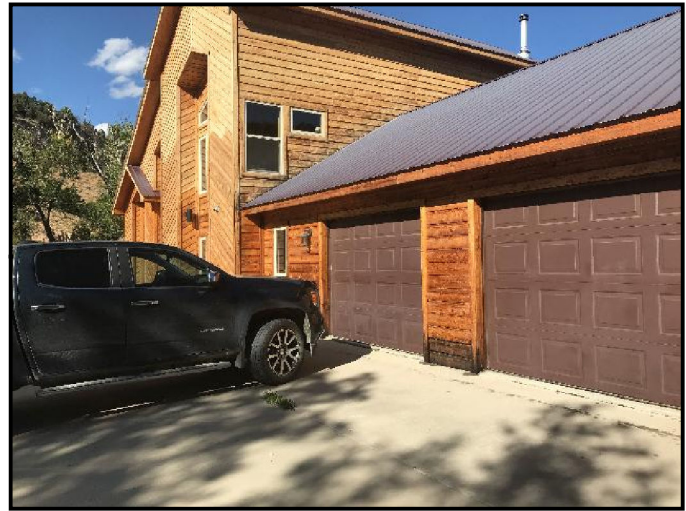
Hazards: Brush around structure, yard debris

Notes: All wood structure w/ treated stain.
Wood deck.

Mitigation Description: Brushing

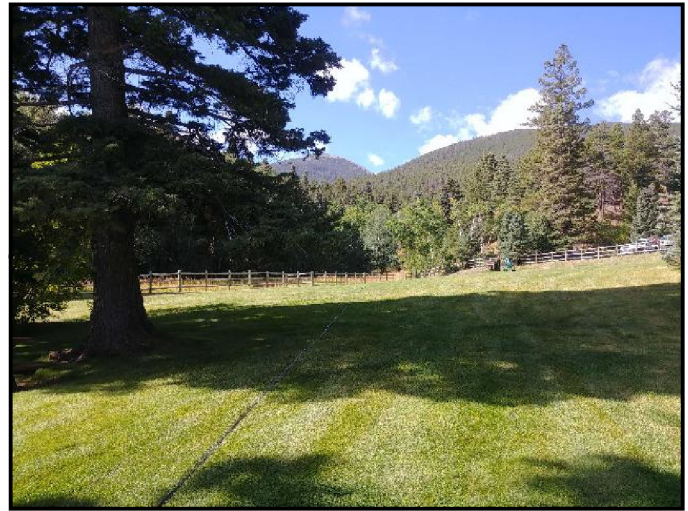
Structure ID: 320

Hazards: Long one way access road

Notes: Historic livable log cabin surrounded by green lawn

Mitigation Description: Very little
