Poncha Pass Structure Assessment

Structure ID: 255

Collected Date/Time: 9/24/2019 10:15:00 PM
Collected By: Chris Masson
Inspector's Position: Divs

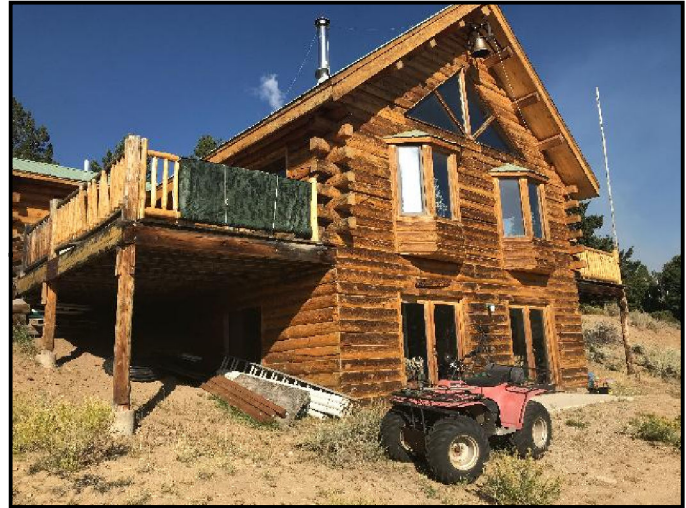
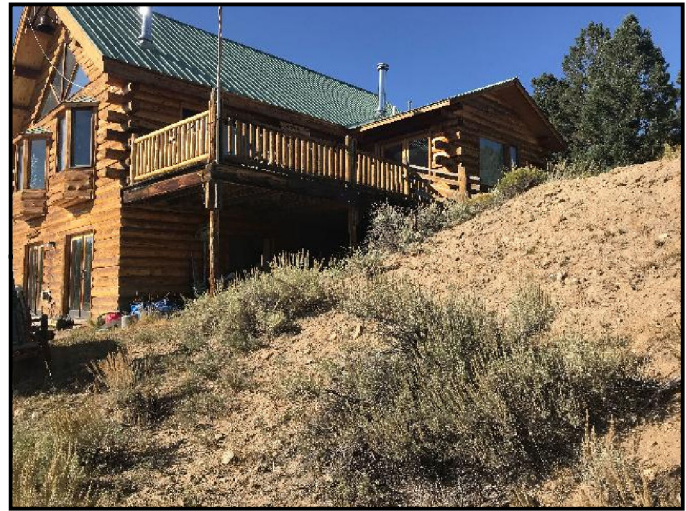
Hazards: Fuels, slope

Notes: Wood deck, small pond below structure, some debris around structure

Mitigation Description: Weed whacking and saw work

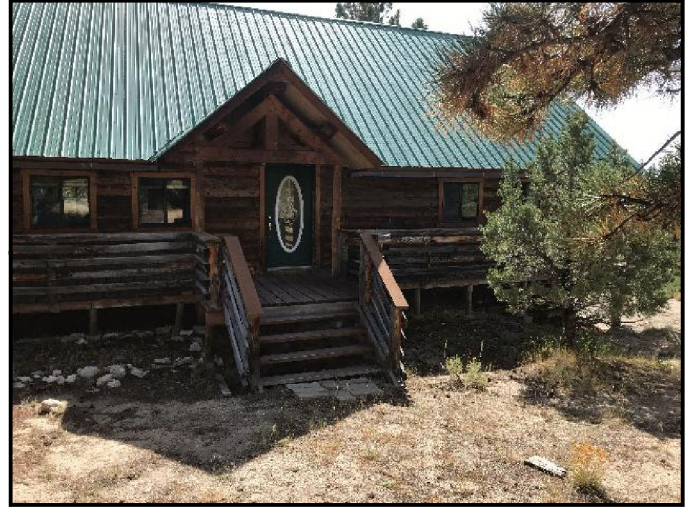
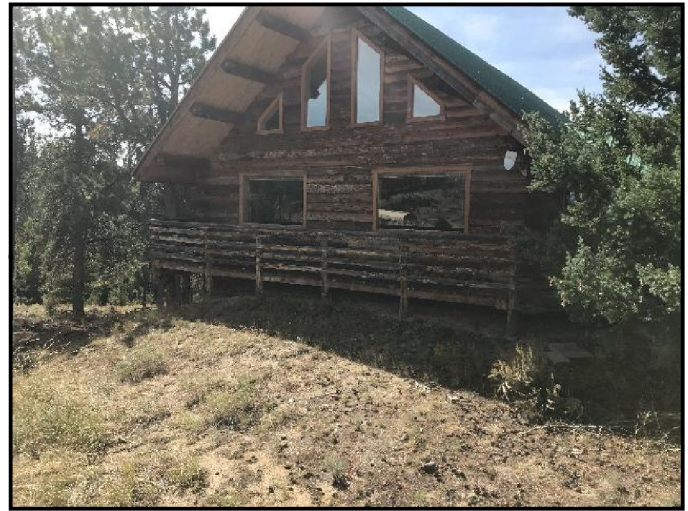
Structure ID: 257

Hazards: Fuels, slope, long stretch of road from highway 285

Notes: Cabin construction, wood deck, wood stairs, out buildings are constructed from wood, debris

Mitigation Description: Saw work and weed whacking

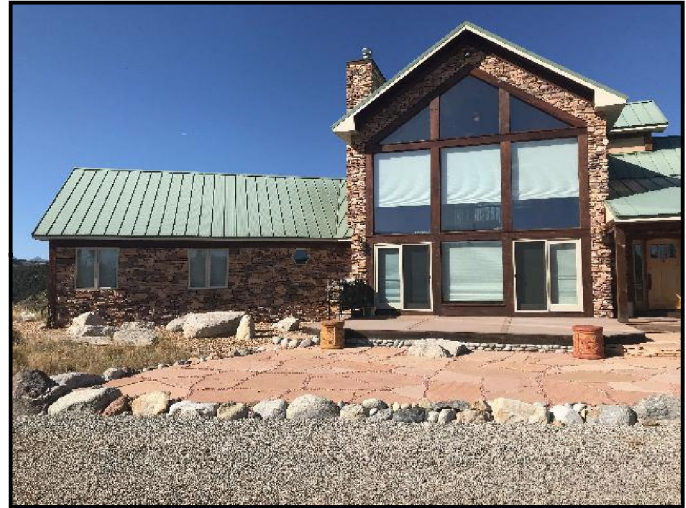
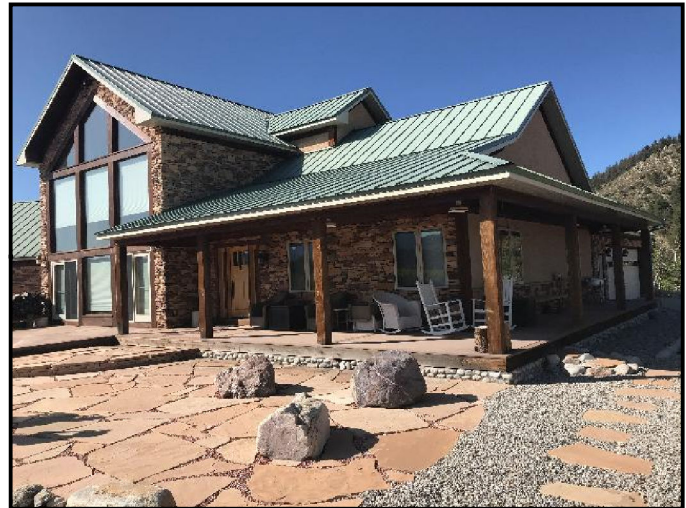
Structure ID: 258

Hazards: Fuel, abundance of grass/sage around structure, slope

Notes: Gravel and rock path around structure, fuels below structure, wood pile on deck

Mitigation Description: Weed whacking and thinning

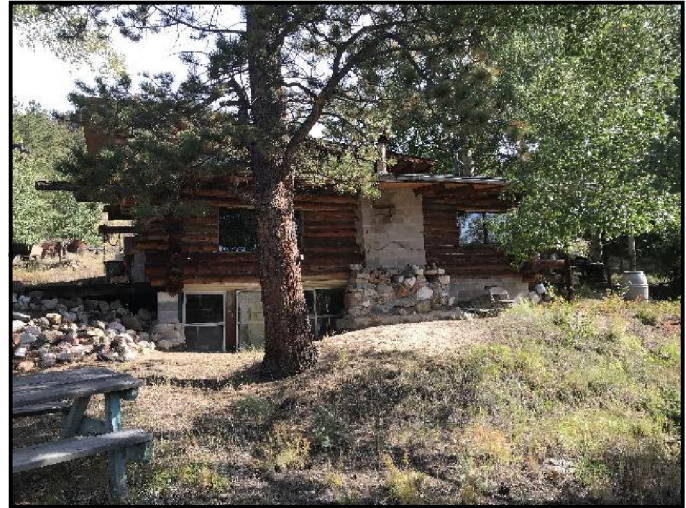
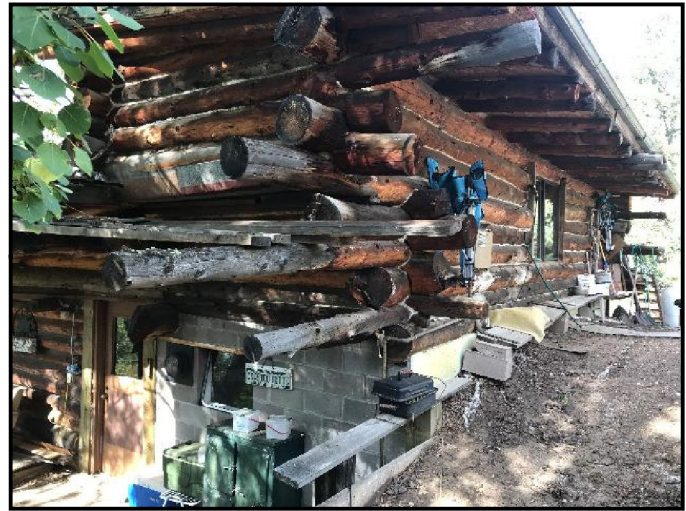
Structure ID: 259

Hazards: Fuels, slope, access, debris

Notes: Structure tucked into the trees, some clearance behind, mid-slope

Mitigation Description: Saw work and weed whacking

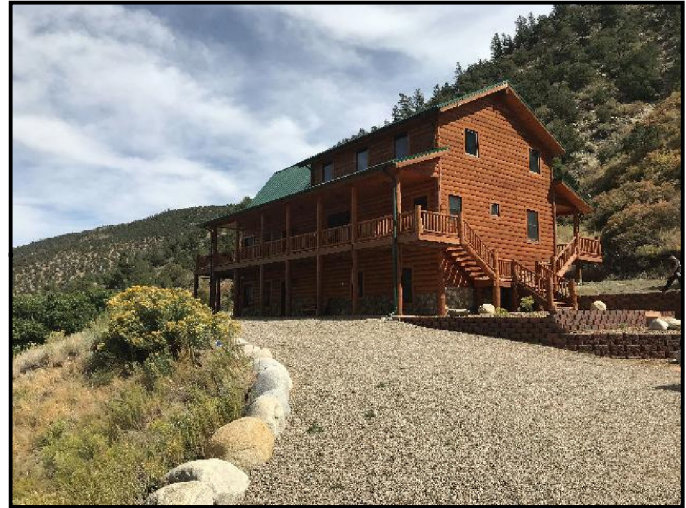
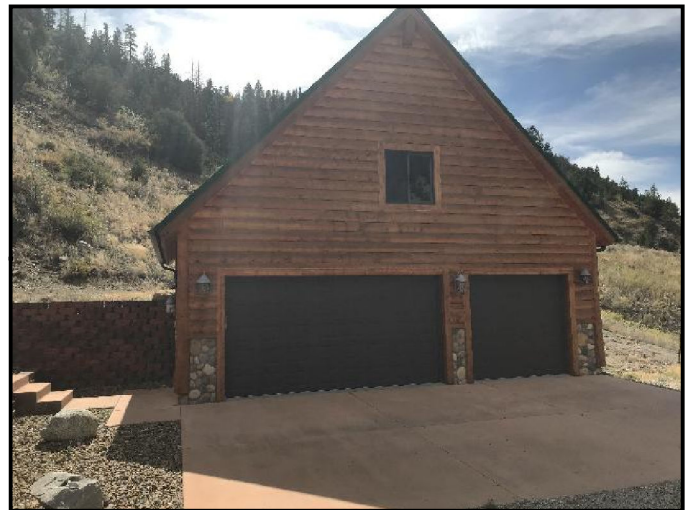
Structure ID: 260

Hazards: Fuels above structure, mid-slope

Notes: Multiple level wood decking, some gravel terracing, retaining walls, clean around structure

Mitigation Description: Thinning and brushing, weed whacking

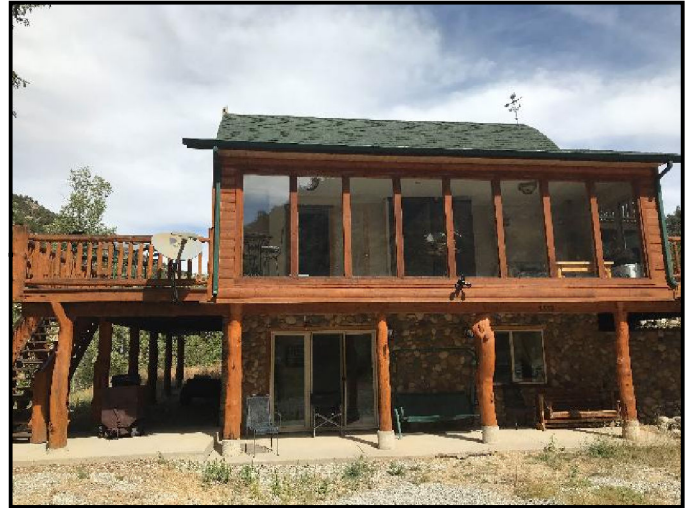
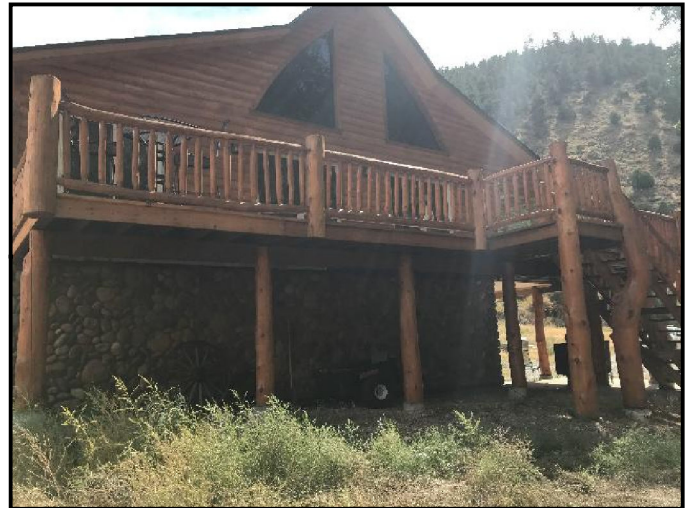
Structure ID: 261

Hazards: Fuels above structure

Notes: Wood deck, weeds up to some portions of structure, River directly below structure

Mitigation Description: Weed whacking

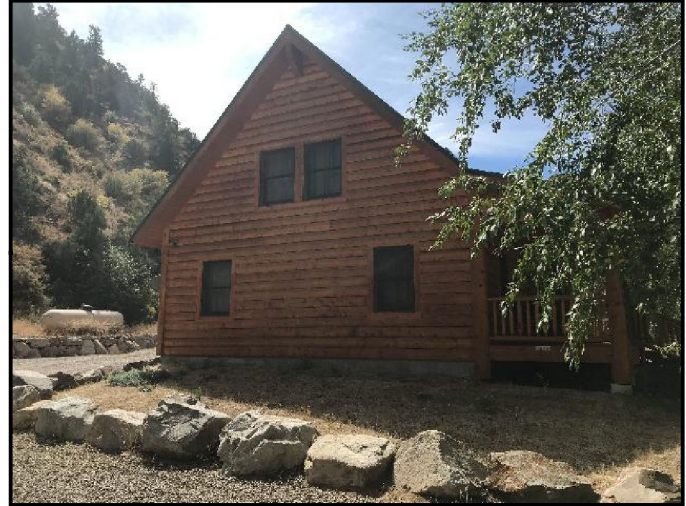
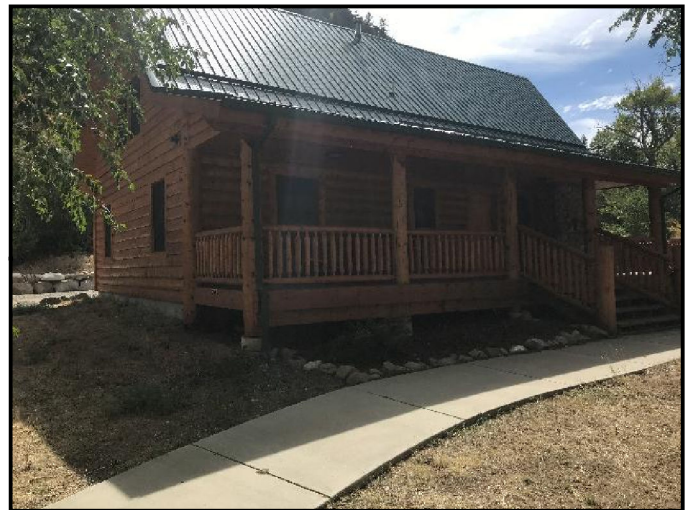
Structure ID: 262

Hazards: Slope, fuels behind structure

Notes: Well maintained, gravel/ cement path around portions of structure, wood deck, River below structure

Mitigation Description: Weed whacking

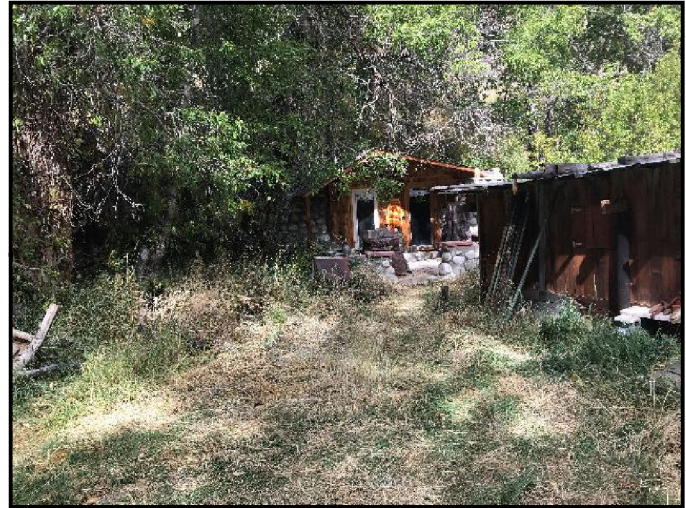
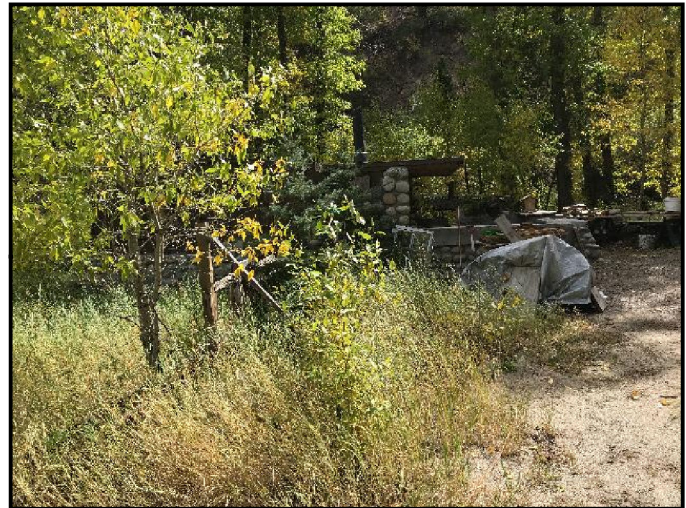
Structure ID: 263

Hazards: Large amounts of debris, busy highway access, heavy grass fuel loading

Notes: Multiple structures, disrepair, close proximity

Mitigation Description: Weed whacking and saw work

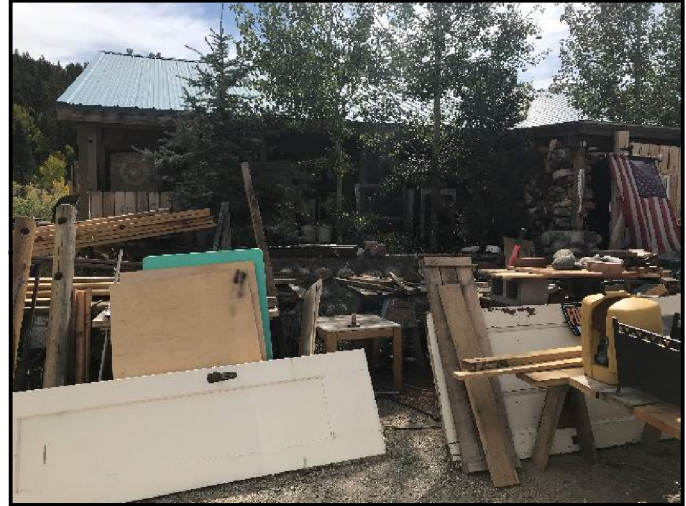
Structure ID: 264

Notes: Ramshackle structure, large amounts of debris surrounding

Mitigation Time (in hours): 4
Mitigation Description: Weed whacking

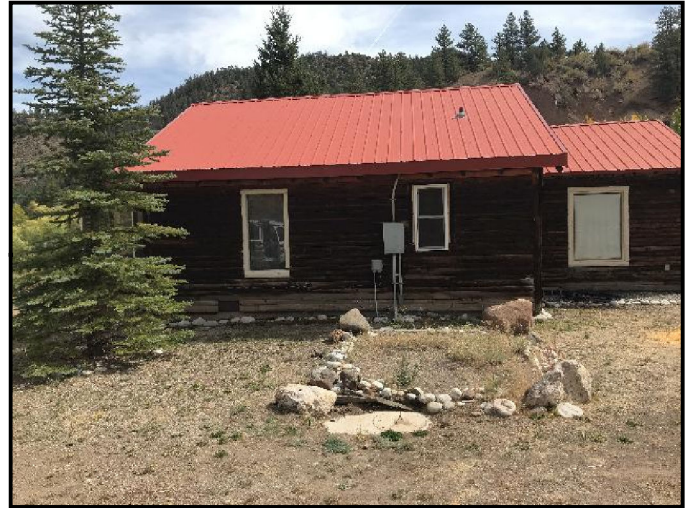
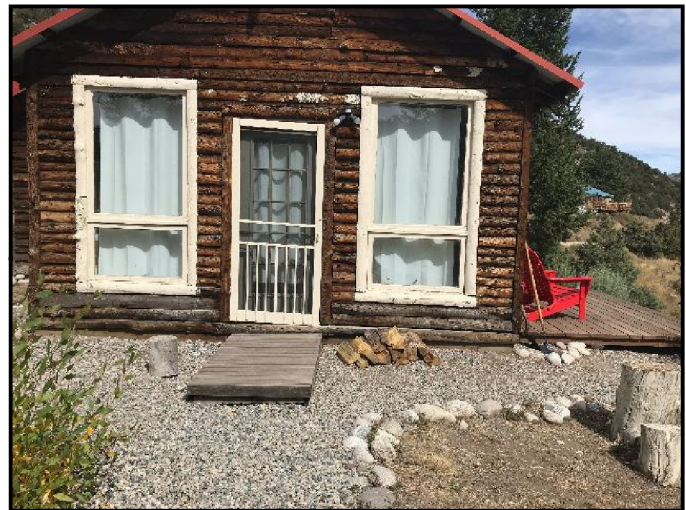
Structure ID: 265

Hazards: Busy highway access, slope, fuels, heavy grass and sage

Notes: Log cabin, small wood deck, River directly below structure

Mitigation Description: Weed whacking, some saw work

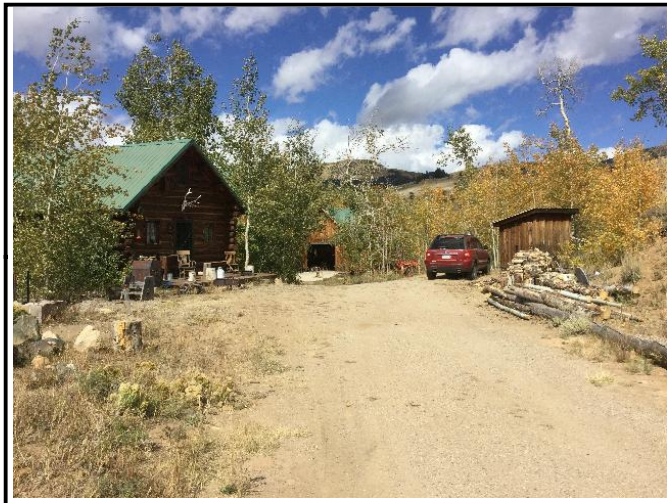
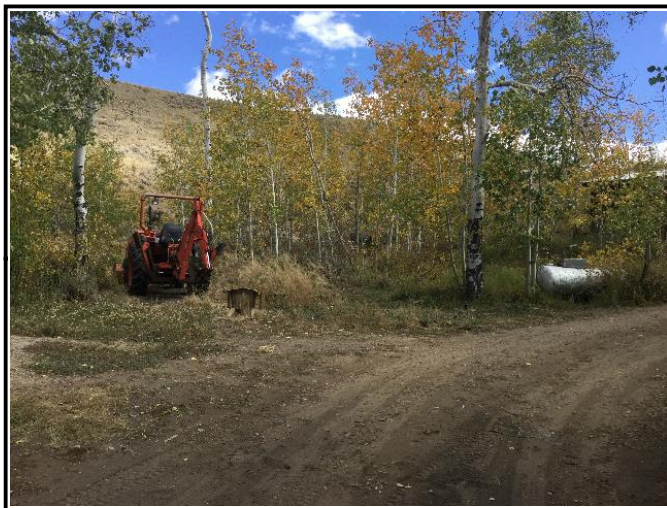
Structure ID: 268

Hazards: Propane tanks. Tractor. Wood piles. Fuel containers.

Barrel with trash. Camper trailer.

Mitigation Description: Brush out. Move wood pile. Move propane tanks.

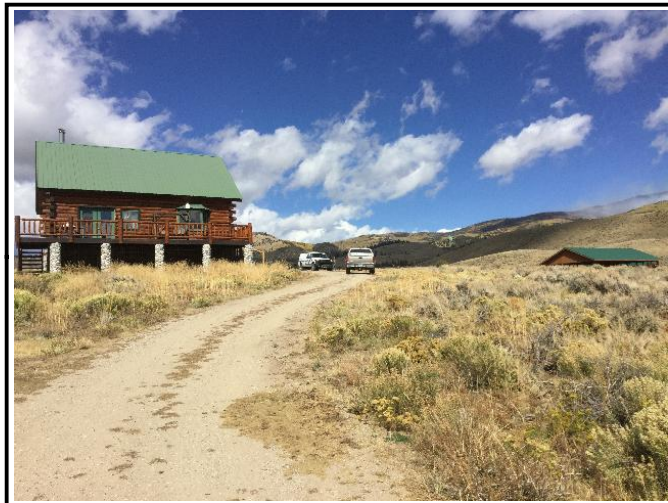
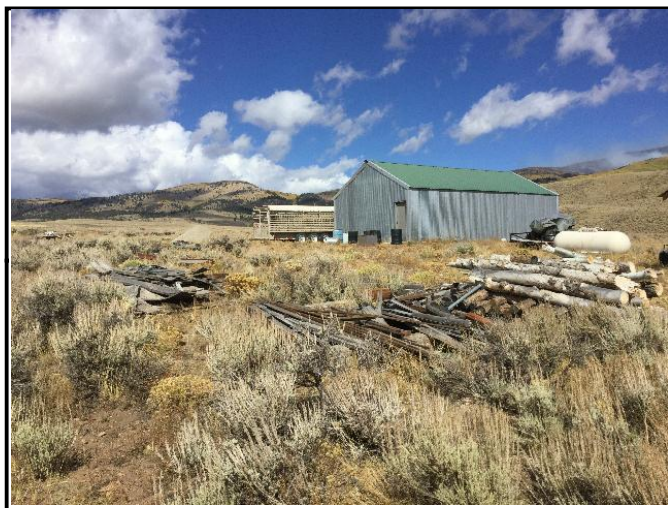
Structure ID: 269

Hazards: Propane tank. Livestock. Fuel inside garage. Wood piles. Drums with unknown content. Open pit of construction debris.

Brush out near out buildings.

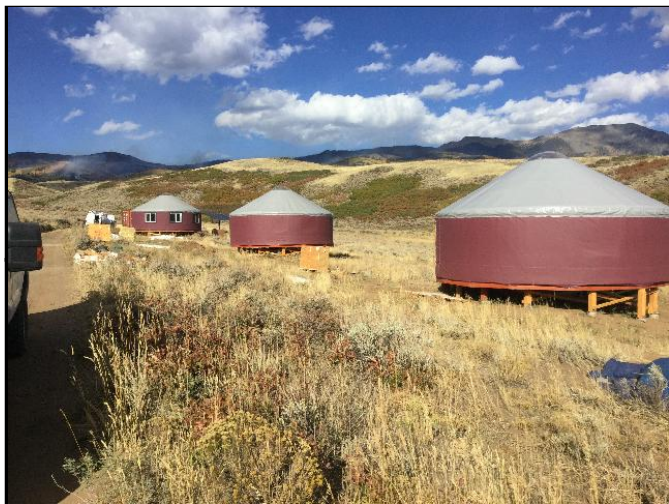
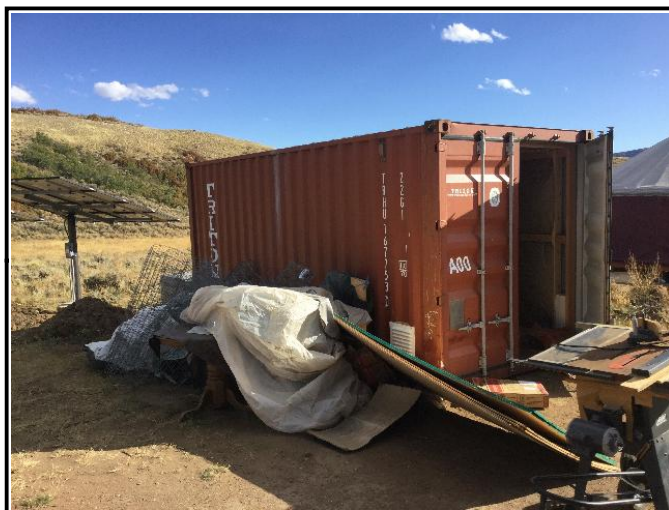
Structure ID: 270

Hazards: Construction debris. Fuel containers.

Notes: 3 yurts. Constructed of plastic Type materials. May burn well. One hurt under construction

Mitigation Description: Brush out. Move construction debris.

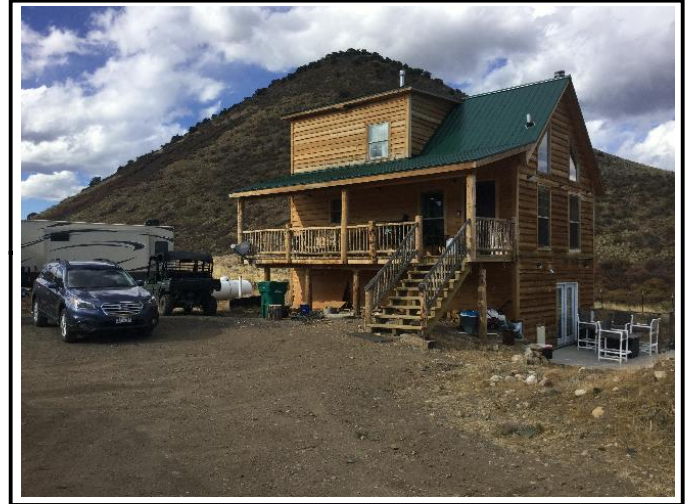
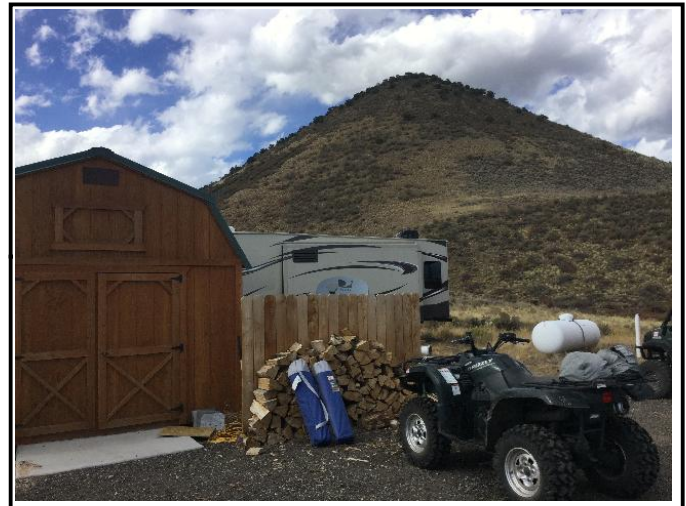
Structure ID: 271

Hazards: Propane tanks. Open trench in back. Wood piles. Powerlines.

Mitigation Description: Move combustibles away from structures. Brush out.

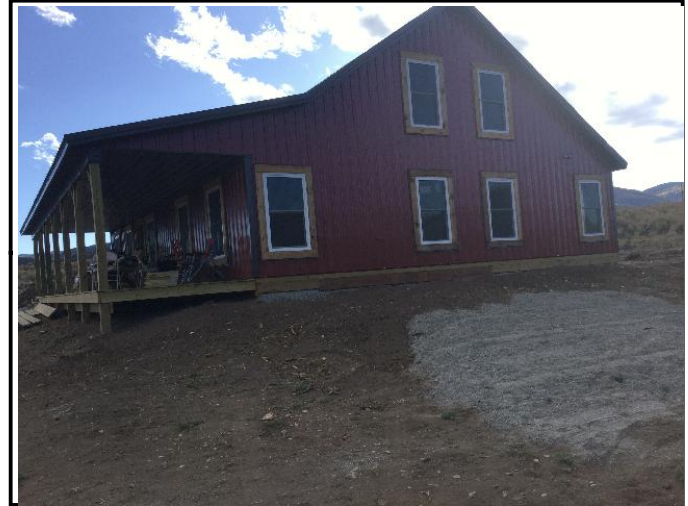
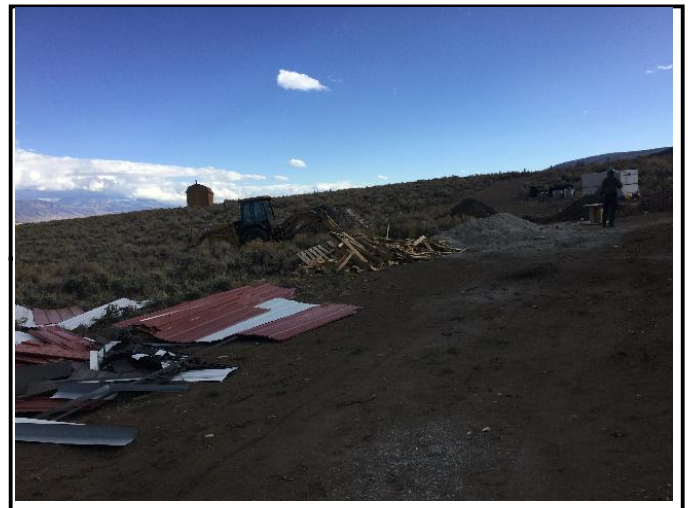
Structure ID: 272

Hazards: Under construction. Construction debris. Open trench.

Notes: New construction. Open trenches. One wood outbuilding.

Mitigation Description: Move construction debris.

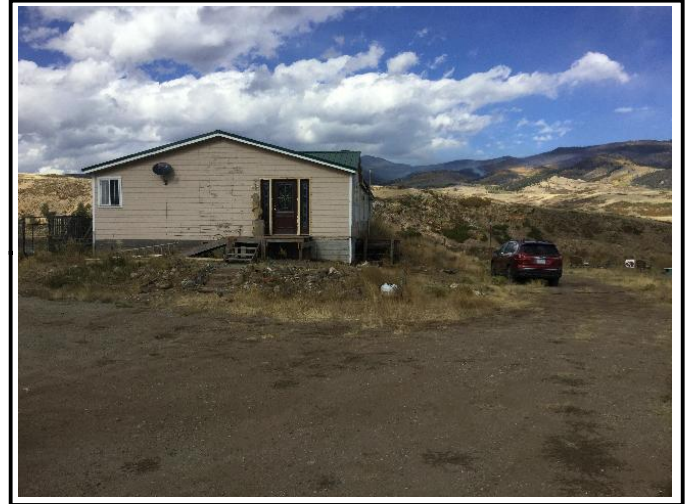
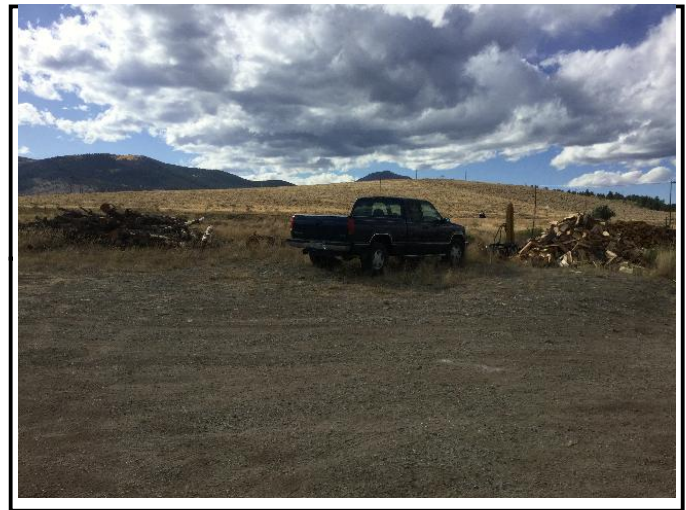
Structure ID: 273

Hazards: Propane tanks. Hazmat in back. Trash piles.

Notes: House is surrounded by driveway. Fuels are grass.

Mitigation Description: Move combustible materials away from house.

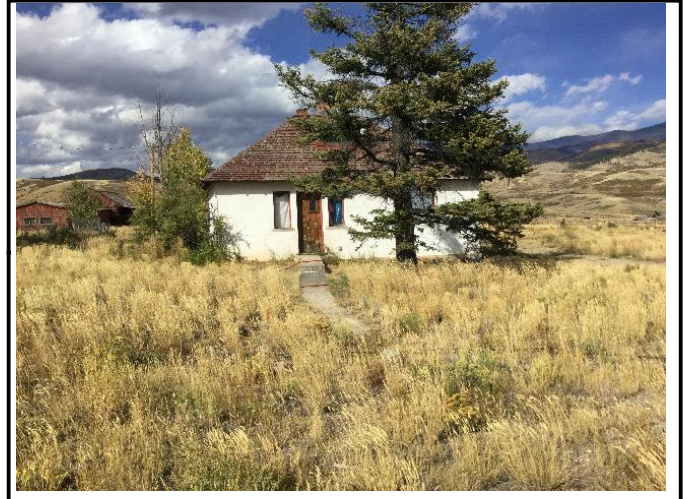
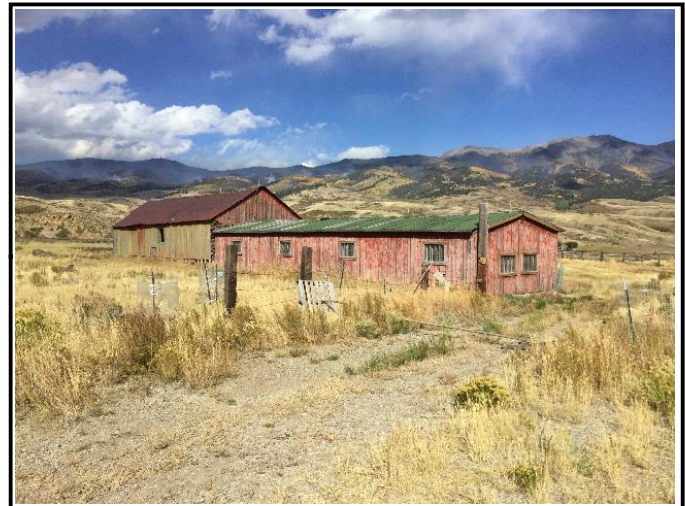
Structure ID: 274

Hazards: Buildings look old and possibly abandon. Power lines. Unknown building contents and use.

Notes: Buildings look abandon or unused.

Mitigation Description: Move materials away from house. Brush out.

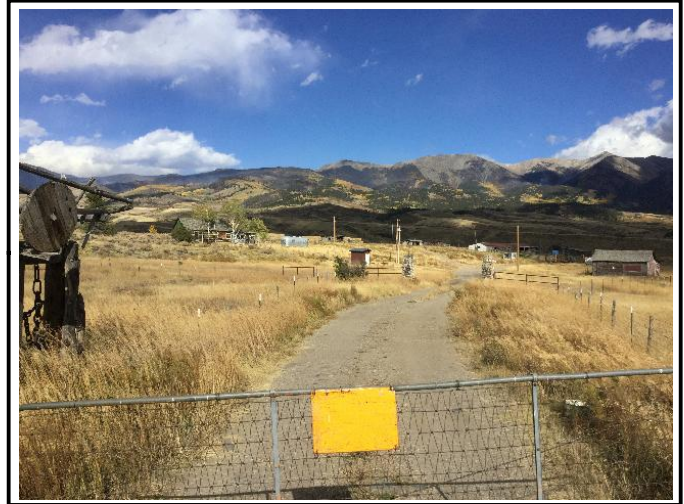
Notes: Unknown status. Gate locked. Looks unoccupied. Most buildings look old and unused at this point.
