West Creek Structure Assessment

Structure ID: 401

Location: 9100 highway 50, 401

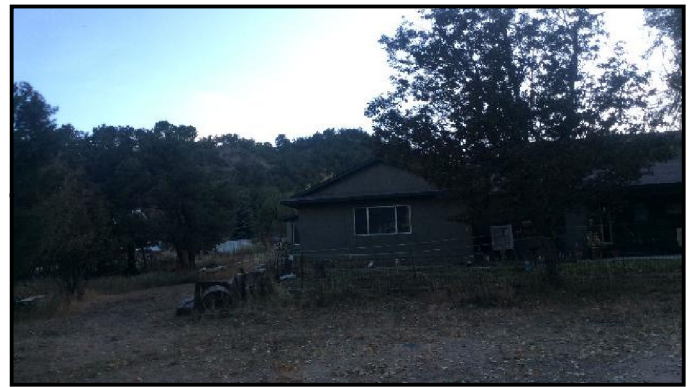
Structure ID: 403

Hazards: Fire wood and attached out buildings

Mitigation Description: Debris removal, some limbing.

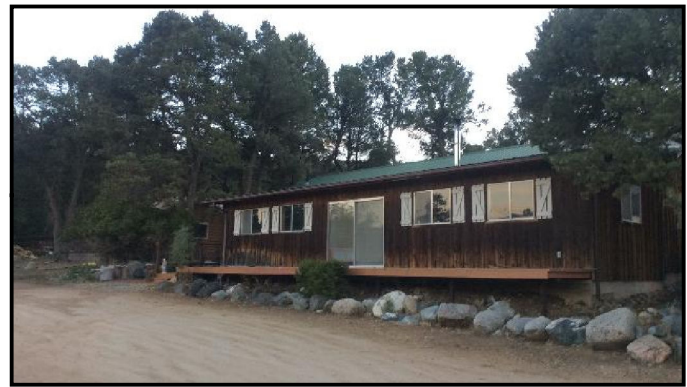
Structure ID: 407

Notes: Well maintained property

Mitigation Description: Debris removal, some limbing, and small tree removal.

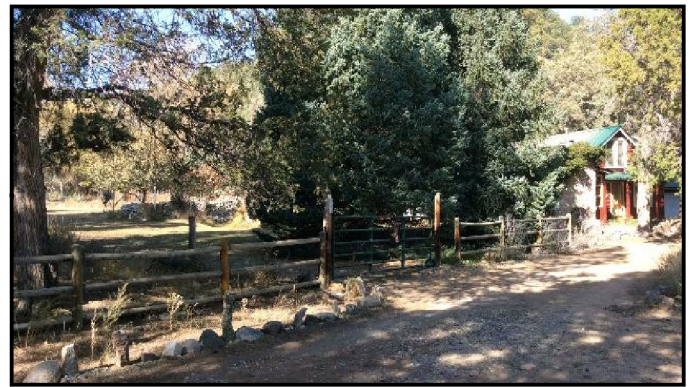
Structure ID: 415

Hazards: Juniper, scrub oak

Mitigation Description: Light work, brushing

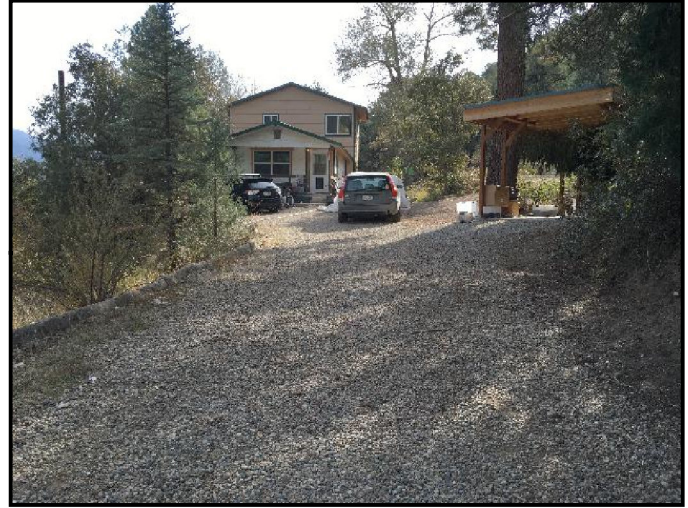
Structure ID: 416

Hazards: Marijuana production, trash on downhill side of the house.

Mitigation Description: Pump sprinklers with creek as water source, slash removal

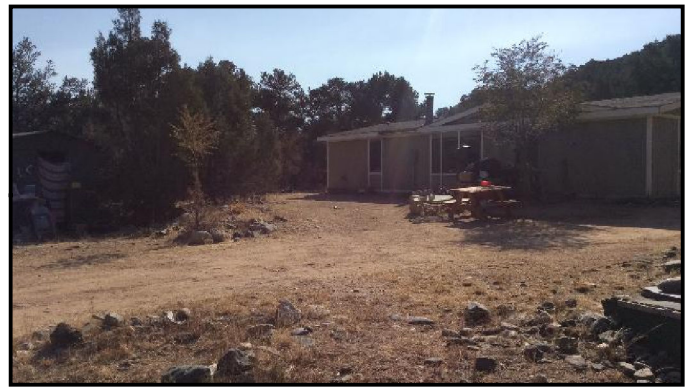
Structure ID: 419

Hazards: Propane tank, wood piles

Notes: Manufactured home, propane close to structure

Mitigation Description: Light saw work, brush removal

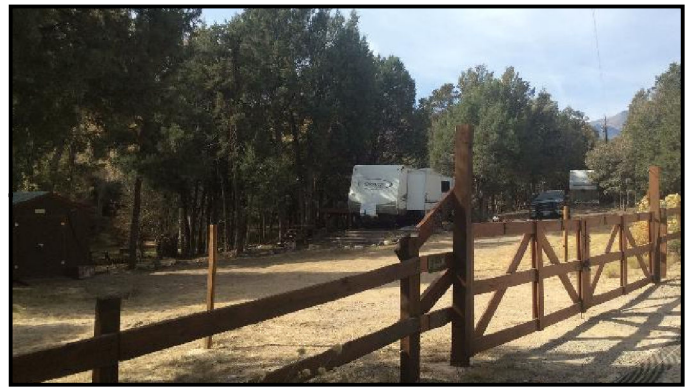
Structure ID: 420

Hazards: Over head powerlines.

Notes: 2 Rv's with attached decks.

Mitigation Description: Limbing, weed wacking, debris removal

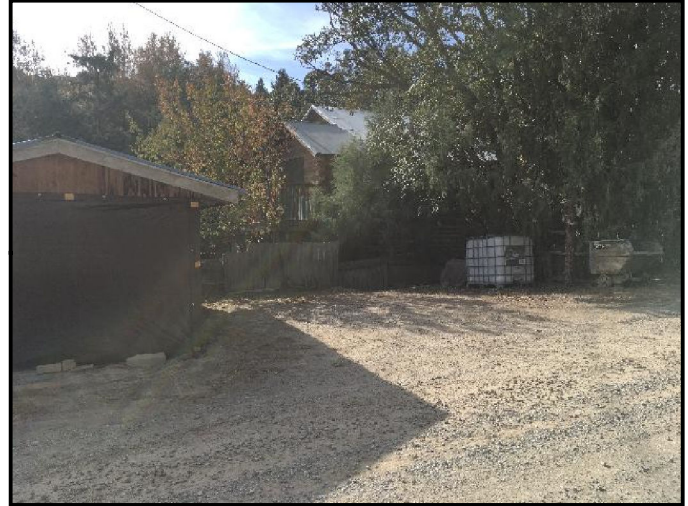
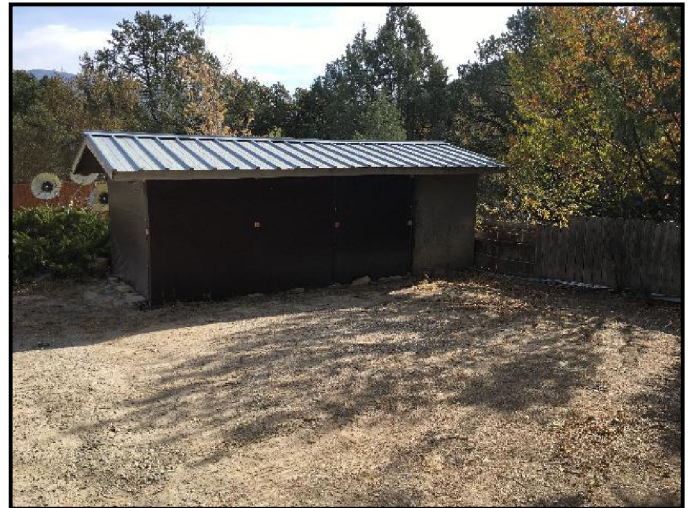
Structure ID: 426

Hazards: Propane tank near house

Notes: Slash piles in heard. Fuels near house. Wooden decking not maintained

Mitigation Description: Pump sprinklers with creek as water source

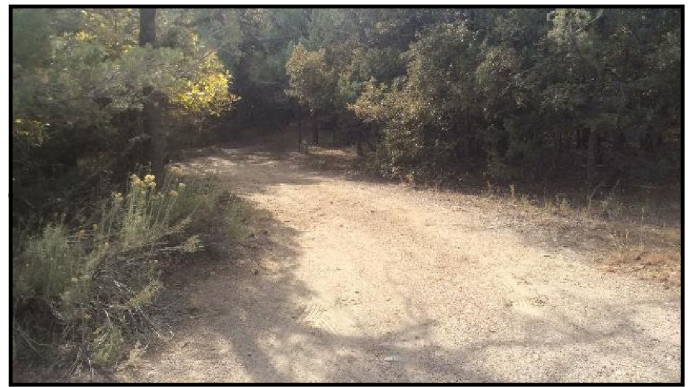
Structure ID: 434

Hazards: Heavy fuels, minimal to no mitigation has been done.

Notes: Older construction, wood siding touching in the ground, light flashes fuel touching on all sides.

Mitigation Description: Cutting, limbing, ground litter removal, sprinkler setup.

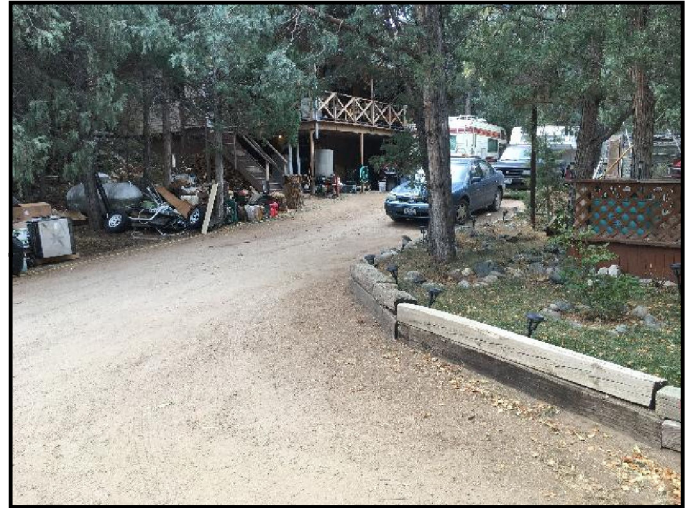
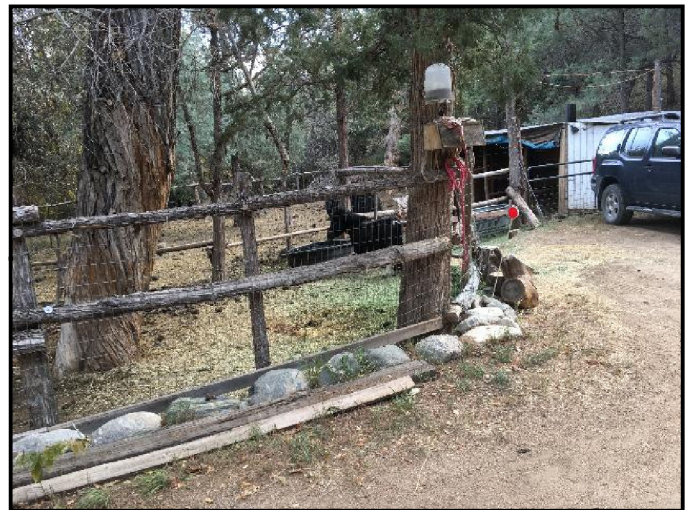
Hazards: Lots of material near the house. No defensible space on uphill side. Large stack of firewood under stairs.

Notes: Propane near house with lots of burnable material near it. Horses on site.

Mitigation Description: Weed-eater around house and garage. Pump sprinklers with creek as water source

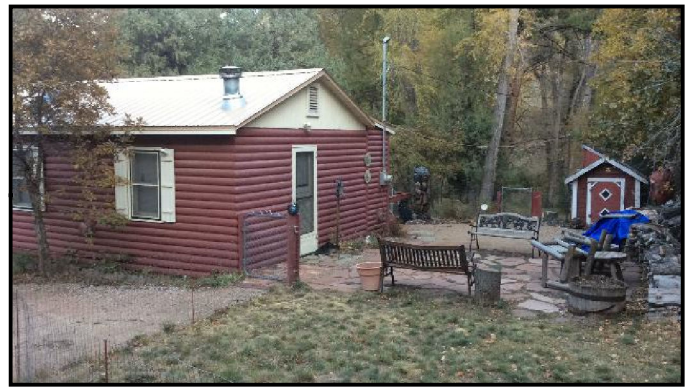
Structure ID: 450

Hazards: Fuel loading close to structure , propane next to structure, wood pile under oak trees, overhead power behind structure.

Notes: Propane next to structure, creek close to structure, scrub oak next to siding

Mitigation Description: Scrub oak next to structure requires light to moderate saw work.

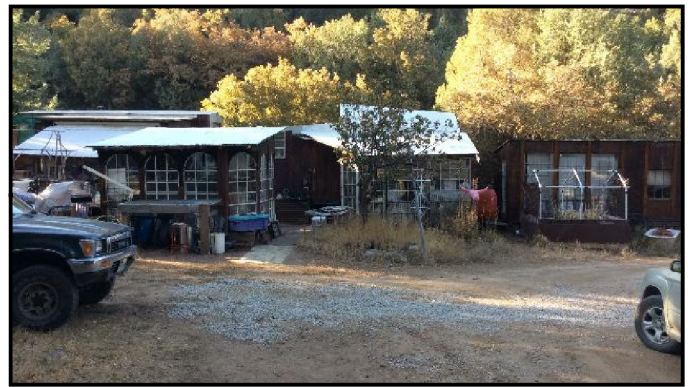
Structure ID: 454

Hazards: Lots of structures around property. Fuel loading of timber close to house.

Mitigation Description: Very dense oak/shrubs/conifer surrounding main structure and out builds. Heavy saw work.

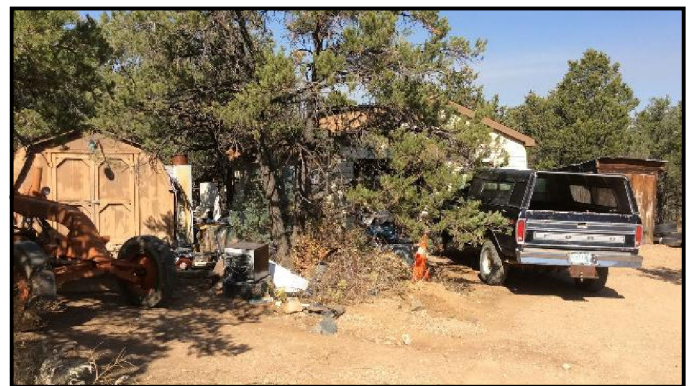
Structure ID: 463

Hazards: Poor accessibility, multiple/many vehicles on site, very tight pinion and juniper up to main structure and throughout property

Notes: Many vehicles on site and fuel cans, poor access. Very tight continuous fuel loading of pinion juniper up to main structure.

Mitigation Description: High amount of saw work, removal of wood pile and combustible materials

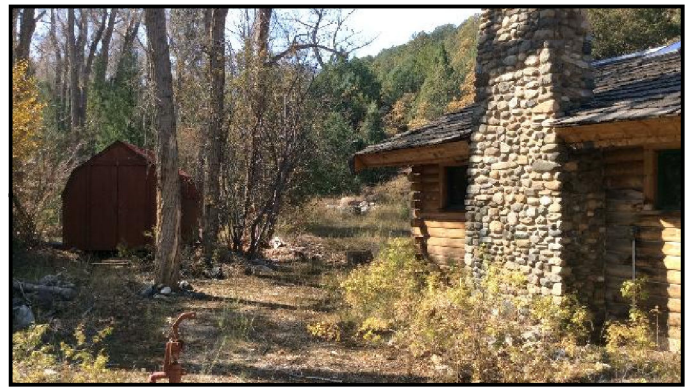
Hazards: Over head power, house built in chimney, scrub oak and juniper not mitigated with in 10 feet of primary structure

Notes: Propane next to structure, stream next to structure.

Mitigation Description: Moderate saw work, weed wack, removal of wood pile by back door

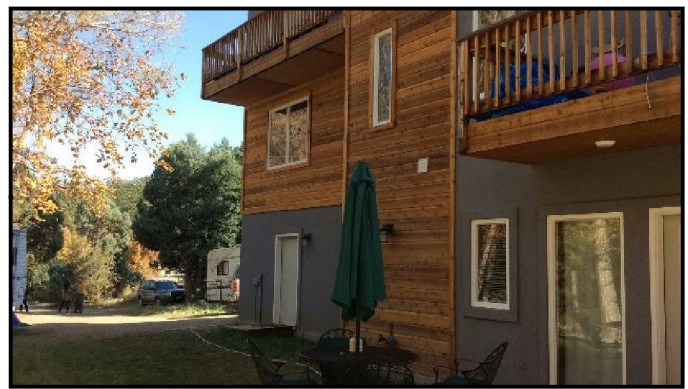
Hazards: Bridge on entrance of drive

Notes: Two RVs on site, dense oak and fir within 40'

Mitigation Description: Moderate saw work, weed wacking
