NPS Wildand Fire Risk Assessment - Facility Assessment

Facility: B-1042-N Pit Privy, at North Fork Patrol Cabin

Unit - Location: ROMO - Backcountry Patrol Cabin
FMSS ID: 37214
Structure Type: Building
Structure Use: Public
Owner: NPS
Field Crew: Vaughn
Last Site Visit Date: 9/26/2014

Facility: B-0017-H Patrol Cabin, North Fork

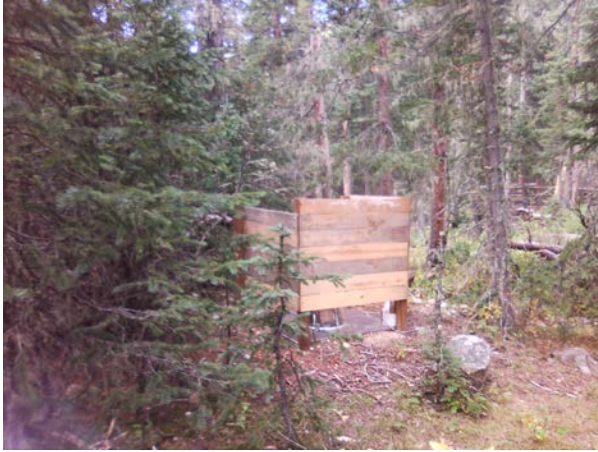
ROMO_37214_B-1042-N Pit Privy, at North Fork Patrol Cabin_Front2.jpg

Score: 113
Rating: High

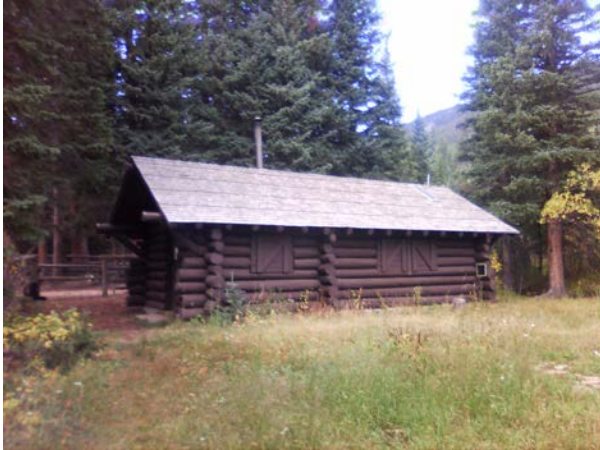
ROMO_37058_B-0017-H Patrol Cabin, North Fork_Front.jpg

Score: 103
Rating: High

Zone	Treatment Description	Pers Hours	Treatment Cycle	Treatment Priority	Treatment Status	Date Next Treatment Recommended	Equipment Description	Equip Qty
1	Mow dead/dying grass to less than 4 inches -	1	1 Year		Unknown	9/26/2014	Miscellaneous-Weed Wacker	1
	Flammable ground cover such as leaf litter, woody debris or highly flammable vegetation should be removed -	1	1 Year		Unknown	9/26/2014	-	
	Open crown spacing 10 to 30 feet depending on slope -	20	5 Year		Unknown	9/26/2014	Miscellaneous-	1
2	Open crown spacing 10 to 30 feet depending on slope -	40	5 Year		Unknown	9/26/2014	-	
	Firewood should be moved at least 50 ft from the facility and 15 horizontal feet from tree canopies -	1	5 Year		Unknown	9/26/2014	-	
	Flammable ground cover should be removed or isolated -	10	1 Year		Unknown	9/26/2014	-	
	Remove dead or dying component of shrubs and trees -	20	5 Year		Unknown	9/26/2014	-	
	Limb trees 6 to 15 feet above ground -	6	5 Year		Unknown	9/26/2014	-

Triage Category	Tactic Description	Pers Hours	Equipment Description	Equip Qty	
	Install sprinkler system - Equipment list sufficient for all structures in area.	4.00	Fuel-2 Cycle Mix, 32:1, GL	10	
			Hose-Cotton-synthetic 1.5" x 100ft,LG	3	
			Pump Kit-Volume 3, KT	2	
			Hose-Garden 0.75" NH x 50ft,LG	12	
			Sprinkler Kit-Sprinkler (2008) kit	3	
			Fuel Can-5 GL, DOT/OSHA	2	
	Fuels reduction -	120.00	-		
	Structure wrap - wrap structure and leave		20.00	Misc Structure Protection-Stapler, heavy duty, BX	2
				Misc Structure Protection-Staples, heavy duty 0.5", BX	1
				Misc Structure Protection-Structure wrap, 54" x300ft, RL	10

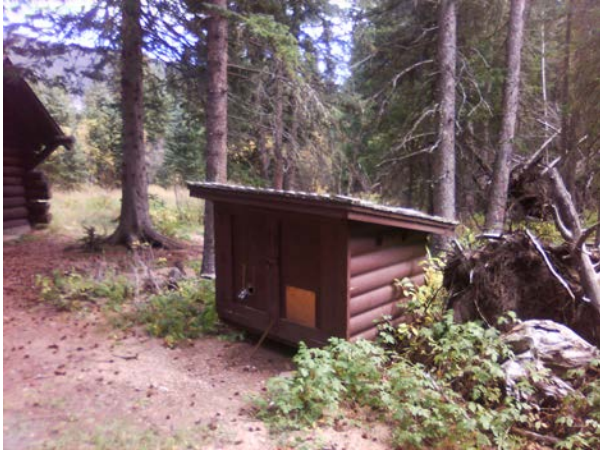
ROMO_37102_B-0223-N Wood Shed North Fork_Front2.jpg

Score: 113
Rating: High
