NPS Wildland Fire Risk Assessment - Community Assessment

Community: Beaver Meadows West Residential Area

Unit - Location: ROMO - Beaver Meadows

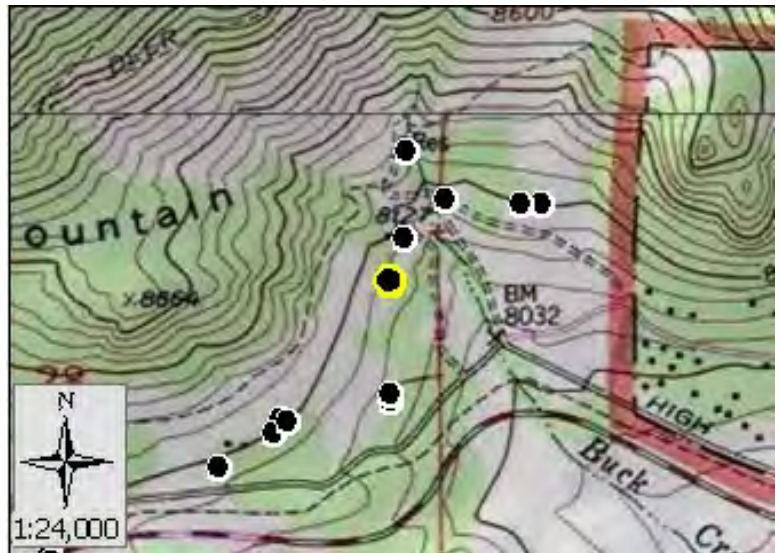
Primary Access: Road
Ingress/Egress: One roads in/out
Access Width: 1.5 lanes (>18ft)
Access Condition: Non-surfaced- gravel,dirt,grade>5%
Bridge Condition: None/nonflammable,load limit will not limit response
Access & Turnarounds: Access is <300 ft from facility w/o turnaround
Facility Number/Sign: None or not clearly visible
Defensible Space: >100ft treated
Fuel Load (w/in 300 ft): Light
Fuel Type (w/in 300ft): Shrub or timber
Topography (w/in 300ft): Slope 5% to 20%
Roof Material: Combination of fire resitant and combustible
Siding Material: Wood or open sided
Foundation: Open or deck
Fences/Decks: None or noncombustible
Firewood: None
Propane Tanks:
Water Supply: No reliable water source nearby
Overhead Hazards: No overhead hazards
Safety Zones: Potential safety zone(s) in area
Additional Obstacles: None
Triage Category:
Hazmat:
Assessment Comments: Seasonal housing

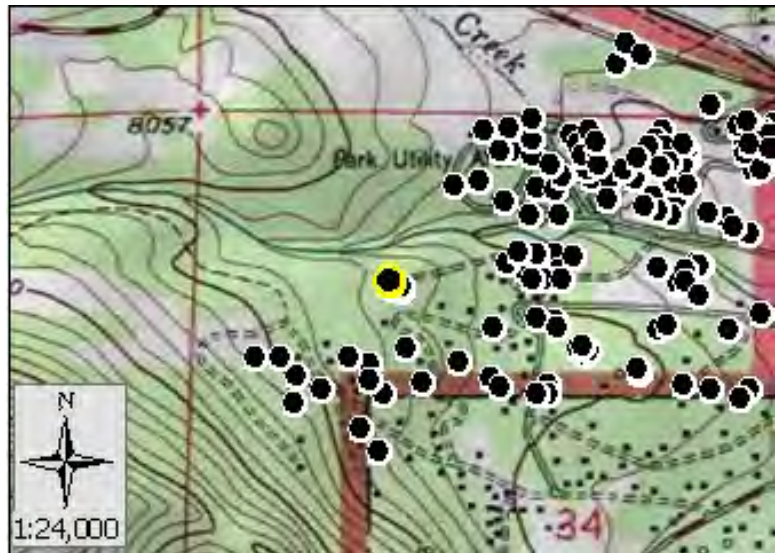
Primary Access: Road
Ingress/Egress: Two or more roads in/out
Access Width: 1.5 lanes (>18ft)
Access Condition: Surfaced-paved, grade<5%
Bridge Condition: None/nonflammable,load limit will not limit response
Access & Turnarounds: Access is <300 ft from facility w/turnaround
Facility Number/Sign: Marked and clearly visible
Defensible Space: >100ft treated
Fuel Load (w/in 300 ft): Moderate
Fuel Type (w/in 300ft): Shrub or timber
Topography (w/in 300ft): Slope 5% to 20%
Roof Material: Combination of fire resitant and combustible
Siding Material: Wood or open sided
Foundation: Open or deck
Fences/Decks: None or noncombustible
Firewood: Adjacent to/under deck of facility
Propane Tanks:
Water Supply: Pressurized hydrant(s) or fixed sprinkler system
Overhead Hazards: No overhead hazards
Safety Zones: Potential safety zone(s) in area
Additional Obstacles: Hazmat, UXO,etc. , PLEASE COMMENT
Triage Category:
Hazmat: This building is located inside the park bone yard with various unknown hazardous material materials stored here including flammable material

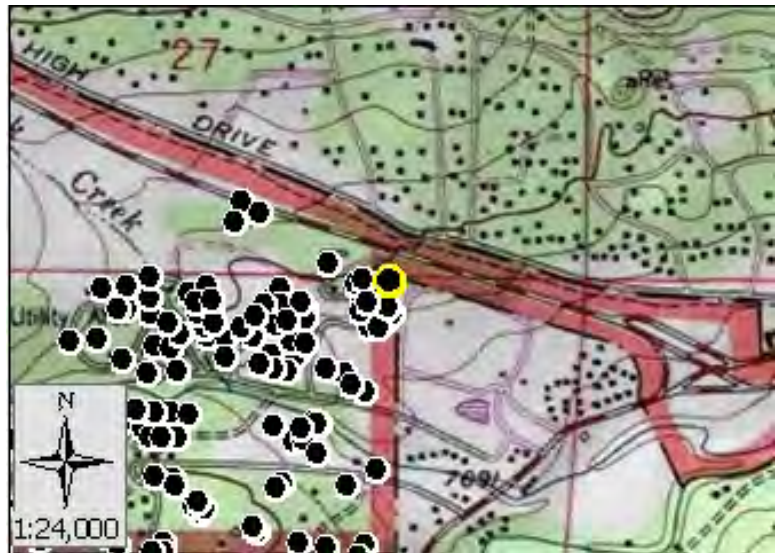
Primary Access: Road
Ingress/Egress: Two or more roads in/out
Access Width: 1.5 lanes (>18ft)
Access Condition: Surfaced-paved, grade<5%
Bridge Condition: None/nonflammable,load limit will not limit response
Access & Turnarounds: Access is <300 ft from facility w/turnaround
Facility Number/Sign: Marked and clearly visible
Defensible Space: >100ft treated
Fuel Load (w/in 300 ft): Light
Fuel Type (w/in 300ft): Shrub or timber
Topography (w/in 300ft): Slope <5%
Roof Material: Combination of fire resitant and combustible
Siding Material: Wood or open sided
Foundation: Closed, 6in to 30in masonry exposed
Fences/Decks: None or noncombustible
Firewood: None
Propane Tanks:
Water Supply: Pressurized hydrant(s) or fixed sprinkler system
Overhead Hazards: No overhead hazards
Safety Zones: Potential safety zone(s) in area
Additional Obstacles: Hazmat, UXO,etc. , PLEASE COMMENT
Triage Category:
Hazmat: Household hazmat
Assessment Comments:

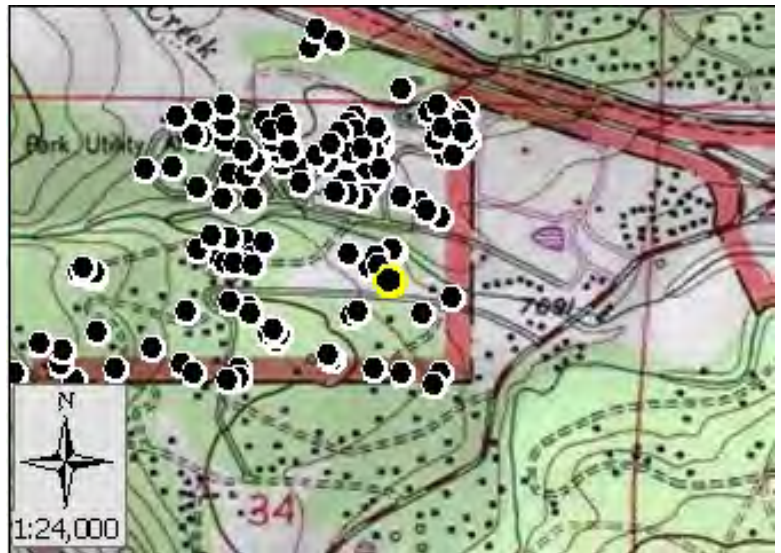
Hazmat: Sewage facility
Assessment Comments:

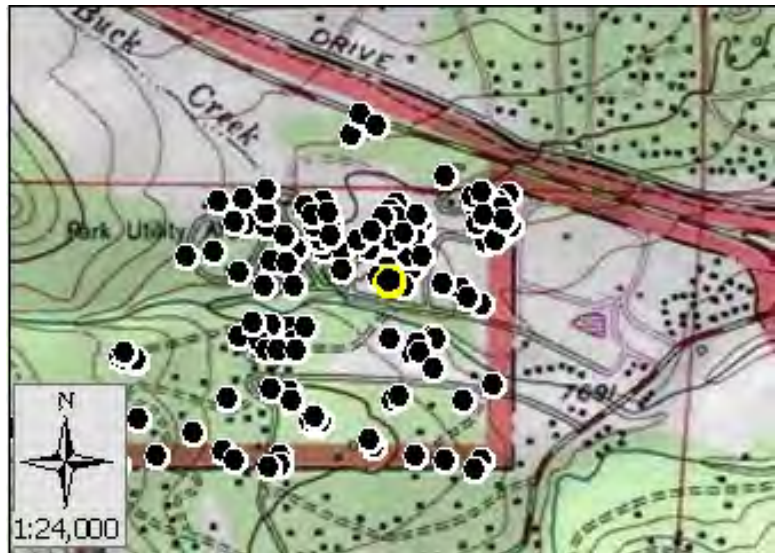
Primary Access: Road
Ingress/Egress: Two or more roads in/out
Access Width: 1.5 lanes (>18ft)
Access Condition: Surfaced-paved, grade<5%
Bridge Condition: None/nonflammable,load limit will not limit response
Access & Turnarounds: Access is <300 ft from facility w/turnaround
Facility Number/Sign: Marked and clearly visible
Defensible Space: >100ft treated
Fuel Load (w/in 300 ft): Light
Fuel Type (w/in 300ft): Grass,tundra,northern hardwood litter
Topography (w/in 300ft): Slope 5% to 20%
Roof Material: Noncombustible or not applicable
Siding Material: Wood or open sided
Foundation: Closed, 6in to 30in masonry exposed
Fences/Decks: None or noncombustible
Firewood: None
Propane Tanks:
Water Supply: Pressurized hydrant(s) or fixed sprinkler system
Overhead Hazards: No overhead hazards
Safety Zones: Potential safety zone(s) in area
Additional Obstacles: Hazmat, UXO,etc. , PLEASE COMMENT
Triage Category:
Hazmat:
Assessment Comments: Historical artifacts stored in this building

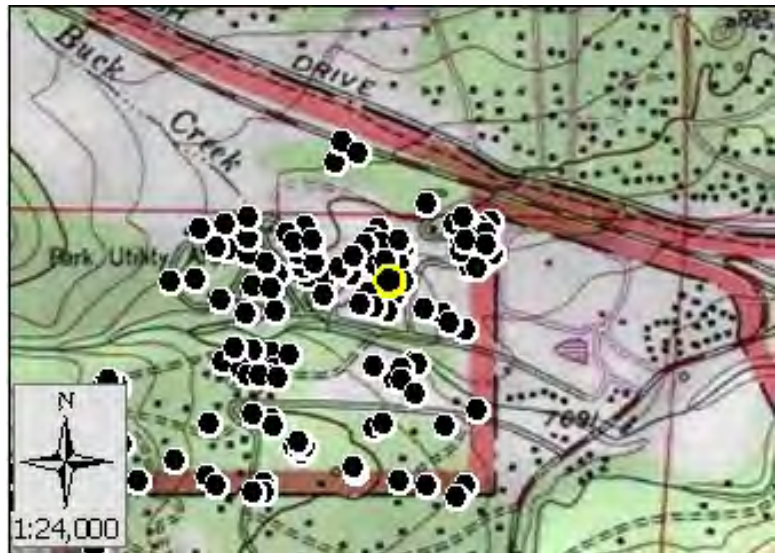
Primary Access: Road
Ingress/Egress: Two or more roads in/out
Access Width: 1.5 lanes (>18ft)
Access Condition: Surfaced-paved, grade<5%
Bridge Condition: None/nonflammable,load limit will not limit response
Access & Turnarounds: Access is <300 ft from facility w/turnaround
Facility Number/Sign: Marked and clearly visible
Defensible Space: >100ft treated
Fuel Load (w/in 300 ft): Light
Fuel Type (w/in 300ft): Grass,tundra,northern hardwood litter
Topography (w/in 300ft): Slope <5%
Roof Material: Combustible or no roof
Siding Material: Wood or open sided
Foundation: Closed, < 6in masonry exposed
Fences/Decks: None or noncombustible
Firewood: None
Propane Tanks:
Water Supply: Pressurized hydrant(s) or fixed sprinkler system
Overhead Hazards: No overhead hazards
Safety Zones: Potential safety zone(s) in area
Additional Obstacles: Hazmat, UXO,etc. , PLEASE COMMENT
Triage Category:
Hazmat: Pesticide stored on site
Assessment Comments:

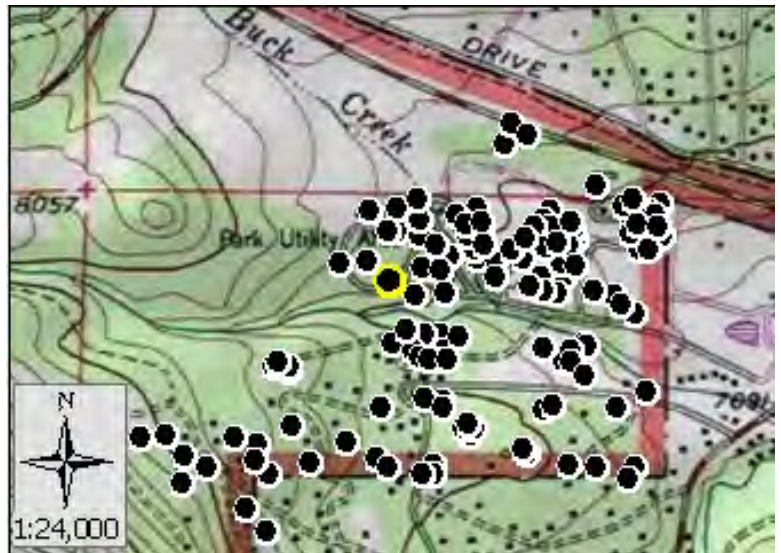
Primary Access: Road
Ingress/Egress: Two or more roads in/out
Access Width: 1.5 lanes (>18ft)
Access Condition: Surfaced-paved, grade<5%
Bridge Condition: None/nonflammable,load limit will not limit response
Access & Turnarounds: Access is <300 ft from facility w/turnaround
Facility Number/Sign: Marked and clearly visible
Defensible Space: >100ft treated
Fuel Load (w/in 300 ft): Light
Fuel Type (w/in 300ft): Shrub or timber
Topography (w/in 300ft): Slope 5% to 20%
Roof Material: Combustible or no roof
Siding Material: Wood or open sided
Foundation: Closed, 6in to 30in masonry exposed
Fences/Decks: None or noncombustible
Firewood: None
Propane Tanks:
Water Supply: Pressurized hydrant(s) or fixed sprinkler system
Overhead Hazards: No overhead hazards
Safety Zones: Potential safety zone(s) in area
Additional Obstacles: Hazmat, UXO,etc. , PLEASE COMMENT
Triage Category:
Hazmat: Propane grill
Assessment Comments:

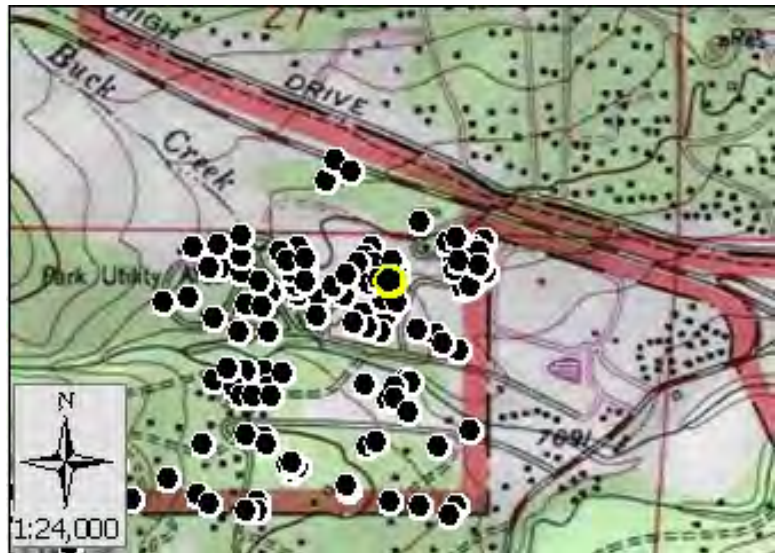
Primary Access: Road
Ingress/Egress: Two or more roads in/out
Access Width: 1.5 lanes (>18ft)
Access Condition: Surfaced-paved, grade<5%
Bridge Condition: None/nonflammable,load limit will not limit response
Access & Turnarounds: Access is <300 ft from facility w/turnaround
Facility Number/Sign: Marked and clearly visible
Defensible Space: >100ft treated
Fuel Load (w/in 300 ft): Light
Fuel Type (w/in 300ft): Grass,tundra,northern hardwood litter
Topography (w/in 300ft): Slope <5%
Roof Material: Combustible or no roof
Siding Material: Wood or open sided
Foundation: Closed, 6in to 30in masonry exposed
Fences/Decks: None or noncombustible
Firewood: None
Propane Tanks:
Water Supply: Pressurized hydrant(s) or fixed sprinkler system
Overhead Hazards: No overhead hazards
Safety Zones: Potential safety zone(s) in area
Additional Obstacles: Hazmat, UXO,etc. , PLEASE COMMENT
Triage Category:
Hazmat: Tires
Assessment Comments:

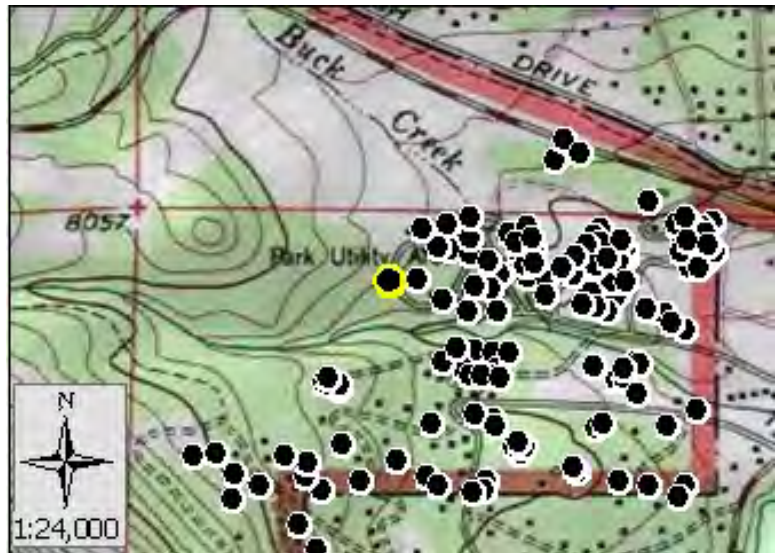
Primary Access: Road
Ingress/Egress: Two or more roads in/out
Access Width: 1.5 lanes (>18ft)
Access Condition: Surfaced-paved, grade<5%
Bridge Condition: None/nonflammable,load limit will not limit response
Access & Turnarounds: Access is <300 ft from facility w/turnaround
Facility Number/Sign: Marked and clearly visible
Defensible Space: >100ft treated
Fuel Load (w/in 300 ft): Moderate
Fuel Type (w/in 300ft): Shrub or timber
Topography (w/in 300ft): Slope 5% to 20%
Roof Material: Combination of fire resitant and combustible
Siding Material: Wood or open sided
Foundation: Open or deck
Fences/Decks: None or noncombustible
Firewood: None
Propane Tanks:
Water Supply: Pressurized hydrant(s) or fixed sprinkler system
Overhead Hazards: No overhead hazards
Safety Zones: Potential safety zone(s) in area
Additional Obstacles: Hazmat, UXO,etc. , PLEASE COMMENT
Triage Category:
Hazmat: Propane grill
Assessment Comments:

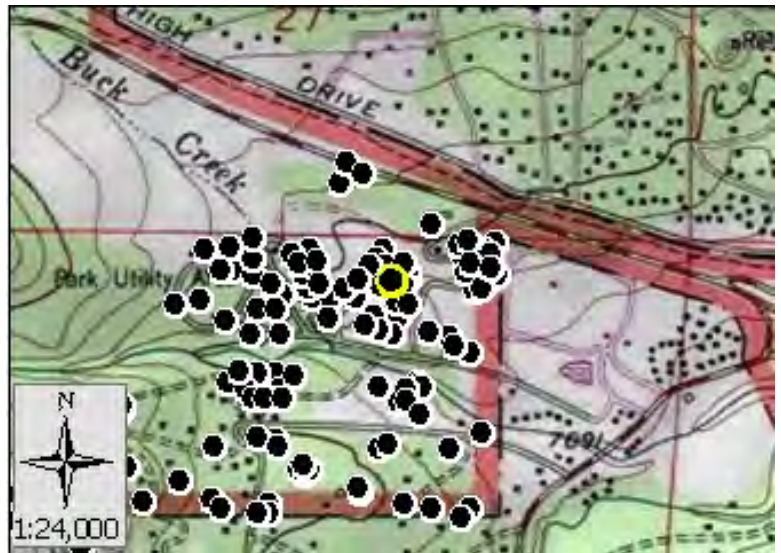
Assessment Comments: This building is not very susceptible to wildfire, but it is critical to keep fire out of it due to the amount of hazmat in it.
