NPS Wildland Fire Risk Assessment - Community Assessment

Community: Longs Peak
Unit - Location: ROMO - Longs Peak
Field Crew: Dave Frey
Last Site Visit Date:

NPS Wildand Fire Risk Assessment - **Community Assessment**

NPS Wildand Fire Risk Assessment - Facility Assessment

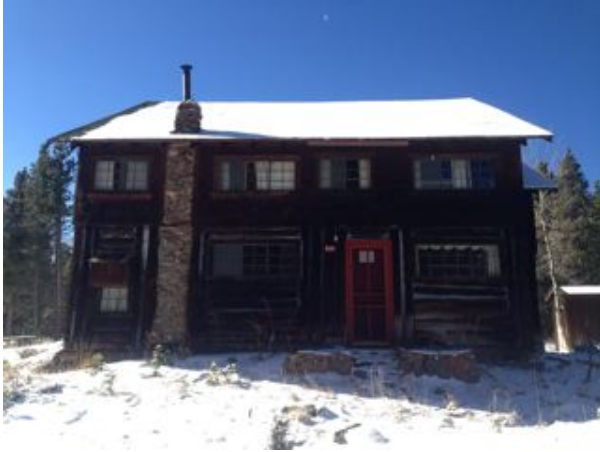
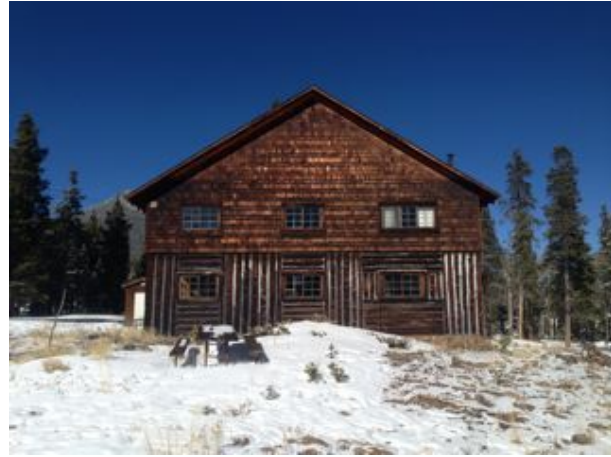
2014_ROMO_23692_B-0836-H Leiffer Cabin - old_x.jpg

Assessment Comments: The Lieffer cabins are historic buildings located near the Longs Peak road. They are located approximately half a mile off of Hwy 7 along an unmarked road between parcels of private property. The area is surrounded by closed canopy lodgepole forest. There is defensible space around the cabins and an air monitoring station is nearby in a meadow. Near the cabins there is an unknown tower and related equipment that is surrounded by forest. It does not show up in the structure database, but needs to be protected.

Triage Category	Tactic Description	Pers Hours	Equipment Description	Equip Qty
	Fuels reduction - Initial attack in the area of the Lieffer cabins is the same as most of the park. Two type six engines and a helicopter responding to a new start would be able contain the fire before it spreads to the surrounding area.	72.00	Engine/OtherVehicle-Wildland Light Engine, Type 6 or 7, EA	2
	Other, please describe. - Evacuations and public safety	200.00	-	
	Helicopter bucket drops - Initial attack in the area of the Lieffer cabins is the same as most of the park. Two type six engines and a helicopter responding to a new start would be able contain the fire before it spreads to the surrounding area.	8.00	-

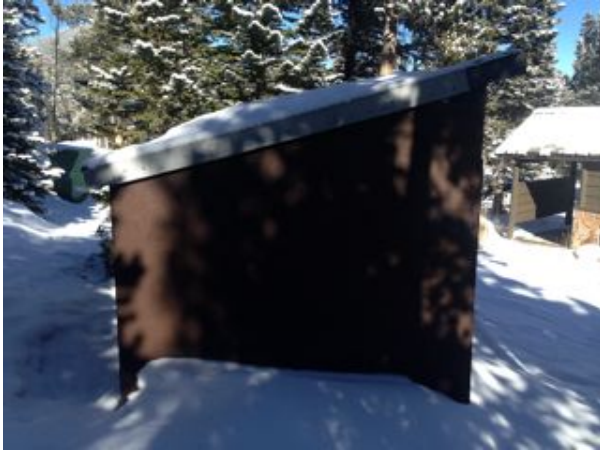
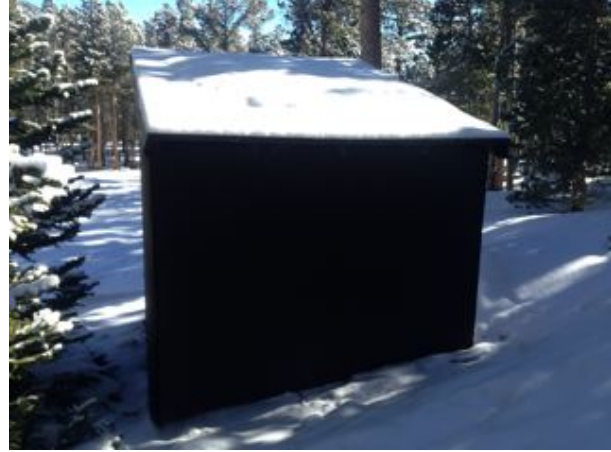
2014_ROMO_23746_B-1058-N Vault Toilet Longs Peak Campground_x.jpg

Triage Category	Tactic Description	Pers Hours	Equipment Description	Equip Qty
	- The vault toilet in the Longs Peak campground is made primarily from non-flammable materials and has concrete all the way around the foundation. It is surrounded by a closed canopy lodgepole forest. The area has no safety zones for fire fighter safety.	0.00	-

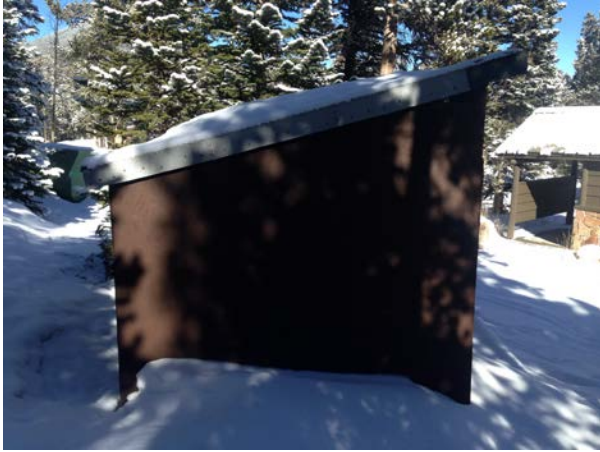
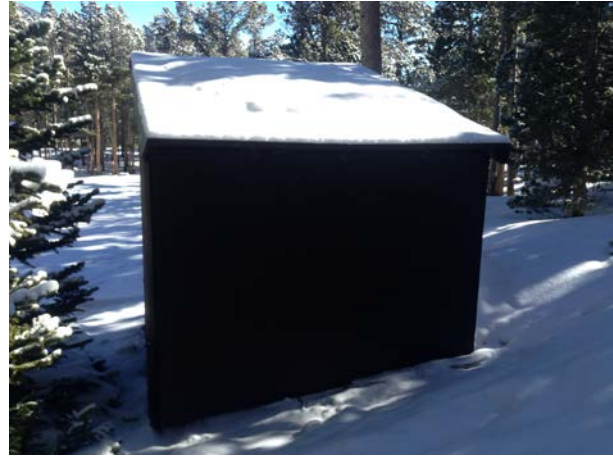
2014_ROMO__FIREWOOD STORAGE_x.jpg

Triage Category	Tactic Description	Pers Hours	Equipment Description	Equip Qty
	- The firewood storage shed in the Longs Peak campground is a non-defensible building. It is made from flammable materials, there is no foundation, and it is surrounded by closed canopy lodgepole forest. There are no safety zones to provide for fire fighter safety.	0.00	-
